## Manh Choh Mine Field Inspection Report

<b>Inspection Date:</b>	September 16, 2024
<b>Time:</b>	8:55M to 11:40AM
<b>Weather:</b>	10,000 foot ceiling of overcast clouds with steady winds of 6 knots. The average temperature was 41°F.
<b>Agency Personnel:</b>	DNR: William Groom, Carolyn Curley, and Jesse White
<b>Operator Contact:</b>	Peak Gold: Paige Lambert
<b>Inspection Objectives:</b>	Site Inspection

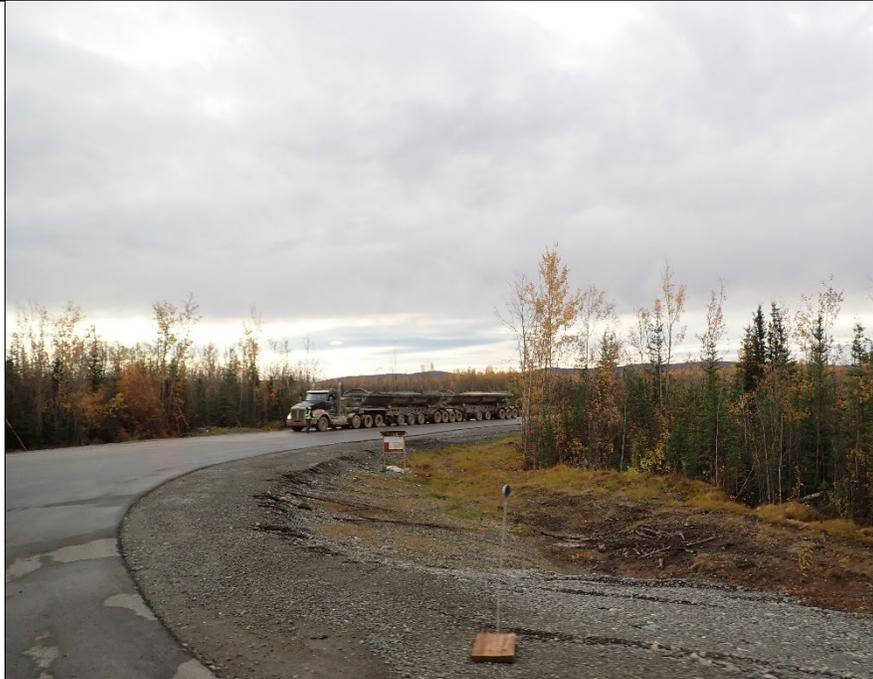
Photo 1: Access Road

The company extended the asphalt apron 500 feet to the cattle guards (Photo 1). Additional cattle guards are scheduled to be installed. Agency personnel observed the activities at the driver changeout pad (Photo 2). Berms have been built along sections of the road (Photo 3). Areas along the road noted during DNR's June 13<sup>th</sup>, 2024 inspection have been addressed with appropriate best management practices to prevent erosion (Photos 3 through 7).

The asphalt apron has been extended 500 feet on the access road at the intersection of access road and Alaska Highway.

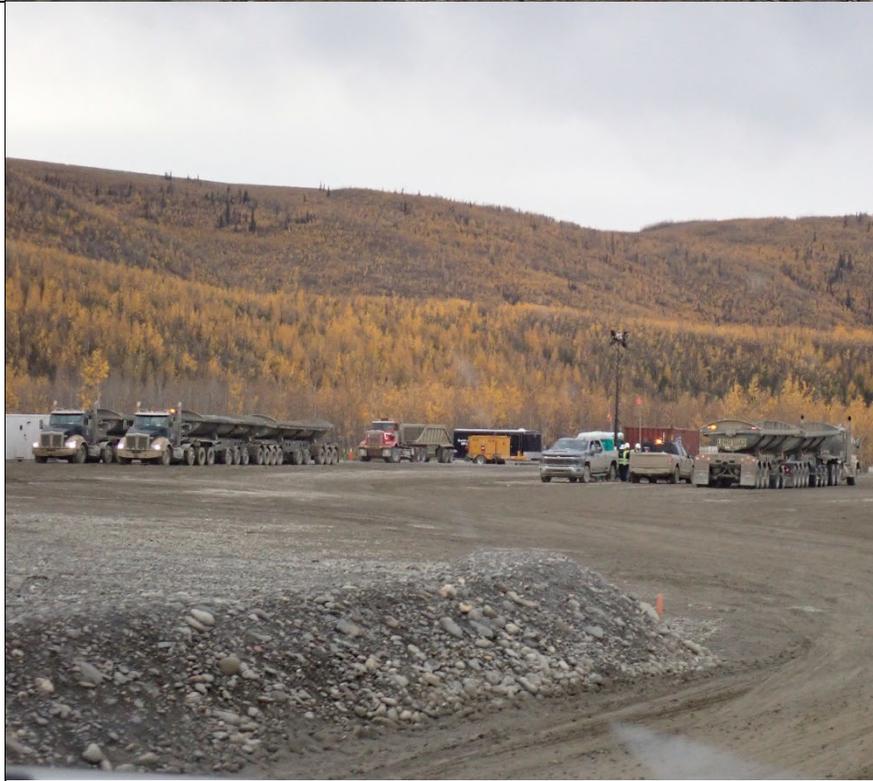
Photo 2: Access Road

Incoming and outgoing trucks were observed at the driver changeout pad. Questions were asked regarding the tarps covering the ore. The tarps are replaced on a regular basis or when damage is noted.

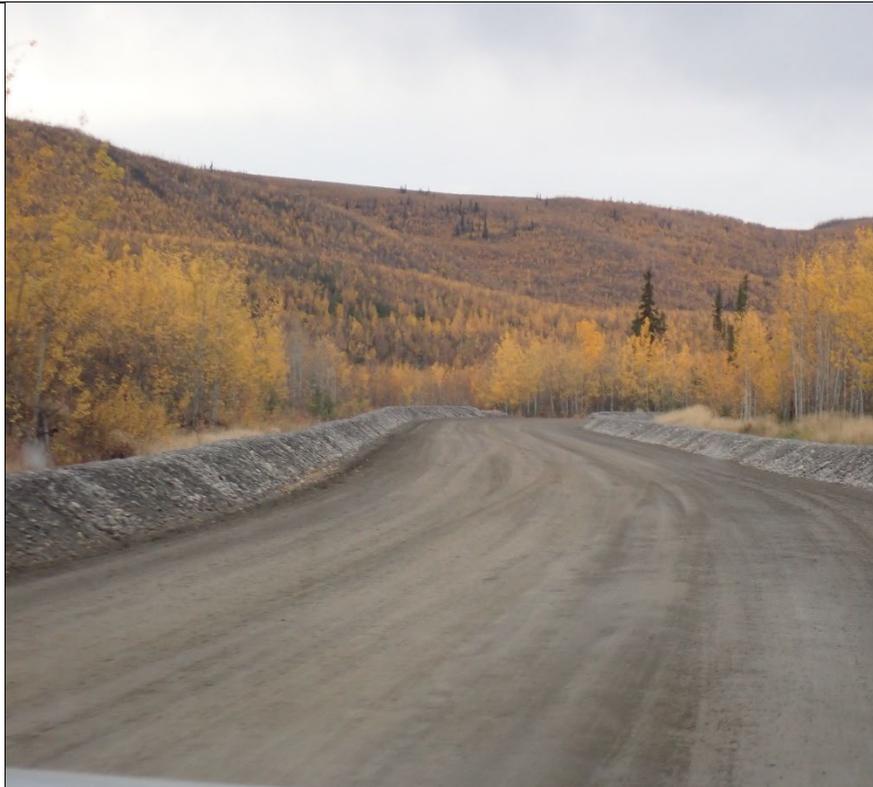
Photo 3: Access Road

Berms have been placed along sections of the access road, conforming to MSHA requirements.

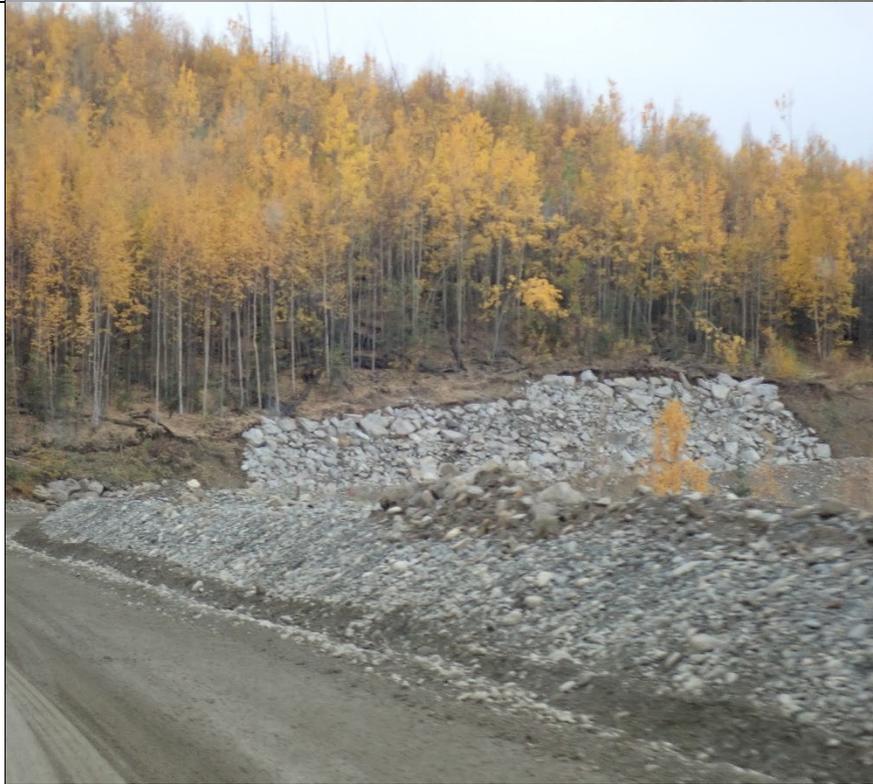
Photo 4: Access Road

Sections of the access road between Mile 8 and Mile 9 have been armored.

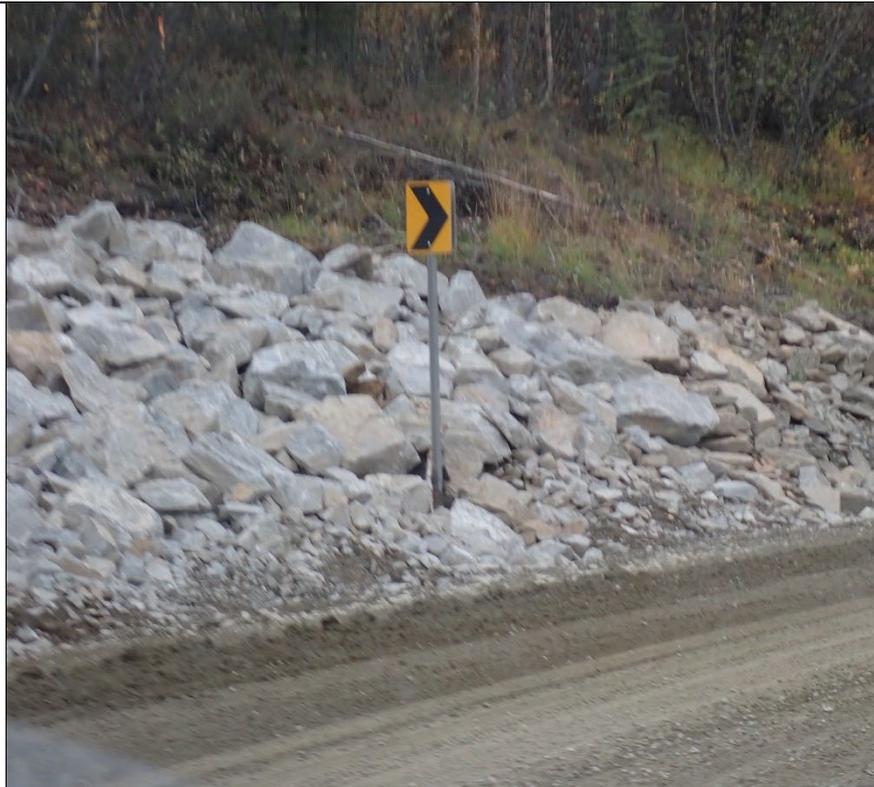
Photo 5: Access Road

Sections of the access road between Mile 8 and Mile 9 have been armored with rocks to prevent erosion.

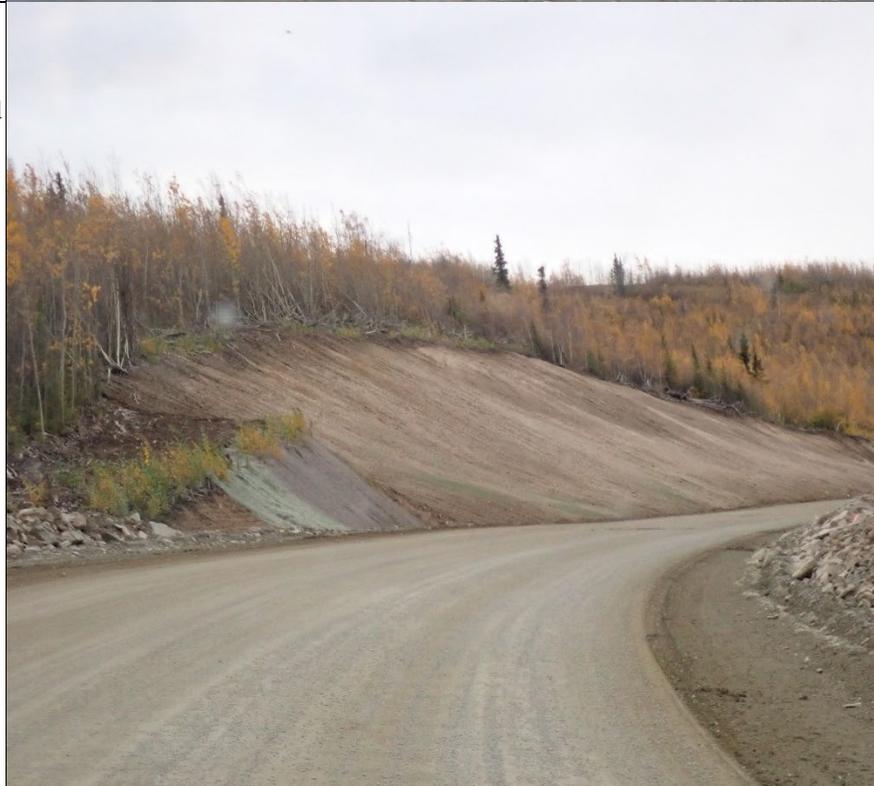
Photo 6: Access Road

The cut bank near MP 10 had previously been covered with jute matting to prevent erosion. This material has been removed and the bank regraded and seeded.

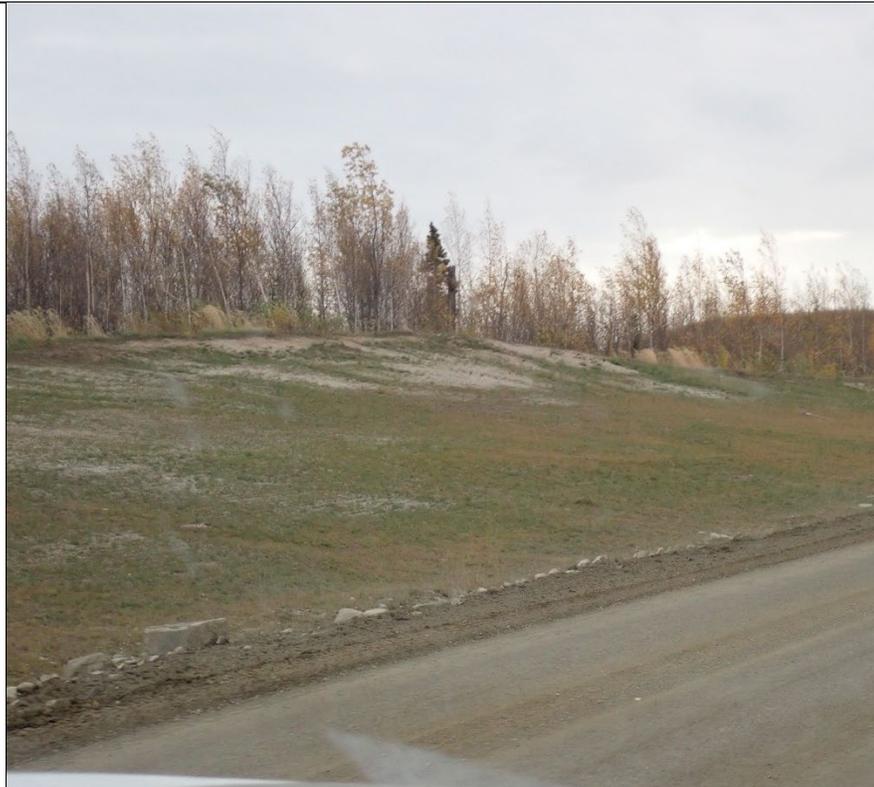
Photo 7: Access Road

Vegetation is growing on regraded sites.

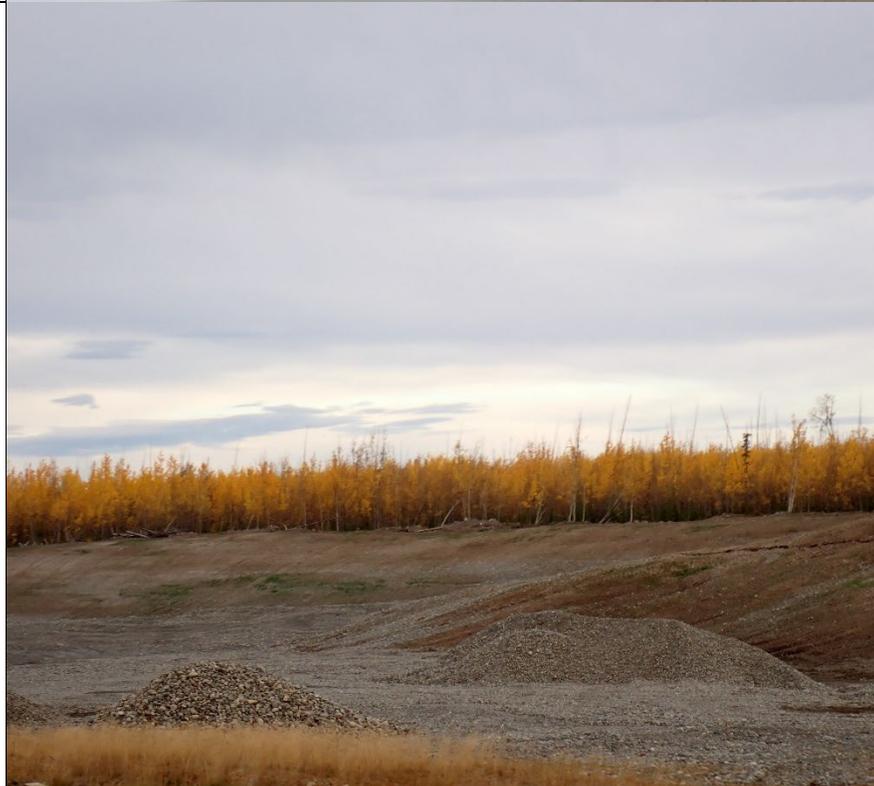
Photo 8: Material Sites

Material has been stockpiled for road maintenance and berm construction at various sites along the access road. A representative stockpile location was a gravel area near the driver changeout pad (Photo 8).

Gravel stockpiles for berm construction and road maintenance are readily available at this site near the driver changeout area.

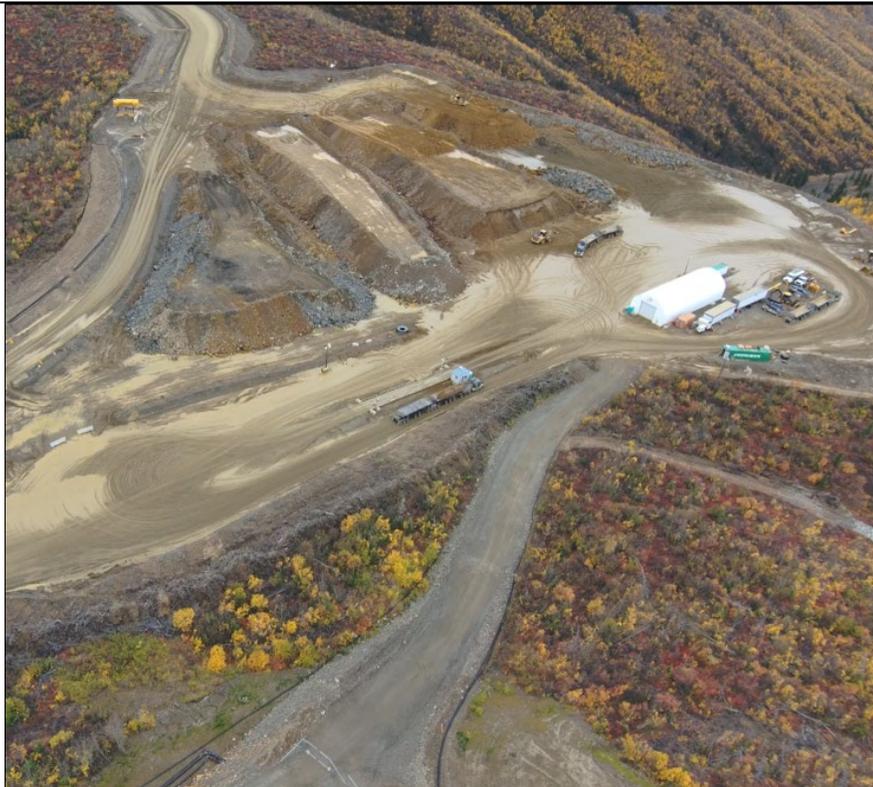
Photo 9: Ore Loadout Pad

Agency personal observed activities on the Ore Loadout Pad (Photo 9). Despite wet conditions, the site was maintained, and surface water was managed.

Activities and conditions were observed at the Ore Loadout Pad.

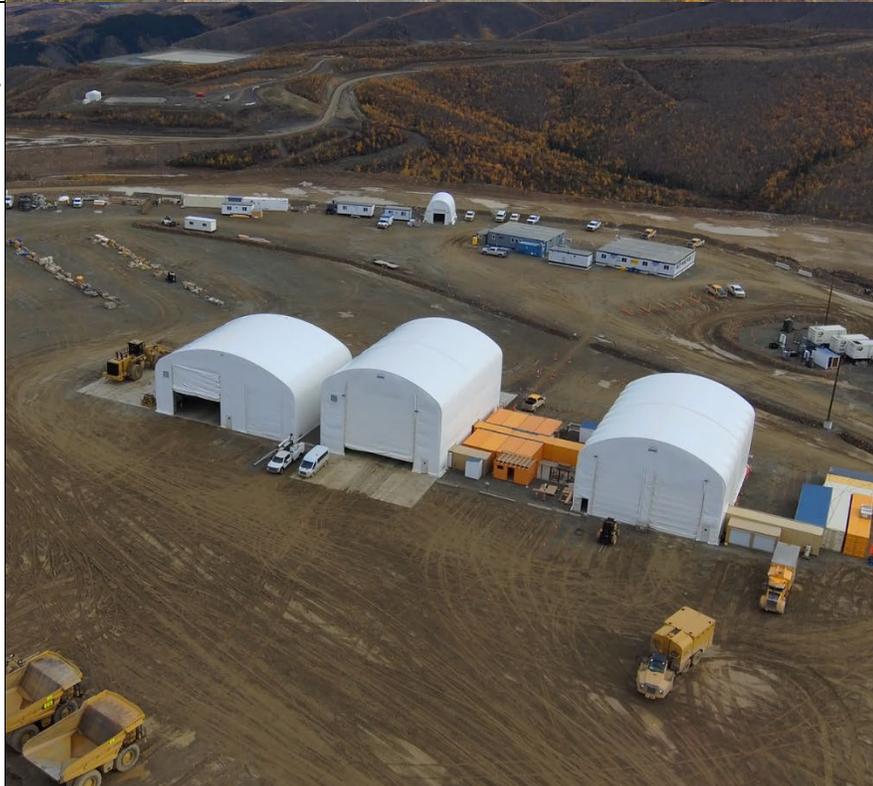
Photo 10: Infrastructure Pad

The site offices, warehouse, equipment maintenance, emergency services, generators, wash bay, and fuel depot are located on the Infrastructure Pad (Photo 10). The pad was neat, orderly, and free of debris.

Operations support activities are located on the Infrastructure Pad.

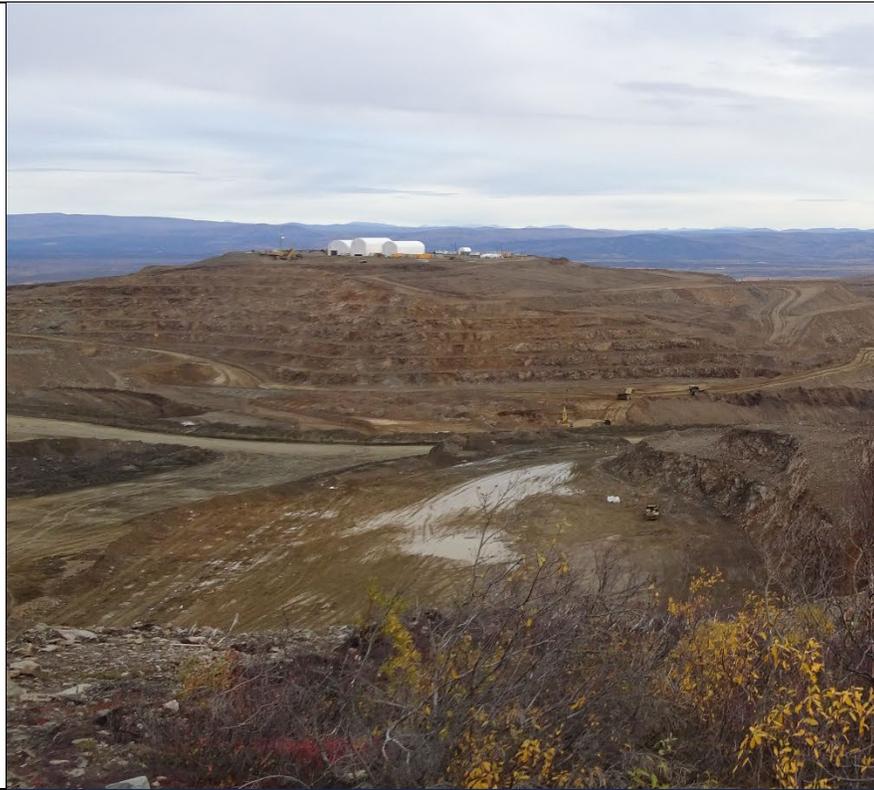
Photo 11: Pits

North Pit with infrastructure pad and NWRD.

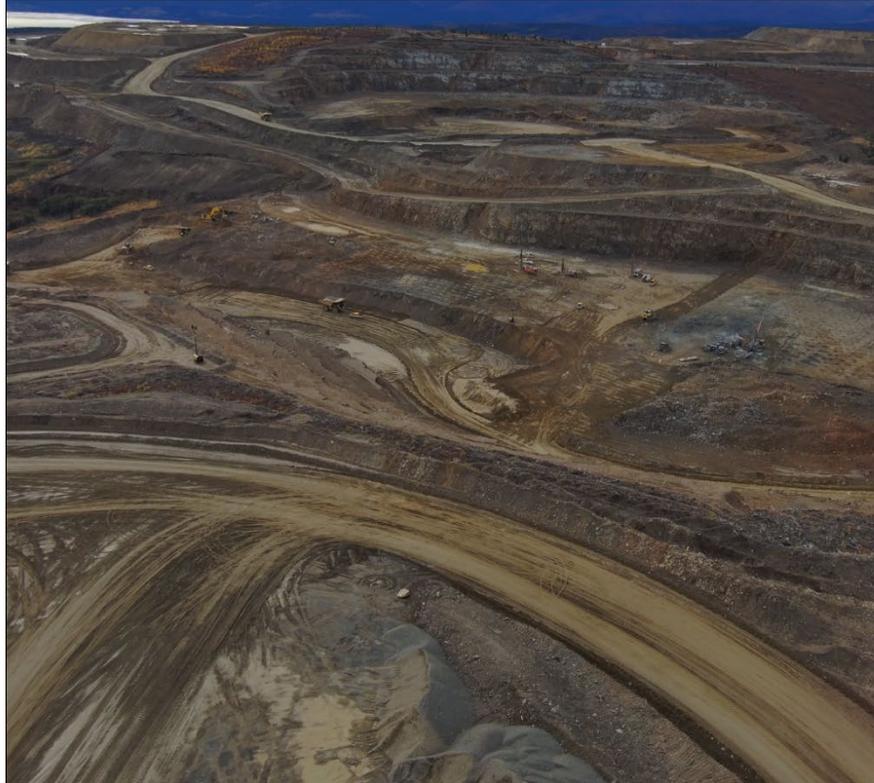
Photo 12: Pits

The North Pit (foreground) and South Pit (background) as viewed from drone flight over infrastructure pad.

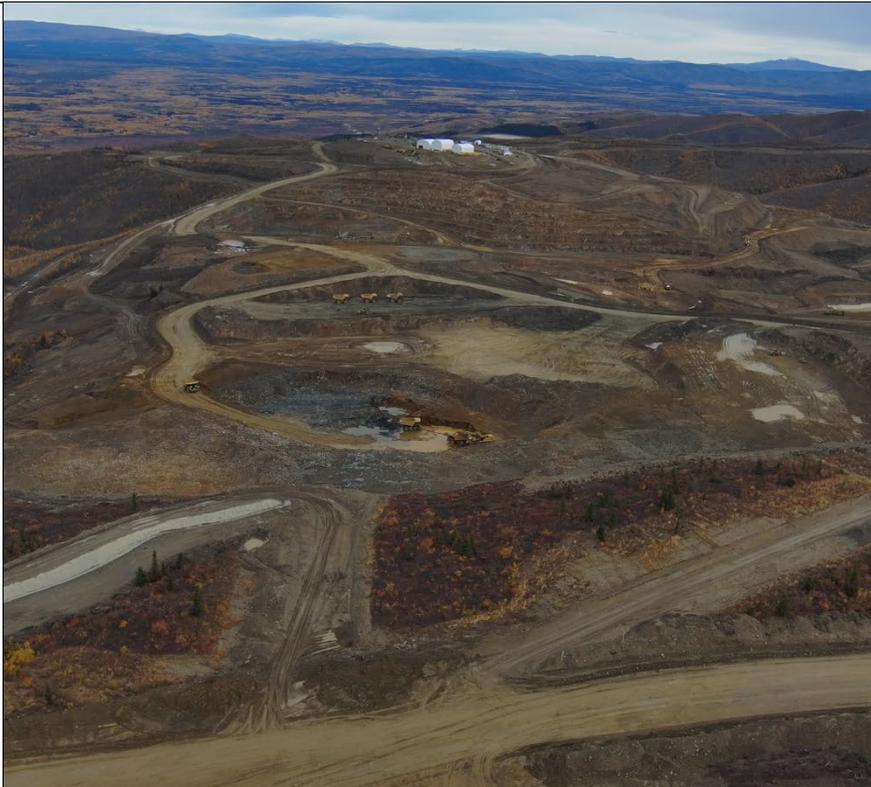
Photo 13: Pits

Activities in the South Pit as viewed via drone flight imaging.

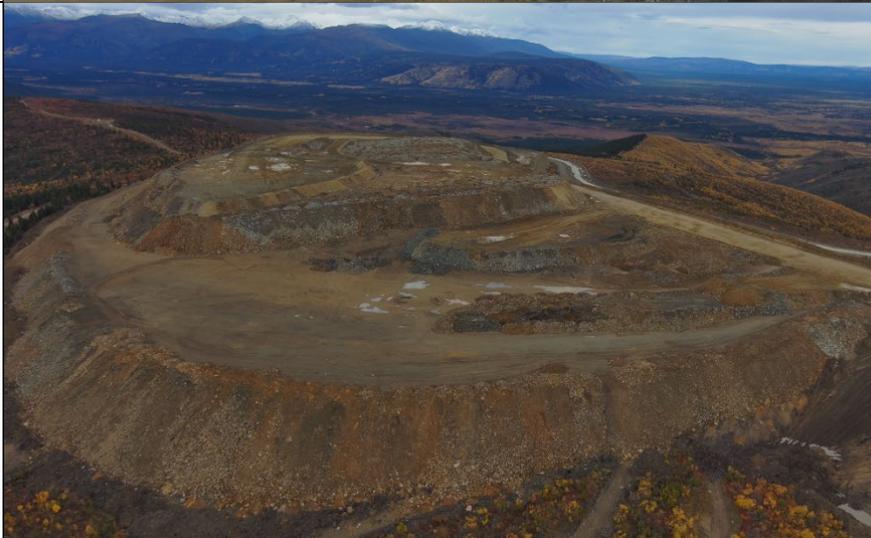
Photo 14: Dumps

South Waste Rock Dump with Wet & Dry stockpiles

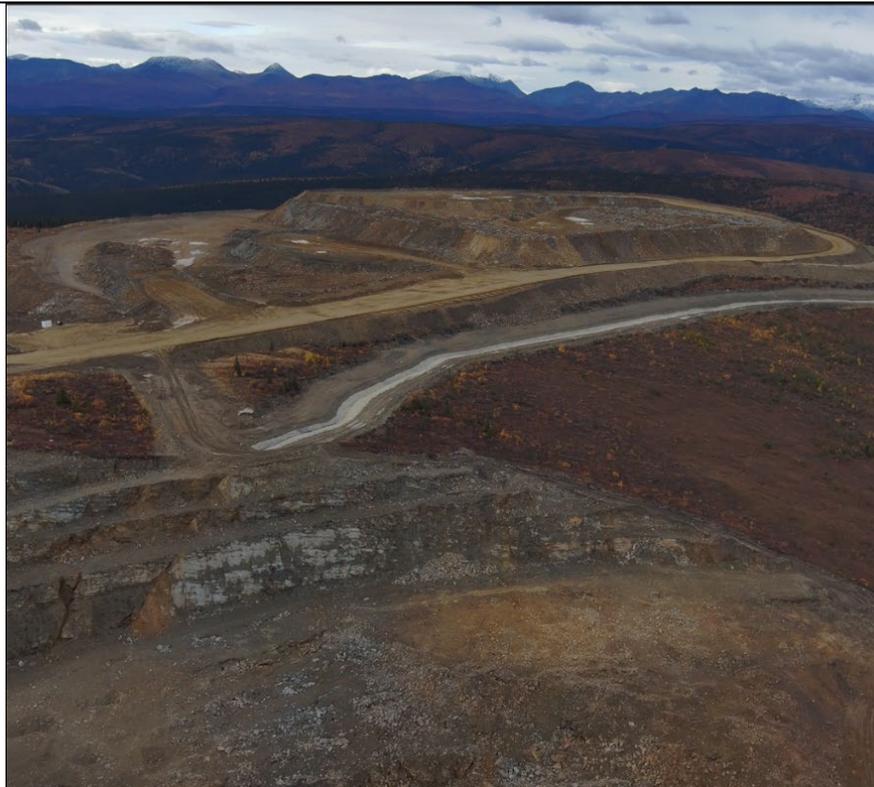
Photo 15: Dumps

South Waste Rock Dump as viewed from the north. The water diversion channel collects contact water from the dump and channels the flow to treatment facilities.

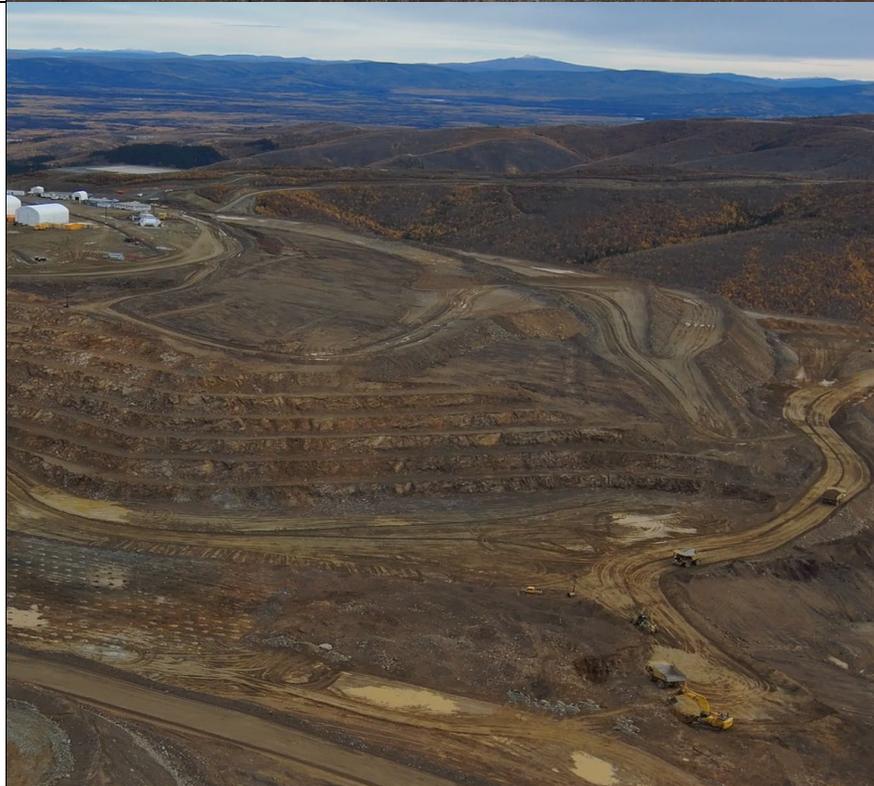
Photo 16: Dumps

North Waste Rock Dump as viewed looking north.

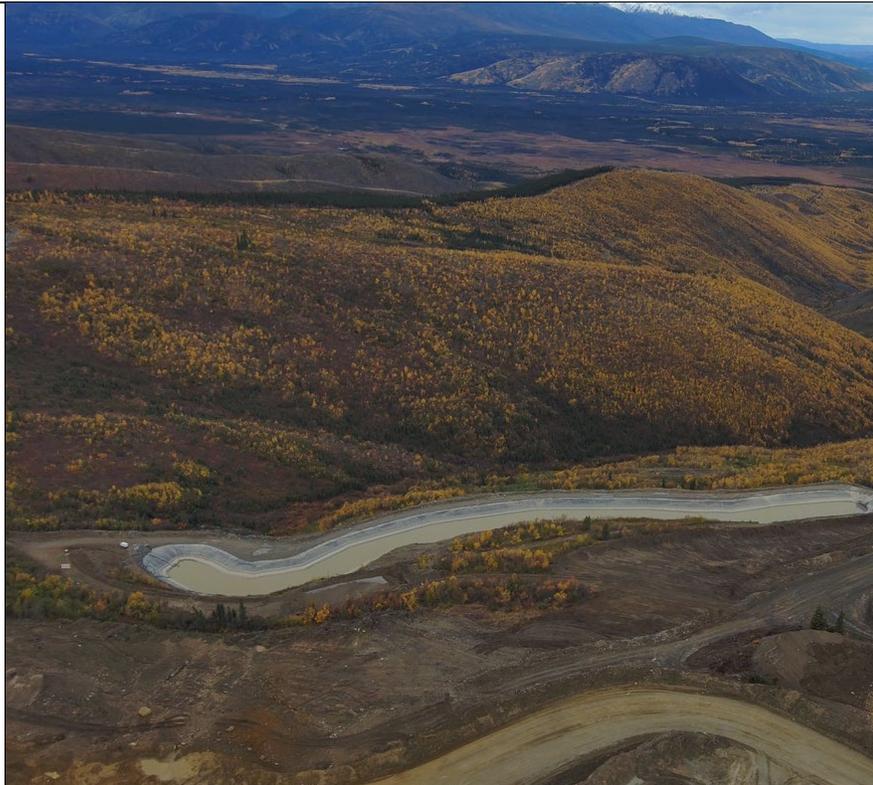
Photo 17: Ancillary Facilities

West retention basin for water management.

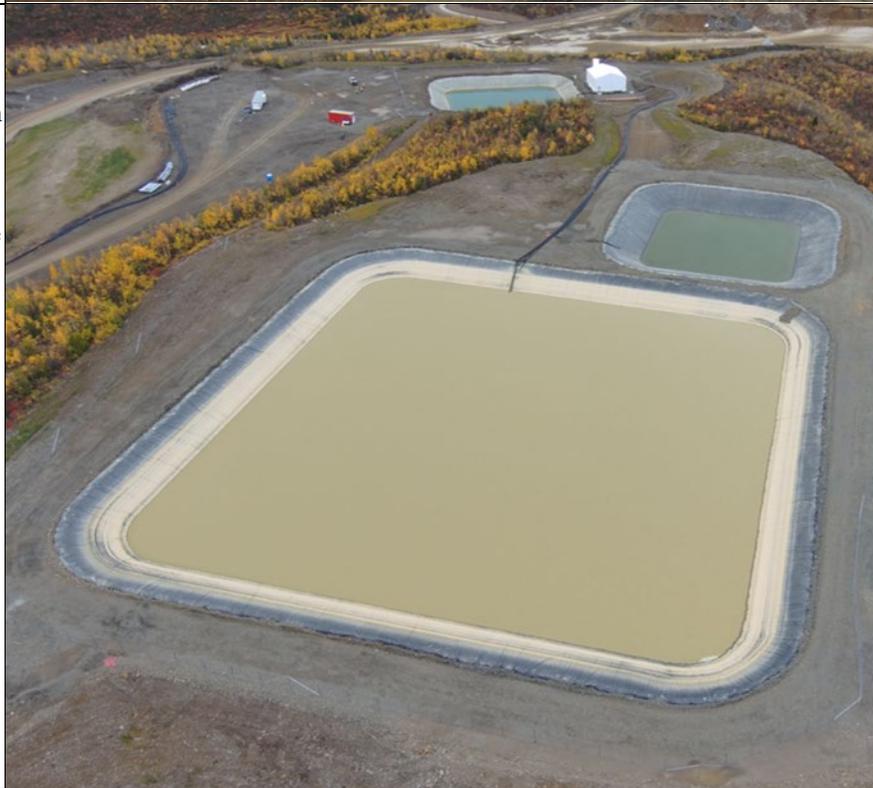
Photo 18: Ancillary Facilities

Water Treatment Ponds with the Untreated Water Pond in the foreground with the smaller Brine Pond. The Treated Water Pond is in the background by the RO facility.

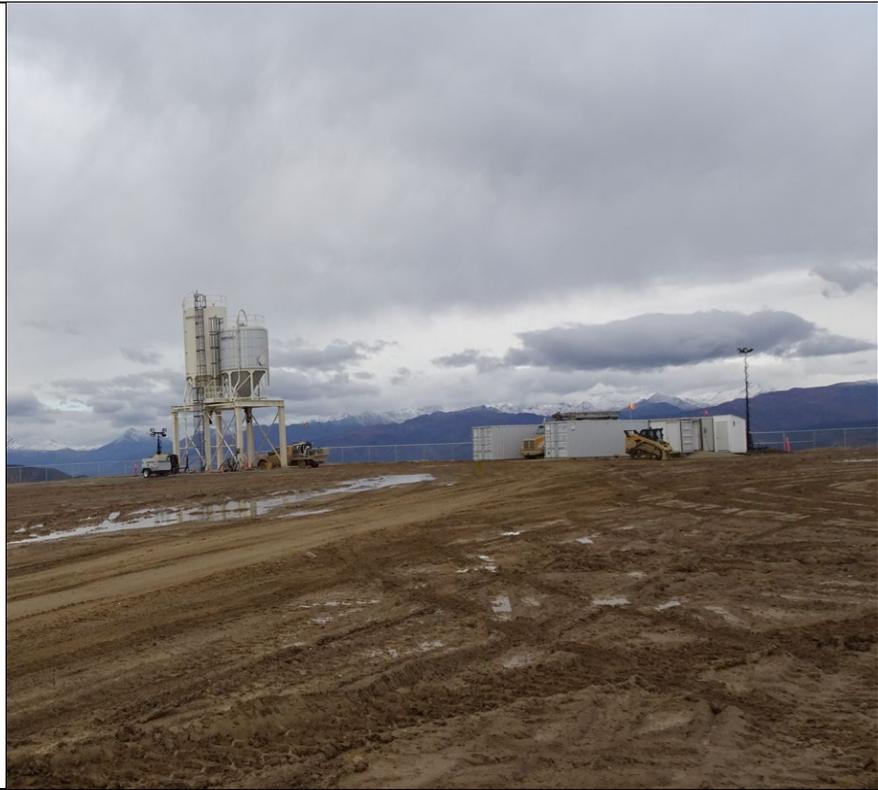
Photo 19: Ancillary  
Facilities

Explosives Pad
