Manh Choh Mine Field Inspection Report

Inspection Date:	June 25, 2025
Time:	9:00 AM to 1:00 PM
Weather:	Partly cloudy in the morning becoming overcast with broken clouds in the afternoon clearing later in the day. Slight breeze at lower elevations with winds reaching around 20mph higher up with an average temperature of 60°F.
DNR Personnel:	Aaron Kruse, William Groom, Ashley Adoko
DEC Personnel:	Trisha Bower, Laona DeWilde
Manh Choh Personnel:	Paige Lambert, Luke Walker
Inspection Objectives:	Site Inspection

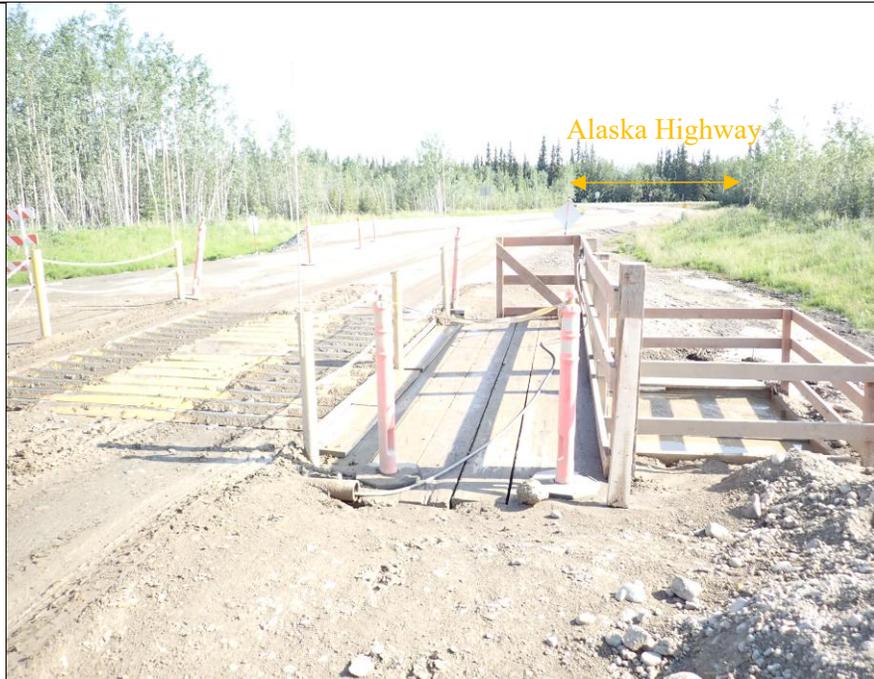
Photo 1: Cattleguard and paved apron prior to entering the Alaska Highway (north) used to control *sediment track out* onto the highway.

Just right of the cattleguard is the hand-washing station.

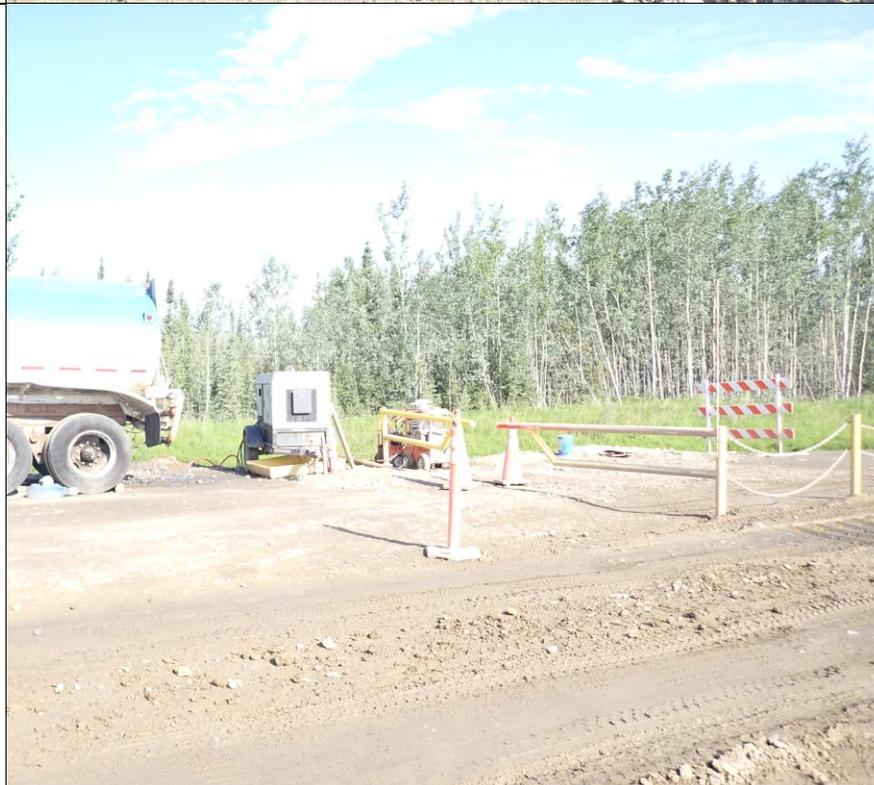
Photo 2: Water tanker and high-pressure washer located on the opposite side of the access road from the wash station.

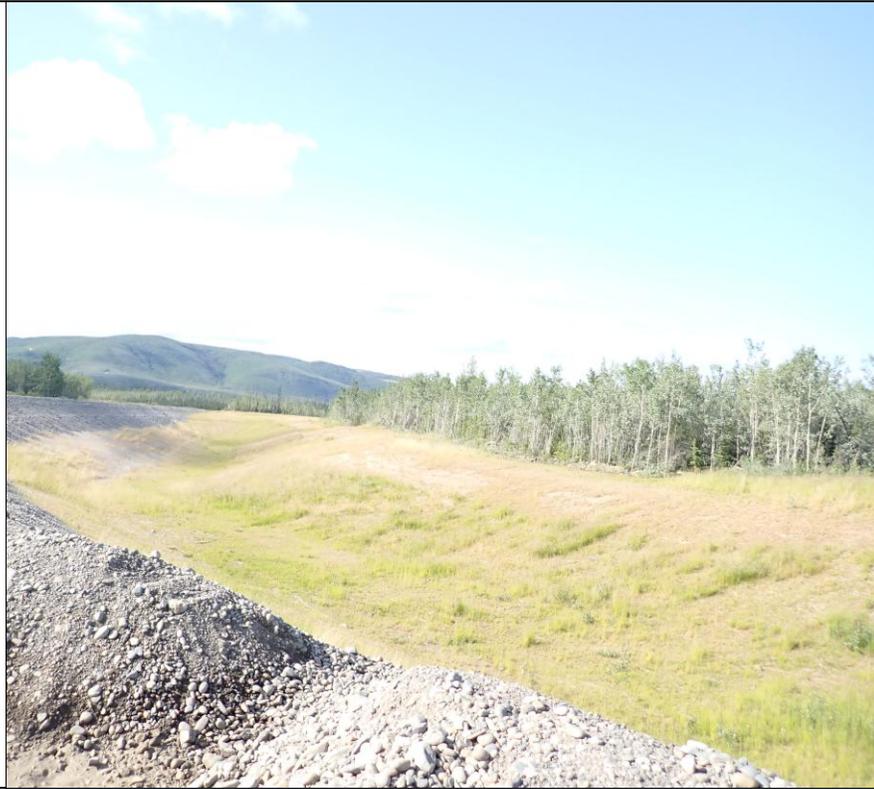
- The borrow sites at Mile Post (MP) 2.5 and 3.25 are inactive and have been reseeded multiple times before last fall. The area along the road was regraded and stabilized exhibiting about two years' worth of vegetative growth (Photos 3 and 4).

Photo 3: Sloped, contoured, and seeded inactive borrow pit at MP 2.5 exhibiting several years of vegetative growth.

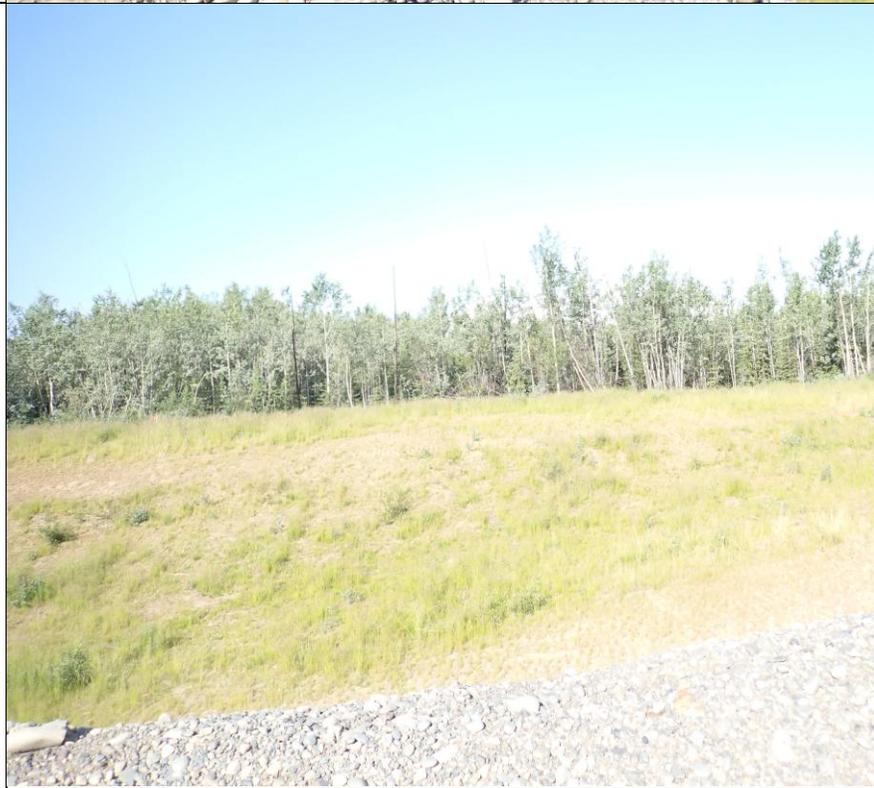
Photo 4: Sloped, contoured, and seeded inactive borrow pit at MP 3.25 exhibiting several years of vegetative growth.

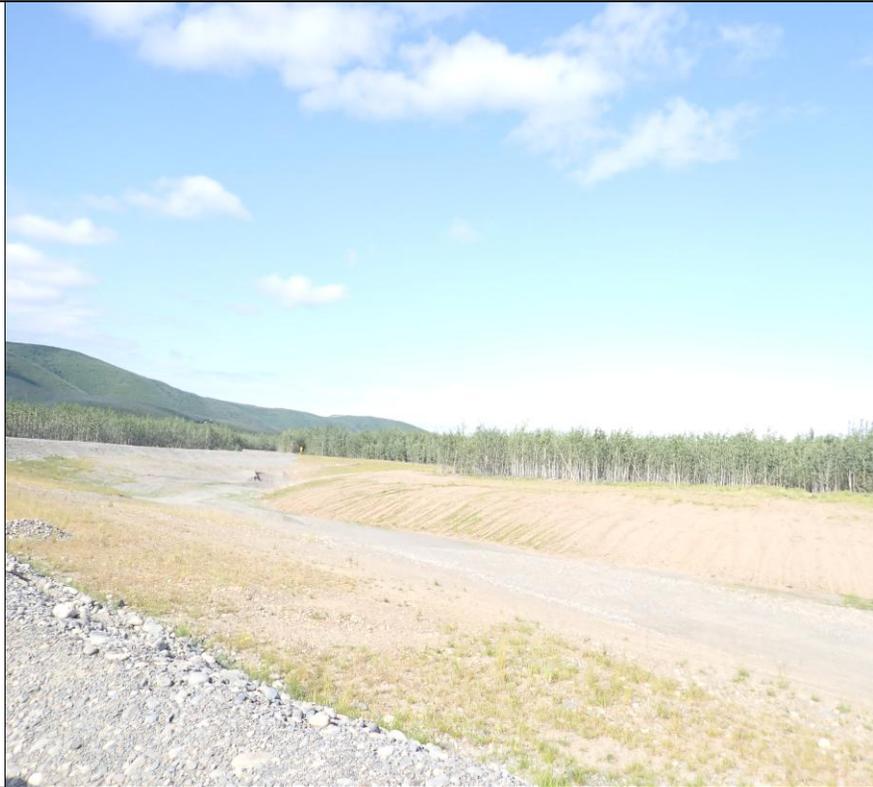
- The borrow site at MP 5 was active last year with material used to berm the access road and may continue to remain active. Topsoil was pushed back and piled for storage to later be used as cover material for reclamation (Photo 5).

Photo 5: Borrow site at MP 5 was active last year to provide material to berm the mine access road.

Topsoil was pushed to the back of the borrow site for storage to be used later as cover material for reclamation.

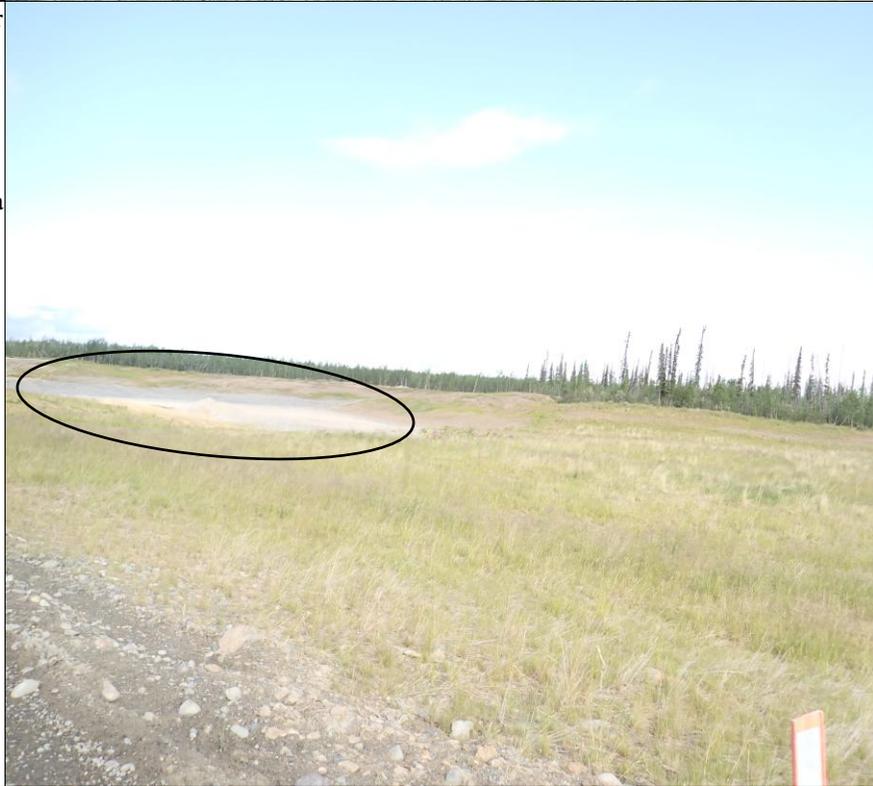
Photo 6: Most of the area for the borrow site at MP 7.2 has been reclaimed with several years of growth since seeding.

It still has a small active area for material removal (circled).

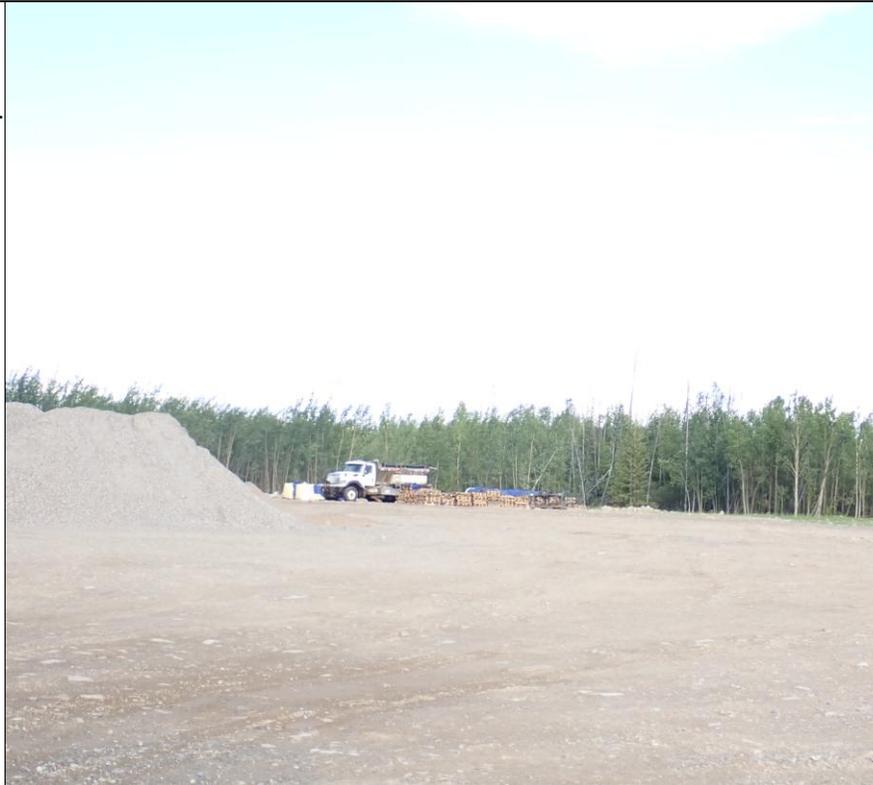
Photo 7: Within the southwest corner of the borrow site at MP 7.2 is a mine contractor staging area.

This area is also used for stockpiling aggregate road material.

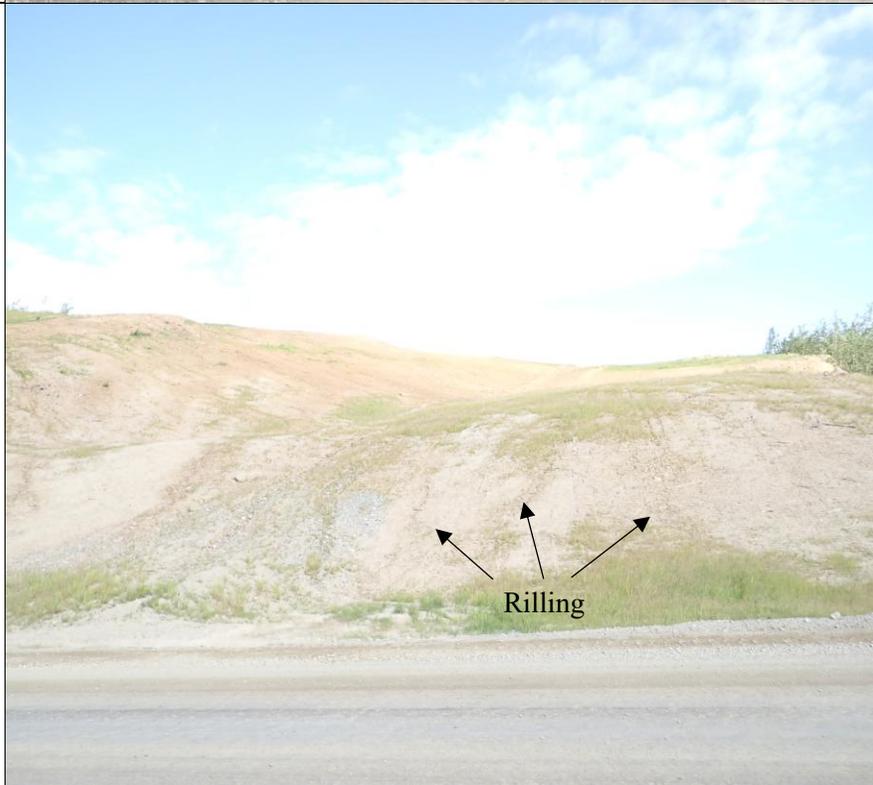
- The borrow site at MP 10 has had some issues with wind blowing seeds away through the saddle at its peak. An organic cover has been established along most of the slope face; however, some barren areas along the base of the slope had minor rilling (Photo 8).

Photo 8: Borrow site at MP 10 has been graded, contoured, and reseeded.

New growth and establishment of vegetation have been hindered by wind blowing seeds away.

Minor rilling is present, mostly at the lower end of the slope.

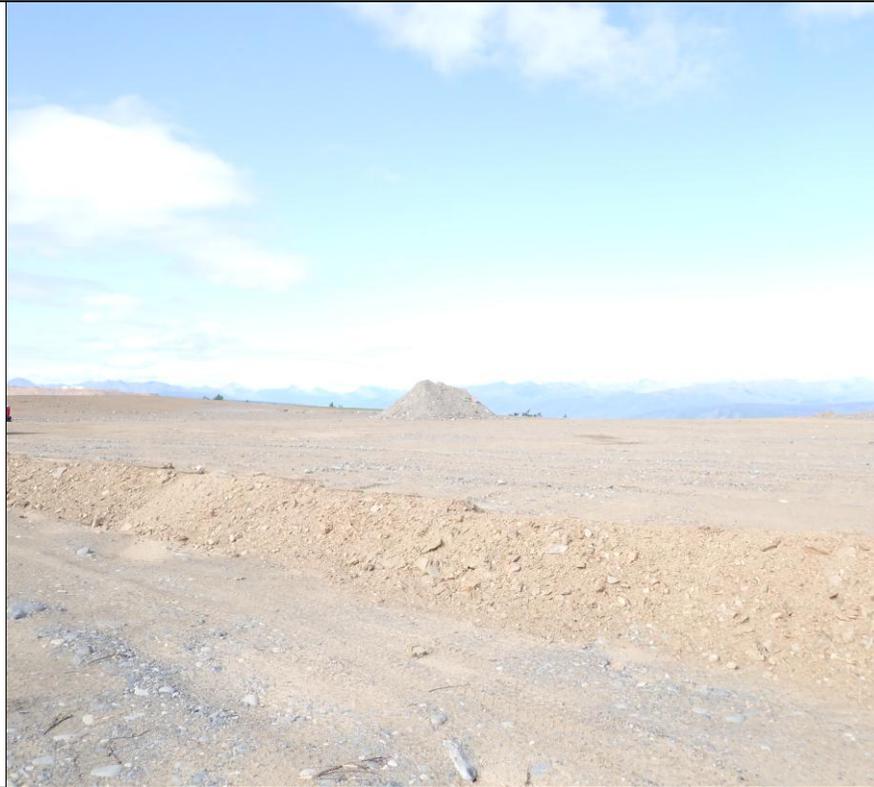
Photo 9: Borrow site at MP 12.8 has been expanded for use as a future laydown yard.

This area is still used for stockpiling aggregate material.

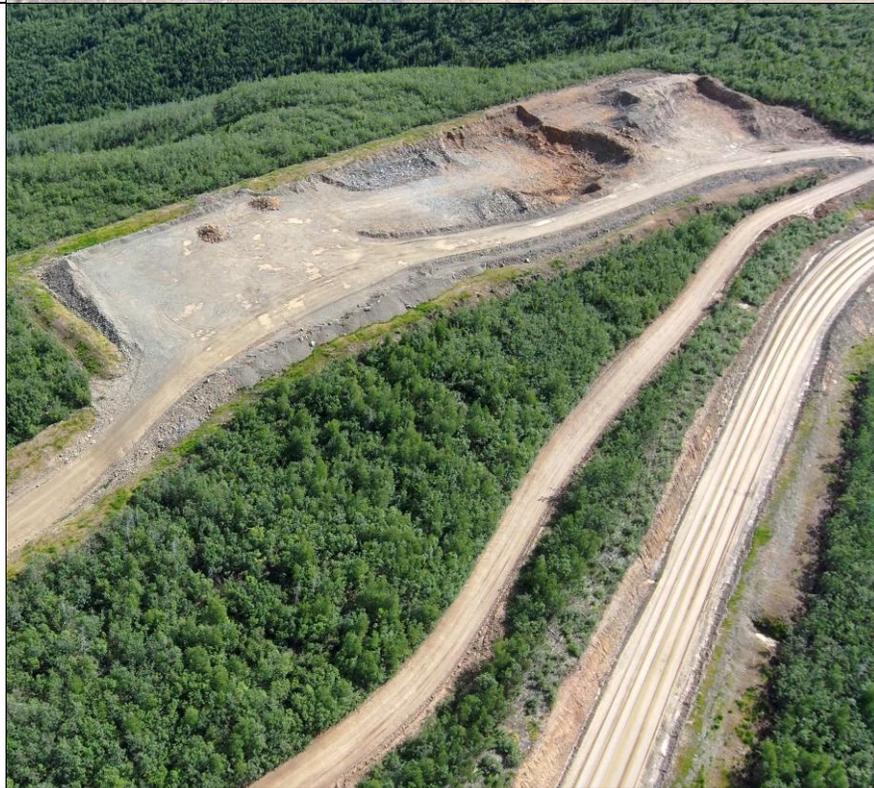
Photo 10: Material Site 1 is active and located near the ore loadout area at MP 14.5.

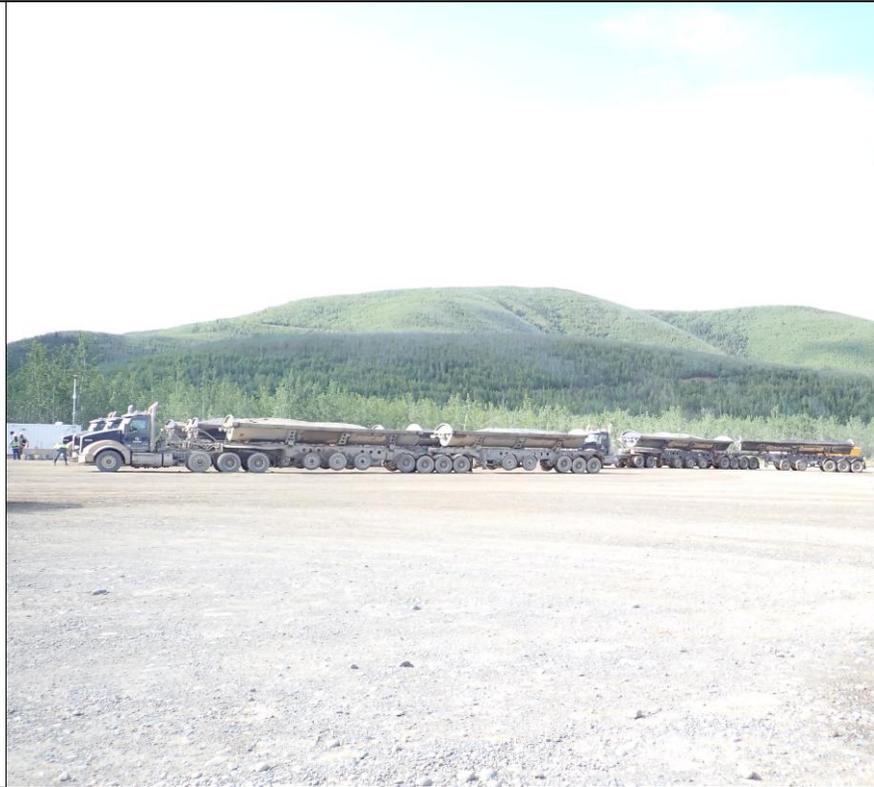
Photo 11: Truck change out yard between drivers from the mine to those who will truck the ore to Fort Knox for milling.

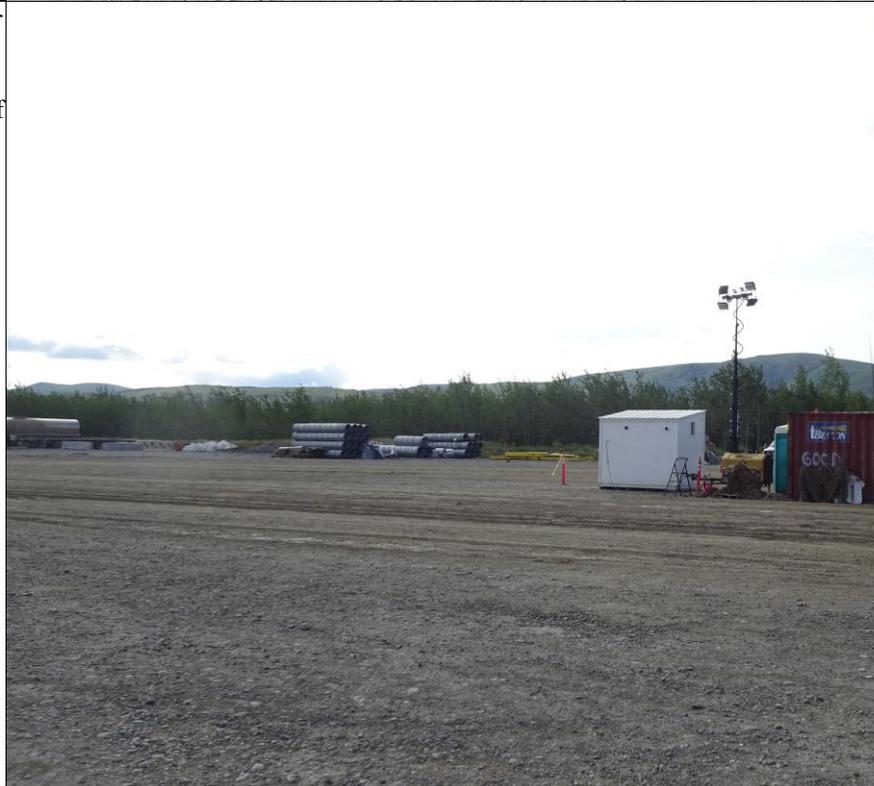
Photo 12: Culverts and other road building/maintenance material and equipment stored along the periphery of the truck change out yard.

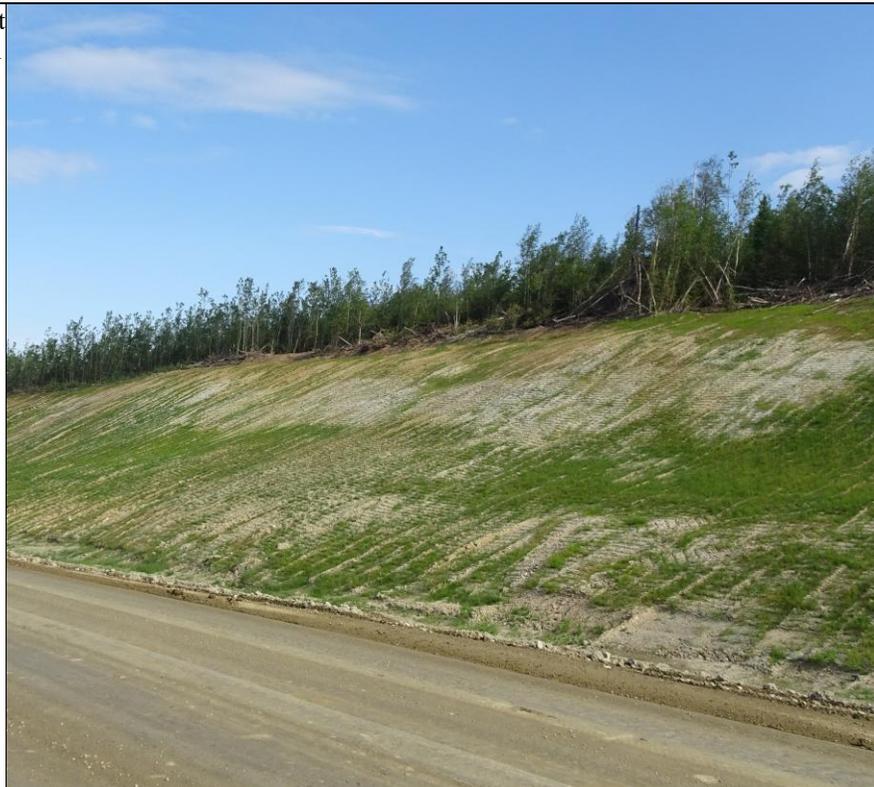
- 1.4. At milepost 9.5, there is a road cut that experienced excessive erosion that undercut the jute matting in the spring of 2024. DNR has monitored the BMPs Kinross has put in place to stabilize the area and prevent further degradation. Last year Kinross removed the jute matting, re-sloped the cut to an angle of repose, and seeded. Currently the slope is in stable condition with good vegetative growth across its surface. There are still some barren spots that will be hand seeded to provide better growth coverage and stability (Photo 13). The sloped cut on the opposite side of the road did not erode in the spring of 2024 and now has had two years of vegetative growth (Photo 14).

Photo 13: Stabilized road cut at MP 9.5 that was re-sloped and seeded after erosional issues from the previous year.

Hand seeding BMP's are proposed to fill in barren areas.

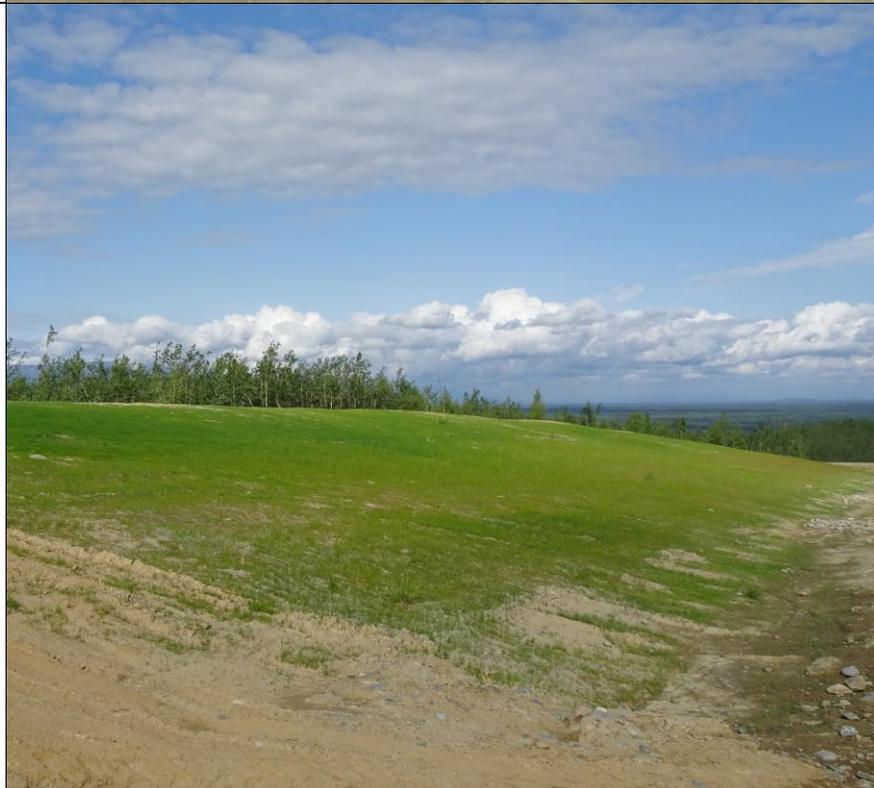
Photo 14: MP 9.5 road cut on the opposite side from photo 13 exhibiting about 2 years of vegetative growth.

No previous issues with soil instability.

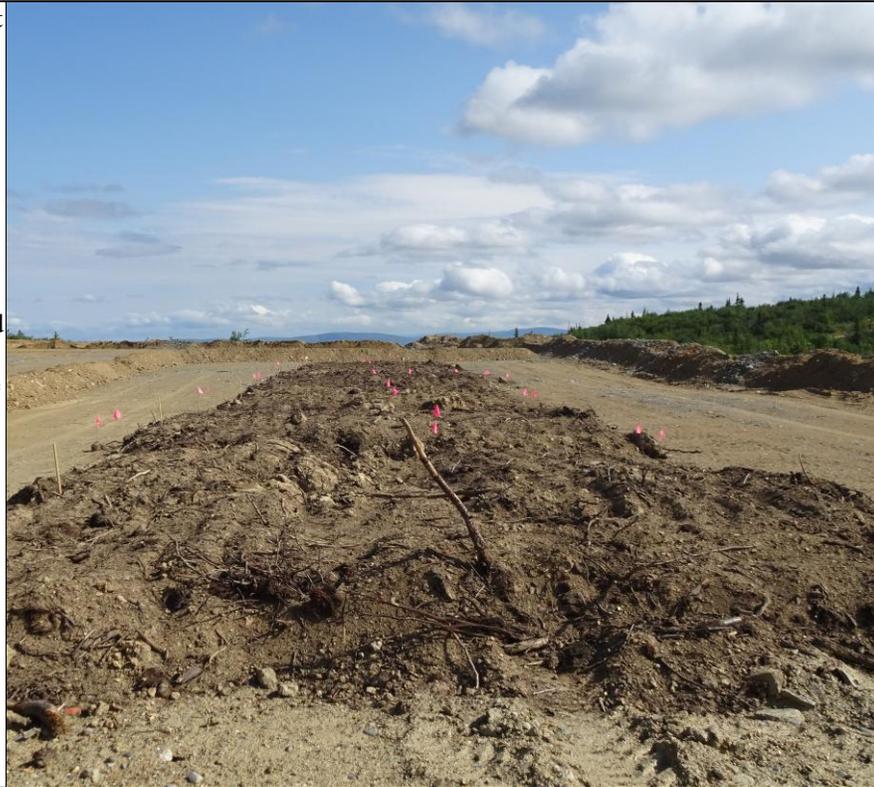
Photo 15: Growth media test plots are located within the eastern portion of the material site at MP 12.8.

Each plot has a consistent mix of organics, but vary in depth of topsoil placed over waste rock.

All test plots have controlled seeding, except one which will be allowed to germinate naturally.

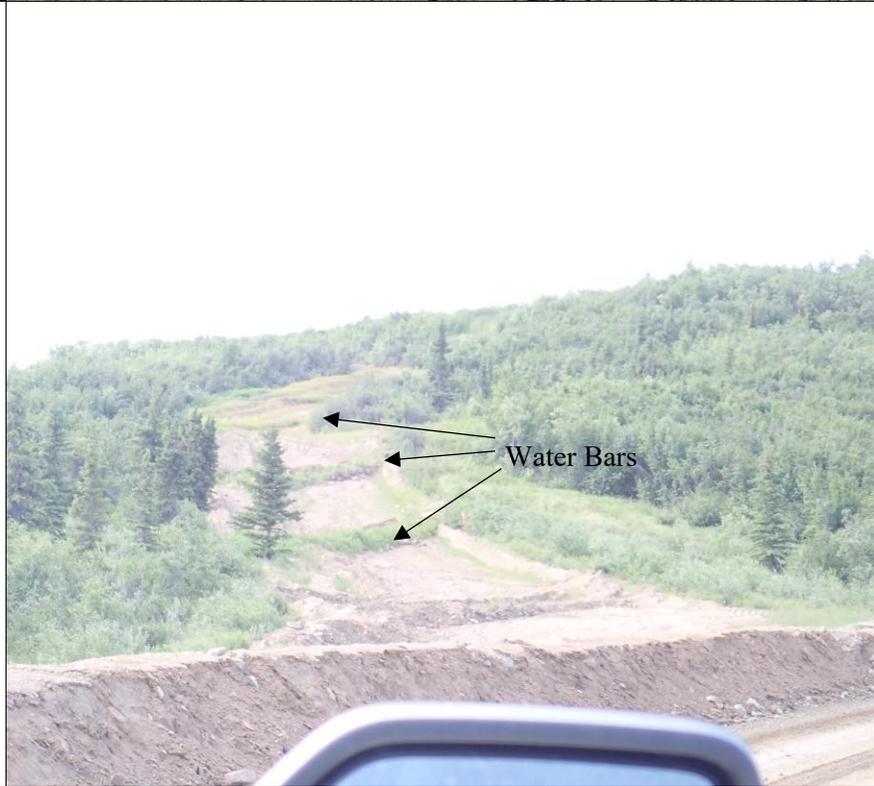
Photo 16: Reclamation of old road alignment. Water bars are in place to mitigate water runoff and aid in seed germination.

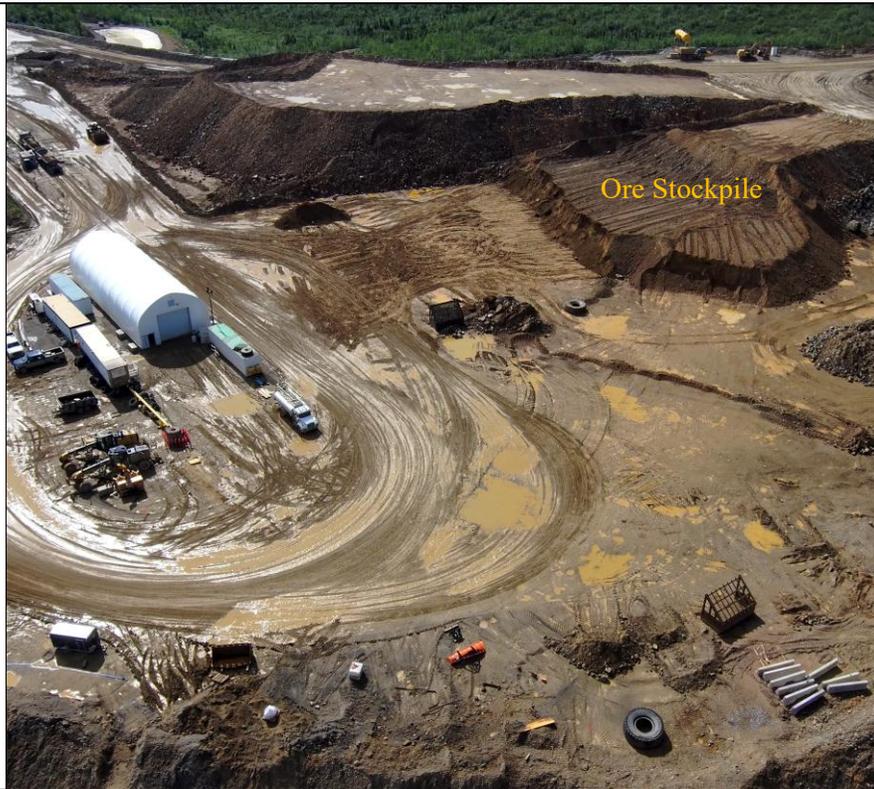
Photo 17: Ore Loadout area facilities include highway truck shop, scales, ore and material stockpiles.

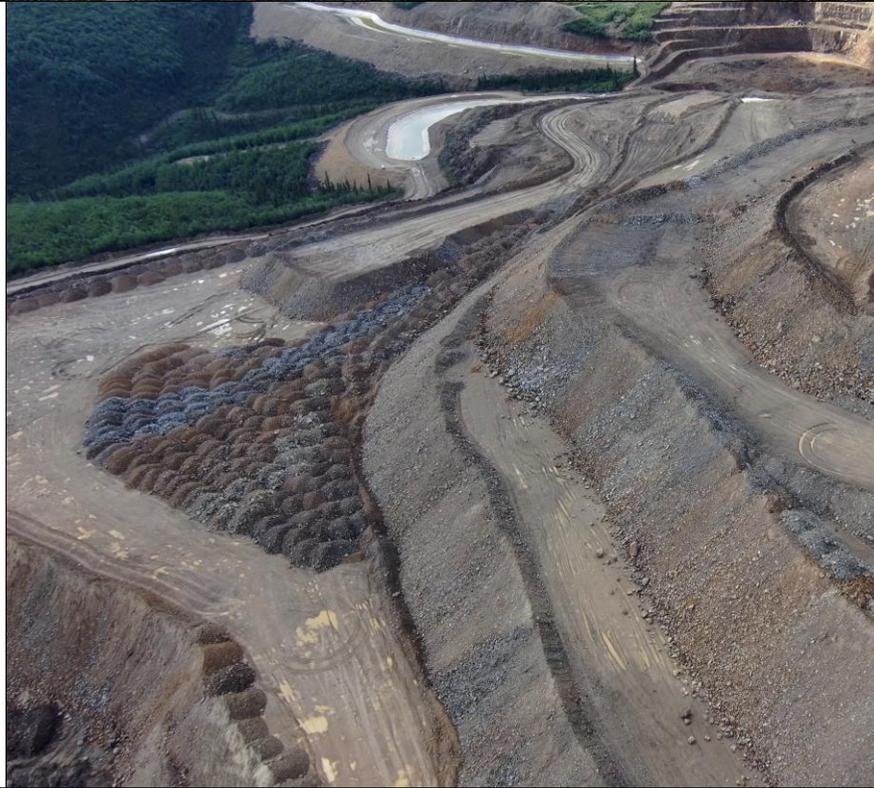
Photo 18: Active deposition of waste rock along the eastern edge of the North WRD.

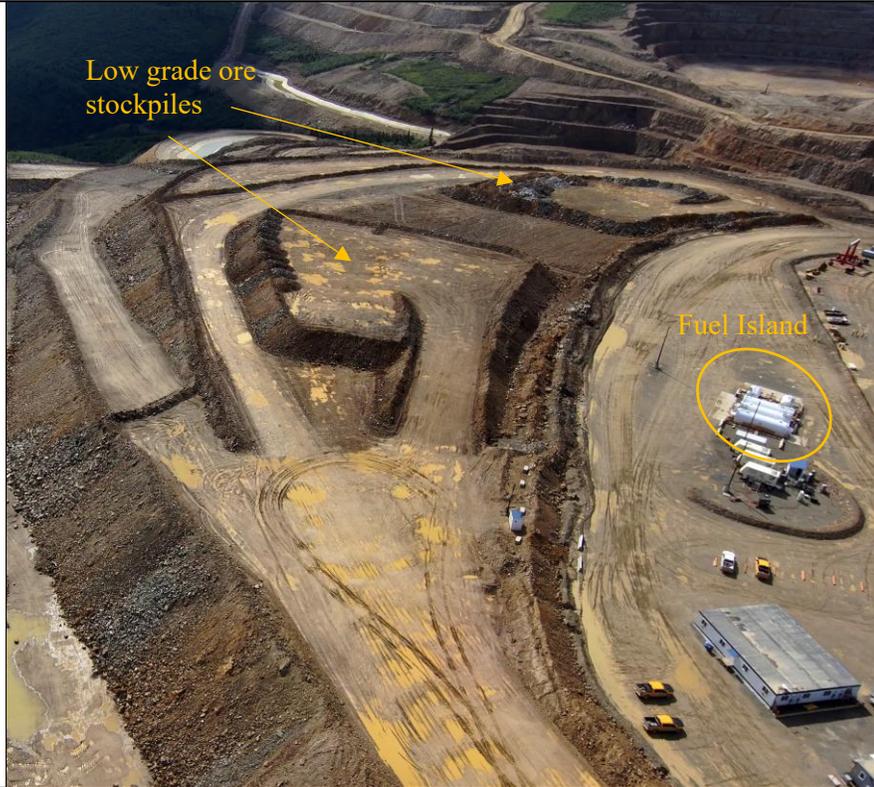
Photo 19: Oxide and sulfide stockpiles of low-grade ore adjacent to the Mine Infrastructure Site located on the southern end of the North WRD.

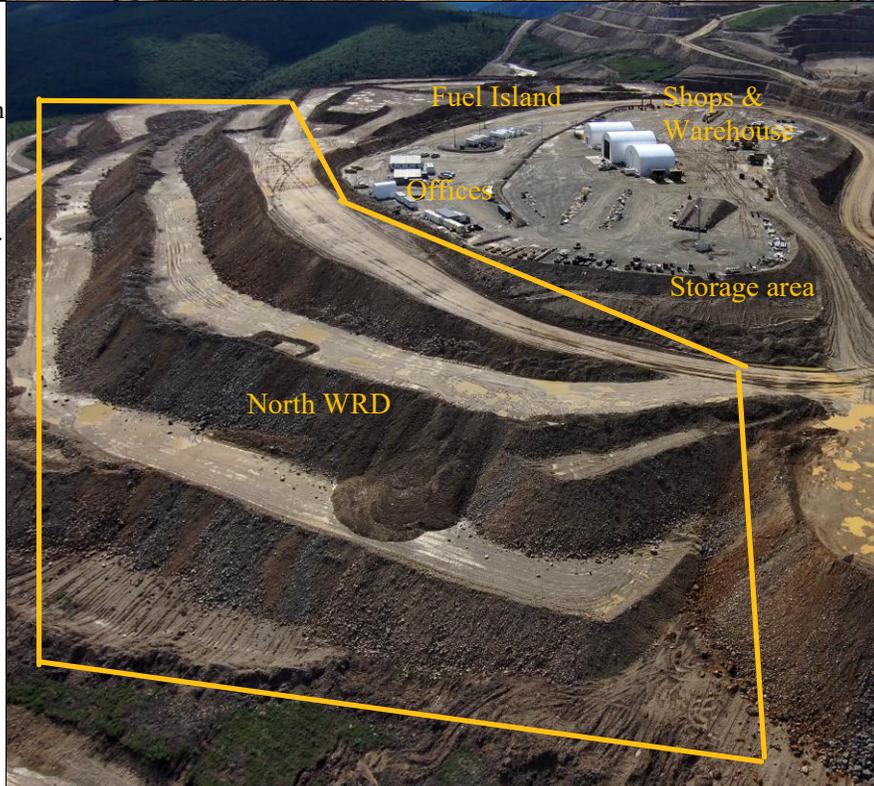
Photo 20: View to the south of the Mine Infrastructure Site that houses all offices, shops, and warehouse. North WRD wraps around most of the extent of the infrastructure pad from the north clockwise to the south.

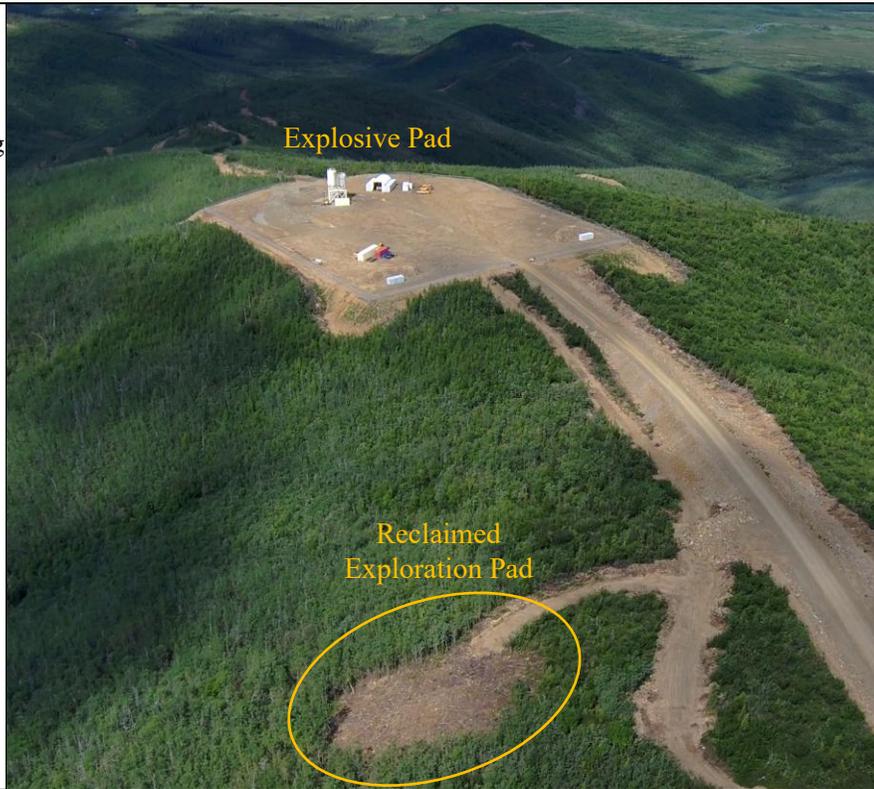
Photo 21: Foreground, old drilling exploration pad has been re-graded with growth media spread over its surface. Background looking northwest is the explosive pad.

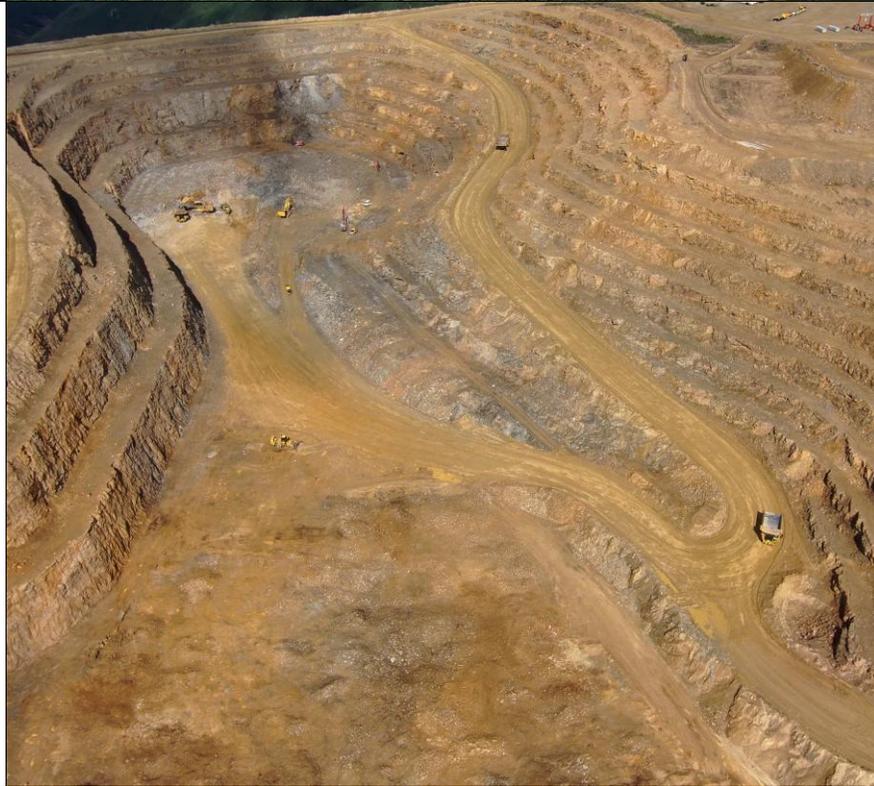
Photo 22: View to the northwest of the North Pit.

Active excavation and removal of material was observed below the north highwall.

North Pit is currently the only source of ore production. It is expected to bottom out later in the year.

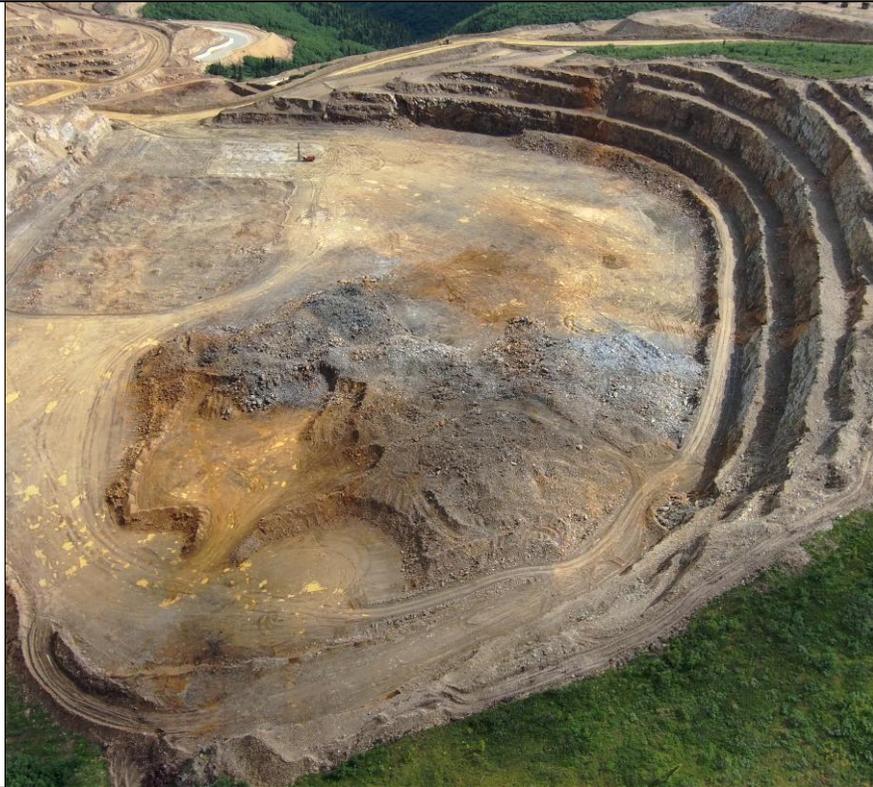
Photo 23: View to the west of the South Pit. Active drilling was observed. Clean waste rock from the South Pit will be placed in the bottom of the North Pit to provide the base above the water table for waste material deposition.

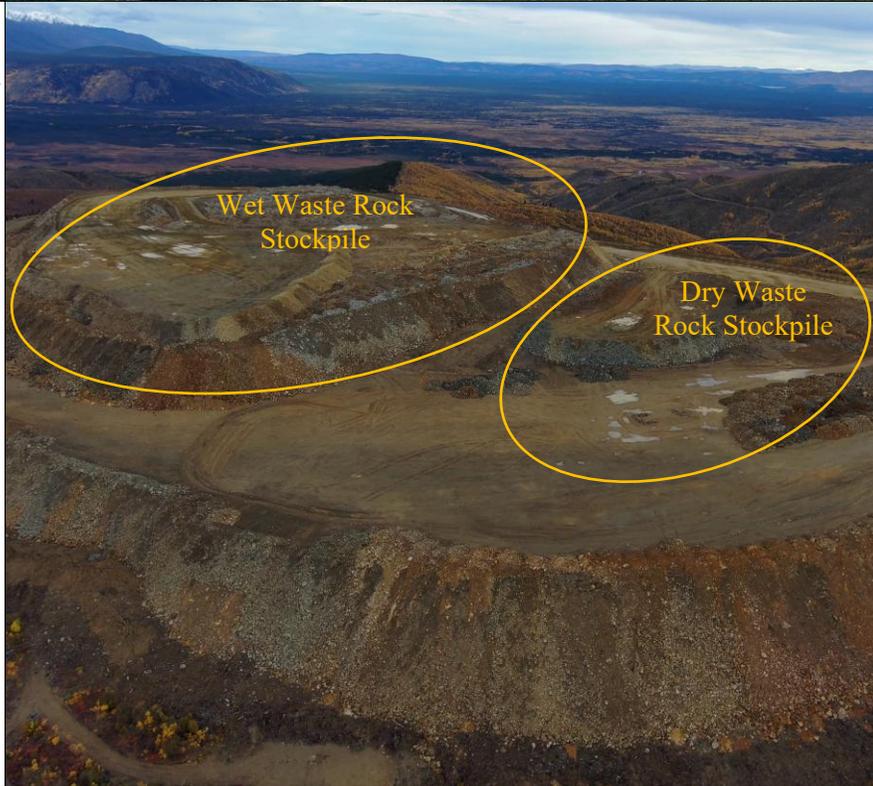
Photo 24: View to the northwest of the western lobe of the Main WRD. This photo was taken in 2024 to show a comparison of new deposition on top of the Main WRD to current volumes between the wet and dry waste rock stockpiles.

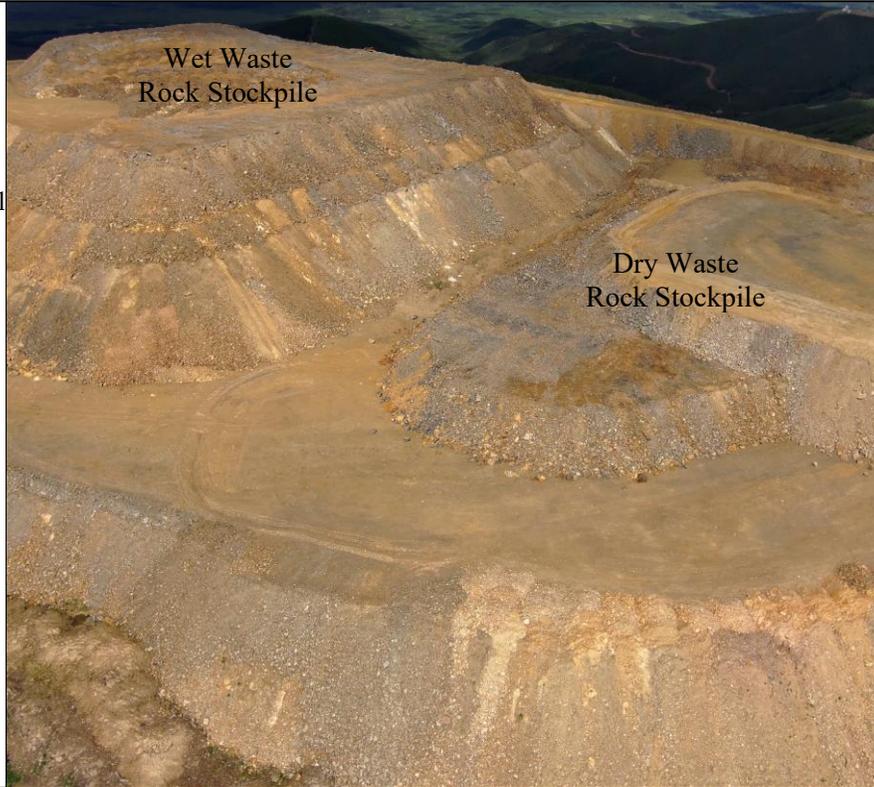
Photo 25: Current buildout of the wet and dry waste rock stockpiles. Several benches of material have been added since last year with a greater depositional volume of wet stack material compared to dry stack material.

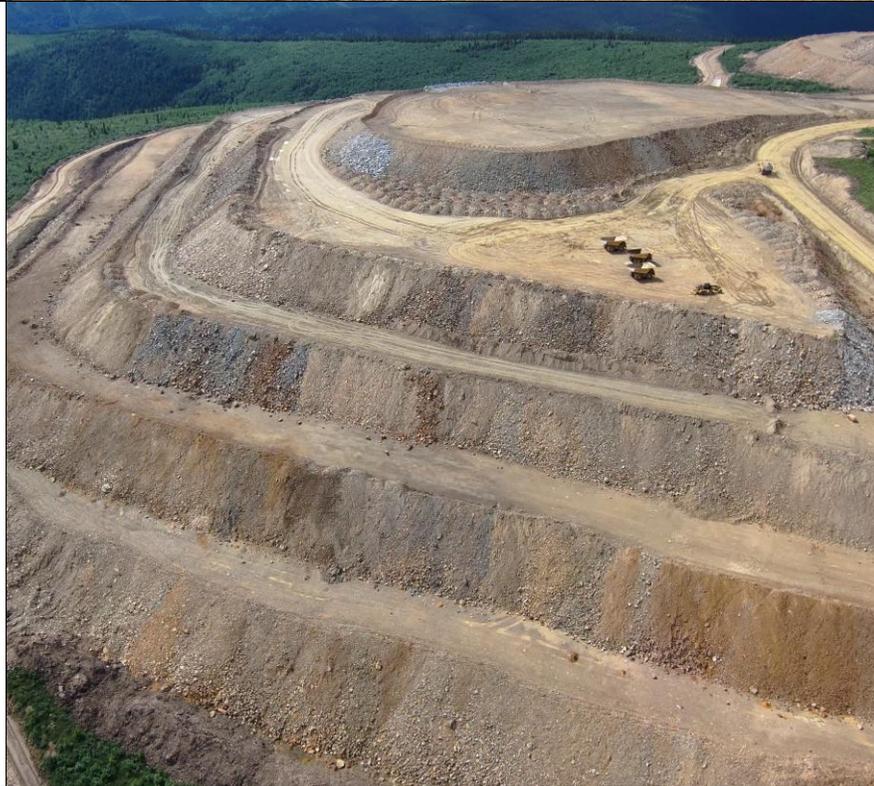
Photo 26: View of the eastern lobe of the Main WRD looking west.

Buildout of several more benches of waste rock has occurred since the previous year.

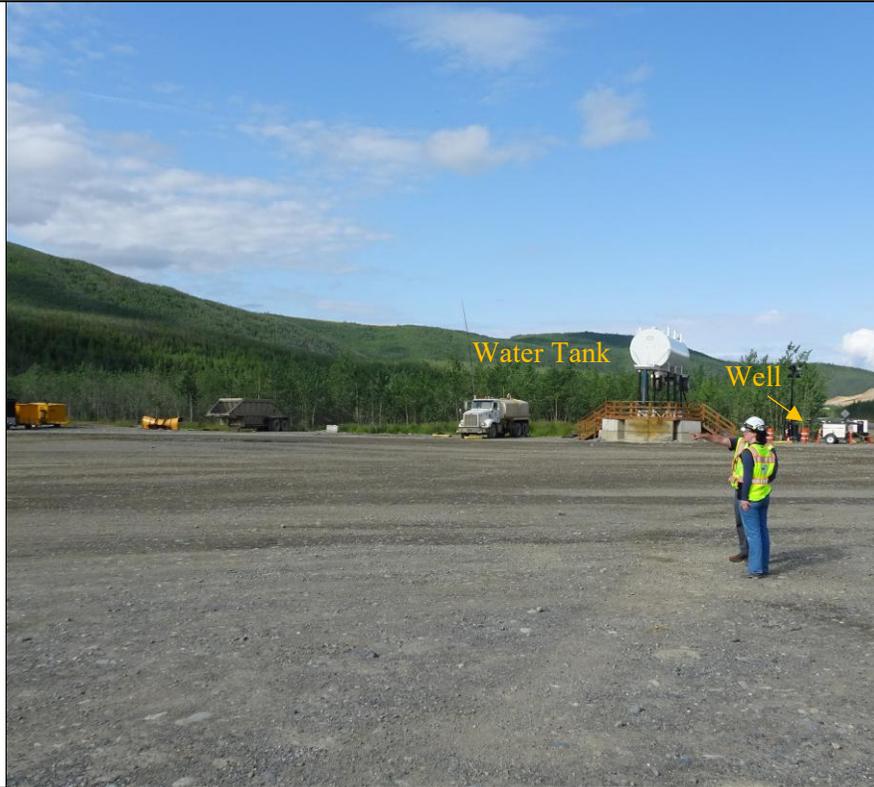
Photo 27: View looking towards the western corner of the ore haul truck change out yard.

Well location for the water draw point is noted to the right of the elevated water tank.

Water is primarily used for dust suppression along the access road.

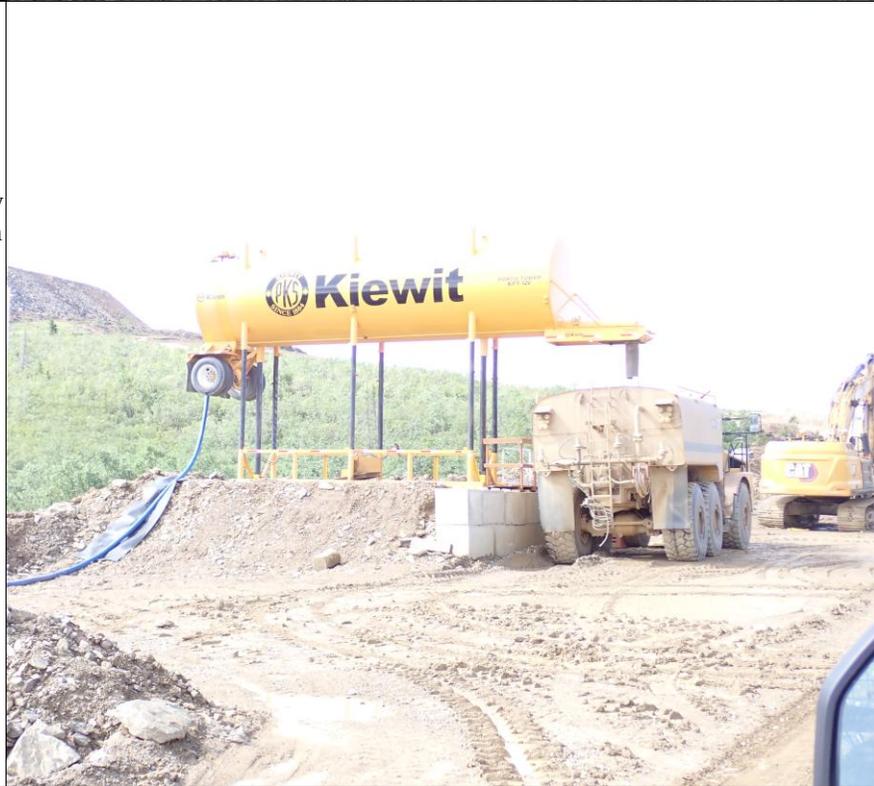
Photo 28: Westerly view at the start of the mine vehicle access road of elevated water tank.

Elevated water tank has water pumped from a nearby lined pond below the eastern extent of the ore load out area.

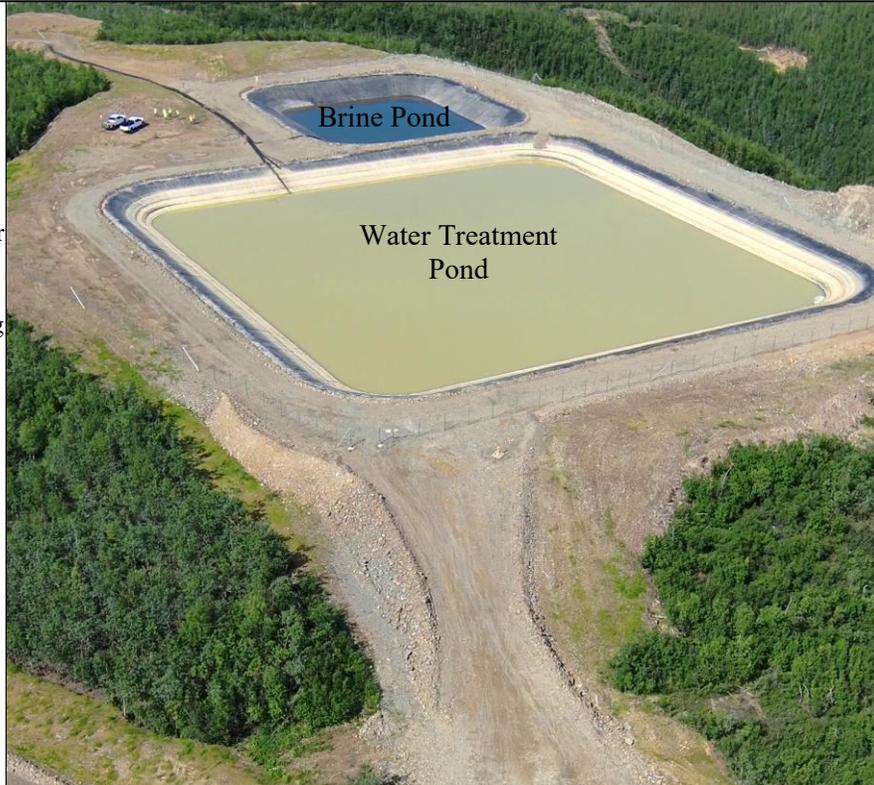
Photo 29: View to the southwest of the Brine and Water Treatment ponds.

Water levels are lower than previous inspection.

Water Treatment Pond water is primarily used for dust control. Brine Pond water is generated from backwashing filters from the RO water treatment facility.

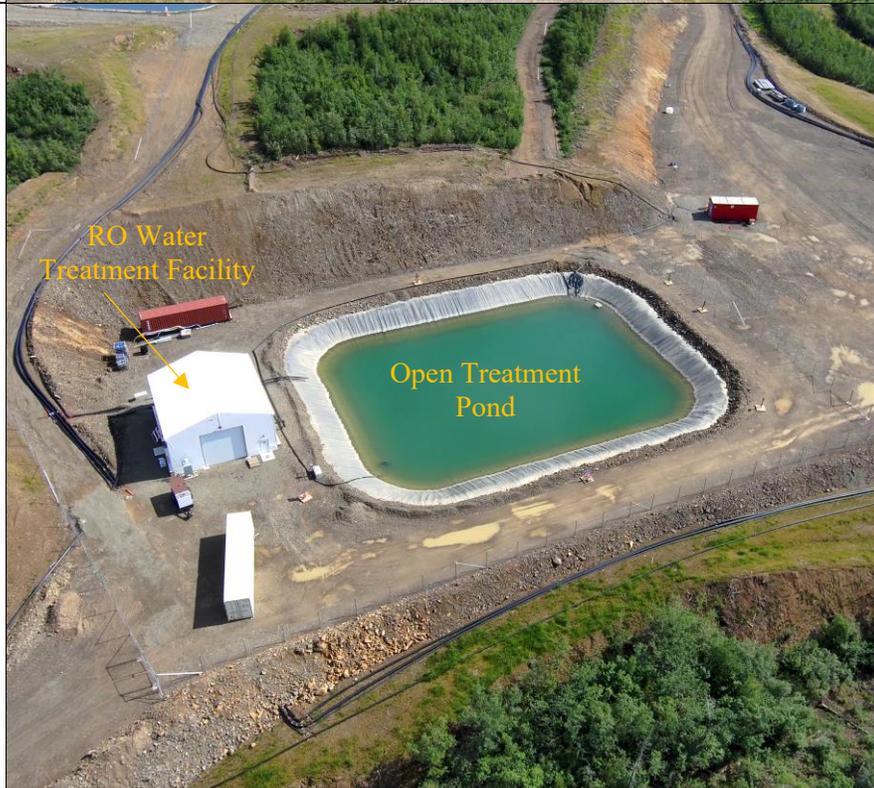
Photo 30: Northeast view of the Water Treatment Pad and associated facilities.

The RO facility is currently not in operation.
