Manh Choh Mine Field Inspection Report

Inspection Date:	June 25, 2025
Time:	9:00 AM to 1:00 PM
Weather:	Partly cloudy in the morning becoming overcast with broken clouds in the afternoon clearing later in the day. Slight breeze at lower elevations with winds reaching around 20mph higher up with an average temperature of 60°F.
DNR Personnel:	Aaron Kruse, William Groom, Ashley Adoko
DEC Personnel:	Trisha Bower, Laona DeWilde
Manh Choh Personnel:	Paige Lambert, Luke Walker
Inspection Objectives:	Site Inspection

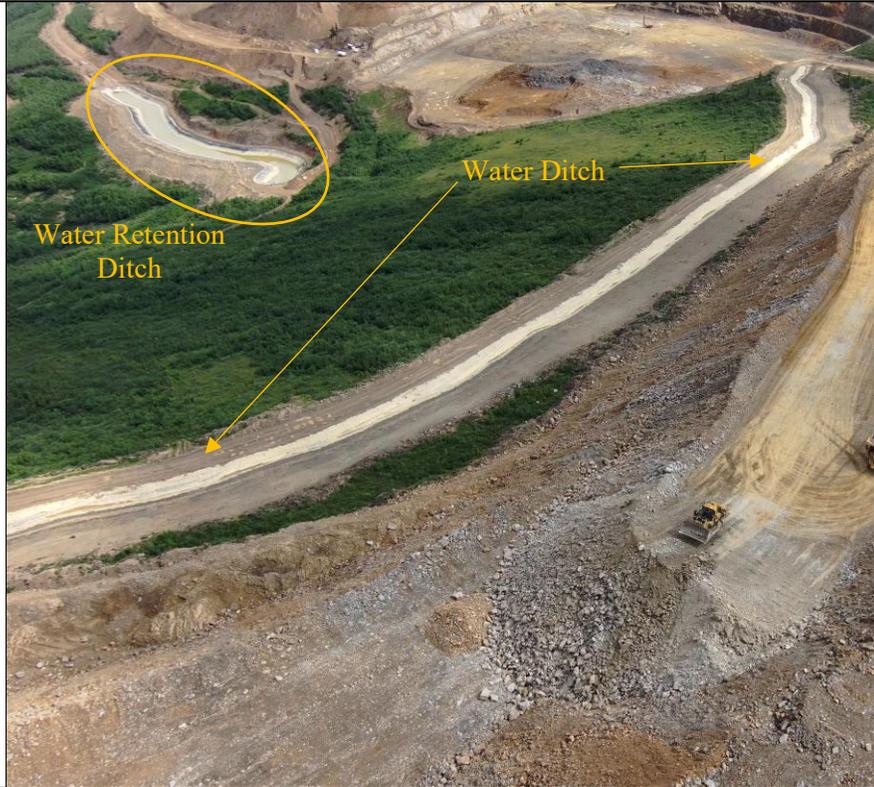
Photo 31: View to the northeast just above the western lobe of the Main WRD.

Water ditches and retention ditches encompass all mine related facilities.

In the background note the location of the South Retention Ditch located just west of the North and South pits.

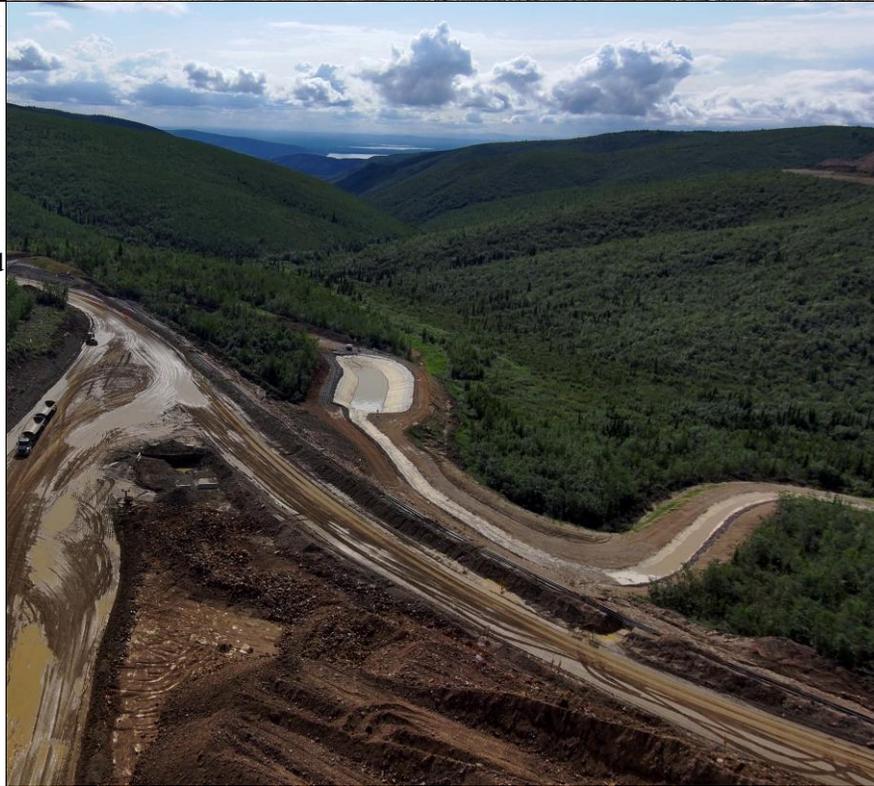
(Photo 32). The water ditches, retention ditches and associated ponds appeared to be in good condition and are well maintained.

Photo 32: View of the South Ditch and Lined Pond that collects water along the eastern edge of the ore loadout yard and mine access road.

This pond and ditch are the water source for the elevated tank in Photo 28.
