## Manh Choh Mine Field Inspection Report

<b>Inspection Date:</b>	September 19, 2025
<b>Time:</b>	1:00 PM to 4:00 PM
<b>Weather:</b>	Overcast in the afternoon with a cloud ceiling of $\approx$ 2000 feet with broken cloud cover later in the day. Slight breeze at lower elevations with gusts around 10mph higher up with an average temperature of 50°F.
<b>DNR Personnel:</b>	Aaron Kruse, William Groom, Erika Alexander, Jonathan Kummer
<b>Manh Choh Personnel:</b>	Brent Culleton, Doreen Mark
<b>Inspection Objectives:</b>	Site Inspection

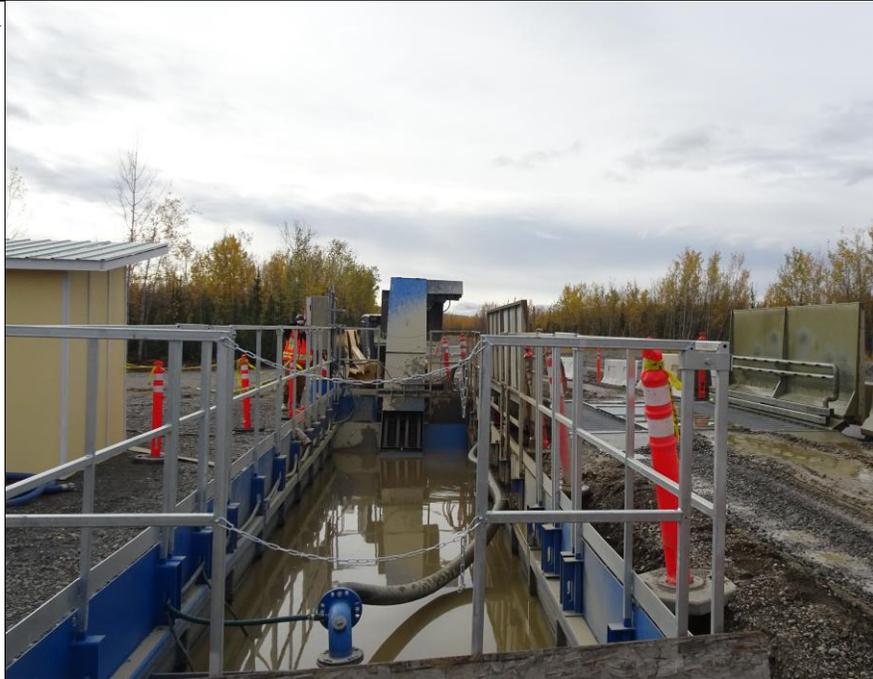
- 1.1. Track out of sediment from vehicles onto the Alaskan Highway has been a concern of Kinross for several years. Kinross has implemented several Best Management Practices (BMPs) to address the issue. DNR first documented a cattleguard installation in the spring of 2024 to help vibrate loose material from vehicles. Later that fall, the company extended the asphalt apron 500 feet from the highway to the cattleguard. Currently, an automated wash station is in place that cleans the undercarriage and tires of vehicles before turning onto the Alaska Highway (Photo 1). The wash-station is periodically mucked with a skid steer loader where sediment is sampled for testing, temporarily stored onsite, and then hauled to a borrow pit. This new automated wash station uses a recirculating water system that is filled by tanker truck and only operates in temperatures above freezing.

Photo 1: View looking south of the automated wash station on the mine access road located approximately 1000 feet from the Alaska Highway.

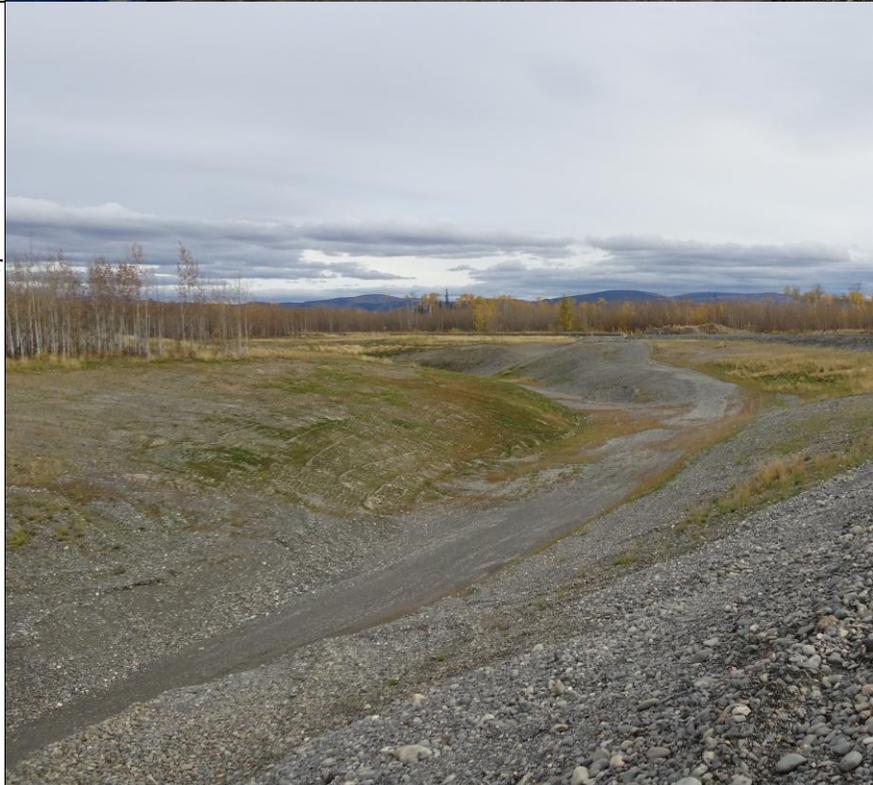
- The borrow site at MP 5 is still active with operations only occurring within the northern area. This is also the disposal site for mucked material from the automated wash station. Most of the site has been reclaimed with several years of vegetative growth (Photo 2). Final reclamation of the borrow site is proposed after mine closure.

Photo 2: View to the north of the borrow site at MP5.

Most of the area has been recontoured and seeded for reclamation.

This borrow site will continue to remain active for aggregate production.

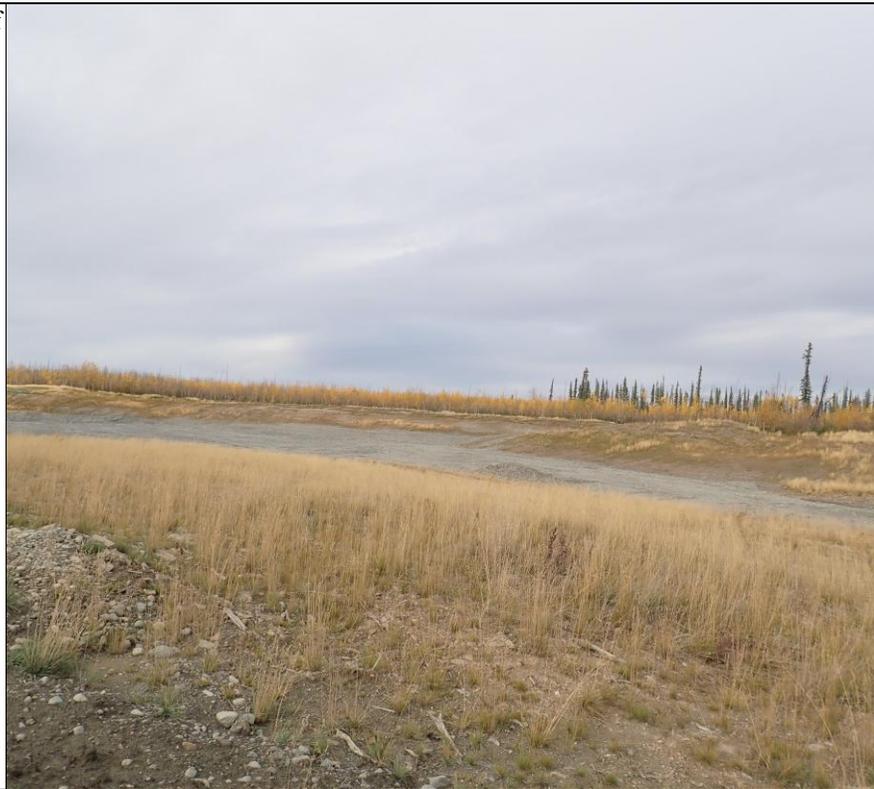
- At MP 7.2, much of the borrow pits area has been reclaimed (Photo 3); however, within its western end remains an active material site. The active area includes a small yard which is used for storage and has several stockpiles of aggregate rock (Photo 4).

Photo 3: View to the west of the borrow site at MP 7.2.

Most of this area has been reclaimed; however, the western end will remain an active material site.

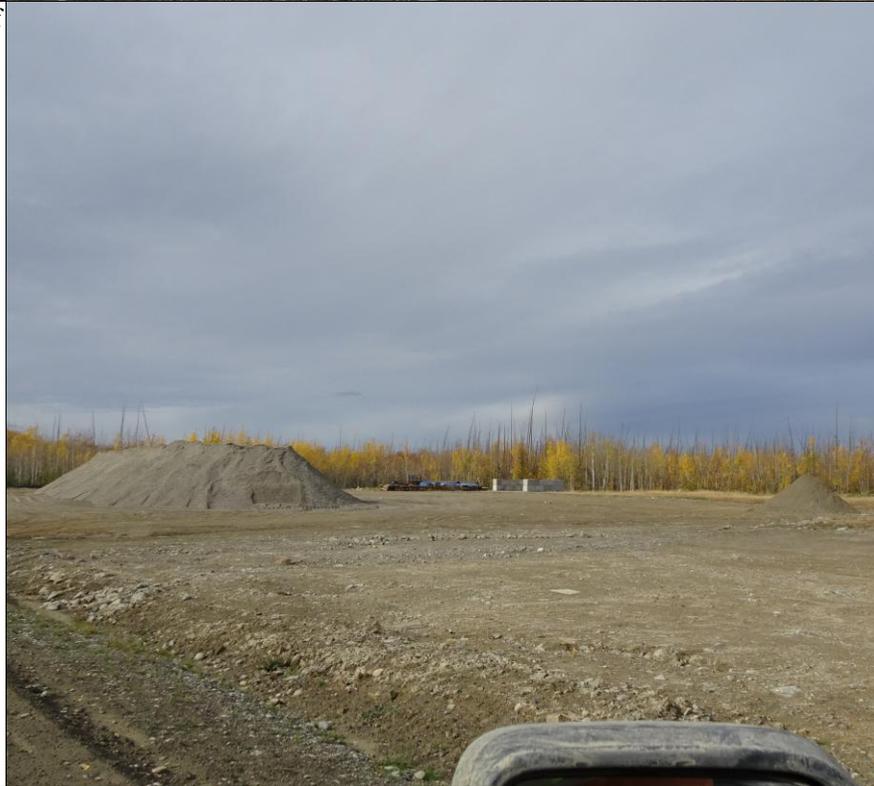
Photo 4: View to the west of the storage yard and aggregate stockpiles located on the western edge of the borrow site at MP 7.2.

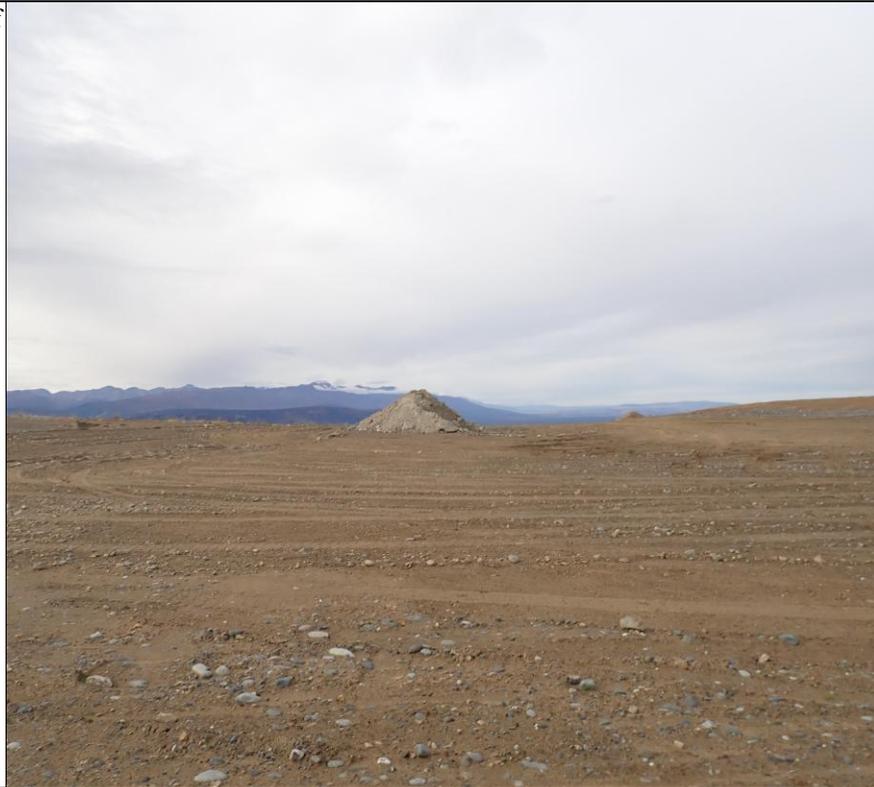
- At MP 12.8 there is a large borrow pit that has been expanded to be used as a laydown yard; however, it is still an active site with material stockpiles (Photo 5). Organic material has been stockpiled at the southern end of the yard for use at a later date (Photo 6).

Photo 5: View to the west of a small stockpile of material at MP 12.8 borrow site.

Most of the area has been expanded to be used as a laydown yard; however, it is still an active material site.

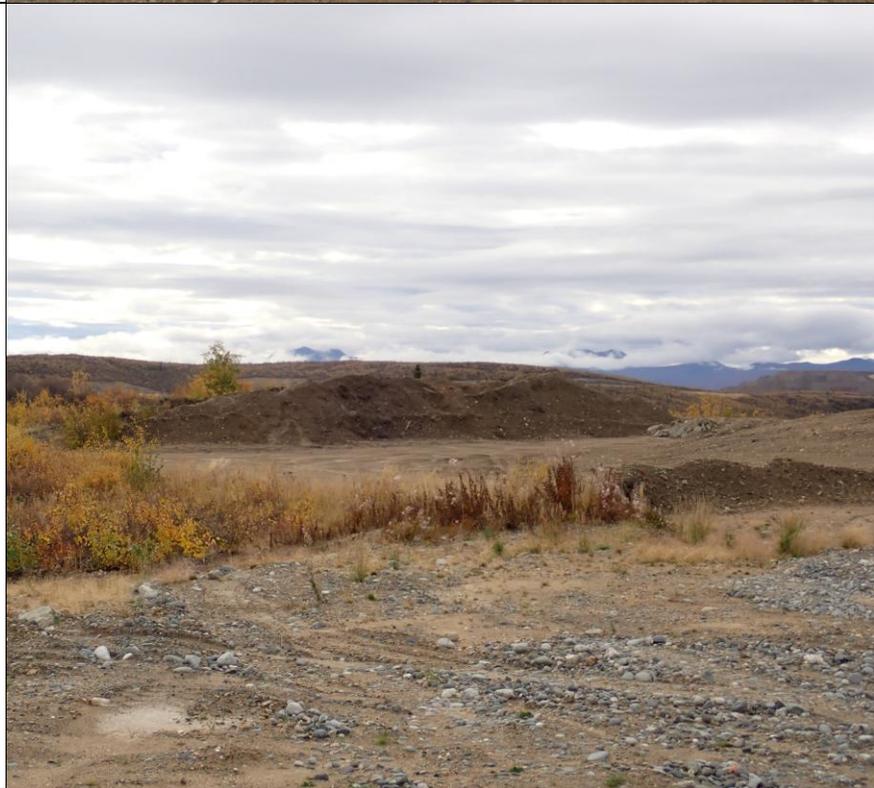
Photo 6: MP 12.8 borrow site organic stockpile located at the southern end of the yard.

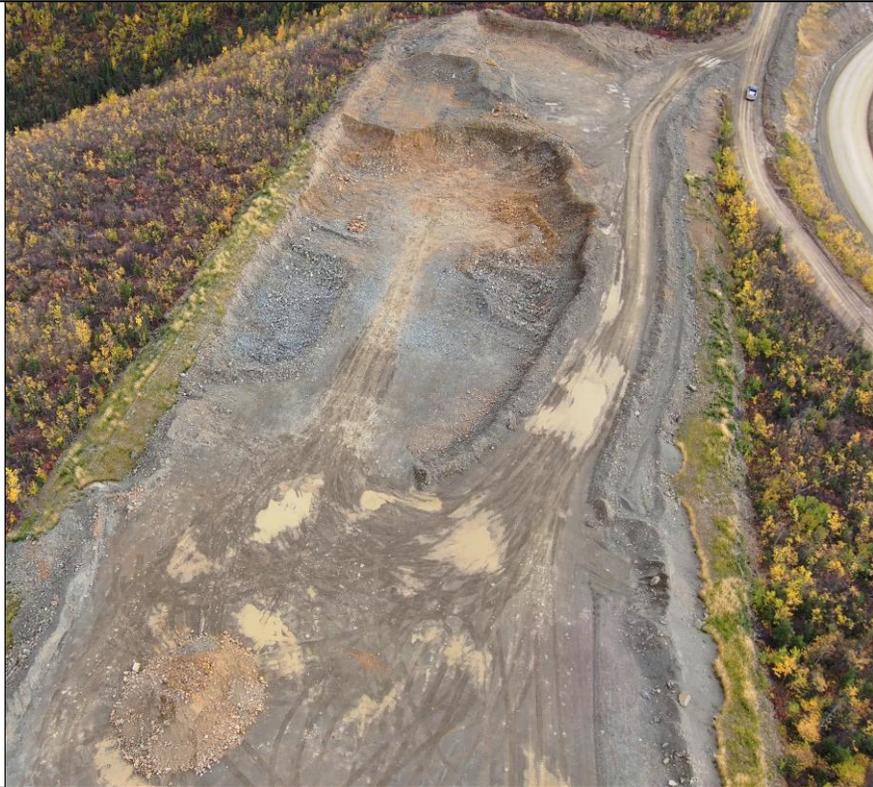
- Material Site 1, located at MP 14.5, is active with aggregate stockpiles on its eastern end with a centralized excavation pit (Photo 7).
- 1.3. The ore haul truck change out and storage yard is well organized with a continuous exchange between driver and vehicle. Old culverts are stored on site from previous road construction and were stacked and sorted. Other road maintenance materials and equipment are staged for easy access and are properly stored (Photo 8).

Photo 7: Material site 1, located at MP 14.5 close to the water treatment pad and ore loadout yard.

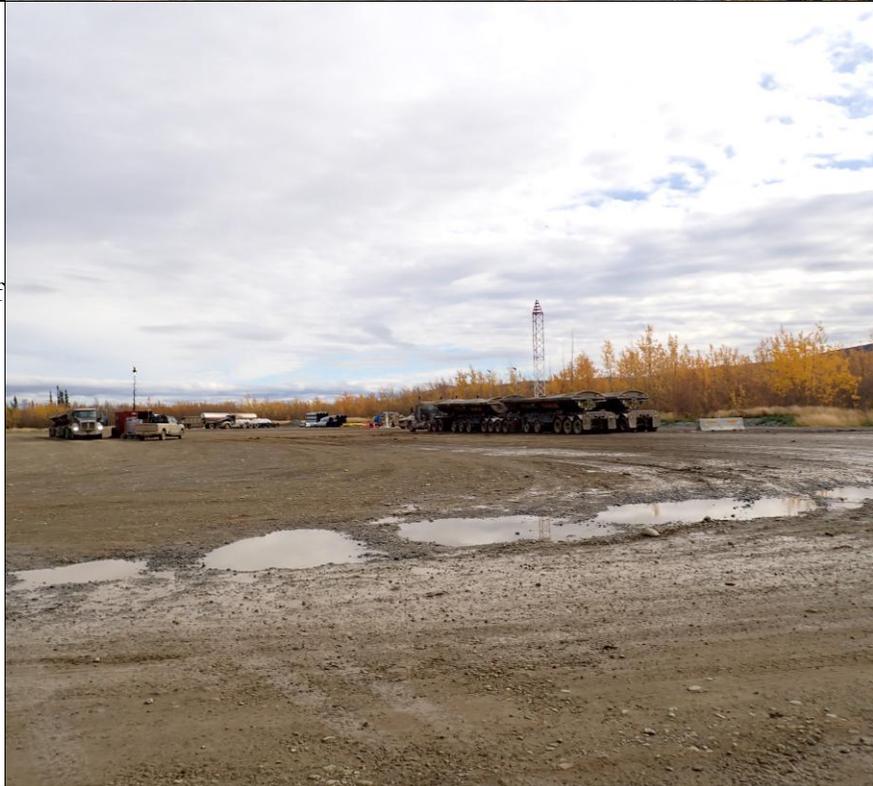
Photo 8: Truck change out yard between drivers from the mine to those who will truck the ore to Fort Knox for milling.

Culverts and other road building/maintenance material and equipment stored along the periphery of the truck change out yard.

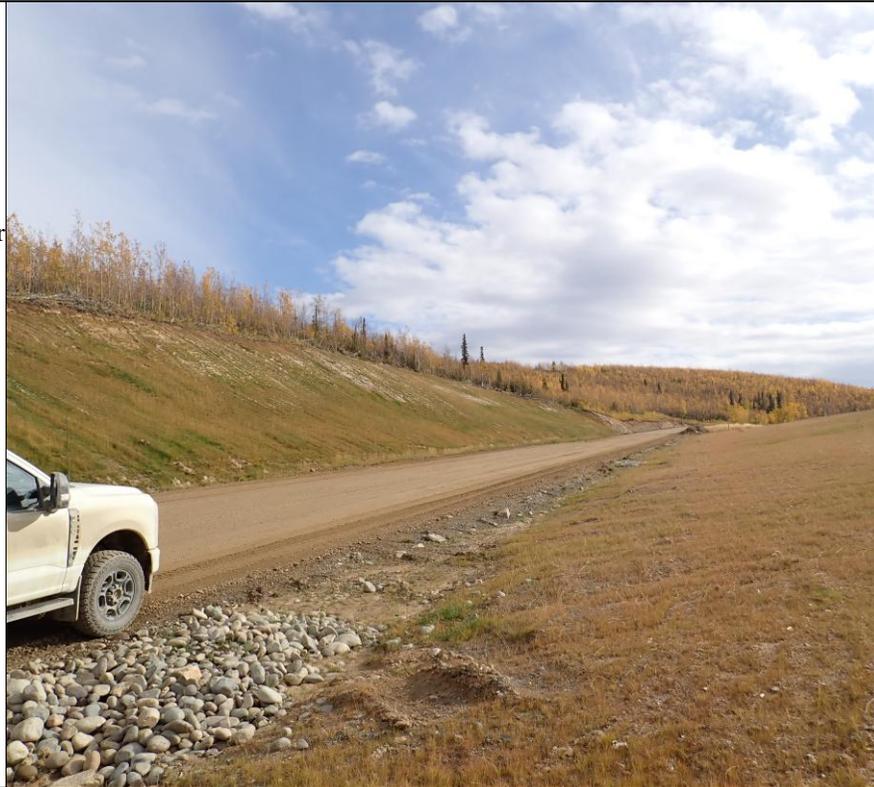
- 1.4. At milepost 9.5 is a road cut that experienced excessive erosion undercutting the jute matting in the spring of 2024. DNR has monitored the BMPs Kinross has put in place to stabilize the area to prevent further degradation. Last year Kinross removed the jute matting, re-sloped the cut to an angle of repose, and seeded. Currently the slope has had one year of vegetative growth and has remained stable. The sloped cut on the opposite side of the road did not experience erosional issues and has had two years of vegetative growth (Photo 9).

Photo 9: MP 9.5 left side of road cut has been stabilized, re-sloped, and seeded after erosional issues from the previous year.

Right side of road has had no erosional issues with over two years of vegetative growth.

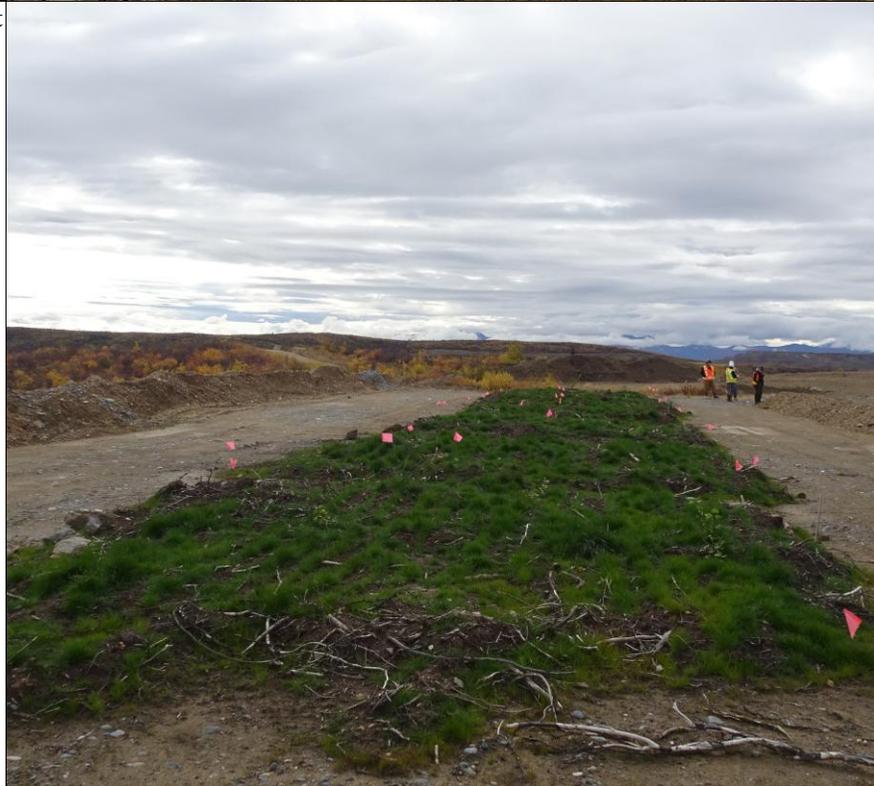
- 1.5. The growth media test plots, located at MP 12.8 on the eastern edge of the borrow site, is a recent addition that began earlier this spring. There are several test plots, each with a consistent mix of organics but vary in depth of topsoil placed over waste rock from the North WRD. All the test plots have controlled seeding, except one, which was not seeded for comparison of natural vegetative regrowth. DNR was onsite in June just a few weeks after these test plots were prepared before plant germination began. Approximately four months since DNR's previous inspection, there is now noticeable vegetative growth within each test plot (Photo 10).

Photo 10: Growth media test plots are located within the eastern portion of the material site at MP 12.8.

Each plot has a consistent mix of organics but vary in depth of topsoil placed over waste rock.

Photo shows approximately four months of growth since germination in June.

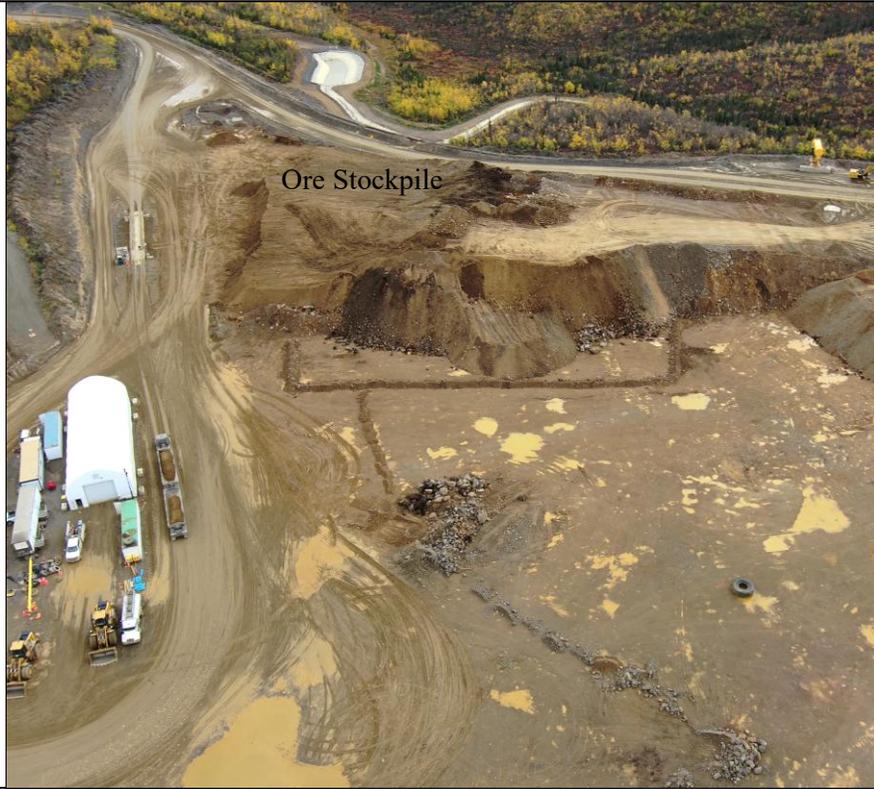
- 1.6. The Ore Loadout Area footprint has remained consistent with supporting facilities which include a highway truck shop, office trailers, and weigh scales. The peripheral area along the northwestern highway truck yard is used for storage of equipment. Mine haul trucks stockpile ore along the southern extent of the loadout area where it is loaded into highway b-train tractor-trailers (Photo 11).

Photo 11: Ore Loadout area facilities include highway truck shop, scales, ore and material stockpiles.

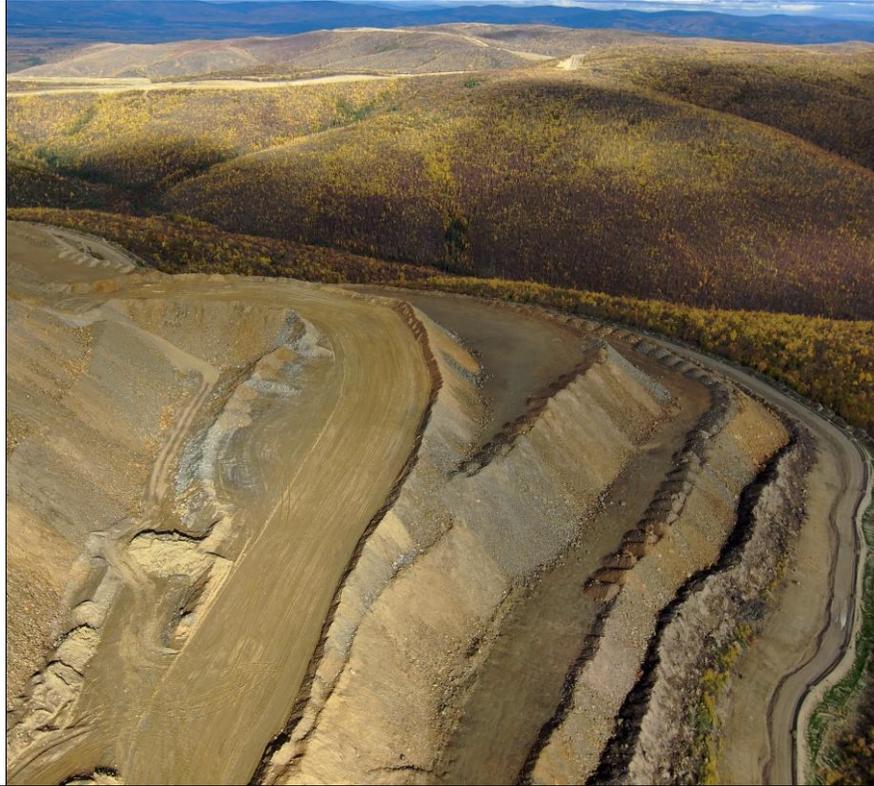
- 1.7. The Mine Infrastructure Site houses the main facilities for Kinross and their contractors. The pad area footprint remains consistent; however, active waste rock deposition continues in the North WRD along its benches on the northern side of the Mine Infrastructure Site (Photo 12). Small oxide and sulfide stockpiles of low-grade ore (Photo 13) have been placed across from the fuel island on top of the North WRD southern corner. The main pad area is comprised of offices, maintenance shops, warehouse, fuel island, support equipment storage, communication tower and generator facility (Photo 14). At the northern extent of the infrastructure pad is the marginal low grade ore stockpile (Photo 15), which has increased in area but not height since the previous inspection.

Photo 12: Active deposition of waste rock along the northern benches of the North WRD.

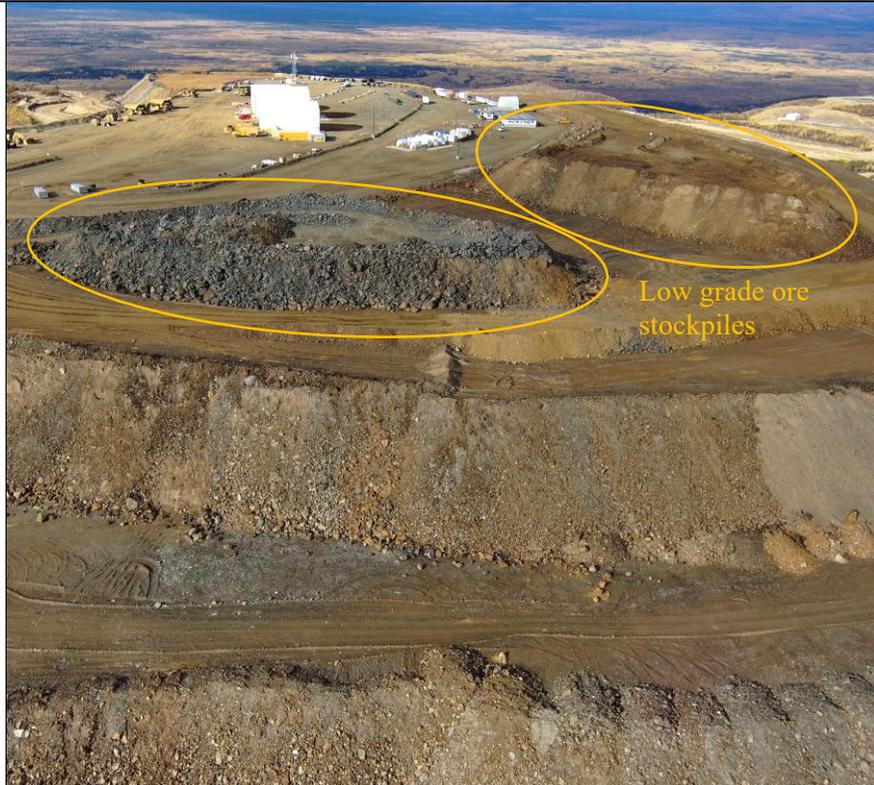
Photo 13: Oxide and sulfide stockpiles of low-grade ore adjacent to the Mine Infrastructure Site located on the southern end of the North WRD.

Both stockpiles have doubled in volume from previous inspection in June.

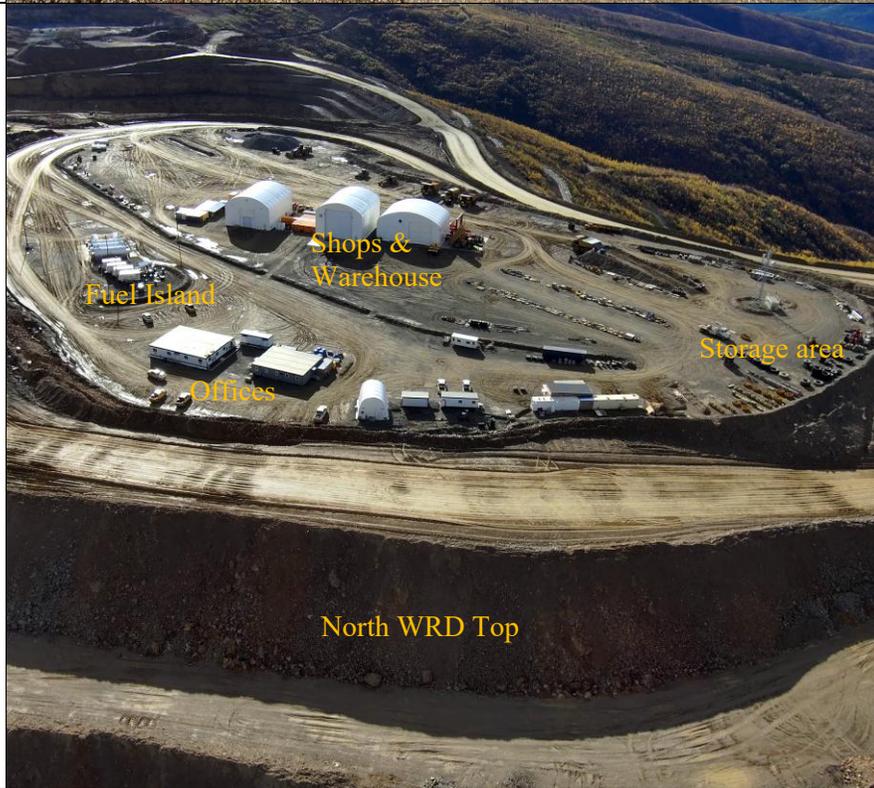
Photo 14: View to the west of the Mine Infrastructure Site that houses all offices, shops, fuel island, and warehouse.

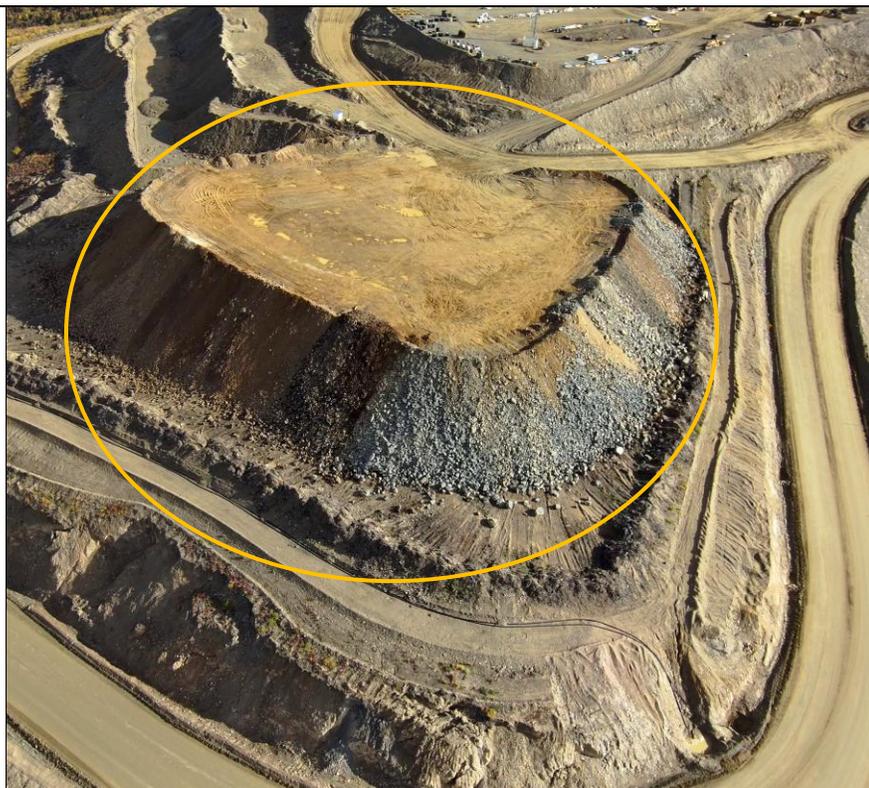
Photo 15: View to the south of the marginal low grade ore stockpile (circled).

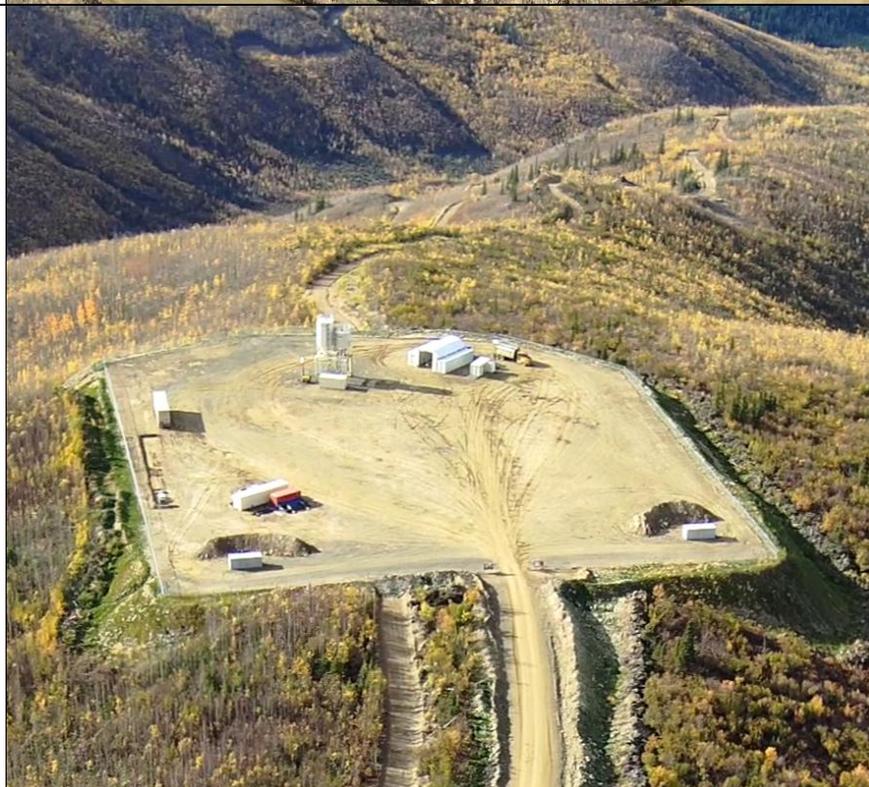
- 1.8. The Explosive Pad, located northwest of the infrastructure site, is well organized and maintains a good separation for working around and between the magazines (Photo 16). Off the road to the Explosive Pad is a reclaimed drill pad from 2024 that is beginning to show natural growth of vegetation (Photo 17).

Photo 16: View towards northwest of the explosive storage pad.

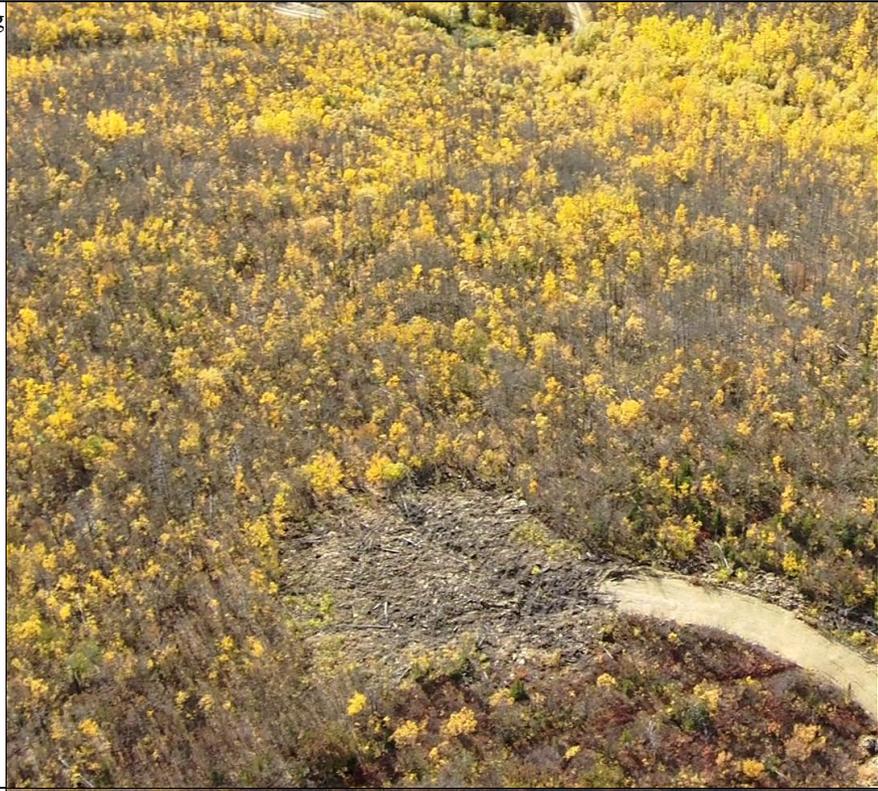
Photo 17: Reclaimed drilling pad off the road to the explosive storage pad.

Natural vegetative growth is just starting to show some coverage.

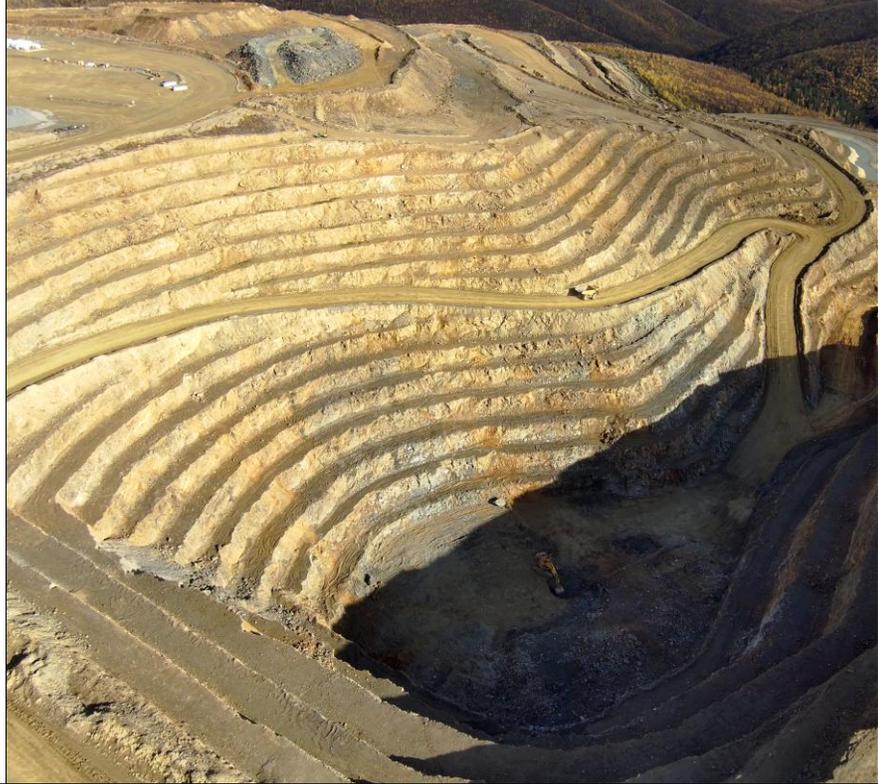
- 1.9. Active excavation was observed for both the North and South Pits. North Pit continues to produce ore, but it is expected to bottom out later this year (Photo 18). South Pit was observed with active drilling for preparation in blasting alongside removal of waste rock that was currently being loaded and hauled to the Main WRD (Photo 19).

Photo 18: View to the northeast of North Pit.

Active excavation and removal of material was observed below the north highwall.

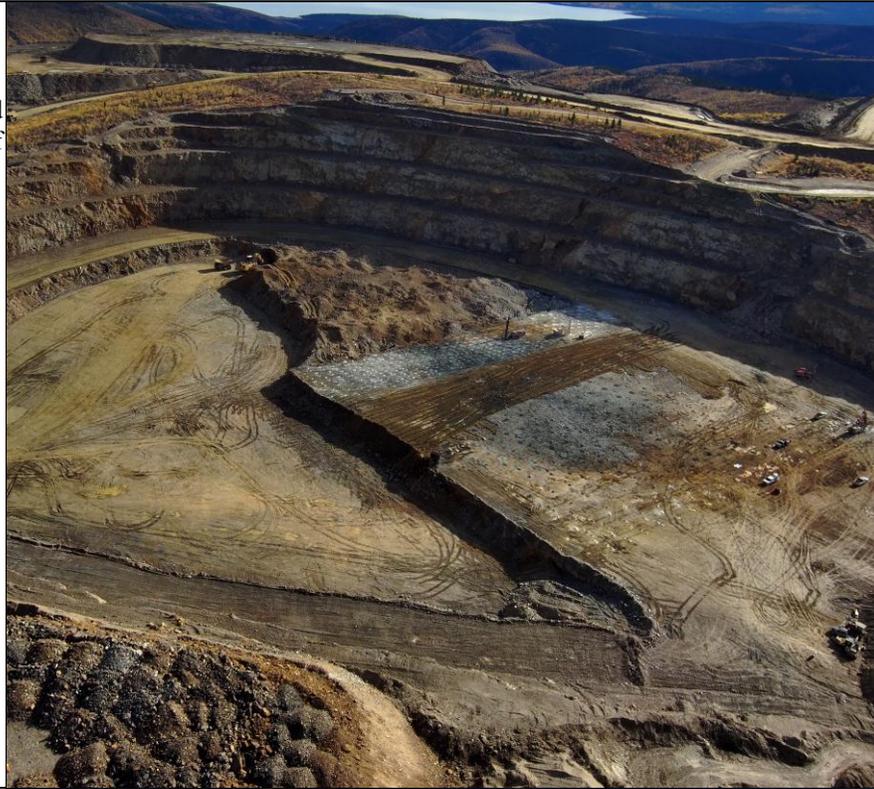
Photo 19: View to the southeast of South Pit.

Active drilling was observed along with active removal of material.

Haul trucks were transporting material to the Main WRD and Dry Waste Rock Stockpile.

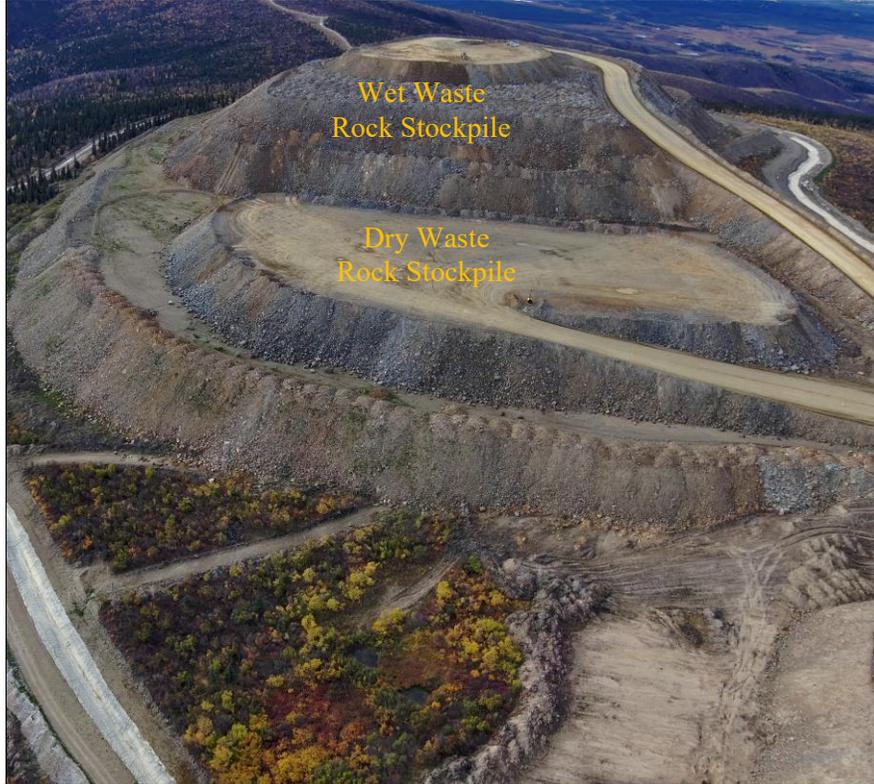
- 1.10. DNR staff deployed a drone atop the Dry Waste Rock Stockpile to document it, the Wet Waste Rock Stockpile, and Main WRD. Both the Wet and Dry Waste Rock Stockpiles have been placed on top of the western lobe of the Main WRD. During this inspection, DNR staff observed a well-developed buildout for the dry and wet stockpiles (Photo 20), which will be relocated into the

Photo 20: View to the west of the western lobe of the Main WRD where the Wet and Dry Waste Rock is stockpiled.

The buildout of both stockpiles has expanded in material volume within the same tiered benches since DNR's spring inspection.

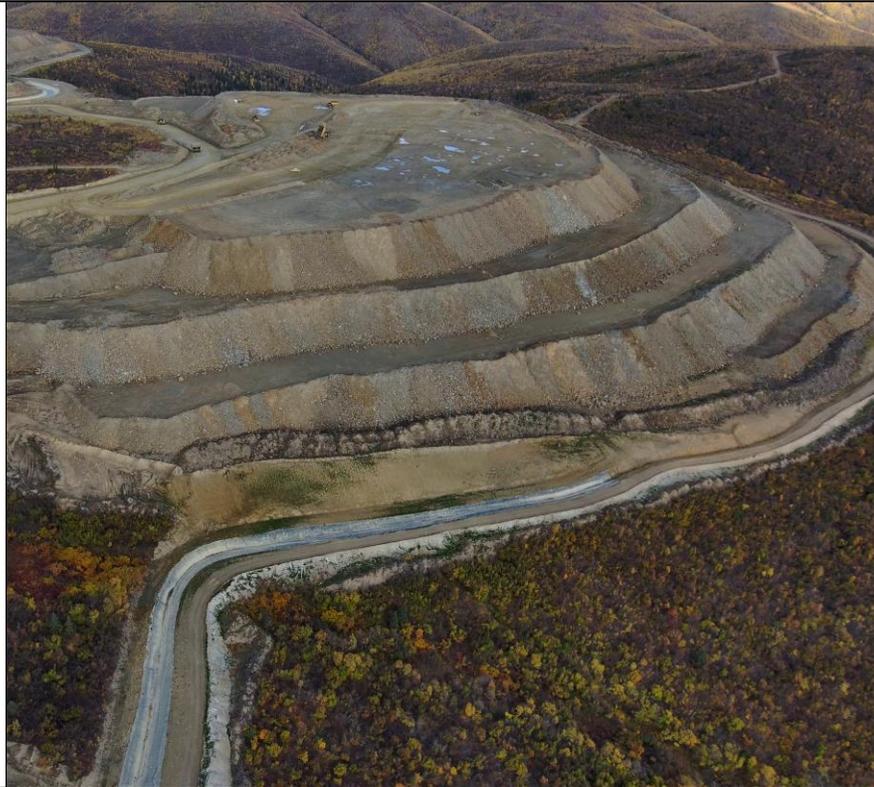
North and South Pits after mining is complete. The buildout of the Main WRD eastern lobe continues with expansion of the upper tiered bench (Photo 21) from what was documented earlier this spring. Its overall disturbed footprint has remained the same; however, its volume continues to increase along with its elevation as outlined within Manh Choh's Reclamation and Closure Plan submission for the Main WRD scheduled development.<sup>3</sup>

Photo 21: View of the eastern lobe of the Main WRD looking north.

Buildout of the top tiered bench has expanded in material volume since DNR's spring inspection.

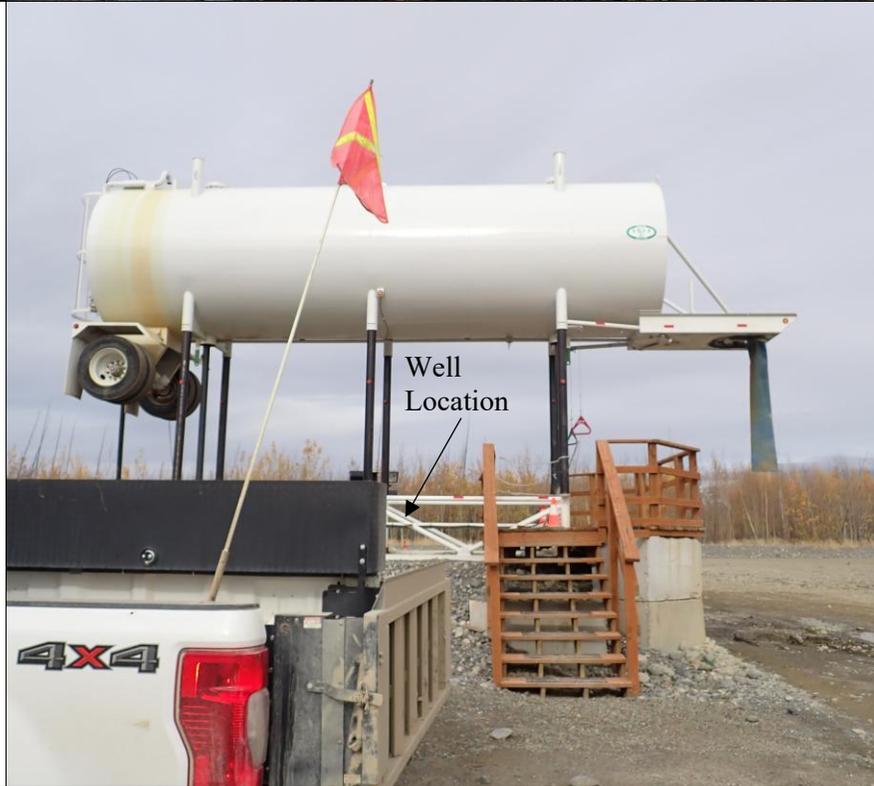
- 2.1. An elevated water tank was documented for dust suppression usage. This elevated water tank is located at the western corner of the ore haul truck change out yard. The tank, water withdrawal well, and surrounding area are well maintained, and structures are in good condition (Photo 22). This elevated tank is also the water source for trucking water to the automated wash station.

Photo 22: View looking north at the western corner of the ore haul truck change out yard.

Well location for the water draw point is noted to the right of the elevated water tank (hidden behind tank foundation).

Water is primarily used for dust suppression along the access road.

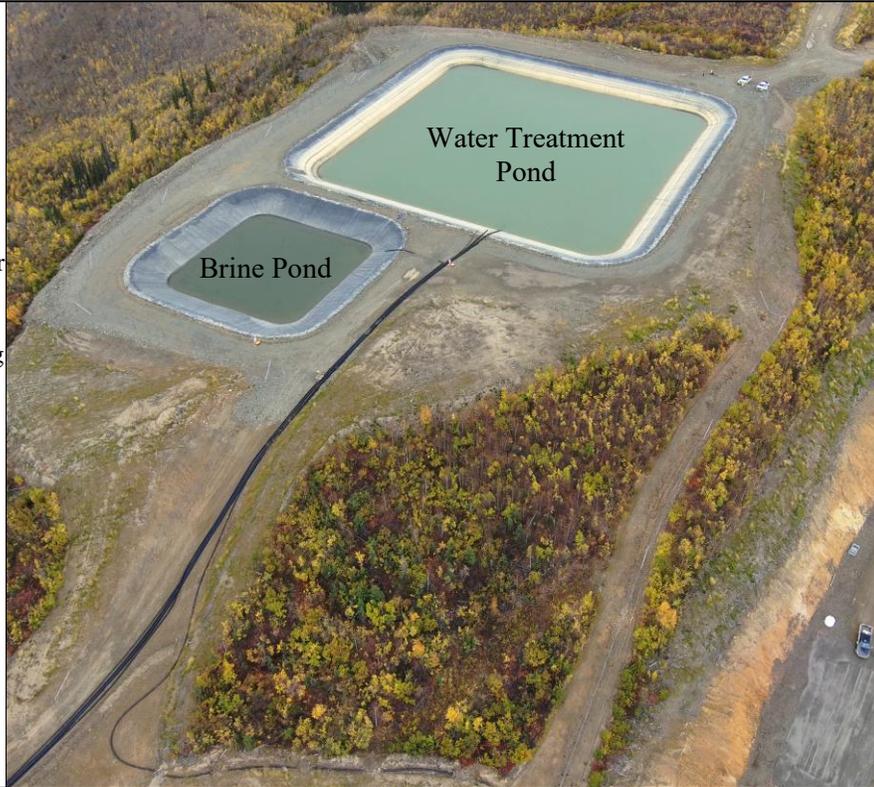
- 2.2. DNR staff deployed a drone over the Water Treatment Pad to document water levels of each pond and facility condition. Both the smaller Brine Pond and larger Untreated Water Pond, located at the upper elevation of the pad, appeared to have water storage volumes which have remained consistent since the previous spring inspection (Photo 23). Water from the larger pond is primarily used for dust suppression, while brine water is generated from back washing filters from the Reverse Osmosis water treatment facility next to the Treated Water pond (Photo 24). Overall pad and facilities are well organized and in good condition.

Photo 23: View to the northeast of the Brine and Water Treatment ponds.

Water levels have remained constant since the previous June inspection.

Water Treatment Pond water is primarily used for dust control. Brine Pond water is generated from backwashing filters from the RO water treatment facility.

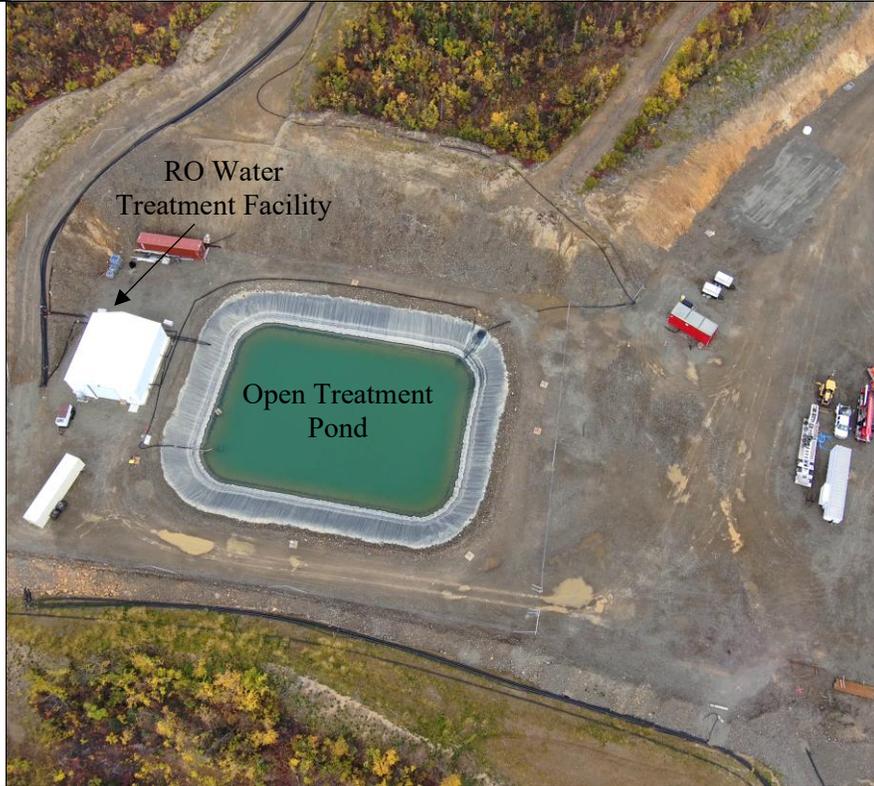
Photo 24: Northeast view of the Water Treatment Pad and associated facilities.

The RO facility, and surrounding Water Treatment Pad are well organized and in good condition.

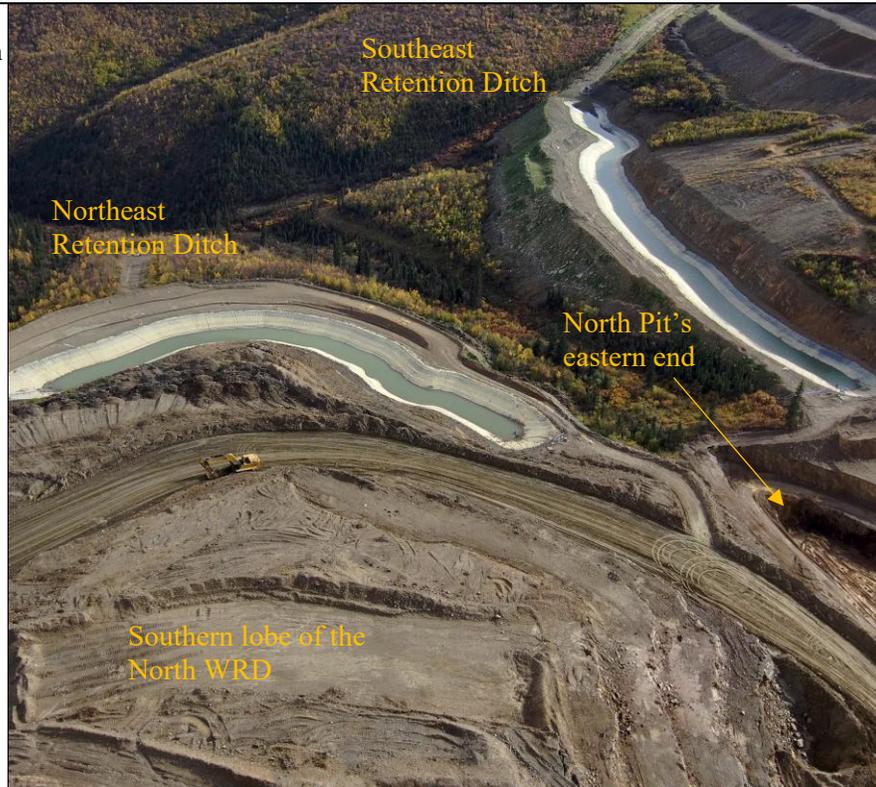
- 2.3. Water Ditches and Retention Ditches surrounding the perimeter of mine were documented through aerial imagery. The northeast, southeast and west ditches were clean of debris with no visible water except in the lined retention ditches (Photo 25). Both the North and South Ditch lined ponds, located adjacent to the ore load out area, contained water levels that were lower than what has normally been observed from previous inspections. Sediment accumulating in a section downslope from the access road within the South Ditch was observed with water ponding behind it (Photo 26). The water ditches, retention ditches and associated ponds appeared to be in good condition and well maintained.

Photo 25: View to the south between the North and Main WRD eastern lobe.

Water ditches and retention ditches encompass all the mine-related facilities.

Photograph is of the Northeast and Southeast retention ditches.

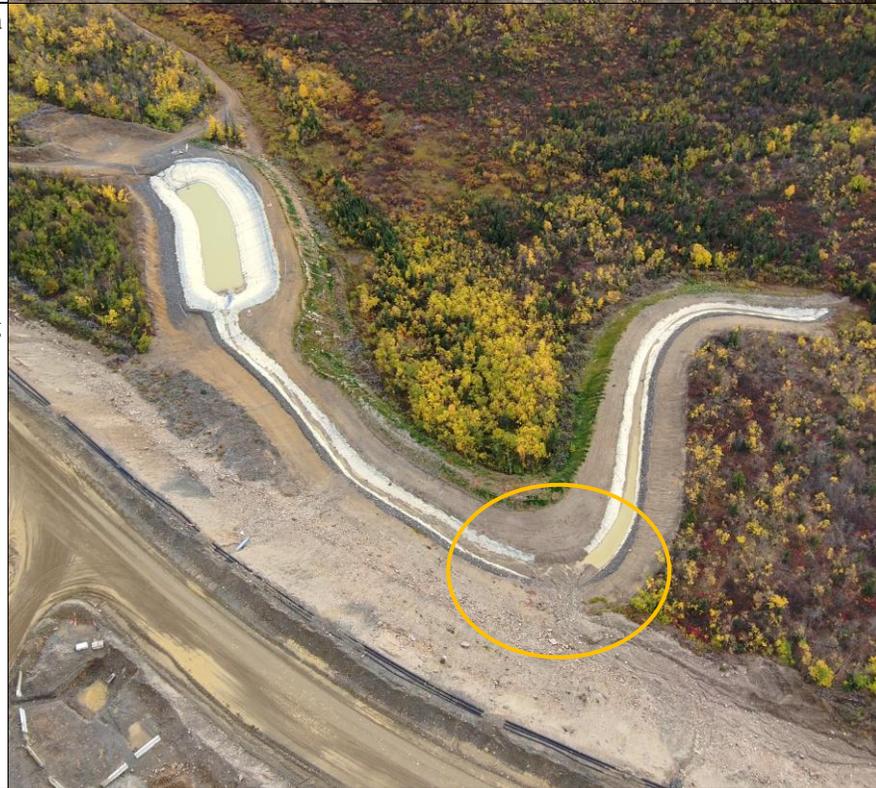
Photo 26: View of the South Ditch and Lined Pond that collects water along the eastern edge of the ore loadout yard and mine access road.

Sediment from the access road was observed to have accumulated within the corner of the ditch impeding water flow (circled).
