Photos from the site inspection:

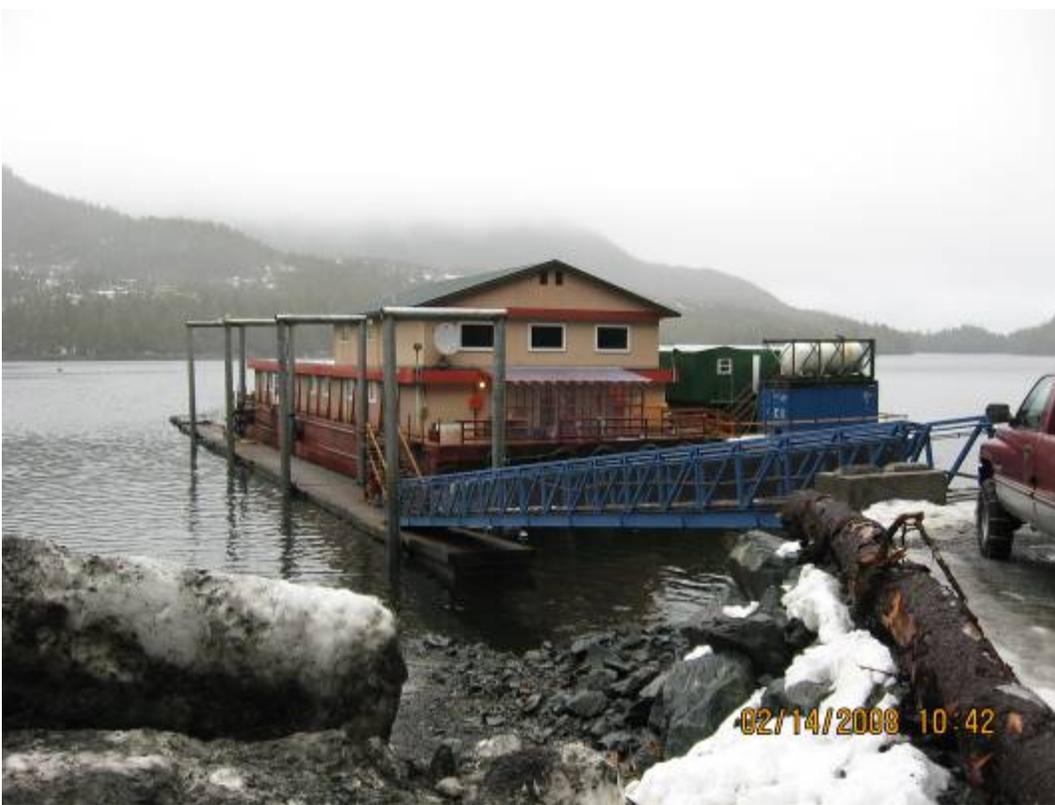
Barge accommodation at the barge landing

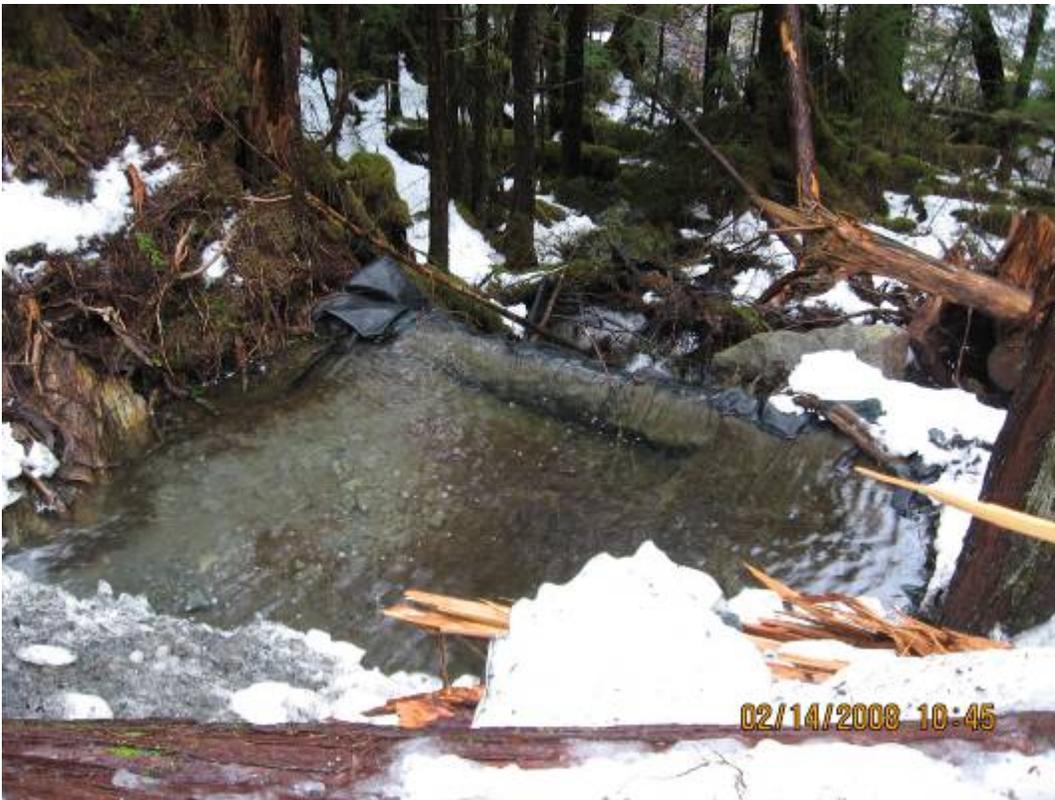
Sedimentation pond beside road

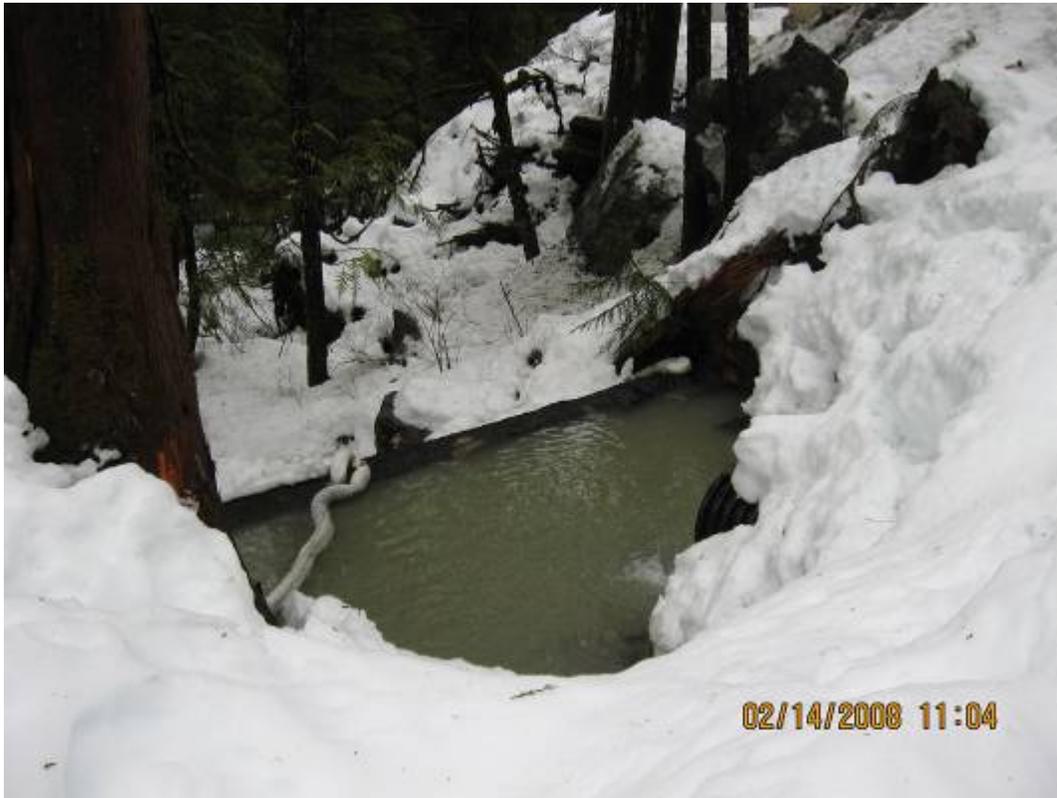
Sedimentation pond beside road with turbid water and oliophyllic sausage

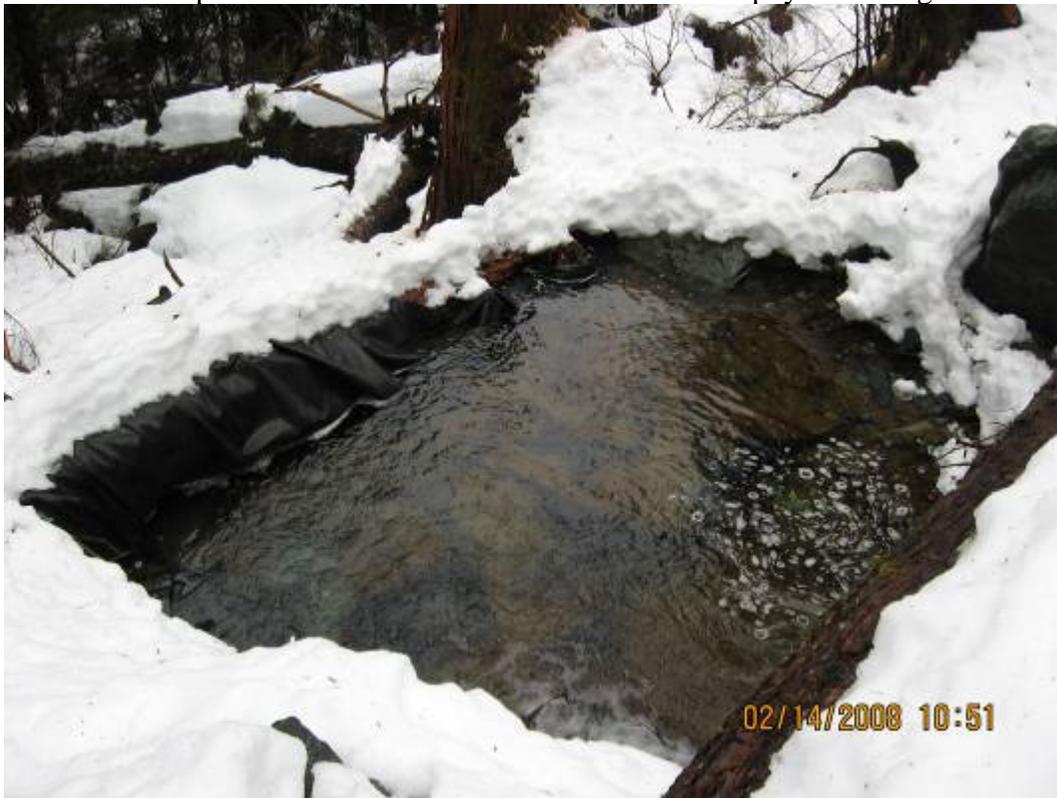
Sedimentation pond beside road

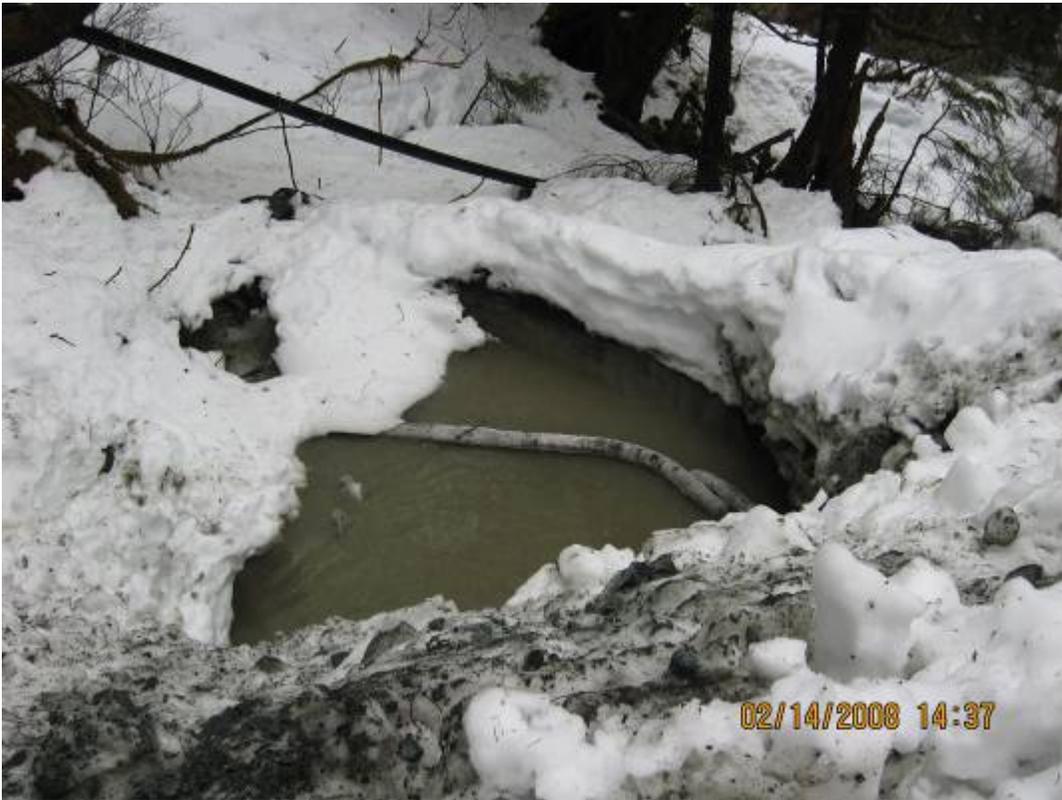
Sedimentation pond beside road with turbid water and oliophyllic sausage

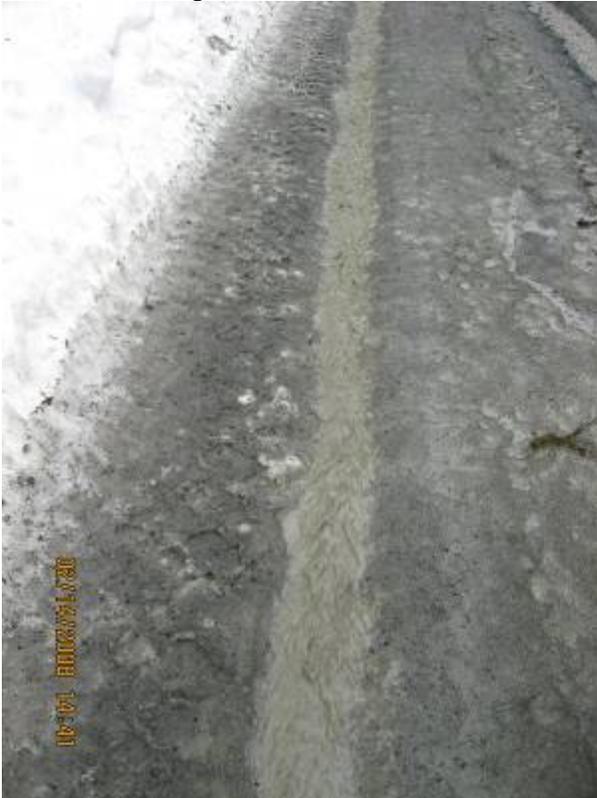
Road storm water trapped in wheel tracks

(2) Critical sections of the road were resurfaced with 3-inch minus road base and crowned so that water runs off the road. This has eliminated the channeling problem in the tire tracks very well.

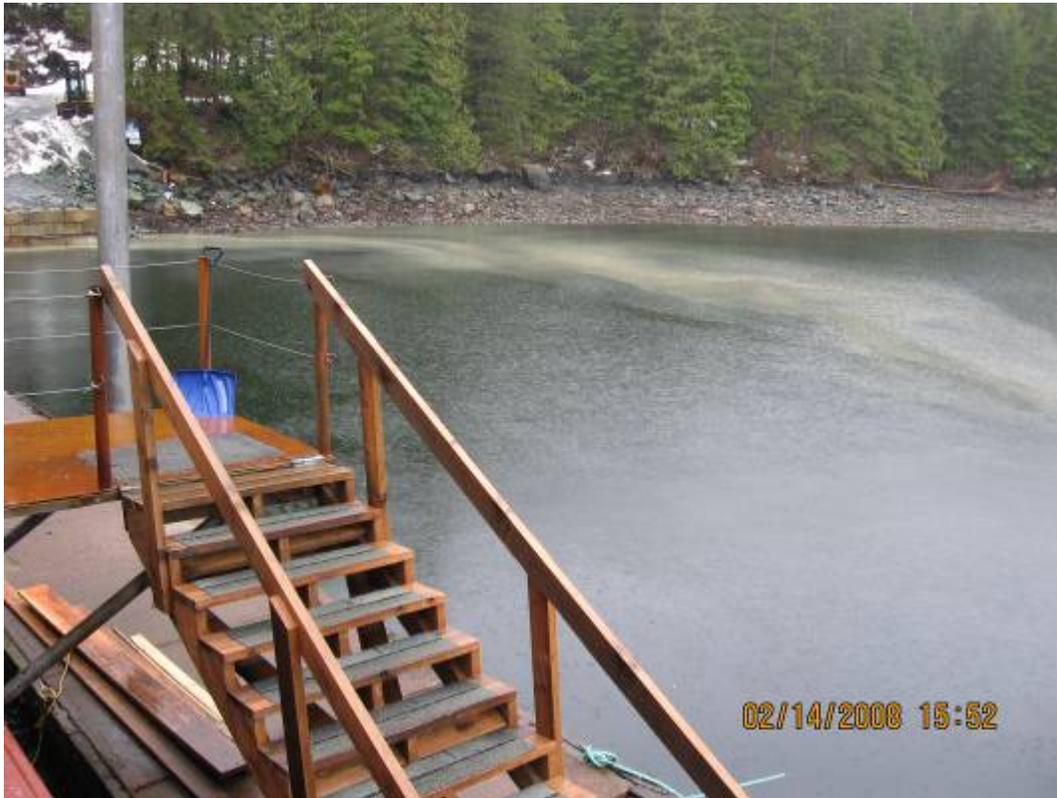
Sediment plume from road runoff

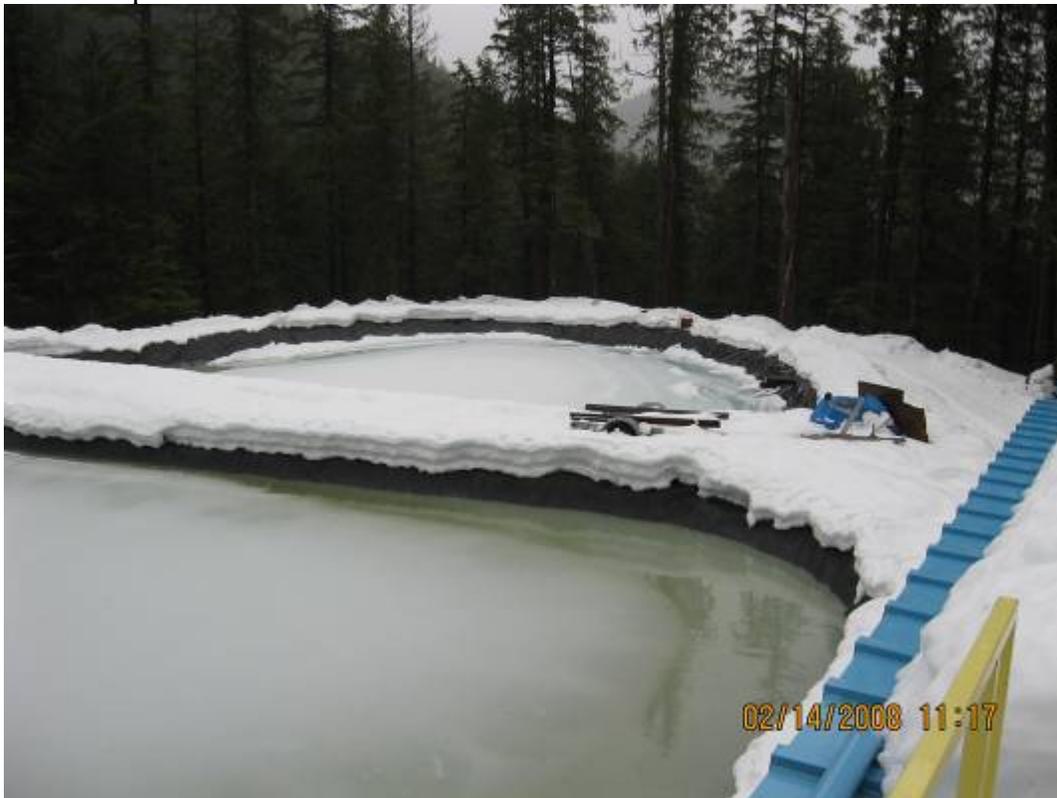
Water treatment system sedimentation basins

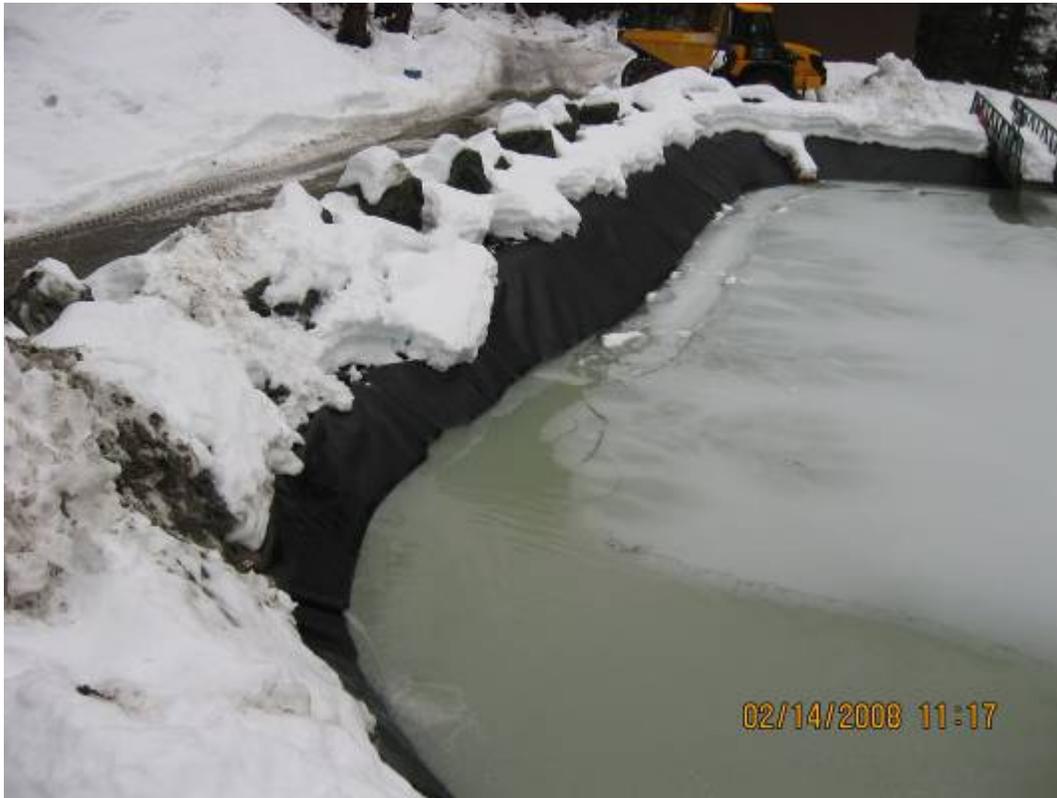
Water treatment system sedimentation basin – inlet pipe at left (~ 20 gpm)

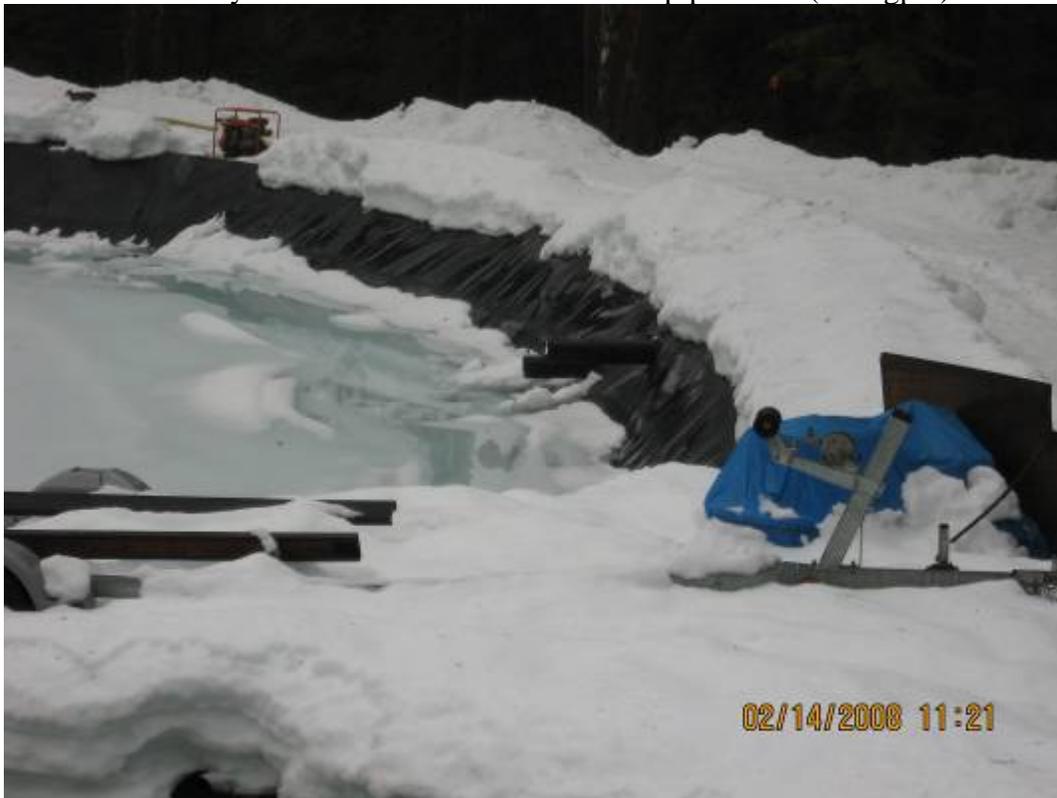
Water treatment system sedimentation basin outlet pipes

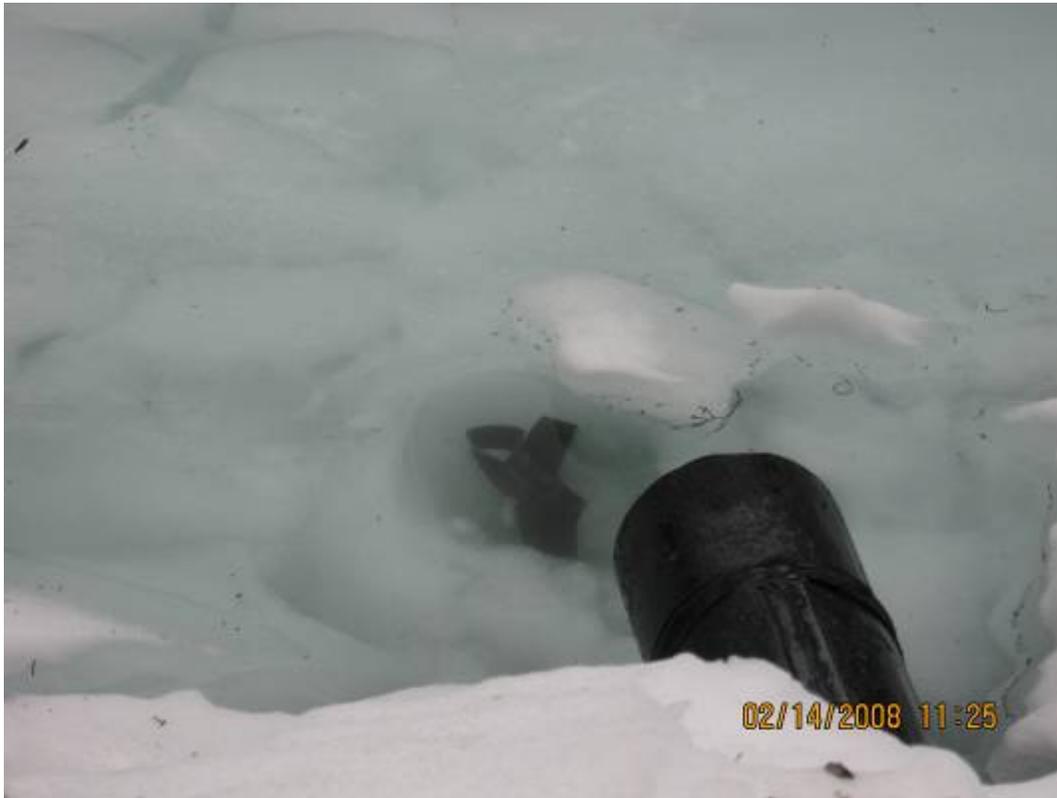
Water treatment system sedimentation basin – clear water to mine shaft

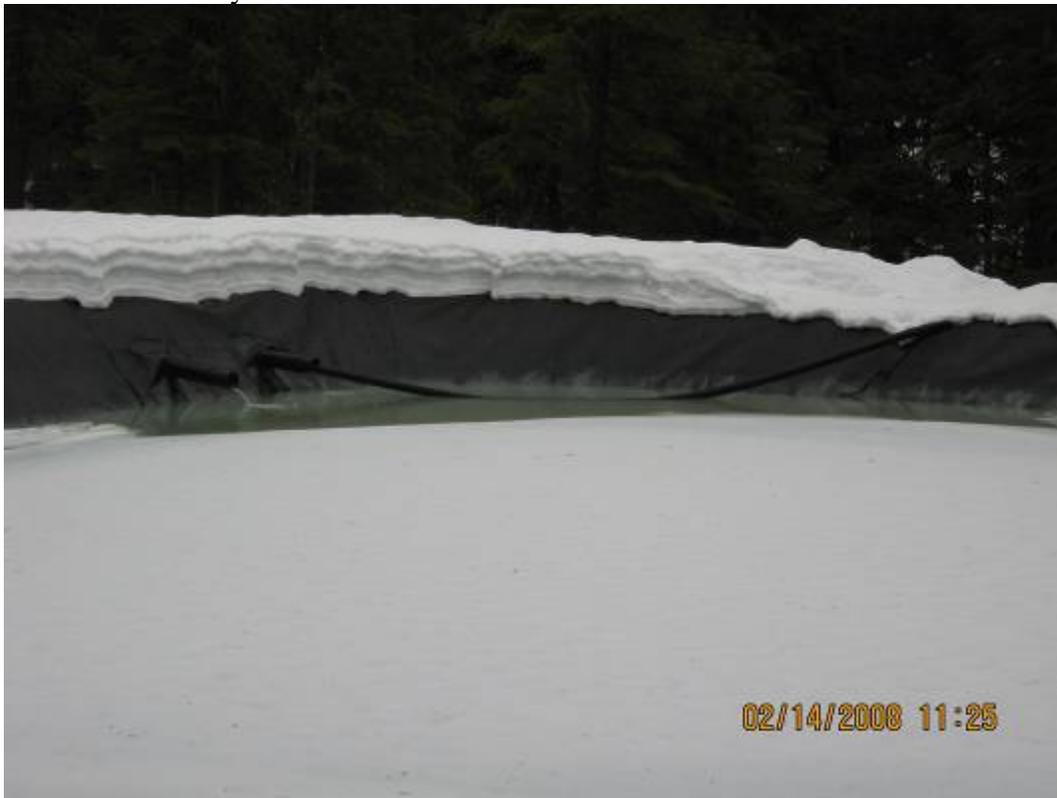
PAG line (to go on top of embankment) and pipe from upper to lower basin.

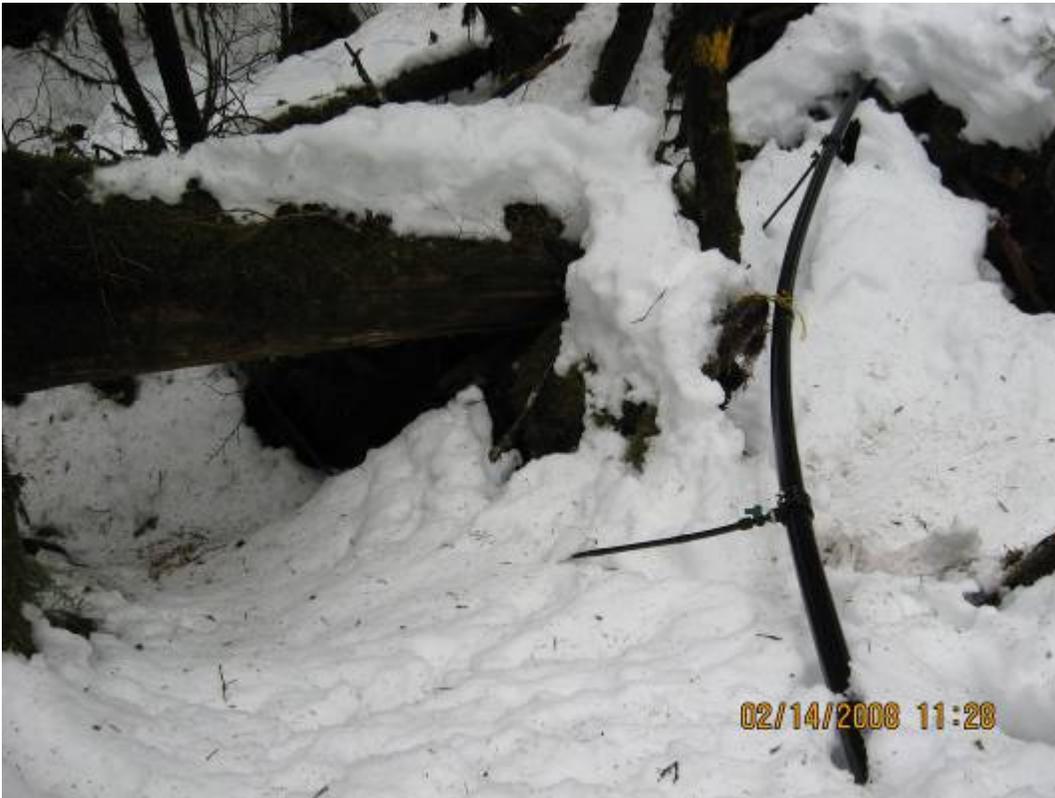
Land application lines

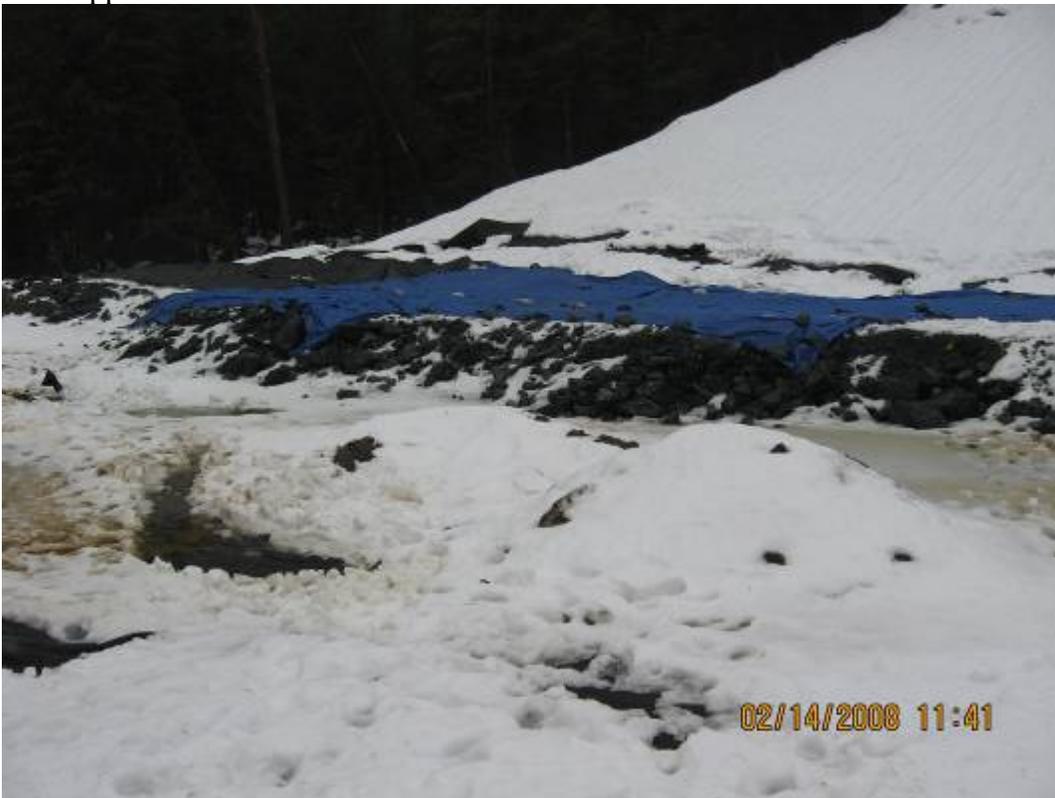
PAG site – PAG material covered by blue tarp

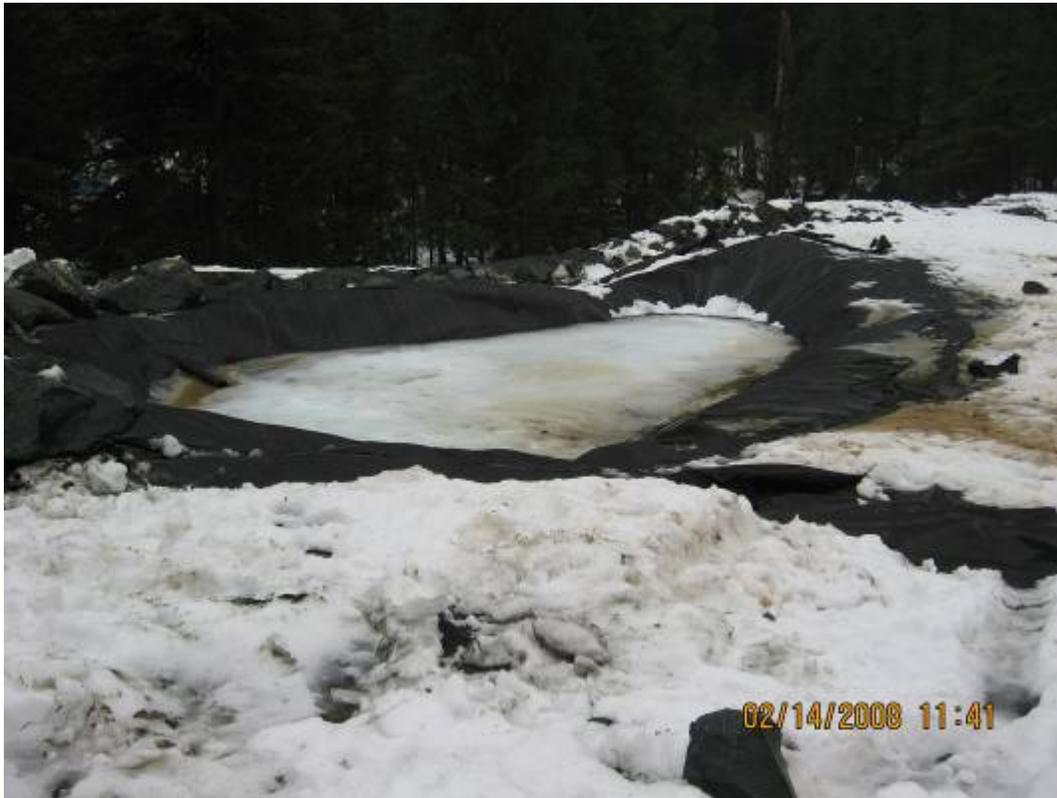
PAG site runoff collection pond

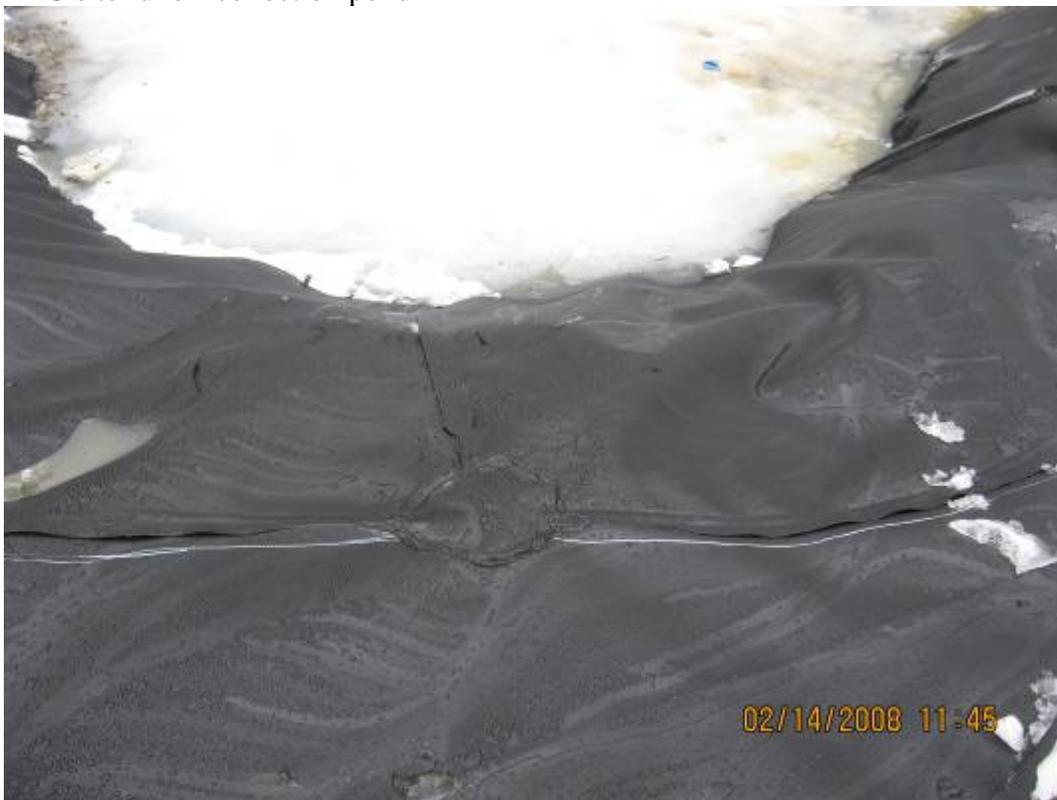
PAG site liner

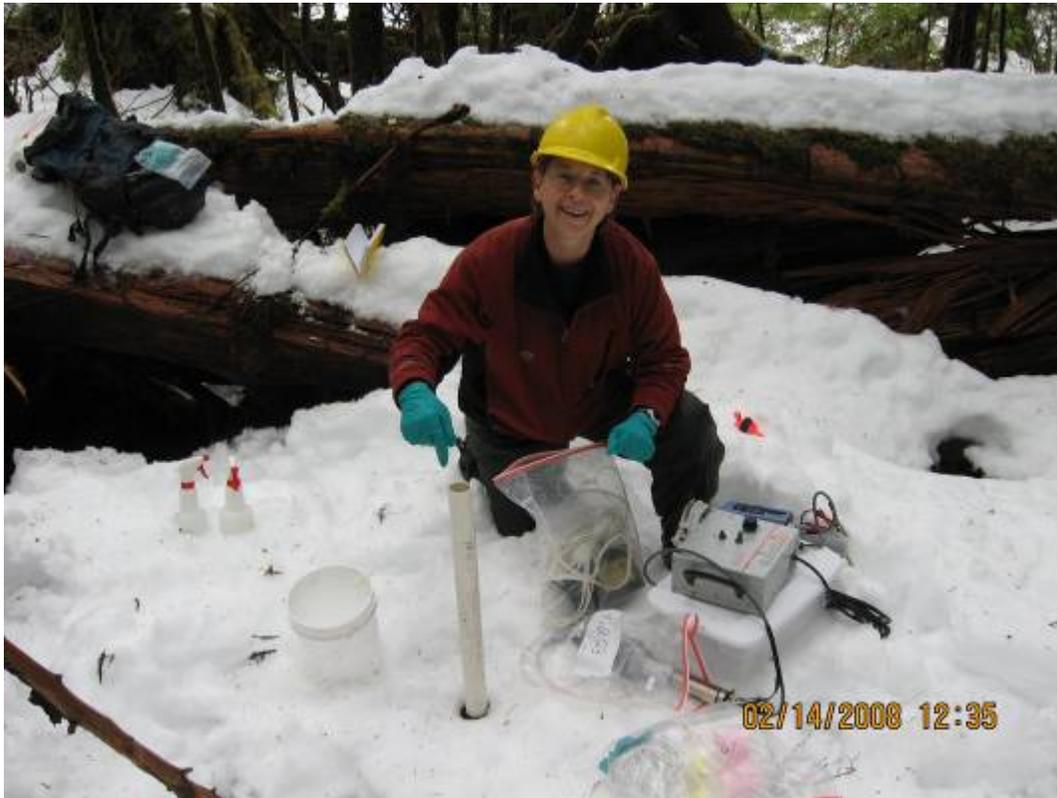
Barry Hogarty sampling MW7

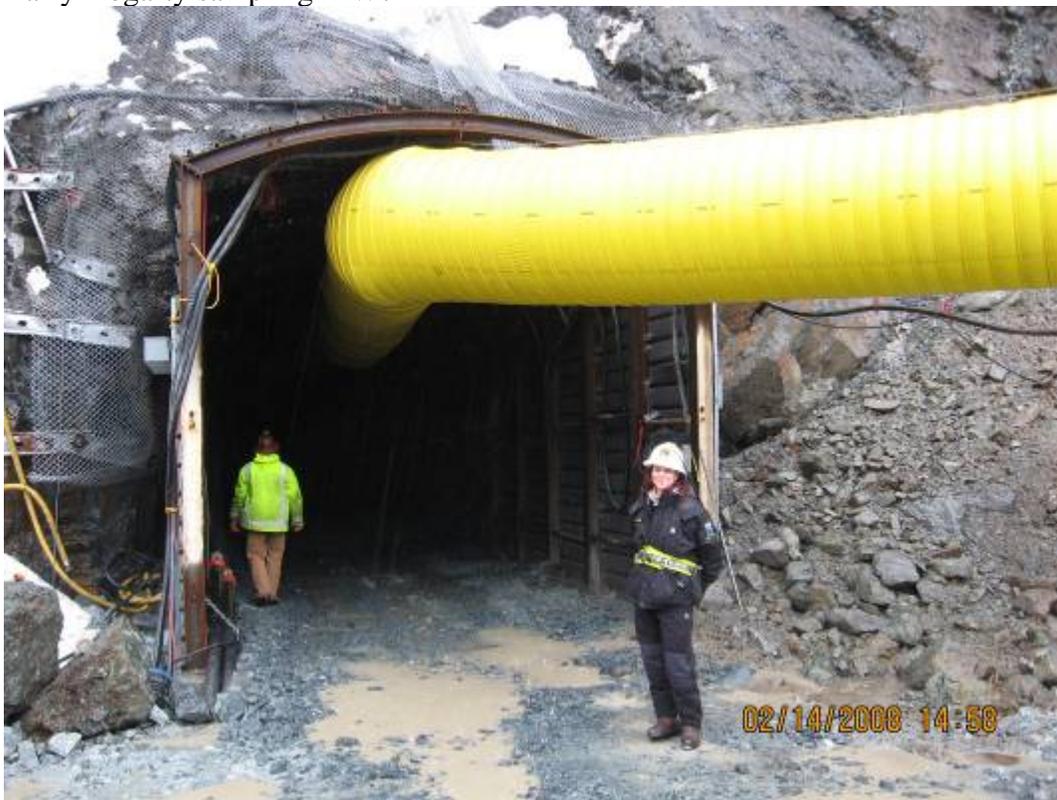
Portal entrance / Honor Carpenter, ADEC

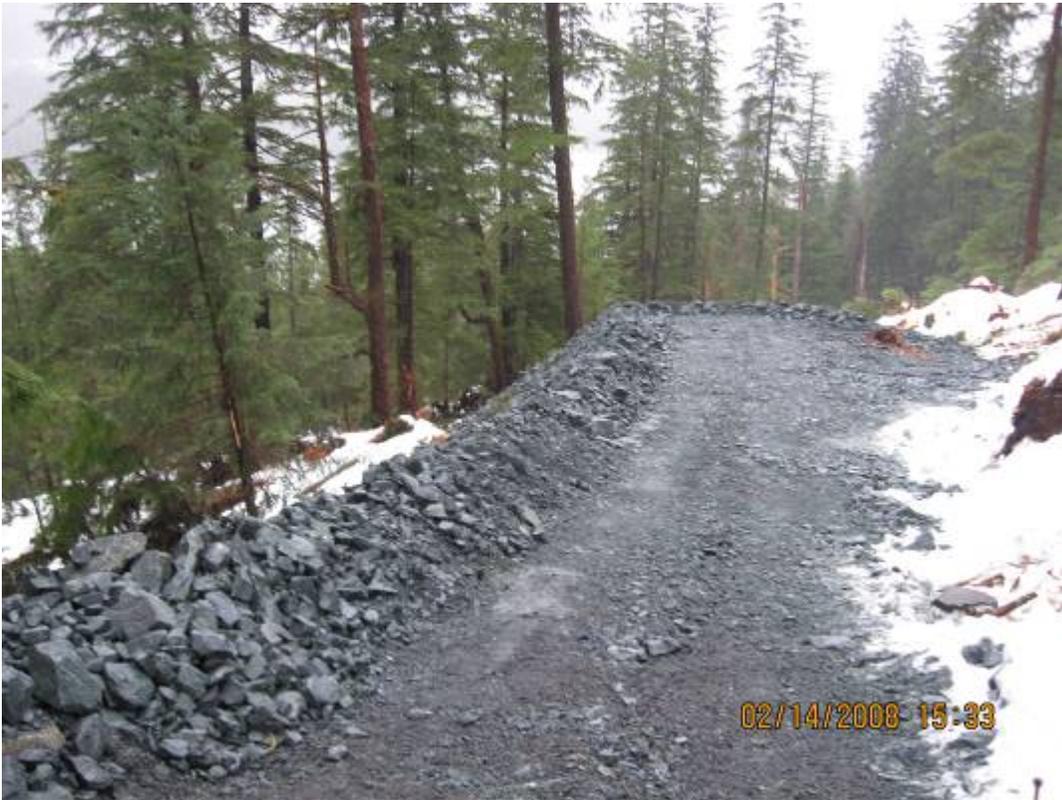
NAG site at the base of the pile
