FIELD INSPECTION REPORT NIBLACK MINING COMPANY

Inspection Date: May 7, 2008
Report Date: May 19, 2008
Weather: Mild, partly sunny with no rain
Inspection Objectives: To conduct a routine inspection of the general project area and compliance with the ADEC Waste Management Permit.
Operator Contact: Darwin Green, VP Niblack Mining Company, Geologist
State Personnel: Ed Emswiler, ADEC; Kenwyn George, ADEC
Steve McGroarty, ADNR
Other Personnel: Greg Killinger, USFS – District Ranger
Dennis Benson, USFS, Recreational Lands, Minerals & Heritage
Jeff DeFreest, USFS, Tongass National Forest Mines Manager
Laura Hudson, Project Manager / geologist
Ken Danielson, Camp Manager
Barry Hogarty, water quality sampling
Redpath construction foreman
Documentation: Photos were taken and are available for inspection at ADEC in Juneau

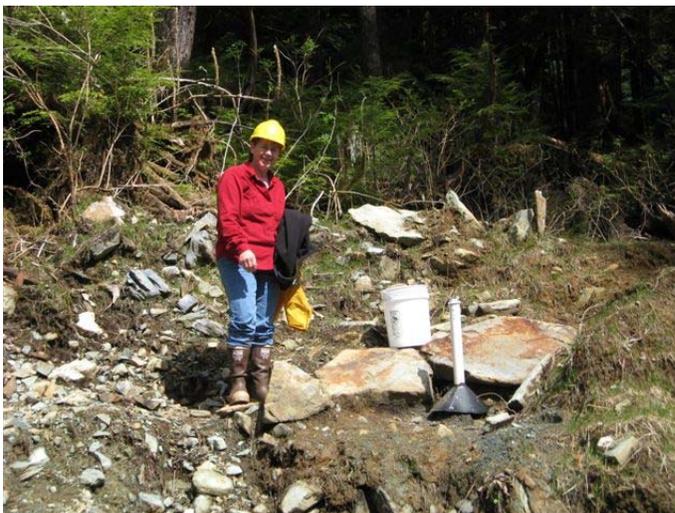
Sampling Sites: Barry Hogarty provided a tour of the surface water and shallow well sampling sites. Wells were drilled to a depth of approximately 2.5 feet and the well casing was installed to approximately 2 feet with slotted PVC pipe. They were completed with silicone sand and bentonite was placed above the slots. Samples are taken after 3 well volumes are removed. Samples results are generally low in dissolved oxygen and pH with an odor of H₂S (which is an indication of surface water from the natural peat layer that surrounds the wells).

Barry Hogarty at a ground water monitoring well. Cone installed around the pipe to shed surface water so that a better ground water sample can be obtained.

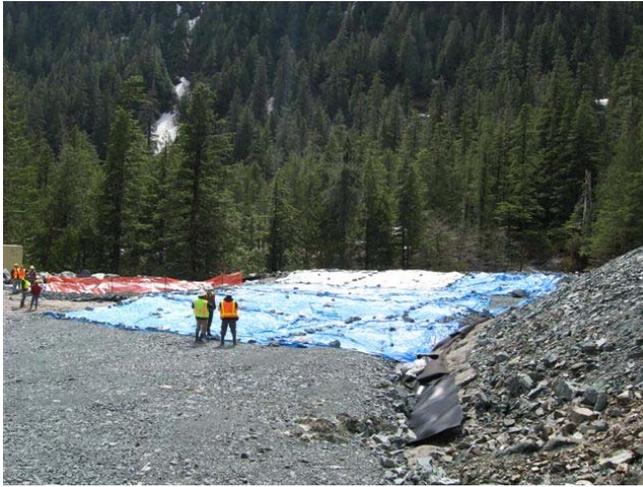
Potentially Acid Generating (PAG) Rock Site: Approximately 6 blast rounds have been stored at the PAG site. This rock is approximately 4 feet thick and cover an area of ¼-acre The rock had been largely covered by a blue tarp to shed water and minimize contact with the waste rock. According to Kenwyn George, additional rock did not appear to have been added to the site since his site visit on February 14, 2008. Water in the holding pond associated with the site was probably mostly non-contact storm water with a smaller amount of contact water. Visual

PAG site with PAG waste covered with a blue tarp to shed rainwater. Some seeps through, so future rock will be laid with a surface slope to shed the water.

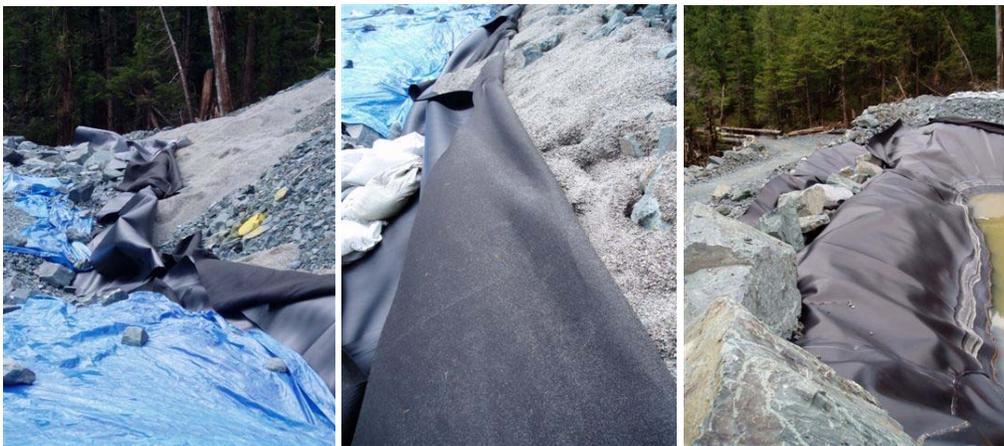
According to Darwin Green, the liner system was constructed as follows:

1. 6-inches of sand bedding directly over the bedrock foundation.
2. Geotextile
3. 80-mil HDPE
4. Geotextile
5. 6-inches of sand as a service layer
6. PAG waste rock

According to the approved plan, there would be 1-foot of both sand service layer and bedding layer. The 6-inch sand layers represent a deviation to the approved plan and may have an effect on the integrity of the liner system. This should be verified for accuracy. An action item to this report would be that Niblack Mining Company submits as-built drawings of the facility with photos taken during construction showing the thickness of the various layers.

Liner system showing sand, geotextile and geomembrane. Right photo shows how the liner is anchored.

1. Inform the Department of how you will clean the ponds without breaking the liner system, what depth of sediment that will trigger cleaning of the ponds, and when you think you will first need to clean the ponds, if at all
2. Submit as-built drawings of the PAG site with photos of the construction showing the thickness of the various layers of the liner materials including the sand bedding and service layers. Verify the thickness of the sand bedding and service layers.
3. Because of irregularities in the construction of the PAG facility having to do with leak detection, the fractured foundation, possible issues regarding the thickness of the service

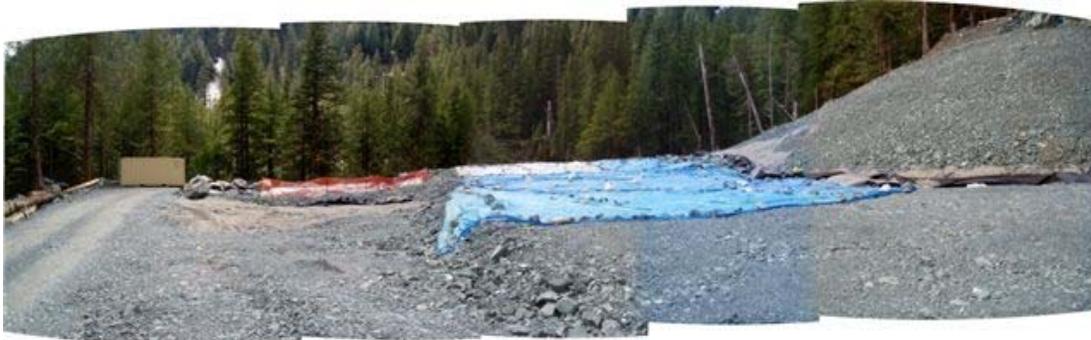
PAG site lined pond and backslope

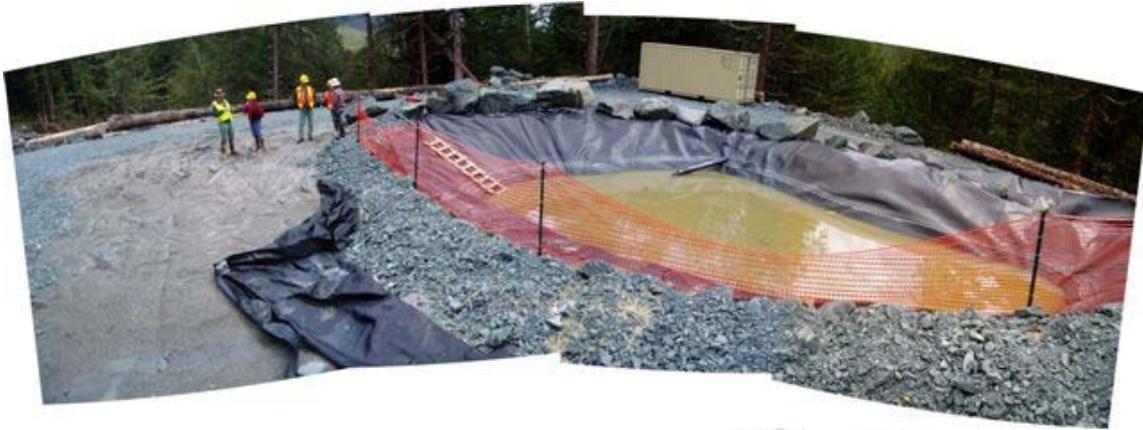
PAG site lined pond that flows by gravity to the sedimentation ponds

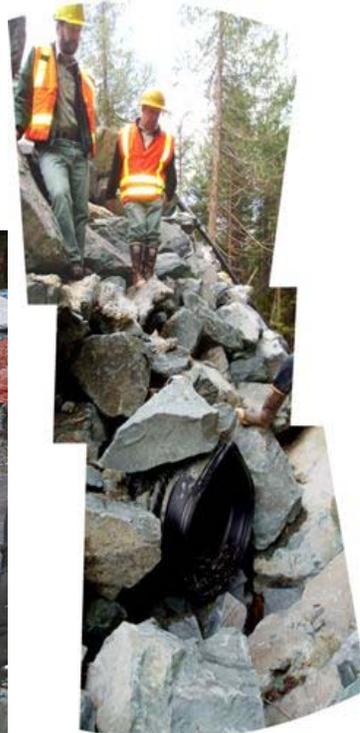
The leak detection culvert beneath the PAG site was observed. No water was detected leaving the culvert. The perforated PVC culvert was placed at the lower aspect of the facility and surrounded by rock prior to placement of the liner system mentioned above. Mr. Green reported that blasting of the rock pit in preparation of the foundation may have created small cracks or fissures in the foundation rock and that the leak detection system may not fully be able to collect all of the water passing a ruptured liner because of these cracks. This means that the leak detection system will not be 100% effective at detecting leaks in the liner system.

PAG site underdrain

Because of this, Niblack is advised to ensure that operators work to maintain the integrity of the liner during disposal operations and diligently conduct visual inspections of the leak detection system. At closure attention will be given to ensuring that all of the stored PAG/ML waste will be picked up from the PAG facility and placed back into the exploration adit. **SEE ACTION ITEMS.**

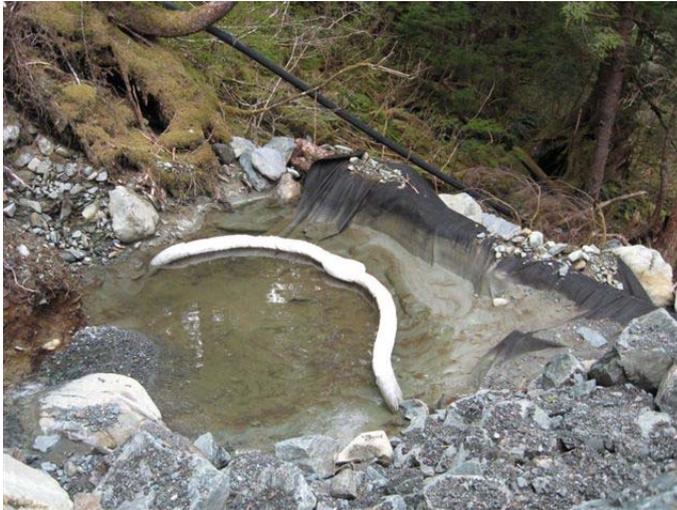
Storm water. Because it had not been raining and was not raining when we were at the site, the efficacy of the storm water ponds could not be judged. However, there did not appear to be sediment downstream of the ponds. A pond that collected storm water from the portal and adjacent landing area had an oil absorbent boom in it.

Storm water sediment pond with oil collection boom to capture residual hydraulic fluid from a spill at the mine portal.

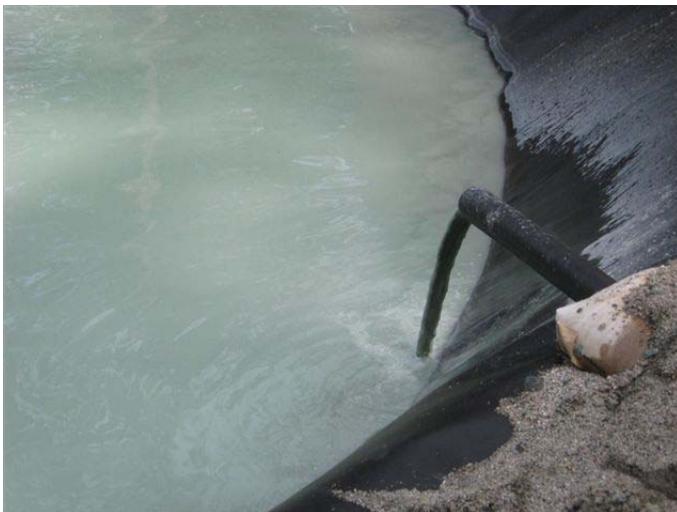
Sedimentation Ponds: The two sedimentation ponds for the mine dewatering water were full and operating. Water entering the first pond from the mine at a rate of ~ 40-45 gpm was extremely turbid and sediment laden. A gravity feed drip flocculent tank was located at the inlet to the ponds, however, the efficiency of the feed is poor because of variation of flow into the pond (mine sump pump is either operating or idle). Water was then allowed to flow into a second pond by gravity via surface outlet pipe work between the two ponds opposite the inlet to the first pond. Water from the “Potentially Acid Generating (PAG) Site” was allowed to drain by gravity into the second pond because the small flow and metals loading of the discharge from the PAG facility was low. The flexible pipe that delivered water at the ponds could be positioned at either pond. There was marked visual turbidity to the water of the first pond. The visual turbidity in the second pond was markedly less. It appeared as though the sedimentation process via gravity between the two ponds was somewhat effective. Water quality from the ponds, for the two samples taken in 2007 was seen to be low in metals and not adversely impacting the quality of ground water.

Mine dewatering water entering the first water treatment pond.

There needs to be a system in place to clean the ponds without breaking the liner system. **SEE ACTION ITEMS.**

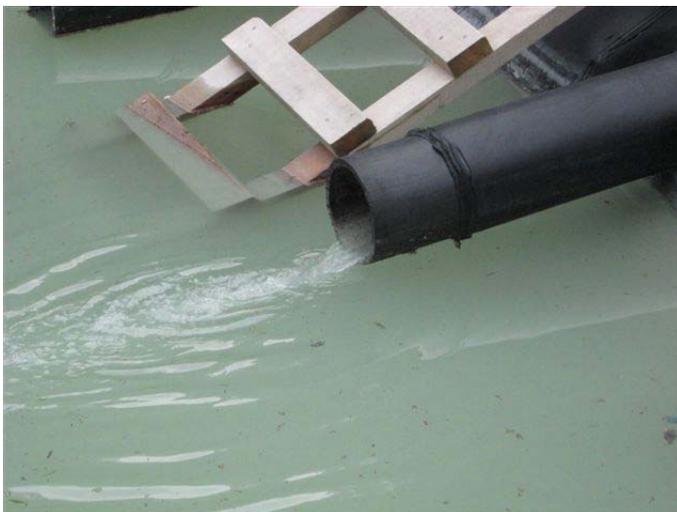
Water partially treated – sediments reduced by the use of flocculants – this water is passing from the first to second treatment ponds.

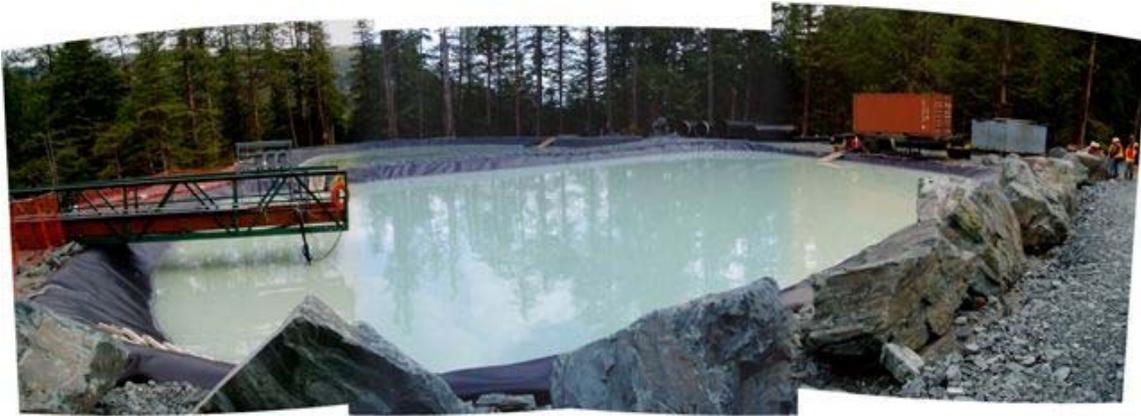
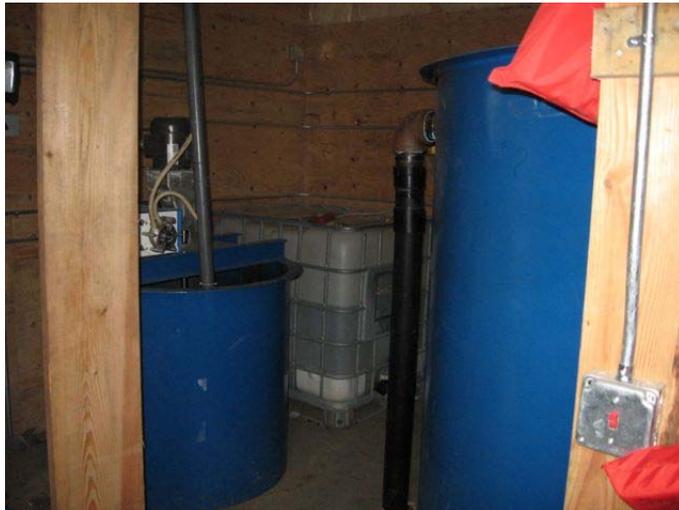
A water treatment plant constructed at the sedimentation ponds was complete but has not yet been used. The main purpose of this plant is to adjust pH (with lime), A secondary purpose is to increase sedimentation in the pond by the use of flocculants. The capacity of the plant is 140 gpm. It contained a tank where lime is added from a chemical feed pump and batch tank and then mixed for 15 minutes. After lime treatment, the water is then transferred into another tank where a flocculant is added from another chemical feed pump and batch tank and then mixed for 15 minutes. After treatment, the water is delivered by PVC pipe to the second pond for sedimentation.

Water treatment plant with lime mixing tank, lime contact tank and flocculant tank.

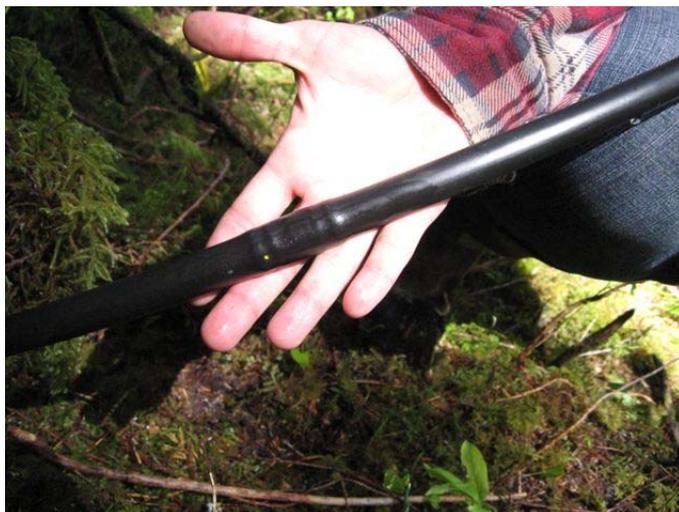
Drip Emitter System: As mentioned above there is some turbidity observed in the second pond; some of this fine material clogs the fine drip orifices in the land application drip lines. The capacity of the drip lines is 150 gpm; to date the maximum flow has been 80 gpm. The average flow has been approximately 28 gpm and approximately 780,000 gallons has been delivered to wetlands through the system since April 24th. At the end of each drip line is a valve that is routinely opened to flush the line. Niblack is considering creating larger holes at less frequent intervals. Presently there are drip holes every 1-foot along the lines, which are on average 6-feet apart. Each hole in the emitter system was capable of dripping 1 gallon of effluent per hour. Because of the very slow and widespread drip irrigation, there is no surface runoff from the effluent. Also because of the low flow only a limited amount of the total infiltration area is in use. Safety equipment around the pond includes life rings and ladders, and there was a life jacket in the treatment building.

Land application drip line.
