PEBBLE PROJECT

2021 Reclamation Report

MLUP No. 6118

DECEMBER 2021

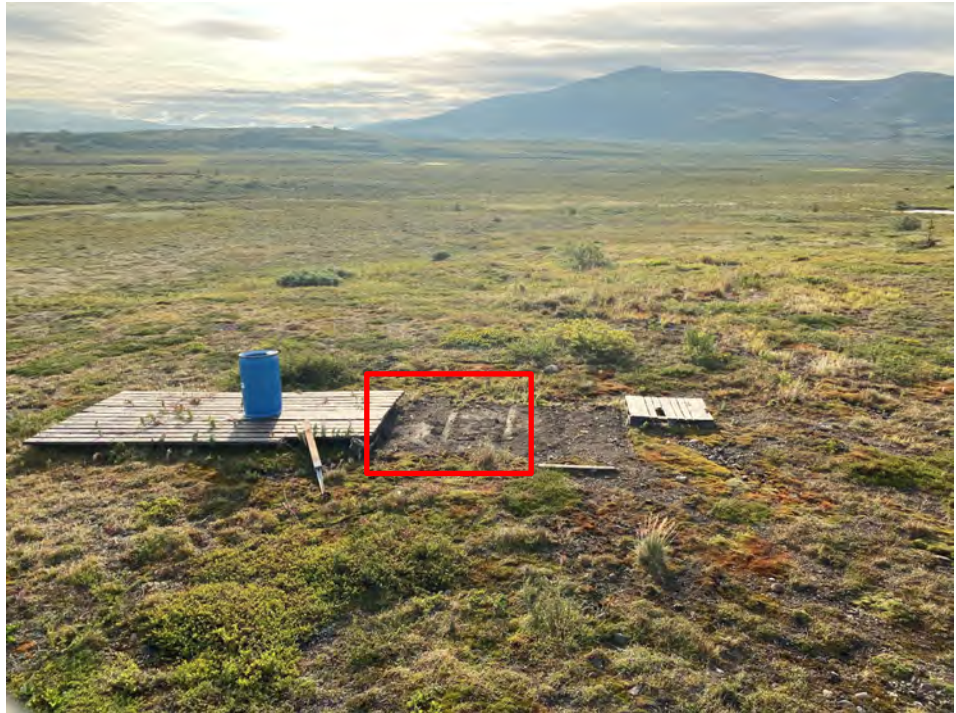
4. Borehole 11531
Former West Bay 4 site.

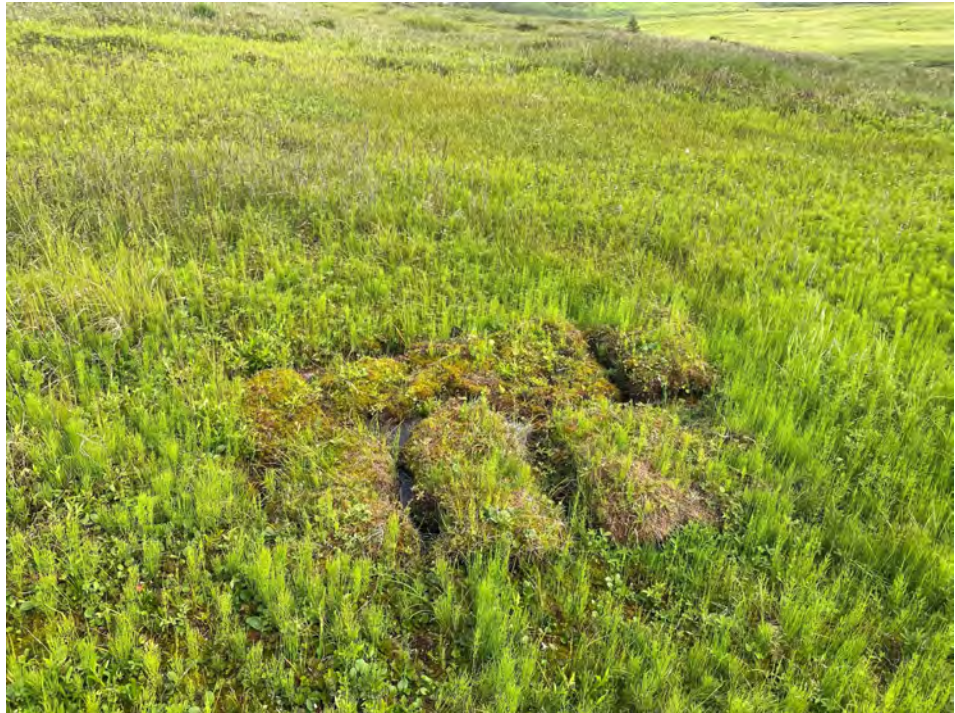
28. Borehole GH08-156

Borehole repaired and reclaimed in 2020. Photo shows post-reclamation site on 7/23/2021.
