DIVISION OF MINING, LAND AND WATER

## Field Inspection of the Pebble Copper/Gold Project

July 26-27, 2007

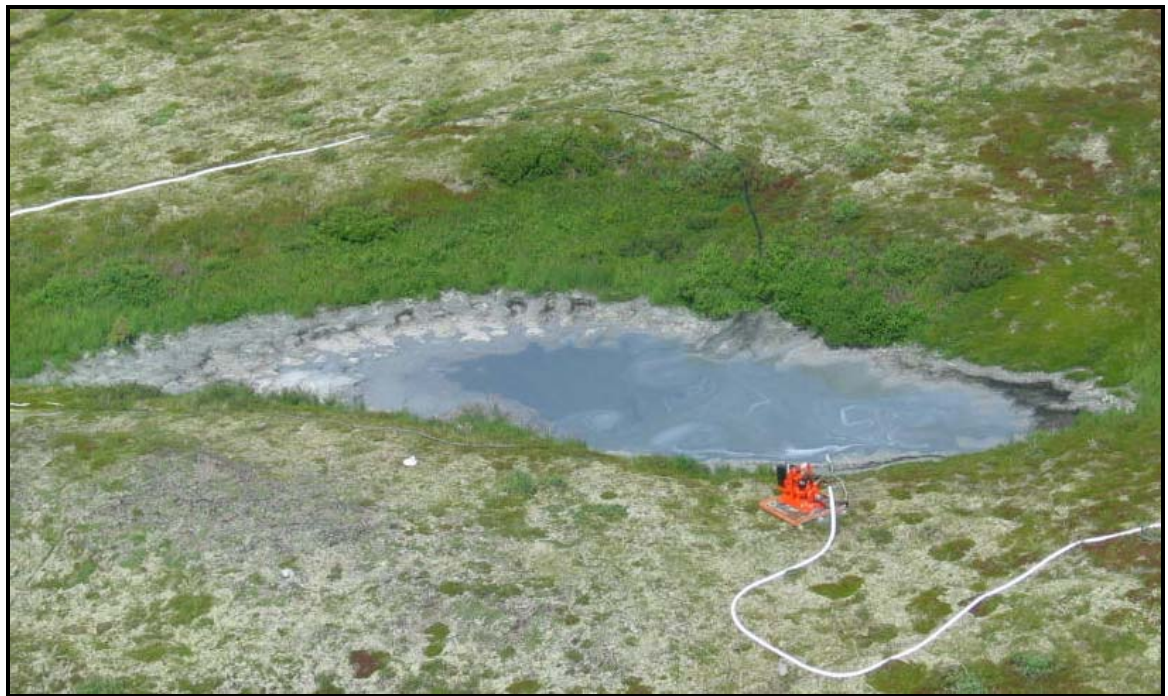
There is some concern in places where multiple wells are being discharged into topographic depressions. This practice can result in considerable amounts of clay material being deposited in the depression. (See photo #14.) It might be better to discharge the water over a larger area. However, by depositing the clays and cuttings

Photo #14. Clay deposited in a dry depression by discharged drilling fluids.

in only a few depressions, there will be less area to reclaim after drilling. Alternately, Northern Dynasty might use a flocculant in their sumps, precipitating the clays in the pits, for later burial. Another alternative is to recirculate the drilling fluids. We are talking to Northern Dynasty personnel about the possibilities.

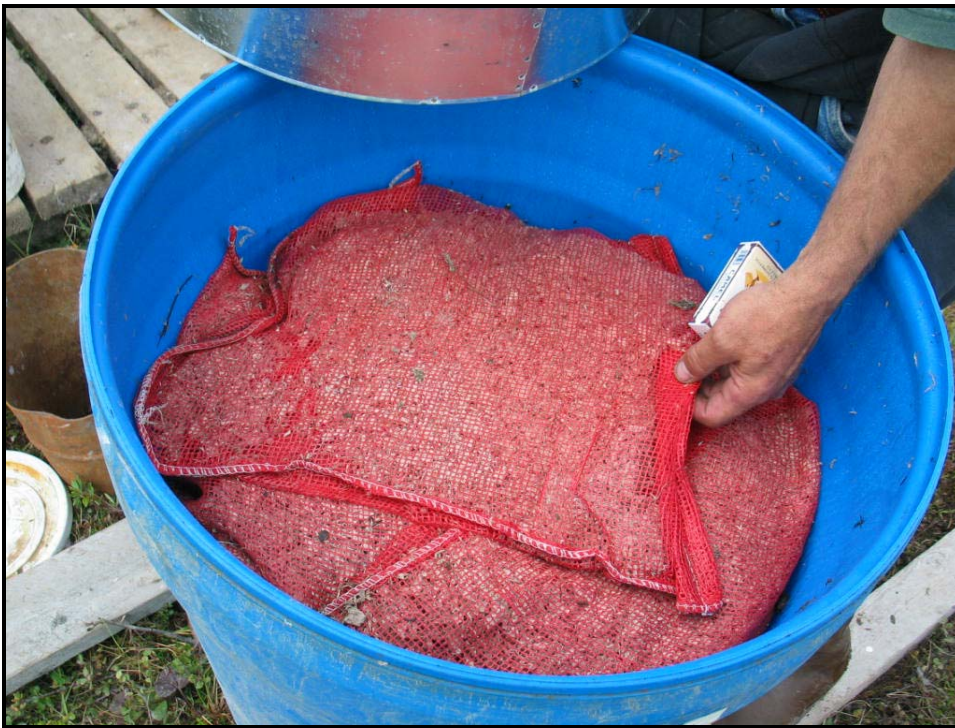
- Spill kit and scrubber barrel. The spill kit contains absorbent materials for cleaning up spills. The scrubber barrel is filled with a material that separates petroleum products from water. Any accidental mixture of petroleum and water is poured in the top. Hydrocarbons are trapped by the material, and water flows out of a hole at the base of the barrel. (Photos #16 and 18)

Photo #18. Petroleum absorbent material in a scrubber barrel.

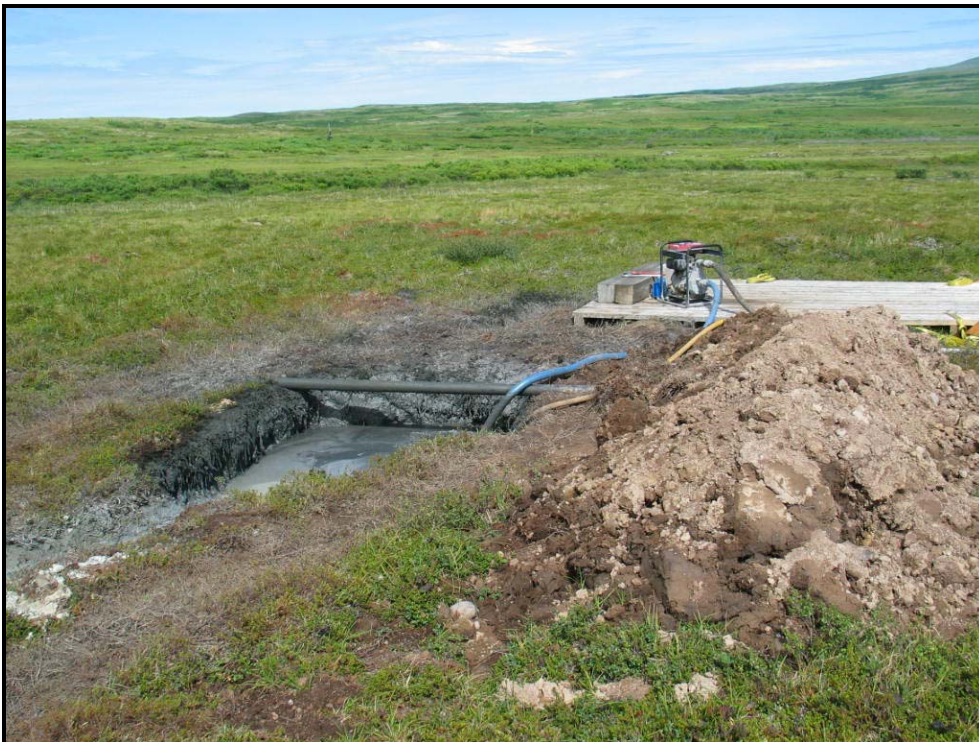
Photo #19. Sump at drill #6.

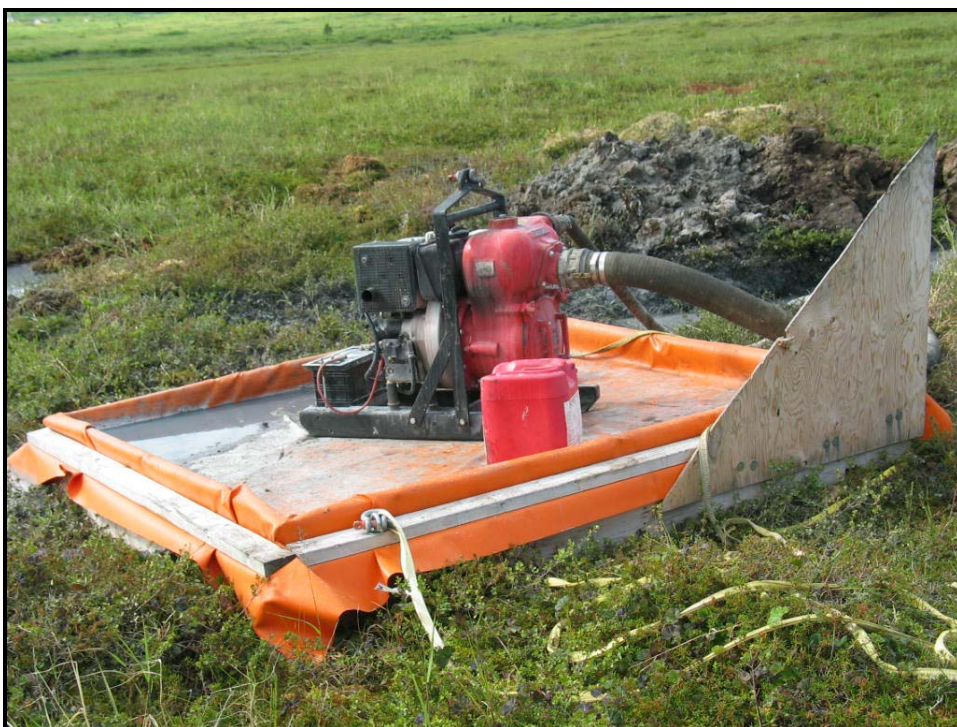
Photo #23. Sump pump at drill #7. Pump is in a containment structure due to proximity to wetland.

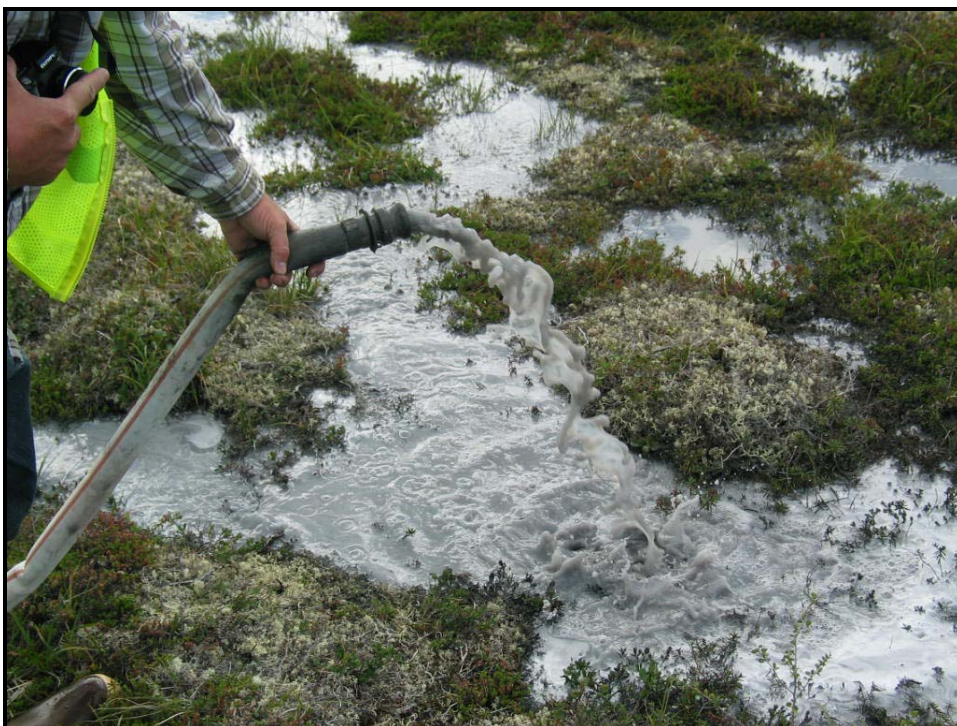
Drill #7 (See photo #21) was operating in a lowland about 300 yards south of Upper Talarik Creek, close to a wetlands. The drilling return was being pumped about 150 yards up hill away from the wetland. The water seeps into the ground over a short distance. (See photos #24-26.)

Photo #24. Drill #7 discharge onto tundra.

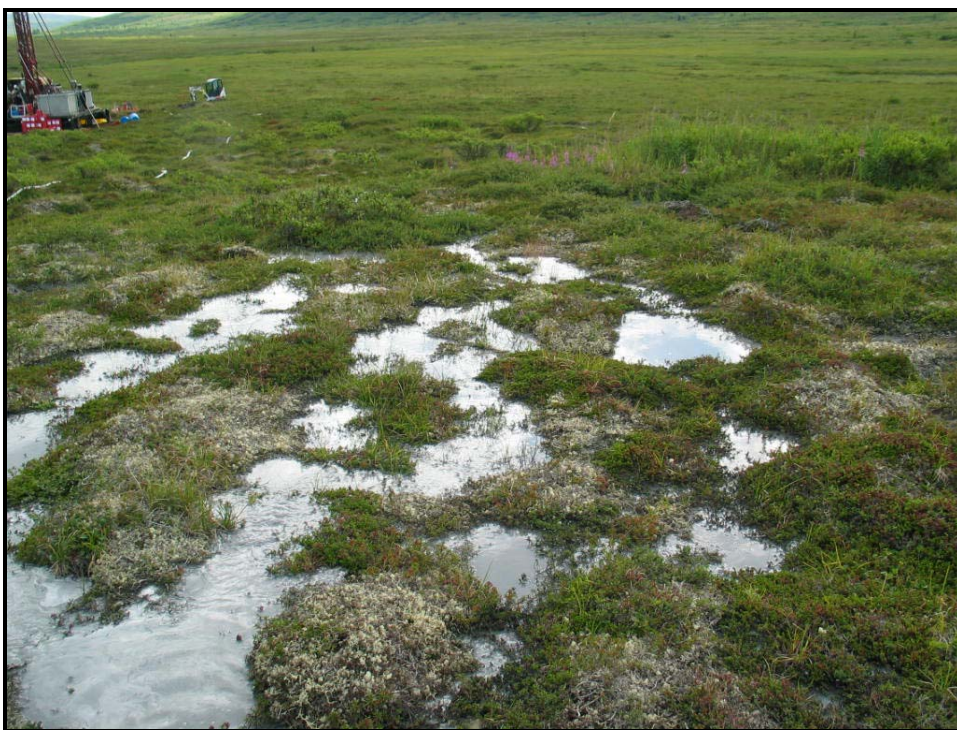
Photo #25. Drill #7 discharge onto tundra. Water seeps into the ground over a short distance.

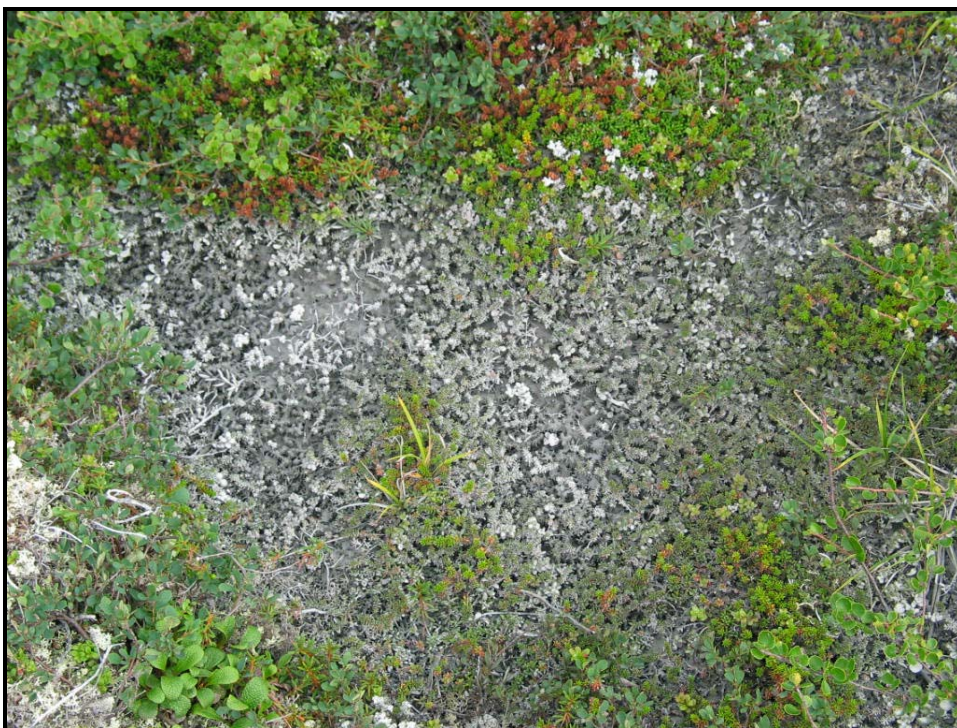
Photo #25. Clay residue left on tundra from drilling discharge.

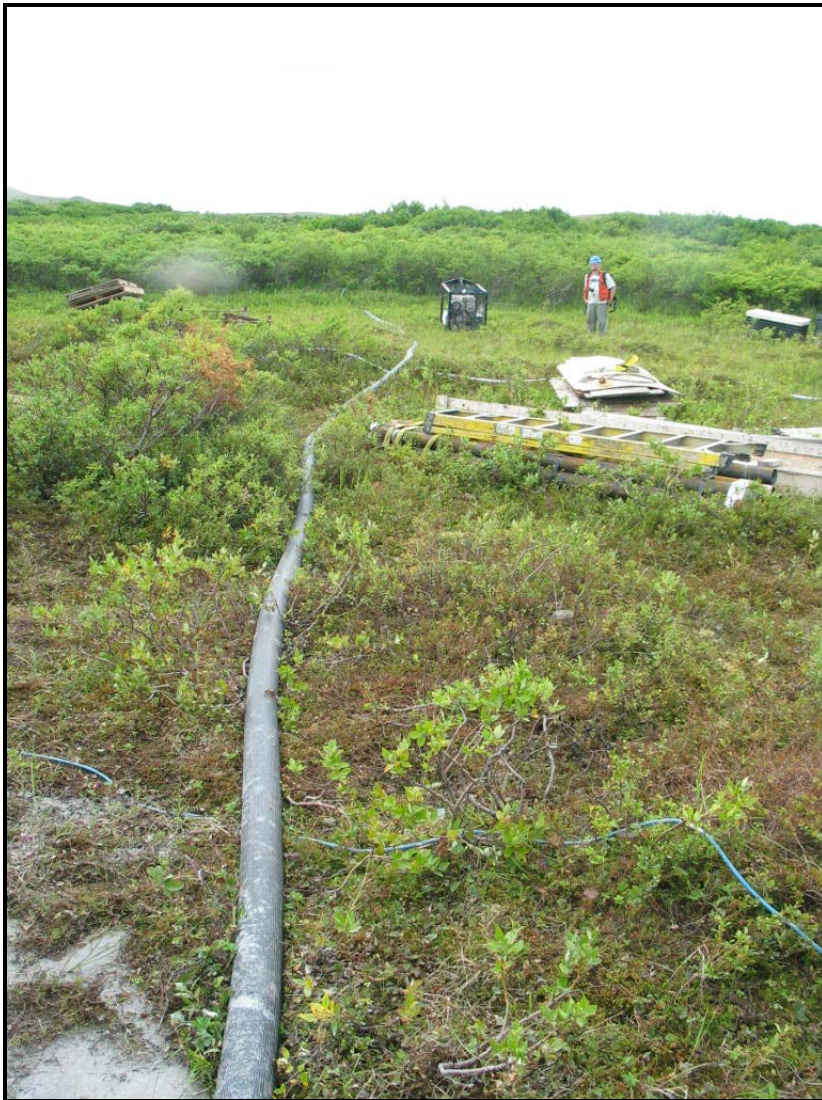
Photo #27. Hose carrying drilling fluids uphill to a topographic depression.

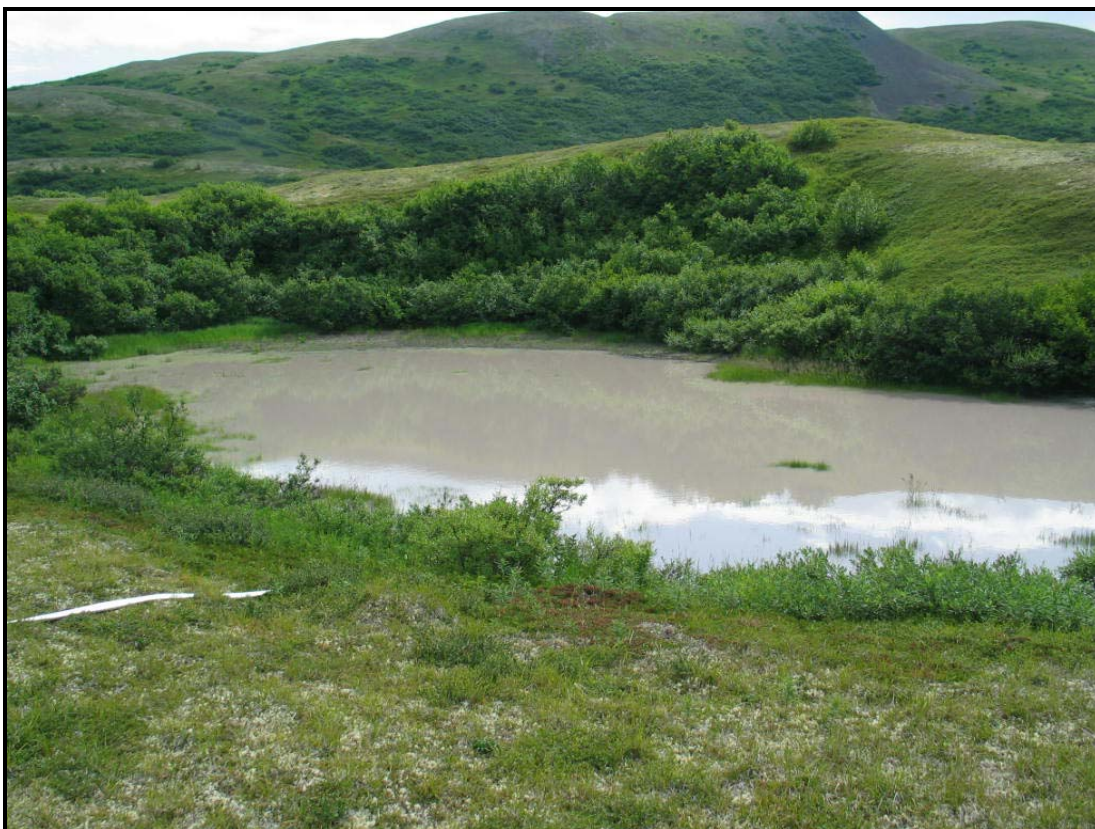
We also inspected drill #1 on the second day. According to the driller's estimate, the hole was making 15-20 gallons of water per minute into the hole, but there was no artesian flow to the surface. There have been no artesian flows from any wells drilled to date in 2007. This hole is located near the 2006 hole that produced a strong artesian flow. (See Southwest Alaska Mine Inspection Tour, 6/14/06-6/16/06 report, by Bill Cole.) Drilling fluids are being pumped approximately 3/8 mile up hill and discharged into a previously dry depression. (See photos #27 and 28.) No drill water is being discharged into any existing water body.

Photo #28. Topographic depression with discharged drilling fluid.

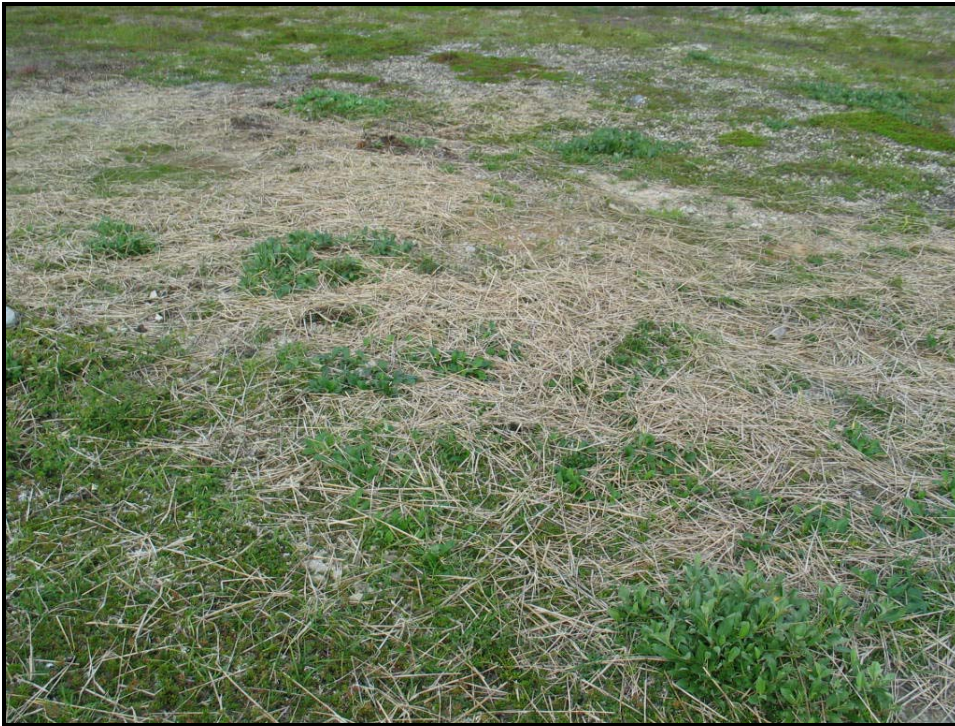
Photo #39. Reclamation at DDH 7364. Site has been treated with straw to prevent erosion, and seeded with grass. Note new vegetation.

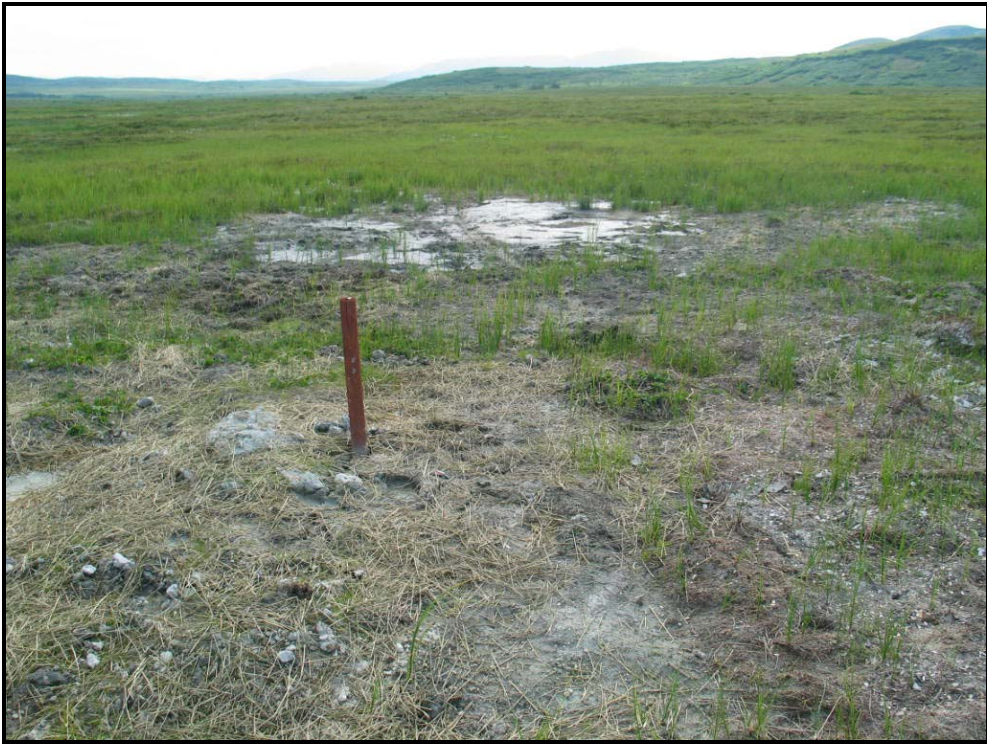
Sumps could not be dug for some of the holes drilled this past winter and spring (fewer than 10) because the ground was frozen. (See photos 46 and 47 in Part II of this report.) Cuttings and drilling fluids from these holes were discharged directly onto the ground. This is a customary practice, and is generally allowed. However, Lena Brommeland, of Northern Dynasty, has informed me that they are currently working to identify drill locations for the coming winter and dig appropriate sumps in advance. This should result in few, if any holes having their cuttings deposited directly onto the tundra.

Photo #46. DDH 7358. This is one of the holes drilled during the spring without a sump.

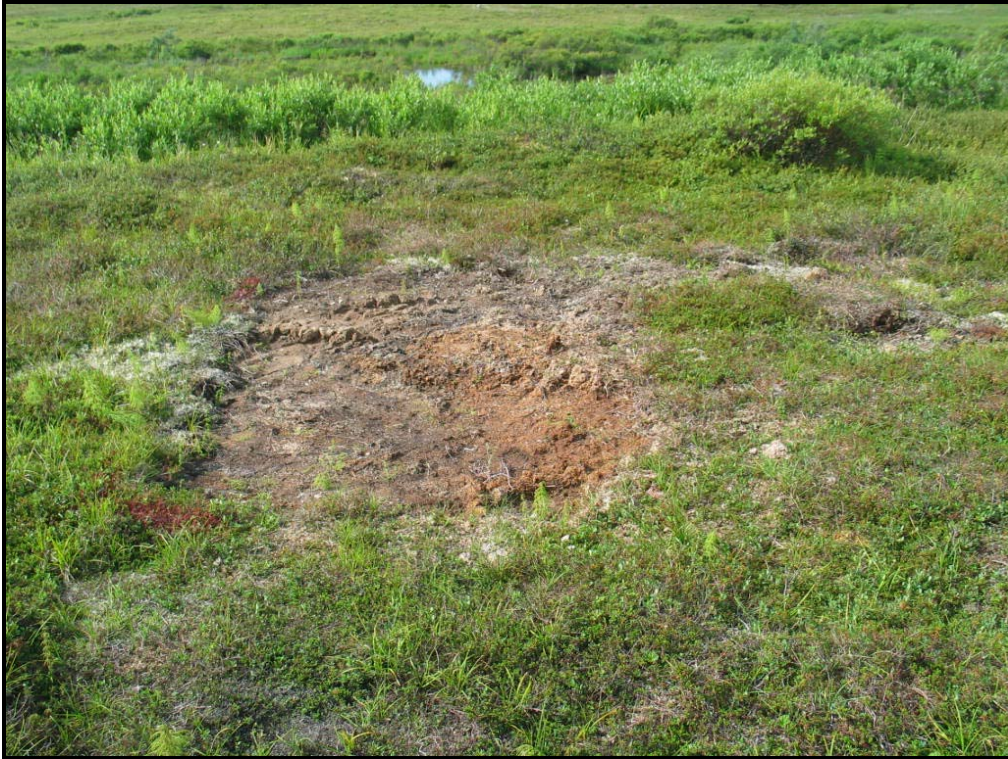
On May 9, 2007 Northern Dynasty had a small spill of 2-5 gallons of diesel fuel while slinging a fuel tank away from DDH 7366. The tank nozzle caught on the containment wall and broke, spilling the diesel. The diesel spilled onto the tundra approximately 200 yards east southeast of the hole. At the time, the tundra was frozen, so the spill only penetrated a few inches. The light backhoe was used to scoop up the contaminated soil. An area of tundra approximately 7'x10' was removed and taken to Oregon for disposal. The spill was properly reported at the time. We inspected the spill site on July 27<sup>th</sup>. The soil had a very faint smell of diesel when we held it to our noses, but the site appears to have been cleaned more than adequately. (See photos #57 and 58.)

Photo #57. May 9, 2007 diesel spill site.

Northern Dynasty has made several design changes to minimize the chances of this type of spill occurring in the future. Among these changes is the redesign and purchase of top loading double walled tanks, such that the nozzles cannot catch on the containment wall.

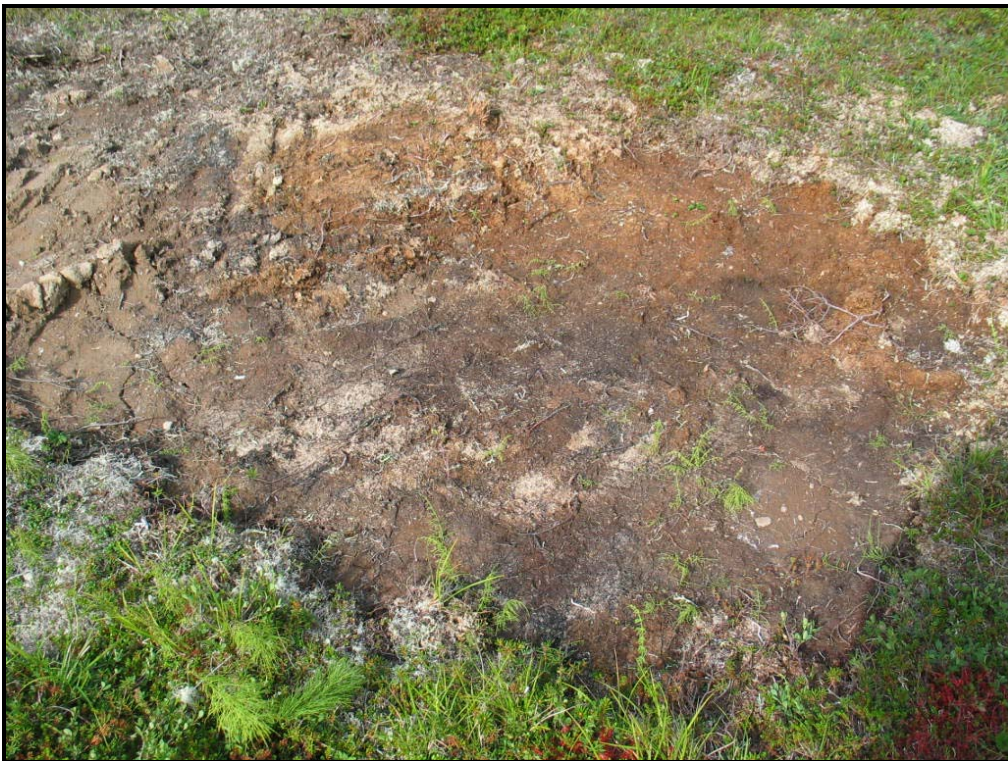
Photo #58. May 9, 2007 diesel spill site.

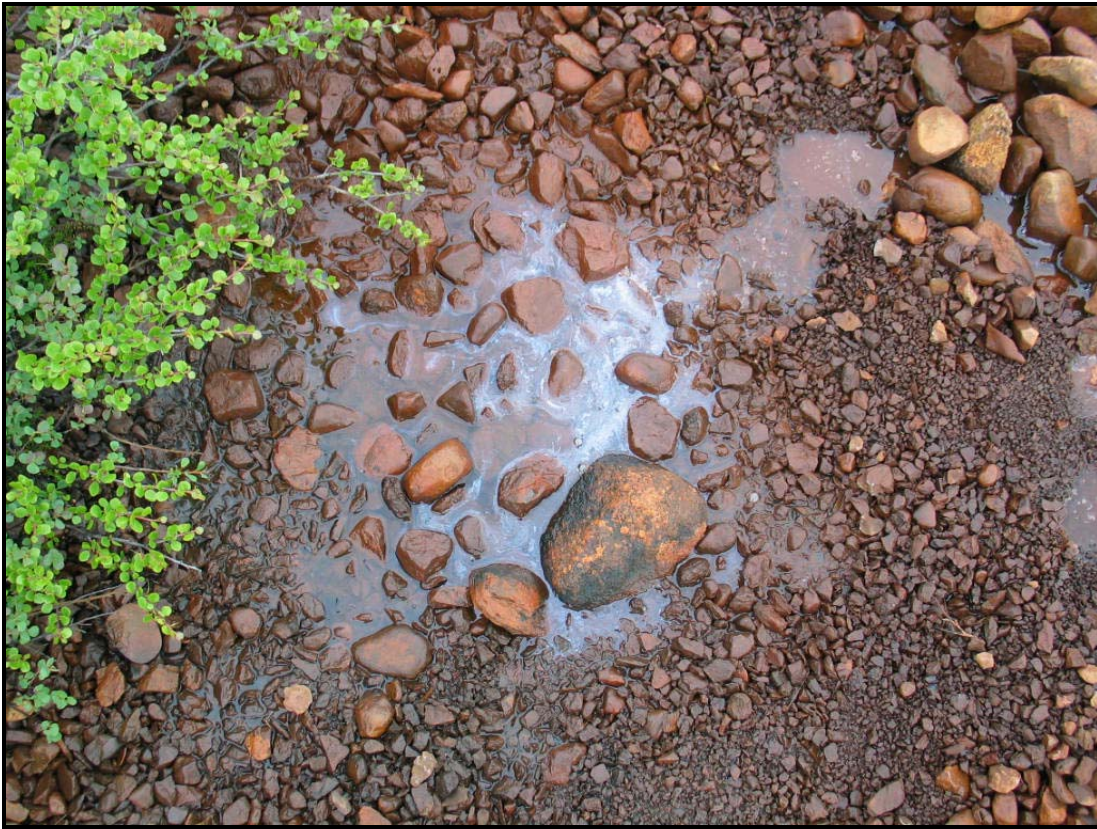
In places we noted oily looking bacterial films in the wetland water. These develop due to bacteria metabolizing the iron and manganese. The films can be distinguished from oil because when broken up, they stay broken apart and do not flow back together. (See photo #67.) (Ref: <http://pubs.usgs.gov/gip/microbes/intro.html>)

Photo #67. Bacterial film due to metabolism of metal oxides.
