Field Monitoring Report -- Pebble Copper/Gold Exploration Project --

Personnel: Ron Benkert – ADF&G	Inspection Date: 10-13-2010
	Site Contact: Jeff Norberg
	APMA #: A106118
Inspection Type:	■ Wildlife Observed:
o Complete: x	 Bear: 1 brown bear – N. Fork Koktuli R.
o Partial:	o Caribou:
∘ Follow-up:	o Moose:
 Response to Public Complaint: 	o Waterfowl:
	o Fish:
Weather Conditions:	$_{\odot}$ Other: bald eagle, ptarmigan – N. Fork
o Temperature: 25 F	
○ Wind: 15 – 20 mph	Water level at Frying Pan Lake:
o Precipitation: none	$_{\odot}$ Observed inflow: Not observed
o Visibility: unlimited	\circ Observed outflow: Not observed
 Sky Conditions: partly cloudy 	Frying Pan Lake was frozen over
o Ground Conditions: dry/freezing

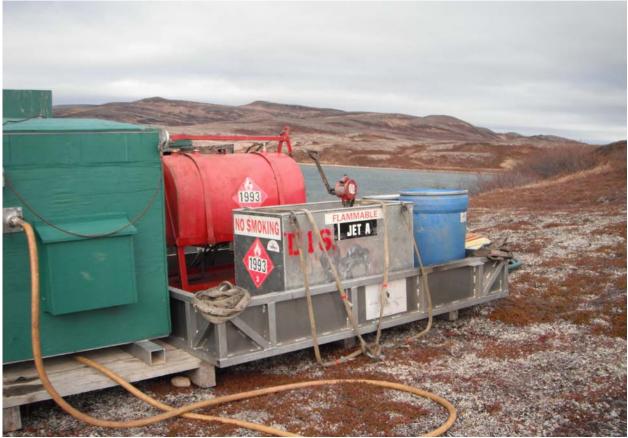
Drill Rig #3 – Drill Hole 10523 - Fuel Containment and Spill Kit

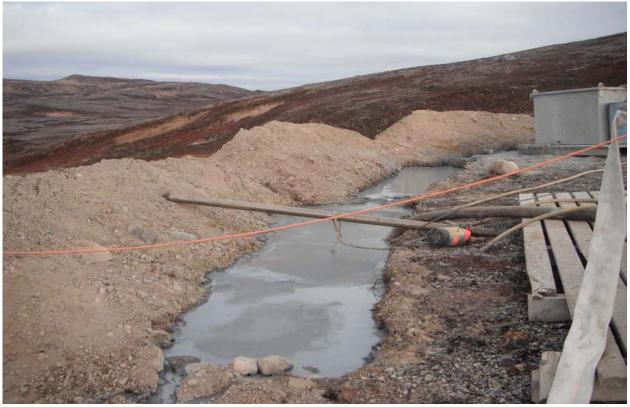
Drill Rig #3 – Drill Hole 10523 – Sump Pit

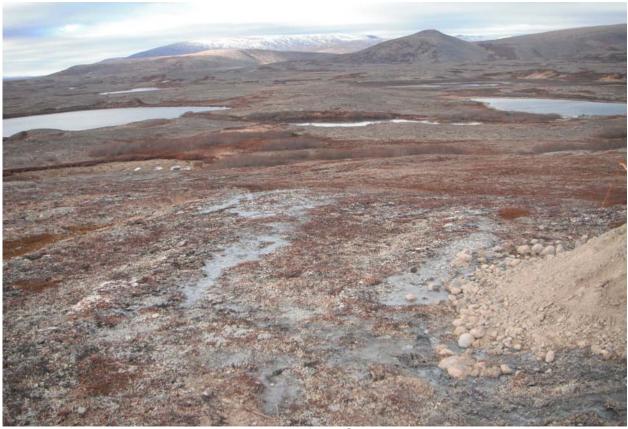
Drill Rig #3 – Drill Hole 10523 – Discharge from Sump Pit

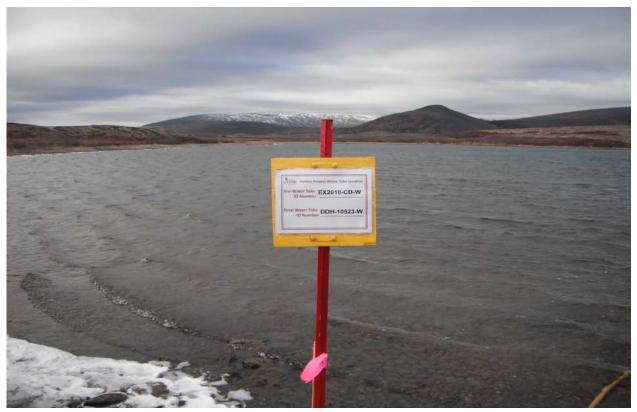
Drill Rig #3 - Drill Hole 10523 - Water Source and Signage

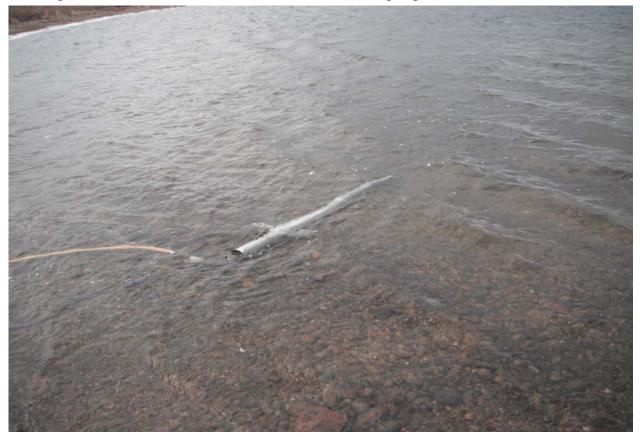
Drill Rig #3 - Drill Hole 10523 - Screened Intake Structure

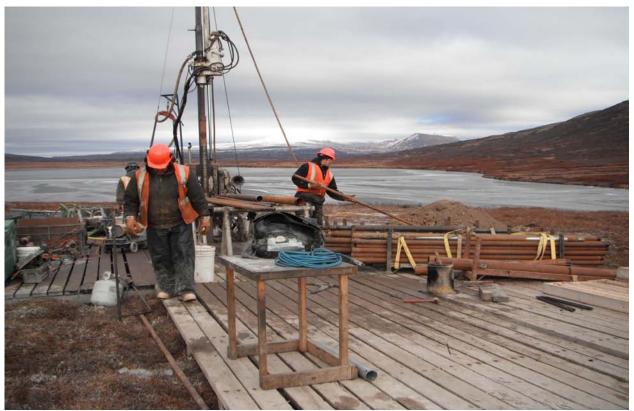
Drill Rig #2 – GH 10266 – Frying Pan Lake in Background

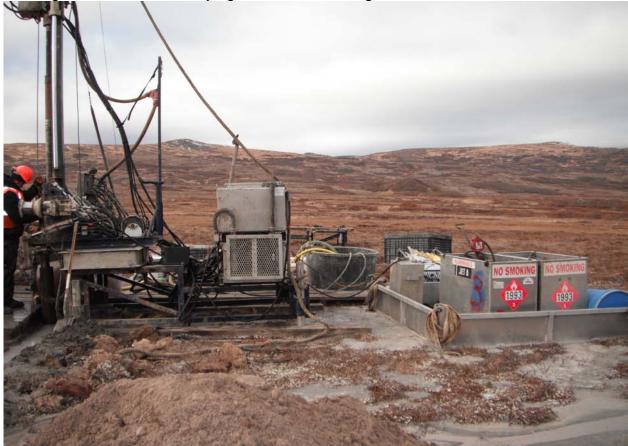
Drill Rig #2 - GH 10266 - Fuel Containment

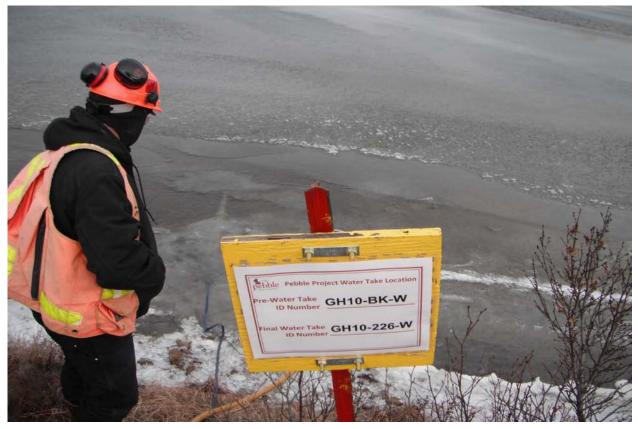
Drill Rig #2 – GH 10266 – Water Source Signage and Intake Structure (under ice)

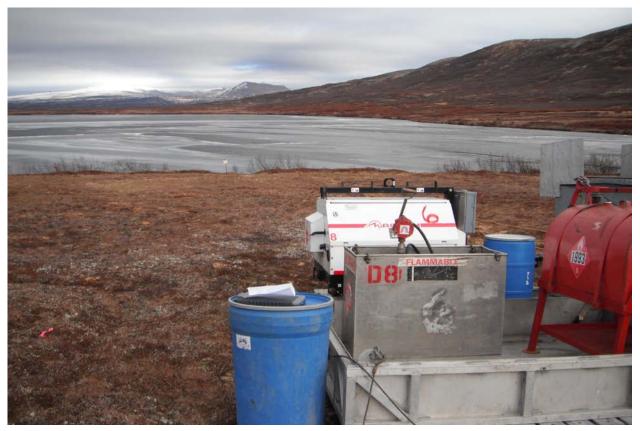
Drill Rig #2 – GH 10266 – Water Source Pump Location and Fuel Containment

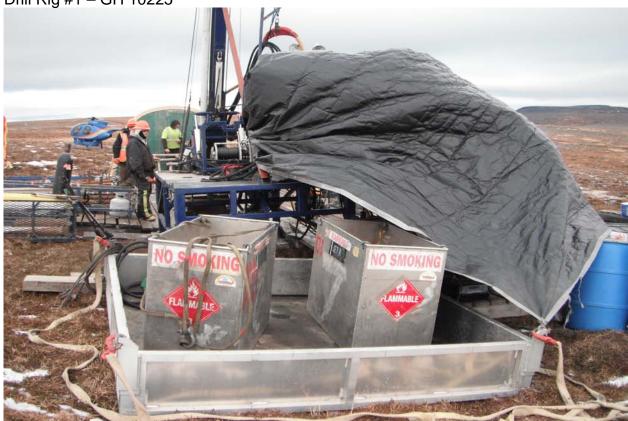
Drill Rig #1 – GH 10225 – Fuel Containment and Spill Kit

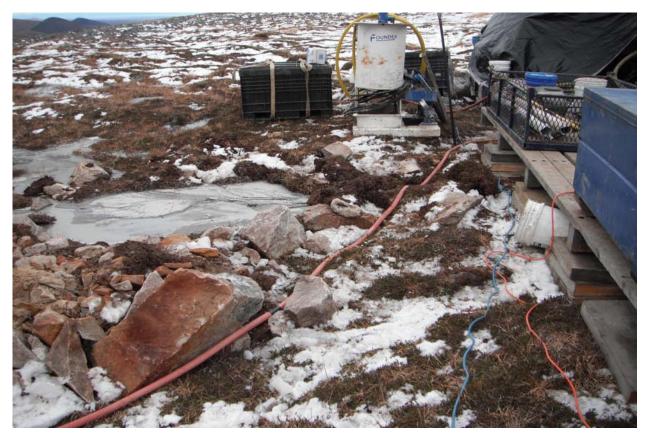
Drill Rig #1 – GH 10225 – Sump Pit

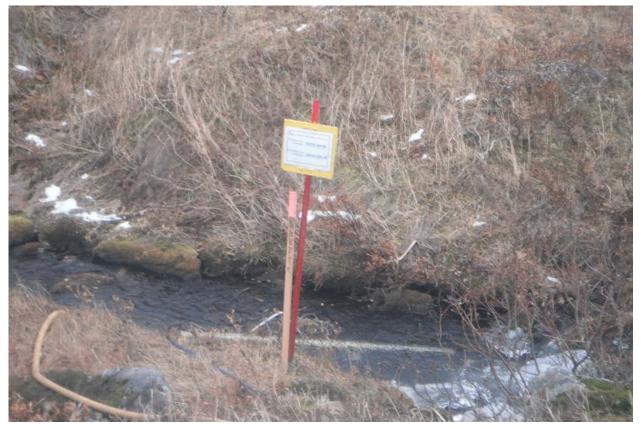
Drill Rig #1 – GH 10225 – Water Intake and Signage

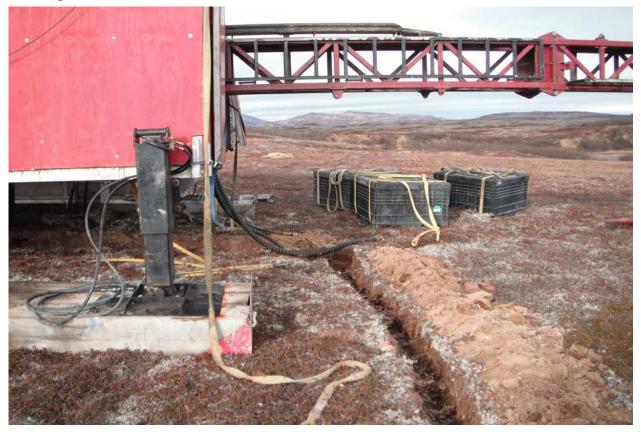
Drill Rig #4 – DH 10524 – Discharge Trench

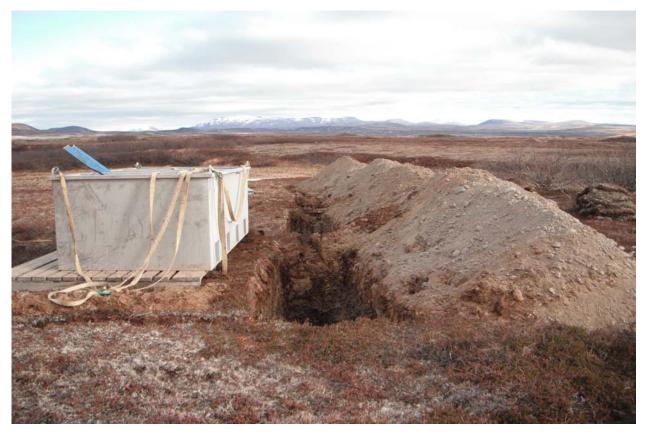
Drill Rig #4 – DH 10524 – Sump Pit and Water Recirculation Tank

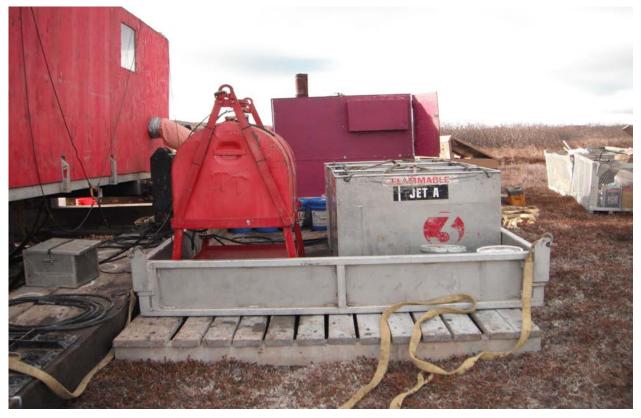
Drill Rig #4 – DH 10524 – Fuel Containment

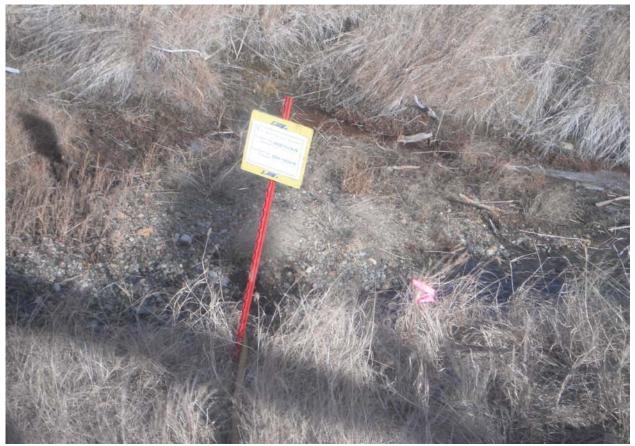
Comments: ADF&G has verified inspected drill locations and water sources were properly noticed, per the PLP Water Withdrawal Notification Plan. The inspection included 2 regular drill rigs and 2 smaller geotechnical rigs. All sites were orderly and had proper tundra mats, fuel containment and spill supplies on hand. Screened intake structures were being used for water withdrawal at all sites. Each site was designated with the proper signage. All fuel sources were a minimum of 100 feet away from waterbodies. Rig #4 was in the process of being set up, but not in operation at the time of the inspection. Rig #4 water source had been signed, but no intake structure had been installed in the creek.

Drill Rig #4 – Water Source and Signage
