2009 Annual Reclamation Report

The Pebble Project

Iliamna, Alaska

Prepared by: JBN Consultants, Inc. Eagle River, Alaska

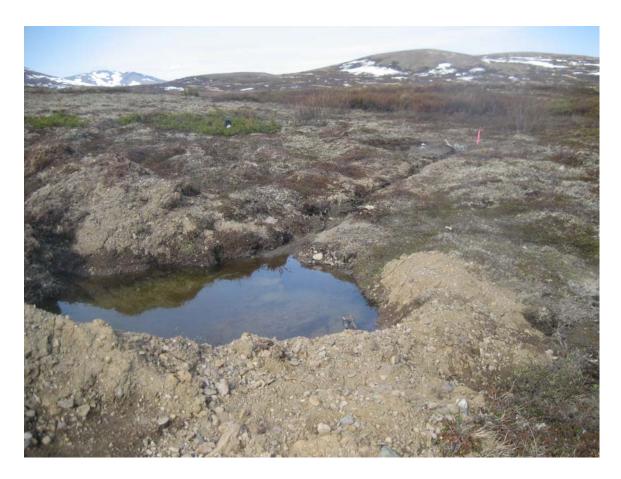
Photo 1: Diamond Drill Hole (DDH) 8435 – Drilled 2008 / Reclaimed 2009: Photo Taken Post Drilling on 25 May 2009: Looking West.

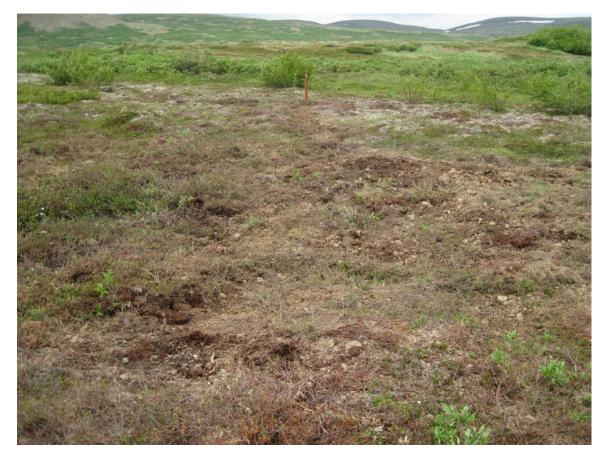
Photo 2: DDH 8435 – Photo Taken Post Reclamation on 20 June 2009; See Photo 1 for Reference; Looking West.

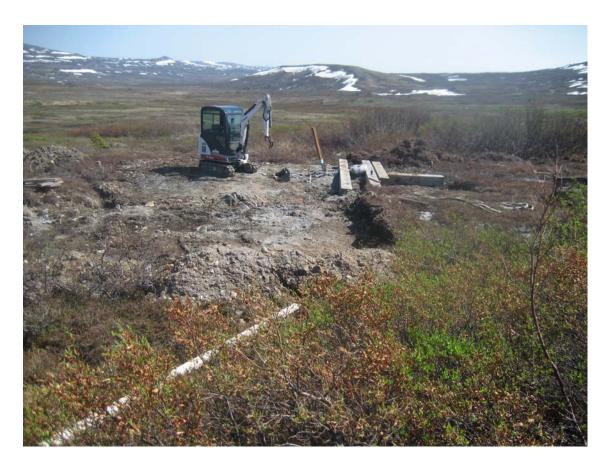
Photo 3: DDH 8438 – Drilled 2008 / Reclaimed 2009: Photo Taken Post Drilling on 26 May 2009: Looking East.

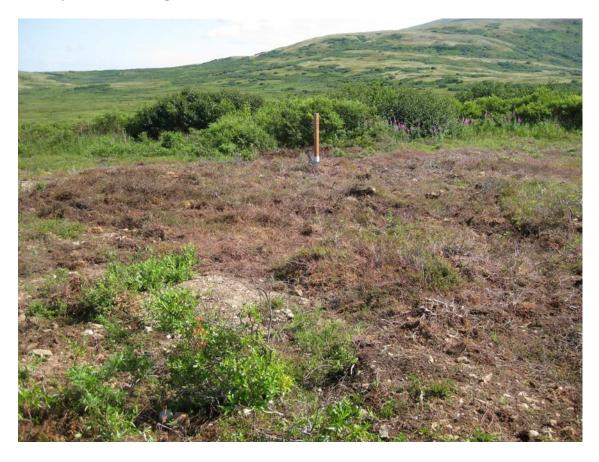
Photo 4: DDH 8438 – Photo Taken Post Reclamation on 1 August 2009; See Photo 3 for Reference; Looking East.

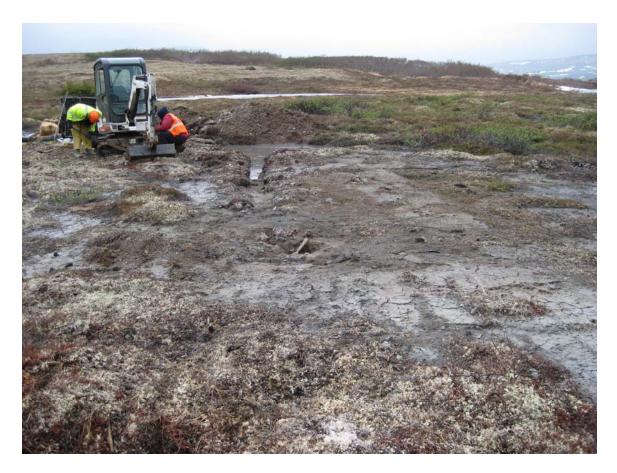
Photo 5: DDH 8440M – Drilled 2008 / Reclaimed 2009: Photo Taken Post Drilling on 31 May 2009: Looking South.

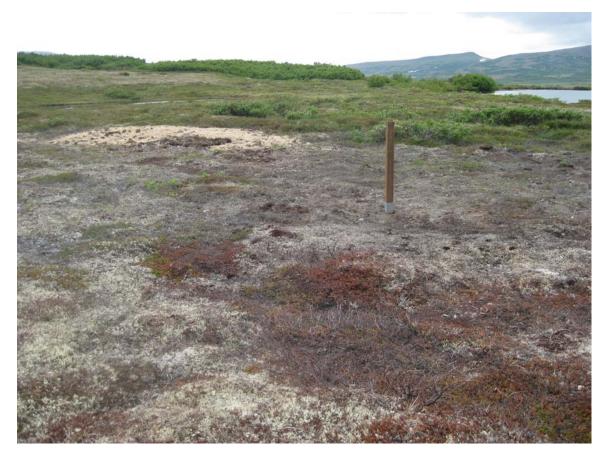
Photo 6: DDH 8440M – Photo Taken Post Reclamation on 24 June 2009; See Photo 5 for Reference; Looking South.

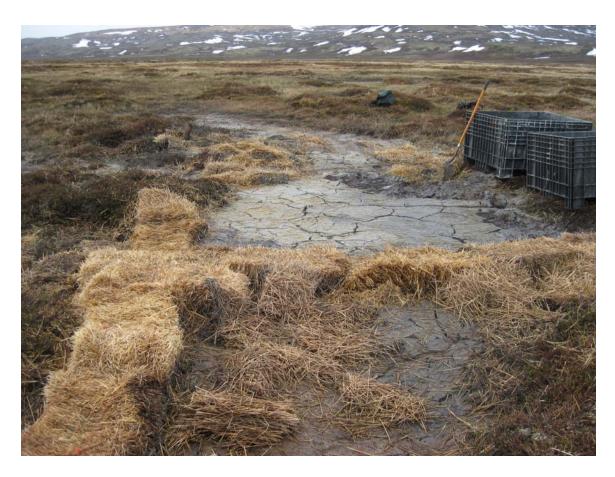
Photo 7: DDH 9445 – Drilled / Reclaimed 2009: Photo Taken Post Drilling on 30 May 2009: Looking South.

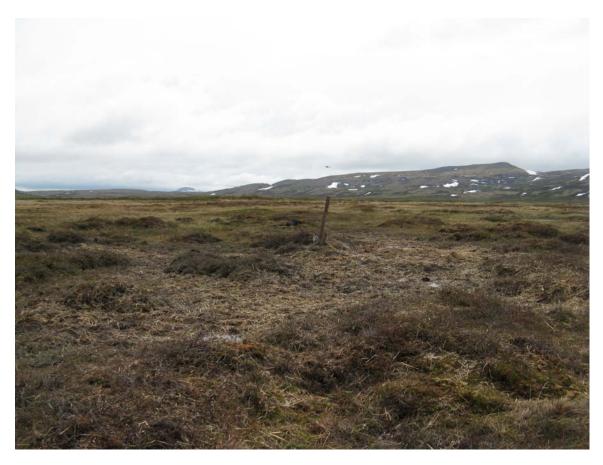
Photo 8: DDH 9445 – Photo Taken Post Reclamation on 4 June 2009; See Photo 7 for Reference; Looking South.

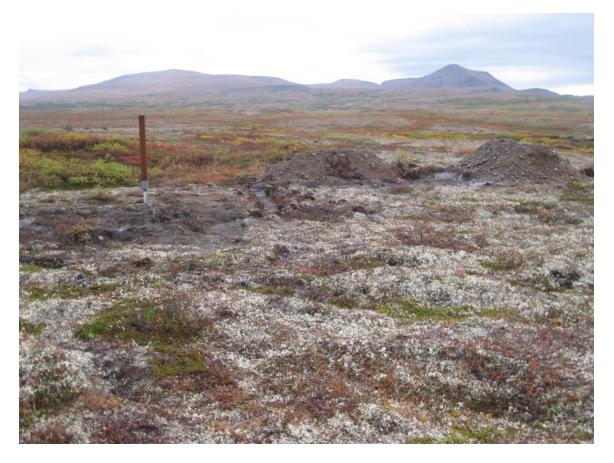
Photo 9: DDH 9458 – Drilled / Reclaimed 2009: Photo Taken Post Drilling on 15 September 2009: Looking North.

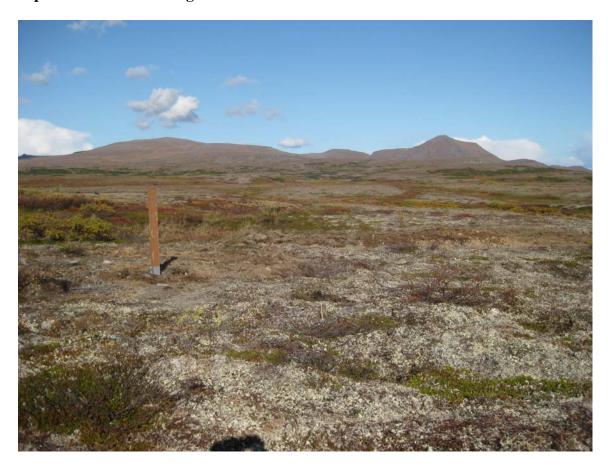
Photo 10: DDH 9458 – Photo Taken Post Reclamation on 19 September 2009; See Photo 9 for Reference; Looking North.

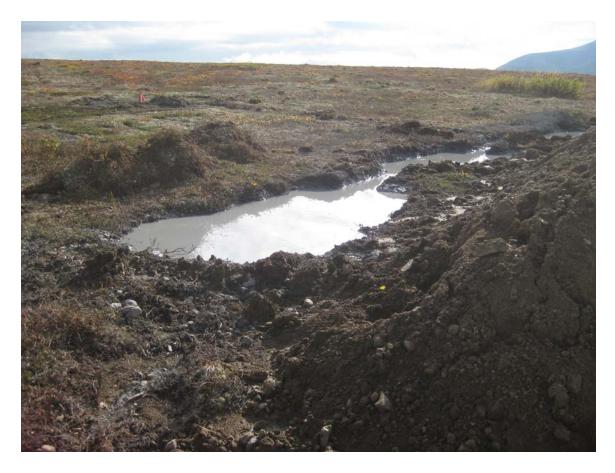
Photo 11: DDH 9460 – Drilled / Reclaimed 2009: Photo Taken Post Drilling on 13 September 2009: Looking East.

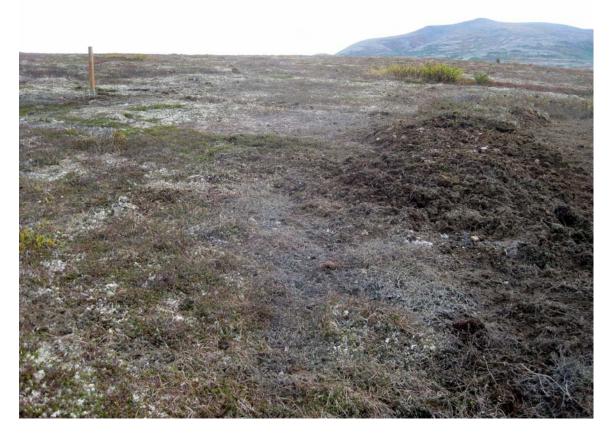
Photo 12: DDH 9460 – Photo Taken Post Reclamation on 18 September 2009; See Photo 11 for Reference; Looking East.

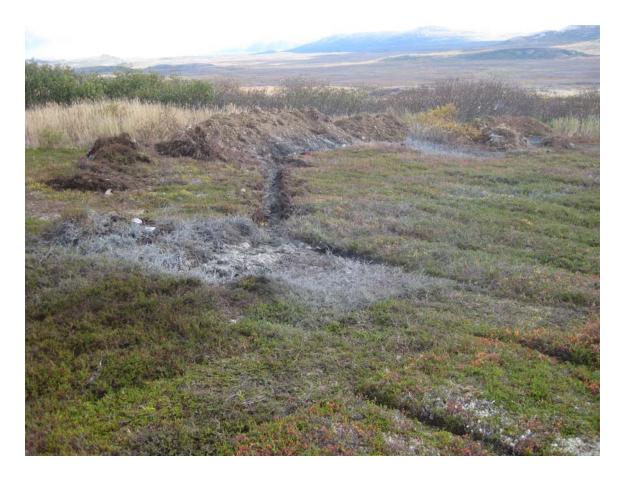
Photo 13: DDH 9463 – Drilled / Reclaimed 2009: Photo Taken Post Drilling on 22 September 2009: Looking East.

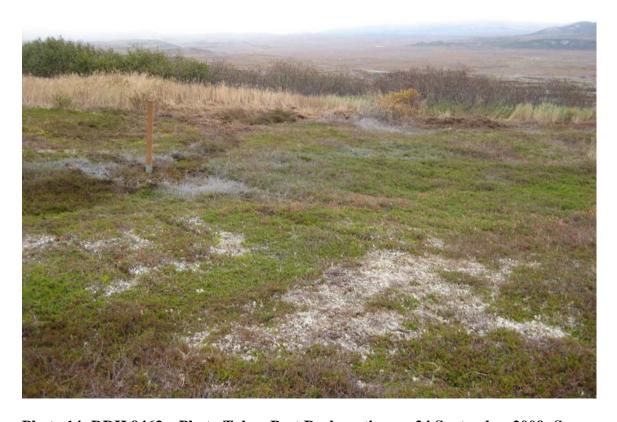
Photo 14: DDH 9463 – Photo Taken Post Reclamation on 24 September 2009; See Photo 13 for Reference; Looking East.

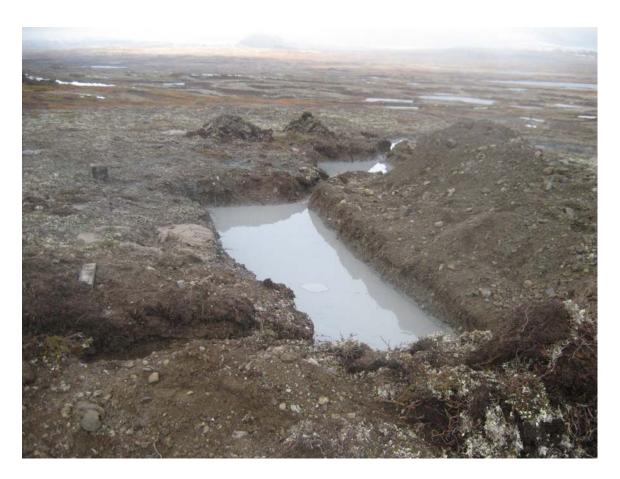
Photo 15: DDH 9467 – Drilled / Reclaimed 2009: Photo Taken Post Drilling on 1 October 2009: Looking West.

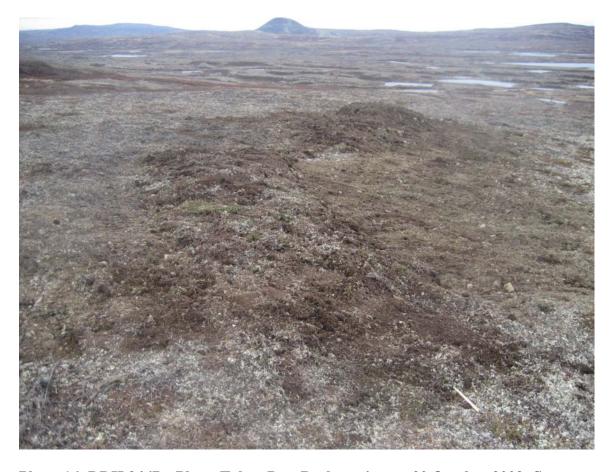
Photo 16: DDH 9467 – Photo Taken Post Reclamation on 20 October 2009; See Photo 15 for Reference; Looking West.

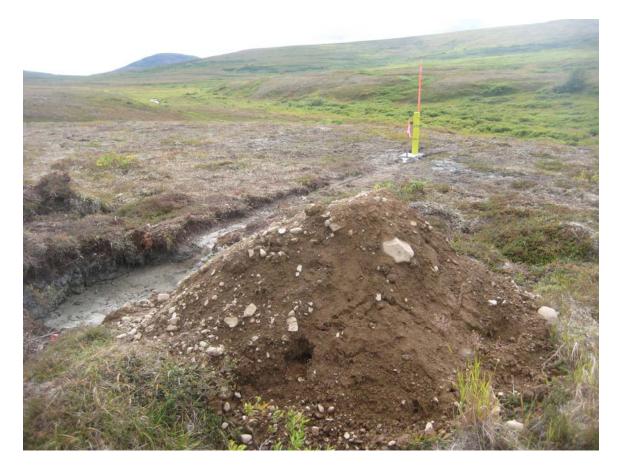
Photo 17: GH08-179 – Drilled 2008 / Reclaimed 2009: Photo Taken Post Drilling on 29 August 2008: Looking South.

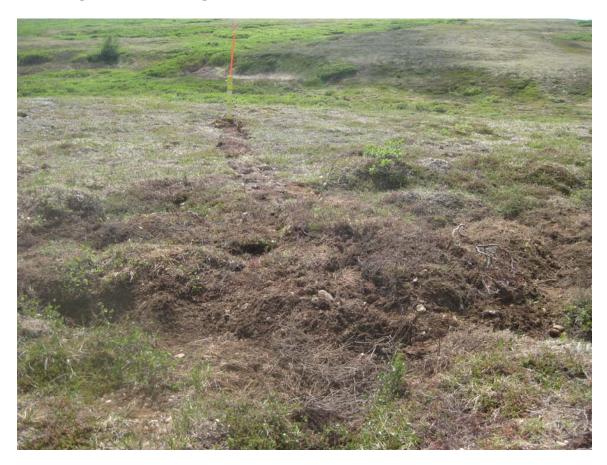
Photo 18: GH08-179 – Photo Taken Post Reclamation on 24 June 2009; See Photo 17 for Reference; Looking South.

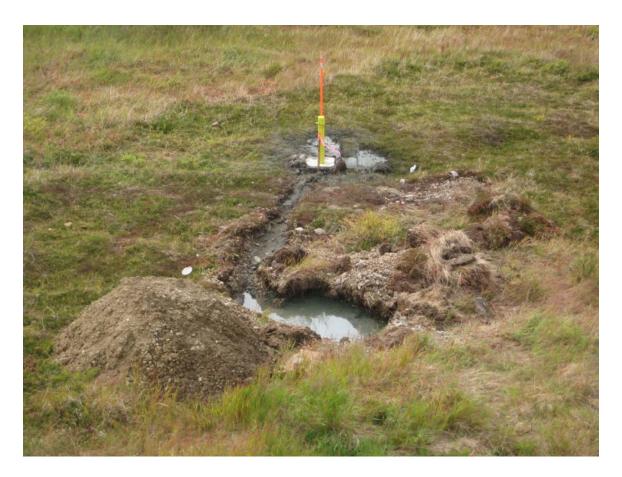
Photo 19: GH08-180 – Drilled 2008 / Reclaimed 2009: Photo Taken Post Drilling on 29 August 2008: Looking West.

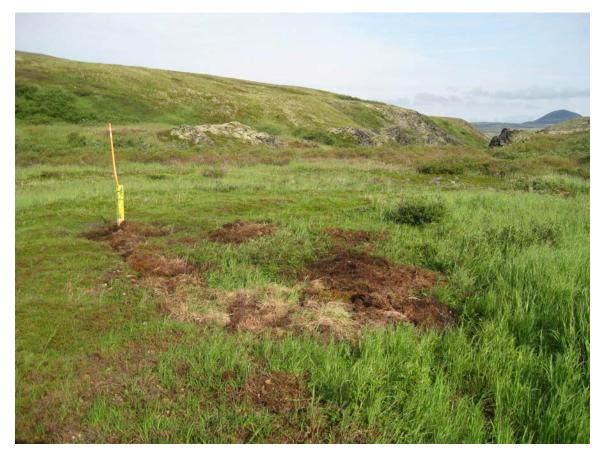
Photo 20: GH08-180 – Photo Taken Post Reclamation on 1 August 2009; See Photo 19 for Reference; Looking West.

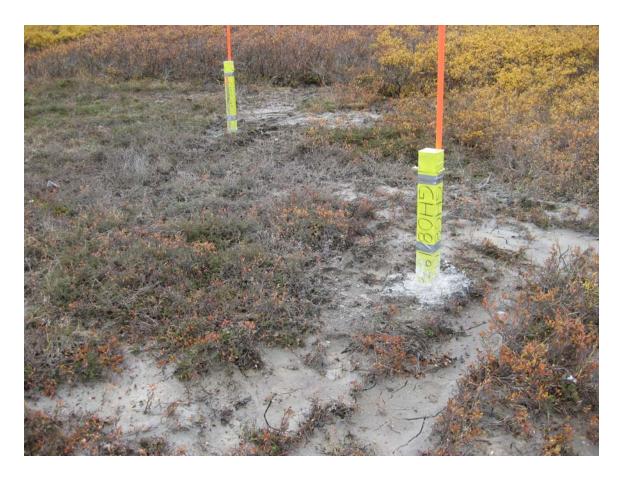
Photo 21: GH08-197 A & B – Drilled 2008 / Reclaimed 2009: Photo Taken Post Drilling on 28 September 2008: Looking West.

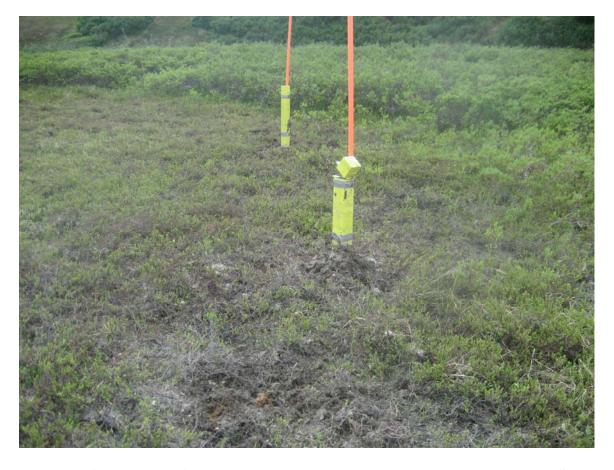
Photo 22: GH08-197 A & B - Photo Taken Post Reclamation on 26 June 2009; See Photo 21 for Reference; Looking West.

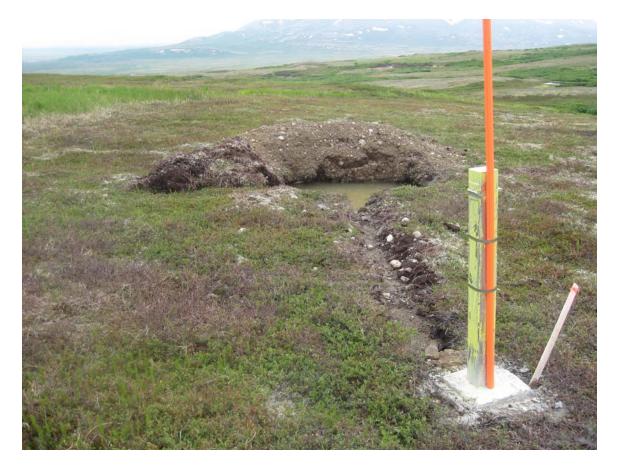
Photo 23: GH08-200 – Drilled 2008 / Reclaimed 2009: Photo Taken Post Drilling on 23 June 2009: Looking East.

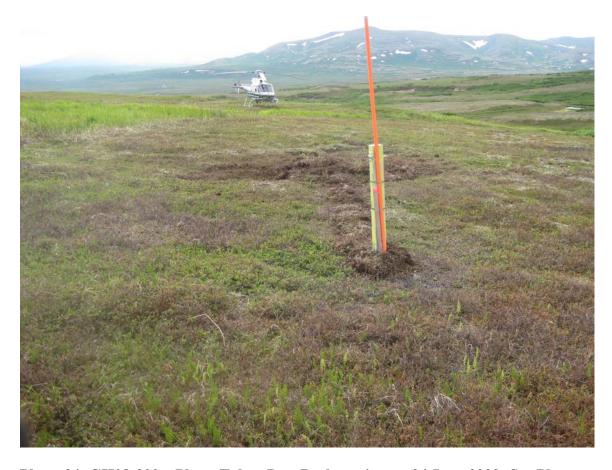
Photo 24: GH08-200 – Photo Taken Post Reclamation on 24 June 2009; See Photo 23 for Reference; Looking East.

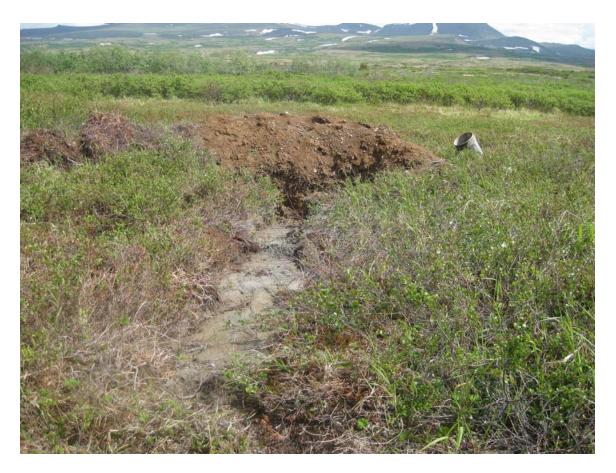
Photo 25: GH08-202 – Drilled 2008 / Reclaimed 2009: Photo Taken Post Drilling on 22 June 2009: Looking North.

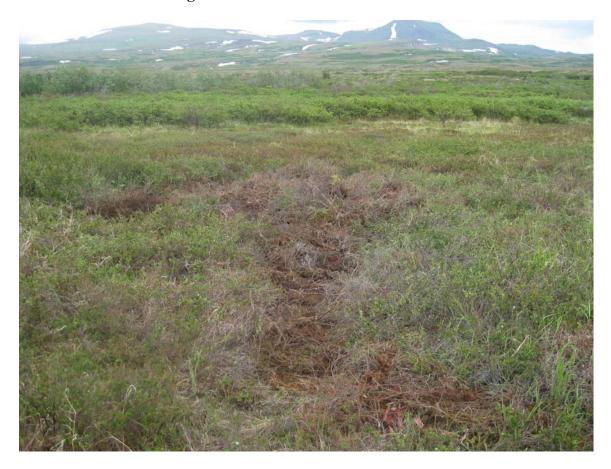
Photo 26: GH08-202 – Photo Taken Post Reclamation on 22 June 2009; See Photo 25 for Reference; Looking North.

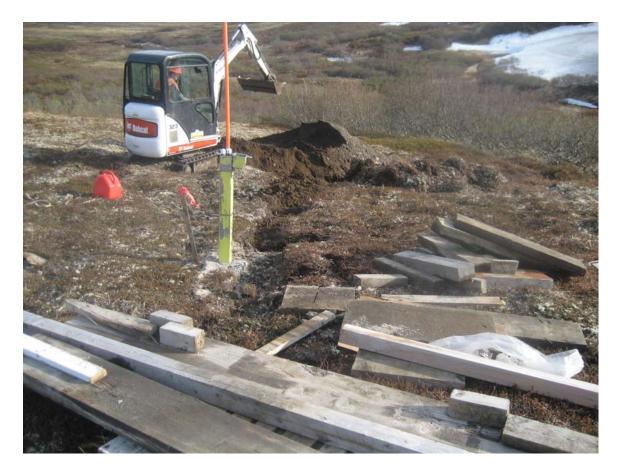
Photo 27: GH08-210 – Drilled 2008 / Reclaimed 2009: Photo Taken Post Drilling on 3 June 2009: Looking North.

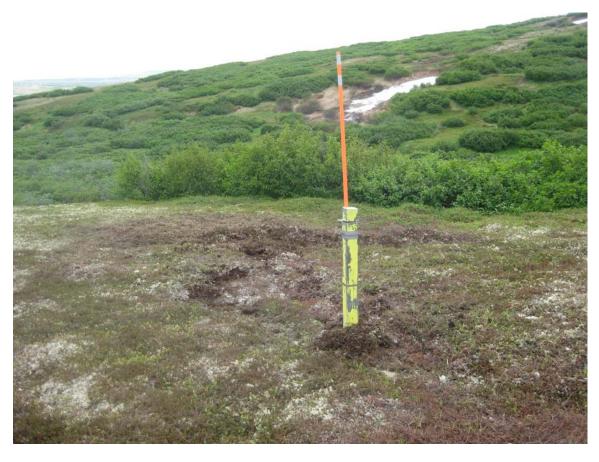
Photo 28: GH08-210 – Photo Taken Post Reclamation on 22 June 2009; See Photo 27 for Reference; Looking North.

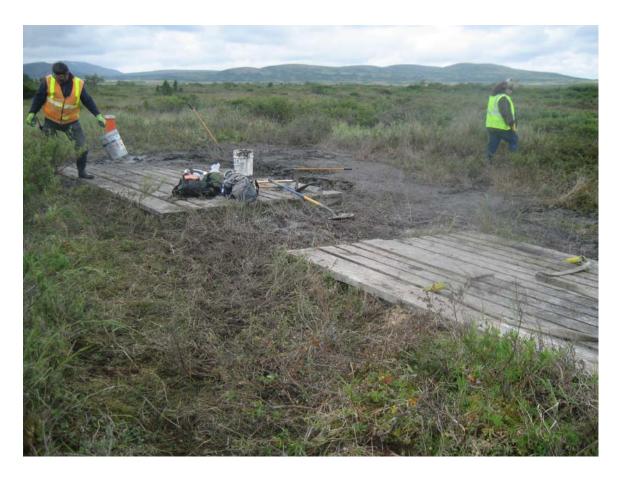
Photo 29: P08-85 – Drilled 2008 / Reclaimed 2009: Photo Taken Post Drilling on 17 August 2008: Looking West.

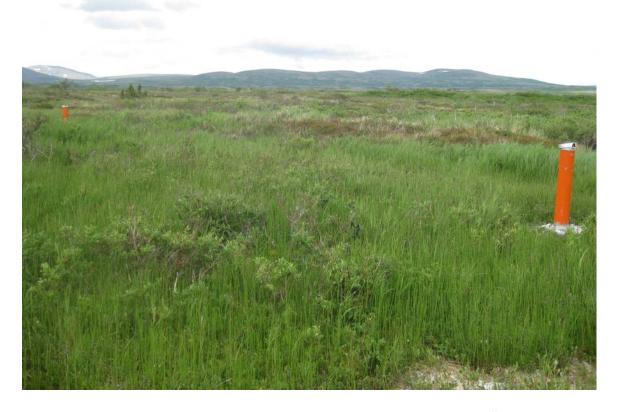
Photo 30: P08-85 – Photo Taken Post Reclamation on 22 June 2009; See Photo 29 for Reference; Looking West.
