MINE PERMITTING ANCHORAGE

Pogo Mine Inspection Report

Inspection Date: June 04, 2024
Time: 9:00AM to 4:30PM
Weather: Mostly sunny, High clouds
Agency Personnel: DNR: Jesse Garnett White, William Groom, and Jackie Cheek
DEC: Tim Pilon
Operator Contacts: Pogo: Russel Gossett, Wendie MacNaughton, and Matt Drews
Inspection Objectives: Site Inspection

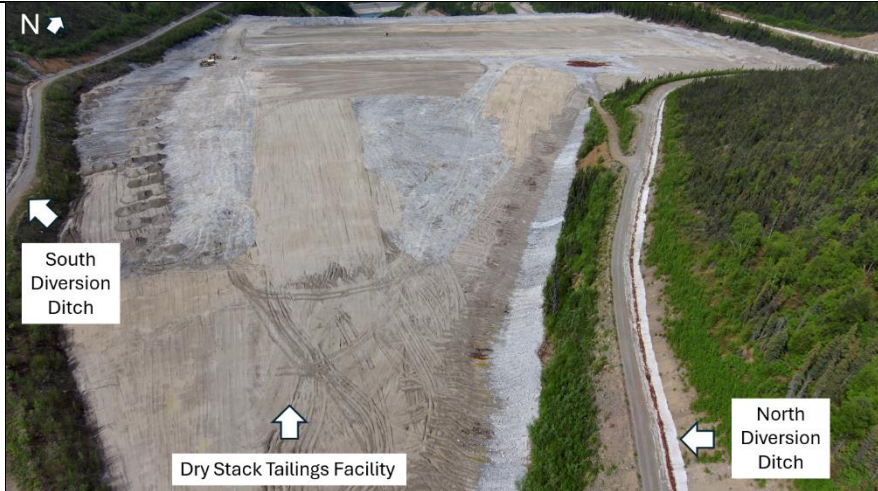
- 1.1. Dry Stack Tailings Facility: The DSTF (Photos 1-5) is an area where approximately 40% of all mineralized waste rock and dewatered flotation tailings are disposed, the remainder is placed underground as a paste backfill. There are a few flow-through drains at the DSTF and surrounding the general placement is a diversion ditch located above the perimeter to prevent runoff from entering the facility. At the time of inspection, the DSTF was in good standing. Tailings and mineralized development rock are co-disposed year-round in the general placement area. The mineralized rock is encapsulated in the tailings to minimize the oxidation of any sulfide minerals present. At the time of inspection, the DSTF was in good condition.

Photo 1: Dry Stack Tailings Facility (DSTF). View from the upper DSTF looking at the expansion extents.

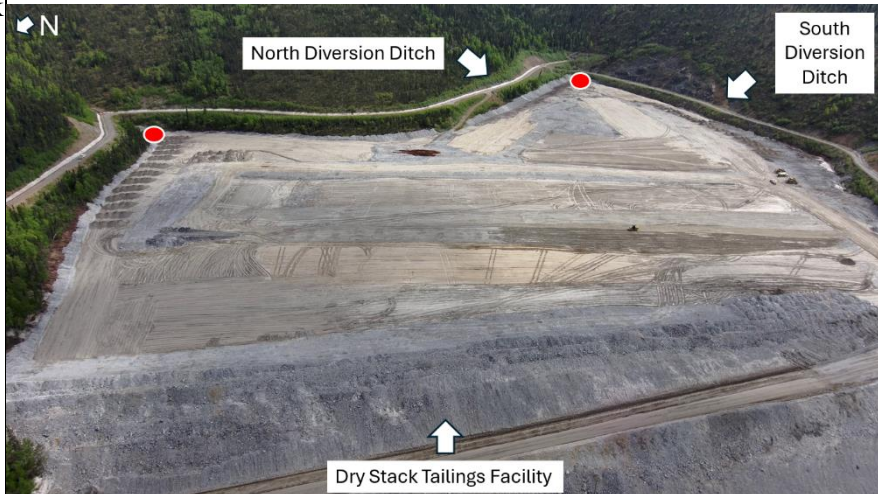
Photo 2: Another view of the DSTF. Red dots mark areas of Flow Through Drains.

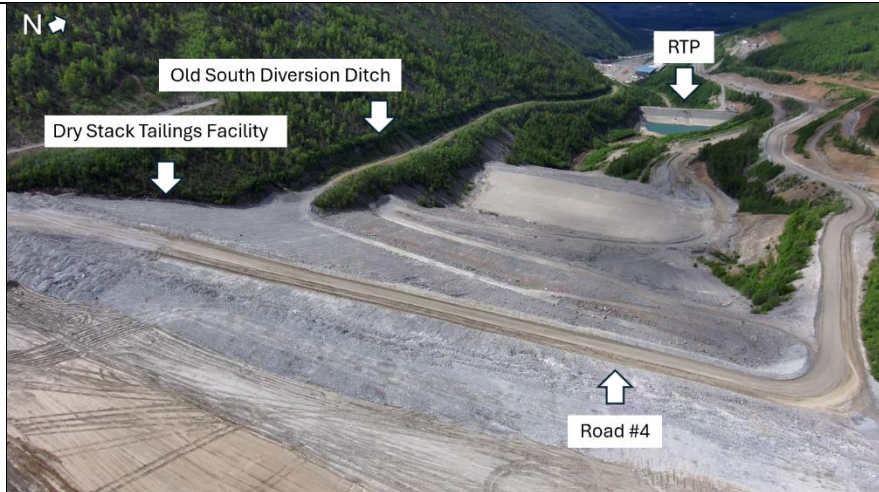
Photo 3: A down valley view of the DSTF. Note the levels of tiered development and shells on the front leading to the toe.

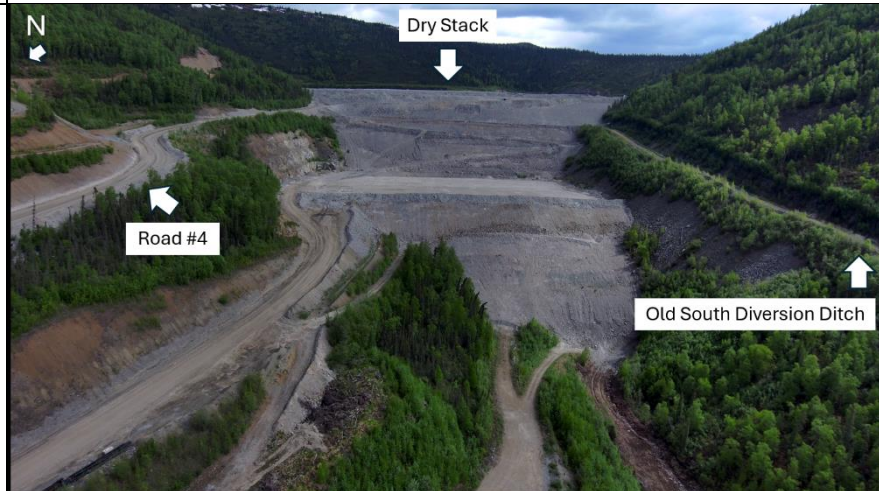
Photo 4: Another view of the DSTF tiered development and shells from above the RST.

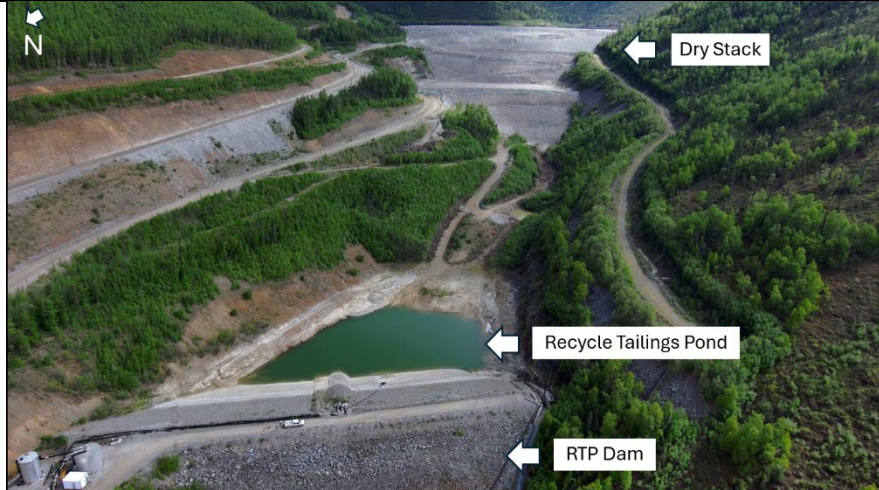
- 1.2. Recycle Tailings Pond and Dam: The RTP and RTP Dam (Photos 5-7) are located just downstream from the DSTF to collect any potential seepage. At the time of inspection, the water storage was below normal level. The spillway was well above the water level and free of any major or obvious debris.

Photo 5: DSTF, RTP, and RTP Dam. Note the low water level behind RTP.

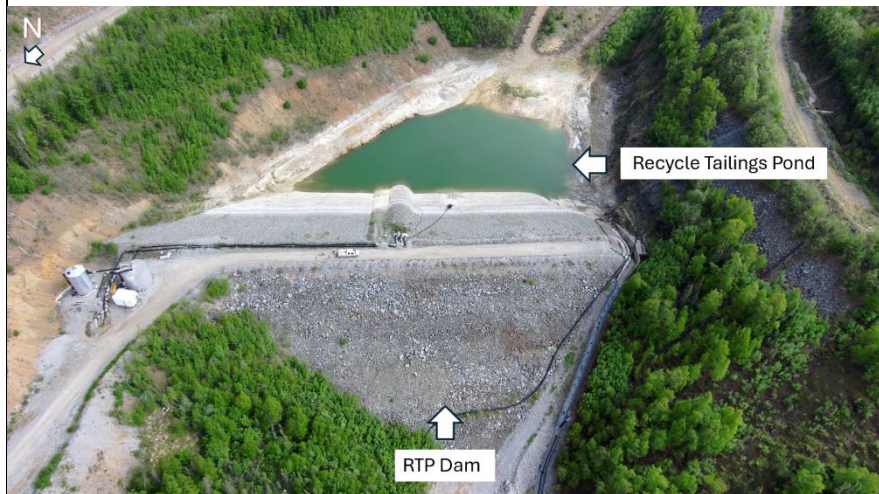
Photo 6: Another view of the RTP and RTP Dam. Note vehicles for scale on the top of the dam, RTP Head Tanks to the left and spillway on the right.

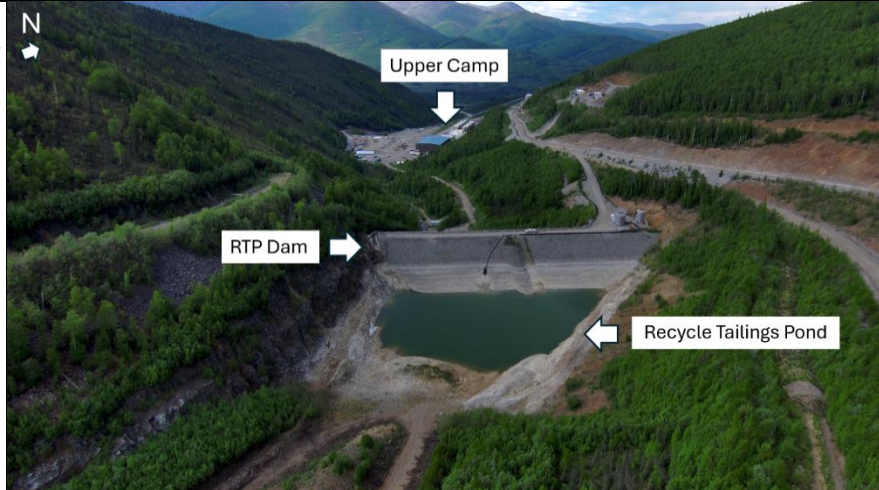
Photo 7: Down valley view of the RTP and RTP Dam. Note the location of Upper Camp.

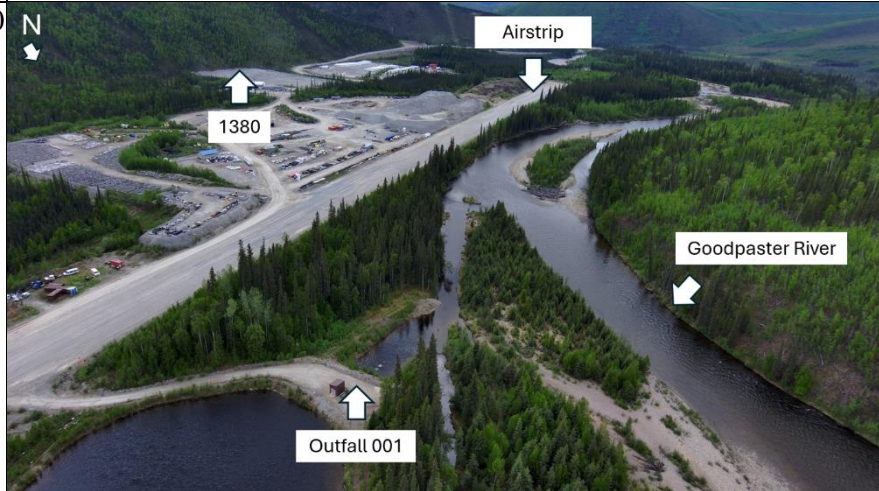
- 1.3. New Portal (1380): At the time of inspection the portal was in its initial construction phase with only a pad being cleared to the location (Photos 8-10).

Photo 8: Location of 1380 Area as seen from above the ORTW.

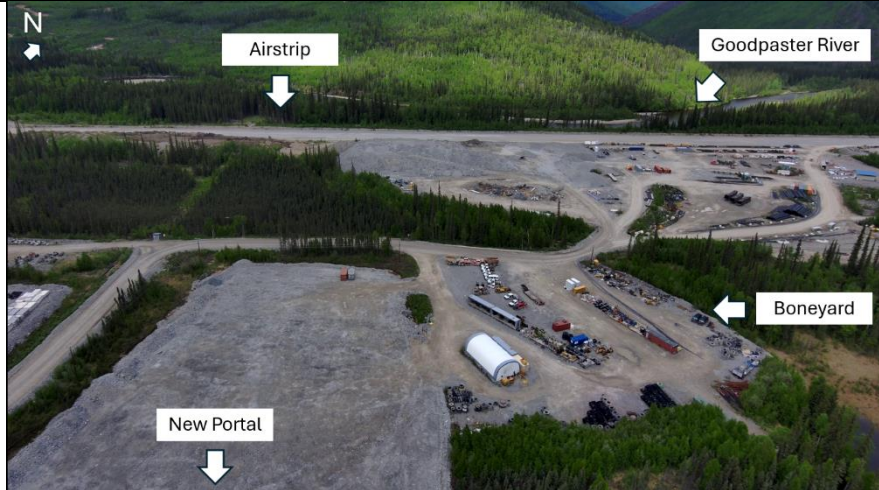
Photo 9: New 1380 Area access pad.

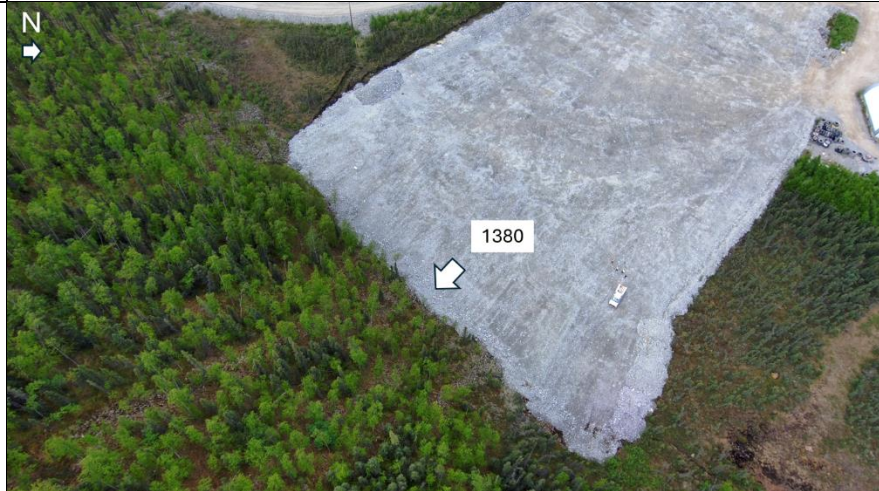
Photo 10: Another view of the 1380 Area access pad where it meets the slope of the hill. Note truck for scale.

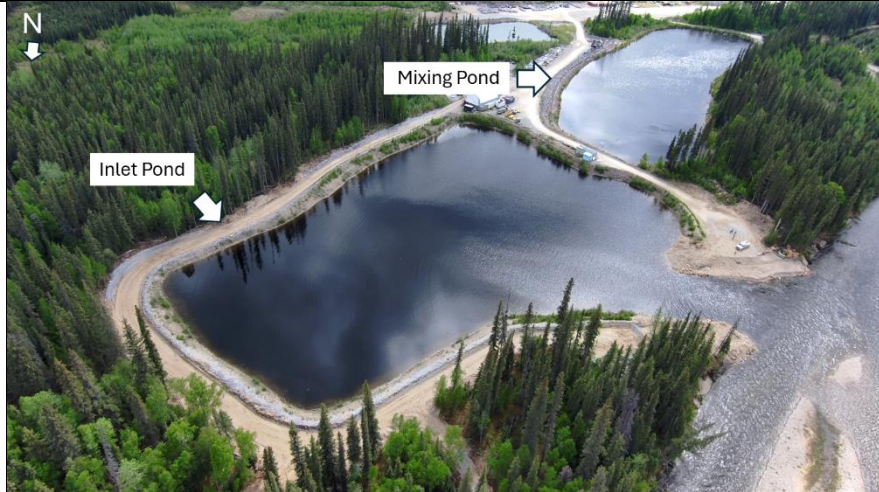
- 2.1. Inlet and Mixing Ponds (Off-River Treatment Works (ORTW)): At the northern end of the mine is the ORTW consisting of two ponds (Photos 11-13). The inlet pond has connectivity with the Goodpaster River, which pumps fresh water into the mixing pond via a pump station. The ORTW pump station has a mixing chamber where effluent water from the treatment plant mixes with fresh water before discharging into the mixing pond. The mixing pond serves as a final zone where larger suspended particles from treated waters may precipitate out before reaching the outfall. Water from the outfall discharges back into the Goodpaster River. At the time of inspection, the ORTW was operating normally.
- 2.2. Outfall 001: The outfall (Photo 13) was operating normally at the time of inspection.

Photo 11: ORTW Inlet and Mixing ponds and Goodpaster River.

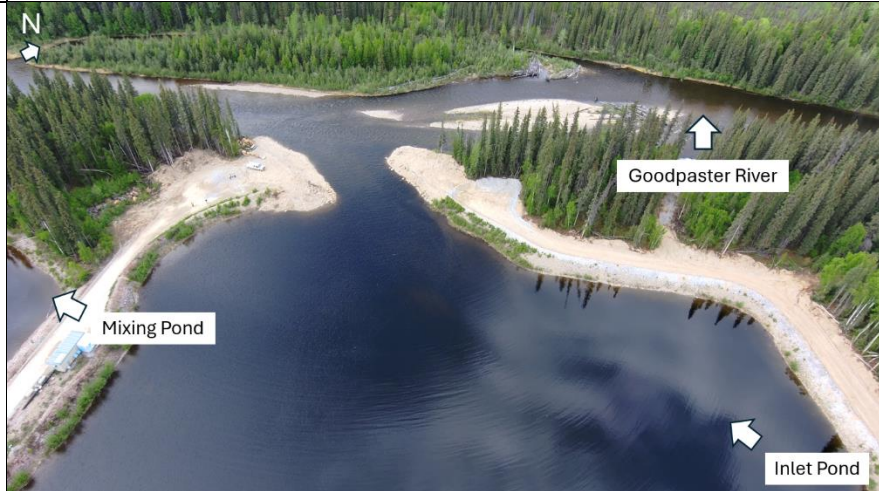
Photo 12: Another view of the ORTW Inlet and Mixing ponds and Goodpaster River.

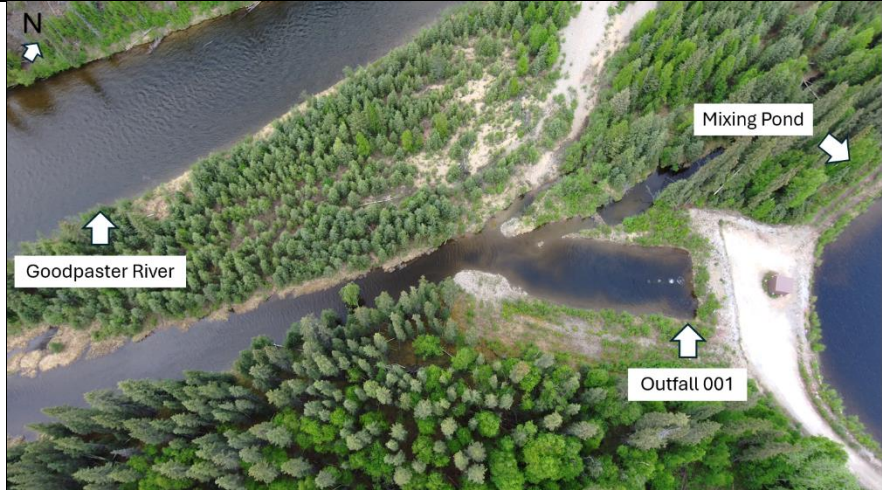
Photo 13: Location of Outfall 001 in relation to the Mixing Pond and Goodpaster River.
