Pogo Mine Inspection Report

Inspection Date: September 3, 2024
Time: 10:00AM to 3:45PM
Weather: Sunny, slight breeze, high overcast, 65°F
Agency Personnel: DNR: Elizabed Angel, Jesse Garnett White, and William Groom
Operator Contacts: Pogo: Russell Gossett, Nathan Kehoe, and Kate Clancy
Inspection Objectives: Site Inspection

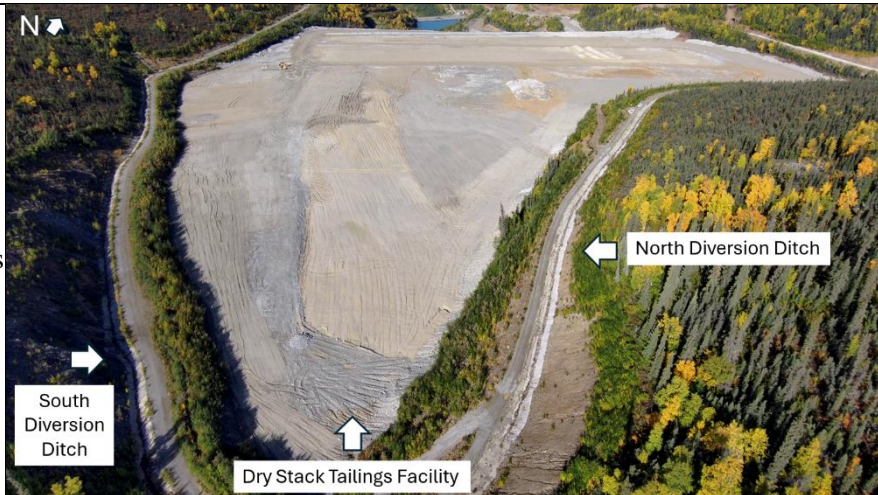
- 1.1. Dry Stack Tailings Facility: The DSTF (Photos 1-3) is an area where approximately 40% of all mineralized waste rock and dewatered flotation tailings are disposed, the remainder is placed underground as paste backfill. There are a few flow-through drains at the DSTF and surrounding the general placement are diversion ditches located above the perimeter to prevent runoff from entering the facility. Tailings and mineralized development rock are co-disposed year-round in the general placement area. The mineralized rock is encapsulated in the tailings to minimize the oxidation of any sulfide minerals present. At the time of inspection, the DSTF was in good condition.

Photo 1: Dry Stack Tailings Facility (DSTF). View from the upper DSTF looking at the expansion extents down valley towards the Recycle Tailings Pond (RTP). Note the locations of the north and south diversion ditches.

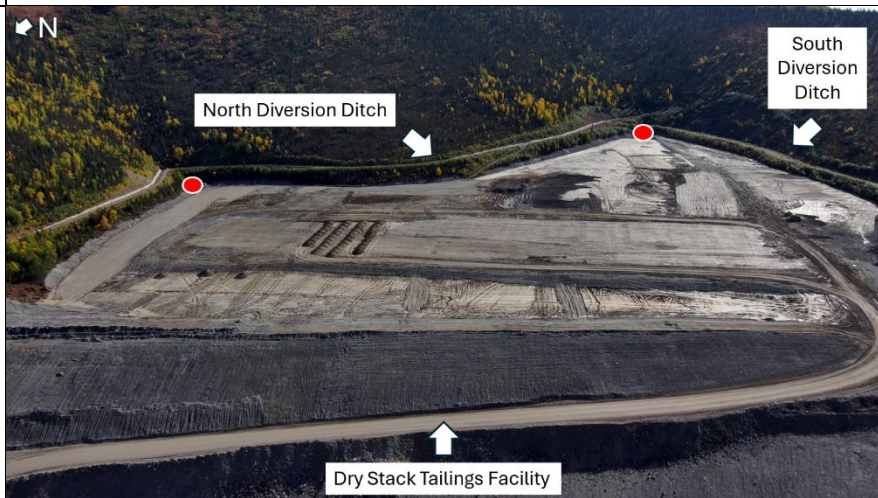
Photo 2: Another view of the DSTF including top and upper shell. Red dots mark areas of Flow Through Drains.

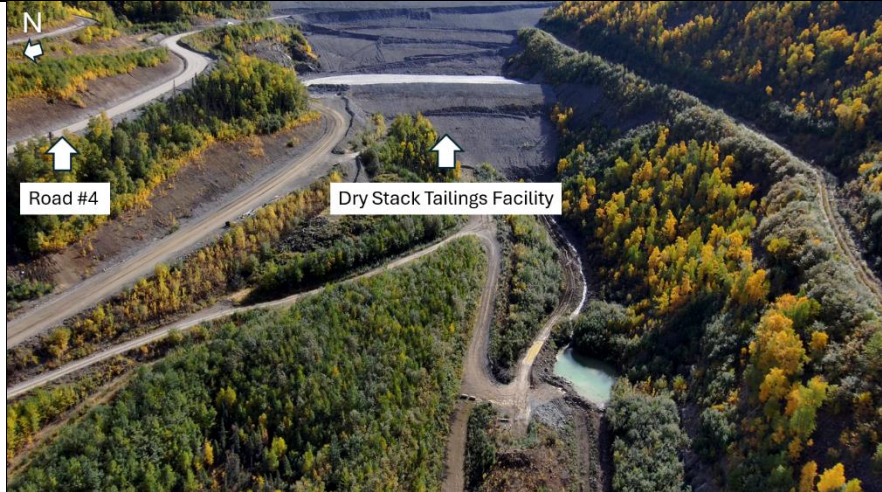
Photo 3: Another view of the DSTF shells from above the RST. Note the Stilling Basin center bottom right of the photo.

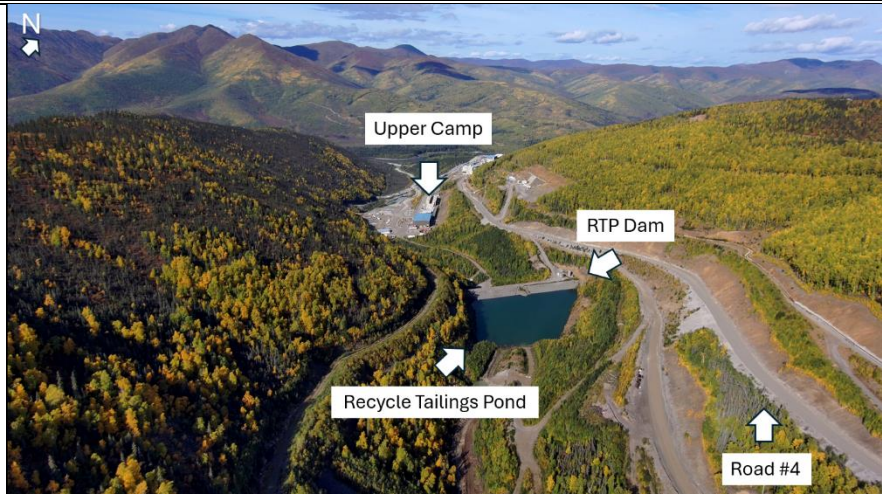
- 1.2. Recycle Tailings Pond and Dam: The RTP and RTP Dam (Photos 4-6) are located just downstream from the DSTF to collect any potential seepage. At the time of inspection, the water storage was at a normal level. The spillway was well above the water level and free of any major or obvious debris.

Photo 4: RTP and RTP Dam. Upper Camp in the background. RTP Water levels had significantly increased from prior inspection in June 2024.

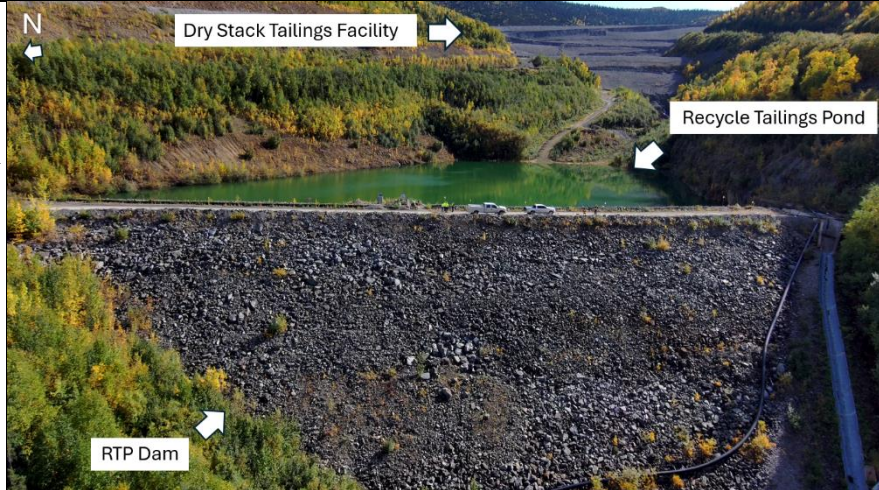
Photo 5: Another view up valley of the RTP and RTP Dam. Shells of the DSTF in the background. Note vehicles for scale on the top of the dam and spillway on the right side of the photo.

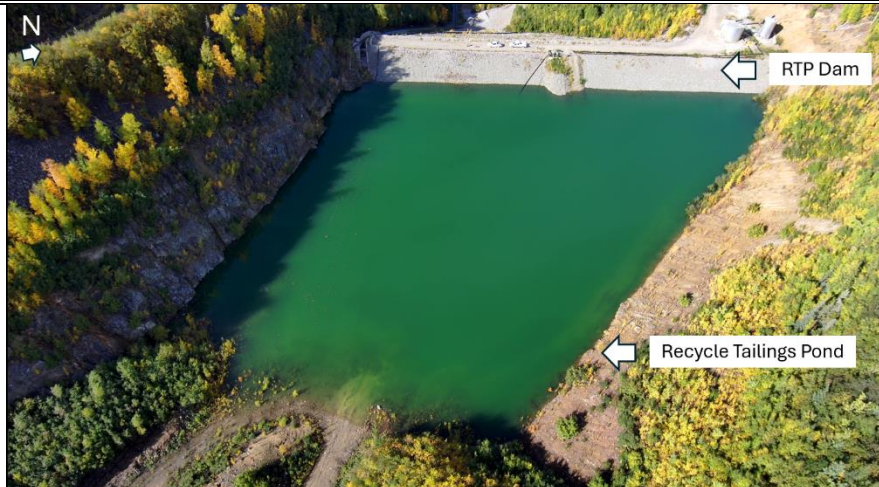
Photo 6: View of RTP Dam and water level. Note RTP Head Tanks in the upper right corner.

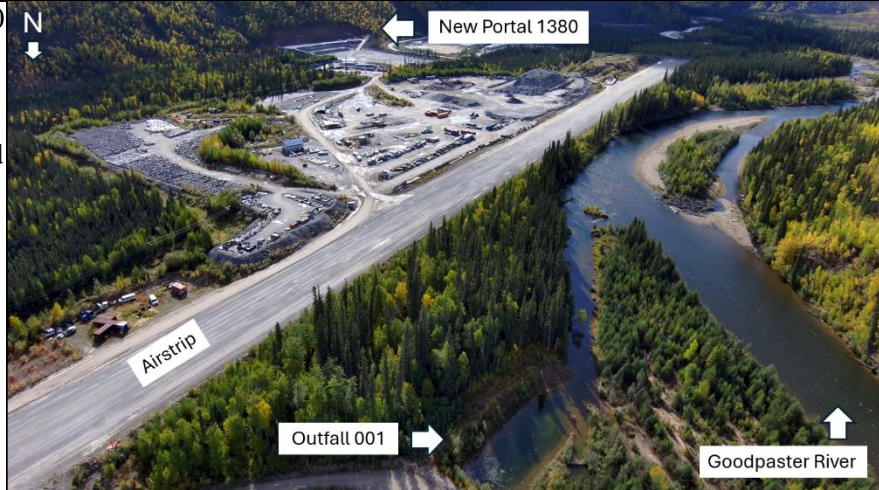
- 1.3. 1380 Area: At the time of inspection, the 1380 Area was in its initial construction phase with only a pad being cleared to the location (Photos 7-11). There will be two portals in the 1320 Area, one for intake and another for exhaust.

Photo 7: Location of 1380 Area as seen from above the ORTW. The 1380 Area will have two portals, one for intake and the other for exhaust.

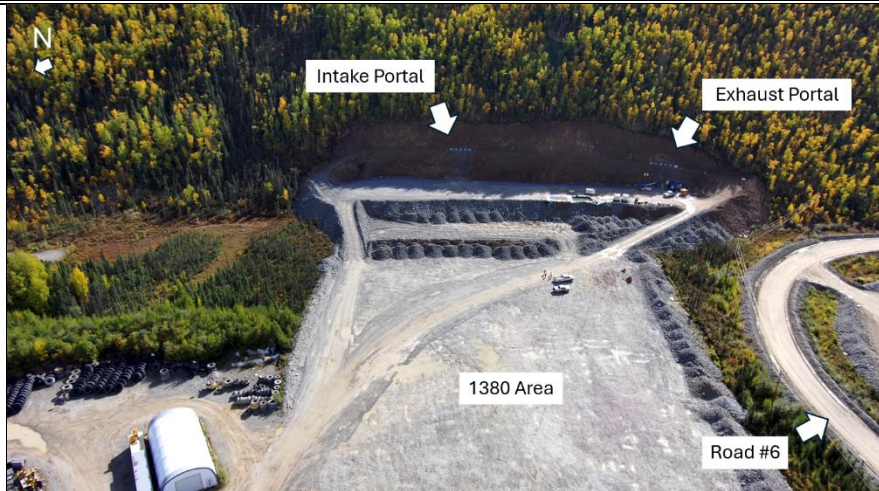
Photo 8: View of 1380 Area progress including locations of Intake and Exhaust portals. Boneyard to the left.

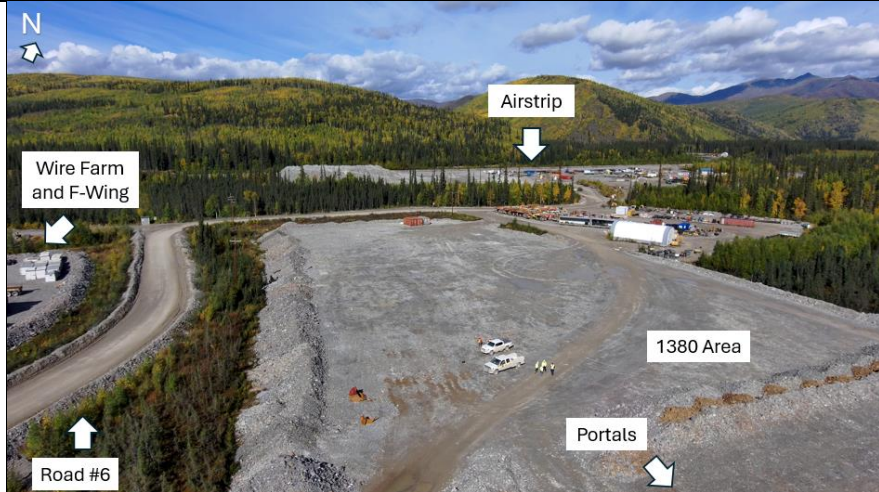
Photo 9: Another view of 1380 Area. Wire Farm and F-Wing to the right.

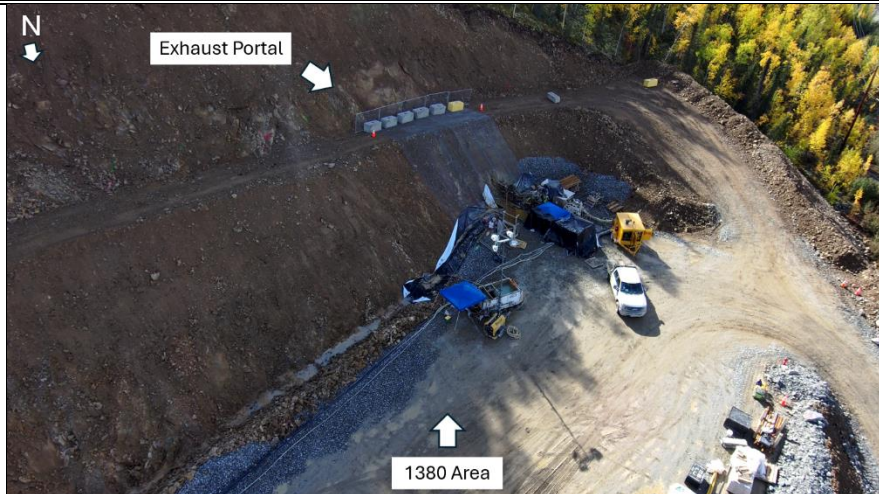
Photo 10: A different view of 1380 Area and location of the Exhaust Portal.

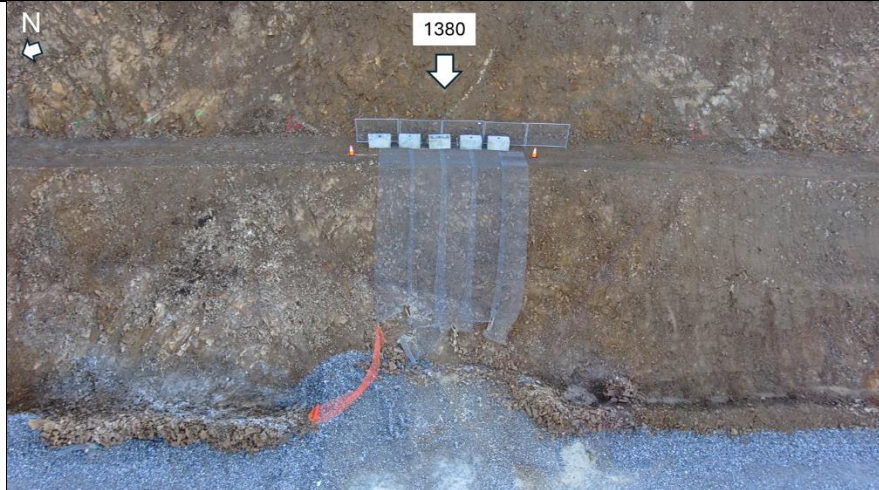
Photo 11: 1380 Area location of the Intake Portal.

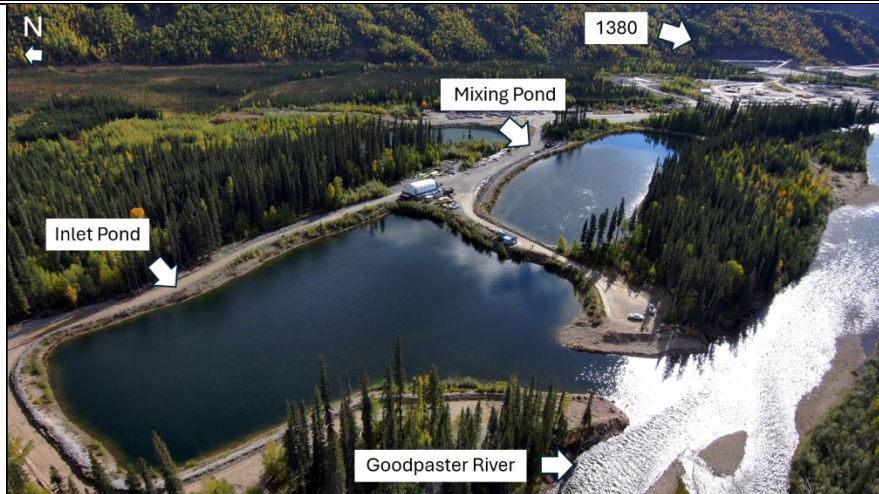
Photo 12: ORTW Inlet and Mixing ponds and Goodpaster River.

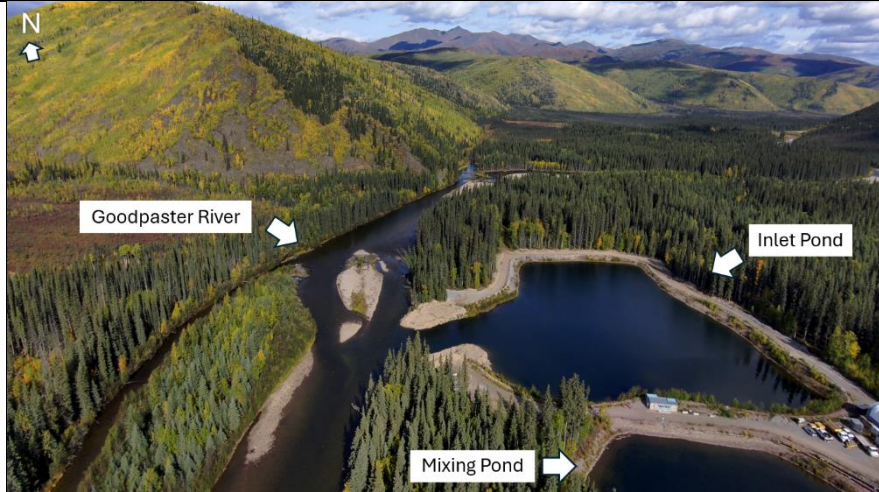
Photo 13: Another view of the Inlet and Mixing ponds and Goodpaster River.

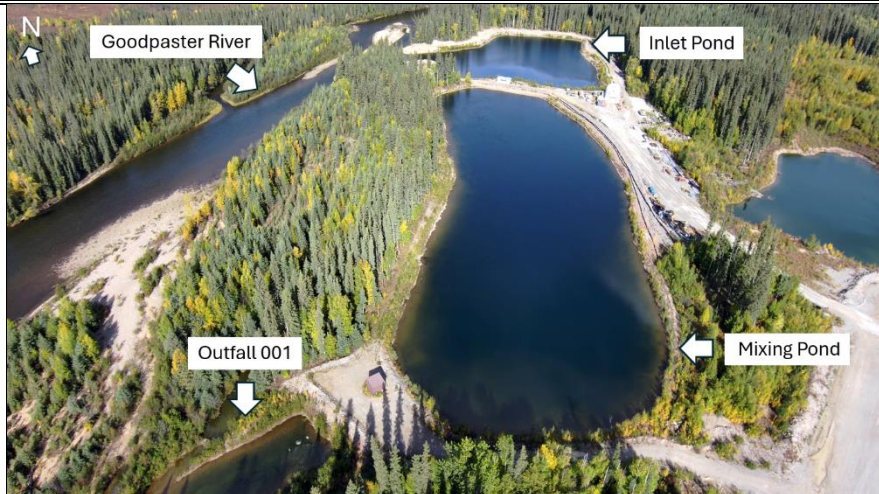
- 2.1. Inlet and Mixing Ponds (Off-River Treatment Works (ORTW)): At the northern end of the mine DNR Staff observed the ORTW (Photos 12-14). The inlet pond has connectivity with the Goodpaster River, which pumps fresh water into the mixing pond via a pump station. The ORTW pump station has a mixing chamber where effluent water from the treatment plant mixes with fresh water before discharging into the mixing pond. The mixing pond serves as a final zone where larger suspended particles from treated waters may precipitate out before reaching the outfall. Water from the outfall discharges back into the Goodpaster River. The ORTW was operating as designed at the time of inspection.
- 2.2. Outfalls: Outfall 001 (Photo 14) and Outfall 002 were operating normally at the time of inspection.

Photo 14: Location of Outfall 001 and view of the Inlet and Mixing ponds and Goodpaster River. The pond to the center right of the photo is/was the Airstrip Borrow Source.

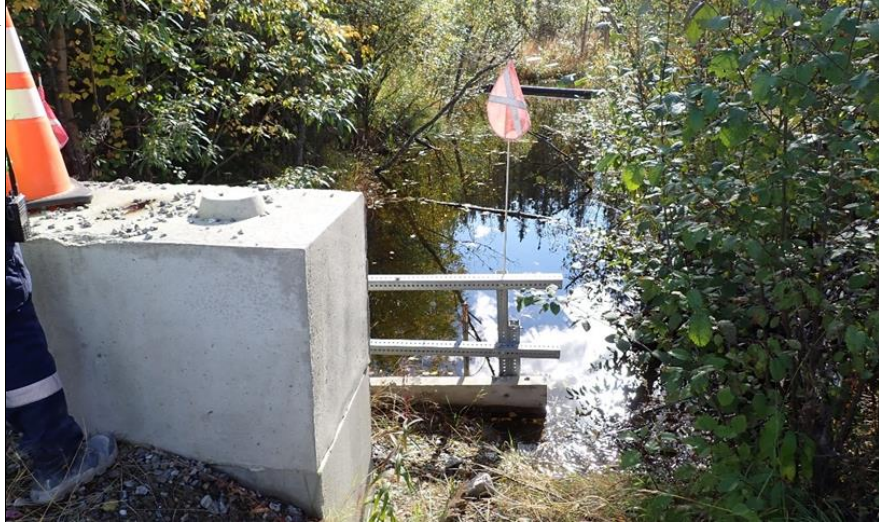
Photo 15: View of Outfall 002.

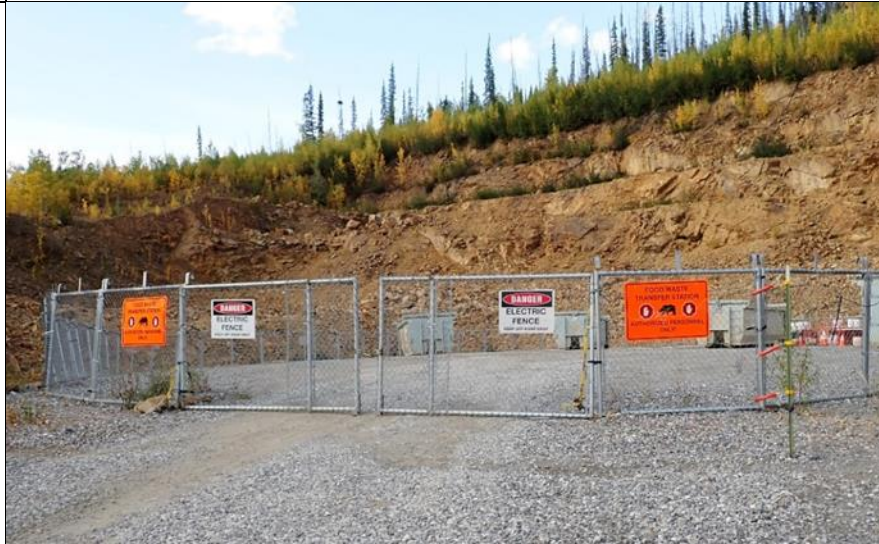
Photo 16: Food Waste Storage and Kinetic Testing Area. Fence is electrified to keep wildlife from entering the area.

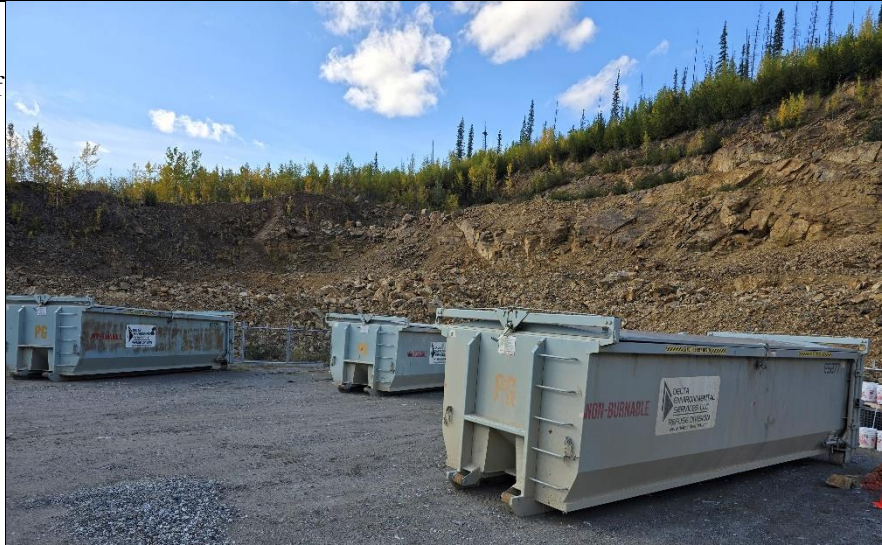
Photo 17: Food Waste Storage and Kinetic Testing Area with view of food waste storage containers.

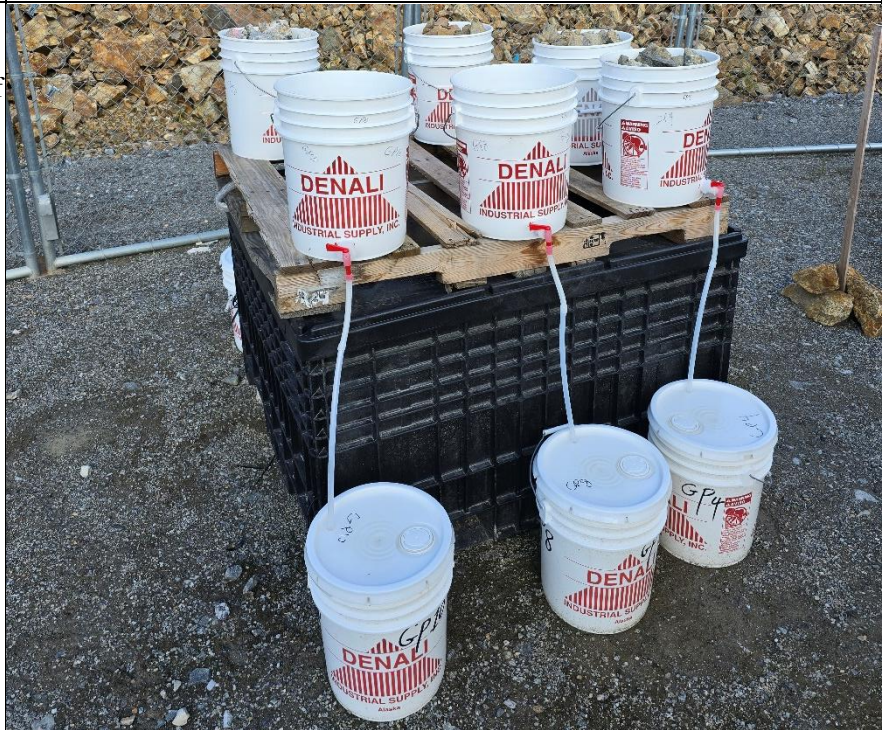
Photo 18: Food Waste Storage and Kinetic Testing Area with view of Barrel Tests.

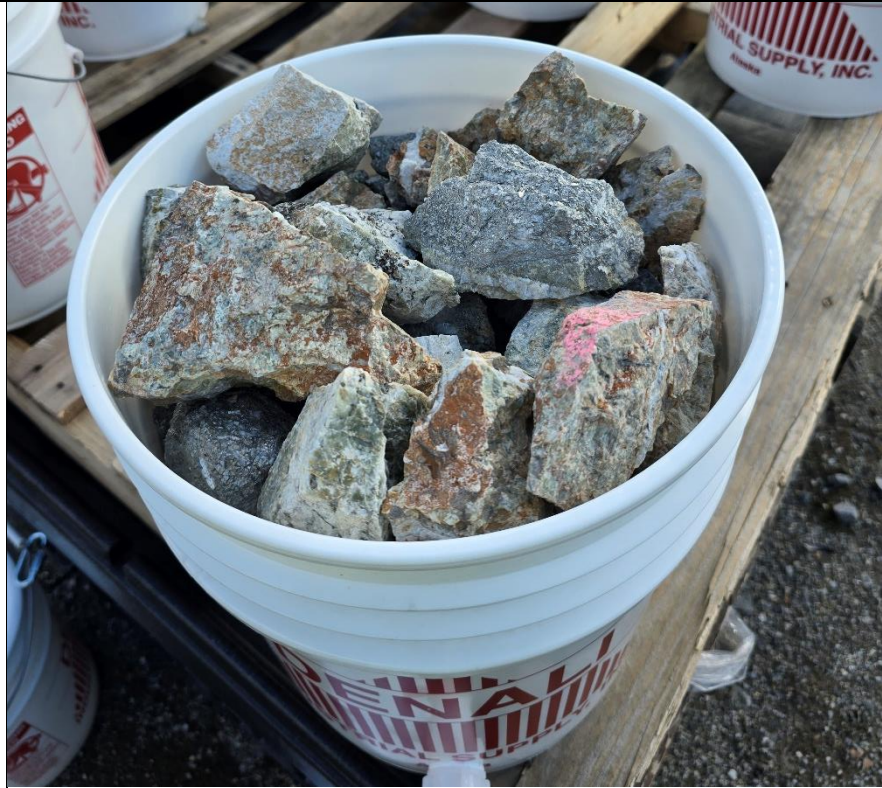
Photo 19: View of Barrel Tests sample.
