Pogo Mine Field Inspection Report

Inspection Date:	June 4, 2025
Time:	12:30PM to 3:30 PM
Weather:	Overcast with broken clouds in the afternoon, becoming partly sunny, cloud cover later in the day. Slight breeze around 15mph with an average temperature of 60°F.
DNR Personnel:	Aaron Kruse, William Groom, Aleria Knudson
Pogo Personnel:	James Meyers, Russell Gossett
Inspection Objectives:	Site Inspection

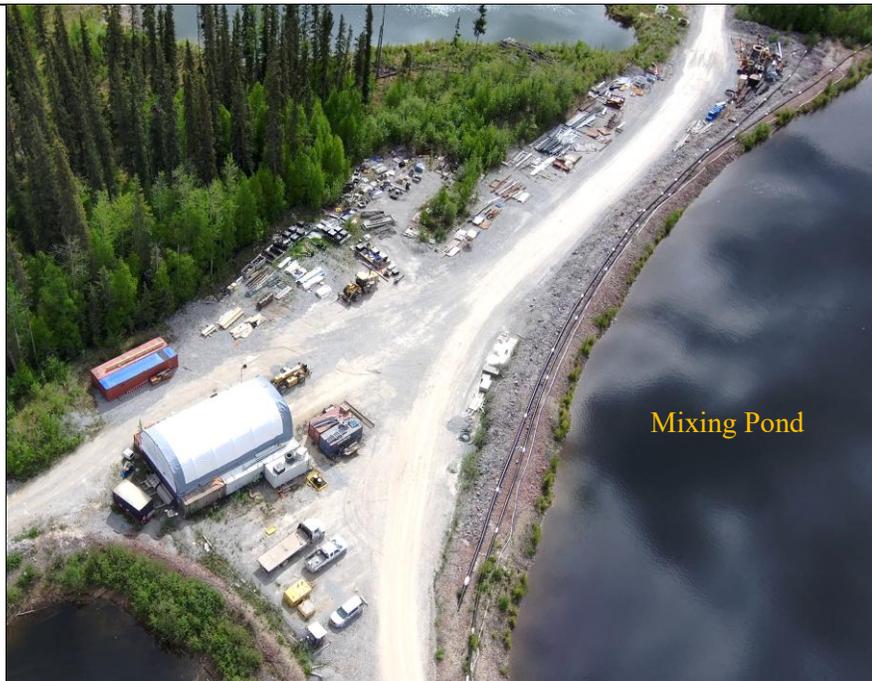
- 1.1. Along the access road to the ORTW is a storage yard mostly comprised of varying pieces of steel, pipe, and a few drums. The yard is well organized and kept in good condition with no notable issues (Photo 1). A drill core storage yard at the end of the runway near ORTW access is also well organized, consisting mostly of pallets of core with some steel, pipe, tanks, and Conex containers (Photo 2). Growth Media Stockpiles 08 and 16 reside just to the east and south of this yard, both of which are in good shape and covered with vegetation (Photo 3 and 4).

Photo 1: Storage yard next to the mixing pond in the ORTW. Varying assortment of well-organized pipe and steel. View looking southeast.

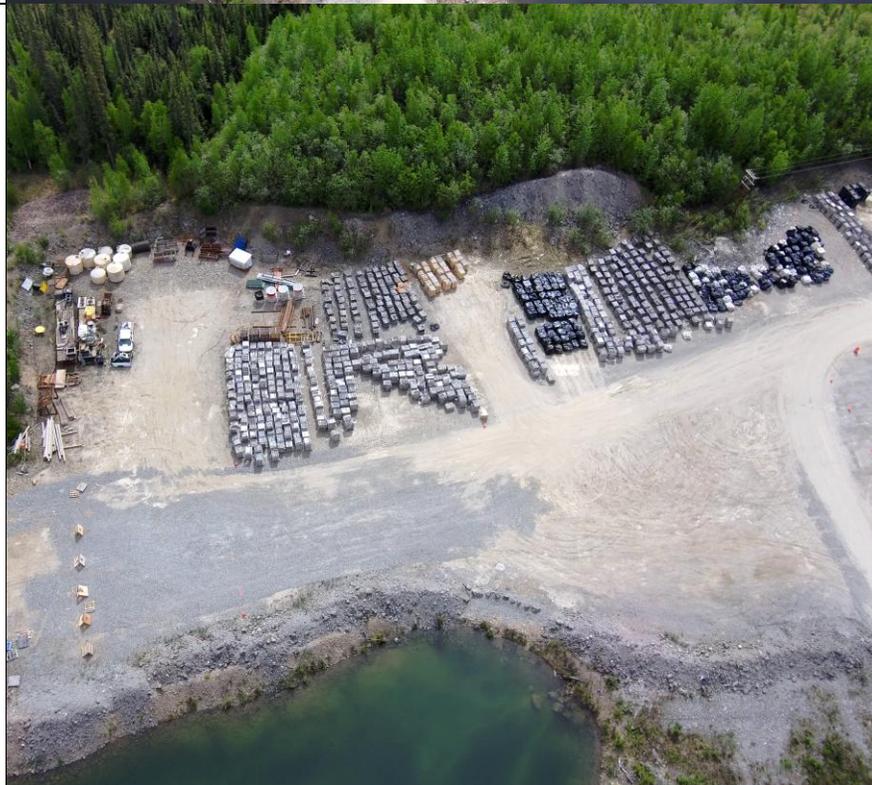
Photo 2: Exploration Core Storage yard. View looking southeast.

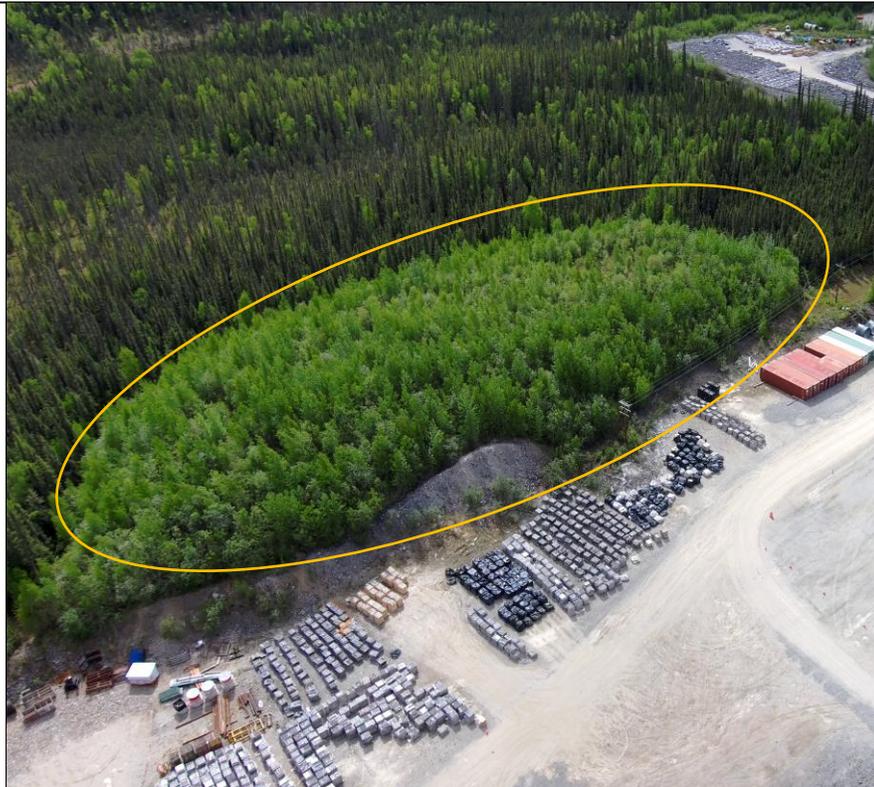
Photo 3: Growth Media Stockpile (GM 16) next to the core storage yard. Well vegetated, stable, and accessible for future reclamation. View looking southeast.

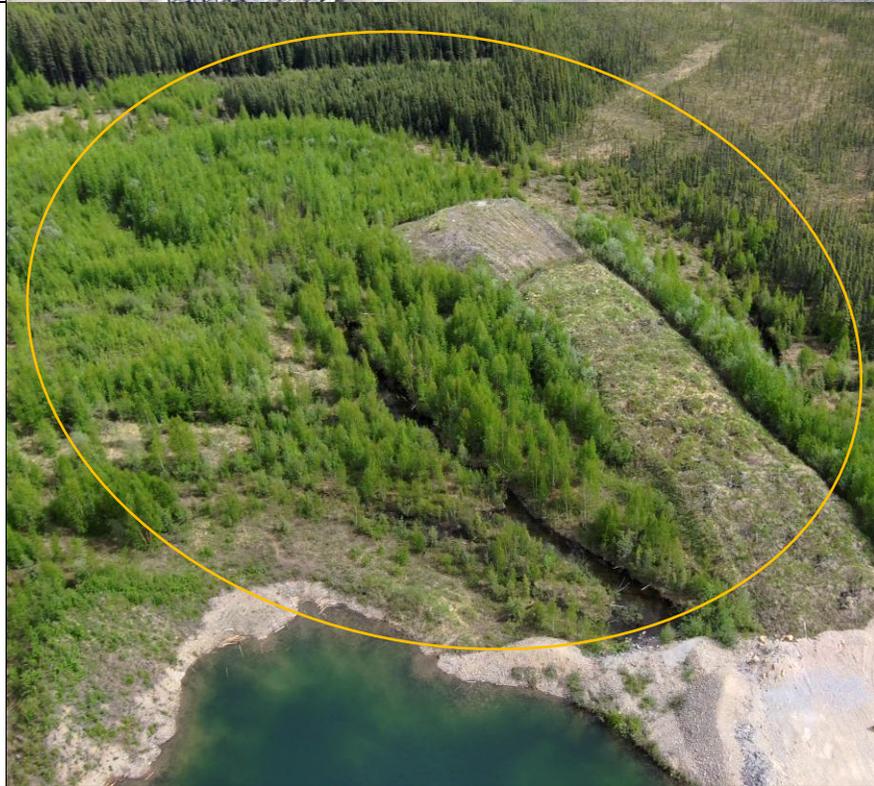
Photo 4: Growth Media Stockpile (GM 08). Older areas are heavily vegetated with more recent organic placements showing good vegetative growth. Located at the northeast end of the runway adjacent to core storage yard.

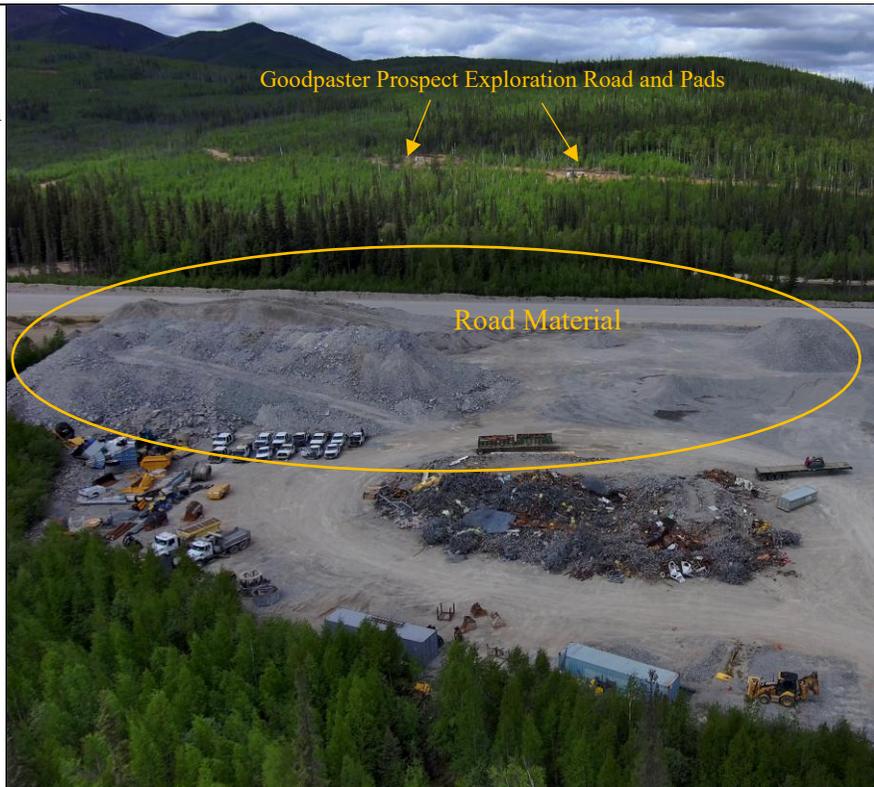
- 1.2. On the west end of the airstrip is the main road material stockpile next to a scrap yard comprised mostly of discarded metal debris and non-operative vehicles (Photo 5). Several distinct material piles are observed of varying size and grade produced from green waste rock from the mine. Adjacent is the Airstrip Organic Stockpile on the western end covered with vegetation (Photo 6). Most of the area around the airstrip is comprised of laydown and storage yards for mine operations.

Photo 5: View looking northwest. Several separate piles of varying grades of road material produced from non-mineralized green rock from the mine. Discarded debris and adjacent to stockpiles.

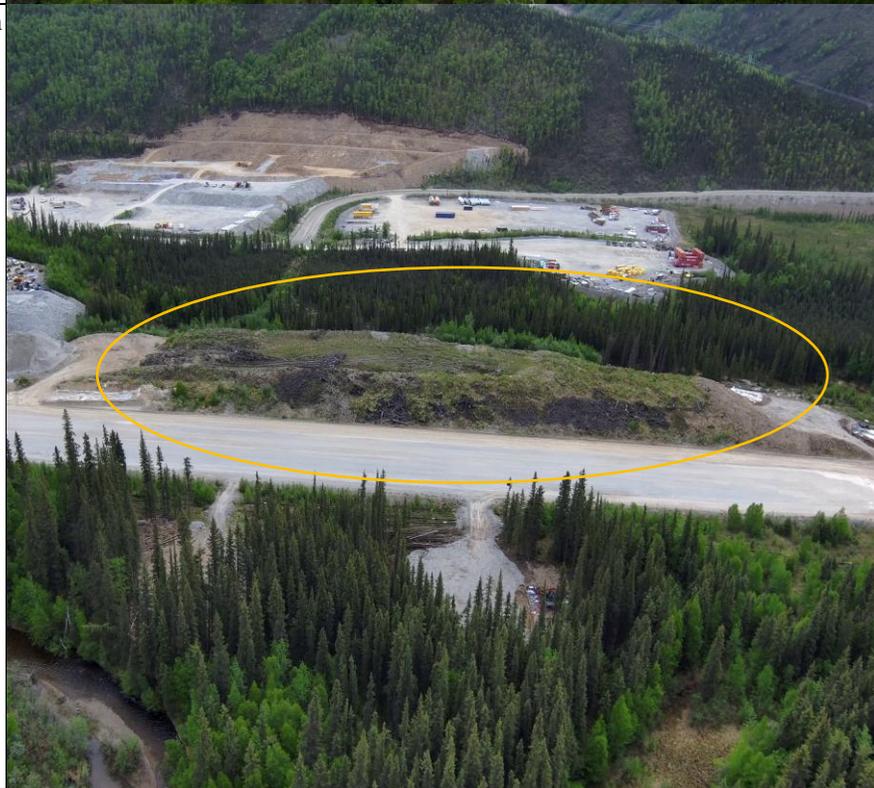
Photo 6: View looking south of the Airstrip Growth Media stockpile. Well vegetated and in stable condition located on the southwestern end of the airstrip.

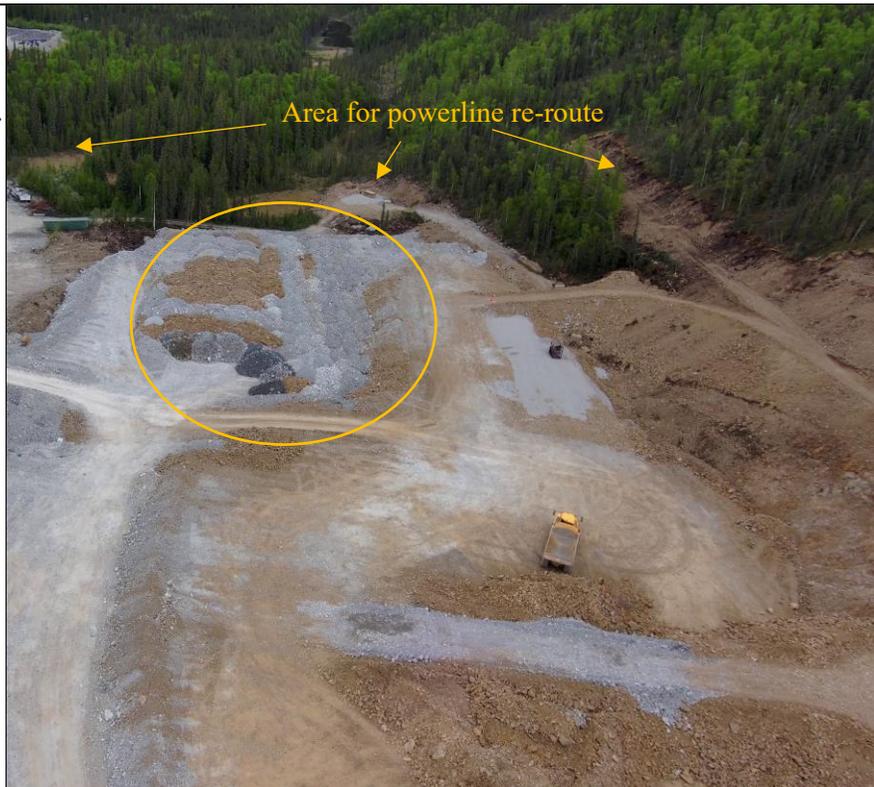
- 1.3. Just south of the eastern extent of the airstrip is the location for the 1380 Portal. At the time of inspection, active pad construction was observed just below a newly excavated benched high wall. Pad construction uses green rock from the mine to bring the elevation up to grade, which will extend to the road when completed (Photo 7). Two ramps to the highwall were in place to begin construction of an intake and exhaust portals (Photo 8). At the eastern corner of pad construction is the location where the main powerline will be re-routed (Photo 9). The main powerline currently runs along the access road and will be removed once installation of the new powerline is complete.

Photo 7: View looking northeast of the early works for the 1380 pad. Piles staged to be spread (circled). This buildout will extend to the access road where the current powerline runs. Background is area for the powerline re-route.

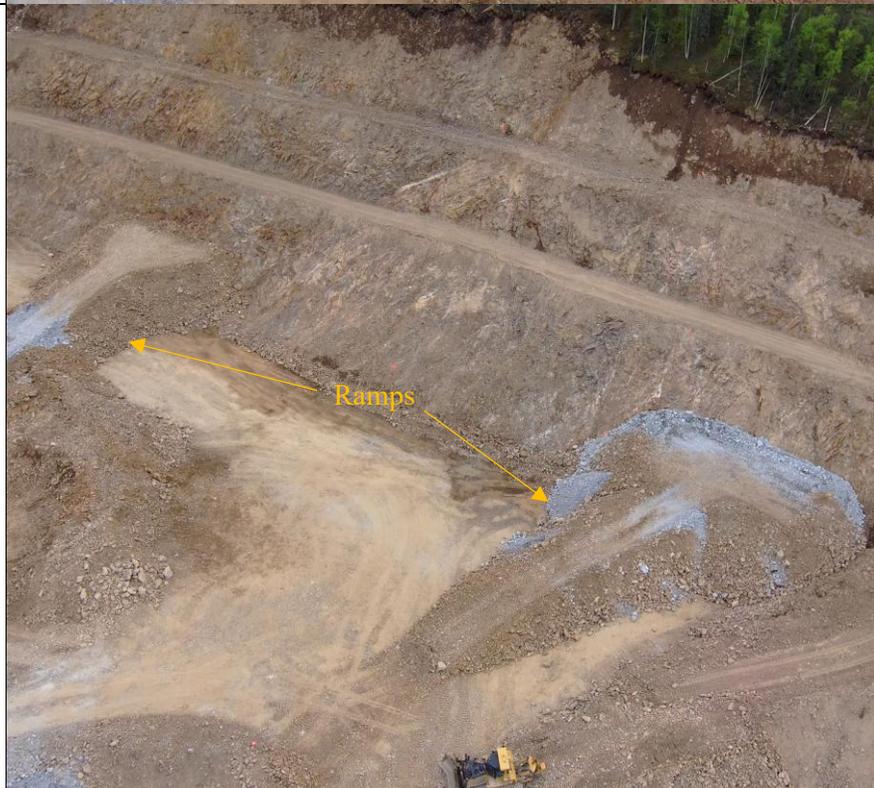
Photo 8: Dirt ramps indicate approximate location for the intake and exhaust portals. Benched highwall viewed southeast. These portals will be used to develop access to the Goodpaster Prospect across the river.

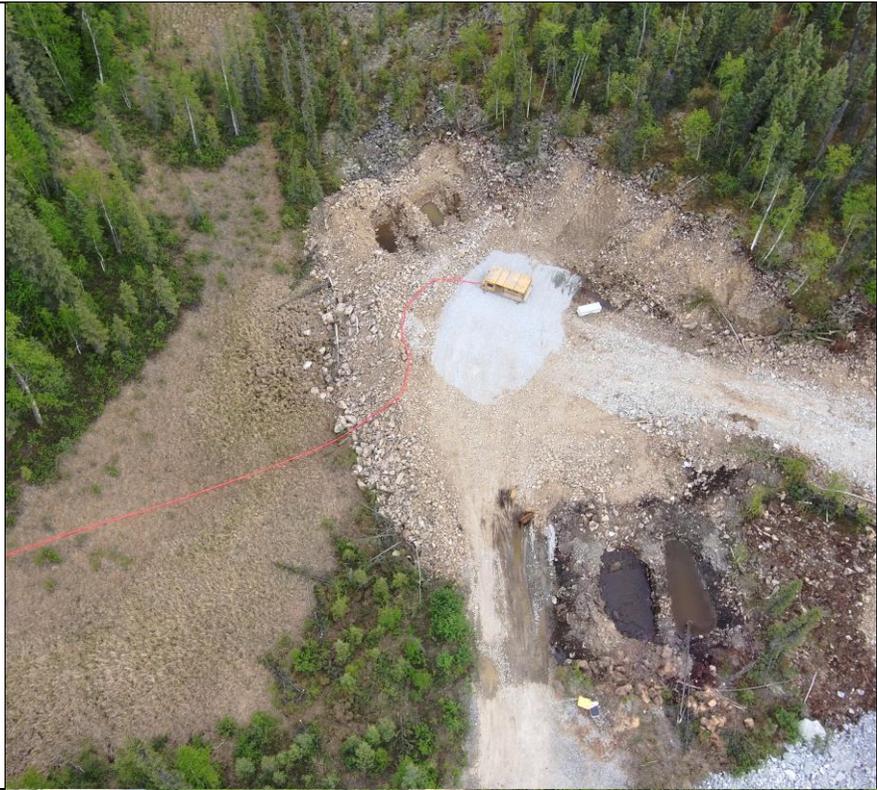
Photo 9: Initial construction for the powerline re-route located in the eastern corner of the 1380 Portal pad.

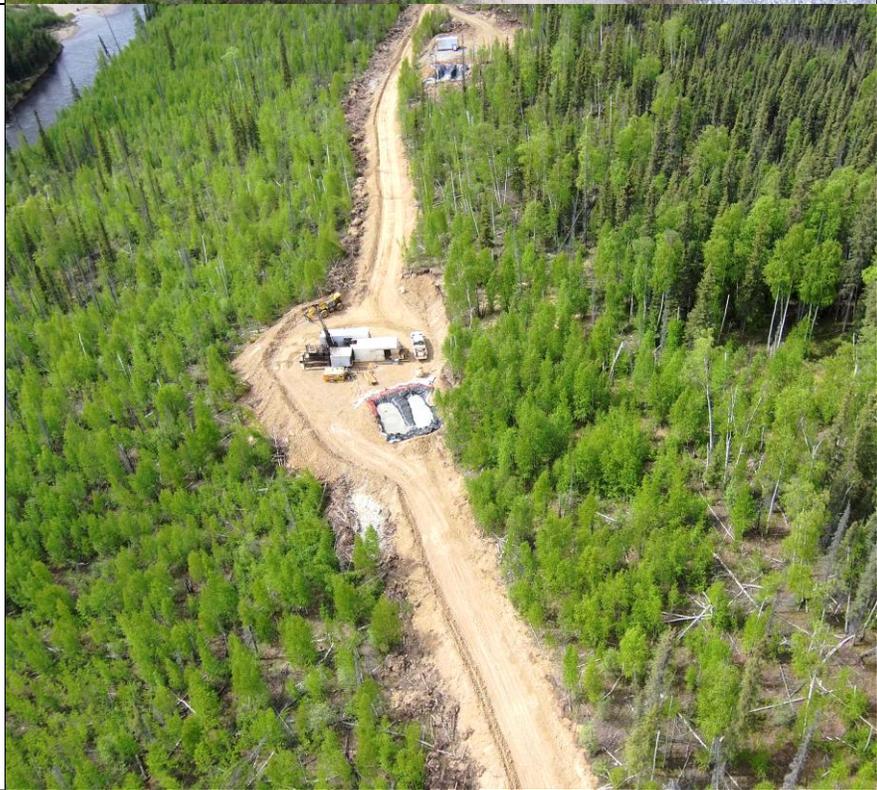
- 1.4. A drone was deployed from a laydown yard next to 1380 Portal pad construction and flown across the river to the Goodpasture Prospect. Active exploration drilling was observed (Photo 10) along with several previous pad locations, each containing two lined drilling fluid sumps (Photo 11). This area will be part of the mine extension supported by the 1380 portals.

Photo 10: Active drilling within the Goodpasture Prospect.

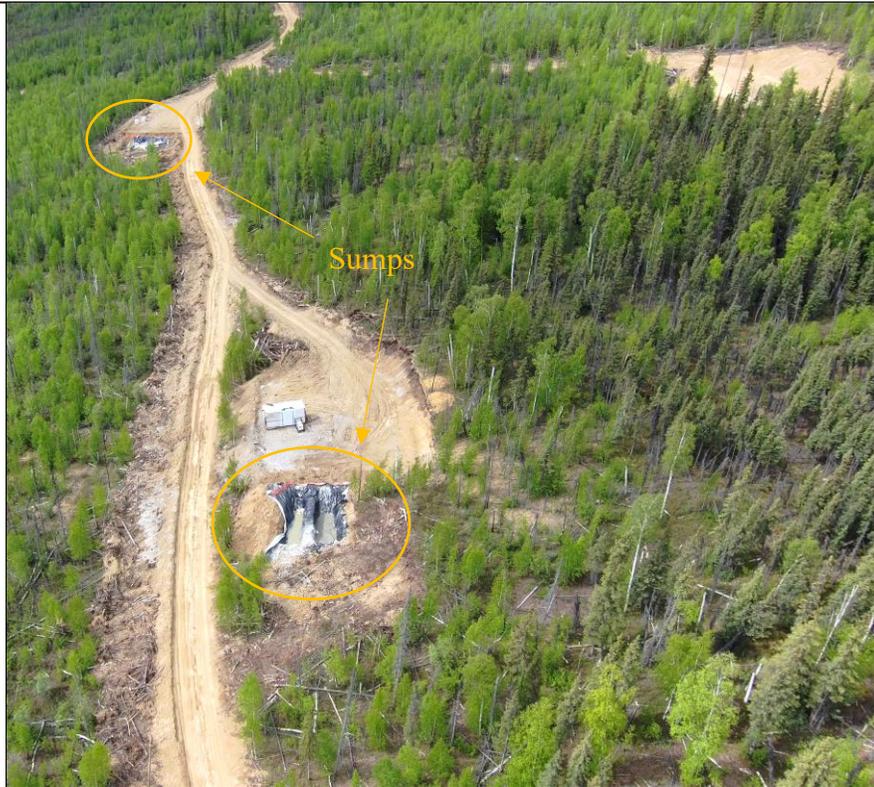
Photo 11: Older drill site locations within the Goodpasture Prospect. Lined drilling fluid sumps have been left in place.

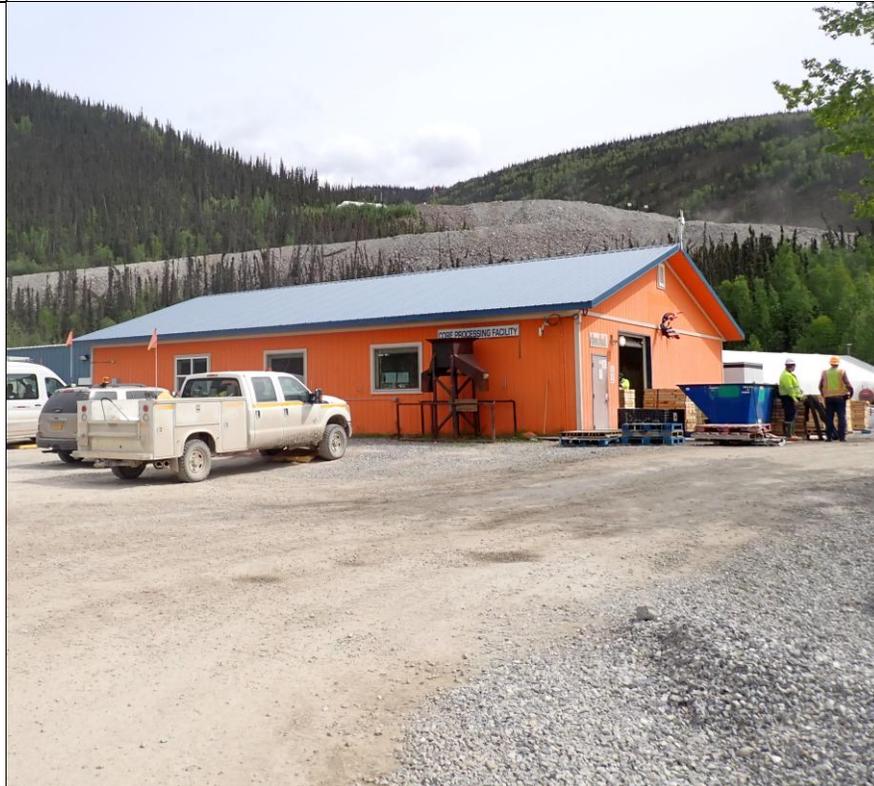
- 1.5. DNR personnel drove to the Lower Camp to document field offices, shops, core processing facilities, and the fuel depot. The area was organized, and buildings were well maintained and in good condition (Photos 12 and 13). Pallets of core and supersacks were also well organized and accessible. The fuel island was clear of any hazardous items and is well documented with signage (Photo 14).

Photo 12: Exploration Core Processing Facility.

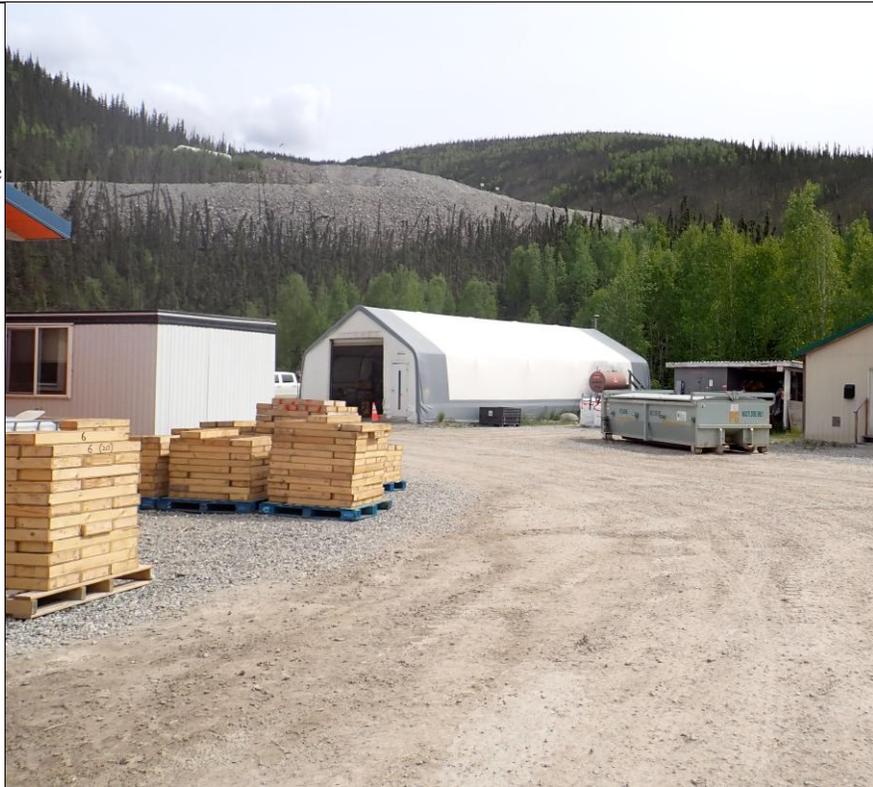
Photo 13: Photo taken just outside of the Core Processing Facility looking south. Core boxes on pallets are situated in front of bay door. Shop and buildings are all well maintained and surrounding area organized.

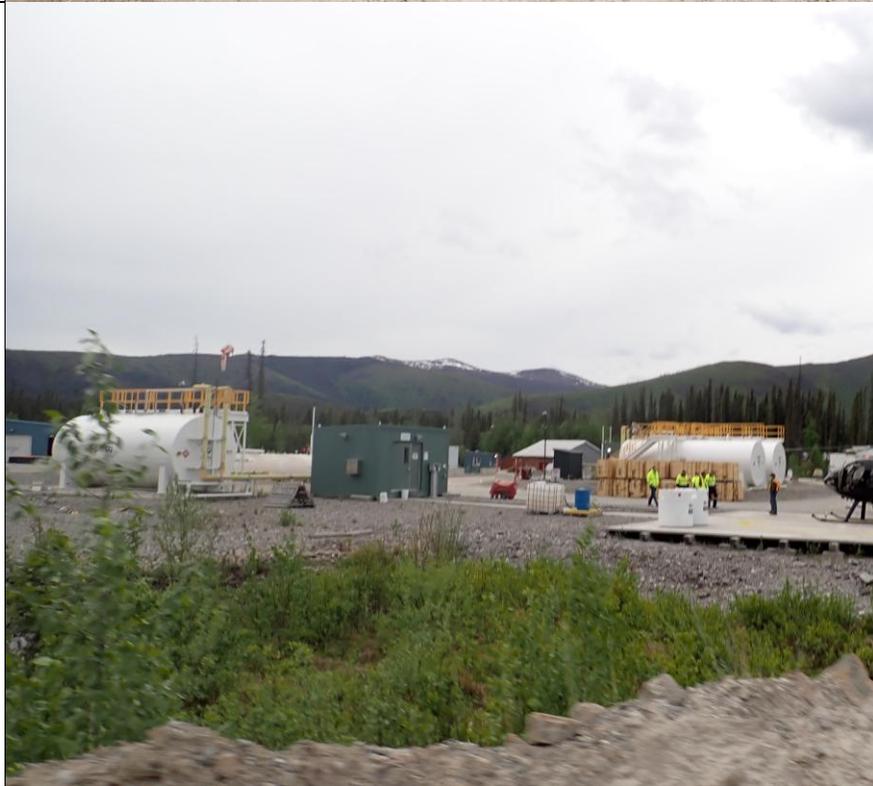
Photo 14: View of the Fuel Island looking southwest.

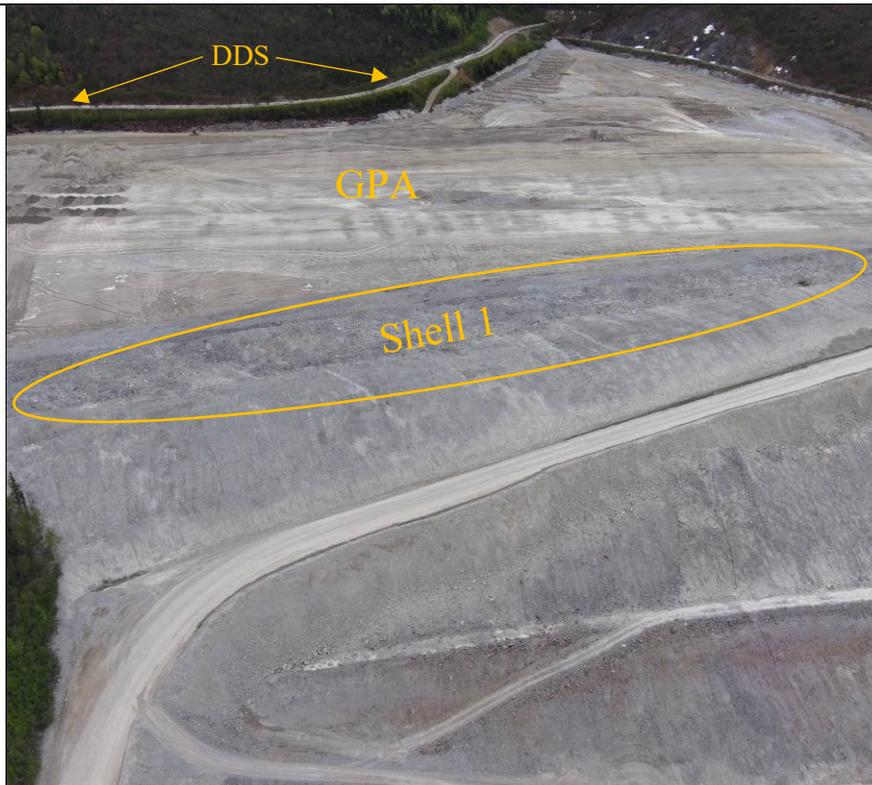
- 1.6. A drone was deployed from the top of the DSTF to document the entire area and ongoing expansion activities of Shells 1 & 2, and continued deposition of rock and tails within the General Placement Area (GPA). Piles of non-mineralized rock were staged along the crowns of both Shells 1 & 2 to raise their elevation as part of the DSTF expansion (Photos 15 and 16). The Shell Zones and embankment placement zone provide structural stability for the DSTF and GPA.² Piles of tails were staged within the GPA, while a vibratory roller compacted tails that were previously spread (Photo 17). Rock has also been staged around the GPA to continue to build up the berm for containment.

Photo 15: Piles of non-mineralized rock placed on the crown of Shell 1 to raise the elevation as part of the DSTF expansion. GPA for tailings and red rock co-disposal in background. View looking southeast.

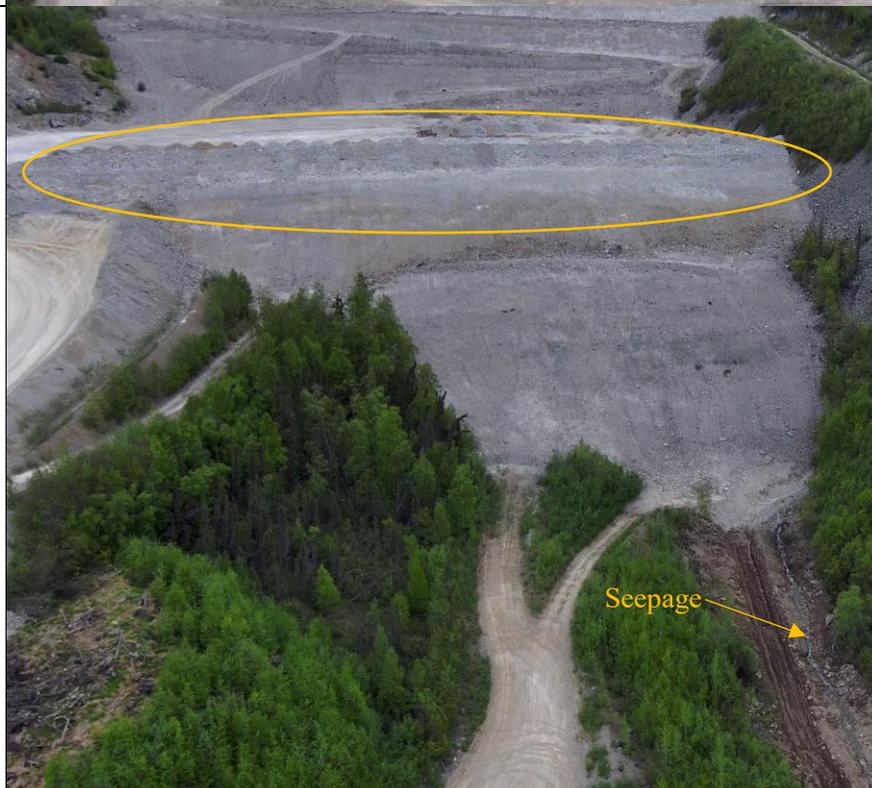
Photo 16: Piles of non-mineralized rock placed on the crown of Shell 2 to raise the elevation as part of the DSTF expansion. Active flow through seepage draining into the RTP.

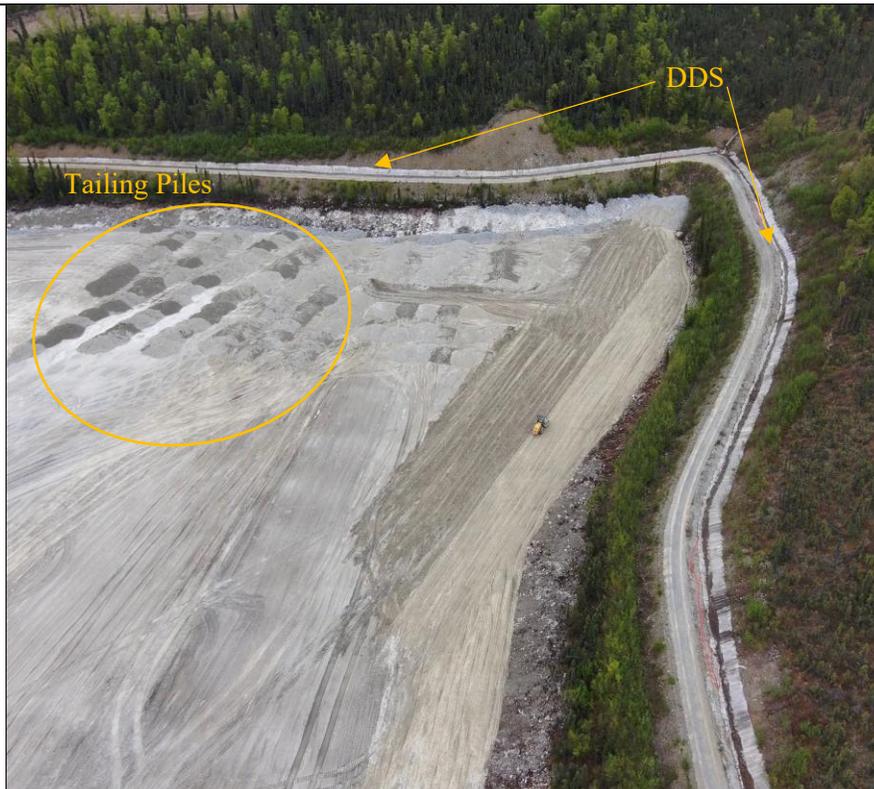
Photo 17: Piles of tailings staged in the GPA to be spread and compacted. Vibratory roller can be seen compacting tailings that have been spread. Water observed within the entire length of the DDS.

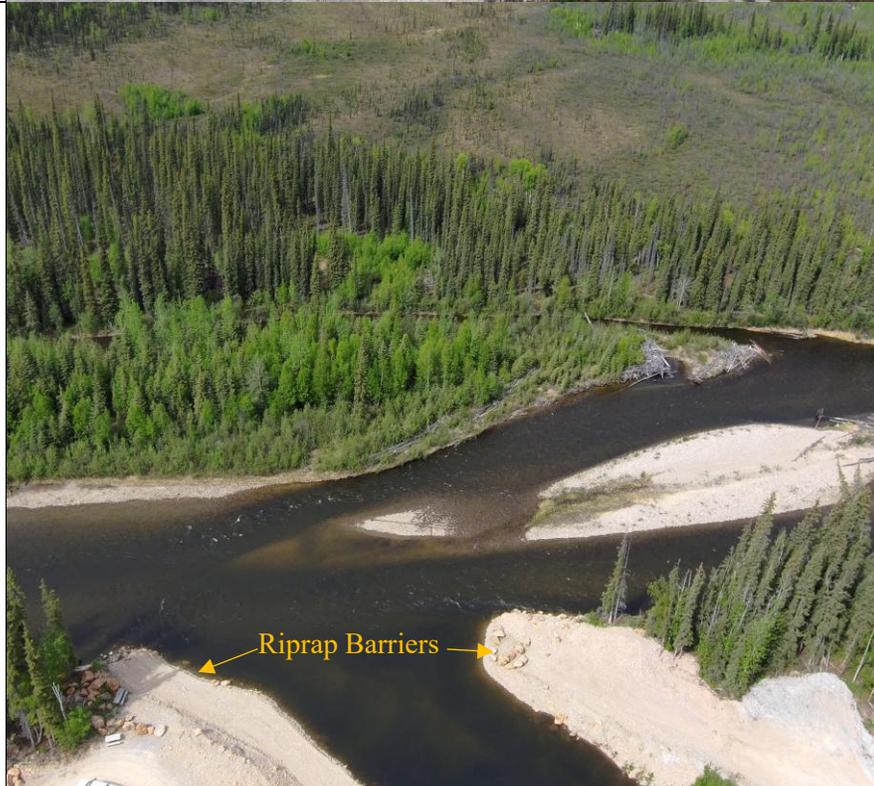
- 2.1. Riprap barriers on each side of the mouth for the ORTW Inlet Pond appeared in good shape with no noticeable erosion from spring breakup along the Goodpaster River (Photo 18). Water was observed actively flowing from facility NPDES001B into the Mixing Pond (Photo 19). Constant water discharged was also noted flowing from the Mixing Pond into the Goodpaster River from Outfall 001 (Photo 20).

Photo 18: Riprap barriers at the mouth of the Intake Pond for the ORTW. Observed to be in good shape after spring snow and ice melt.

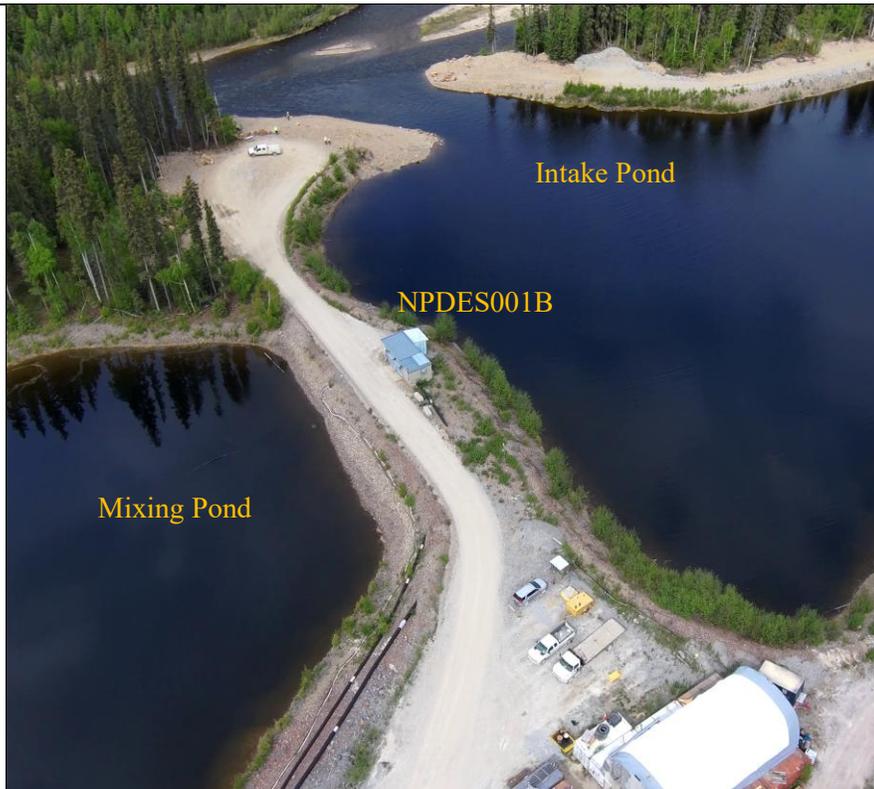
Photo 19: Water observed flowing from the facility NPDES001B into the Mixing Pond.

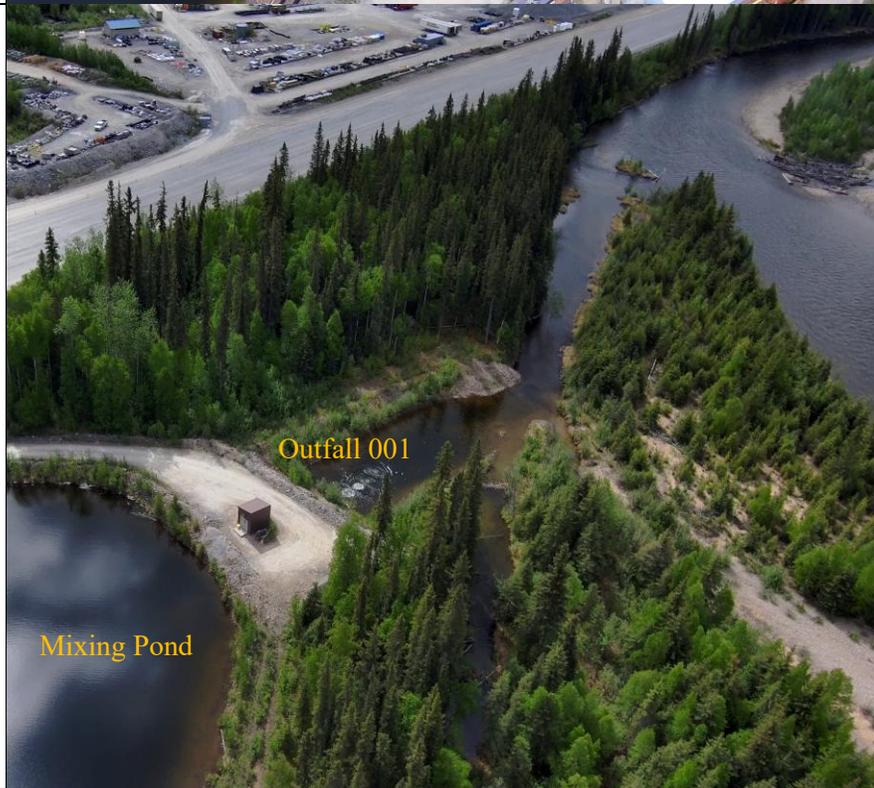
Photo 20: Active water discharge viewed flowing from Outfall 001 into the Goodpasture River.

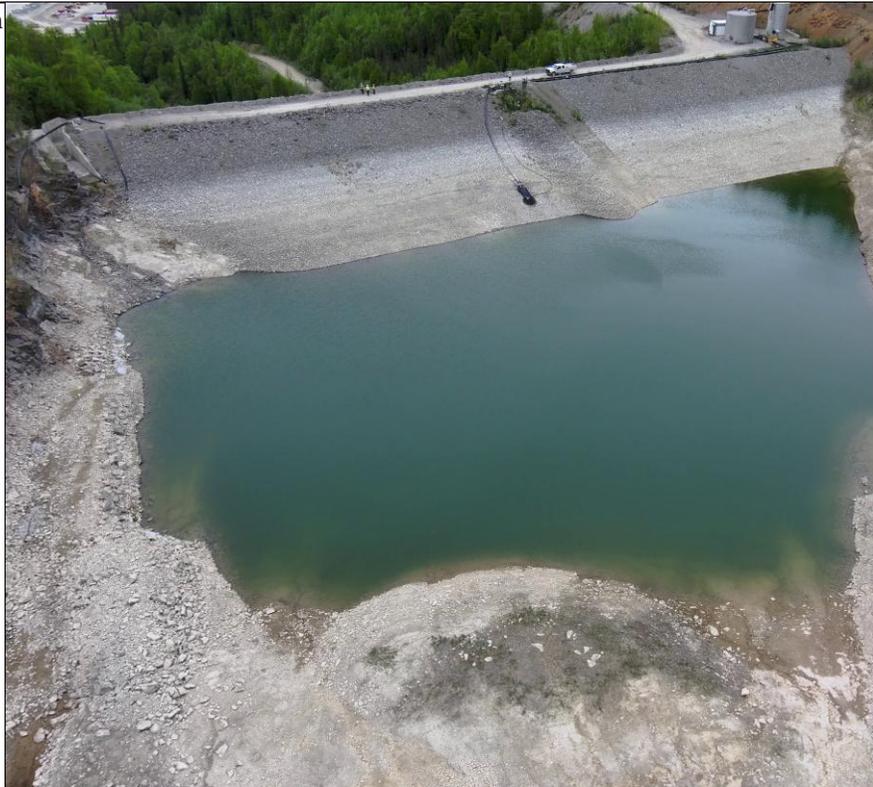
- 2.2. The RTP is located just downstream from the DSTF to collect any seepage that occurs. From the dam, DNR staff deployed the drone to take aerial imagery and document the site and surrounding area. The current water storage was well below what has normally been observed (Photo 21). Water was noted seeping from the DSTF into a small pond upstream of the main impoundment and water body. No surface water connectivity to the RTP was noted from this small pond and is assumed to have groundwater connectivity (Photo 22). The surrounding facilities and spillway were in good condition, and the area appeared to be well maintained.

Photo 21: Water level within the RTP was well below previously observed inspections.

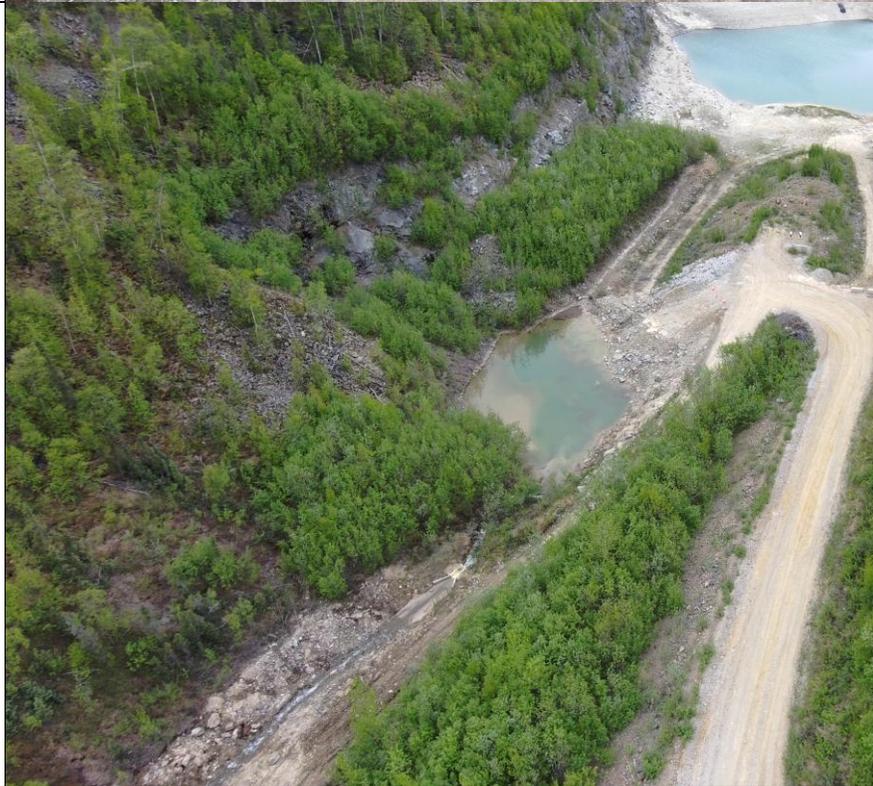
Photo 22: Water observed flowing from the DSTF into the stilling basin; however, no surface connectivity appears between the stilling basin and RTP.

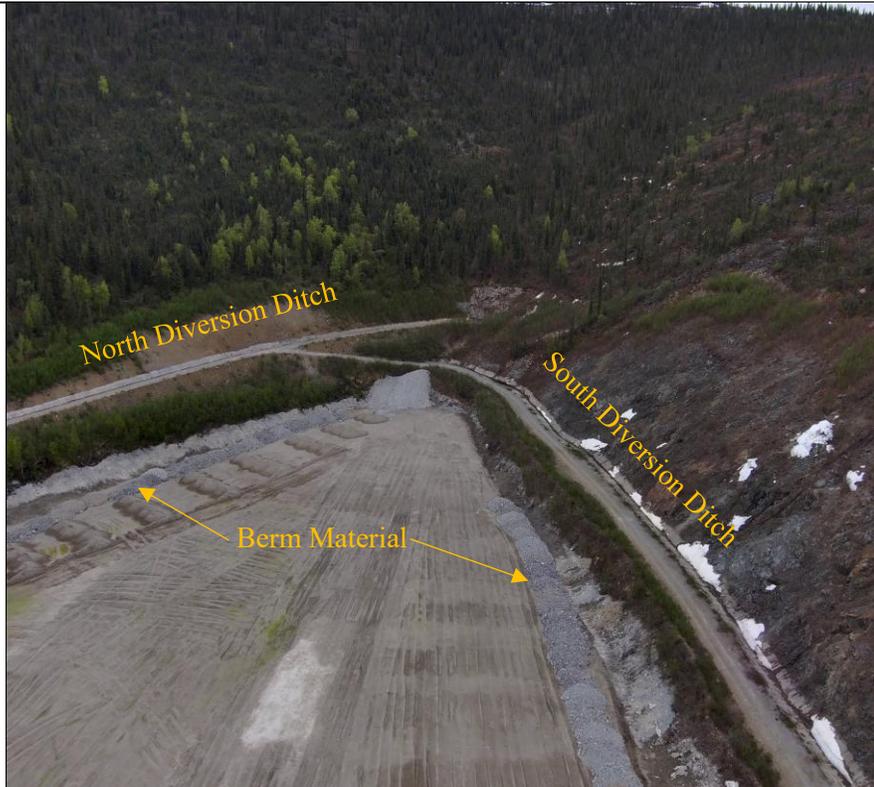
- 2.3. The Diversion Ditch System (DDS) around the DSTF was observed with water within its entire length. Seepage was noted entering the flow through drains located within the DSTF at two of its southern points. Snow was still present within shadowed areas along the surrounding hillside (Photo 23). Most of the water flowed into the diversion ditch from natural drainage points (Photo 24).

Photo 23: Snow present along slopes with active water seepage along the hillside was observed entering the DDS. Piles of non-mineralized material placement used to build up berm around DSTF.

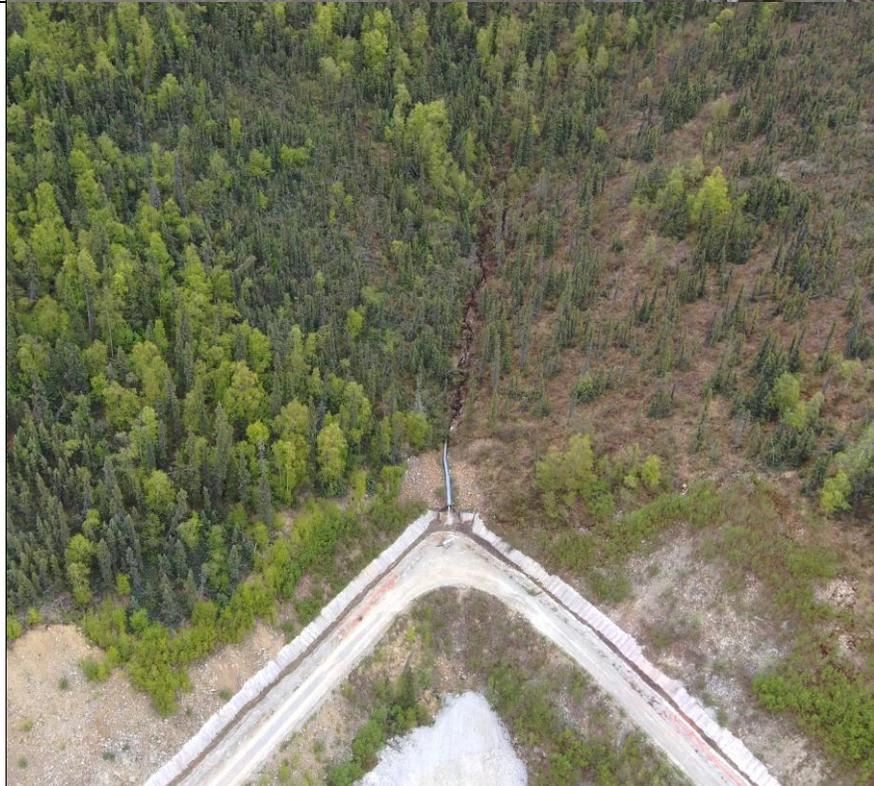
Photo 24: Water observed flowing from natural drainage points into the DDS.
