STATE OF ALASKA

DEPARTMENT OF NATURAL RESOURCES

INSPECTION REPORT POGO WINTER ROAD

Inspection Date: March 2, 2004
Weather: Overcast, windy, and sunny, 0 to +10 F
Time of Inspection: 0930 to 1330 hrs.
Operator Contact: Karl Hanneman, Teck-Pogo Inc.
Agency Personnel: Chris Milles (DNR-DMLW) and Jack Winters (DNR-OHMP)
Inspection Objectives: Inspect Shaw Creek All-season road construction

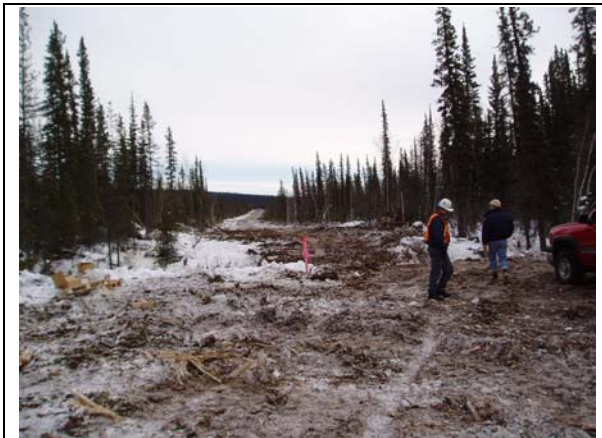
Road clearing at Caribou Creek looking towards mine.

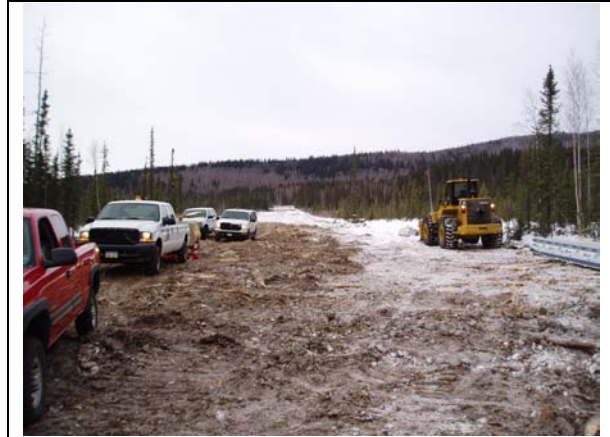
Road clearing before Caribou Creek looking towards Richardson Highway.

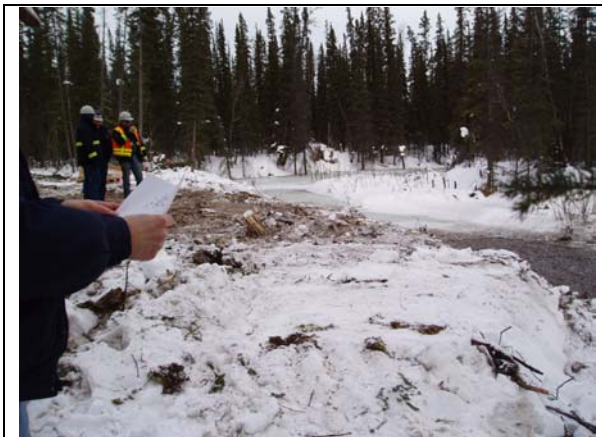
Caribou Creek looking upstream.

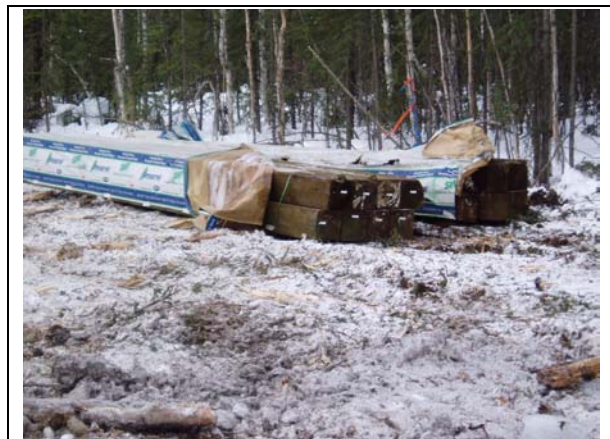
From the AIC staging area, we proceeded up the winter road to MS 7. The winter road was in excellent shape. From MS 7, we proceeded along the cleared road to Caribou Creek to the location of the Caribou Creek permanent bridge. This bridge should be installed within 4 to 5 days. At this location we spoke with AIC representatives that were present and staging some equipment for the bridge installation. The bridge design has been modified from a pile supported bridge to a timber supported bridge that will totally span the creek. Material from MS 7 will be used as fill for the supports.

Caribou Creek bridge timbers.

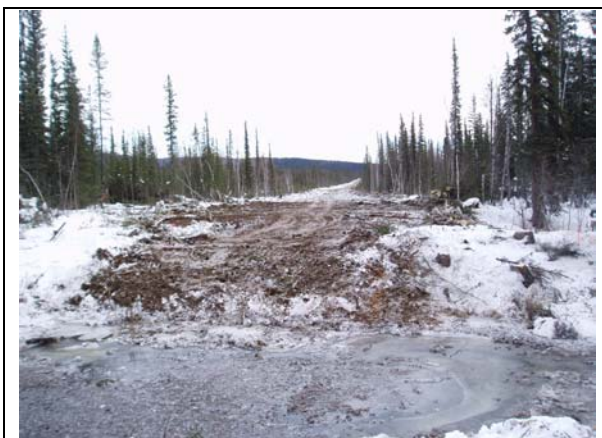
Left bank of Caribou Creek.

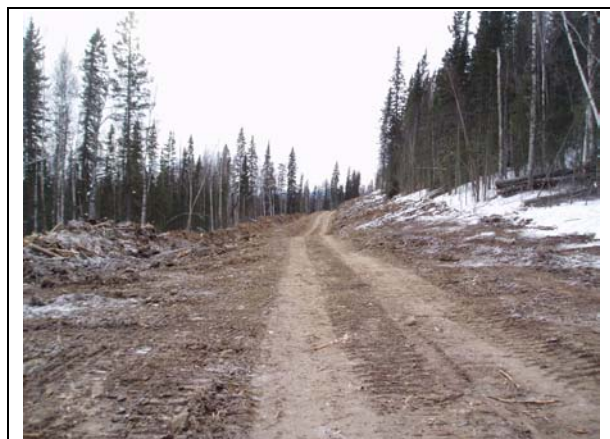
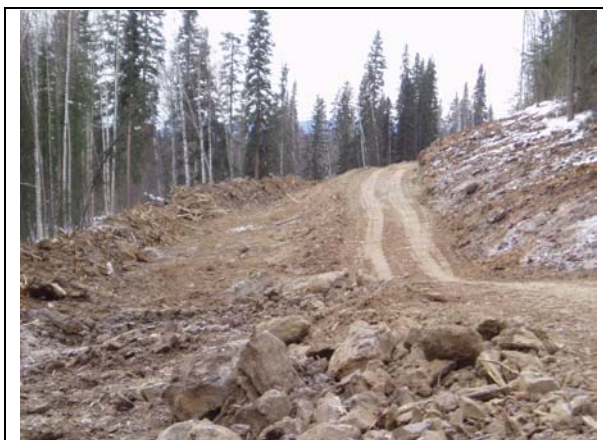
Road clearing between MS 7 and Caribou Creek.

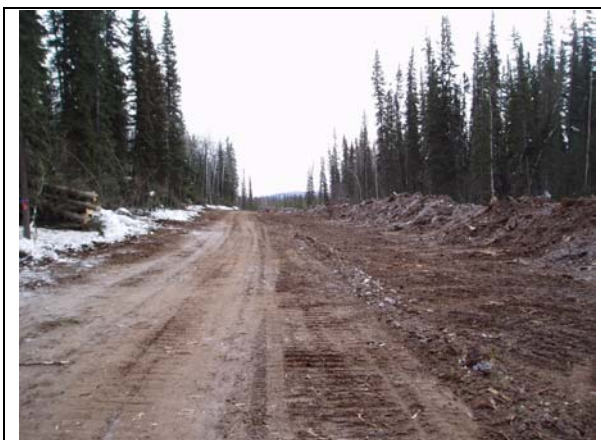
Road clearing west of MS 7.

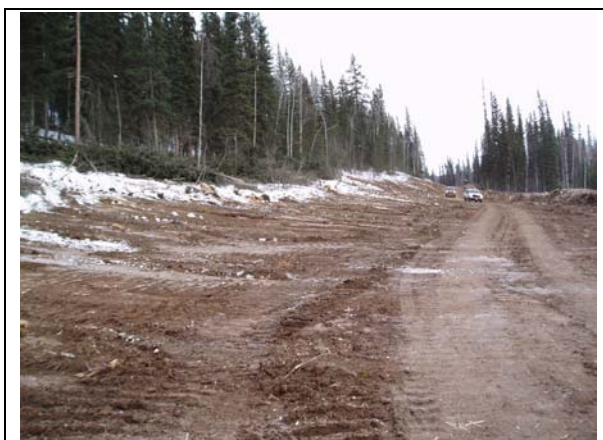
Road clearing at MS 7. MS 7 on left side.

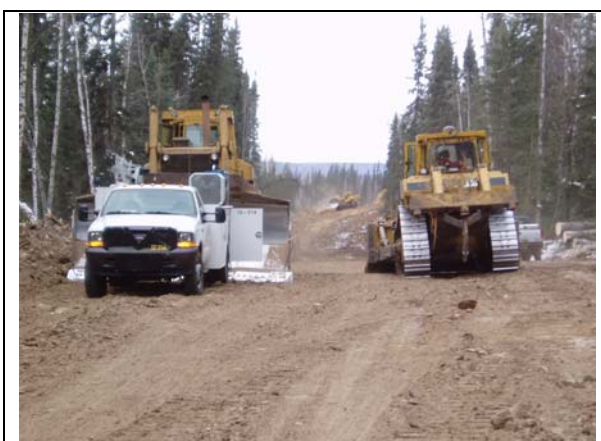
Equipment. Onboard GPS being installed on dozer on right for road clearing.

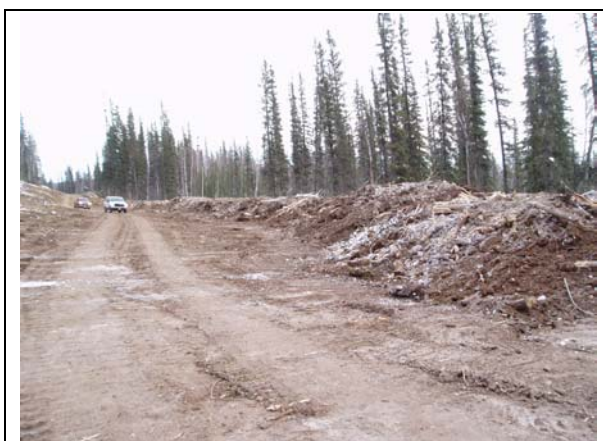
Road clearing at MS 7.

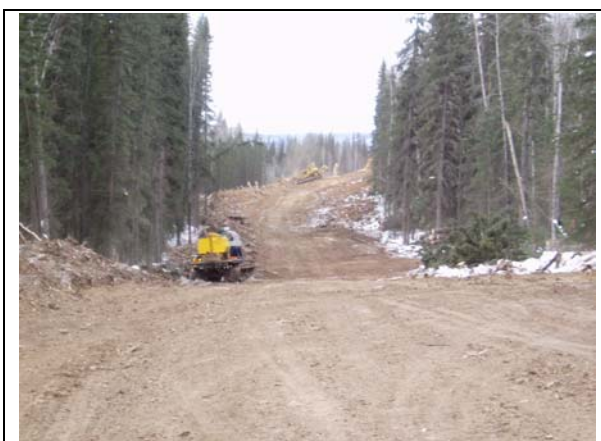
From there we drove back to MS 7 and continued towards the TAPS crossing. The road had been cleared back to approximately station 2200+00 or 5-6 miles from TAPS. The clearing operation has felled and bunched the merchantable timber along the cleared roadway. As shown in the photos, the merchantable timber is in the standing trees but is accessible as the butt ends are facing the cleared area. The DOF was inspecting the timber with prospective contractors. DOF is trying to issue a timber sale for the right-of-way timber that has been felled and bunched.

Road clearing approximately 6 miles from TAPS.

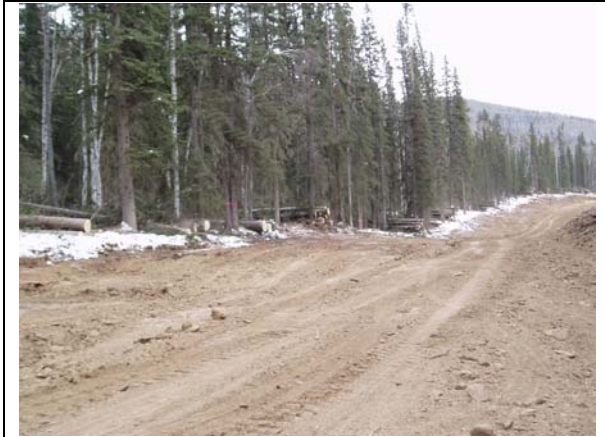
Merchantable timber off road west of MS 7.

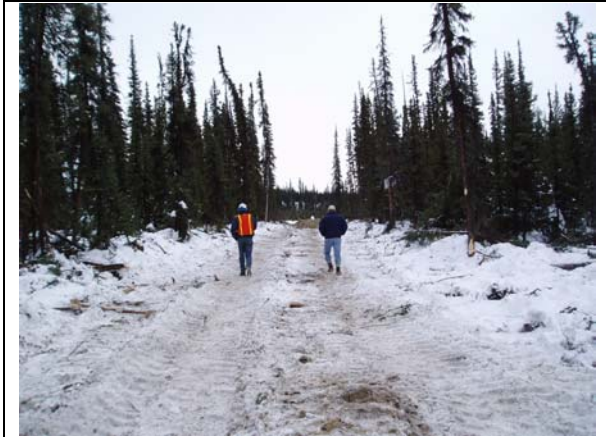
Gilles Creek valley looking toward mine.

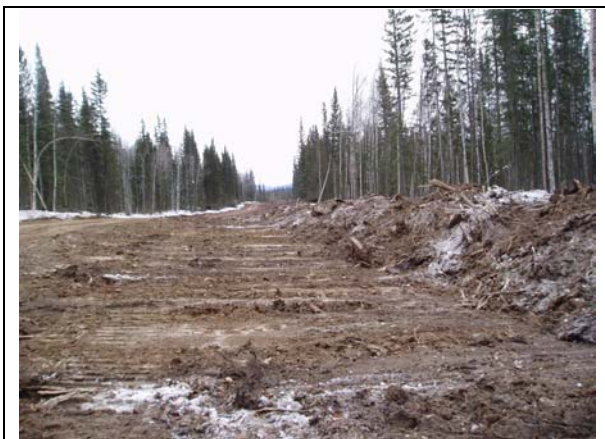
Clearing operation.

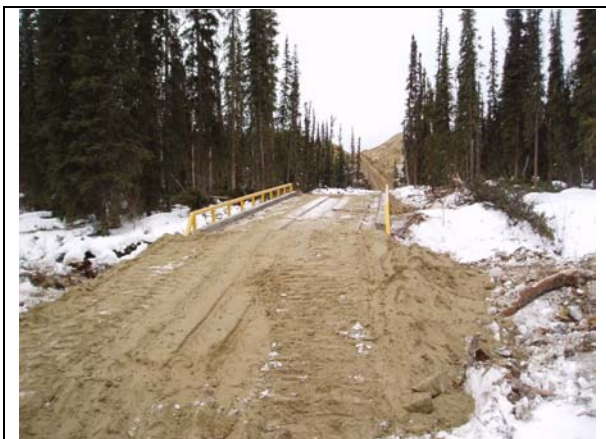
Temporary bridge at Gilles Creek looking westerly.

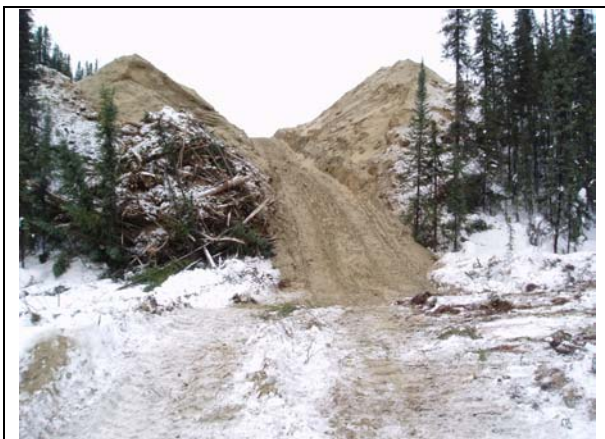
The clearing in this area is visibly wider than in other areas (see the attached photos). Karl explained that where there is greater than 20 feet between the transmission line and the road, the trees between them were not cleared. If the distance between the transmission line and road is less than 20 feet the trees were cleared. In this area, there are other factors involved also. The transmission line spans Gilles Creek using larger towers on either side with a 2000 foot span between. In addition, there is a larger road cut in this area to approach and cross Gilles Creek.

Cut dropping into Gilles Creek valley. Camp location at top of cut on left. Picture is looking westerly.

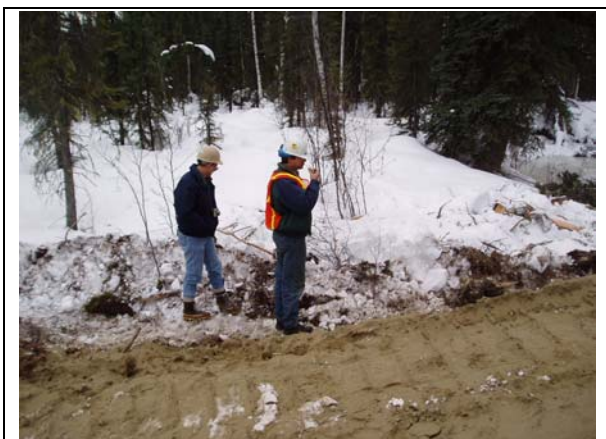
Jack Winters and Karl Hanneman inspecting temporary Gilles Creek bridge.

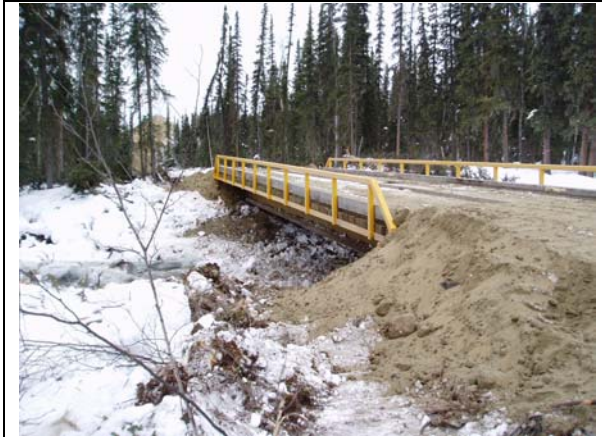
Temporary Gilles Creek bridge.

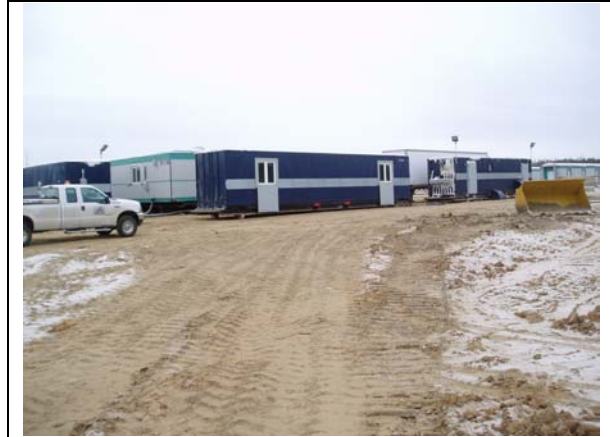
Gilles Camp.

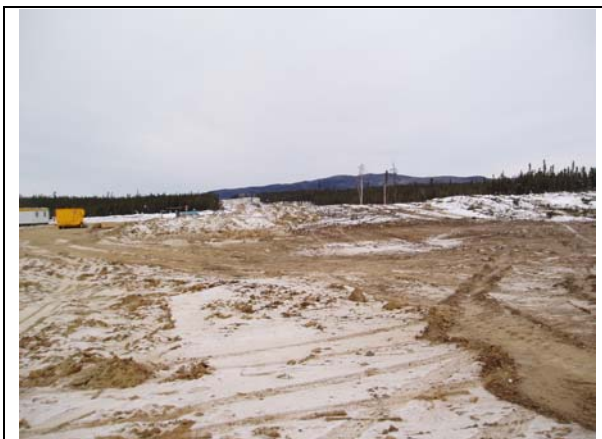
Road/powerline clearing looking west at Gilles Camp.

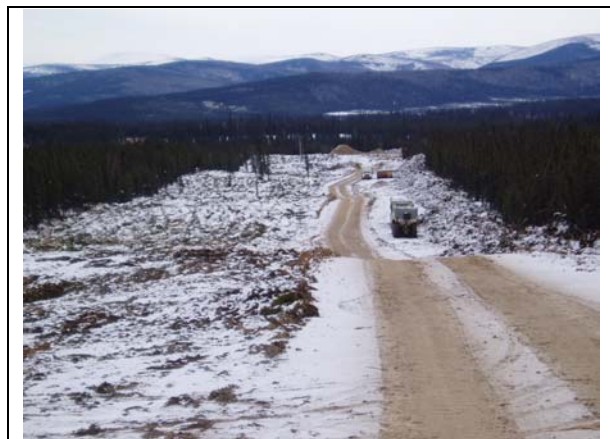
Looking towards mine. Gilles Creek valley past end of clearing.

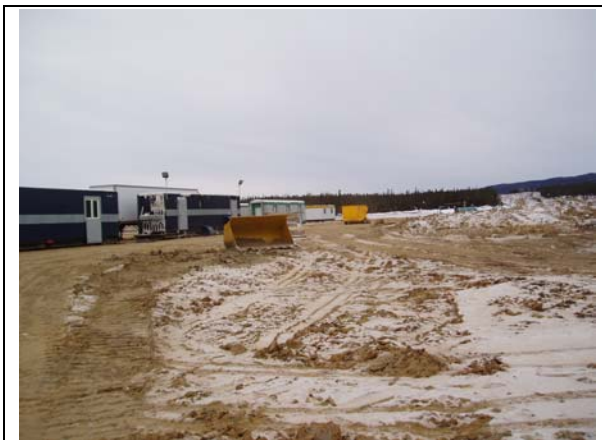
Gilles Camp. Road clearing on right.

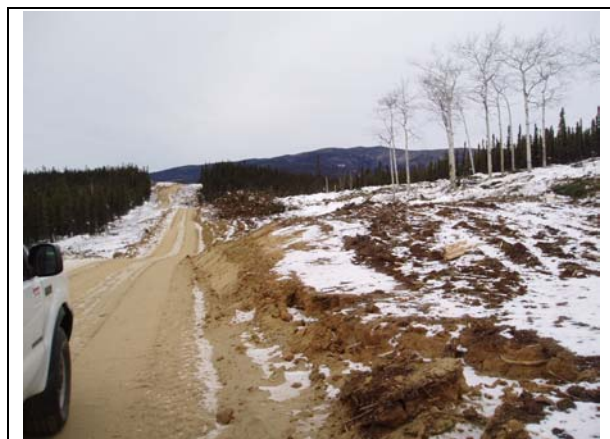
Road and powerline clearing looking westerly from location of picture above.
