DEPARTMENT OF NATURAL RESOURCES

Division of Mining, Land and Water

POGO INSPECTION REPORT

Inspection Date: July 26, 2005
Weather: Clear, Sunny, 70 degrees F., light breeze
Time of Inspection: 10:20 am to 6:00 pm
Operator Contact: Karl Hanneman - Teck Alaska
Agency Personnel: Victor Ross (ACOE), Don Rice (ACOE), Rich Hughes (DCED), Brent Martellaro (ADNR), Jeff Rogers (ADNR), Steve McGroarty (ADNR), Judy Bittner (ADNR), Jim Vohden (ADNR), Jack Winters (ADNR), Luke Boles (ADEC)
Inspection Objectives: General Inspection of Mine Site and Access Road Construction Activity

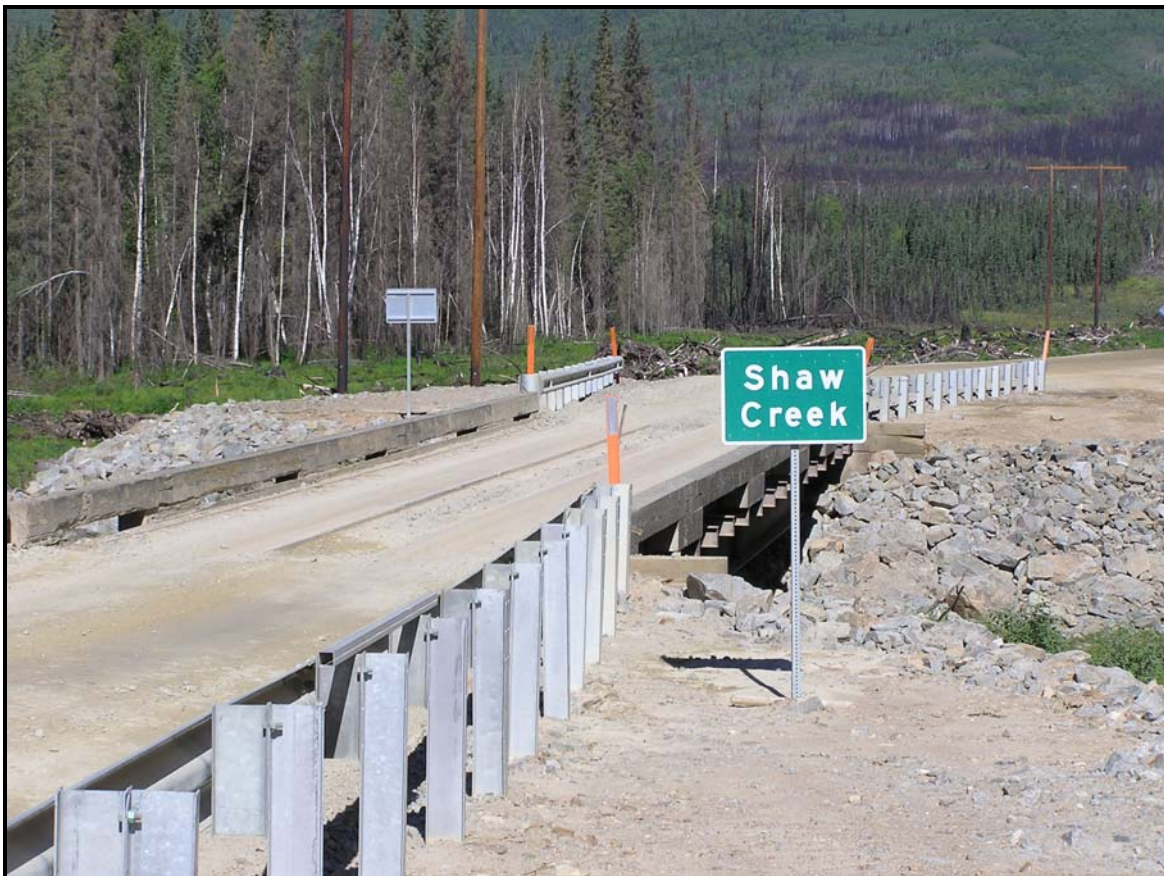
We arrived at the Pogo road gate at approximately 10:20 a.m. and conducted an inspection of the access road, bridges and material borrow sites on the way to the Pogo Mine (Figure 1).

Figure 1 - Shaw Creek Bridge on Pogo Access Road.

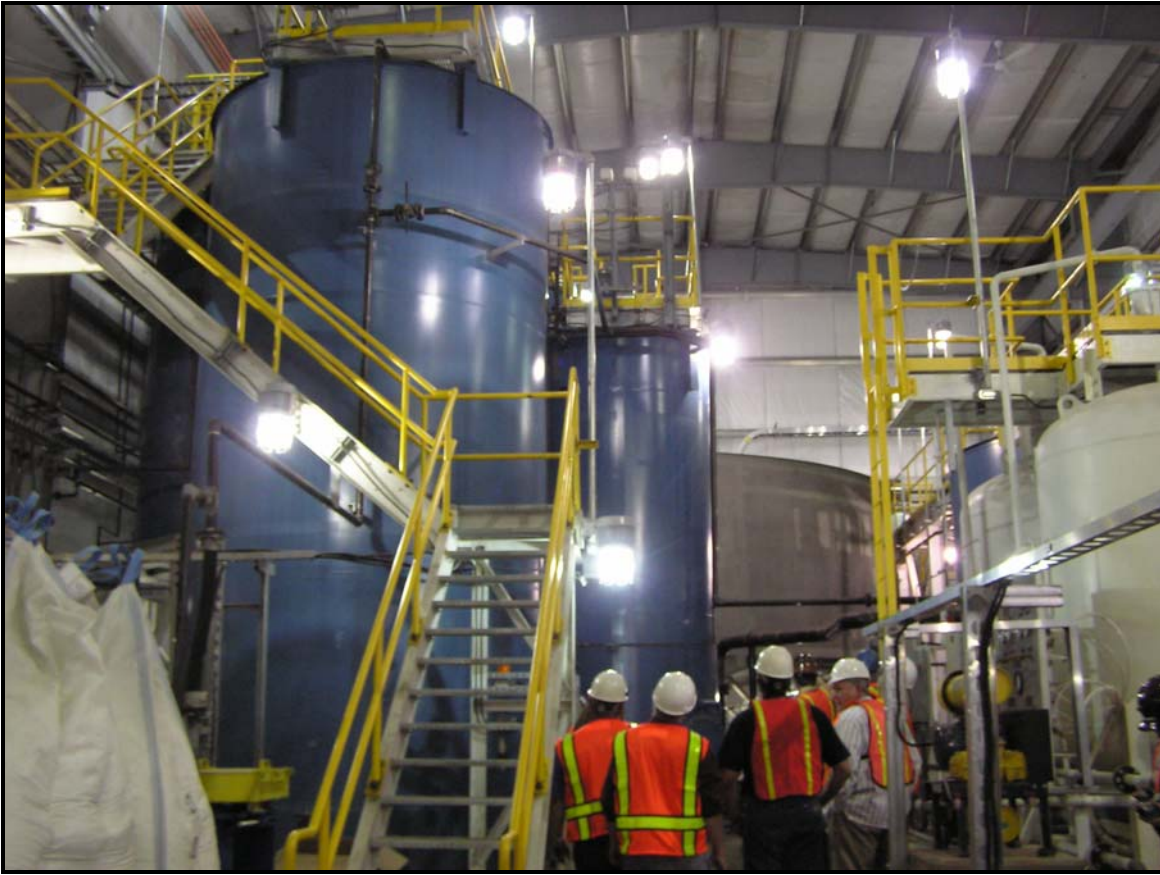
The new water treatment plant located at the exploration adit has been completed and fully commissioned; however, the underground workings are only making approximately 90 gpm, so the water is still being treated in the underground water treatment plant (Figure 2).

Figure 2 - New Water Treatment Plant.

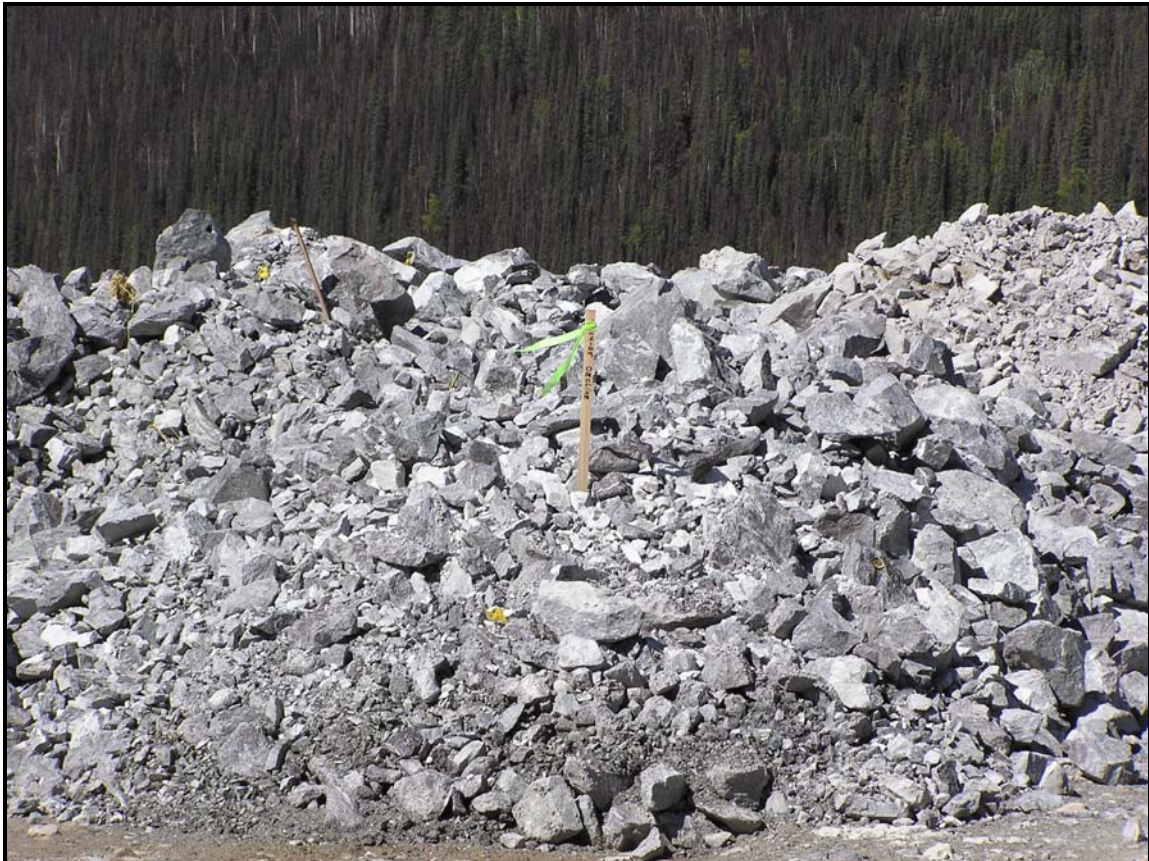
Figure 3 - Underground development rock blast round muckpile designated as non-mineralized.

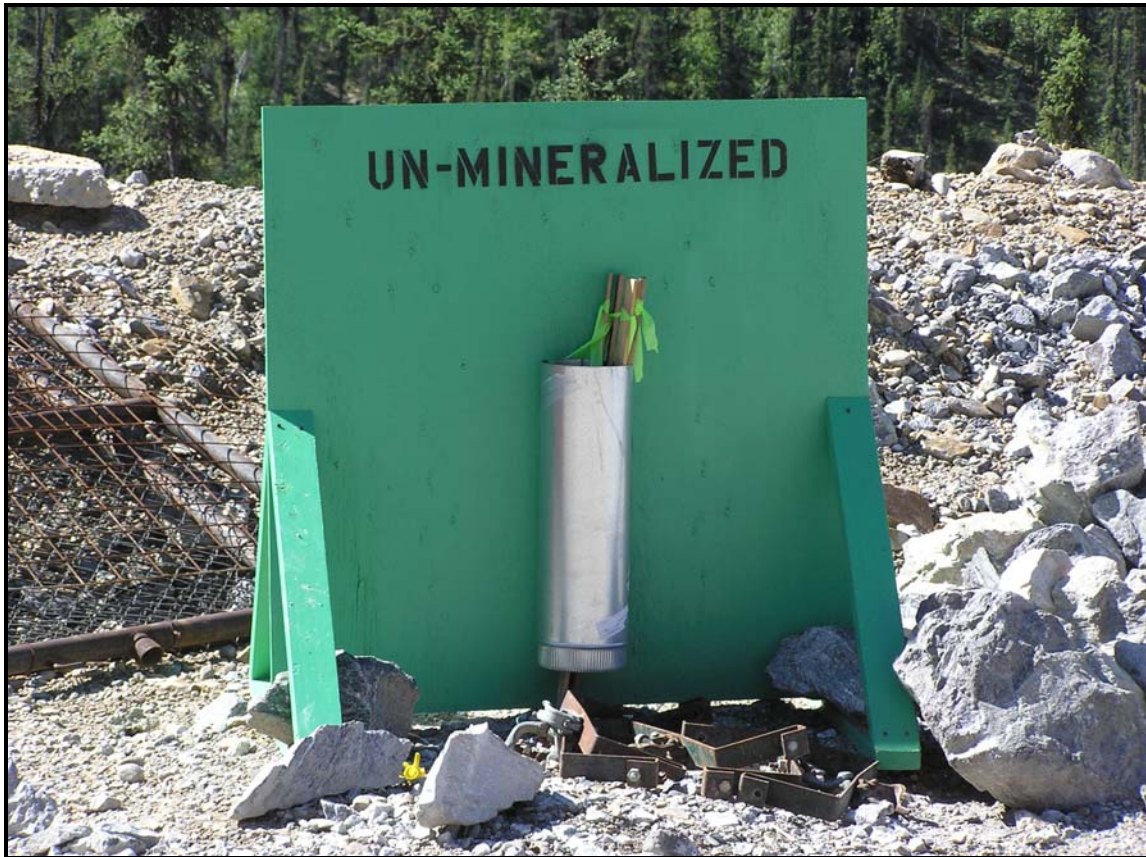
Drill cuttings from individual blast rounds are sampled and analyzed for sulfur and arsenic using the on-site XRF. We observed the development rock segregation area where the muck from individual blast rounds is placed and staked with a survey lathe until analysis can determine whether it is considered mineralized or non-mineralized based upon either the sulfur or arsenic content (Figure 3). When a blast round has been fully removed from the staging area, the survey lathe is deposited into either the non-mineralized or mineralized lathe collection bin to allow for blast round segregation tracking (Figure 4).

Figure 4 - Collection location for survey lathe from non-mineralized waste rock blast rounds.

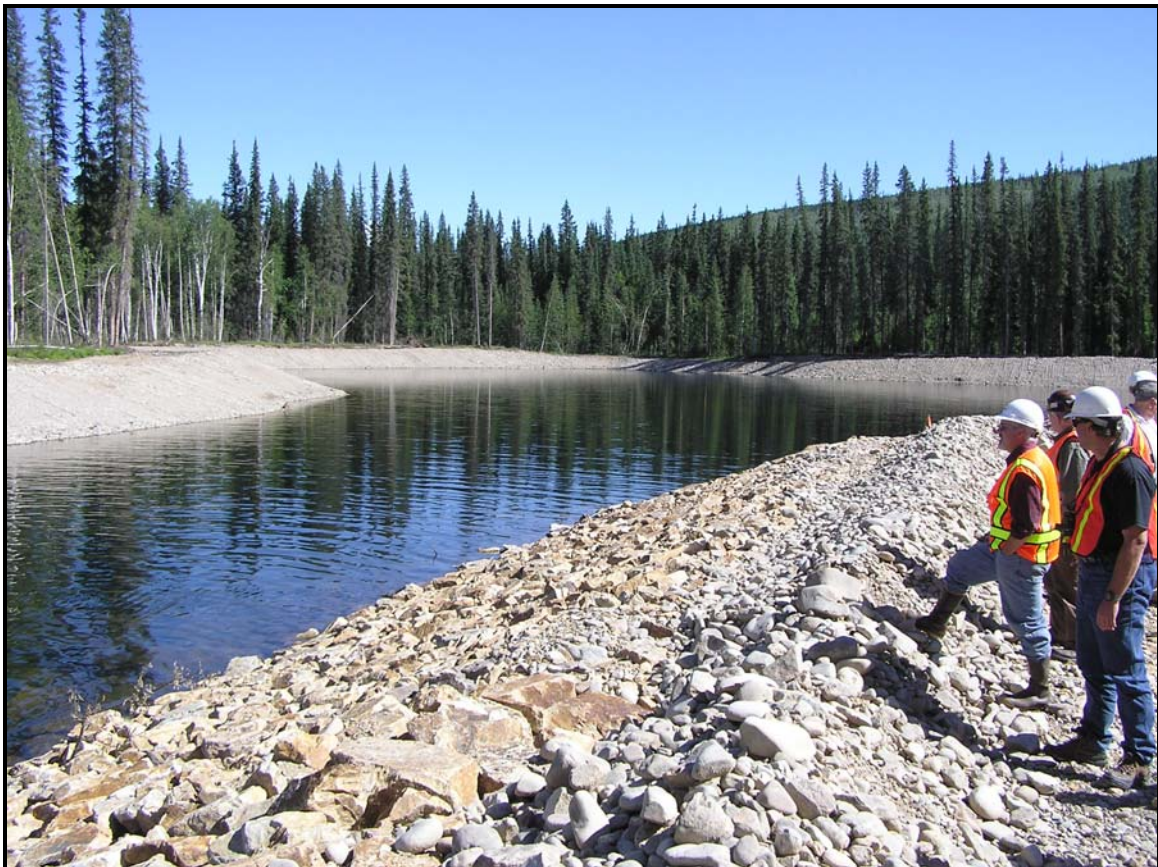
Flow from the Goodpaster River enters the 'inlet pond' of The Off-River Treatment Works (Figure 5) and allows for control of the mixing rate with any discharge of treated mine water. At the time of the inspection there were 2000 gallons of flow through the central dike located between the inlet and outlet ponds without the use any pumps. Water from the outlet pond, travels through a weir that allows regulation of the flow rate. Discharge from the system goes into an outlet channel to the Goodpaster River.

Figure 5 - Inlet pond for Off-River Treatment Works.

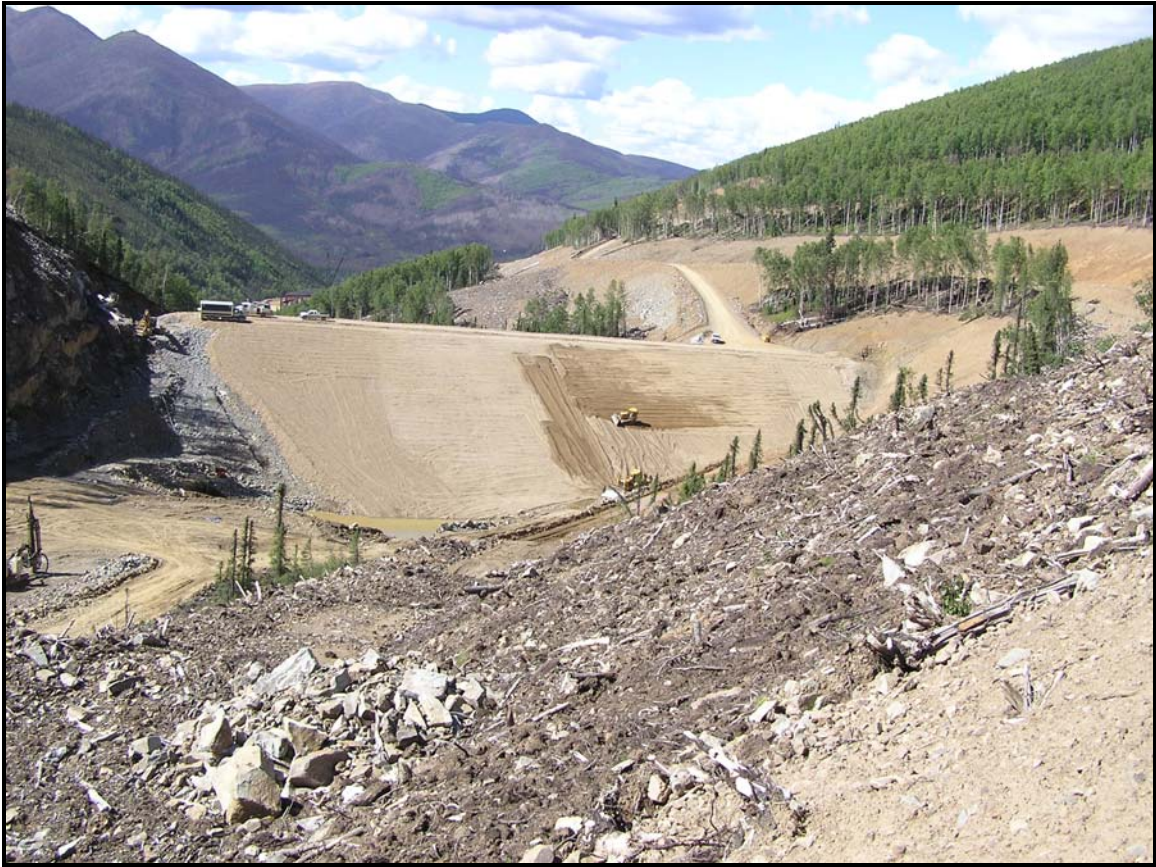
Site preparation work was underway at the dry-stack tailings area and on the Recycle Tailings Pond Dam surface (Figure 6).

Figure 6 - Work on Recycle Tailings Pond Dam.

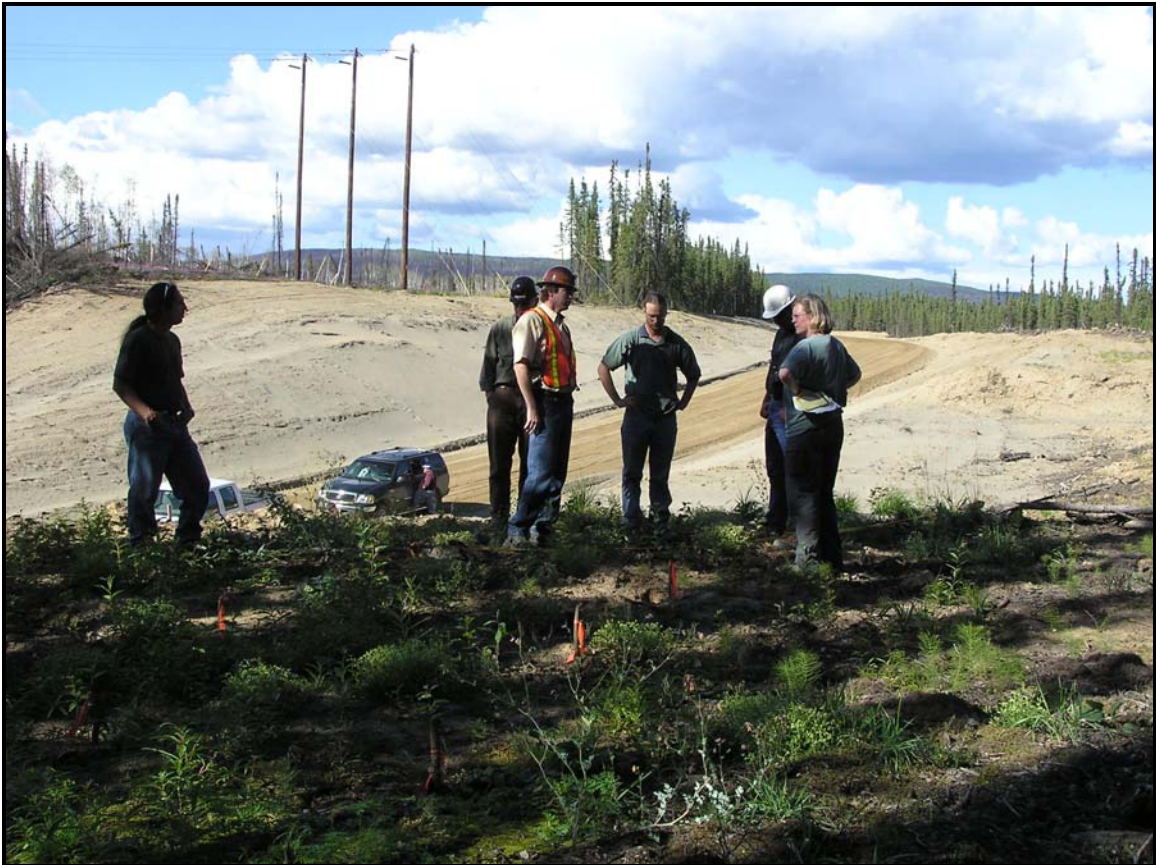
On the drive out the access road we stopped to examine an archeological site that was discovered during the construction of the road (Figure 7).

Figure 7 - Inspection of archeological site discovered during construction of the Pogo Access Road.
