## **POGO INSPECTION REPORT**

**Inspection Date:** September 29, 2005  
**Weather:** Overcast, 30 deg., snowing lightly  
**Time of Inspection:** 11:30 am to 2:30 pm  
**Operator Contact:** Karl Hanneman and Jack DiMarchi - Teck Alaska  
**Agency Personnel:** Brent Martellaro, Steve McGroarty, and Tom Crafford - ADNR  
**Inspection Objectives:** General Inspection

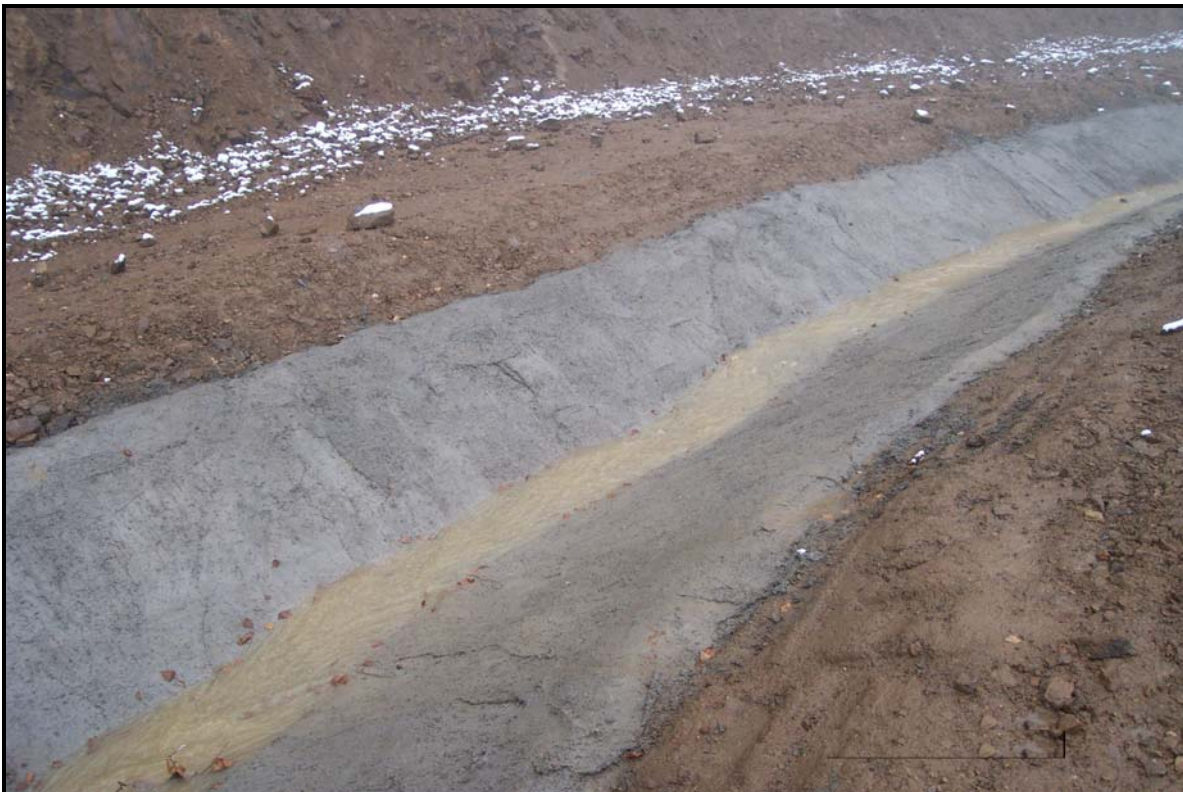
We drove to the North side of upper Liese Creek above the Pogo Mill. Karl pointed out the recent shotcrete work done to line the diversion ditch (Photo 1). The lined portion of the diversion ditch appeared to adequately capture and hold waters from the primary source of Liese Creek, but it is unclear if this ditch would be effective in capturing surface water that seeps into fractures before it reaches the ditch, such as water from snow melt or rain. Still the majority of captured flow was diverted to a point approximately 50 yards below the lined portion of the ditch where the water disappeared into the fractured bedrock (Photo 2). Plans are to shotcrete this section of ditch as well, so the captured flow is diverted to a point below the RTP Dam.

**Photo 1 – Shotcrete lining in diversion ditch on North Side of Liese Creek.**

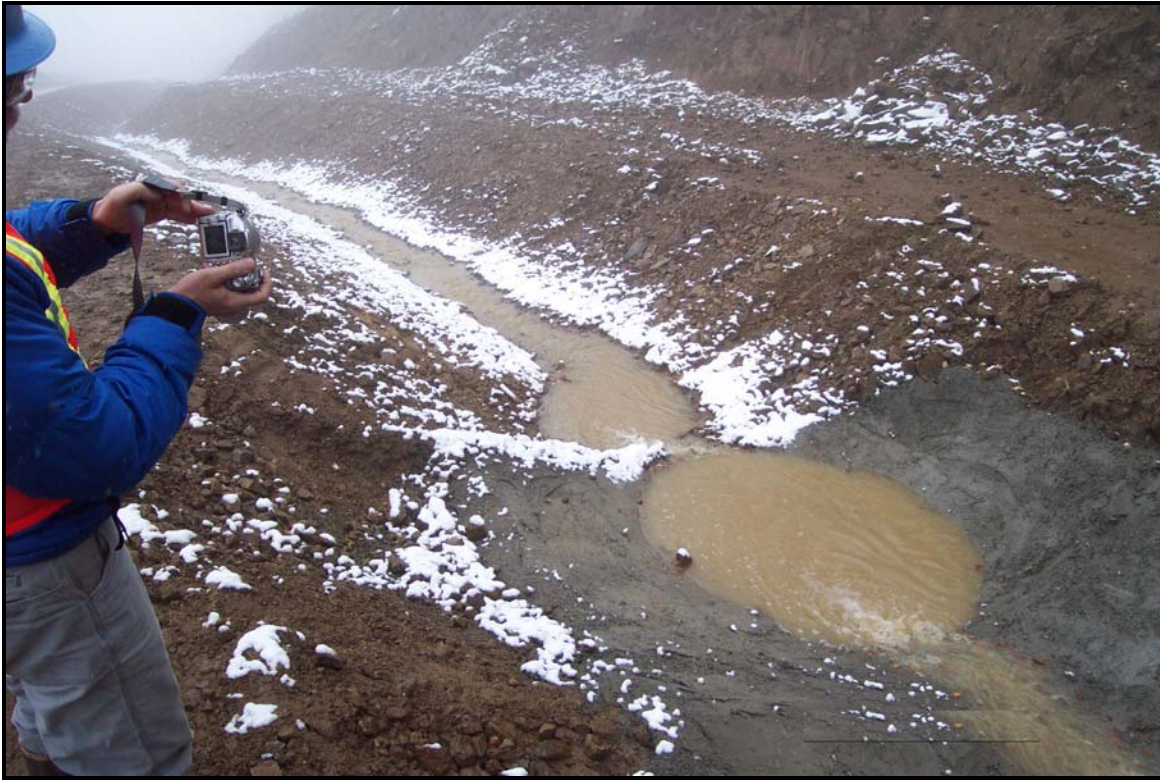
**Photo 2 – Flow in diversion ditch on North Side of Liese Creek, disappears within 50 yards below shotcrete.**

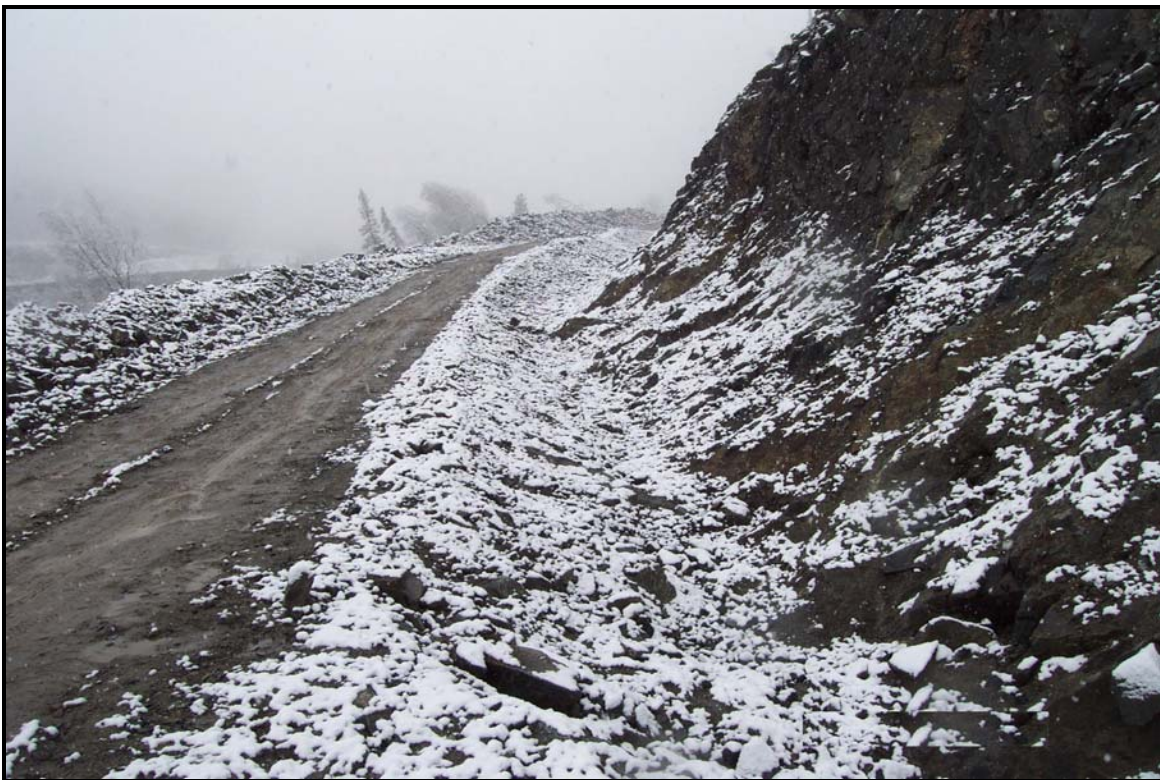
We drove around to the diversion ditch on the south side of Liese Creek. This ditch was not currently collecting any water and did not appear to be effective in collecting minor rain water or seeps due to the fractured nature of the bedrock (Photo 3). However, it is likely that this ditch would capture significant water during spring breakup or high water events.

**Photo 3 – Diversion ditch on south side of Liese Creek.**

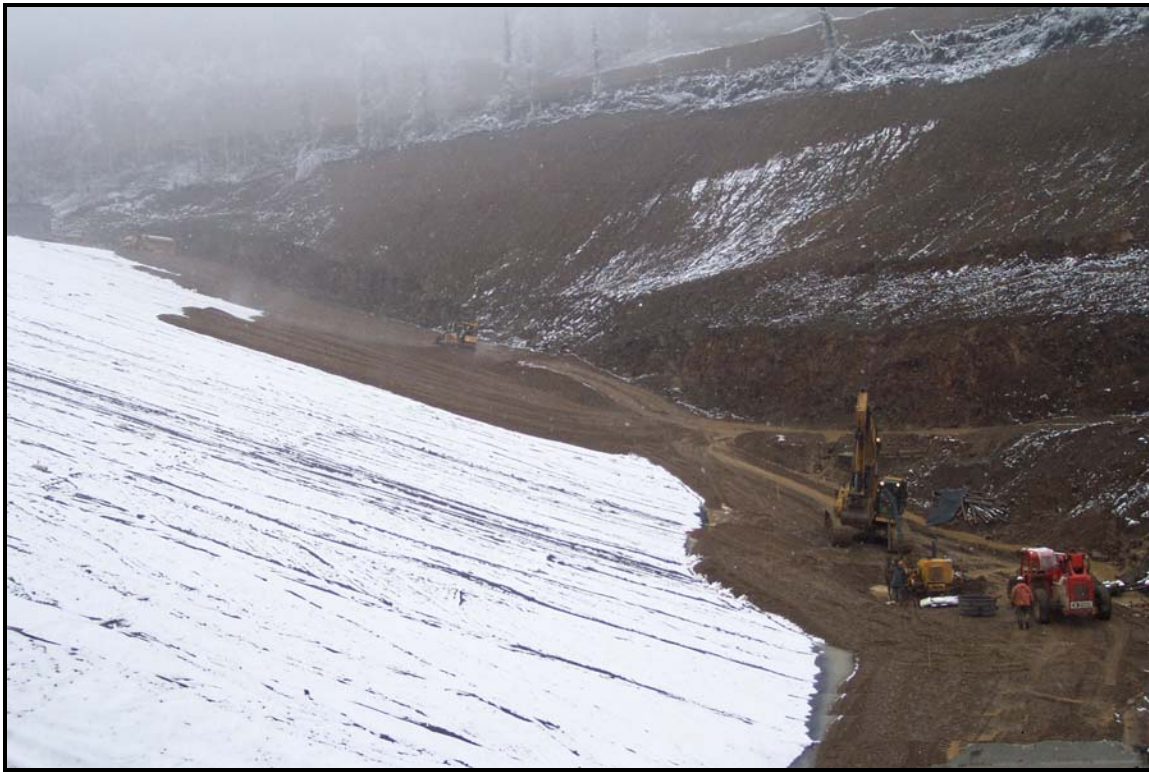
We drove down to the Recycle Tailing Pond (RTP) Dam. The Geotextile and Liner system had been installed on the face of the dam. A dozer was spreading a protective layer of gravel over the liner by pushing uphill. A drill rig was drilling holes for examination of the rock and to conduct packer tests to evaluate the permeability of the grout curtain constructed to control the flow of solution under the RTP Dam (Photo 4). Three seepage collection wells were currently being drilled below the RTP Dam.

**Photo 4 – Work on Upstream Side of RTP Dam.**

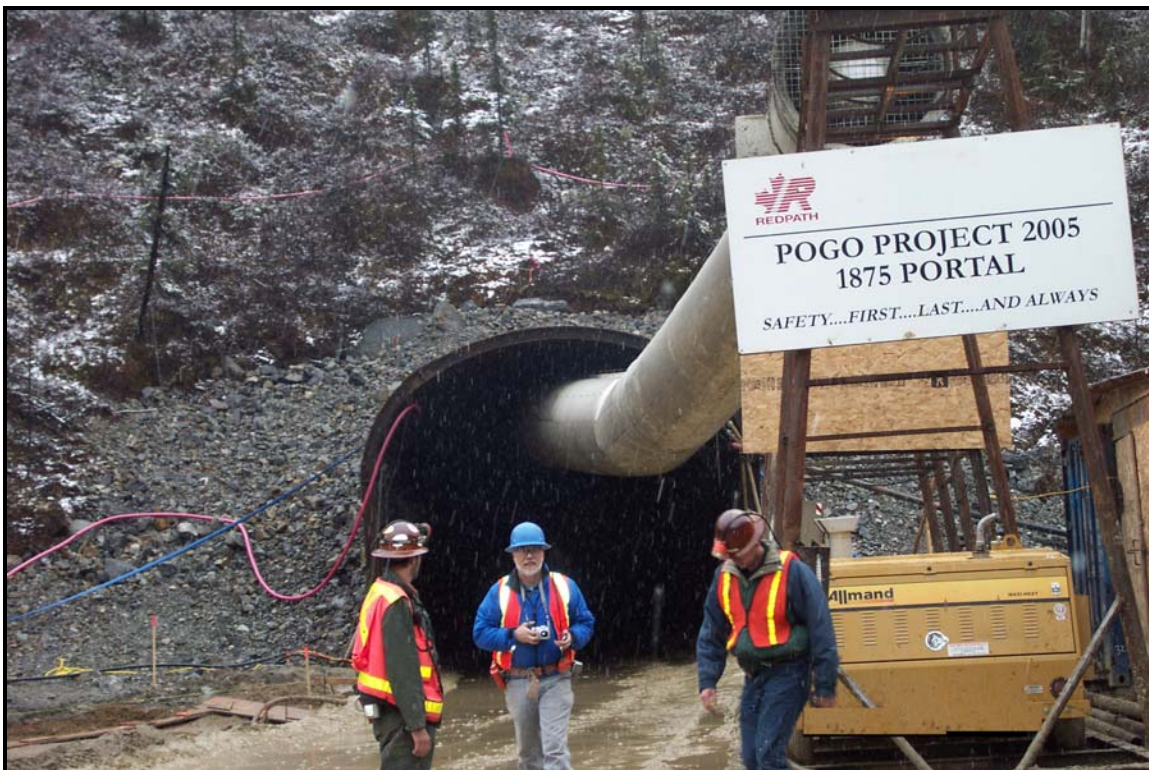
**Photo 5 – The 1875 Portal**

Deposit. We walked to the 1875 portal (Photo 5) and proceeded underground to the working face where stope access development was underway (Photo 6).

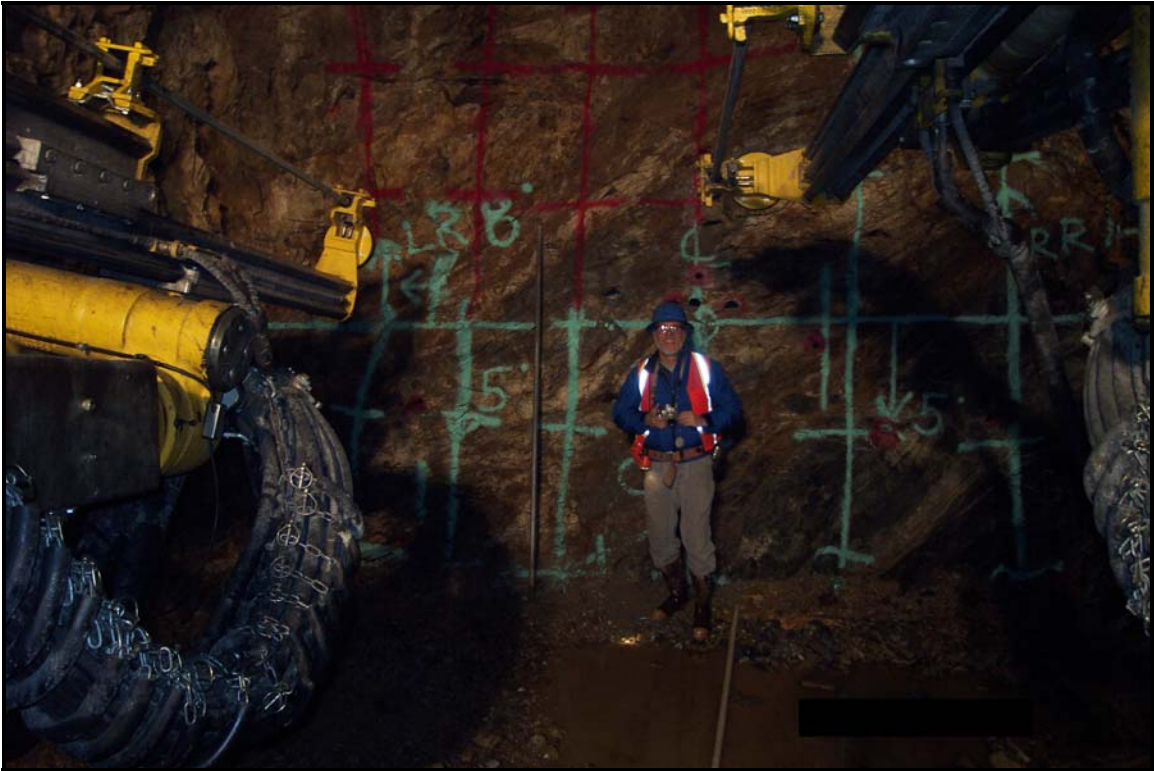
**Photo 6 – Stope development off of the 1875 access decline.**
