DEPARTMENT OF NATURAL RESOURCES

DIVISION OF MINING, LAND and WATER

POGO INSPECTION REPORT

Inspection Date: May 11, 2010
Weather: Windy, Cloudy, 50 degrees F.
Time of Inspection: 8:30 am to 3:00 pm
Operator Contact: Stacy Staley, Larry Davey, Todd Roth, Sally McLeod, Mike Carney, Makoto Umedera, Ben Farnham – Sumitomo Pogo
Agency Personnel: Brent Martellaro, Stephanie Lovell – ADNRR; Tim Pilon, Pete McGee – ADEC; Jack Winters – ADF&G; Lisa Harbo - OED
Inspection Objectives: General Inspection of Mine Site

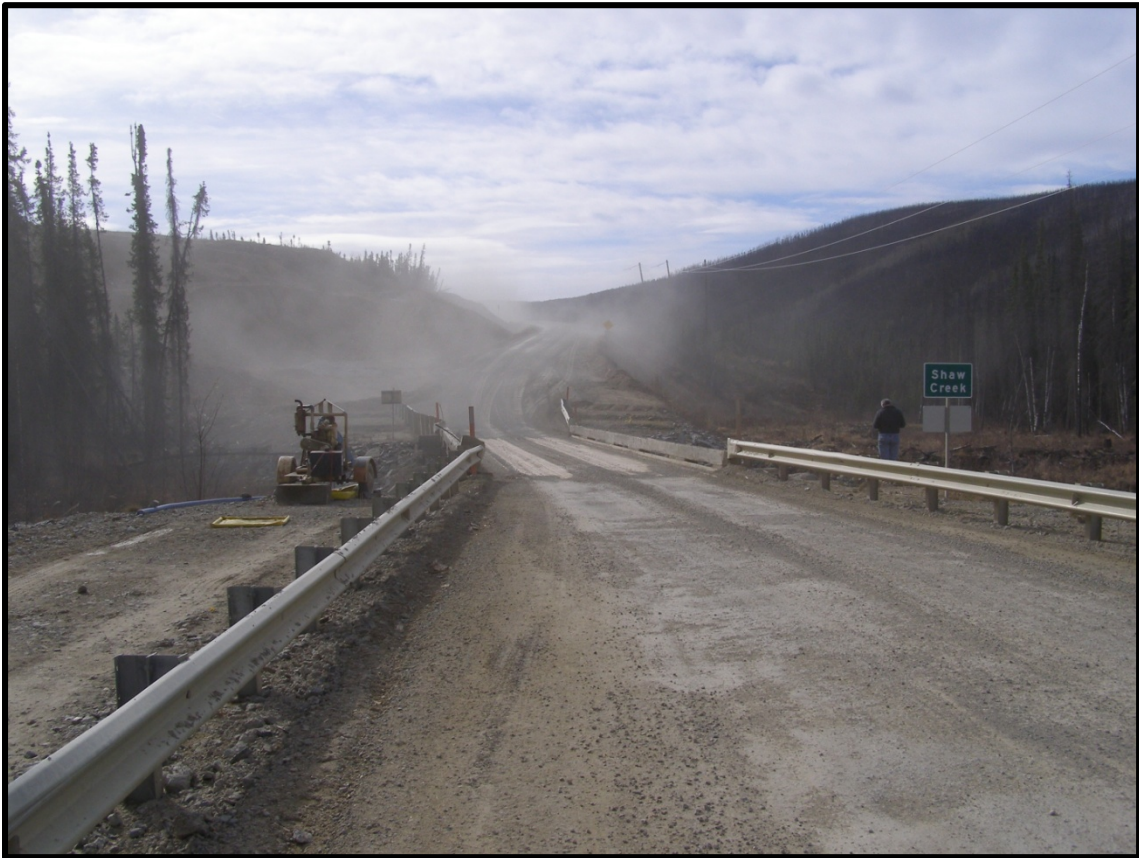
Photo 1 – Shaw Creek Bridge

Agency personnel arrived at the Pogo road gate at approximately 8:30 a.m. The road into the mine site was in good condition and much of the road was recently graded. Some stretches of the road produced significant dust due to dry conditions (Photo 1). Crews were conducting road maintenance and additional capping throughout the first part of the road. Pogo intends to complete new surfacing of the first 23 miles this year.

- Discussions included the dusty conditions on the Pogo road and mine site. Pogo has plans to continue spraying calcium chloride on road areas of new surfacing and where needed. This may require a Temporary Water Use Permit; the company submitted an application to take up to 35,000 GPD from Gilles Creek from May 17th to July 20th.
- Jack Winters discussed the need to keep the bridge sediment traps clean and to provide a ¼ inch mesh screen on the intake of the pump at Shaw Creek.

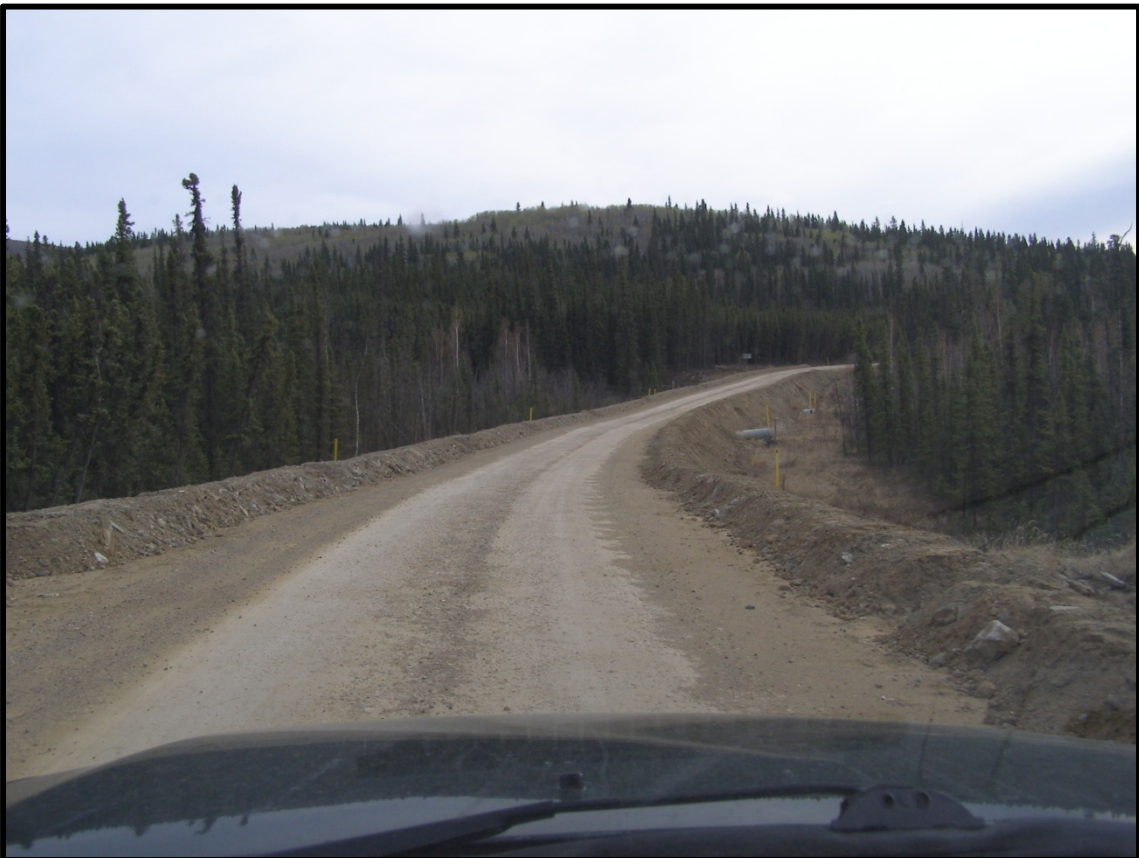
Photo 2 – Newly Constructed Berms

Rock berms have been constructed along many segments of the road because of new MSHA requirements. Pogo had been exempt from this requirement, but a recent determination by MSHA now considers the road a “mine” road because of its exclusive use provisions within the state permits. Pogo will continue berm construction over the next few years on areas where a “rollover” potential exists. The constructed berms result in reduced road surface width especially in segments where both sides require them (Photo 2).

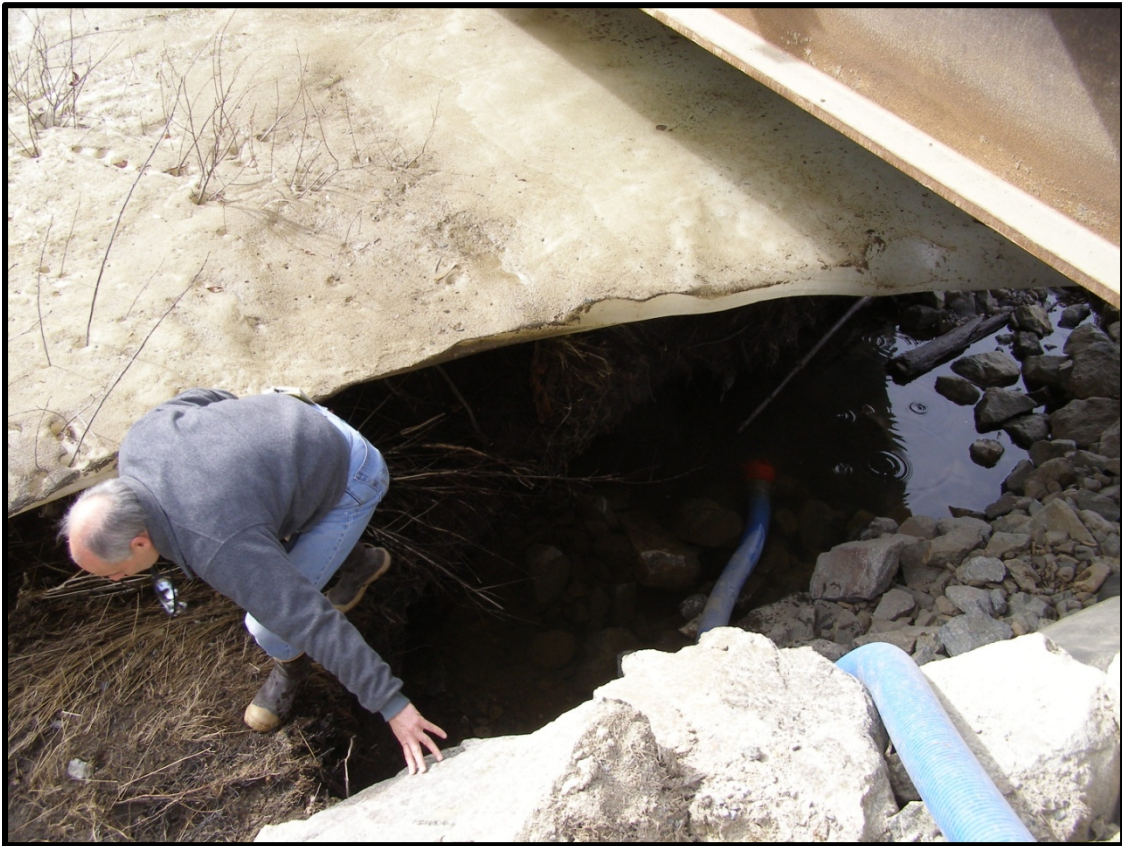
Photo 3 – Pump Intake Line at Shaw Creek

Jack Winters noted that sediment traps on some bridges needed maintenance. A pump inspected at Shaw Creek did not have an approved fish screen (Photo 3).

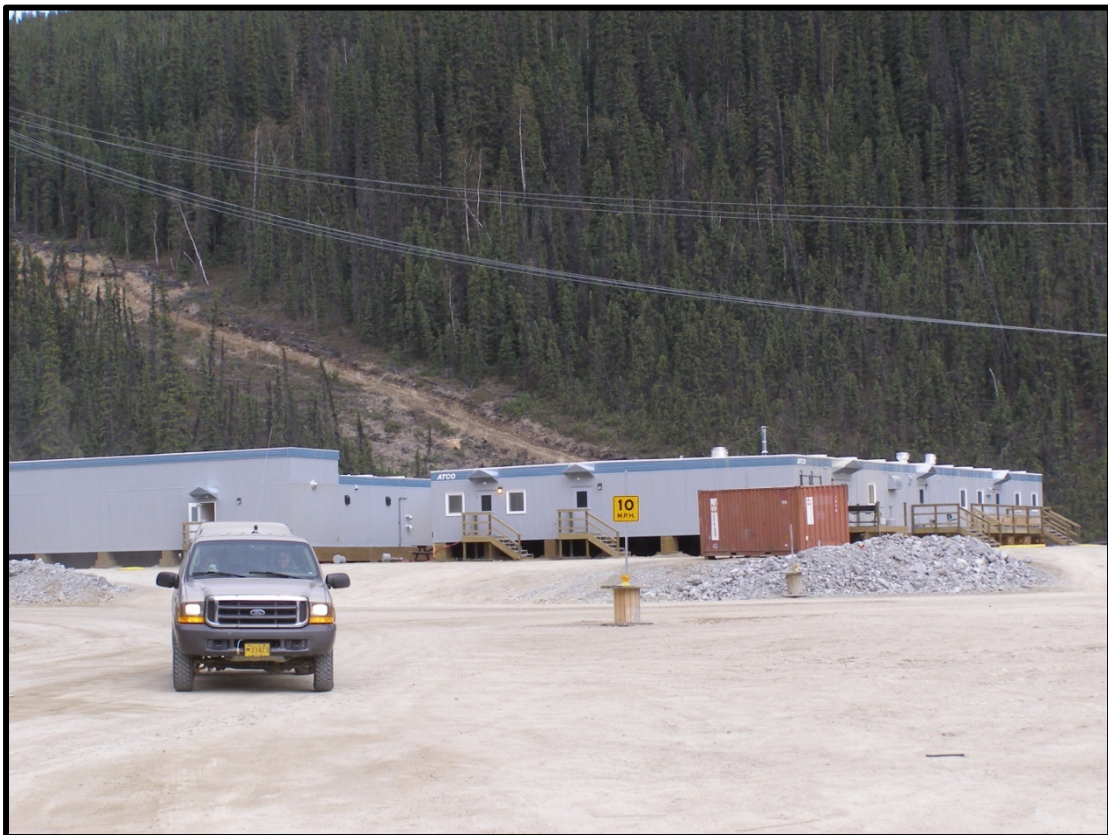
Photo 4 – Lower Camp

We arrived at the Pogo mine site at 10:00 am. Pogo personnel conducted site-specific training and summarized recent projects. Larry Davey introduced us to Todd Roth, his replacement on this day as the new General Manager. Recent work included establishment of the new lower camp (Photo 4) and ongoing evaluations to provide secondary containment methods for the large CIP Tank, Slurry Lines from the mill, smaller Slurry Tanks, and the Ore Conveyor tube house, “Splice House,” near the 1690 portal.

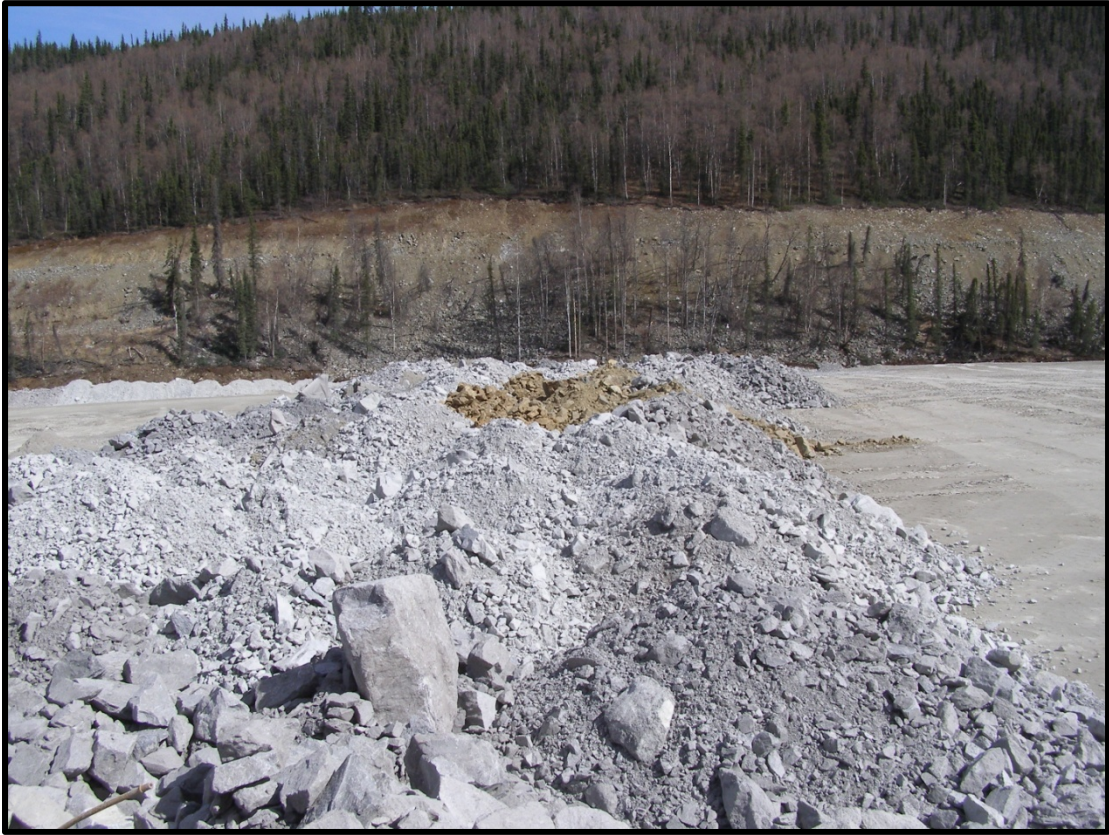
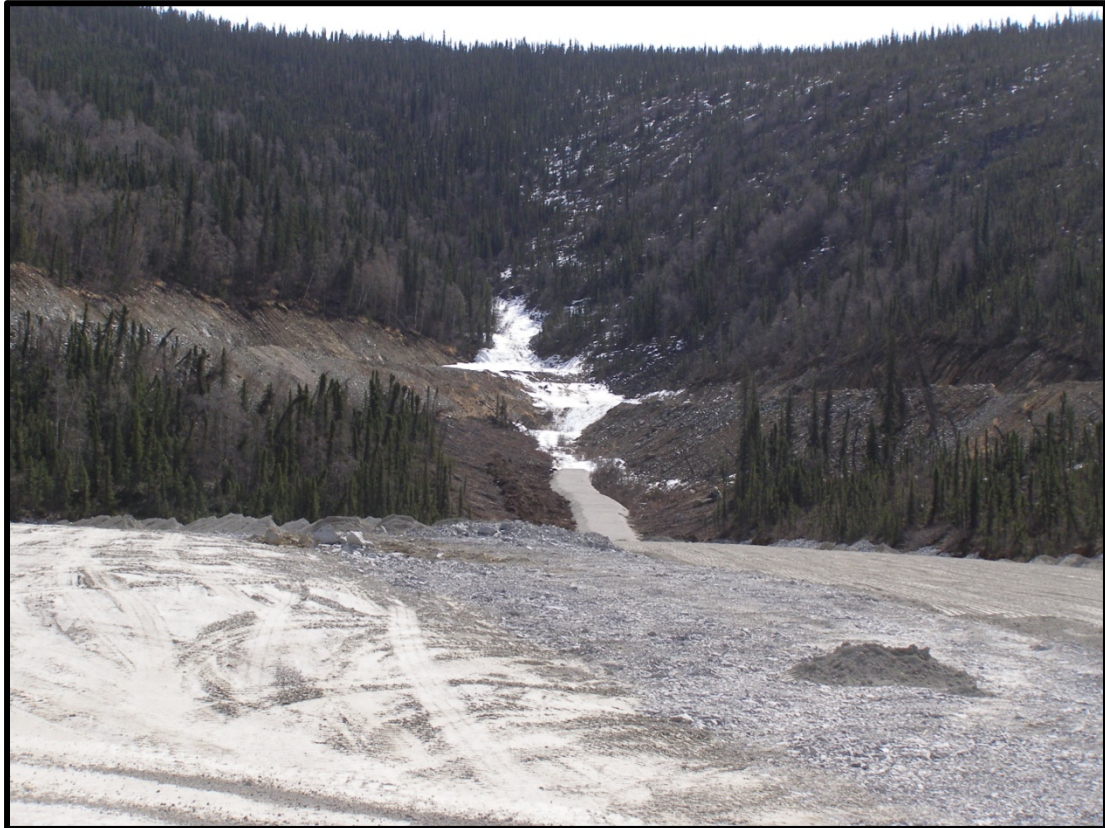
Placement of mineralized waste rock continues on the Drystack in 6-foot lifts, with a minimum of 50 feet from the outer edge. The tailings placement “encapsulates” the mineralized waste in 2-foot lifts (Photo 5 and 6). The extension of finger drains to the final height of the Drystack facility were completed (Photo 7).

Photo 5 – Mineralized Waste Rock on Drystack

Photo 6 – Drystack - Compacted Tailings with Mineralized Rock in the Center

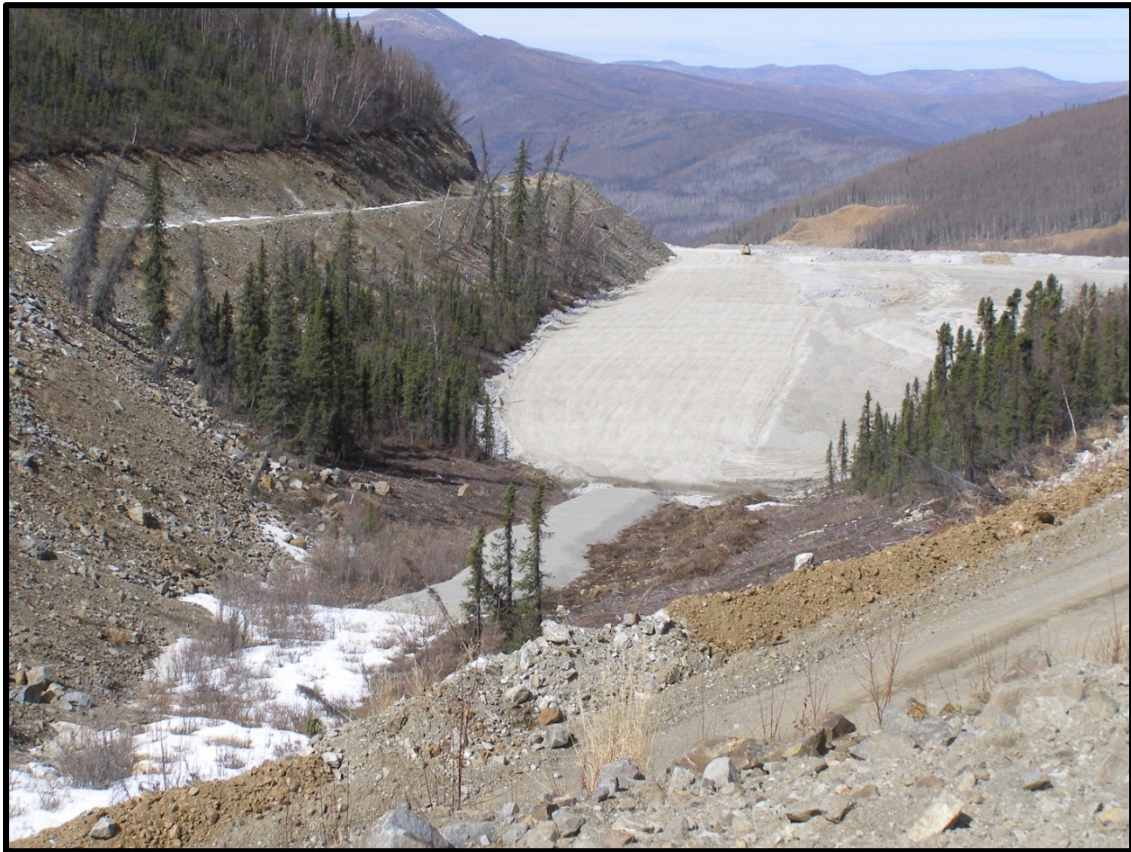
Photo 7 – Drystack Viewed From Diversion Ditch in Upper Liese Creek

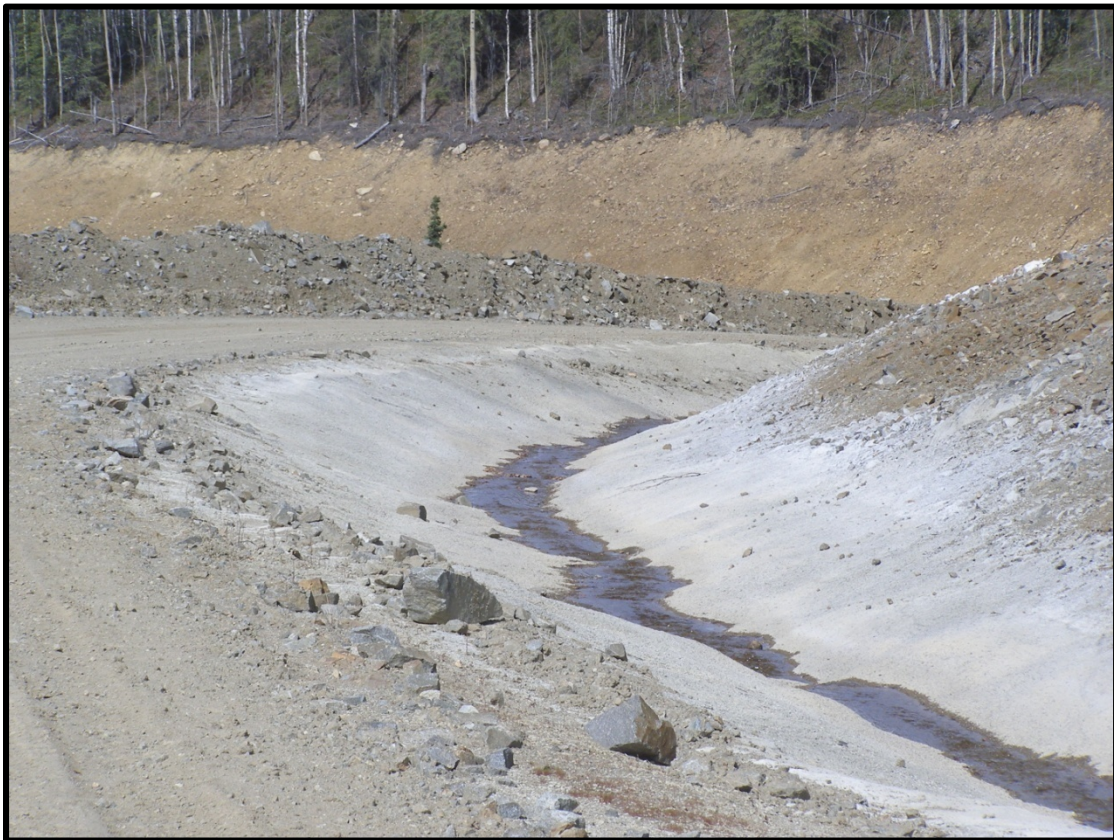
Photo 8 – East Diversion Ditch

The peak of spring runoff has past and very little water flowed through the diversion ditch on the east side of the dry stack (Photo 8). The grouted segment of the ditch successfully carried the water

below the Drystack until it disappeared into the ungrouted fractured bedrock. It is likely that some of this water reports to the RTP via the springs that surface in the hillside just above the RTP.

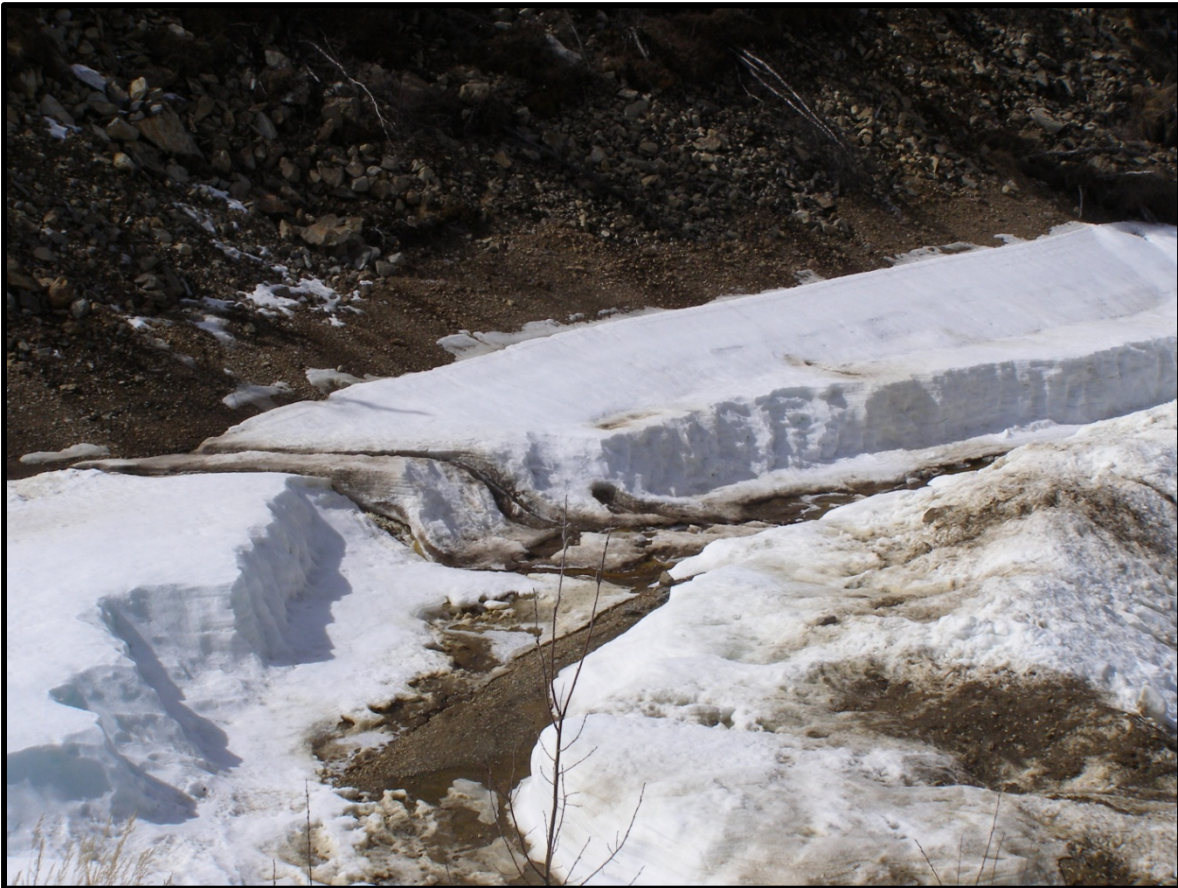
In the headwaters of Liese Creek above the Drystack, overflow ice required excavation to channel water into the diversion ditch along the west side of the dry stack (Photo 9). This combined with last year's grouting efforts seem successful in transferring water to the spillway of the RTP (Photo 10). Consequently there appears to be surface water flowing in Liese Creek from the toe of the RTP dam to the main mine access road (Photo 11).

Photo 9 – Overflow from Upper Liese Creek into West Diversion Ditch

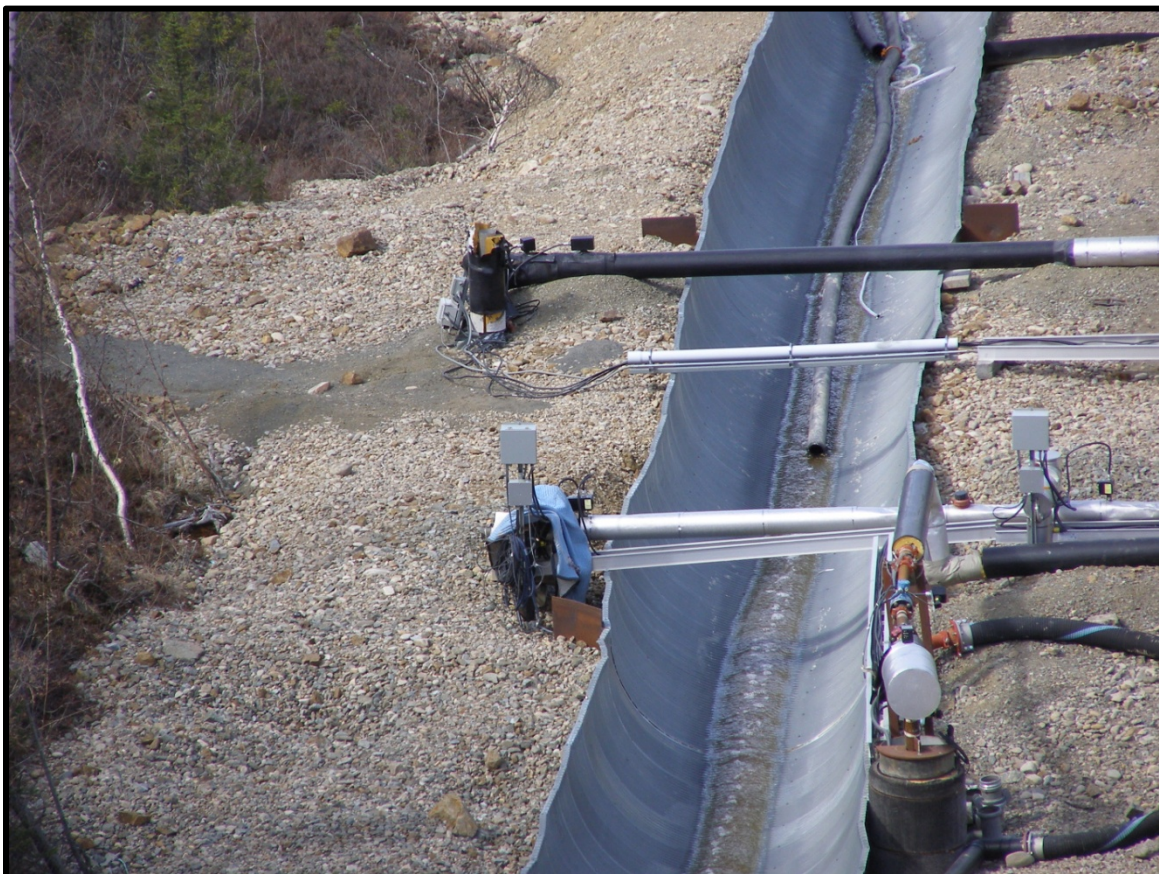
Photo 10 – Water in RTP Spillway from West Diversion Ditch

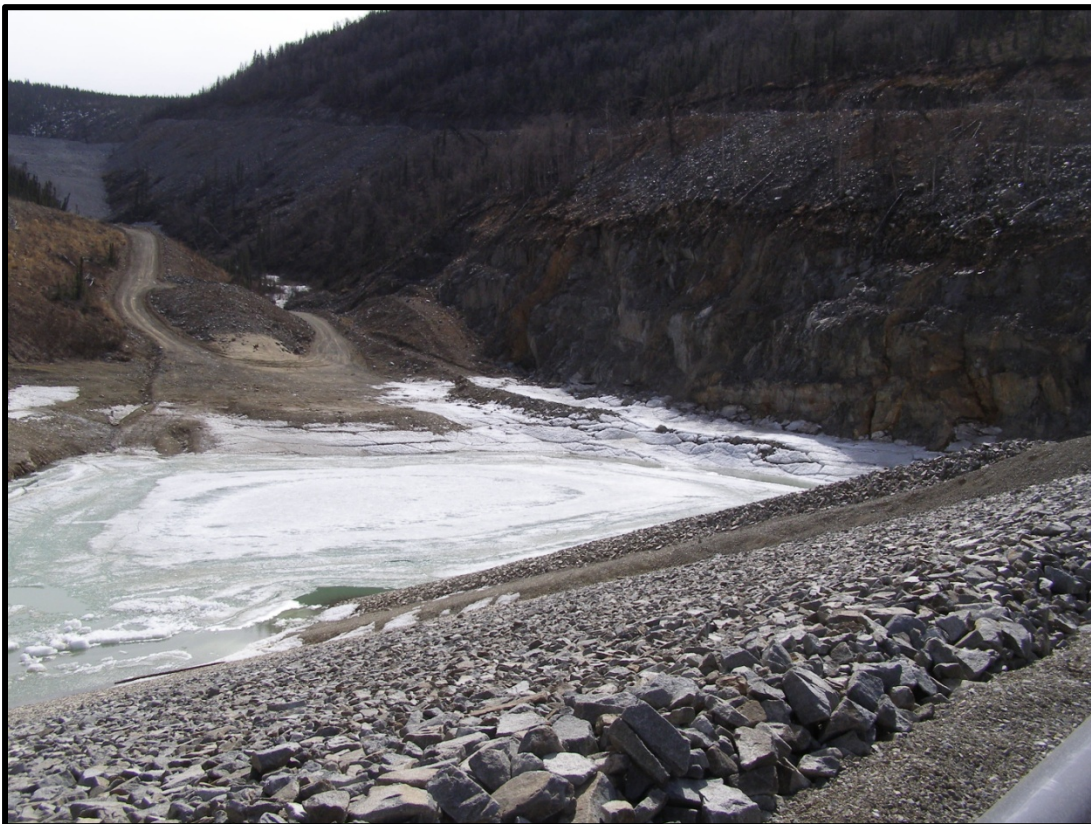
Photo 12 – RTP

The water level in the RTP is quite low considering the post runoff time of year (Photo 12). While the low snowfall this past winter may be much of the reason, the successful diversion of water around the Drystack and RTP is contributing to the control of water balance.
