DIVISION OF MINING, LAND and WATER

POGO INSPECTION REPORT

Inspection Date: June 5, 2012
Weather: Cloudy, 65 degrees F. Recent Rain
Time of Inspection: 10:30 am to 3:00 pm
Operator Contact: Chris Kennedy, Sally McLeod – Sumitomo Pogo
Agency Personnel: Brent Martellaro, Jenny Wynne – ADNR
Inspection Objectives: General Inspection of Mine Site

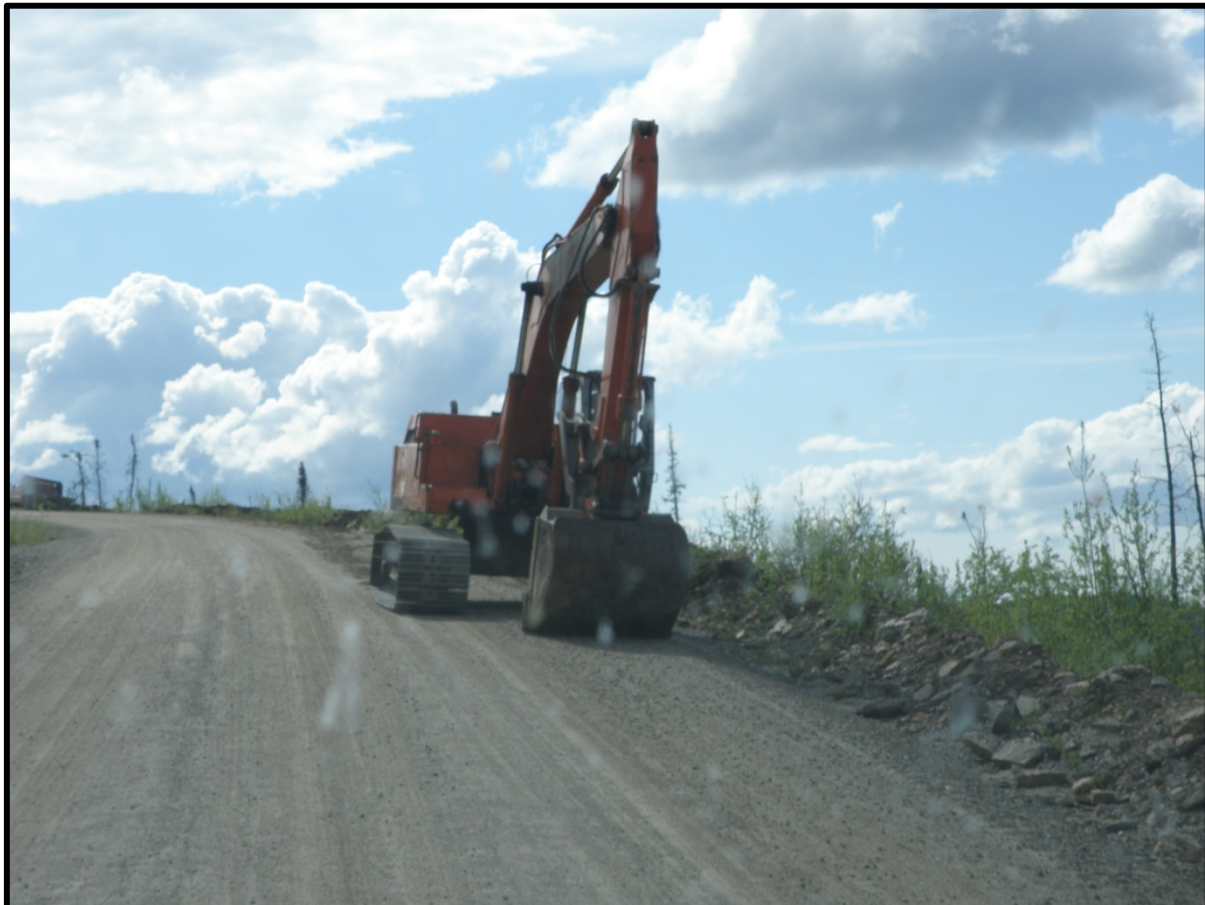
Agency personnel arrived at the Pogo road gate at approximately 10:30 a.m. The road into the mine site was in good condition. Little to no dust was observed due to significant recent rains. An excavator was being utilized to construct additional safety berms near mile 35 (Photo 1).

Photo 1 – Construction of Safety Berms

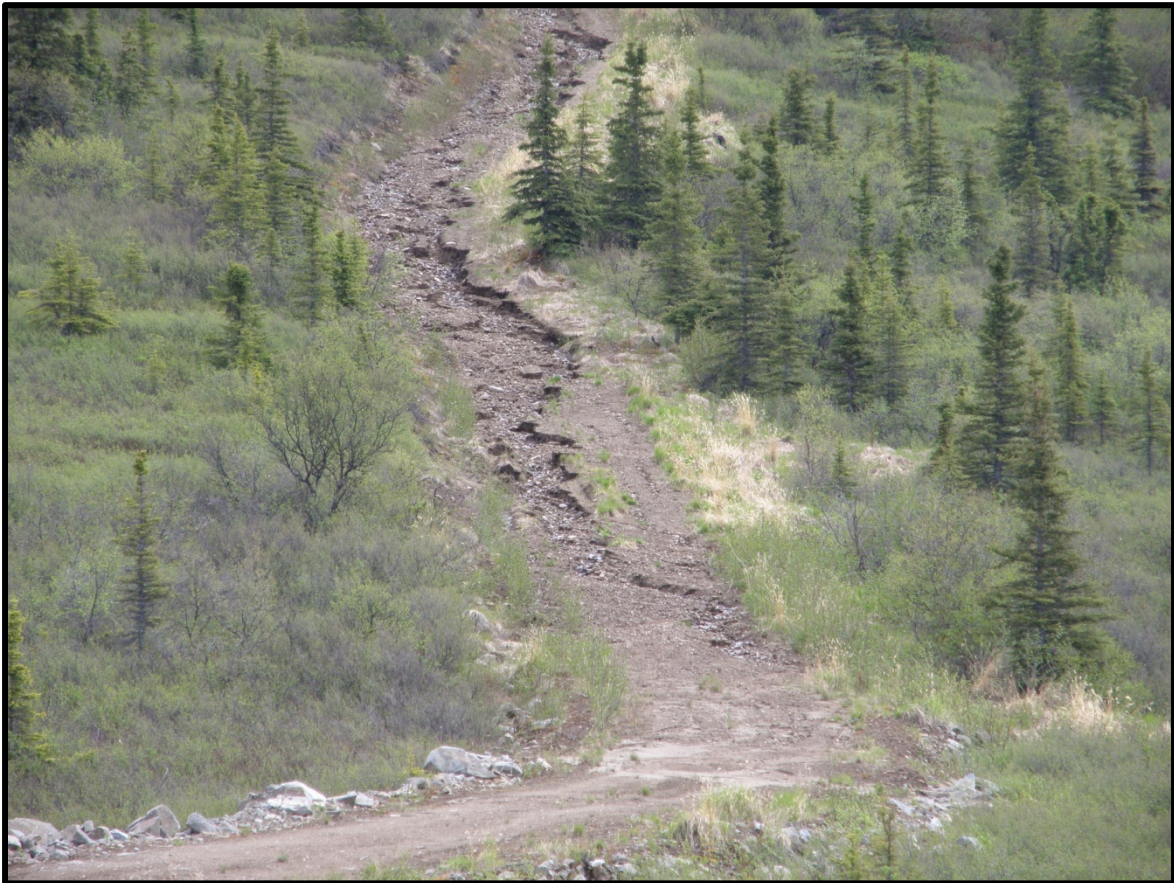
We observed erosion of the access road to the communication tower near mile 38 (Photo 2). This erosion appeared to be the result of recent heavy rains.

Dry Stack placement and other operations continue to be conducted in a manner consistent with the terms of the Plan of Operations Approval. Dumps, stockpiles, and haul roads appear to be maintained in a stable configuration that minimizes the potential for erosion, however, erosion was observed in the access road to the communication tower.

Photo 2 – Erosion of Communication Tower Access Road

The access road to the communication tower is in need of maintenance due to the recent heavy rains. Installation of water bars may be necessary to stabilize the road and prevent additional erosion.

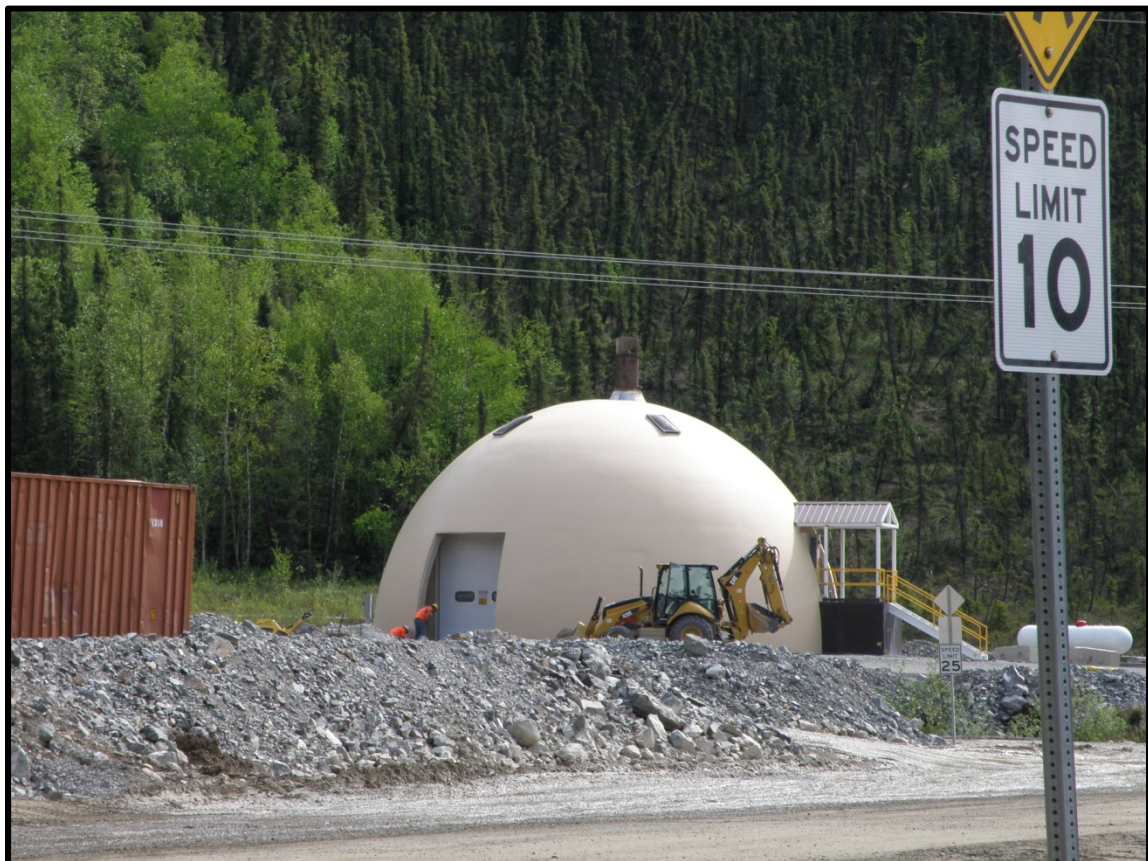
We arrived at the Pogo mine site at 11:30 am. Construction of a new incinerator in the area of the lower camp has been completed (Photo 3). This incinerator began operation in February.

Photo 3 – New Incinerator

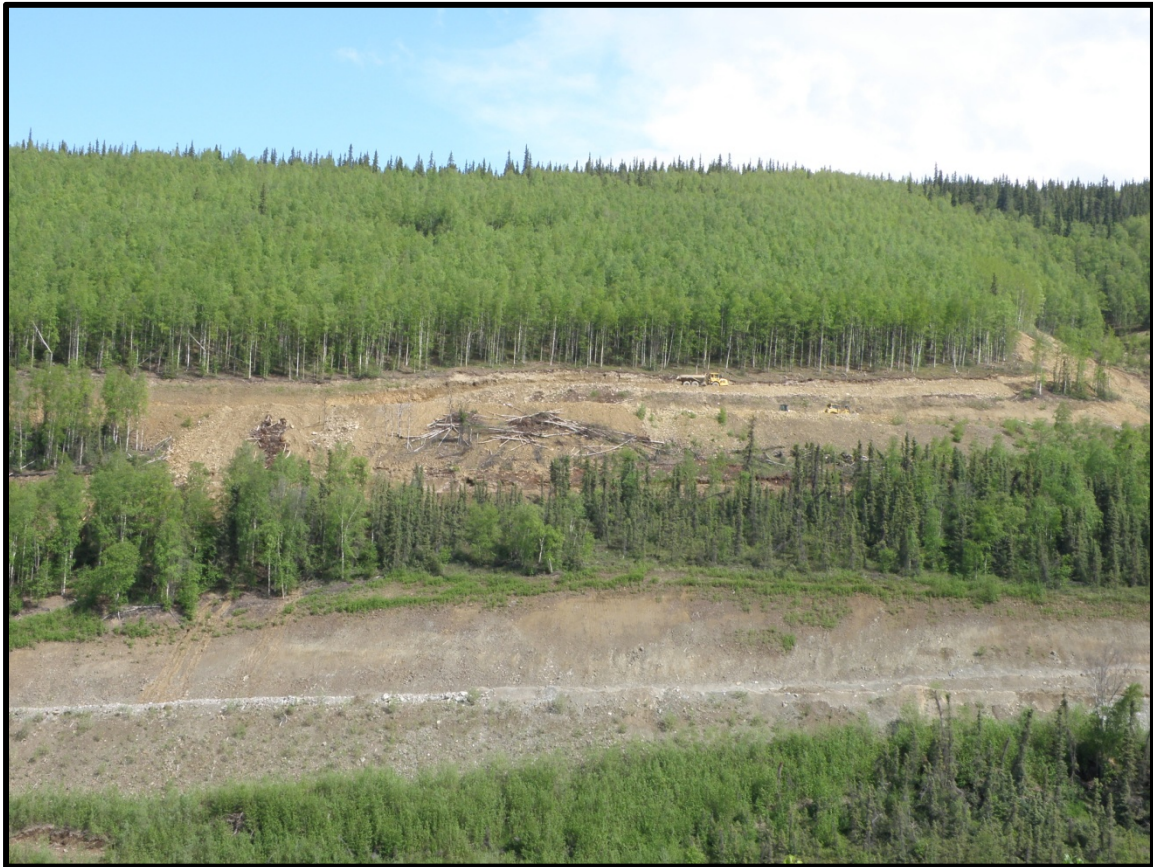
After Pogo personnel conducted site-specific training, we drove to the area of the North diversion ditch. Significant water was observed flowing in the diversion ditch. Crews were active constructing the new diversion ditch that will accommodate the expansion of the Dry Stack (Photo 4). A temporary culvert has been installed to provide access across the current diversion ditch (Photo 5).

Photo 4 – North Diversion Ditch Construction and Old Diversion Ditch

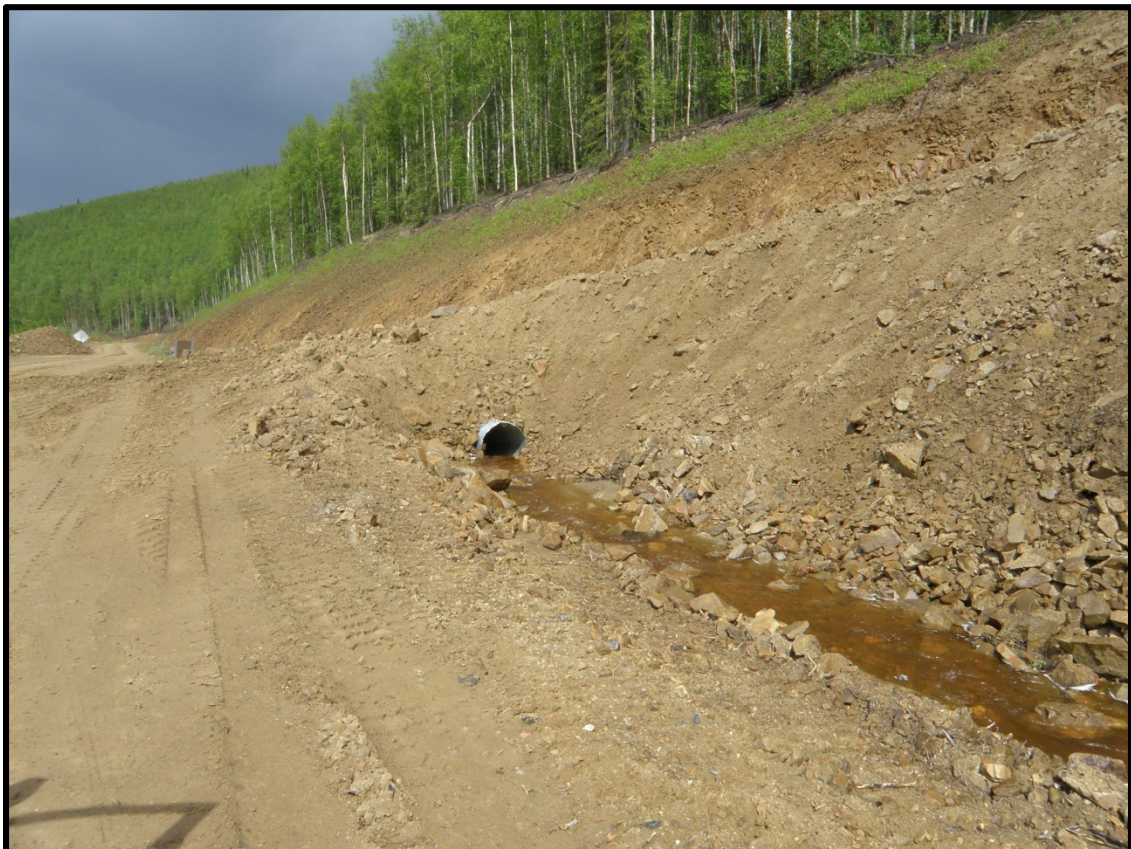
Photo 5 – Culvert and Access Crossing Old Diversion Ditch to New Diversion Ditch

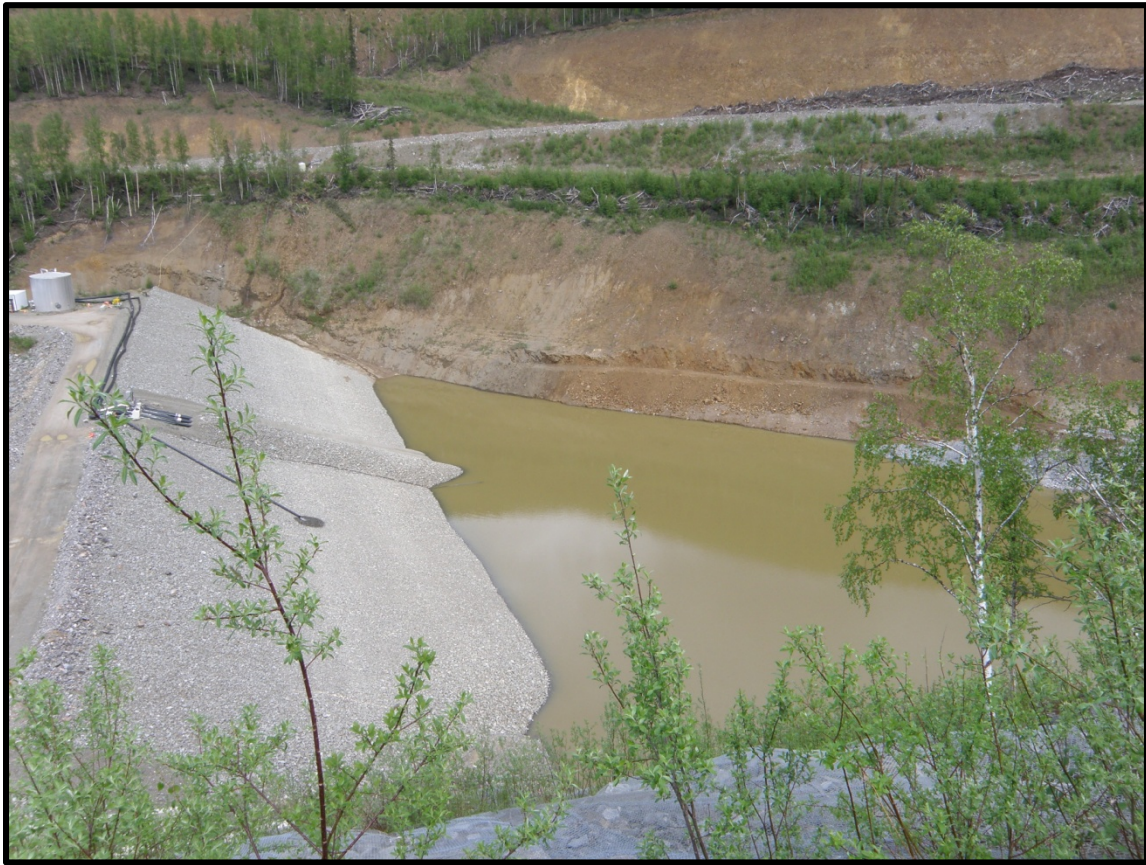
We also observed the RTP and noted the water levels were too high for the planned grouting program to commence (Photo 6). Pogo personnel indicated the RTP contained approximately 10.8 million gallons. Pogo will continue to draw down the water within the RTP with the hope of beginning the grouting program by the end of June.

Photo 6 – RTP

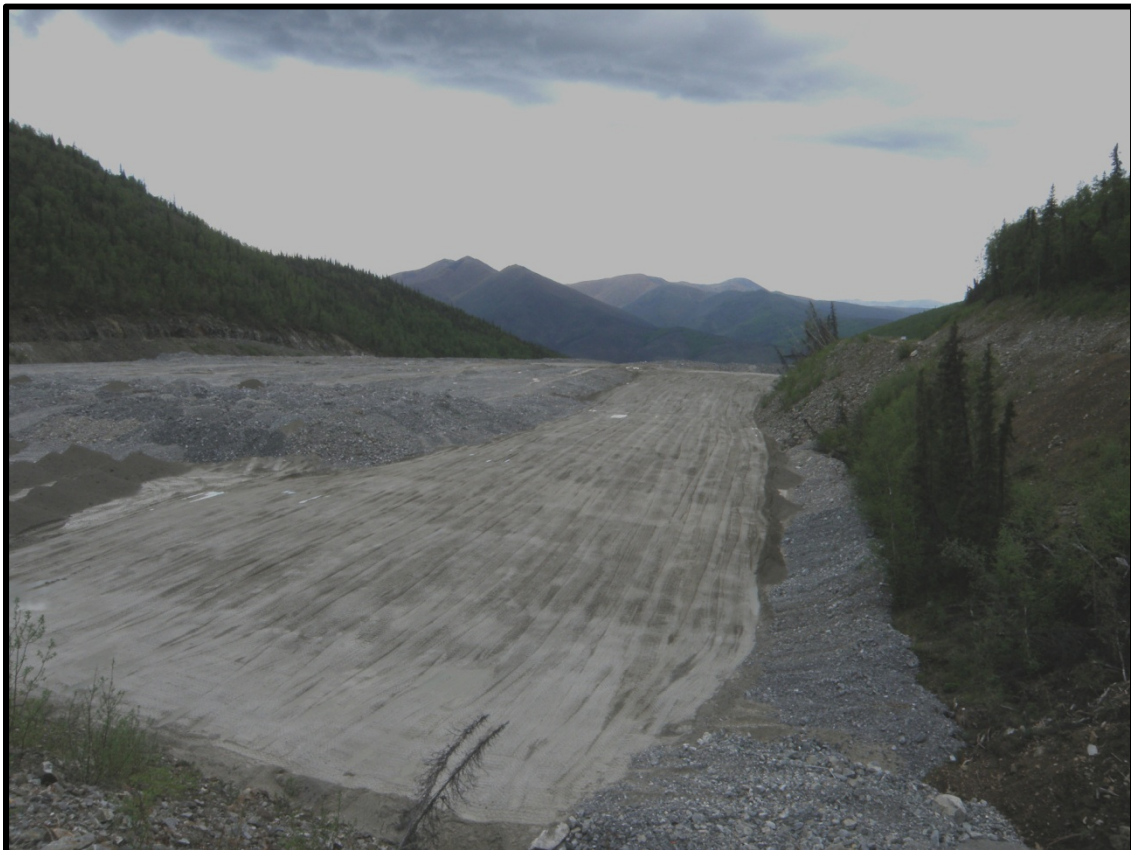
Placement of mineralized waste rock continues on the Drystack in 6-foot lifts, with a minimum of 50 feet from the outer edge (Photo 7). The tailings placement “encapsulates” the mineralized waste in 3-foot lifts. Construction of the Drystack Shell numbers “2” and “3” continues (Photo 8).

Photo 7 – Dry Stack

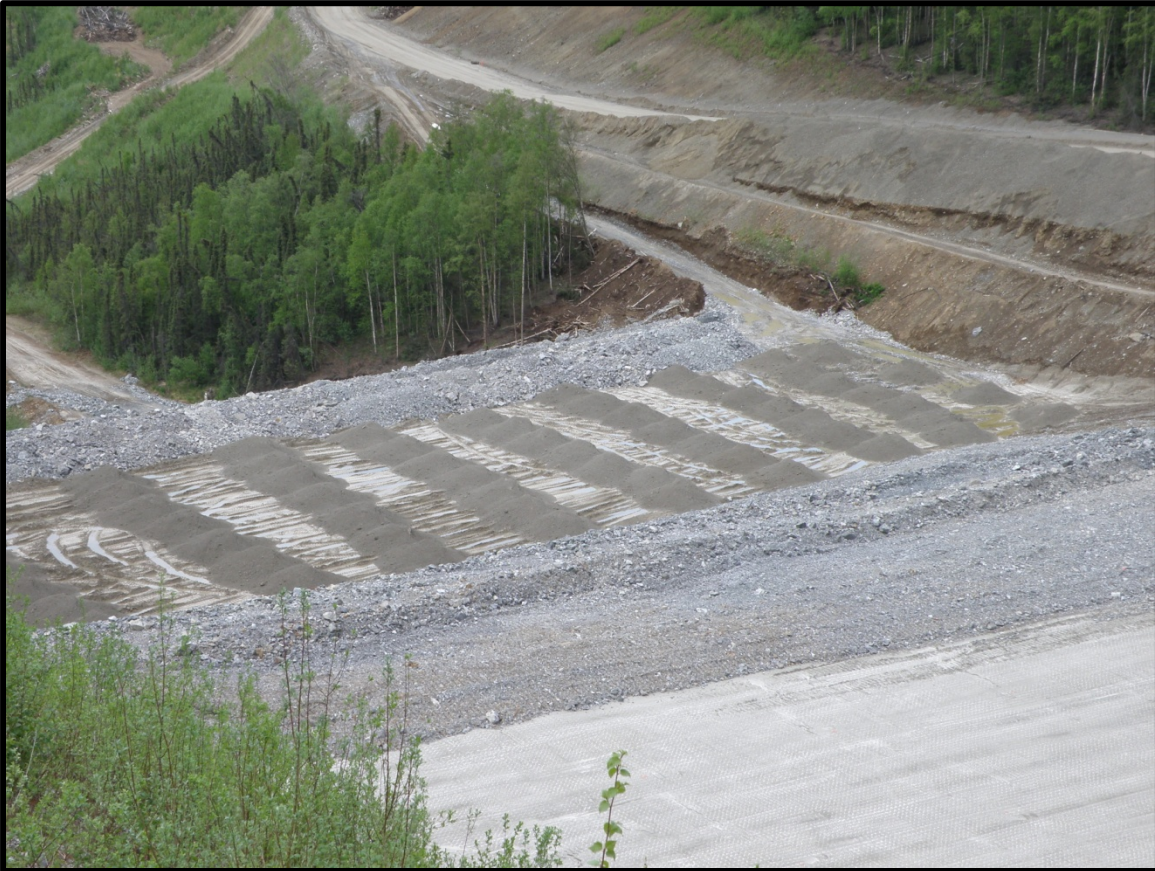
Photo 8 – Dry Stack Shells 2 and 3

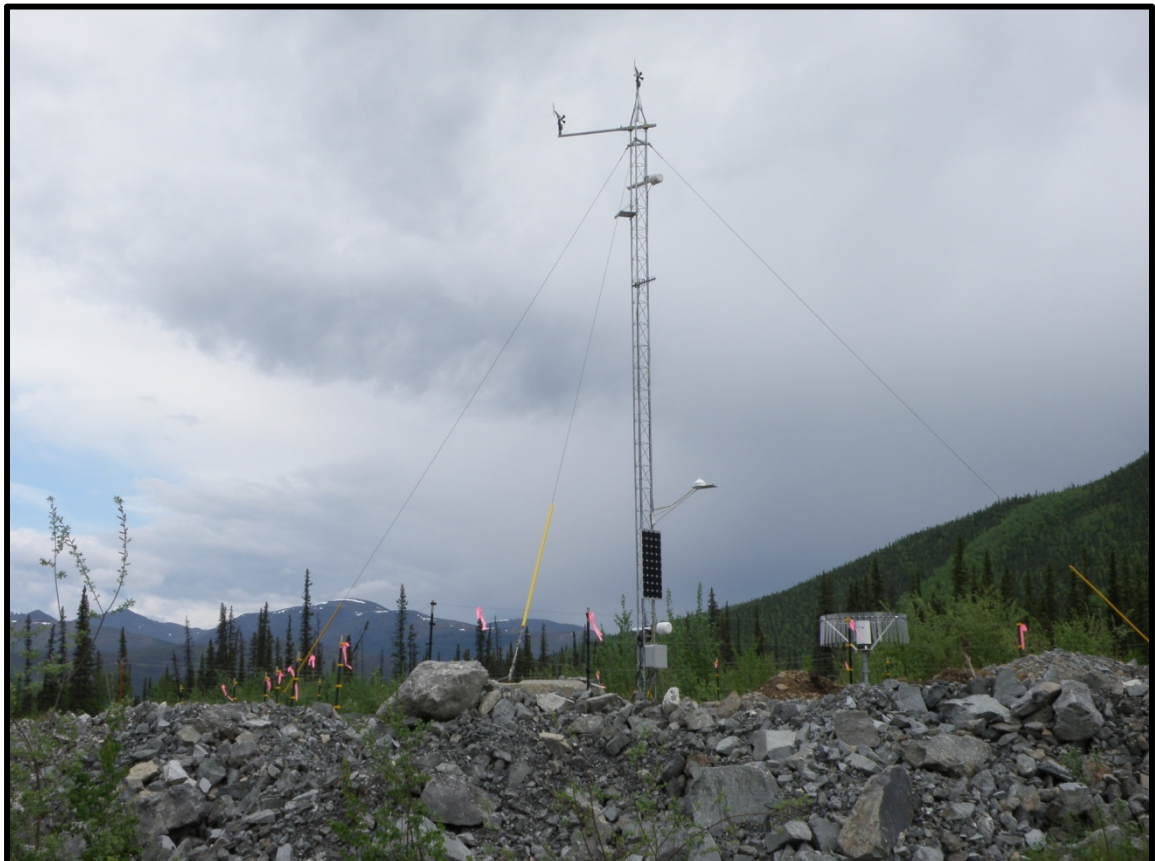
A new weather station has been installed in the area of the airstrip (Photo 9).

Photo 9 – New Weather Station
