## **POGO MINE INSPECTION REPORT**

**Inspection Date:** September 12, 2013

**Inspection Objectives:** General Inspection

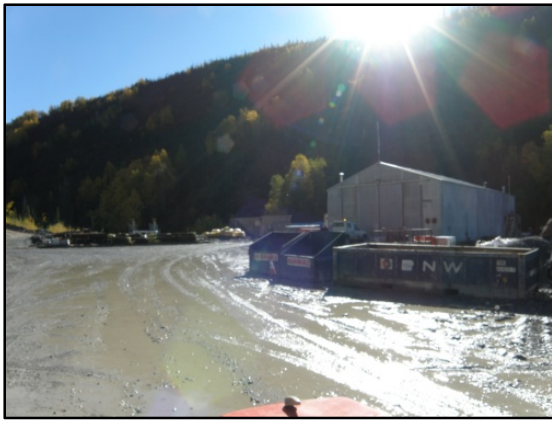
Photo 1: En-route to the 1875 portal

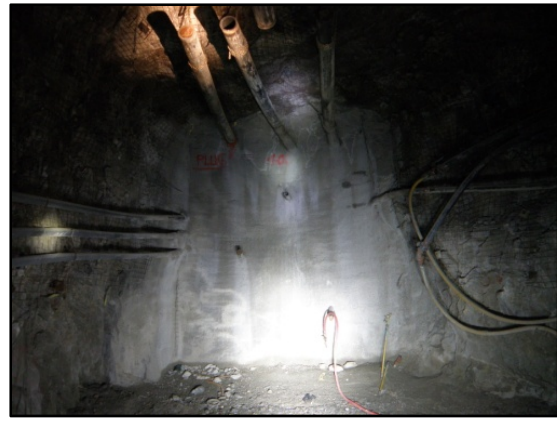
The underground tour began with additional site specific training for underground operations and the issuance of the personal protective equipment specific for underground activities. Agency personnel climbed aboard the tram to take them underground. The 1710-1760 adit that had been reclaimed was viewed. The concrete wall sealed the opening and the paste backfill pumped into the void through the pipes seen in Photo 2.

Photo 2: View of reclaimed 1710-1760 mine workings.

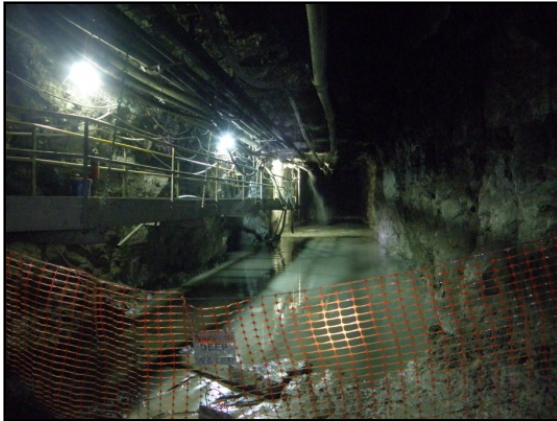
Underground water is collected and pumped to main sumps (Photo 3) where flocculant is added to allow for settlement and reuse. Underground operations viewed were rock bolting (Photo 4 and Photo 5), shot loading (Photo 6 and Photo 7), and movement of ore (Photo 8, 9 and 10).

Photo 3: Underground sump for water treatment and reuse.

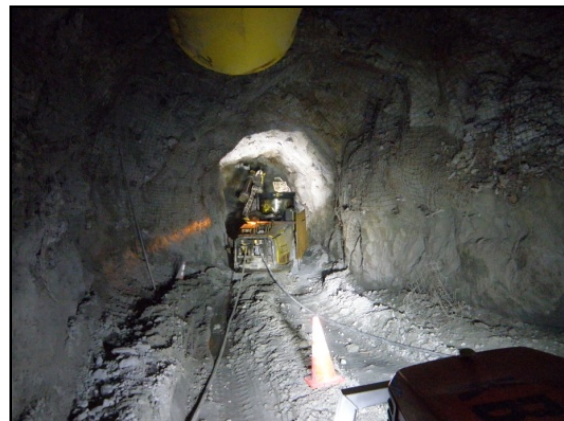
Photo 4: Rock bolting and underground support installation.

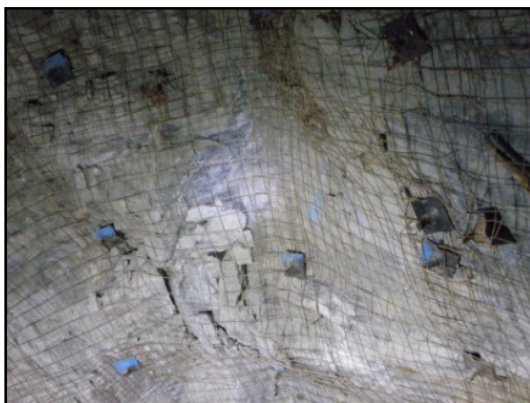
Photo 5: Completed section of roof rock bolting.

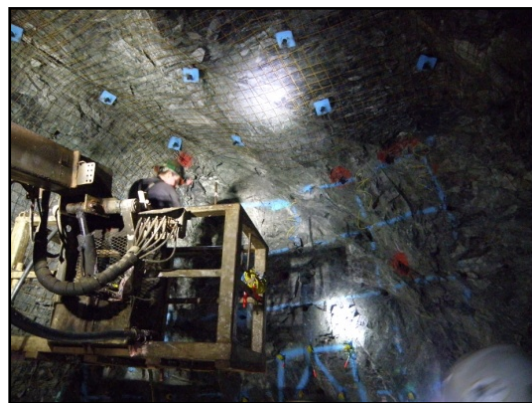
Photo 6: Blaster loading holes for the next shot.

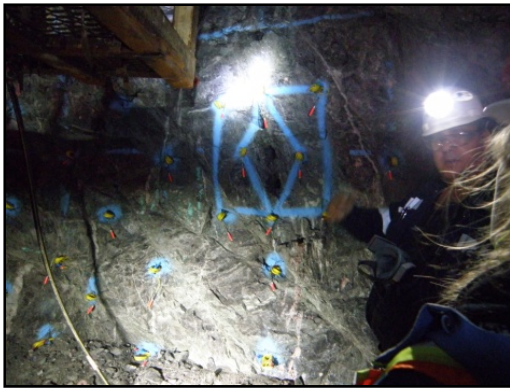
Photo 7: Loaded blast pattern.

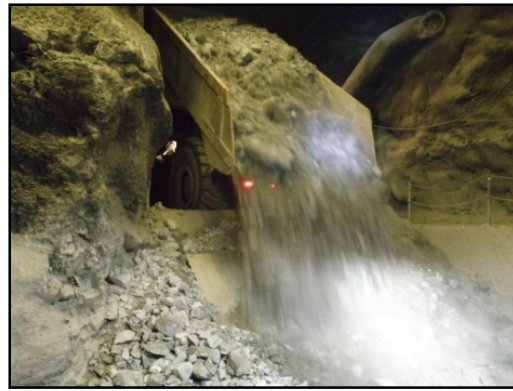
Photo 8: Haul truck dumping ore into the ore pass.

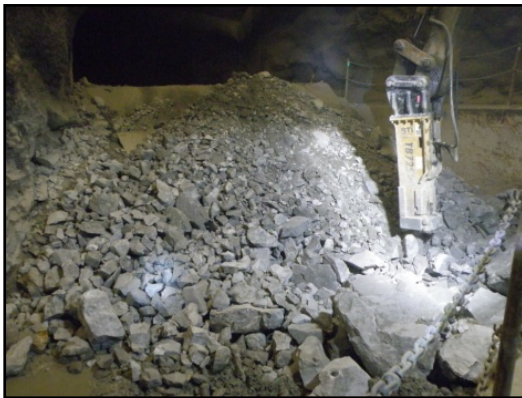
Photo 9: Rock breaker in action.

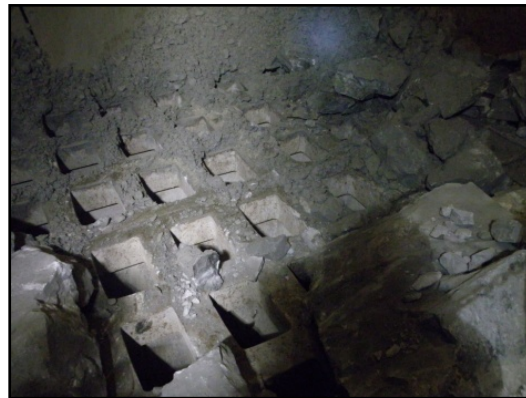
Photo 10: View of the grizzly for the ore pass.

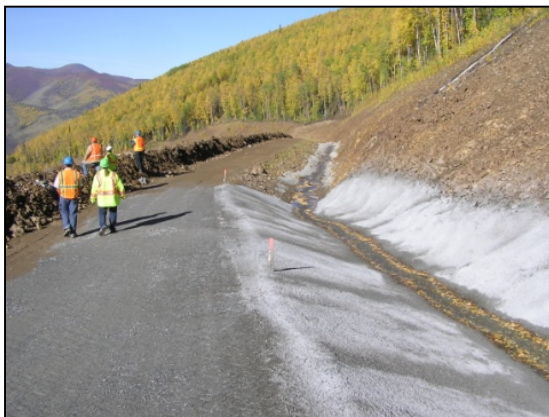
On the surface, agency personnel inspected the diversion ditch tie-in between the new and the old sections. Photo 11 shows the tie-in for the north side diversion ditches. Work has been completed to tie in stream channels to the new diversion ditches (Photos 12 through 16).

Photo 11: North side connection between the old and the new diversion ditches.

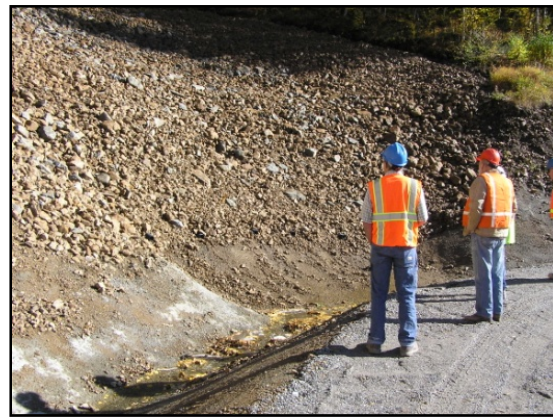
Photo 12: One stream channel intercept with the north diversion ditch system.

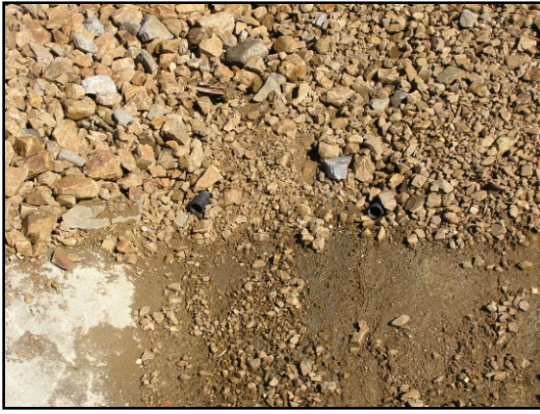
Photo 13: Stream channel #1 intercept with the north drainage ditch.

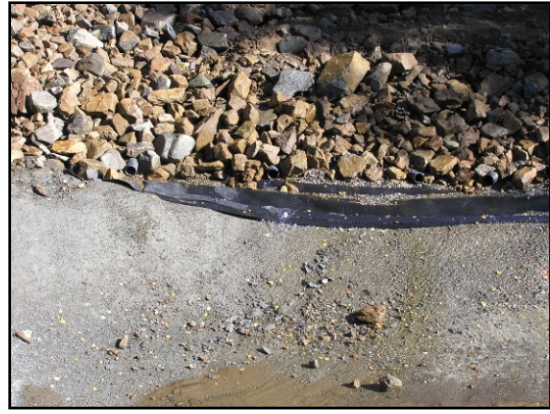
Photo 14: Stream channel #2 tie intercept with the north drainage ditch.

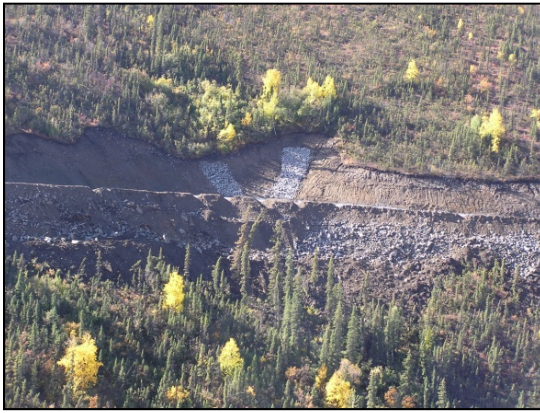
Photo 15: A view of drainage channels for surface streams on the south side.

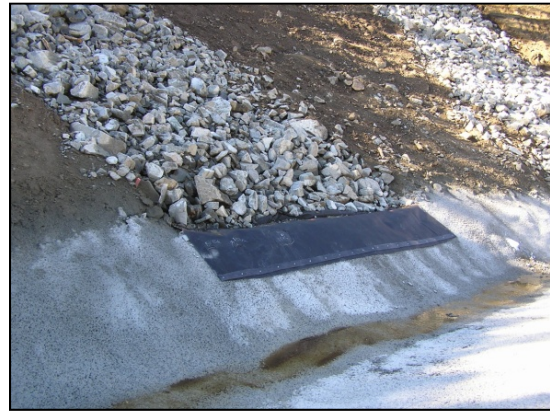
Photo 16: The stream intercept on the south side drainage ditch.

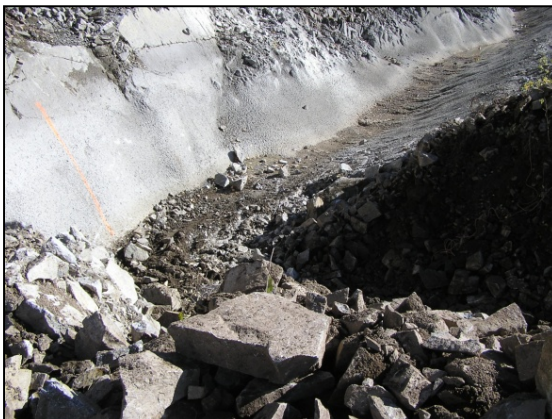
Additionally, on the north side, the old diversion ditch has been breached (Photos 17 and 18). The old north diversion ditch is plugged as shown in Photo 19. Photo 20 shows the drop pipe installed to connect the old and new diversion ditch systems. Photos 21 through 25 show the pipe, flume, and sump system installed for the south diversion ditch. An overview of the connection between the old and new south drainage ditch systems is shown in Photo 26.

Photo 17: A view of the old north drainage ditch.

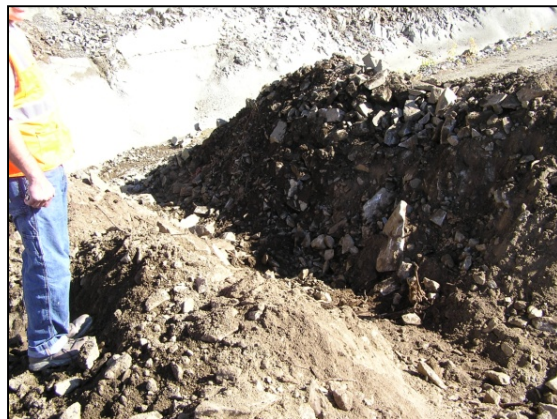
Photo 18: A view of the old north drainage ditch.

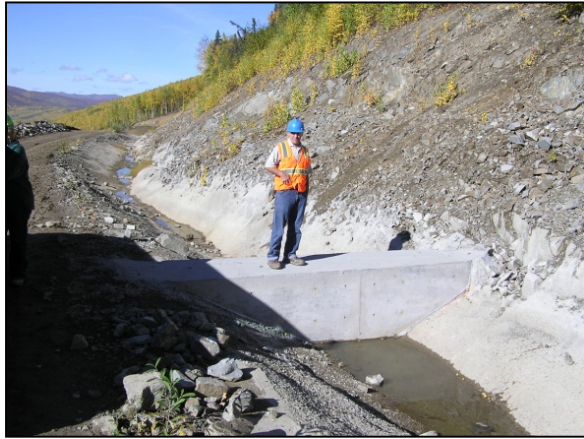
Photo 19: The old north diversion ditch is plugged.

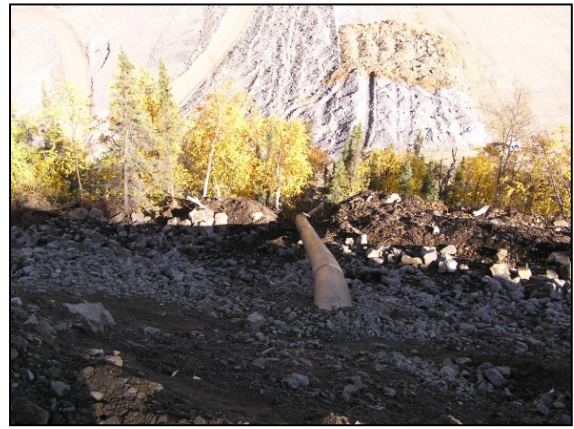
Photo 20: A view of the drop pipe to connect the new south ditch to the old north ditch.

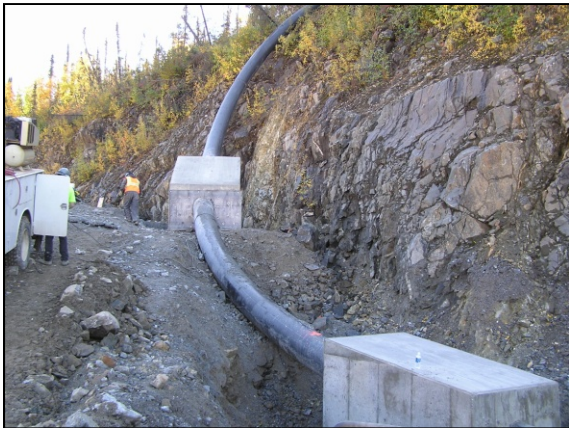
Photo 21: A view of the pipe system for the south new diversion ditch.

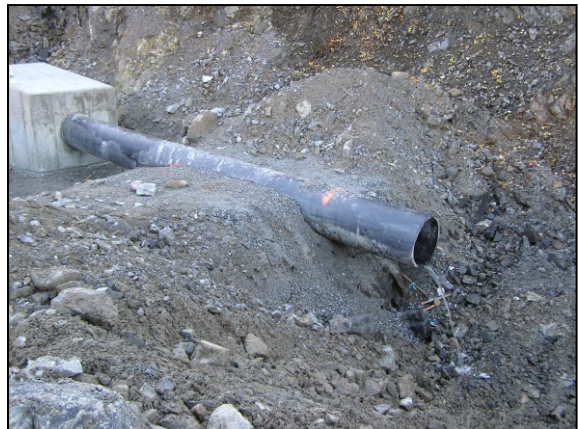
Photo 22: A view of the exit from the south diversion ditch pipe.

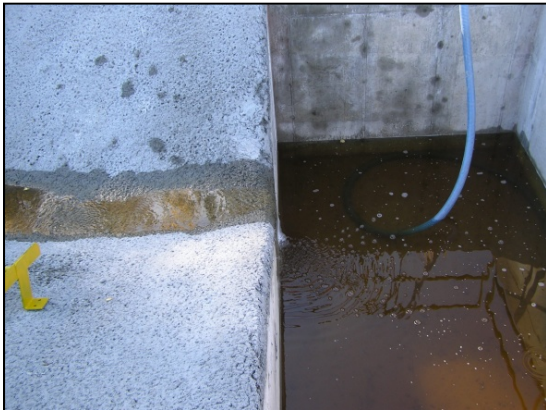
Photo 23: A view looking into the south flume sump.

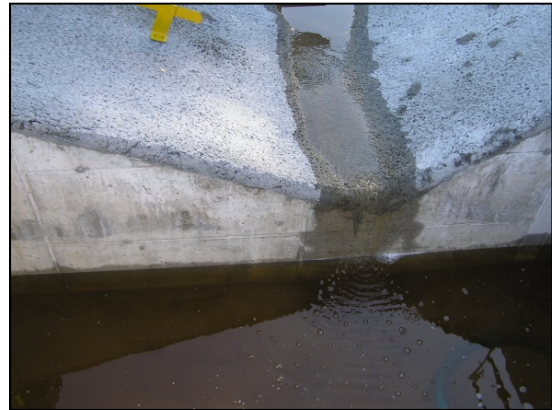
Photo 24: Drainage channel constructed for flow into the south flume sump.

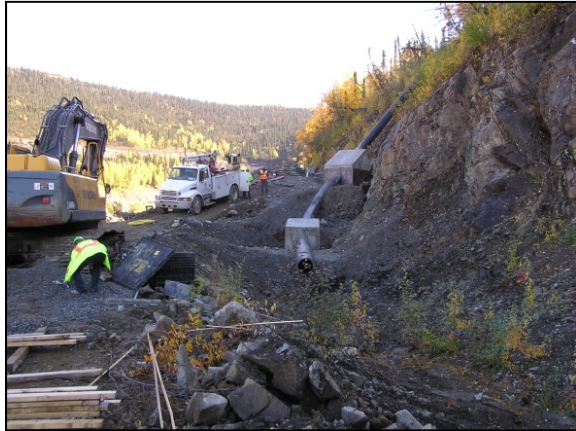
Photo 25: A view of the terrain and the south diversion ditch pipe system.

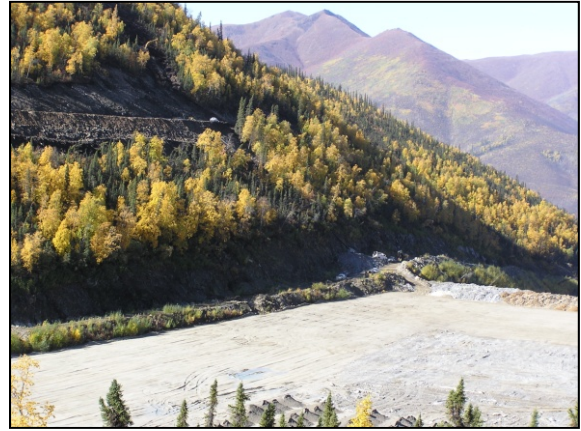
Photo 26: An overview of the area where the south diversion ditch systems are tied together.

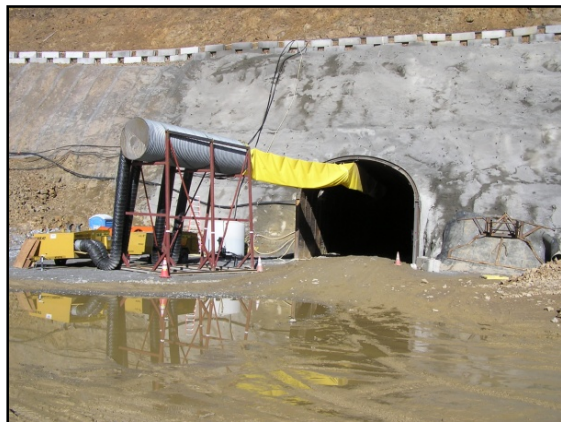
The work for the 2150 portal continues as shown in Photo 27 and Photo 28. General site photos indicate that berms along the access road are in good condition (Photo 29), the seasonal changes are visible (Photo 30), and animal habitat is sustained (Photo 31).

Photo 27: Ventilation installation for the 2150 portal.

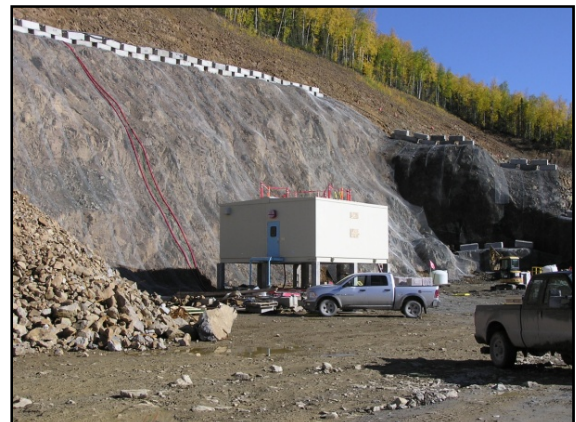
Photo 28: Supporting equipment for the 2150 portal.

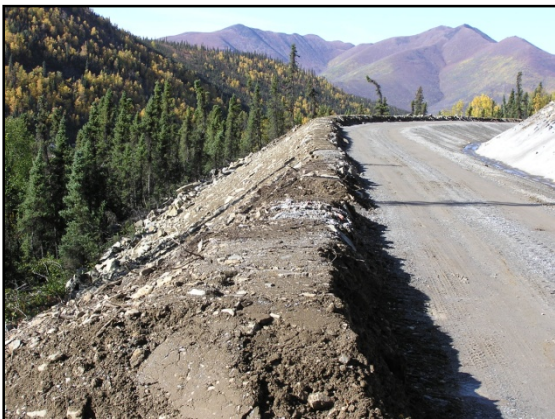
Photo 29: Berms are maintained along the mine roads.

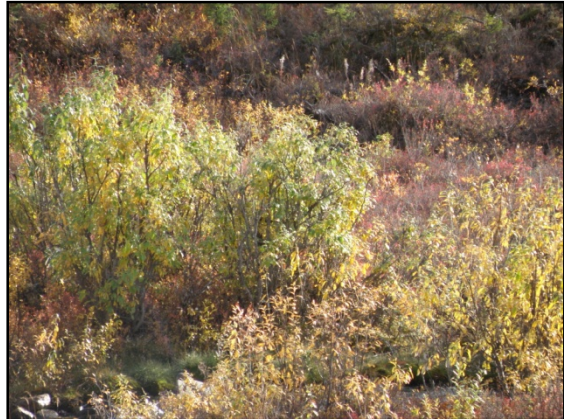
Photo 30: Fall colors evident on the land surrounding the mine activities.
