## **POGO MINE INSPECTION REPORT**

**Inspection Date:** June 3, 2014

**Inspection Objectives:** General Inspection and Site Familiarization Tour

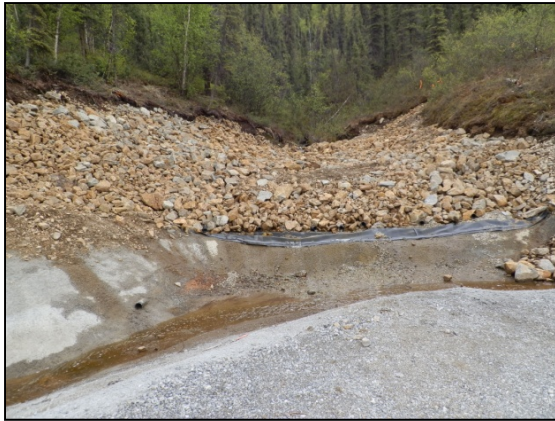
On the surface, agency personnel began by viewing the new diversion ditch and inlets. Inlet 1 was dry while Inlet 2 had water flowing into the ditch (Photo 1) and down the hill in the North Diversion Ditch (Photo 2). Inlet 3 was farther up the road at the headwaters of Liese Creek. Photo 3 shows water flowing down the South Diversion Ditch. The new diversion ditch construction has intercepted more water and prevented contact with mining operations than expected and was reflected in the lower quantity of water stored in the RTP. Agency personnel observed that the Diversion Ditches and the flumes at the RTP Dam for Liese Creek appeared to be in good condition. Agency personnel observed loading on the Dry Stack Tailings Facility (DSTF) which is in conformance with applicable permits (Photos 4-6).

Photo 1: Water flowing into the North Diversion Ditch at Inlet 2.

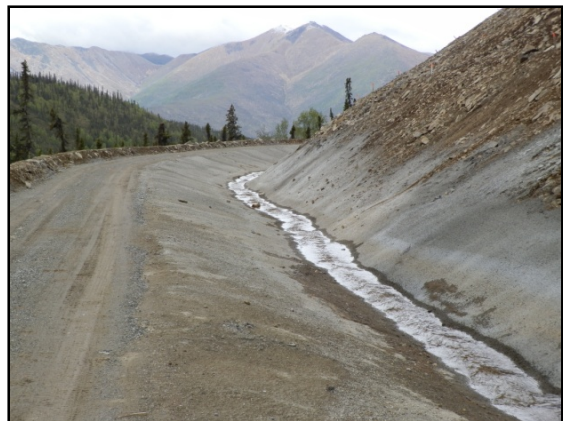
Photo 2: Water flowing down the shotcrete-lined North Diversion Ditch.

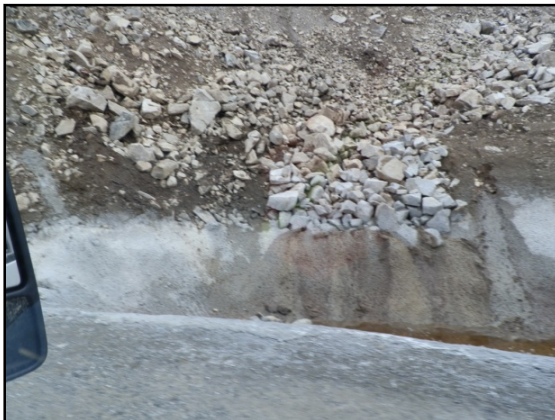
Photo 3: Inlet 3 with water flowing into the South Diversion Ditch.

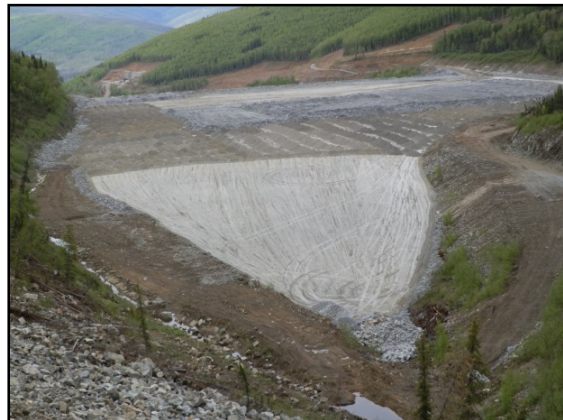
Photo 4: View of the DSTF looking down the valley.

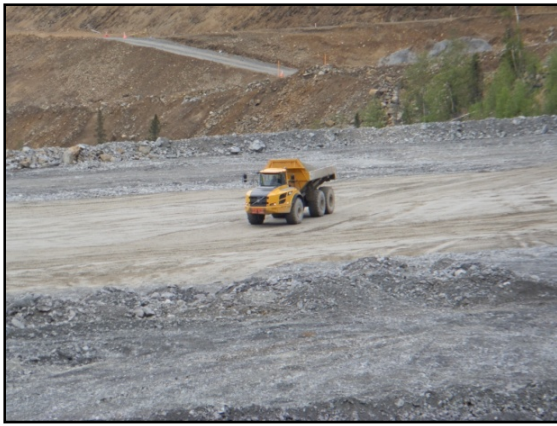
Photo 5: Truck operations on the DSTF Facility.

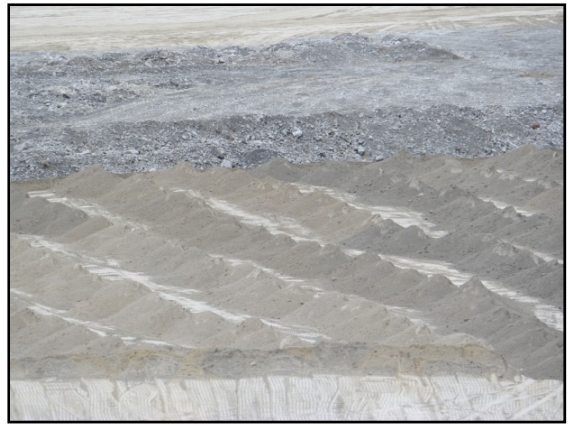
Photo 6: Close-up view of material placed onto the DSTF.

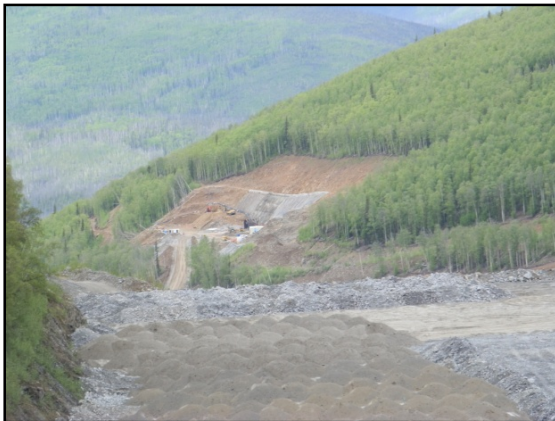
Work continues at the 2150 portal entrance (Photos 7 and 8). A drill located on the bench outside the portal is in the process of drilling a vent raise for the underground workings (Photos 9 and 10). Work has begun on the Mill Bench to replace the existing CIP. En route to the Water Treatment Facilities, helicopter operations supporting the exploration program were seen (Photo 11). The scrubber for the incinerator just arrived on site and is waiting to be installed. The site for Water Treatment Plant #3 has been cleared and prepared for construction (Photo 12).

Photo 7: View of 2150 portal area from above the DSTF.

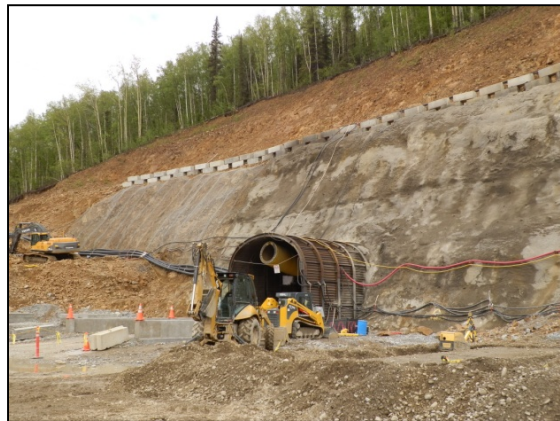
Photo 8: View of 2150 portal.

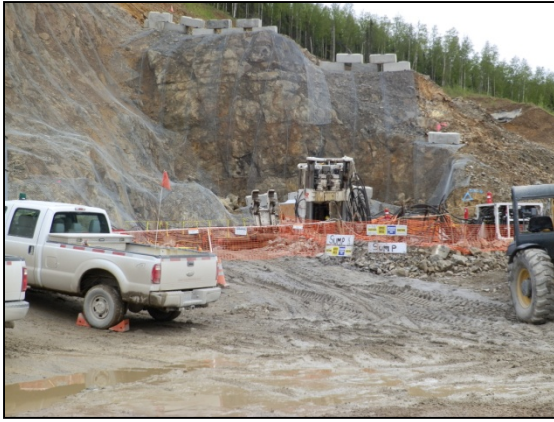
Photo 9: Barricades in place around the drill outside the 2150 portal.

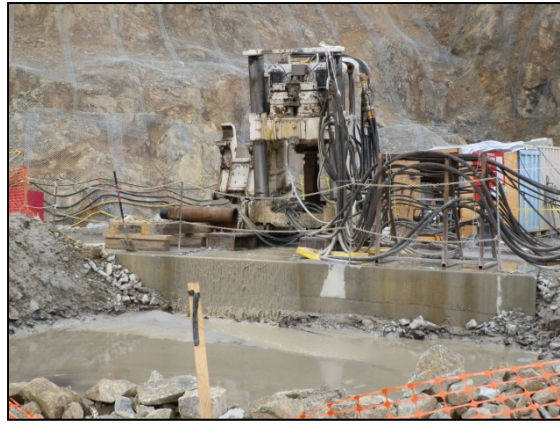
Photo 10: Ventilation raise drilling is in process.

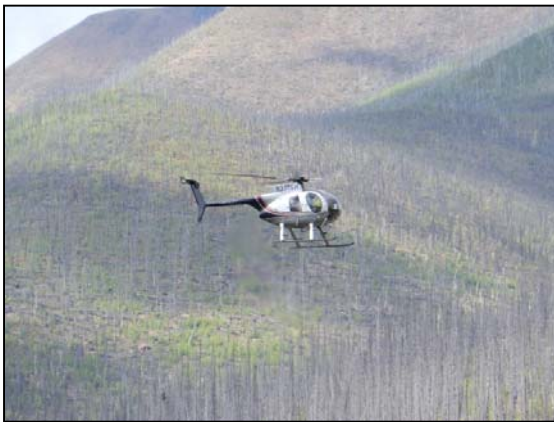
Photo 11: Helicopter-supported exploration activities are on-going this summer.

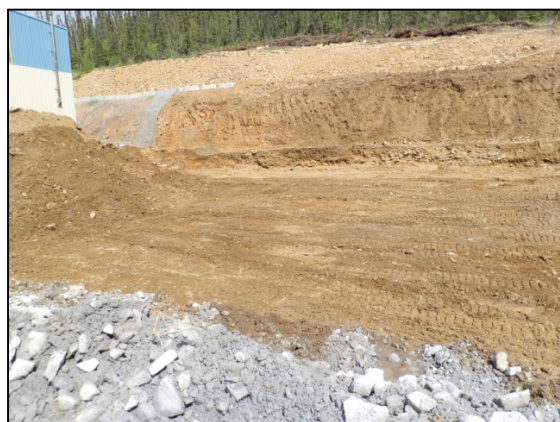
Photo 12: Location for Water Treatment Plant #3 is cleared and getting prepared for construction.

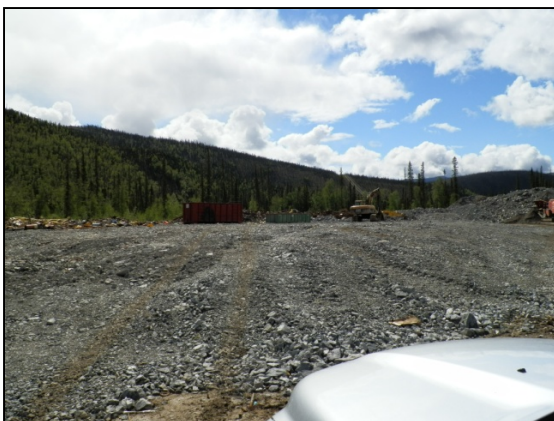
The waste metal storage location was inspected and verified that the pad holding the material was cleaned up and the base pad increased in elevation from last year's flood stage (Photo 13). Agency personnel also inspected the Off-River Treatment Works (ORTW) and noted that inflow into the ORTW (Photo 14) appeared free of visible sediment and that the ORTW appeared to be operated in compliance with applicable permits. The inlet channel (Photo 15), the primary pond (Photo 16), and the secondary pond (Photo 17) were visited on this inspection.

Photo 13: Waste metal storage pad has been cleaned up and raised.

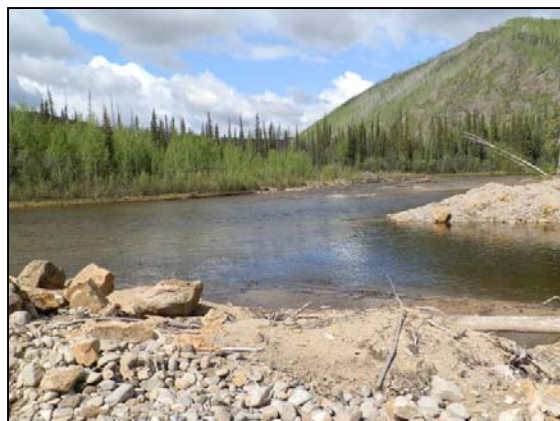
Photo 14: ORTP inlet from the Goodpaster River.

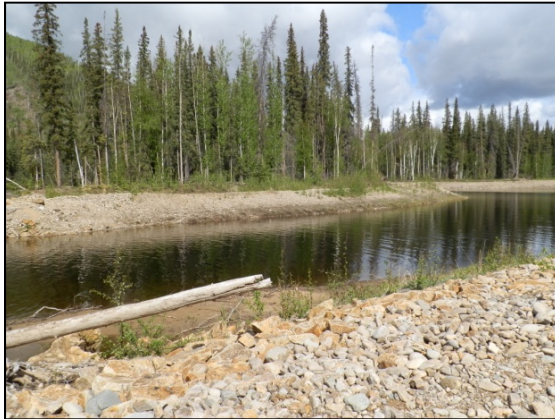
Photo 15: Inlet channel for the ORTW.

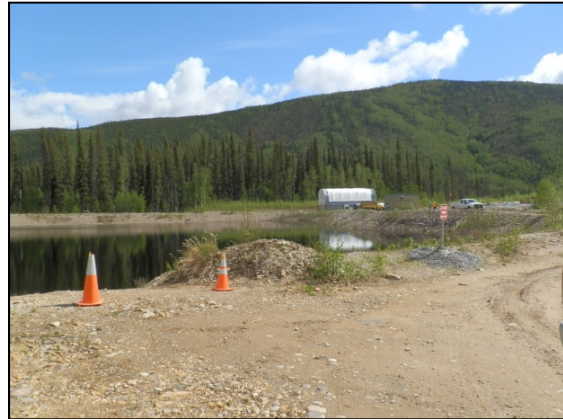
Photo 16: View of ORTW primary pond.

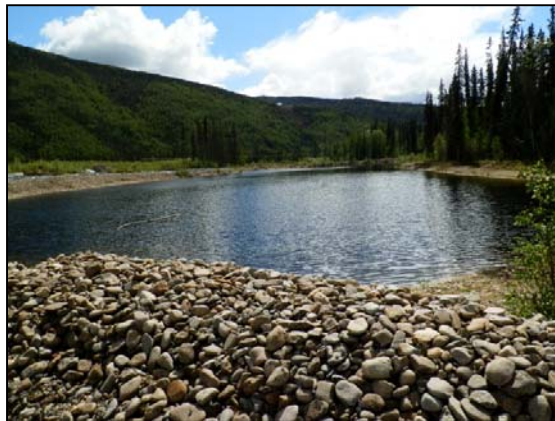
Photo 17: A view of the ORTW secondary pond.

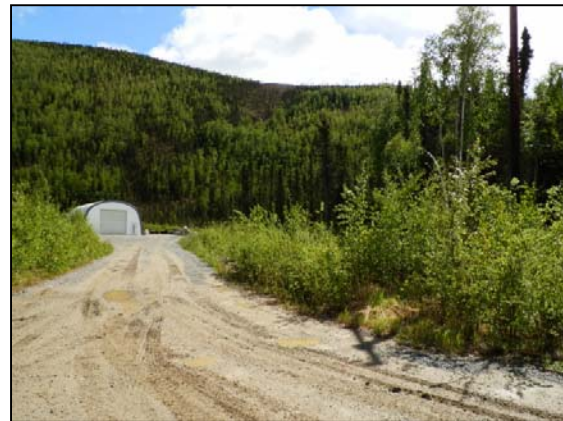
Photo 18: Storage facility near the Pogo airfield.
