## **Pogo Mine Inspection Report**

**Inspection Date:** October 14, 2015  
**Weather:** 28°, Partly Cloudy  
**Time of Inspection:** 10:00 am to 3:00 pm  
**Operator Contact:** Keri DePalma – Sumitomo Metal Mining Pogo LLC (SMMPogo)  
**Agency Personnel:** Brent Martellaro – Alaska Department of Natural Resources (ADNR)  
Stephanie Lovell – ADNR  
Tim Pilon – Alaska Department of Environmental Conservation (ADEC)

**Inspection Objectives:** General inspection of the mine site.

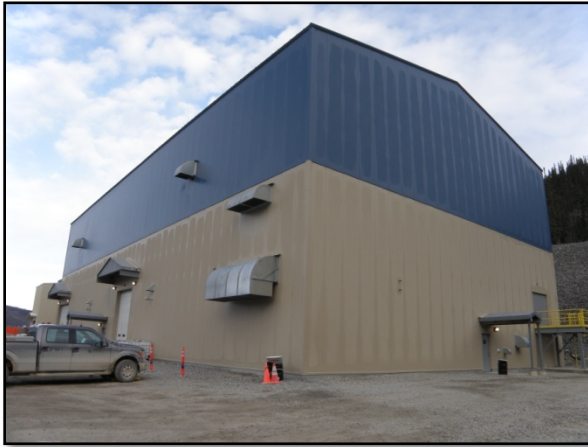
The inspection started at the recently constructed Mine Water Treatment Plant #3 (MWTP#3) (Photo 1). Work was still occurring on certain appurtenances of the treatment plant, but construction of the main systems was complete. Until all areas of the treatment facility are ready and approved to go online, effluent from MWTP#3 serves as influent for Mine Water Treatment Plant #2 (MWTP#2) where it undergoes treatment and then is released to the Off-River Treatment Works. MWTP#3 Clarifier was observed (Photos 2 & 3).

**Photo 1: Completion of MWTP#3**

Construction of MWTP#3 looked complete. All components were constructed or installed, with only minor completion of appurtenances remaining before going online. The secondary containment on the 1690 portal bench for the paste backfill looked sufficient. Placement of tailings on the DSTF appears to be in compliance with permit conditions. The new diversion ditch liner looks to be working as intended to capture and divert water.

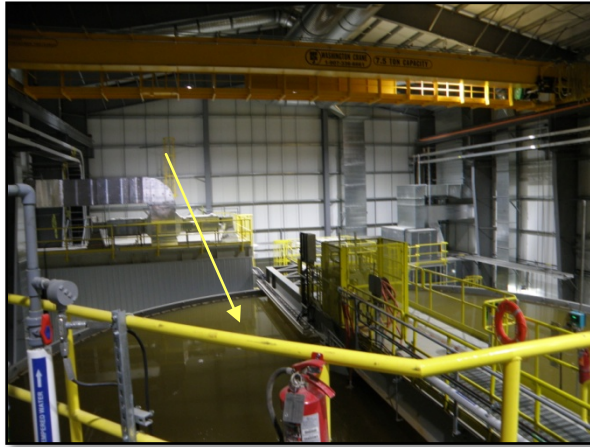
**Photo 2: MWTP#3 Clarifier**

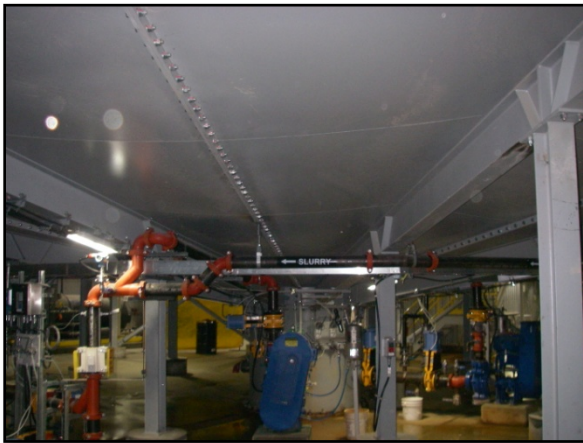
**Photo 3: Bottom of MWTP#3 Clarifier**

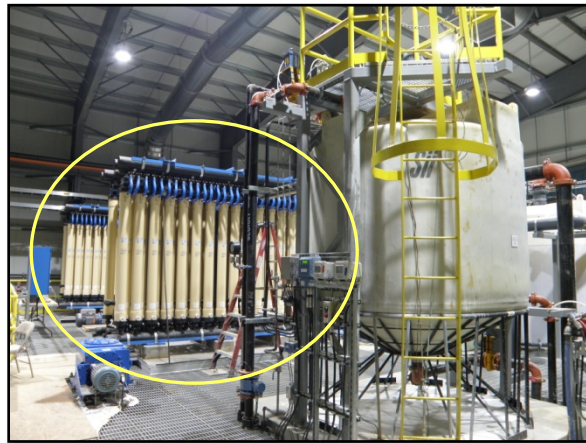
MWTP#3 utilizes a microfiltration membrane system to treat wastewater from three sources, the Recycle Tailings Pond (RTP) head tank, gravel pond, and the mine, whereas sand filters are utilized in MWTP#2. Rows of the Pall microfiltration tubes were installed and online (Photo 4).

**Photo 4: Pall microfiltration tubes**

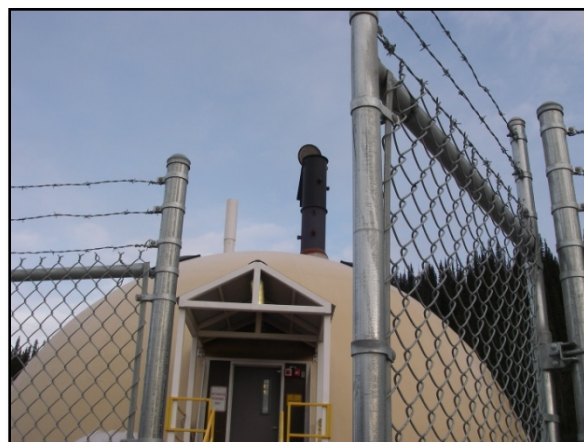
The group then visited the Solid Waste Incinerator, recently enclosed by a chain link and barbed wire fence (Photo 5). The scrubber stack (white) and the burner stack (black) were observed. The incinerator was not in operation, as maintenance on the scrubber system was underway.

**Photo 5: Incinerator stacks and chain link fence**

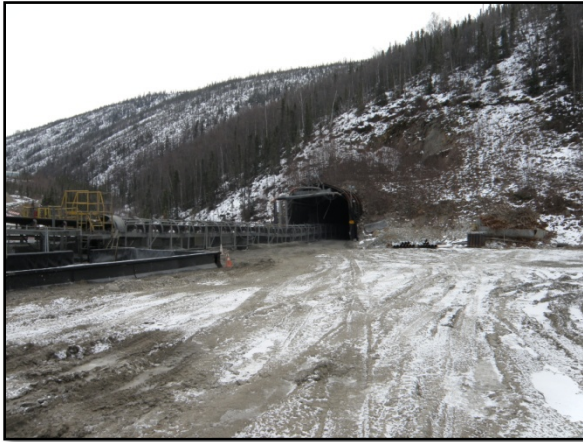
At the 1690 portal bench (Photo 6) is the terminus of the blue tube which houses the ore conveyor and paste backfill line (Photo 7). Agency personnel observed the results of the cleanup from the ruptured paste backfill line. On May 7, 2015, the line ruptured resulting in a spill of the cement-like paste out of the Splice House and onto the gravel lined pad. After cleanup, the remediation included building a new secondary containment eliminating the need for Splice House containment (Photos 8 & 9). The foundation of the Splice House is still visible within the new containment area (Photo 10). The new containment area is enclosed with Jersey barriers covered with liner and reinforced with a bed liner spray.

**Photo 6: 1690 portal bench**

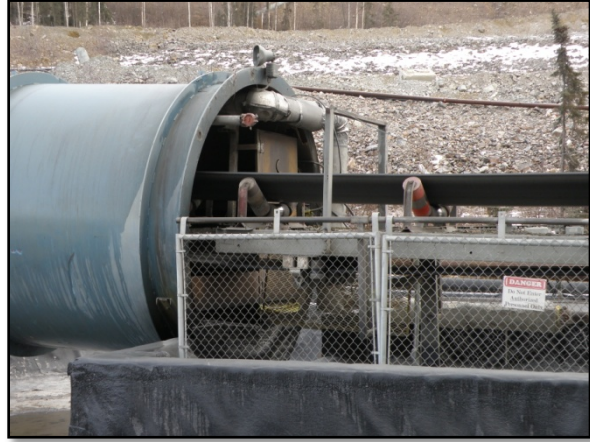
**Photo 7: Terminus of blue tube**

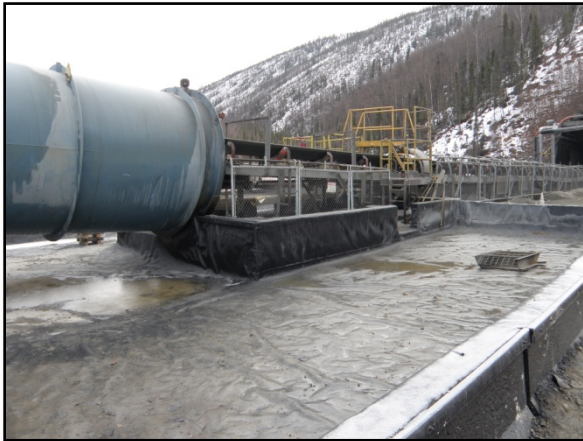
**Photo 8: West side of paste backfill secondary containment**

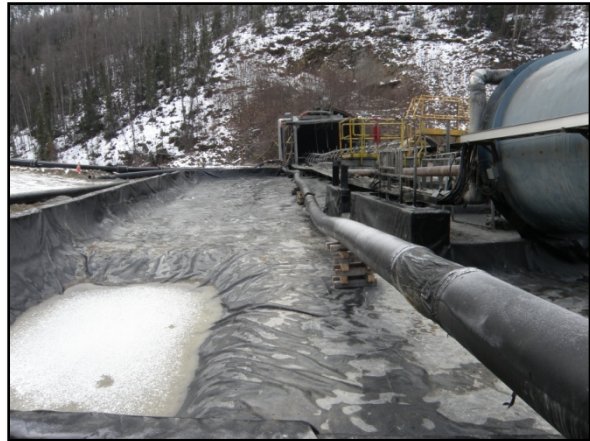
**Photo 9: East side of paste backfill secondary containment**

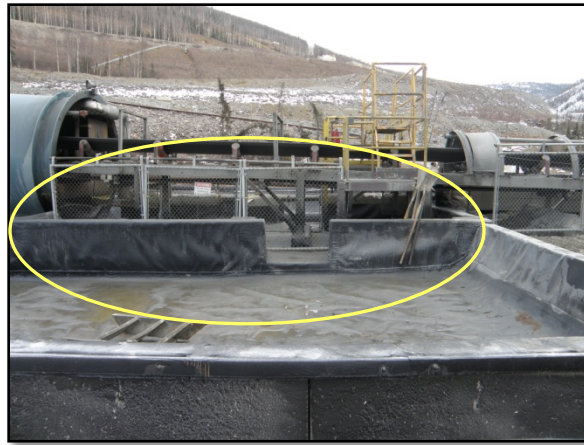
**Photo 10: Foundation from the Splice House**

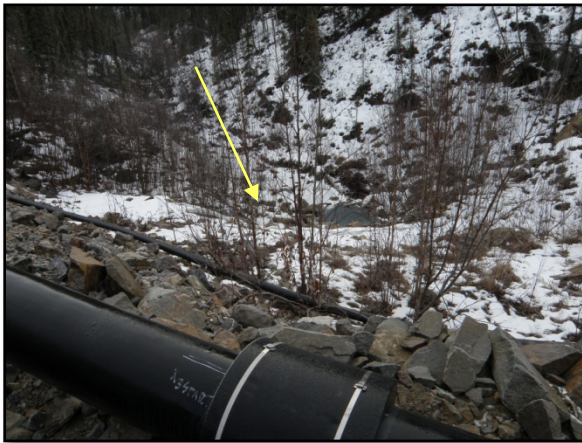
Liese Creek drainage (Photo 11) was visible as the group walked along an access road (Photo 12) to observe the recently dredged and relined Storm Water Sedimentation Pond (Photo 13 & 14).

**Photo 11: Liese Creek**

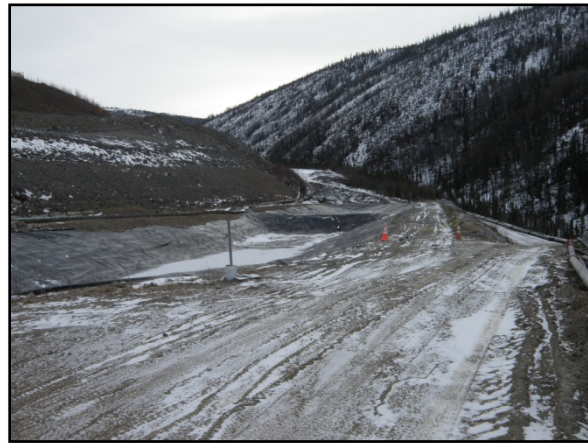
**Photo 12: Access road along Storm Water Pond**

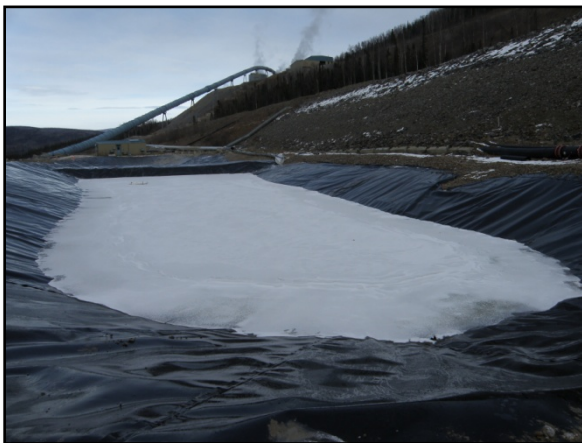
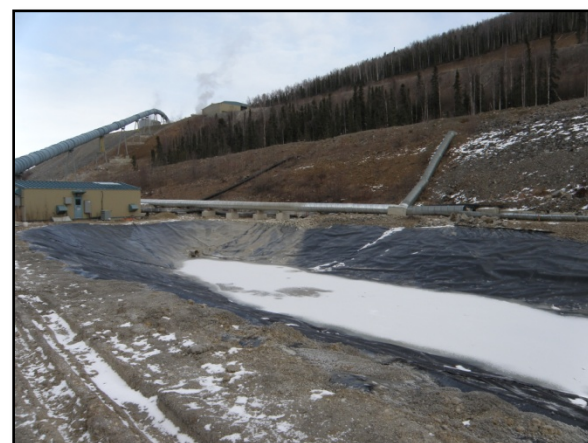
**Photos 13 & 14: Storm Water Sedimentation Pond**

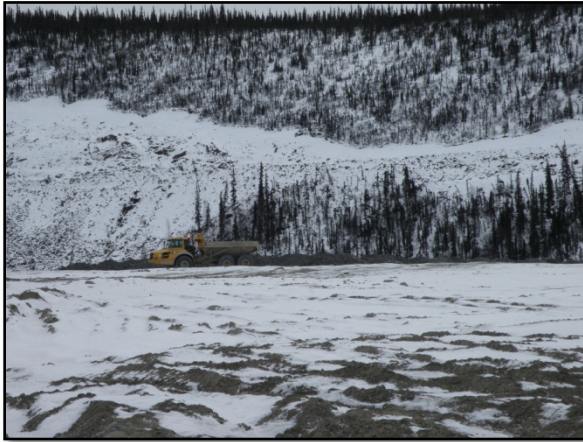
At the Drystack Tailings Facility (DSTF), trucks were actively unloading tails (Photo 15). The group was escorted up the new diversion ditch road to overlook the DSTF (Photo 16). Piles of tailings were placed along the outer edge of the DSTF, and piles of mineralized rock were visible toward the middle of the facility (Photos 17 & 18).

Photo 15: Truck unloading tailings on DSTF

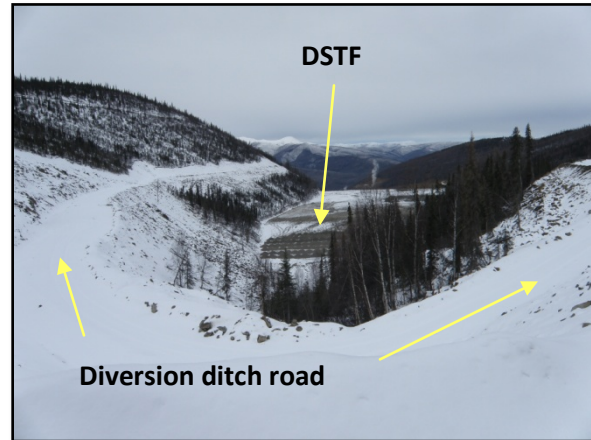
Photo 16: Overview of the DSTF from diversion ditch road

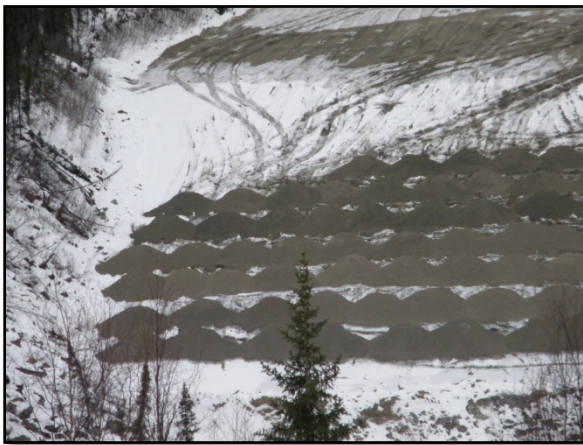
Photo 17: Piled tailings on upper DSTF edge

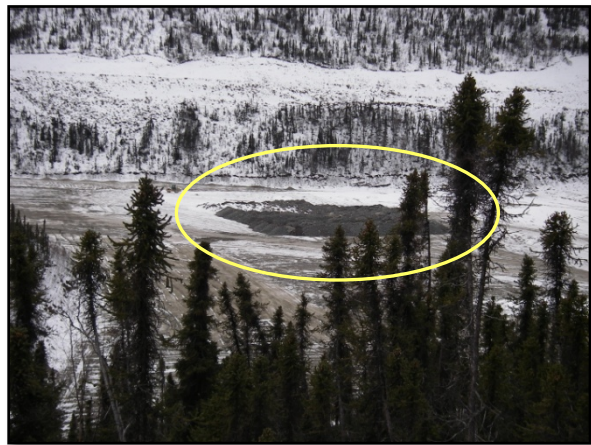
Photo 18: Cell of mineralized rock toward middle of DSTF

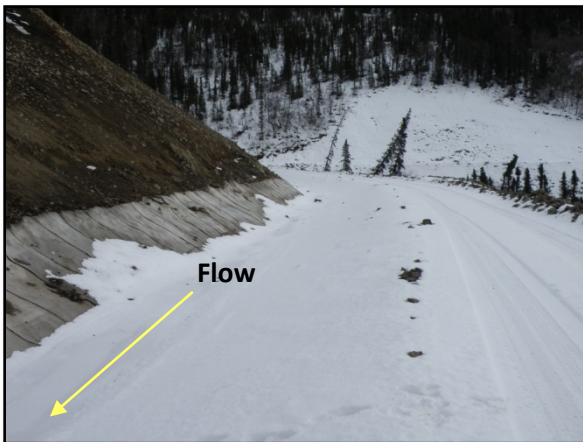
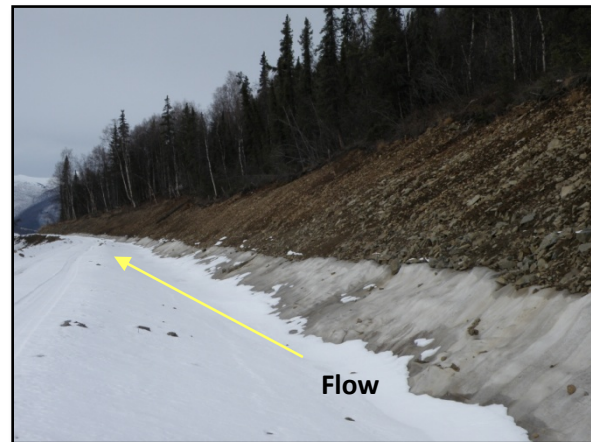
The new diversion ditch had been lined with horizontal segments of a new material consisting of a fabric infused with cement (Photos 19, 20 & 21). Once the material becomes wet, the cement hardens and creates a solid barrier. The hardened segments are secured with screws (Photo 22). Water flowing out of Inlet #2 appears to be captured and diverted along the new diversion ditch.

Photos 19 & 20: New diversion ditch liner (arrow indicates direction of flow)

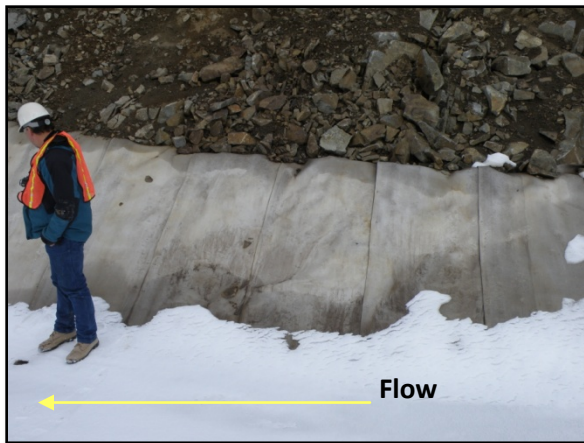
**Photo 21: Section of new liner segments**

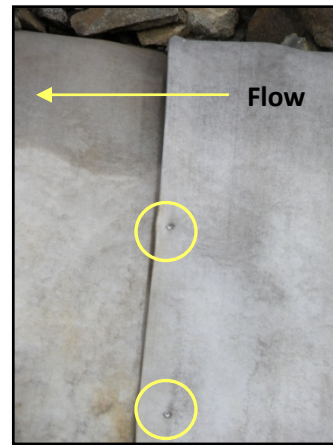
**Photo 22: Screws securing overlap**

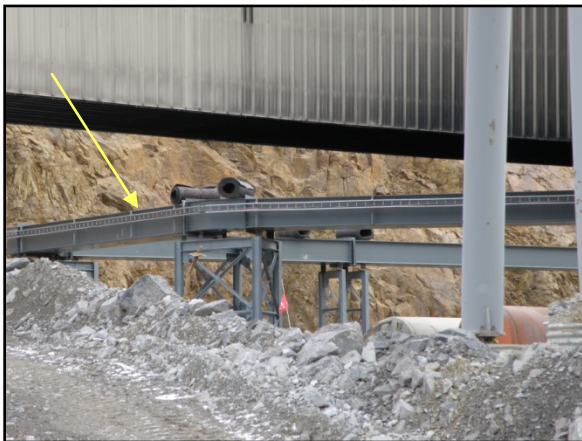
The construction of the infrastructure for 2150 portal paste backfill line was observed (Photo 23). The new CIP tank constructed to replace the old CIP was observed (Photos 24, 25 & 26). Along the mill bench wall, the natural revegetation of woody species was noted (Photos 27 & 28).

**Photo 23: Infrastructure for 2150 portal paste backfill line**

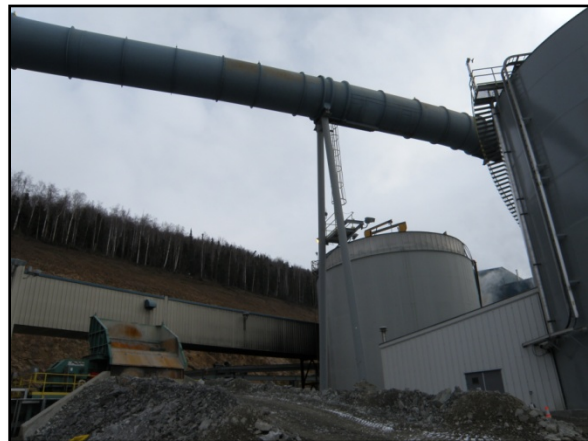
**Photo 24: Old CIP Tank**

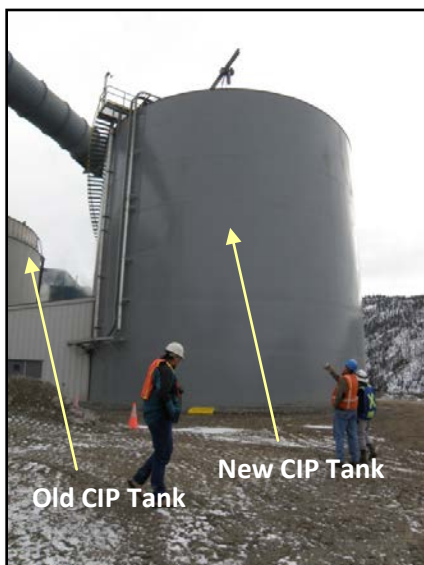
**Photo 25: New CIP Tank**

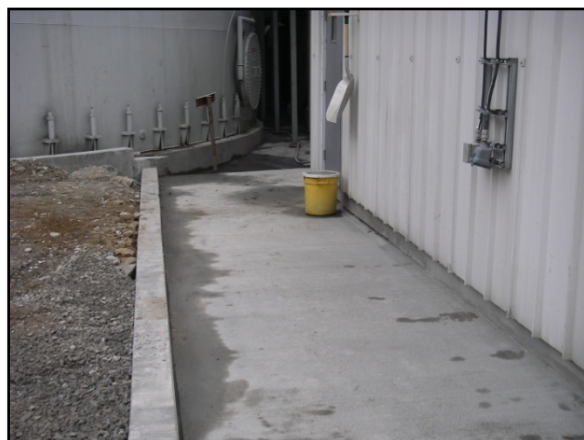
**Photo 26: New cement pad and curb outside paste building**

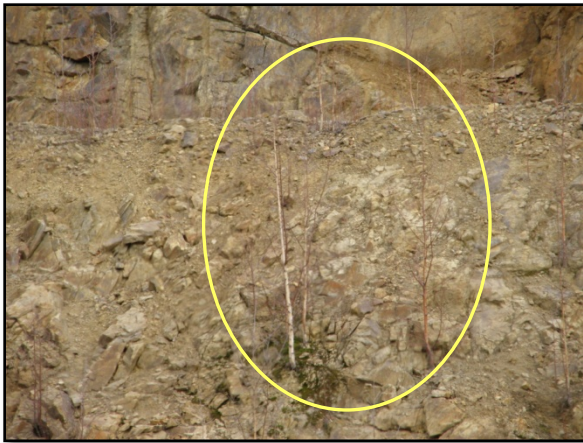
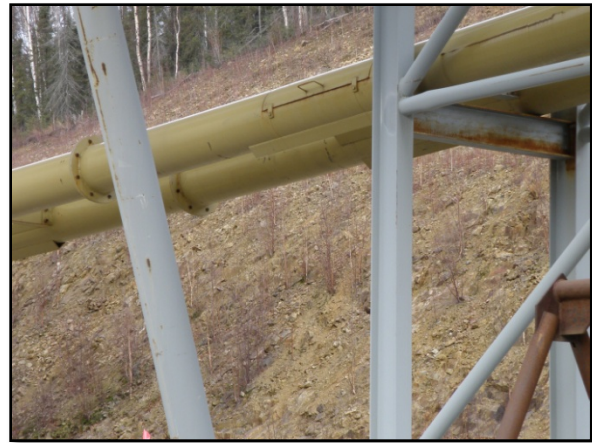
Photo 27 & 28: Natural revegetation of woody species on Mill bench wall
