## POGO MINE INSPECTION REPORT

**Inspection Date:** October 3, 2018  
**Weather:** Clear skies, light wind, 35 ° F  
**Time of Inspection:** 11:30am to 4:00pm  
**Operator Contact:** Jill Ladegard, Brad Valiukas  
**Agency Personnel:** ADNR – Steve Buckley, Brent Martellaro, Carolyn Curley, and William Groom  
**Inspection Objectives:** General Inspection

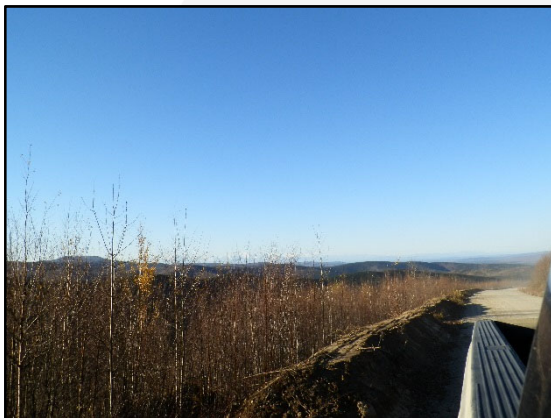
Agency personnel signed into the site prior to traveling on the Mine Access Road. The road was in good condition with little dust until after Mile 30. (Photo 1) Dry, windy conditions and low temperature precluded using water for dust suppression until later in the afternoon. Animal tracks were noted on the side of the road. Grouse were seen before Mile 5. Road work in preparation for winter was evident with the staging and use of equipment at numerous places along the access road. Regrowth in fire-burned area showed revegetation occurring naturally with birch, aspen, and small spruce trees. Upon arrival at the Administration Building, agency personnel were met and escorted to the “Chateau,” environmental section offices, for safety briefings and company updates. Chris Kennedy, Luke Creagh, Jim Ward, and Jeremiah Drewel participated in the safety briefing, company updates, and discussion. After lunch, ADNR staff, escorted by Jill Ladegard and Brad Valiukas, inspected the site using two vehicles.

Photo 1: Access road headed to Pogo Mine.

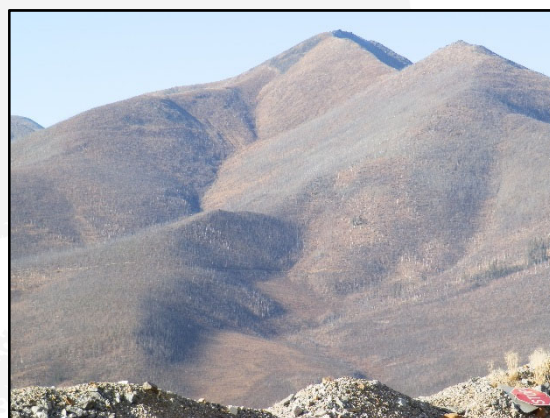
Photo 2: View of exploration road from the Mill Bench.

From the Mill bench, evidence of the exploration drilling road program was visible. (Photo 2) The Mill bench and facilities were observed from the outside. (Photos 3 and 4)

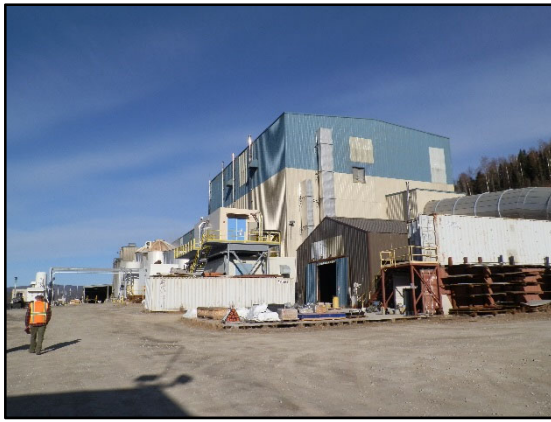
Photo 3: Mill buildings.

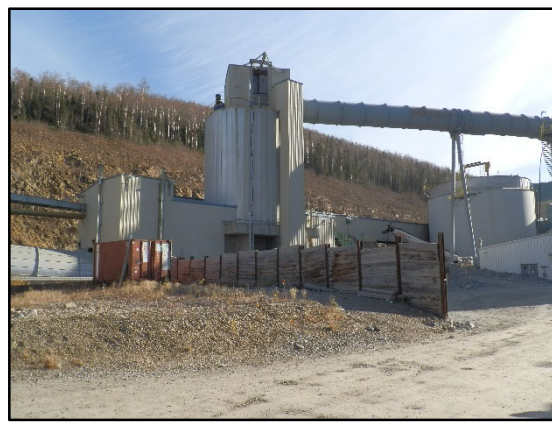
Photo 4: End of Blue Tube on the Mill bench.

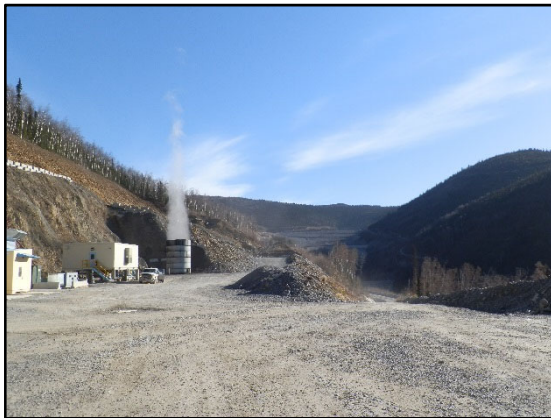
Photo 5: Vent raise at 2150 Bench

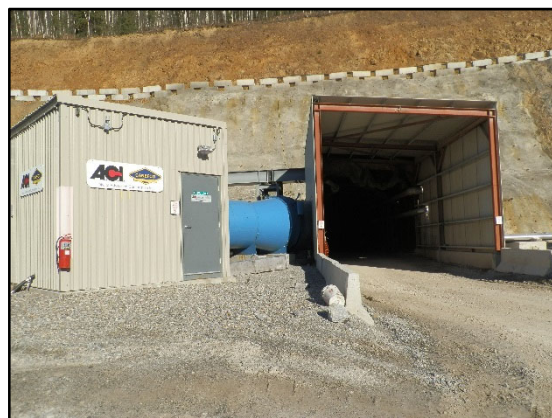
Photo 6: 2150 Portal.

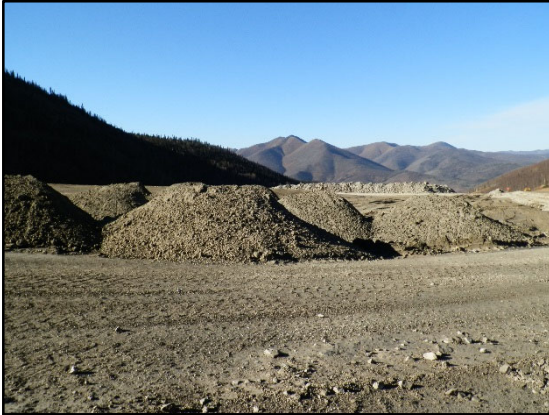
Photo 9: Tails drying on the dry stack facility.

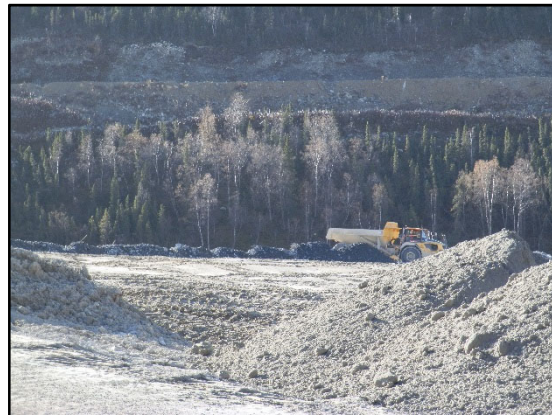
Photo 10: Dry Stack dumping and staging of red rock material.

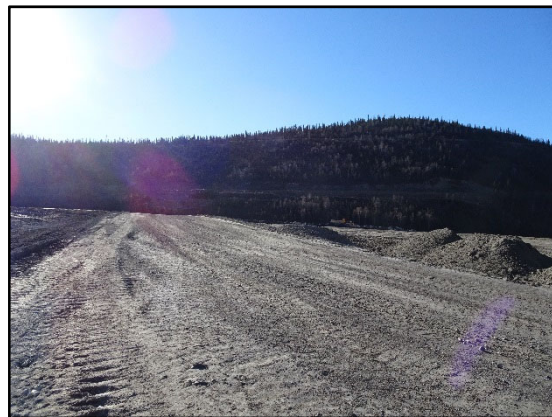
Photo 12: Dry stack haul road.

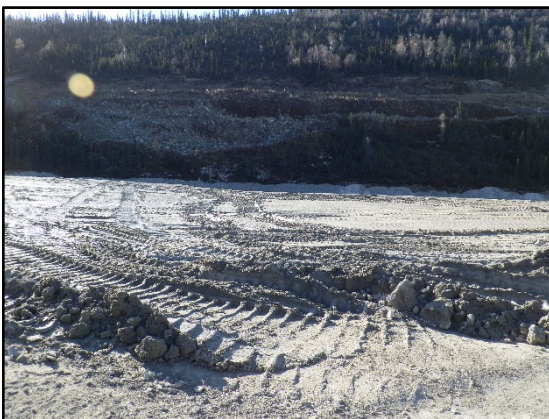
At the Dry Stack Tailings Facility (DSTF), we discussed placement practices and received information from Pogo employee, Joel. Red rock, dumped in 4 lifts of 8-12", is encapsulated with 3 to 4 lifts of tails. Red rock sections are separated with a 50' buffer with 3' of tails on top and a minimum of 100' from the dam. The tails are dumped and allowed to dry in the summer. In winter, tails are dumped during the night shift and spread during the next day shift. Compaction reaches approximately 95% with 6 passes of vehicles. Tests conducted by Pogo indicate that density requirements are met with current placement practices. We observed placement of tails (Photo 9) and red rock material (Photo 10) along with general conditions of the facility (Photos 11 and 12). We noted areas reworked this summer (Photo 13) as per instructions by Dam Safety. Surface cracks noted

earlier may have been caused by several very wet years. Areas were regraded to maintain a 2% grade sloping to the face of the DSTF to aid water shedding. The diversion ditches are checked weekly. Current spot repairs are in progress from the June 2017 flood event.

Photo 13: Dry stack tails section regraded.

Continue monitoring the DSTF surface for cracks  
Discuss potential changes to the ORTW with DEC

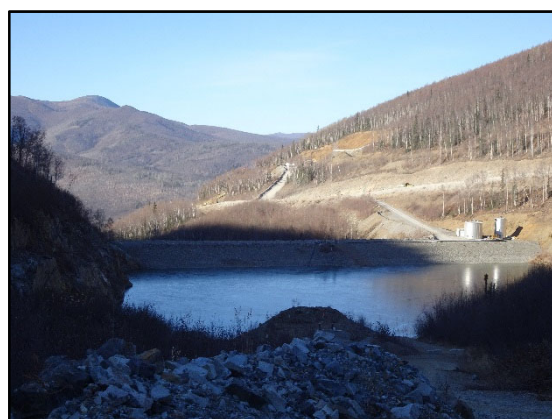
Photo 14: RTP overview looking downstream from DSTF toe.

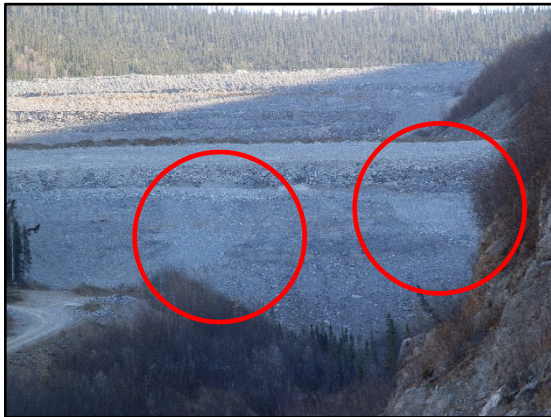
We viewed the DSTF from the toe (Photos 15 and 16). The circles in red on Photo 15 show where erosion on Shell #1 have been reworked.

Photo 15: DSTF viewed from the toe.

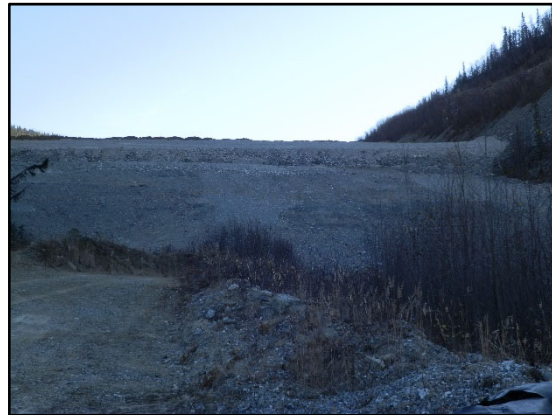
Photo 16: DSTF Shell #1

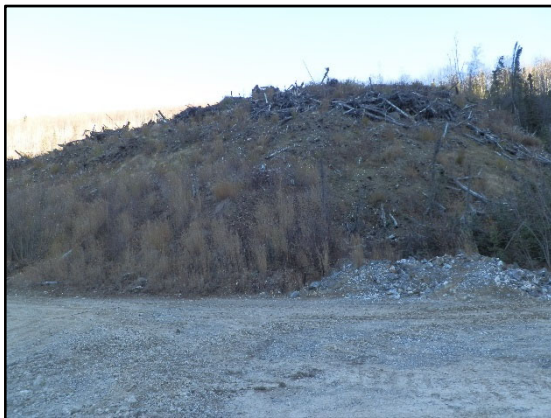
Photo 17: Growth media stockpile located below the DSTF

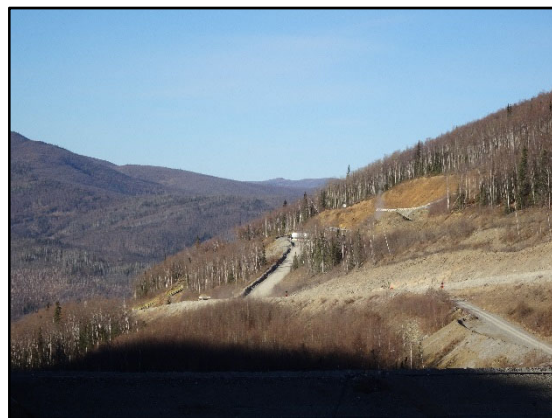
Photo 18: 2150 Portal Bench as viewed from RTP.

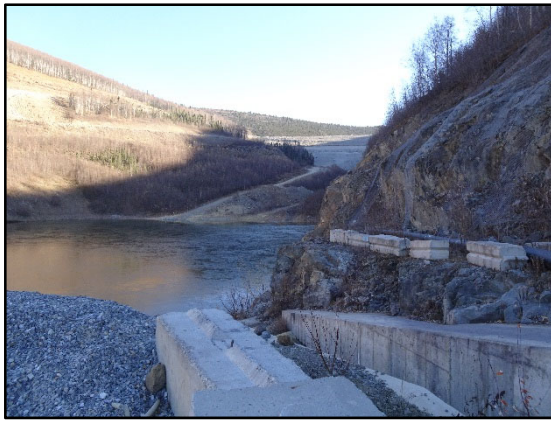
Photo 19: RTP Pond spillway

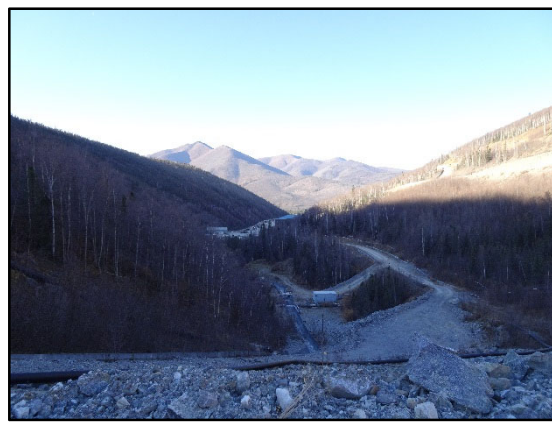
Photo 20: Repaired culvert with Mill Bench in the background.

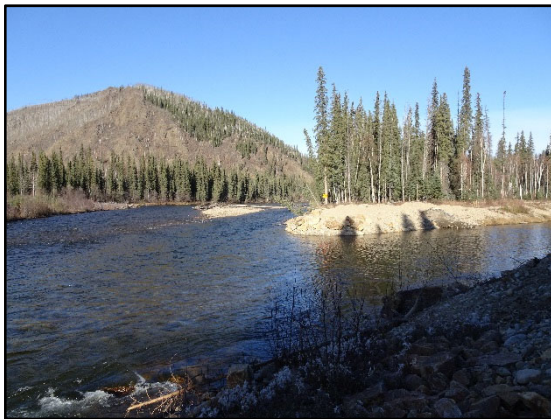
Photo 21: ORTW fresh water intake

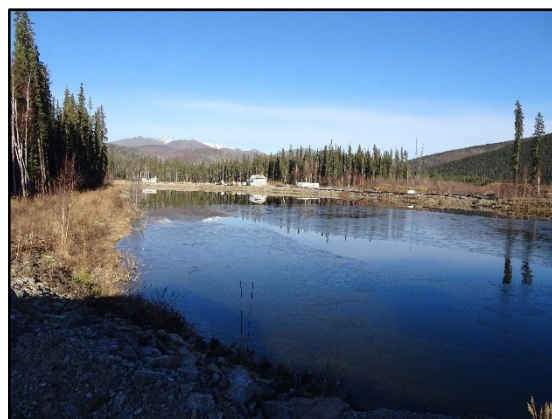
Photo 22: ORTW Mixing Pond.

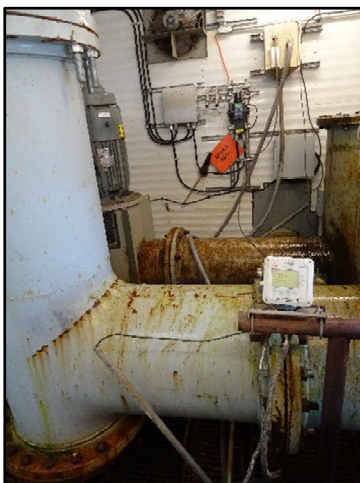
We then headed to the Off-River Treatment Works (ORTW). The process begins with the ORTW fresh water inlet from the Goodpastor River (Photo 21). Water is pumped into the mixing pond (Photo 22) through the pump station (Photos 23-25). The intake water temperature at Outfall 011 was 39 °F at a pH of 7.04 (Photo 23). The treated water is discharged into the mixing zone (Photo 26) before entering the Goodpastor River. We discussed the system efficiency and water management.

Photo 23: ORTW monitoring.

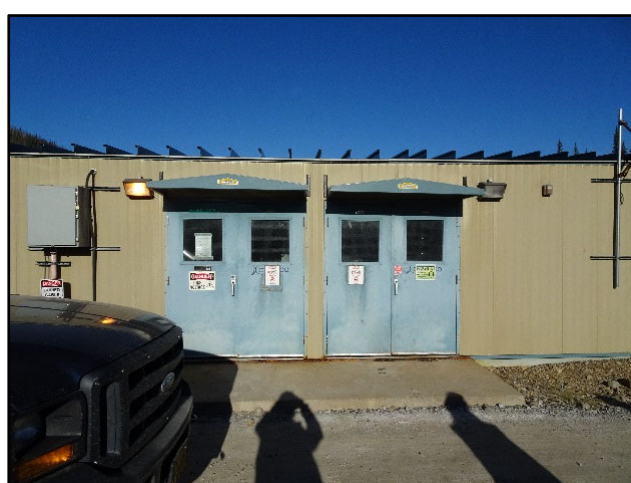
Photo 24: ORTW pumping facility building

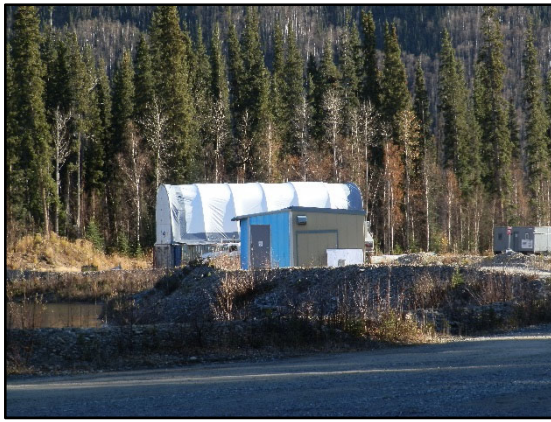
Photo 25: ORTW Facilities

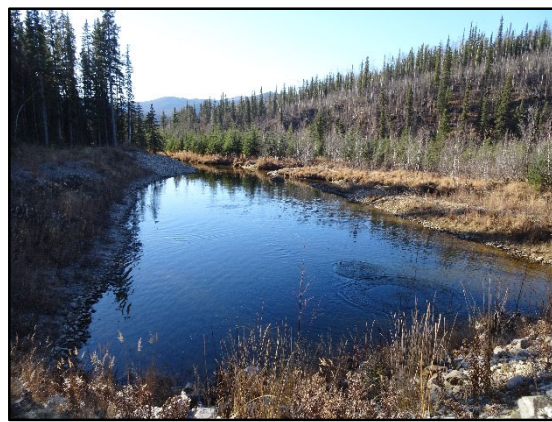
Photo 26: Discharge mixing zone
