## Department of Natural Resources

### Pogo Mine Inspection Report

**Inspection Date:** June 9, 2021

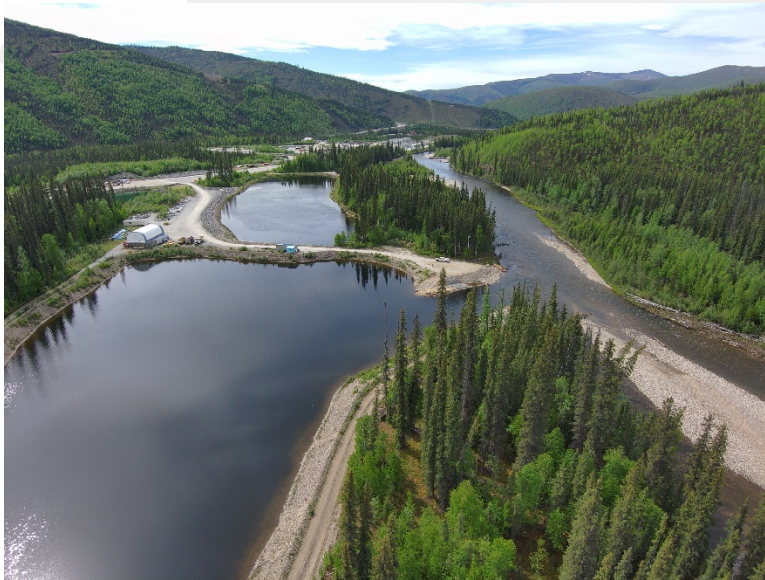
UAS imagery from the inlet to the ORWT from the Goodpasture River

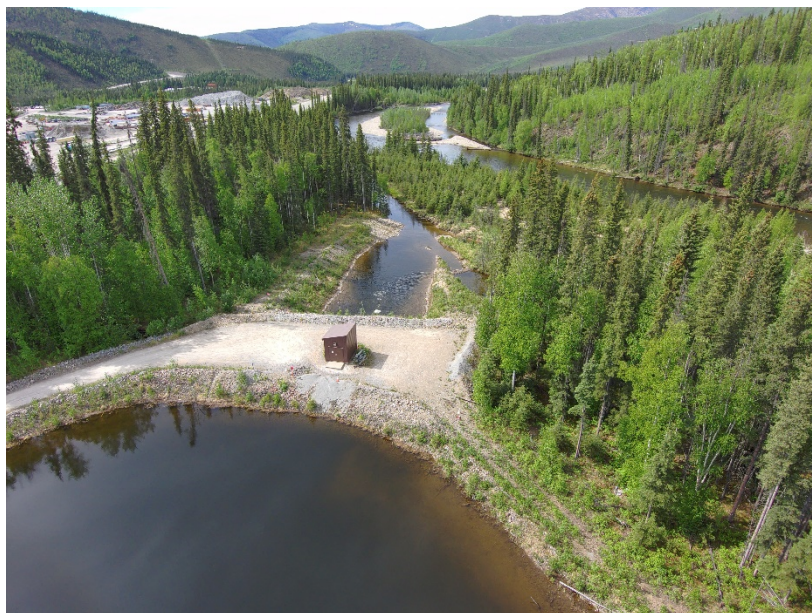
UAS imagery of the pump house and discharge from ORWT to Goodpaster River

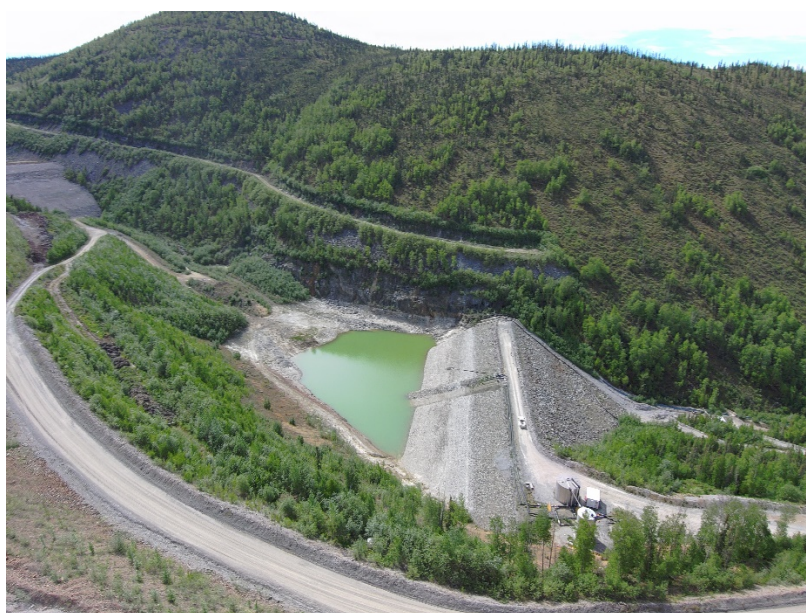
UAS imagery of the RTP Dam and diversion ditch below dry stack tailings

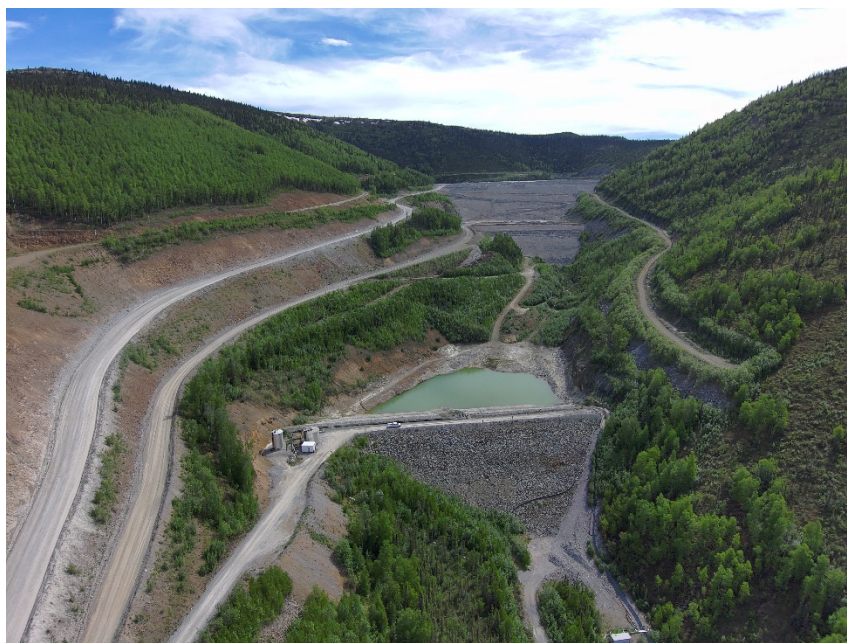
UAS imagery looking at the RTP Dam and dry stack tailings facility.

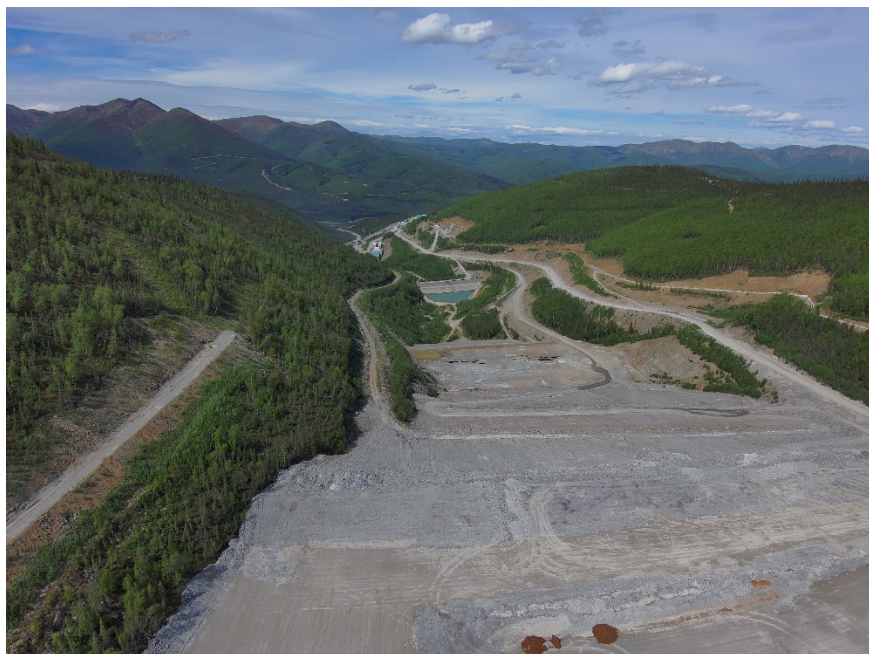
Top of the dry stack tailings facility looking down drainage to mill site.

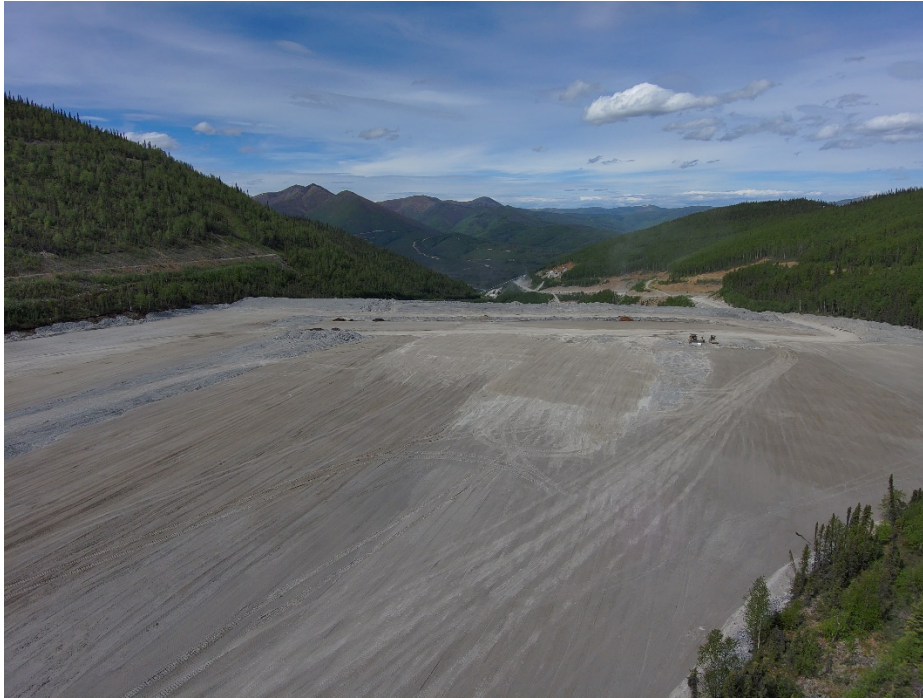
Top of dry stack tailings facility.
