Pogo Mine Inspection Report

Inspection Date: August 26, 2025
Time: 9:00AM to 4:30PM
Weather: Mostly sunny with a few high clouds
Agency Personnel: DNR: Jesse Garnett White and Carolyn Curley (LMPT), Jonathan Kummer (Water), Ben Wagner (Dam Safety), and Charlene Bringhurst (APMA).
Operator Contacts: Pogo: Russel Gossett and James Meyers
Inspection Objectives: Site Inspection

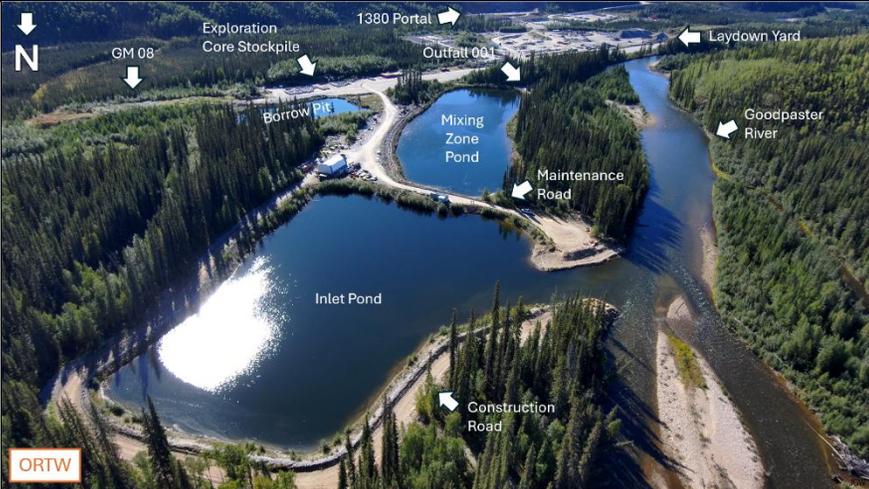
- 2.1. ORTW: At the northern end of the mine is the ORTW consisting of two ponds (Maps 1 and 2, Photos 1, 2, 3, and 8). The inlet pond has connectivity with the Goodpaster River, which pumps fresh water into the mixing pond via a pump station. The ORTW pump station has a mixing chamber where effluent water from the treatment plant mixes with fresh water before discharging into the mixing pond. The mixing pond serves as a final zone where larger suspended particles from treated waters may precipitate out before reaching the outfall. Water from the outfall discharges back into the Goodpaster River. At the time of inspection, the ORTW was operating normally.
- 2.2. Outfall 001: The outfall (Maps 1 and 2, Photos 1 through 3) was operating normally at the time of inspection.
- 2.3. Outfall 002: The outfall (Map 1, Photo 22) was operating normally at the time of inspection.

Photo 1: ORTW: Includes southerly views of the Inlet Pond, Mixing Zone Pond, and Outfall 001. Also, in view is Growth Media 08 (GM 08), exploration core stockpile, laydown yard, and partial views of the 1380 Portal, airstrip, and Goodpaster River.

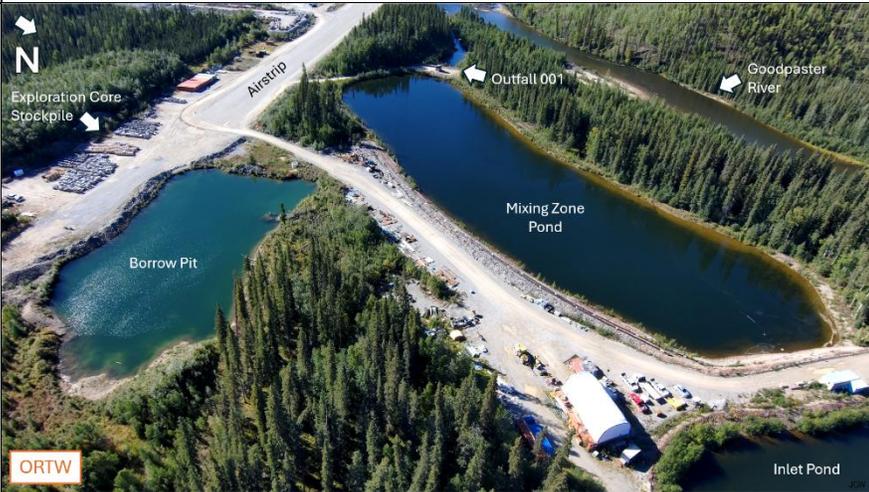
Photo 2: ORTW: View of the Mixing Zone Pond, Outfall 001, water filled borrow pit, and southern end of the Inlet Pond. Also, in view is the exploration core stockpiles, northern end of the airstrip, and a section of the Goodpaster River.

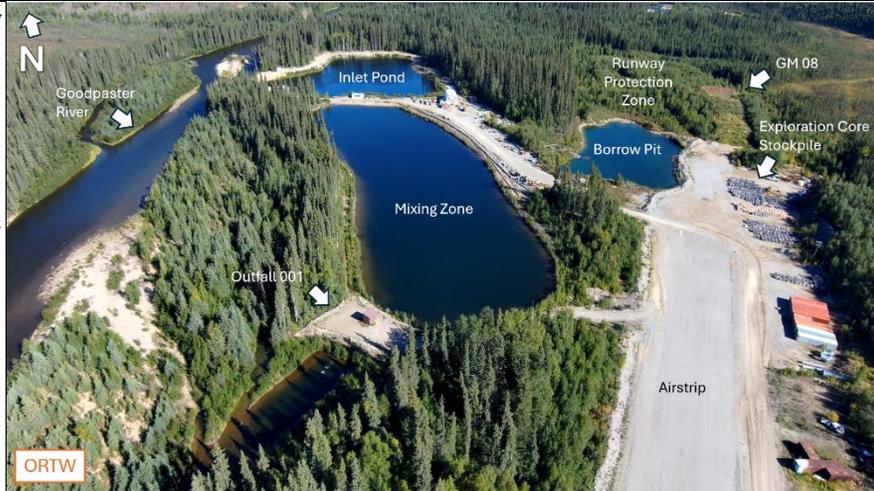
Photo 3: A northerly view of the ORTW including Outfall 001, Mixing Zone Pond, and Inlet Pond.

Also, in view is the exploration core stockpile, northern end of the airstrip, runway protection zone, GM 08, and a section of the Goodpaster River.

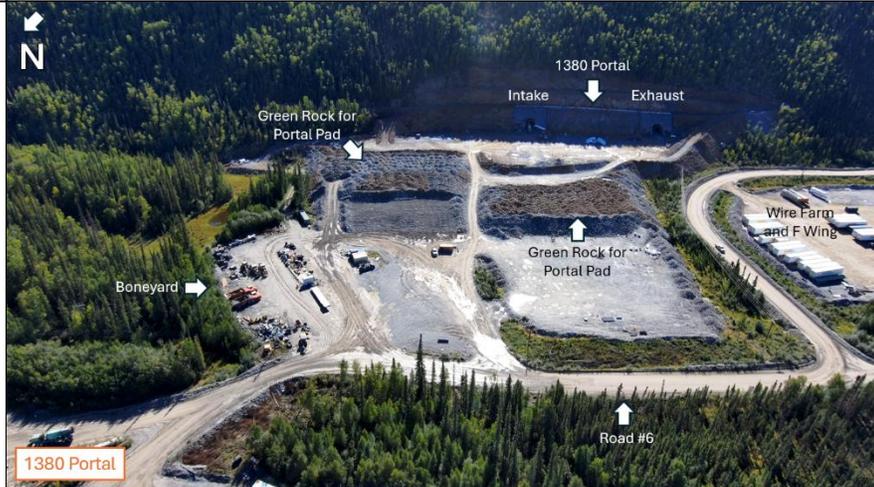
- 1.1. 1380 Portal: The portal development progresses with increasing amounts of waste rock (WRD) being placed on the pad outside of the portal (Maps 1 and 3, Photos 4,5, and 6).

Photo 4: View of the 1380 Portal and associated “green rock” dumps for the portal pad with partial views of the boneyard, road #6, and a partial view of the wire farm and F Wing (see photo 7).

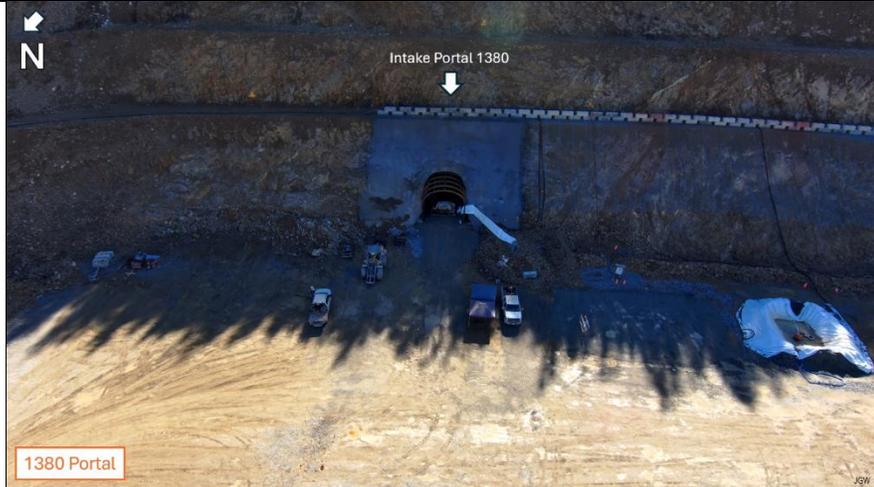
Photo 5: View of Intake Portal 1380.

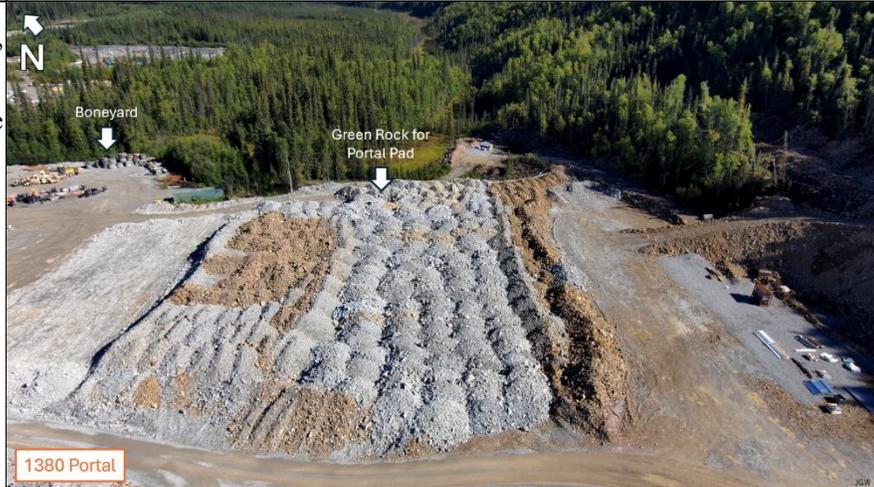
Photo 6: A different view of one of the “green rock” dumps for the portal pad in front of the 1380 intake portal.

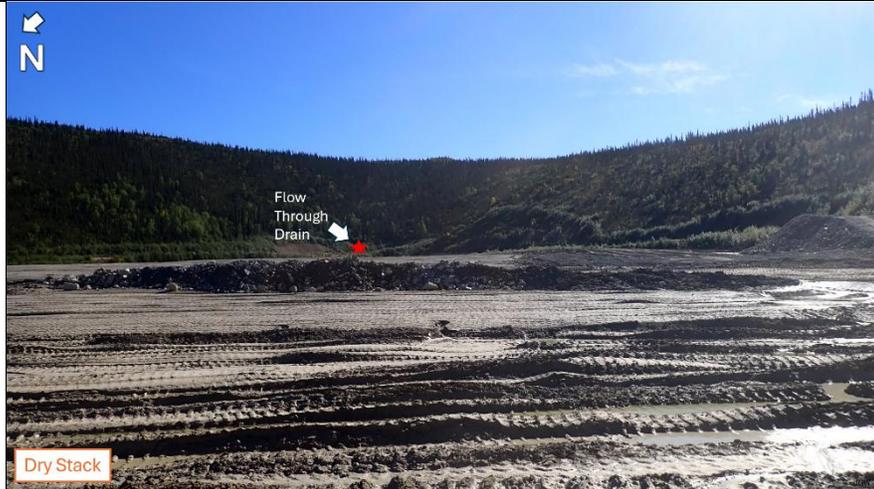
- 1.2. DSTF: The DSTF (Maps 1 and 4, Photos 9 through 16) contains approximately 40% of all mineralized waste rock and dewatered flotation tailings; the remainder is placed underground as a paste backfill. There are two flow-through drains at the DSTF with perimeter diversion ditches preventing runoff water from entering the facility. Tailings and mineralized development rock are co-disposed year-round in the general placement area. The mineralized rock is encapsulated in the tailings to minimize oxidation of sulfide minerals. At the time of inspection there was no major activity occurring on the DSTF. It was in good condition and well maintained.

Photo 9: View of the DSTF from the ground. Note the location of the southeast flow drain (red star).

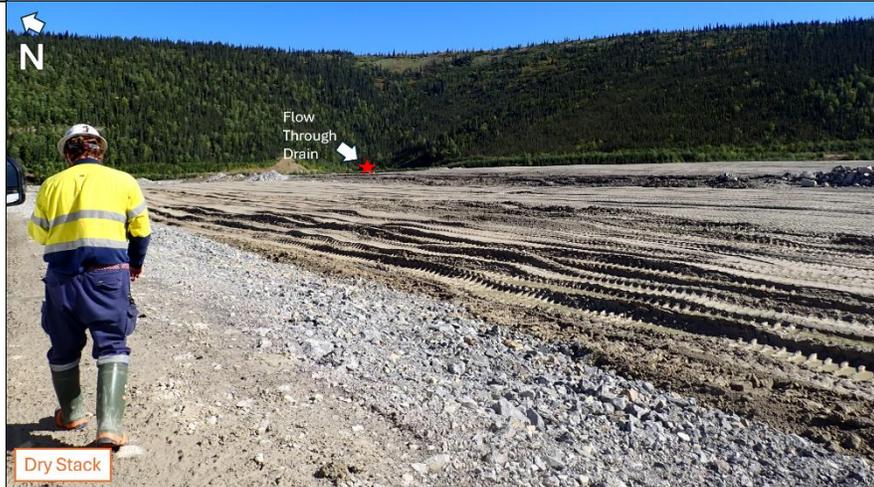
Photo 10: Another view of the DSTF from the ground. Note the location of the east flow through drain (red star).

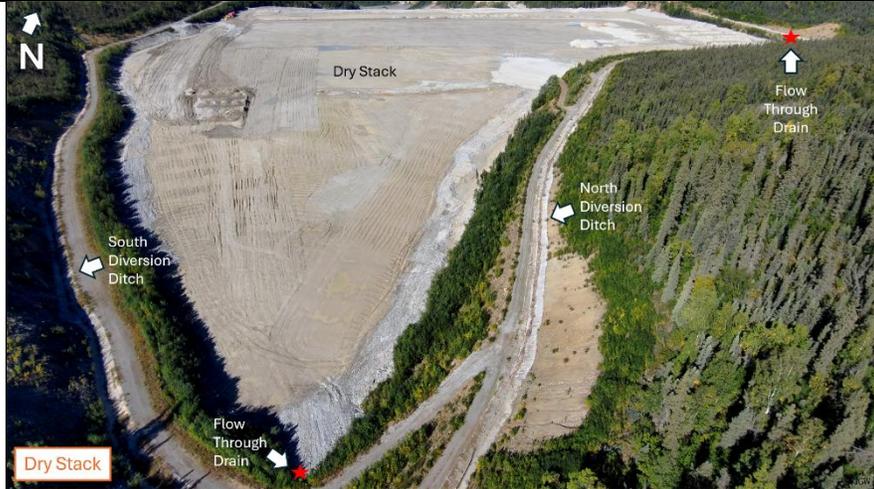
Photo 11: View of the DSTF, associated roads, flow through drains, and diversion ditches.

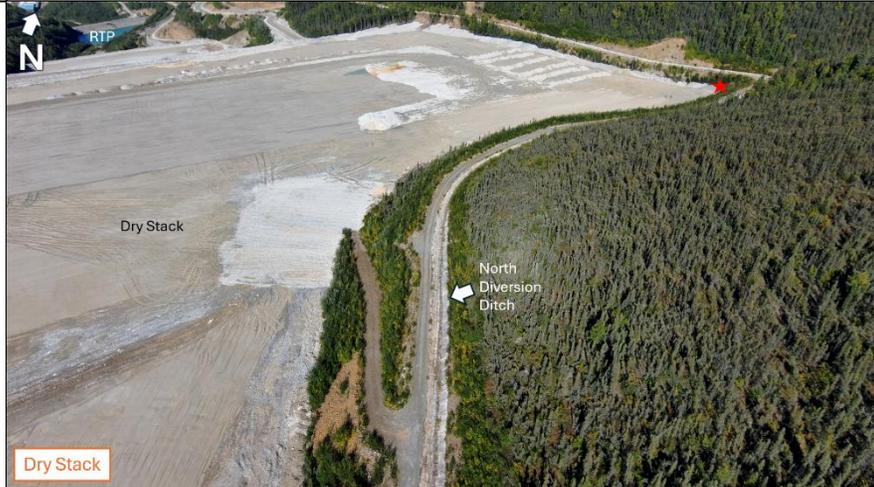
Photo 12: Another view of the DSTF, associated roads, east flow through drain, and partial view of the north diversion ditch. Note the RTP location below the DSTF.

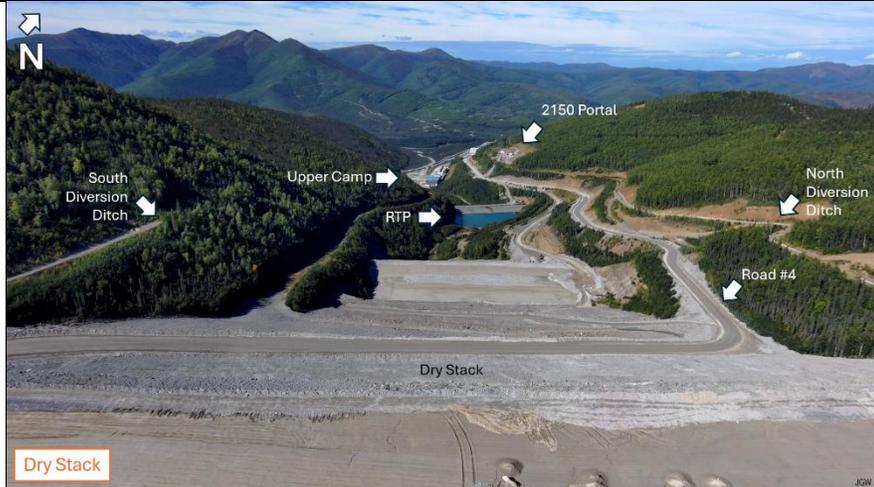
- 1.3. RTP and RTP Dam: The RTP and RTP Dam (Maps 1 and 5, Photos 13, 16, and 17) are located just downstream from the DSTF to collect any potential seepage. At the time of inspection, the water storage was below normal level. The spillway was well above the water level and free of any major or obvious debris.

Photo 13: Down valley view of the DSTF face. Note the locations of RTP, RTP Dam, diversion ditches, Road #4, 2150 Portal, and Upper Camp.

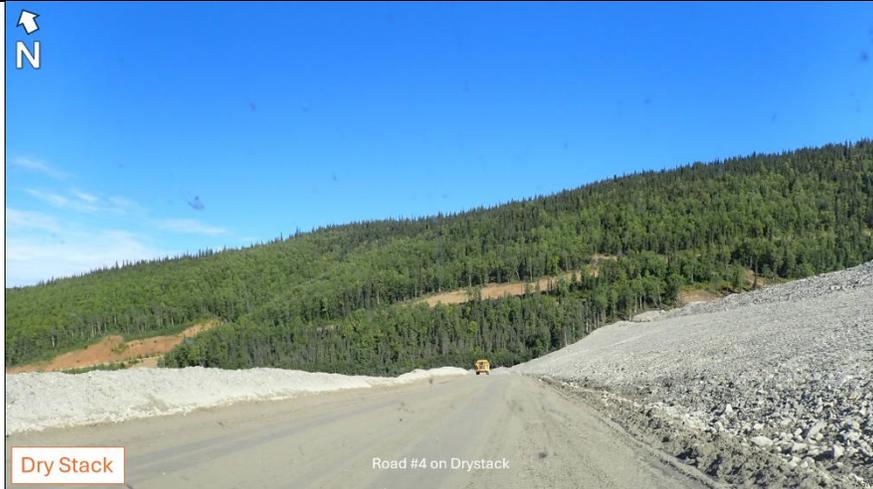
Photo 15: View of Road #4 on the face of the Dry Stack.

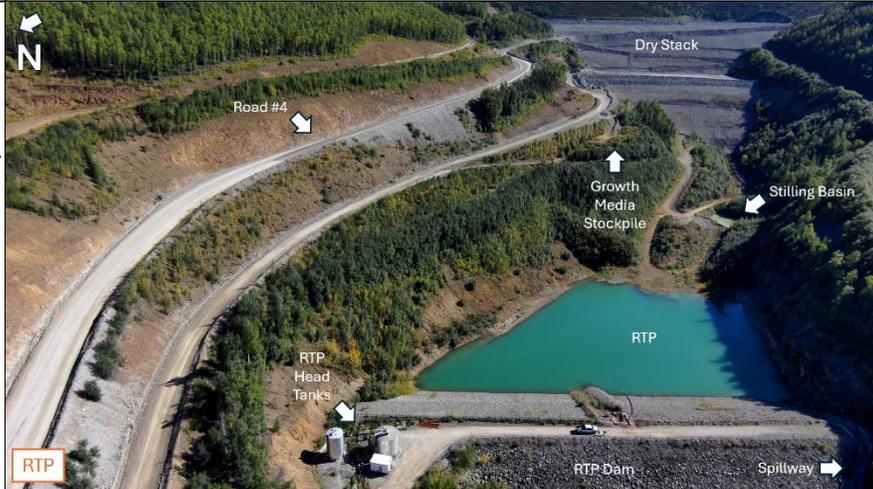
Photo 16: Up valley view of the face of the DSTW, RTP and RTP dam. Note the location of the growth media stockpiles (GM 12-15), Road #4, stilling basin, and RTP head tanks.

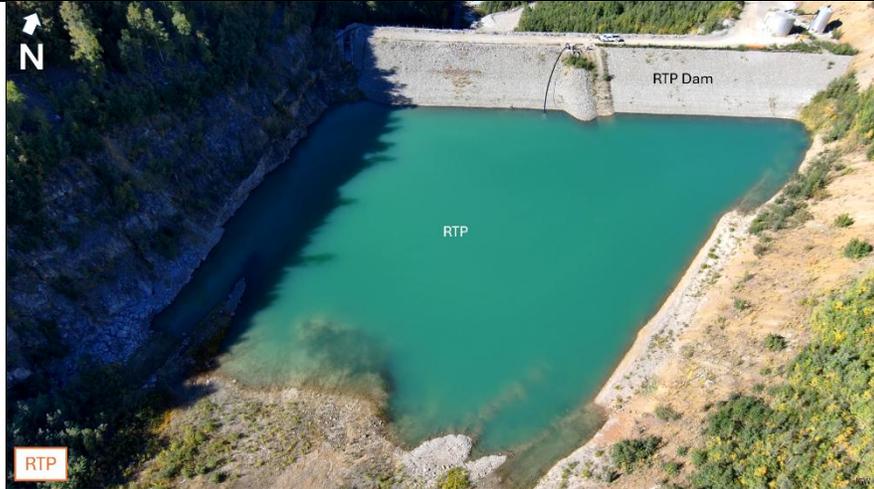
Photo 17: View of the RTP and RTP Dam.
