## Pogo Mine Field Inspection Report

**Inspection Date:** June 18, 2026  
**Time:** 9:00AM to 4:30PM  
**Weather:** Sunny blue skies with increasing cumulous buildup, virga, and sporadic light rain. High clouds by the end of the day with a high temperature of 69°F.  
**Agency Personnel:** DNR-LMPT: Jesse Garnett White, Carolyn Curley, and Skyler Smith  
**Operator Contact:** Pogo: Michael Eckert, Russel Gossett, and James Meyers.  
**Inspection Objectives:** Site Inspection for adherence to Plan of Operations Approval F20249500POOA.1 and associated amendments and Reclamation Plan Approval F20249500A.1.

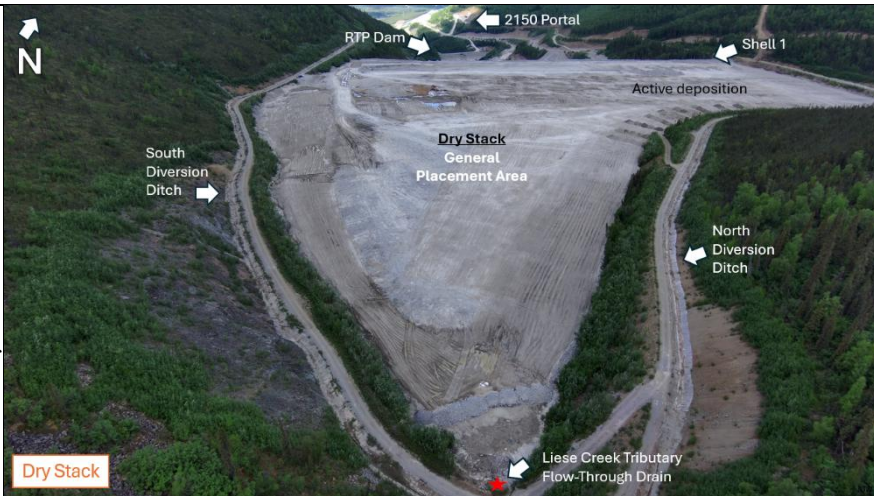
Photo 1:

North-northwest view of the upper reaches of the Dry Stack General Placement Area including deposition of new material and locations of diversion ditches and entrance to the southeast flow-through drain.

Note the locations of Shell #1 and RTP Dam.

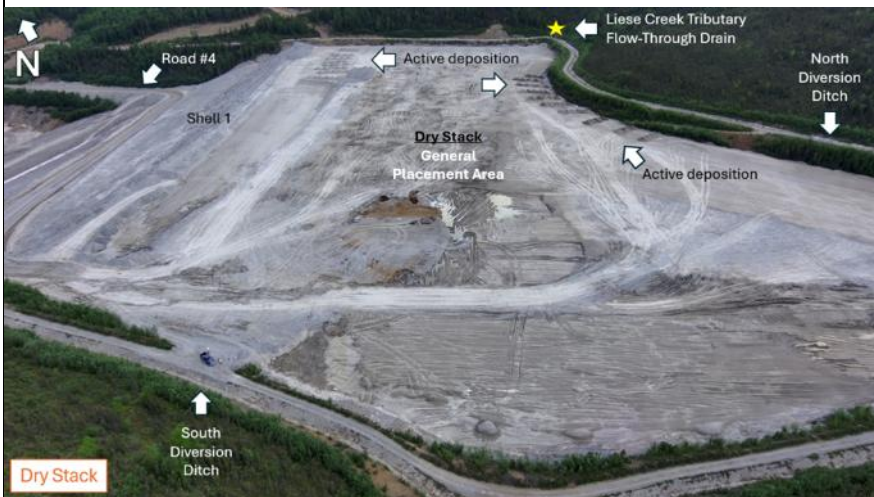
Photo 2:

Easterly view of the upper Dry Stack General Placement Area including deposition of new material and locations of diversion ditches and northeast flow-through drain.

Note the locations of Shell #1.

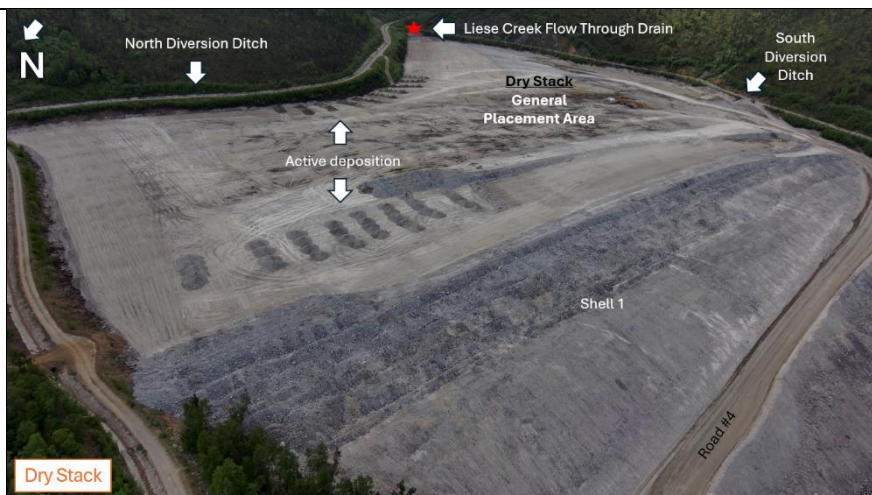
Photo 3:

Southern view of the upper Dry Stack including deposition of new material and location of diversion ditches, southeast flow-through drain.

Note the location of Shell #1.

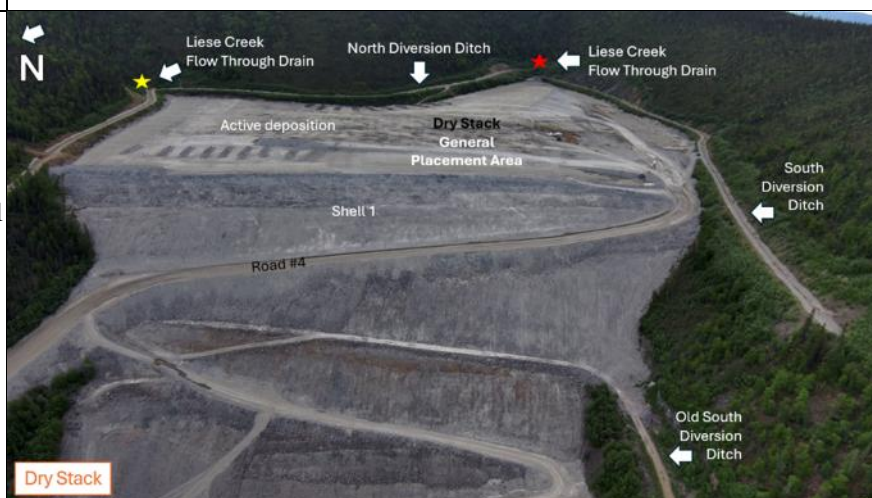
Photo 4:

Southeast view of the upper Dry Stack and Shell #1 including deposition of new material and location of diversion ditches and flow-through drains.

Note the location of the Old South Diversion Ditch.

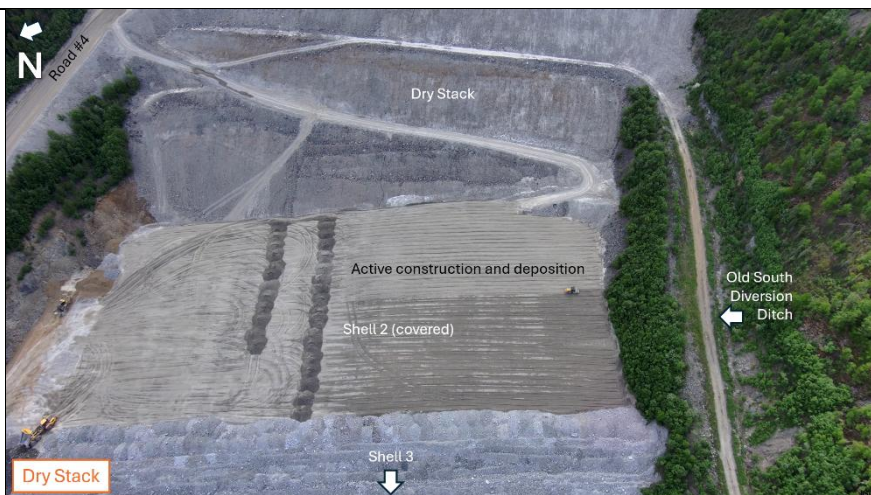
Photo 5:

Southeast view of the middle Dry Stack Shell #1 and active construction and deposition.

Note: Shell #2 (buried/covered) and #3 are being raised together monolithically.

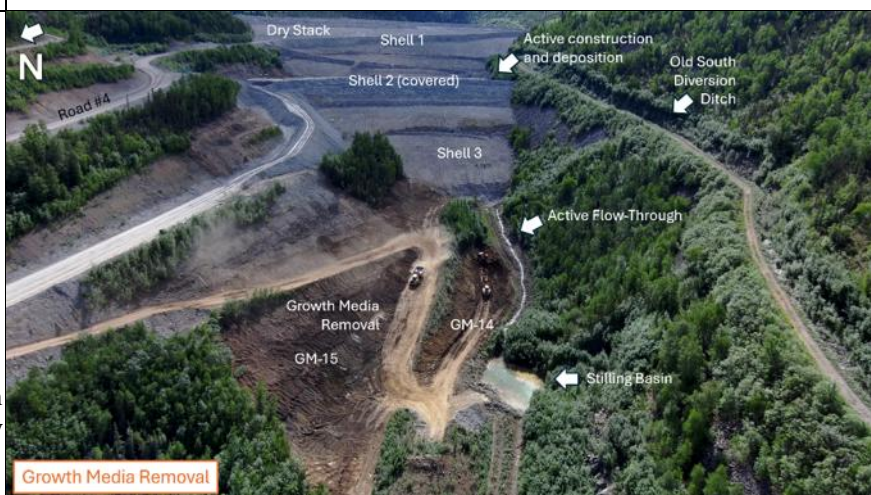
Photo 6:

Southeast view of the lower Dry Stack (Dry Toe).

Active construction and deposition associated with Shells #2 and #3.

Observed removal of growth media is associated with Dry Stack expansion.

Note the location of the Stilling Basin.

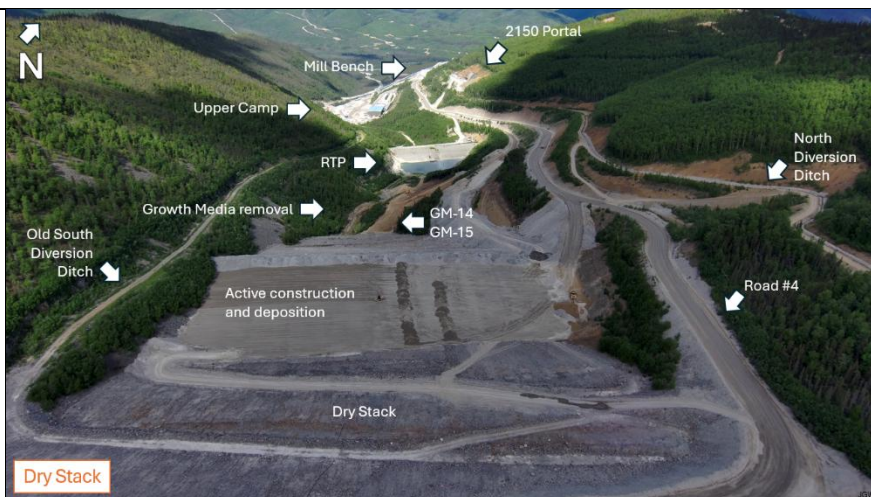
Photo 7:

North northwest view of the middle to lower Dry Stack including diversion ditches, active construction and deposition, and removal of growth media.

Note the location of RTP.

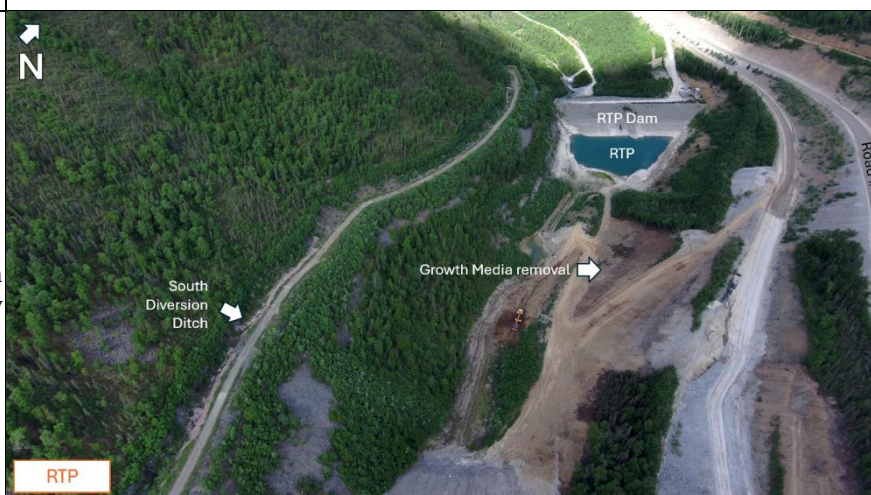
Photo 8:

North-northwest view of the RTP and RTP Dam down valley from the Dry Stack.

Observed removal of growth media is associated with Dry Stack expansion.

Note the locations of the South Diversion Ditch and active growth media removal.

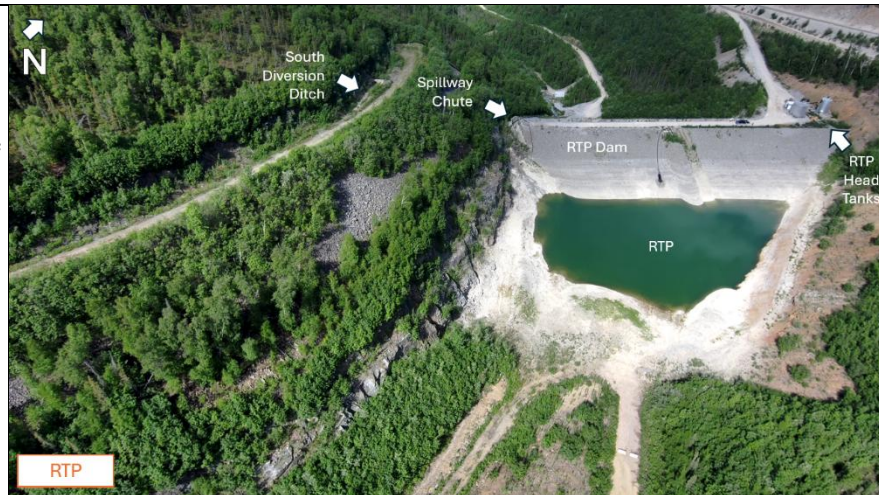
Photo 9:

North-northwest view of the RTP and RTP Dam down valley from the Dry Stack.

Note the location of the South Diversion Ditch and Spillway Chute.

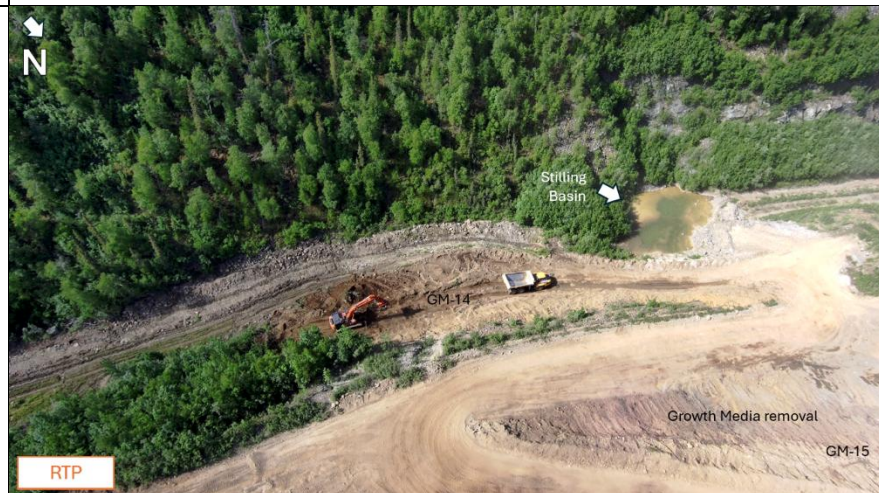
Photo 10:

Observed removal of Growth Media from GM 14 and 15 between the Dry Stack and RTP.

Note the location of the Stilling Basin

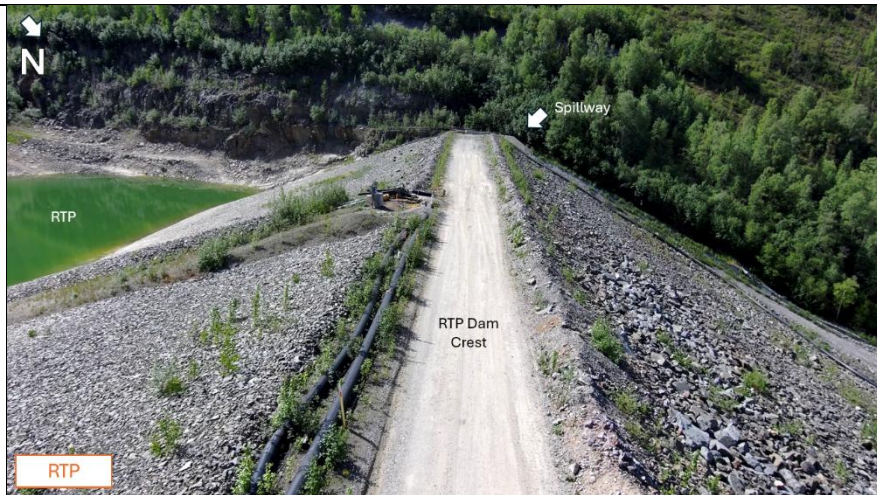
Photo 11:

- 1.2. RTP and RTP Dam: The RTP and RTP Dam (Maps 1 and 2, Photos 7 through 11) are located just downstream from the DSTF to collect potential seepage and active flow-through (Photo 6). At the time of inspection, the water storage level was well beneath the dam crest and spillway. The spillway was free of any major or obvious debris. The area was in good condition and well maintained. There was construction activity occurring above RTP where growth media from GM 14 and 15 was being removed (See Section 1.4).

View of the RTP and RTP Dam crest.

Note the water depth versus height of dam crest and spillway.

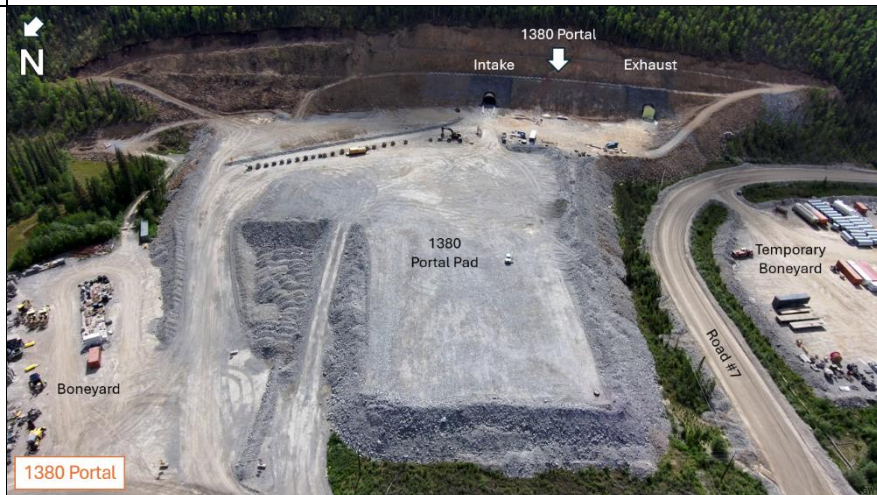
Photo 12:

Southeast view of the 1380 Portal including intake and exhaust portals and portal pad.

Note the location of the Boneyard and Temporary Boneyard.

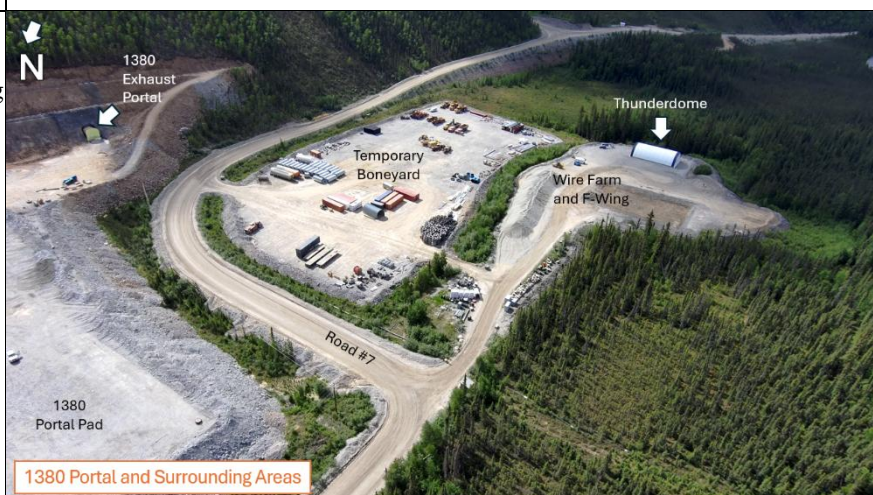
Photo 16:

New facility observed at the Wire Farm that Pogo employees are calling the *Thunderdome* (used for heavy and light duty vehicle and miscellaneous equipment maintenance).

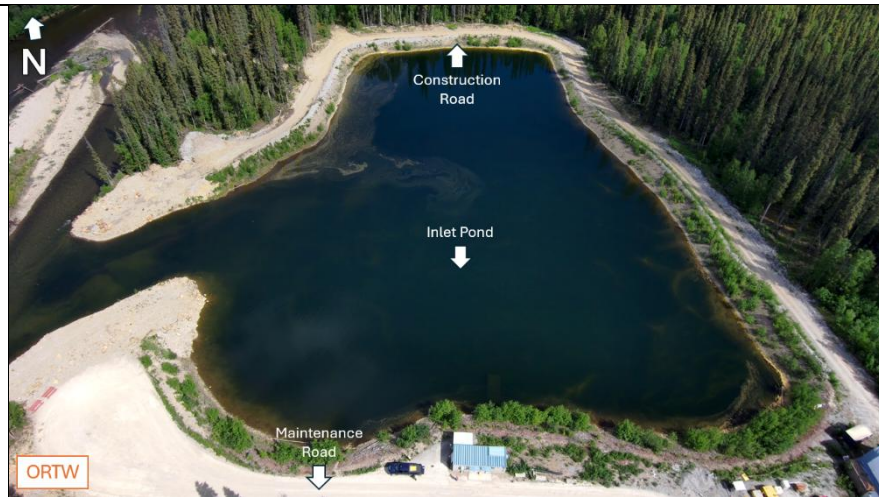
Photo 19:

View of the Inlet Pond.

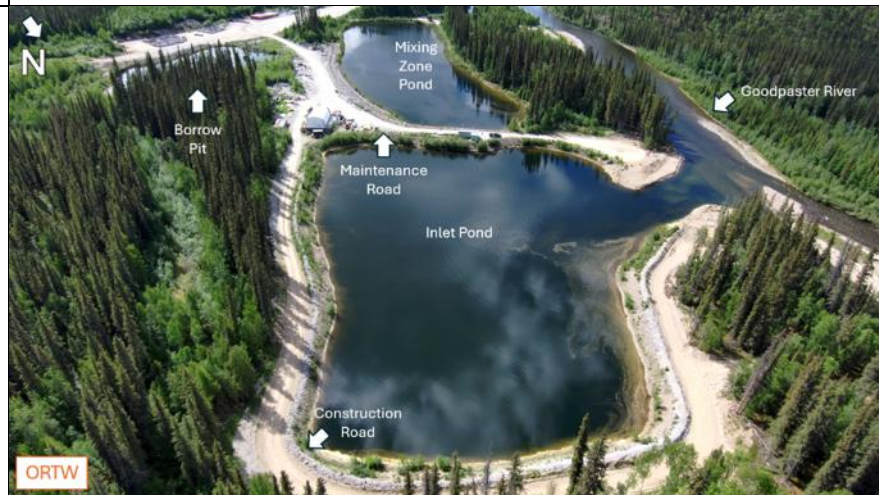
Photo 20:

View of the Inlet and Mixing Zone ponds.

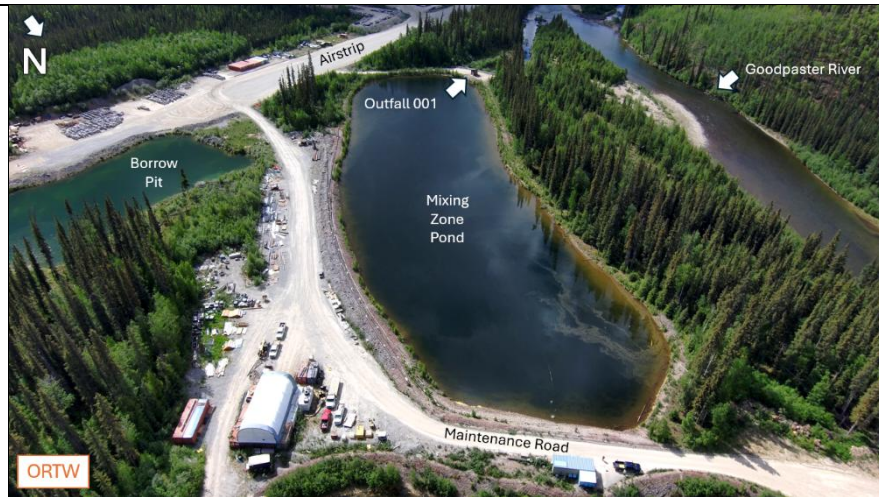
Photo 21:

View of the Mixing Zone  
Pond and Outfall 001.

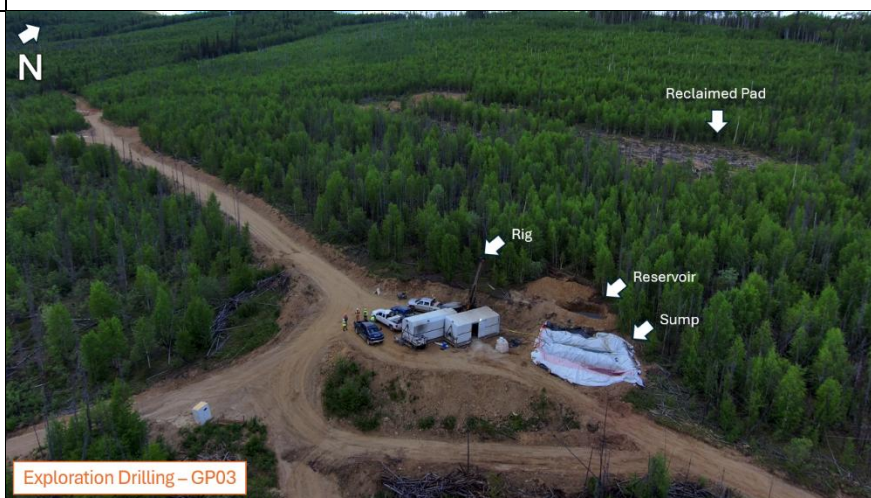
Photo 24:

Active Drilling at GP03.

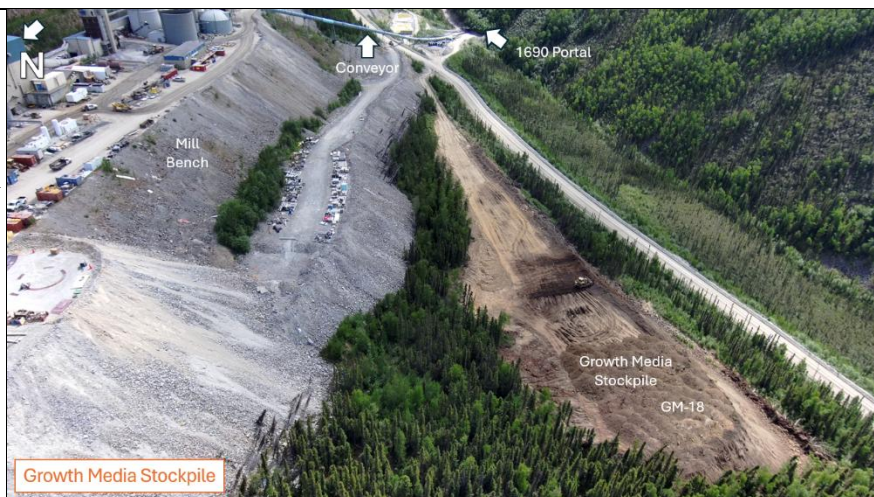
Photo 25:

The material being placed in this stockpile comes from GM 14 and 15 below the Dry Stack Toe.

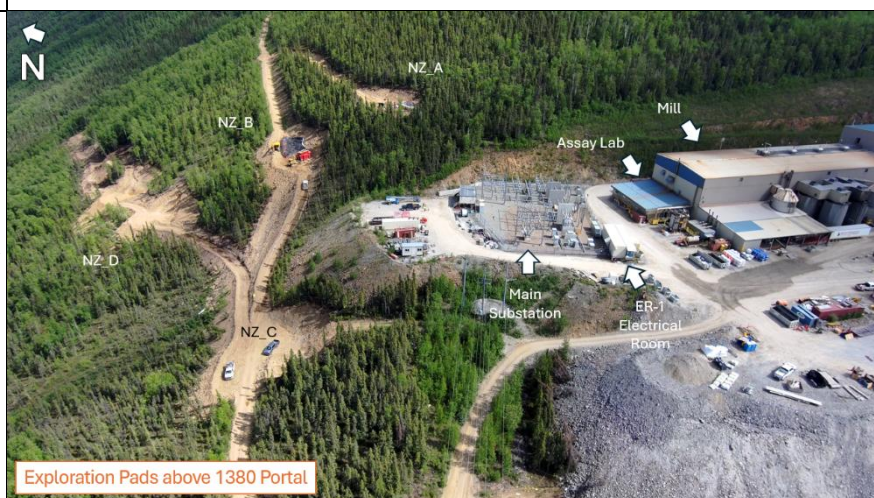
Photo 26:

NZ\_A, B, C, and D.

Note the location of the Mill Bench.
