## **Red Dog Mine and Aktigirug-Anarraaq Extension Project Field Inspection Report**

<b>Inspection Date:</b>	July 24, 2024
<b>Time:</b>	8:30 AM to 3:40 PM
<b>Weather:</b>	Sunny with clear skies and a slight breeze of 5 to 10 mph with a temperature fluctuating around 68°F.
<b>Agency Personnel:</b>	DNR: Aaron Kruse and William Groom SOA Department of Law: Dana Burke
<b>Teck Personnel:</b>	Frank Bendrick and Pam Garrity (H125 Pilot)
<b>Inspection Objectives:</b>	Site Inspection

## **Inspection Maps and Observations of Note**

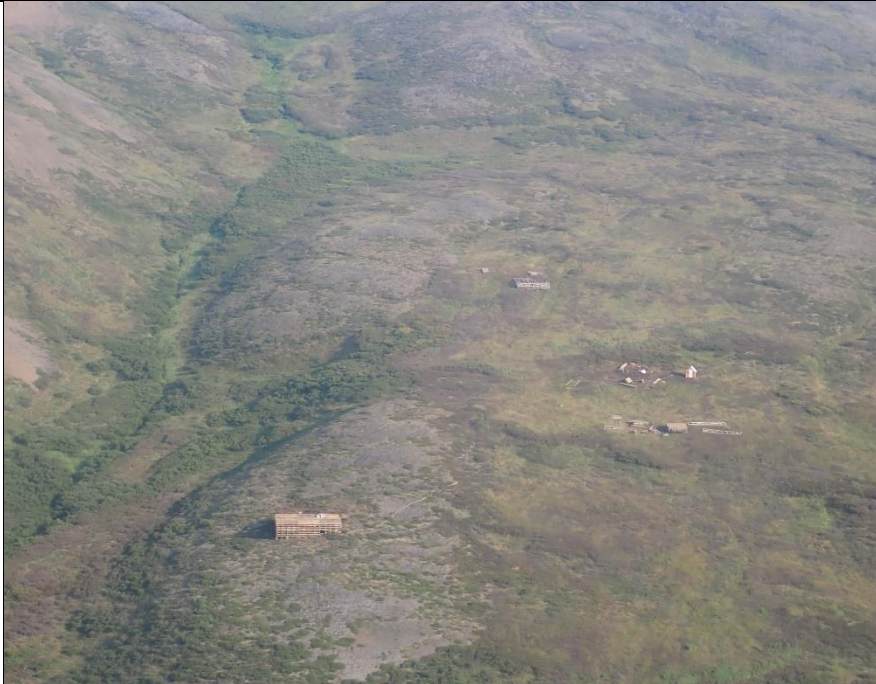
- 1.1. Along the flight path for the proposed road of the AAEP we observed cribbing from older geotechnical drill pads within the proposed access route (Photo 1). There was no notable disturbance from the geotechnical drilling locations nor was there any indication of construction activities. Upon reaching state land, five active exploration core drilling sites were observed (Photo 2). Each location had the drill rig and essential support equipment elevated off the ground on decks to reduce impacts to the surface. A small laydown yard of equipment, cribbing, and pipe used in support of exploration activities resides just south of the drilling platforms (Photo 3).

Photo 1: Geotech drilling platforms left in place along the proposed access road for AAEP.

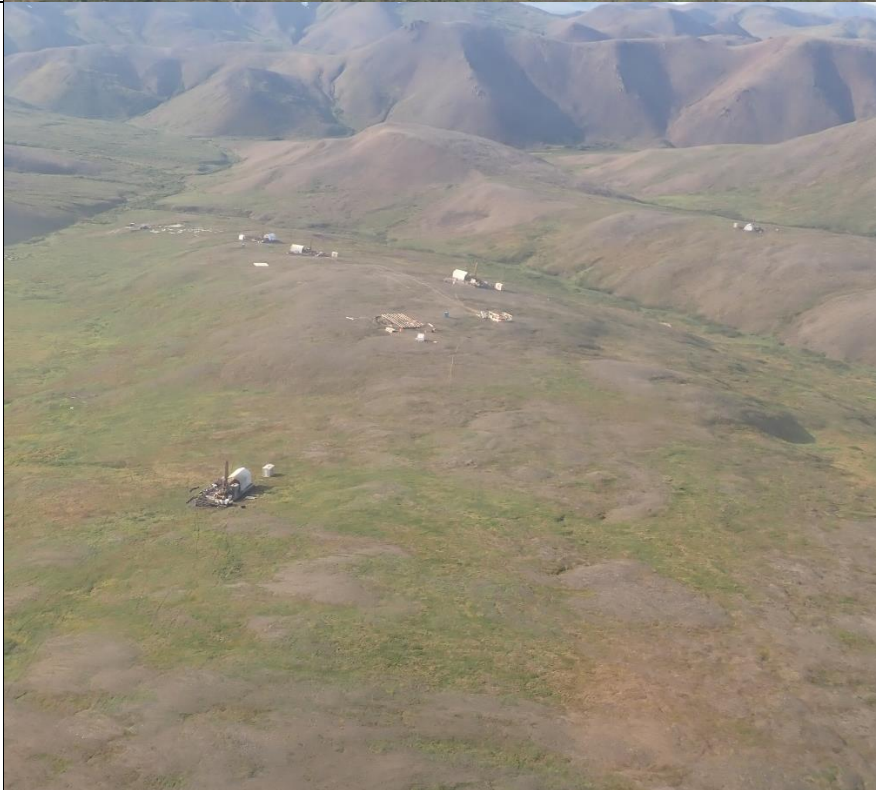
Photo 2: AAEP active drill sites located on the main deposit within state land.

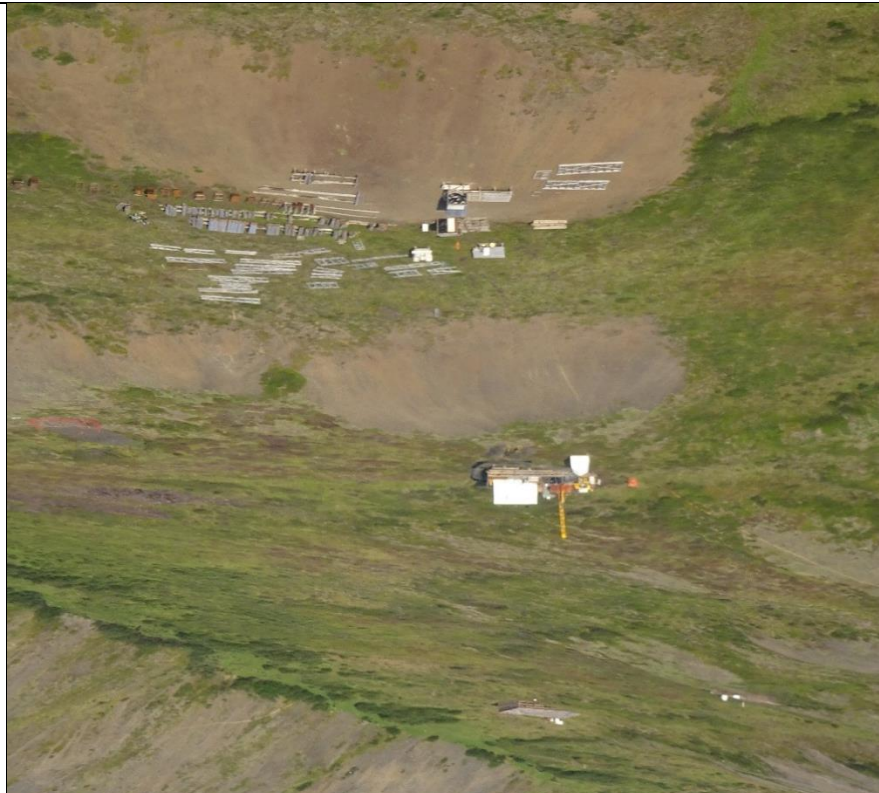
Photo 3: Small laydown yard to support AAEP exploration drilling.

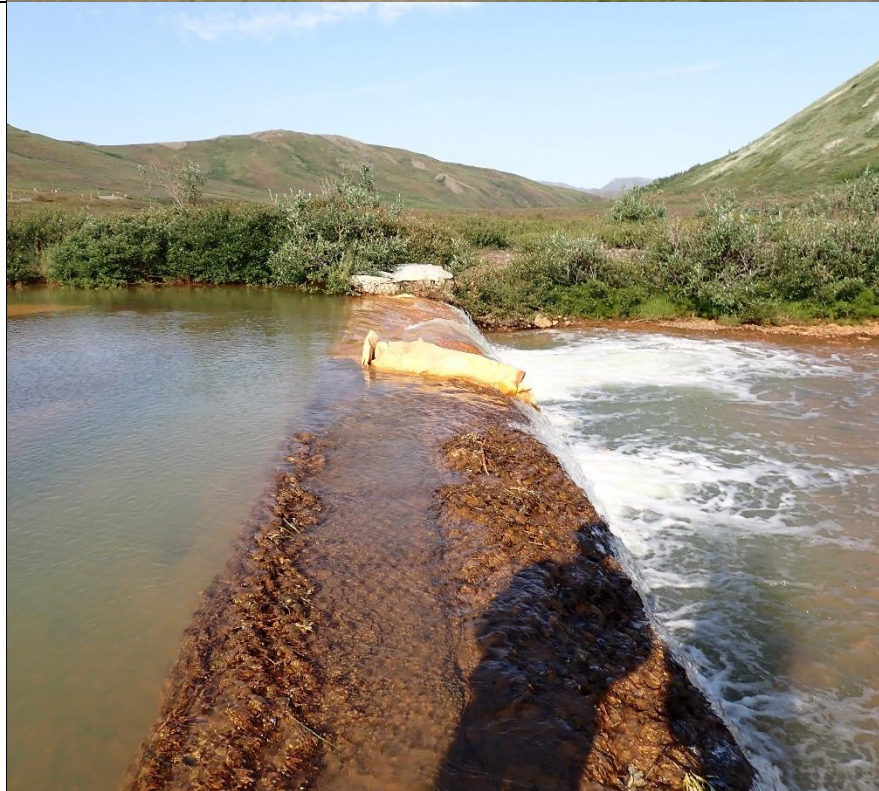
- 2.1. The weir installed downstream from the treated water discharge point on Red Dog Creek was inspected. Sheeted cover material over the wire bound rock weir has begun to degrade with some pieces dislodged from their original fitted positions (Photo 4). Water flow over the weir was consistent over two thirds of its length. No major degradation of its designed function is noted.

Photo 4: Fish weir located downstream from the mill discharge point on Red Dog Creek. Notice some of the sheeted material has dislodged. On previous inspections, the entire weir was covered.

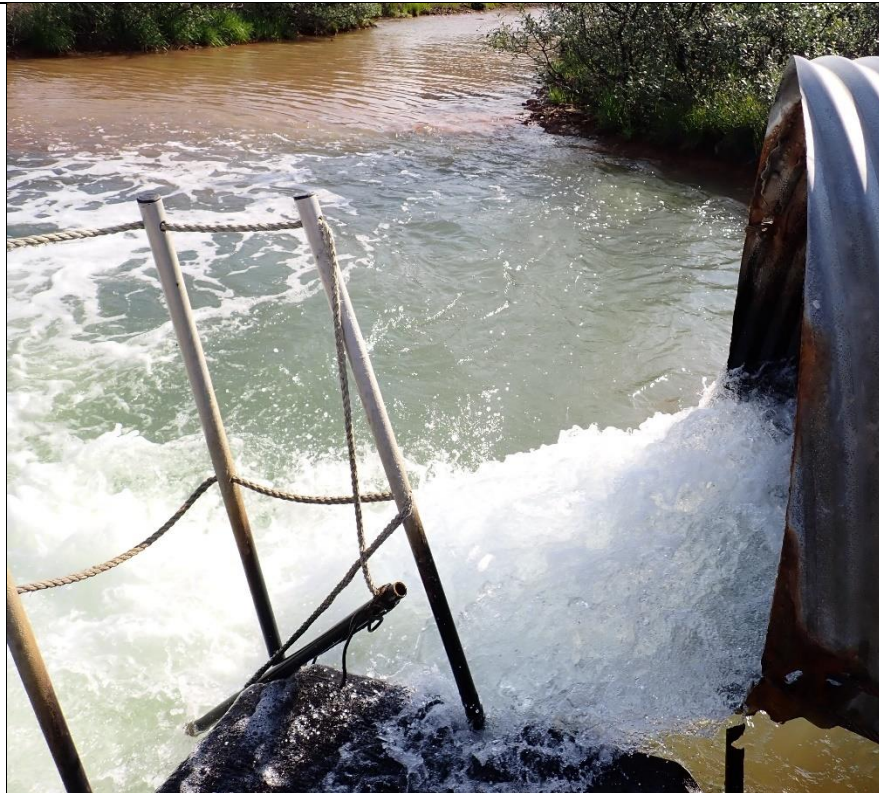
- 2.2. The treated water discharge point on Red Dog Creek had a steady flow of clear water. Water clarity can be seen in Photo 5 between the upstream flow of the creek and the discharge point. A distinct boundary between the natural mineralized background water and treated water is noticeable within this mixing zone.

Photo 5: Treated water discharge flowing into Red Dog Creek. Notice the change in water clarity between the mineralized background water flowing into this mixing zone.

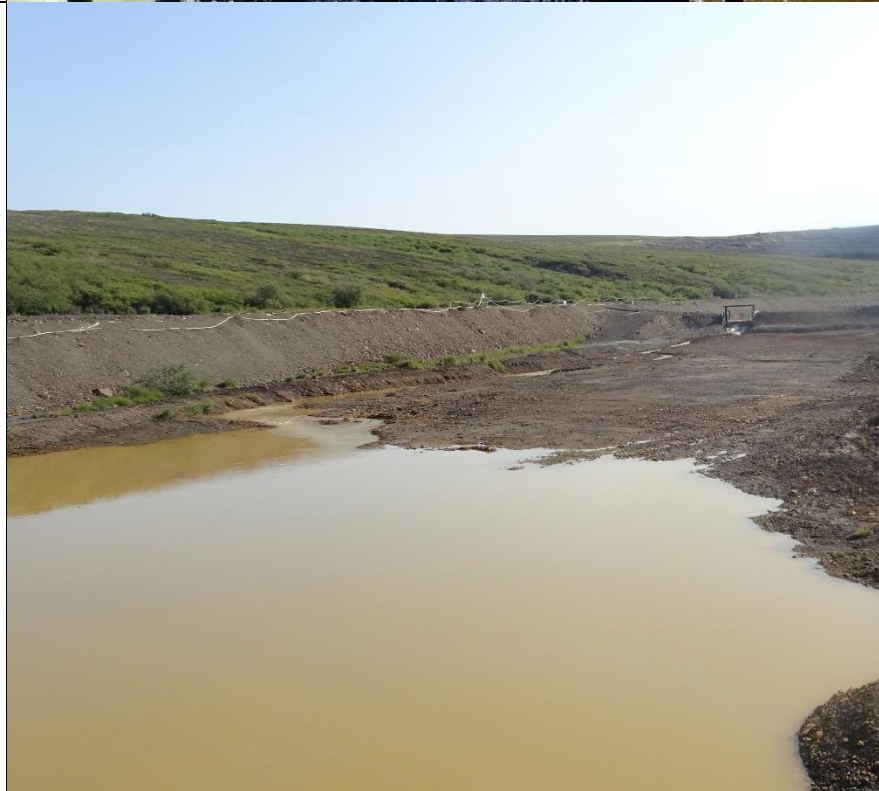
- 2.3. The mine sump (Photo 6) had water flowing into it generated by active pumping from both Aqqaluk Pit, and the Main Pit Lake. All ponded water within the sump's reservoir is pumped directly into the TSF. Water capacity within the sump's impoundment was slightly higher than observed in previous inspections due to a recent major rain event (Photo 7).

Photo 6: Main mine sump with water actively flowing in. This water is pumped from collection points within the mine to the TSF.

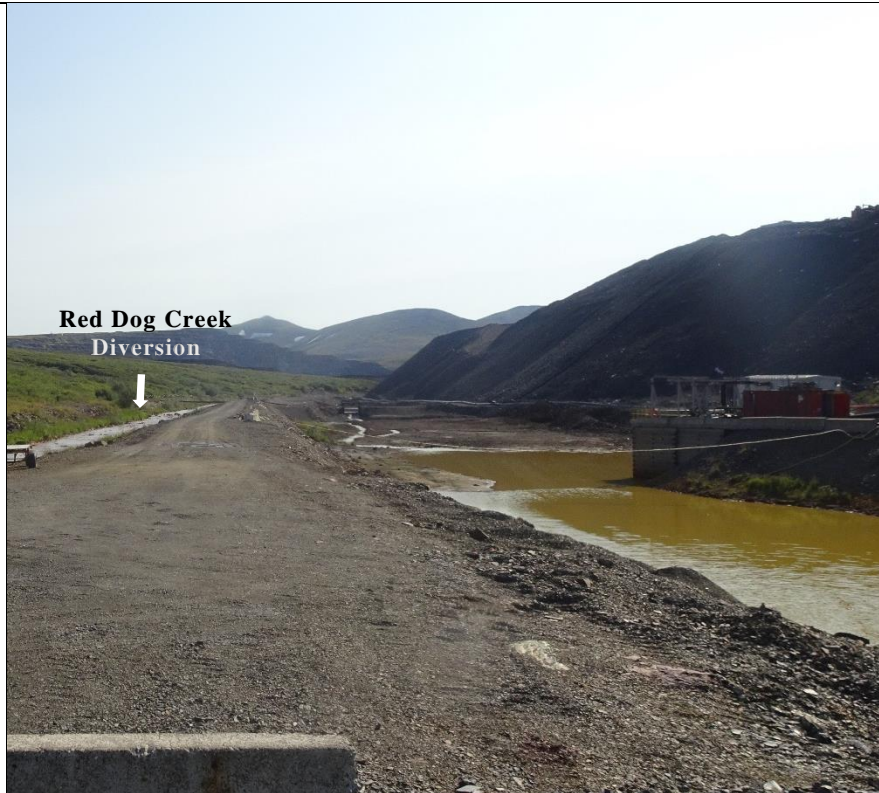
Photo 7: View of the mine sump impoundment. The water volume is above what has been observed during previous inspections. Red Dog Creek diversion runs adjacent to the mine sump returning to its original channel just downstream of the sump impoundment.

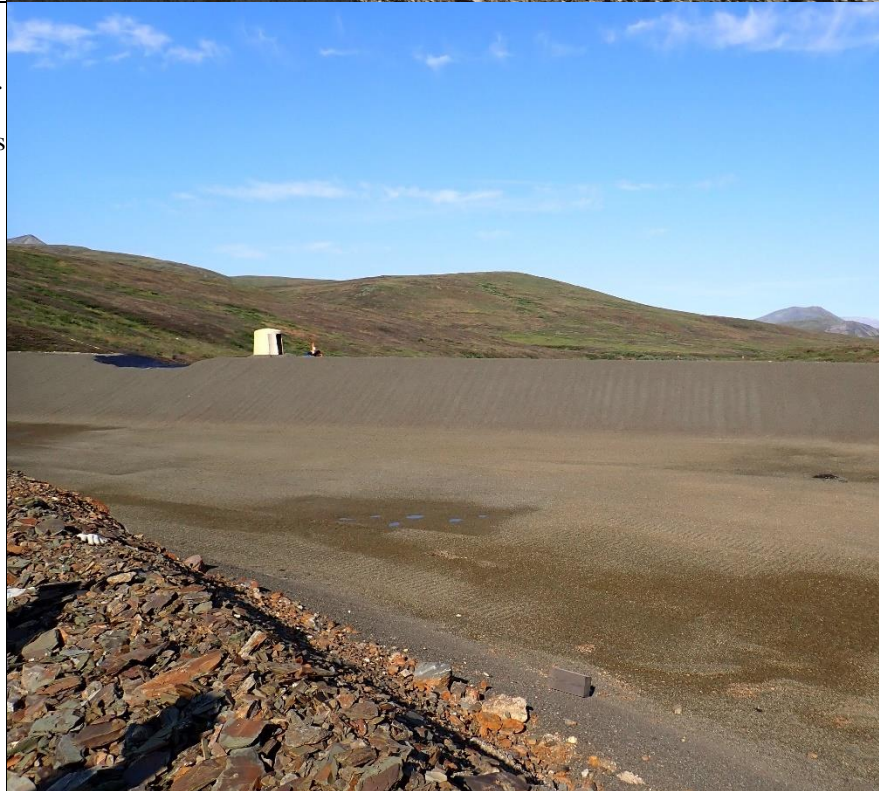
- 2.4. Seepage collection below the Main Dam was almost devoid of any standing water. There were a few centralized areas with puddling and a small area of standing water in the southwestern corner within the impoundment (Photos 8 and 9). On previous inspections, 2022 and 2023, water within the seepage collection has been minimal to none with standing water in the same locations.

Photo 8: View of the Main Dam Seepage Collection Impoundment looking north. Overall upkeep and maintenance of the facility is exceptional.

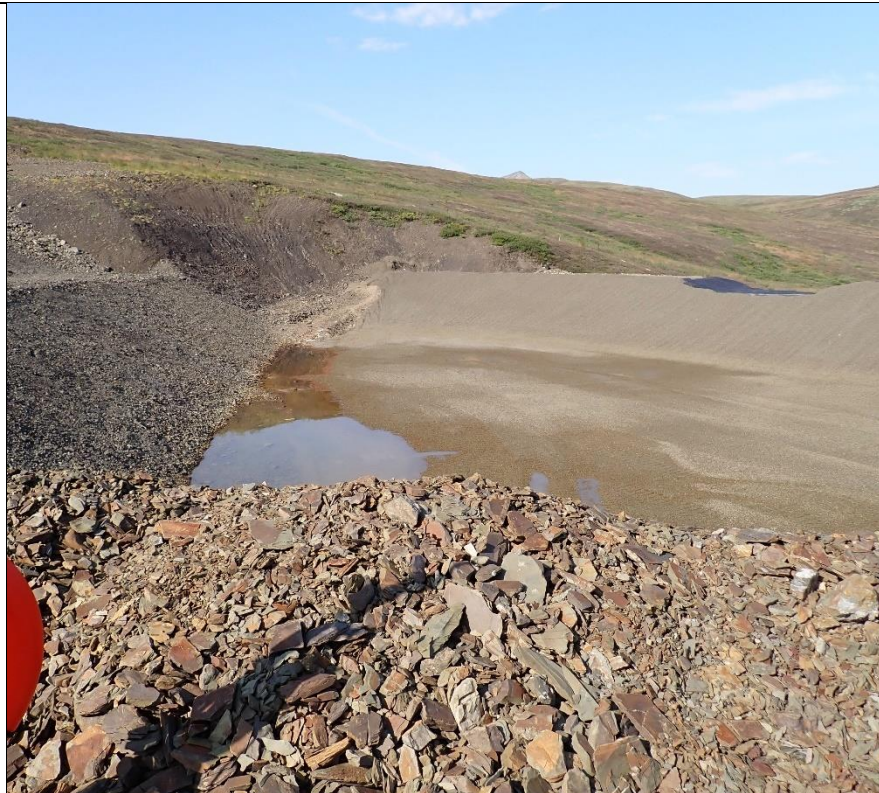
Photo 9: Standing water within the southwestern corner of the Main Dam Seepage Collection area. Standing water has been observed in this location during several inspections.

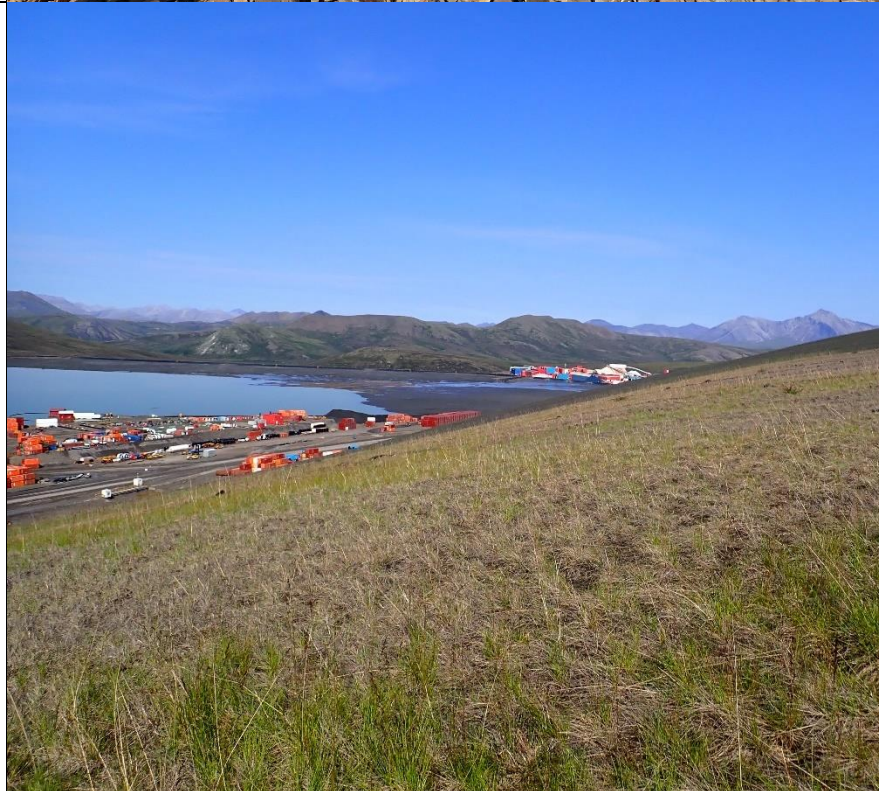
- 1.2. Upon arriving on top of the main WRD, DNR staff observed a reclamation test plot of approximately 17 acres that was seeded in 2017 (Photos 10 and 11). This area has good vegetative cover that has promoted slope stabilization and soil retention. As a comparison, the southern end of the main WRD was seeded last fall, which demonstrates the rate of vegetative growth (Photo 12). Currently, TAK is continuing the closure of the main WRD using a geosynthetic cover to encapsulate waste rock before topping with growth medium and grading. At the time of inspection, only a small portion of the overall area of the main WRD was left to complete for closure.

Photo 10: Main WRD reclamation test plot seeded in 2017 looking north. DNR staff observed good soil retention and distribution of vegetation. No obvious erosion noted on the vegetated area.

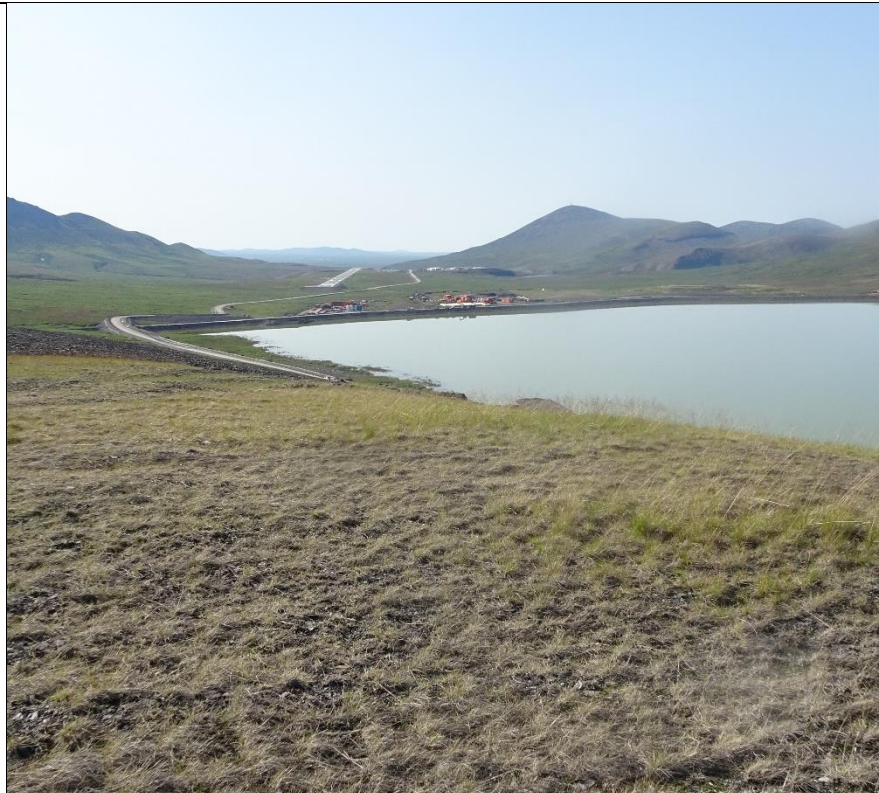
Photo 11: Southwestern view of WRD reclamation test plot.

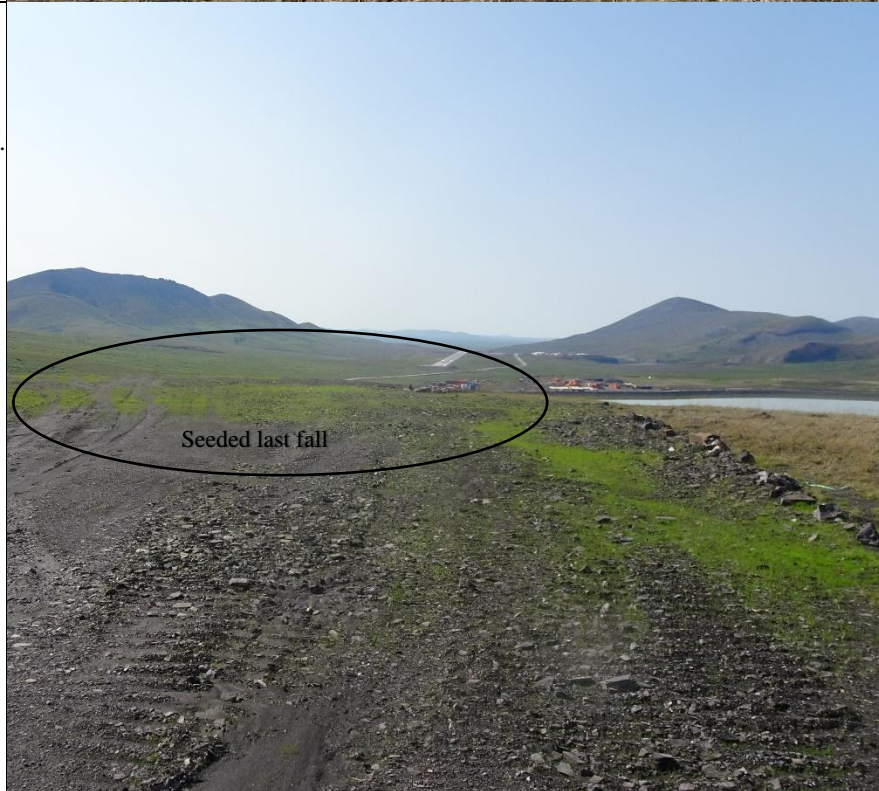
Photo 12: View looking south at the main WRD that was seeded in the fall of 2023. Just to the right is the plot that was seeded in 2017. Notice the rate of growth and dispersion.

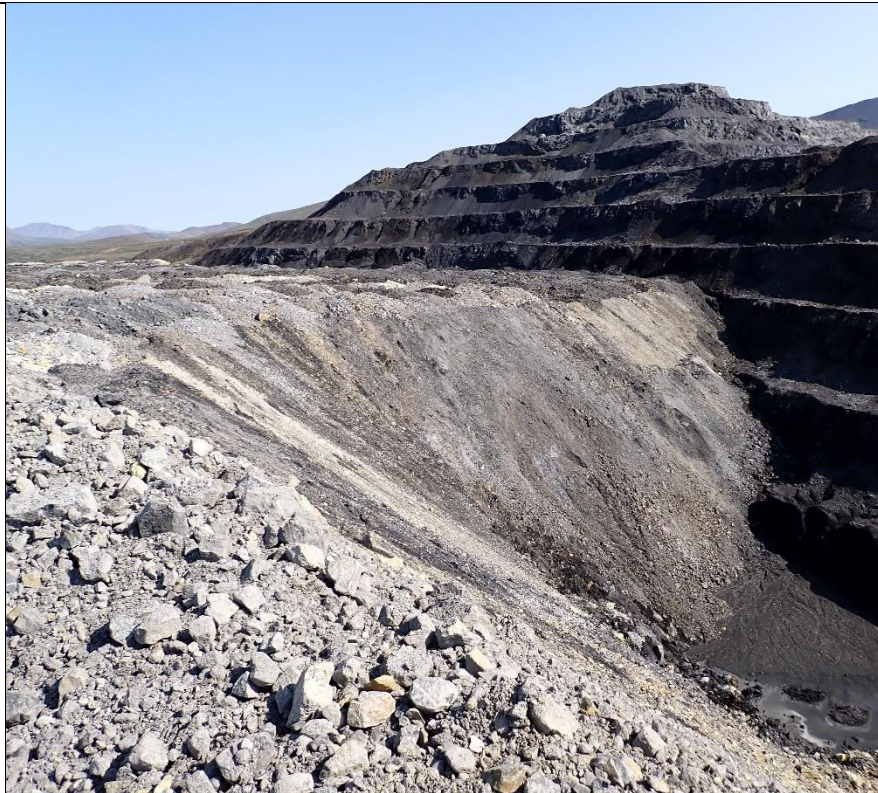
- 1.3. DNR staff observed the Qanaiyaq Pit which is currently being filled with waste rock (Photo 13). Most of the pit has already been infilled and graded in preparation for closure (Photo 14). The remaining high walls will be stabilized and left in place as part of the final reclamation for the site. DNR staff was not able to visit the Qanaiyaq South Pit due to an active blasting area.
- 1.4. On the northern side of the mine is the Aqqaluk Pit where current excavation and blasting is taking place. DNR staff traveled to the north end of the pit to view ongoing operations from an overlook point above the highwall (Photo 17). Surveying was also observed at this location for proposed pit expansion.

Photo 13: Active waste rock used to fill Qanaiyaq Pit. High walls may be left in place under state regulations.

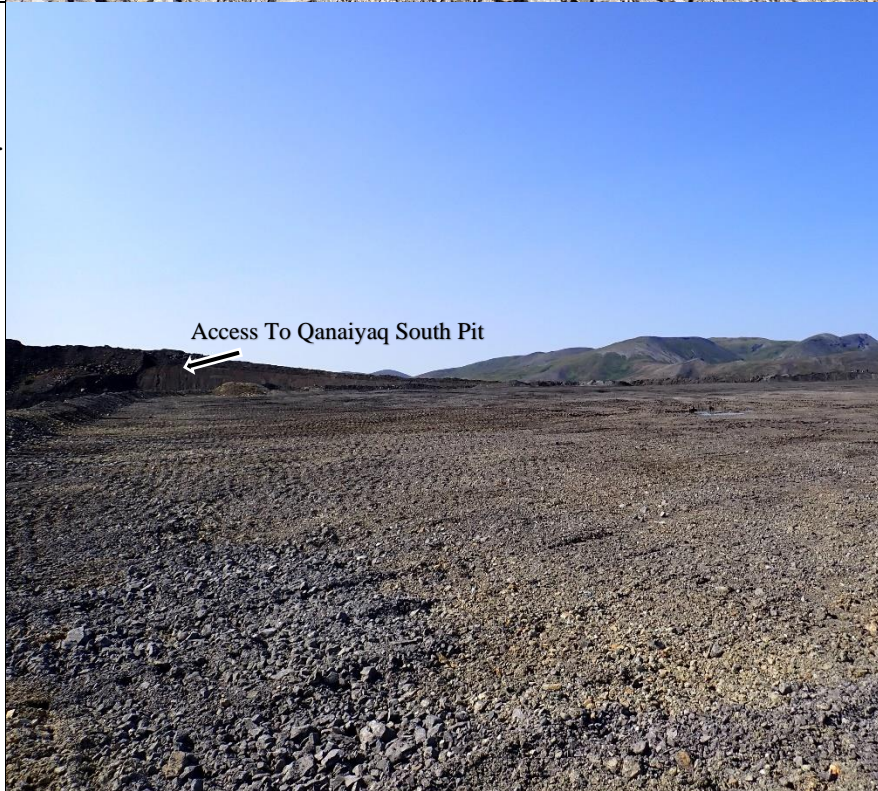
Photo 14: Graded area, looking southwest, of Qanaiyaq Pit. Access to Qanaiyaq South Pit was closed due to active blasting.

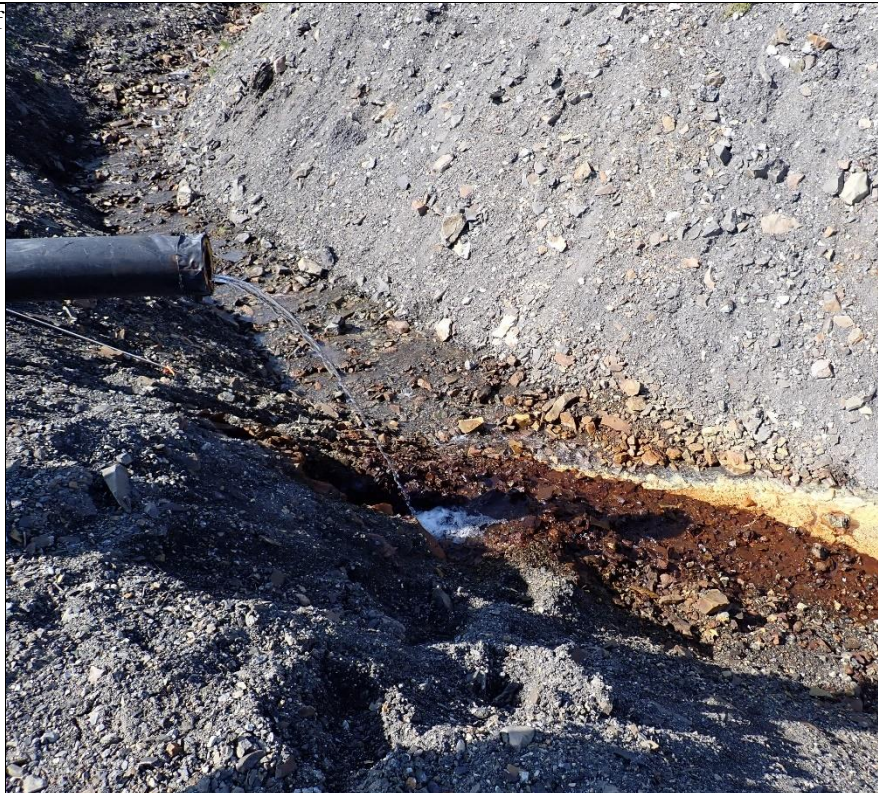
- 2.6. Two rivulets were documented draining from the back side of Qanaiyaq South Pit. DNR staff only photographed the confluence point of both seeps at Hilltop Creek (Photo 15) and documented that water from these drainages were separated from Red Dog Creek and was actively diverted into the mine as part of its water management (Photo 16). The uphill Kaviqsaq seep has been diverted from its natural drainage through a pipe to its current collection point. DNR staff were not able to hike to the source of the piped water due to a lack of bear protection.

Photo 15: Water draining off the back side of South Qanaiyaq Pit. Piped water is from an upstream point that has been diverted. Photo shows the confluence for both drainage points.

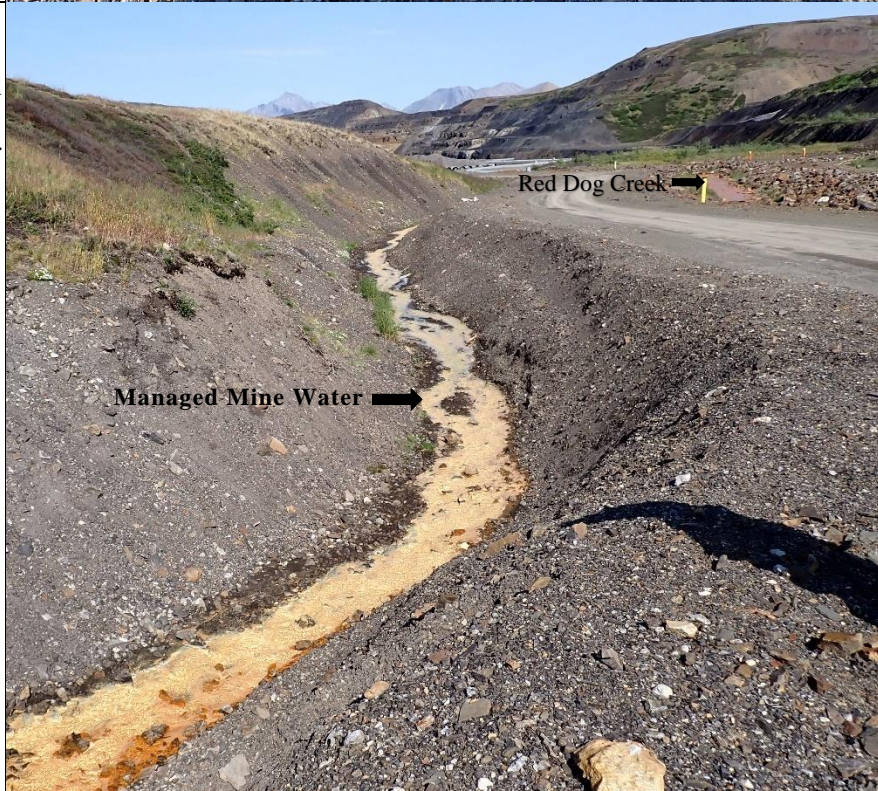
Photo 16: Water captured from the drainage off the back side of South Qanaiyaq Pit. Ditch (Center) is part of the mine water management. Upper right of photo is Red Dog Creek that is separate from the managed mine water.

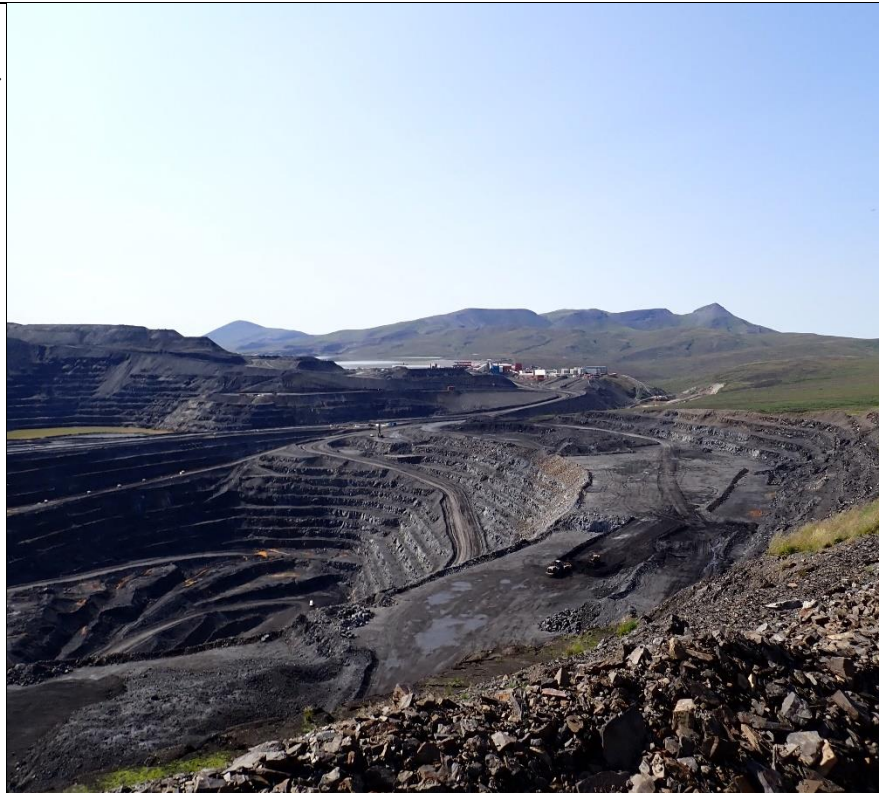
Photo 17: Aqqaluk pit looking southwest. Lower right is active excavation for northward pit expansion.

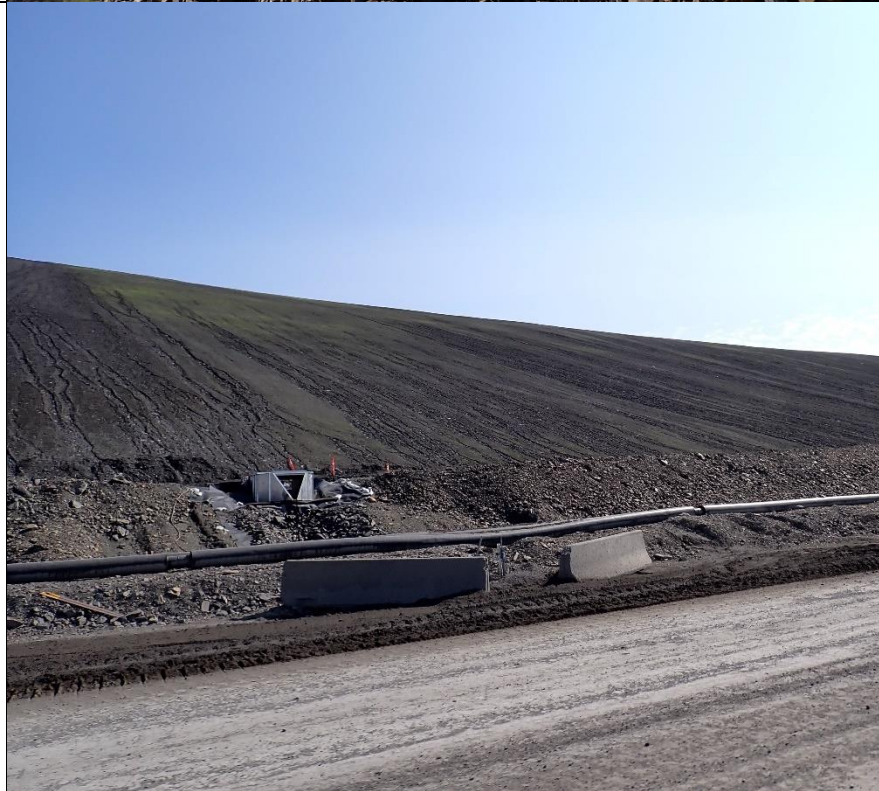
Using an aircraft, TAK seeded a large area of the main WRD after final grading was completed. Unfortunately, most of the seeds were not able to germinate before washing away from an abnormally large rain event. This caused rills within the prepared growth medium all along the western slope, which increased in channel size as the water moved downslope (Photo 18). The lined ditch running parallel to the base of the western side of the WRD without vegetation contained a considerable amount of eroded soil demonstrating the unstable condition along the slope (Photos 19 and 20).

11 AAC 97.200(a)(1) outlines the criteria for a stable soil condition to "...return waterborne soil erosion to pre-mining levels within one year after the reclamation is completed, and that can reasonably be expected to achieve revegetation, where feasible, within five years after the reclamation is completed..." It is also noted under AS 27.19.020 that, "A mining operation shall be conducted in a manner that prevents unnecessary and undue degradation of land and water resources, and the mining operation shall be reclaimed as contemporaneously as practicable with the mining operation leave the site in a stable condition." Current conditions do not meet these standards; however, Mr. Bendrick explained that he was working on implementing best management practices (BMPs) to remediate these issues.

Photo 18: View of rills along main WRD after high precipitation event. Channeling becomes more defined downslope. Recommend using BMPs to re-establish site for seeding.

It is recommended that TAK evaluates some of the reclamation design requirements for the main WRD, specifically for better water management along slopes to prevent rills or other types of soil erosion. It is also recommended that preparation of the growth medium be done in such a manner to help retain seeds to promote germination to mitigate erosion, especially from events such as high winds or abnormal precipitation. As part of the reclamation, seeding should be done as, "...contemporaneously as practicable..." as outlined by AS 27.19.020. This may have reduced the overall area that was affected if each section was seeded once completed.

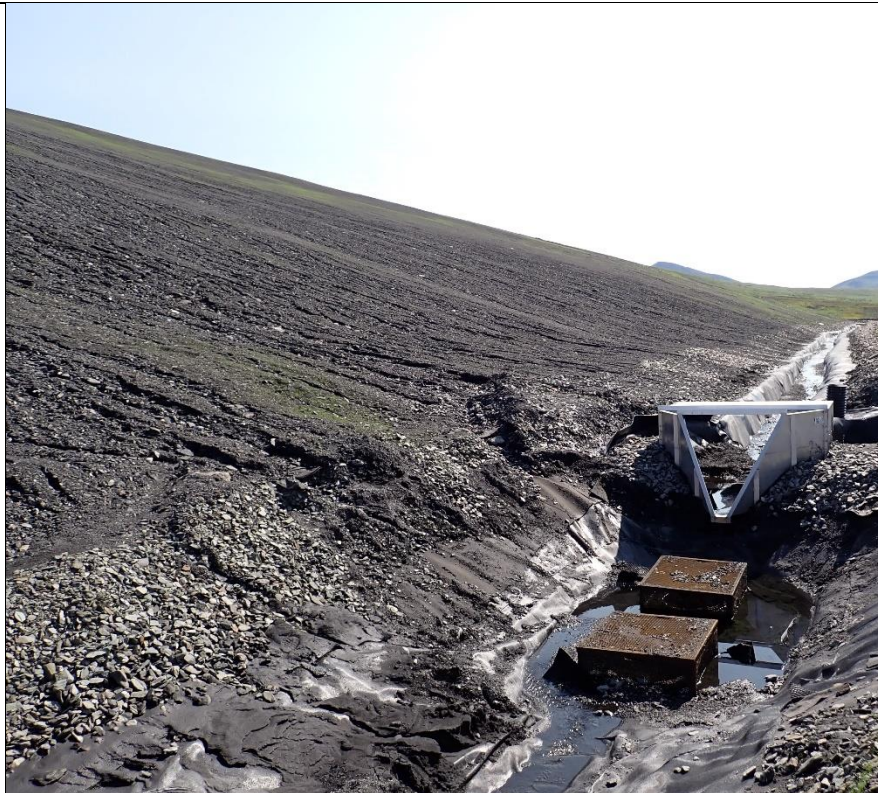
Photo 19: View of ditch that runs adjacent to main WRD. Notice the amount of topsoil that has accumulated within it from erosion.

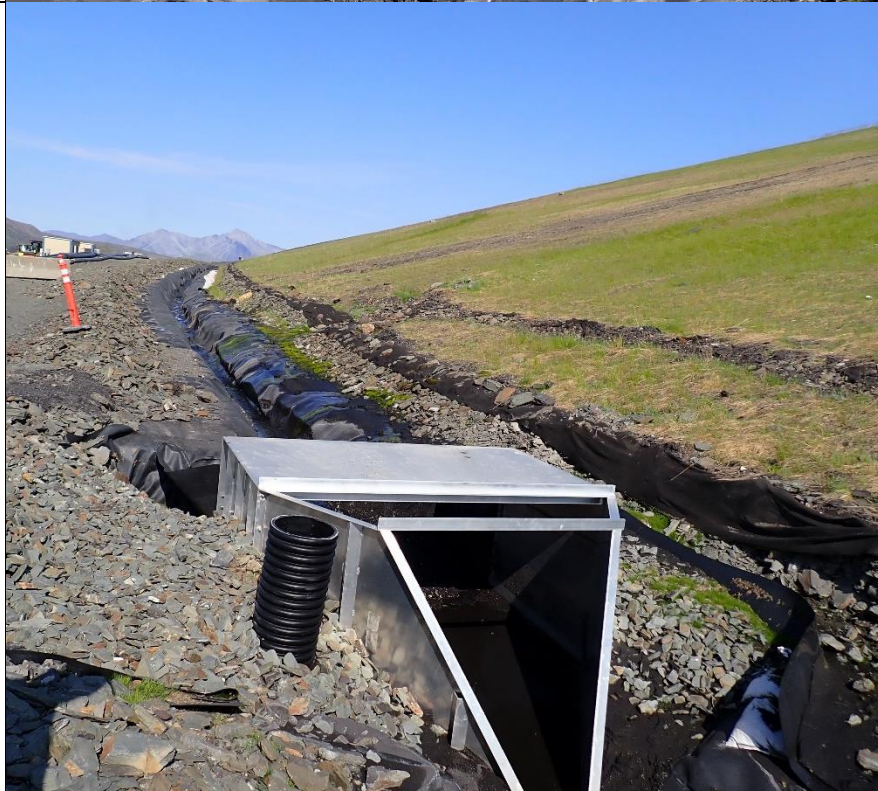
Photo 20: View of the ditch looking north, 180° degrees from Photo 19. No topsoil debris accumulation in ditch from erosion. Right side of photo is the 17-acre reclamation seeded in 2017.

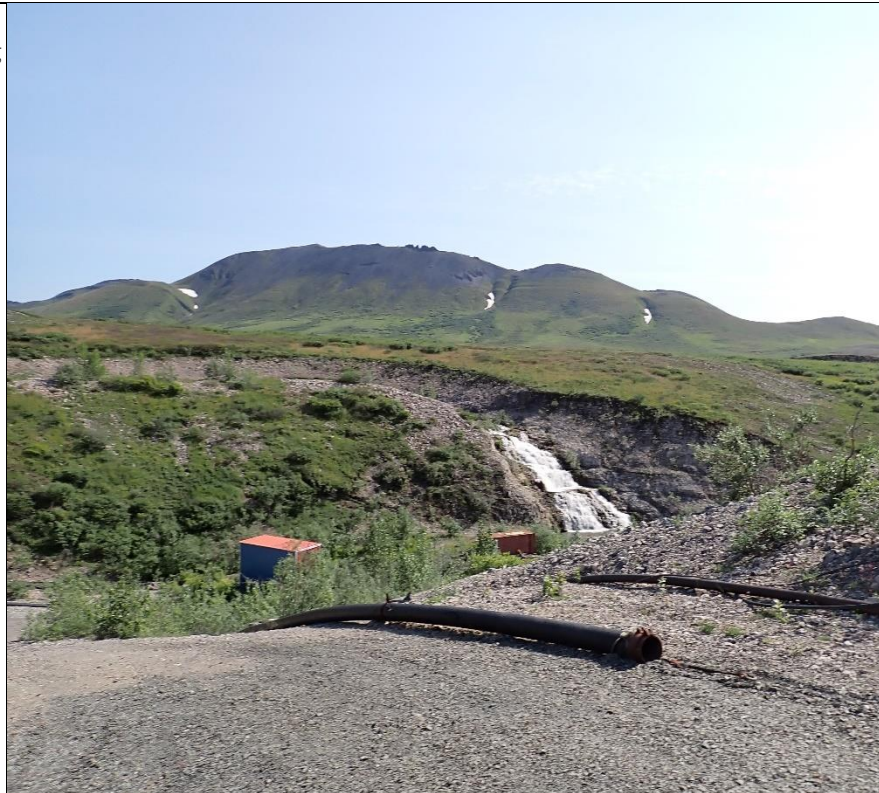
- 2.7. DNR staff stopped at Bons Reservoir to take some photographs of the freshwater supply for the mine. A steady rate of water cascaded over the falls of the spillway from the reservoir (Photo 21). All outbuildings onsite were in good condition and no issues were noted at the dam (Photo 22).

Photo 21: View from atop Bons Reservoir dam looking at the spillway. Below is a pump station for the dam.

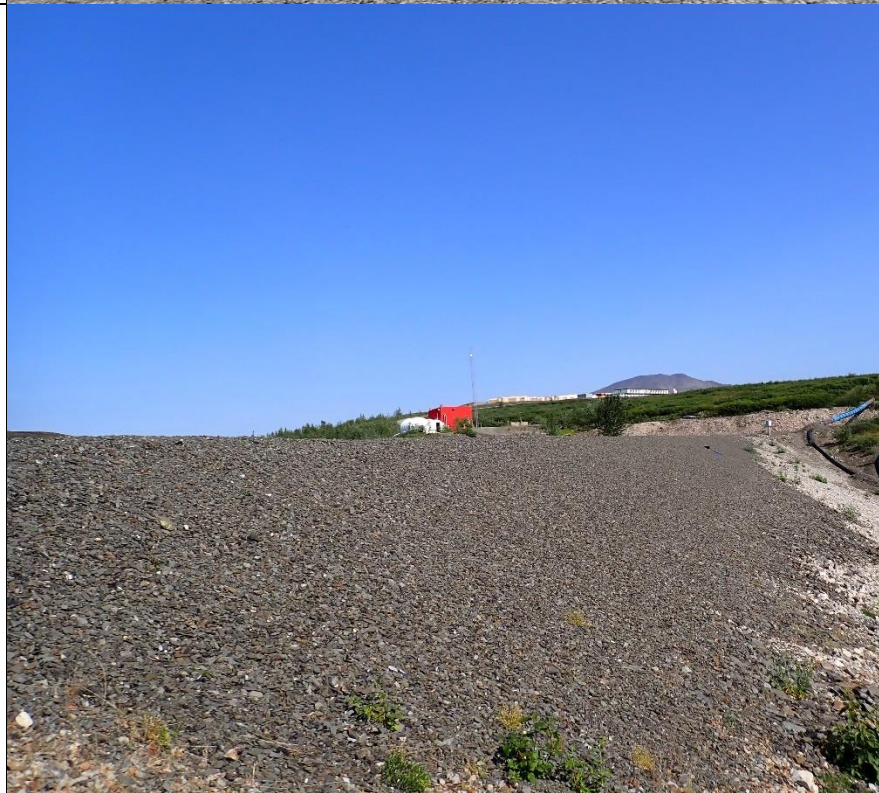
Photo 22: Bons Reservoir dam (center) and freshwater pump station for mine (above).

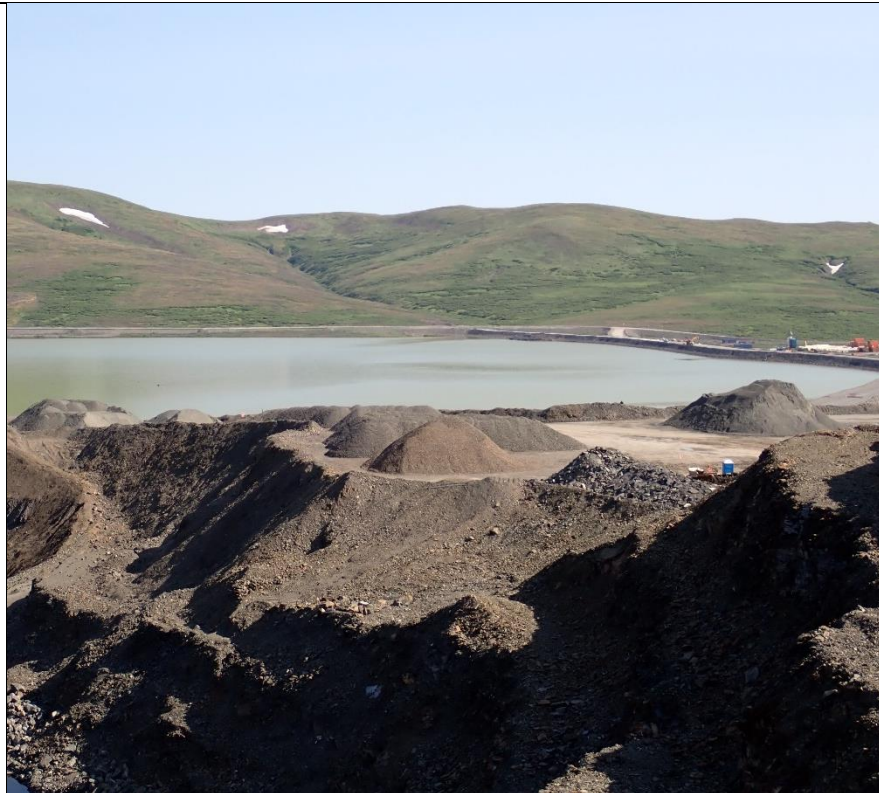
- 1.5. The DD2 is an active material site with several stockpiles for construction material adjacent to the southwestern edge of the TSF. All active excavation observed was at the western extent, above and behind the older pits which have since filled with water (Photos 23 and 24).

Photo 23: DD2 material site stockpiles.

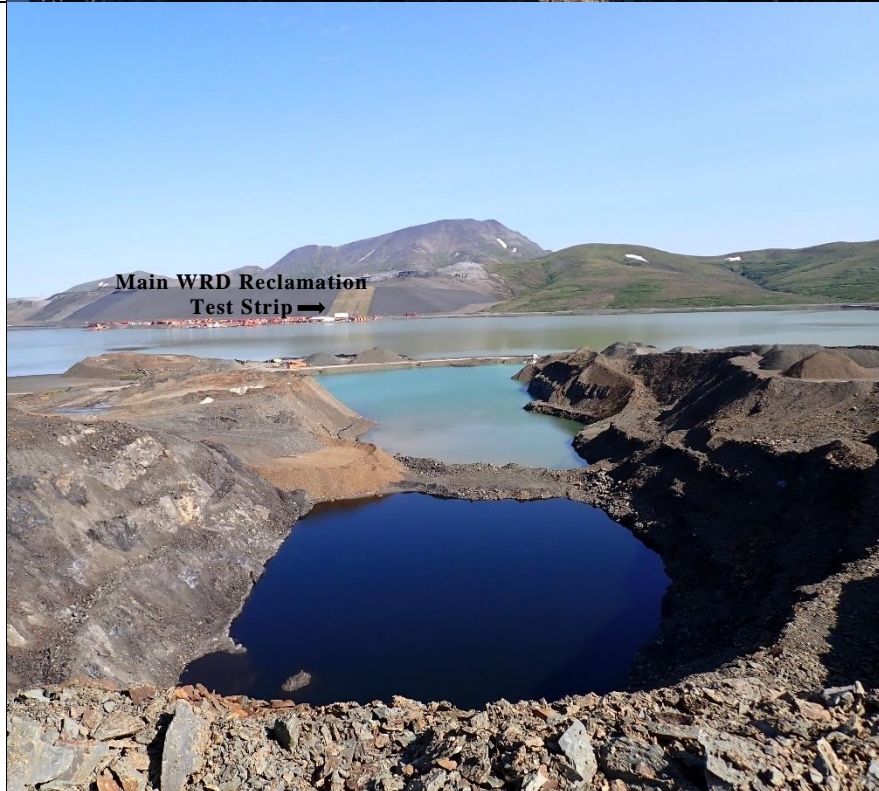
Photo 24: Pits of DD2 have infilled with water which lie adjacent to the southwest side of the TSF. The main WRD (background) can be seen for perspective. Most of the surface area of the WRD has been graded with growth medium.
