Red Dog Mine and Anarraaq-Aktigiruaq Exploration Program Field Inspection Report

Inspection Date:	August 6, 2025
Time:	8:00 AM to 4:45 PM
Weather:	Overcast with scattered showers, 5-10 mph winds, with an average temperature of 56°F
Agency Personnel:	Jesse White, William Groom, Aaron Kruse, and Jonathan Kummer
Teck Personnel:	Frank Bendrick, Marie-Christine Noel, and Katie Mountain (intern).
AA-River Personnel:	Dave Rush, Tim Egger (Construction Contractors)
Inspection Objectives:	Site Inspection

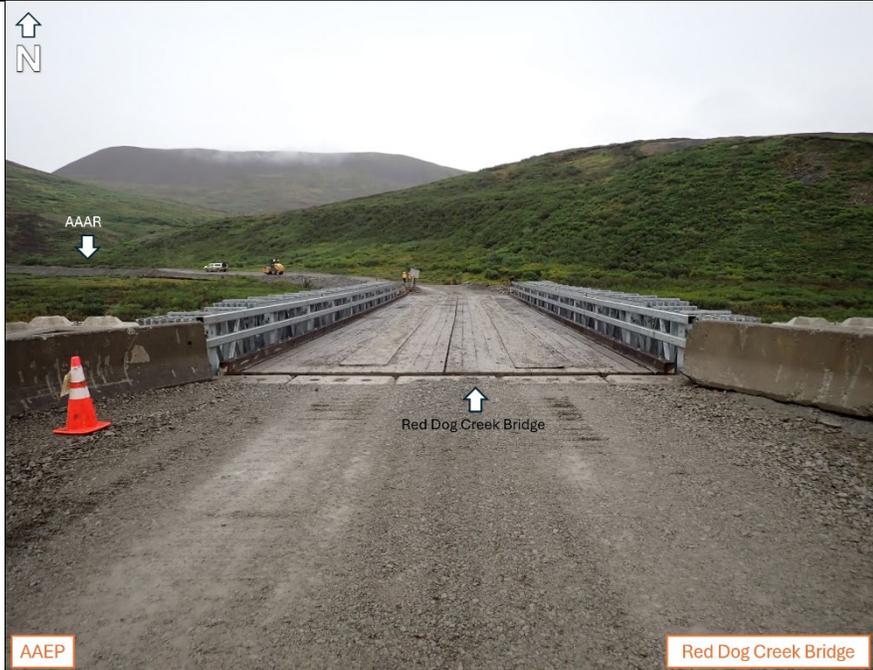
Photo 1: Red Dog Creek Bridge surface and construction.

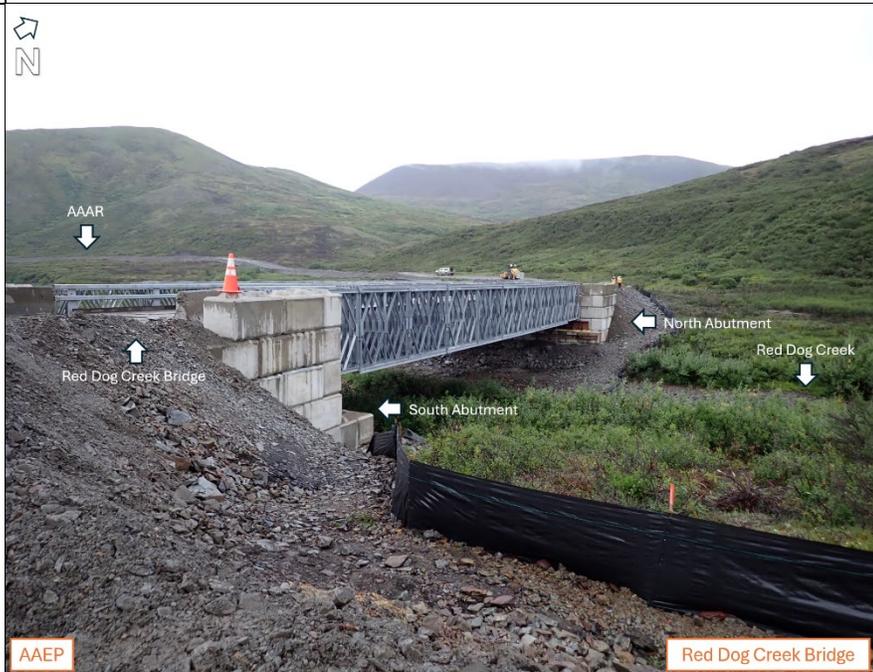
Photo 2: Red Dog Creek Bridge and construction.

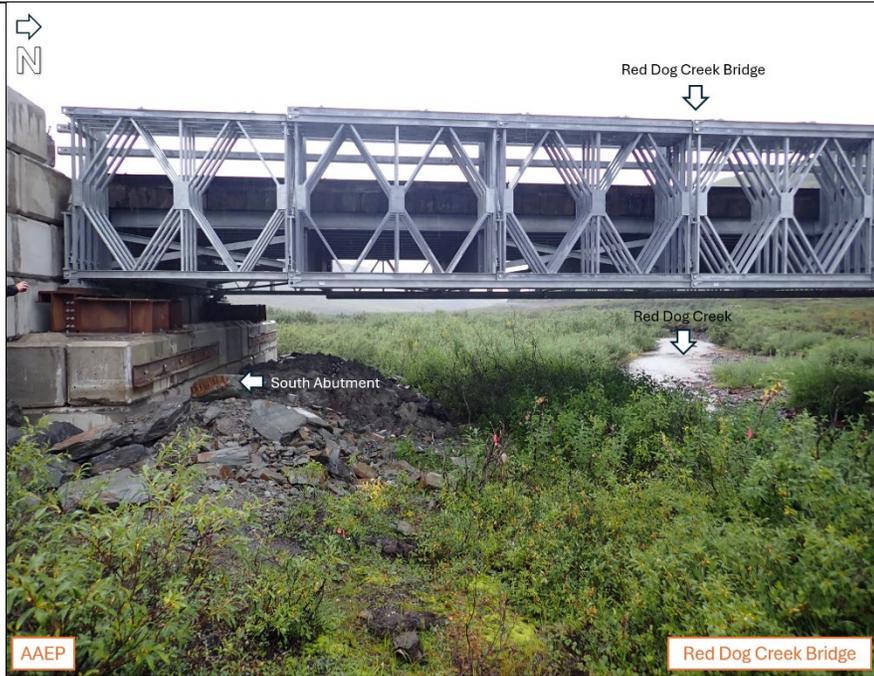
During spring break-up of Red Dog Creek, snow and ice damming diverted stream flow towards the bridge abutment, washing away some of the abutment armor rock. Teck had concerns about undercutting and began implementing temporary measures for remediation. Heating methods used to assist in melting the snow and ice contributed to the blockage. In mid-May, the jersey barriers were adjusted and sandbags placed in the gaps between them. In late May, the jersey barriers and sandbags were removed. By mid-July the Red Dog Creek Abutment Reconstruction Plan was authorized by ADF&G followed by immediate construction work that lasted approximately 3 weeks. Design modifications and repairs including adding blocks and rock filled gabion cages covered with coarse material were completed by mid-August.

Photo 5: Red Dog Creek Bridge reinforced south bridge abutment.

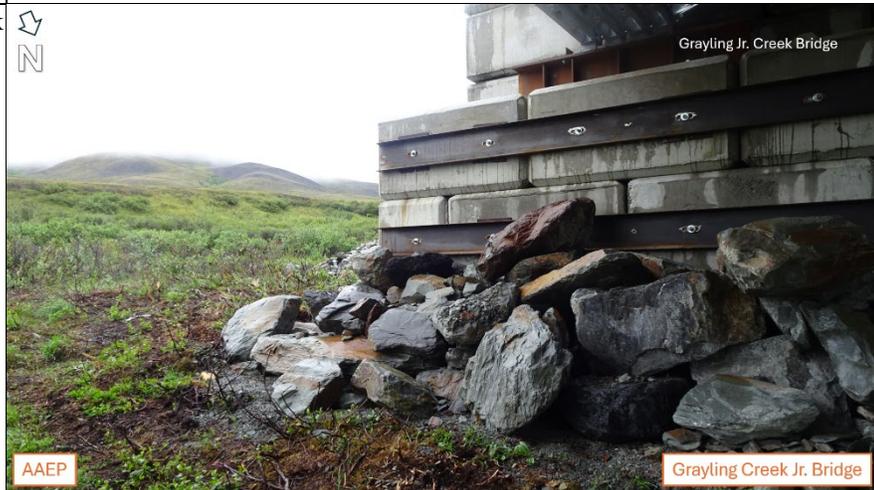
Photo 10: Grayling Jr. Creek Bridge, bridge abutment. Abutment is well armored with riprap boulders.

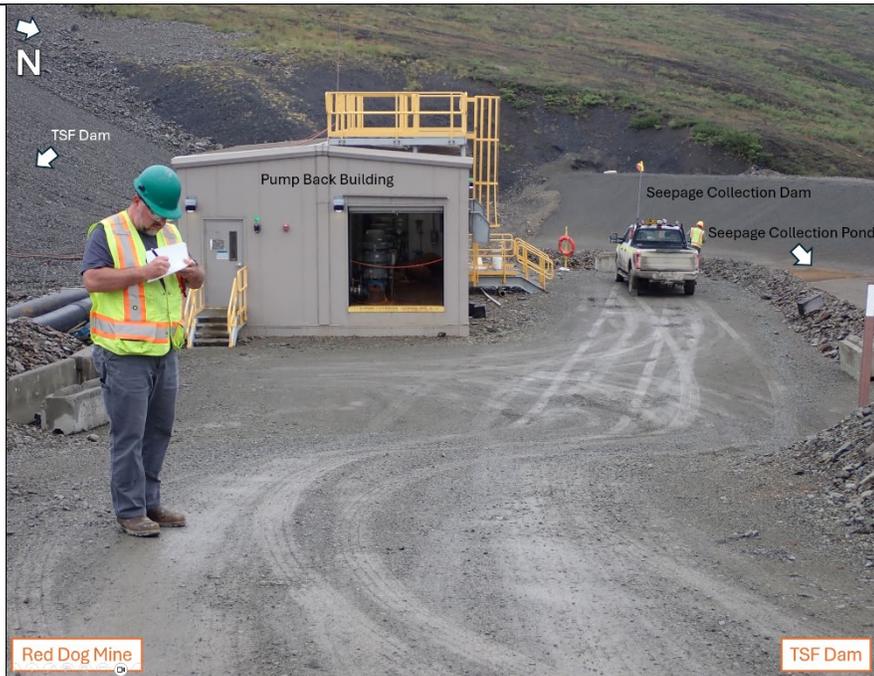
- 2.0. The TSF Main Dam and Seepage Collection Pond, dam, and pump back facility (Map 2, Photos 11-15) looked well maintained and in good working order. The seepage collection pond was empty except for small puddles resulting from precipitation. An active drill rig was situated in the center-middle of the Main Dam installing instrumentation including inclinometer, piezometer, thermistor, and GPS.

Photo 13: TSF pump back building below the TSF Dam. Note the seepage collection dam and empty seepage collection pond.

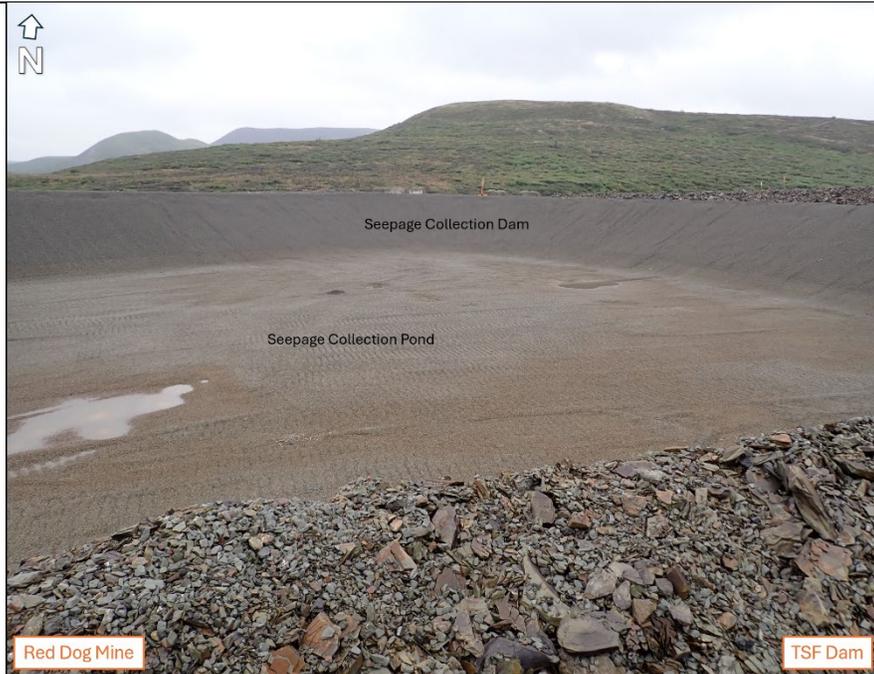
Photo 15: Seepage collection dam and empty pond below the TSF Dam.

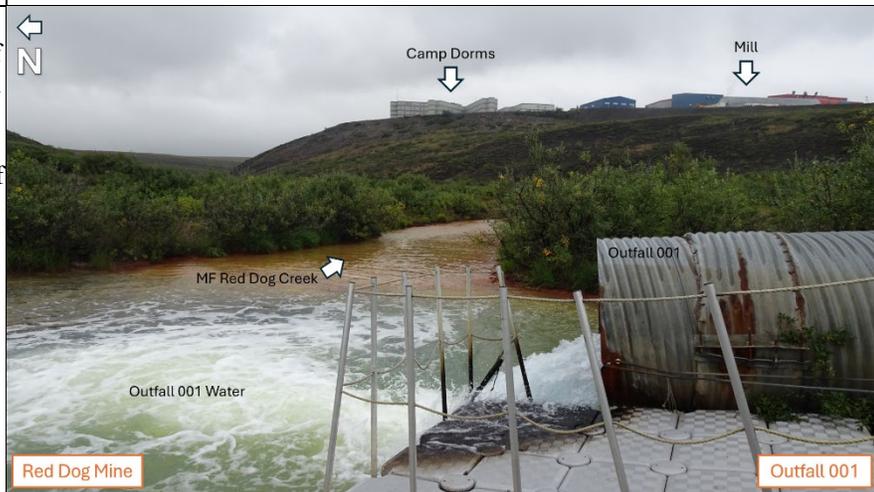
- 2.1. Observations of active water discharge exiting Outfall 001 noting that the treated water discharge point had a steady flow of clean clear water (Photo 16). A distinct boundary between the natural mineralized background water and treated water is noticeable within the mixing zone at Outfall 001 (Photo 17). The Mine Water Collection System and main sump had a minor amount of bright rusty orange water and sediments (Photo 18). The sump was not operating at the time of inspection. When the sump's reservoir contains enough water, it is pumped directly into the TSF. The Middle Fork Red Dog Creek Diversion contained naturally clouded orange flowing water and the Mine Water Diversion Dam was in good condition (Photo 19).

Photo 16: Outfall 001. Note the cleanliness and clarity of the water exiting Outfall 001 compared with naturally occurring clouded orange waters of the Middle Fork of Red Dog Creek.

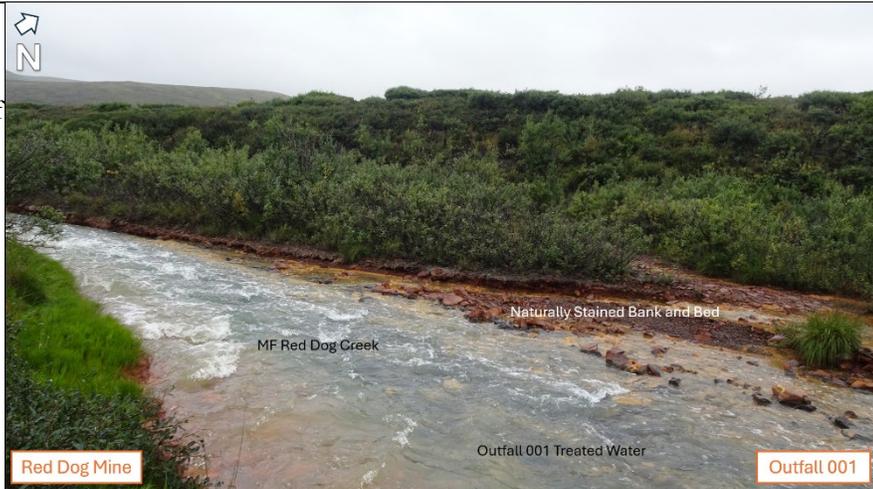
Photo 17: Treated water exiting outfall 001 mixing with natural clouded orange waters of the Middle Fork of Red Dog Creek. Note the bed, banks, and surrounding rocks that are intensely stained with red-orange colors due to the weathering of mineralized bedrock.

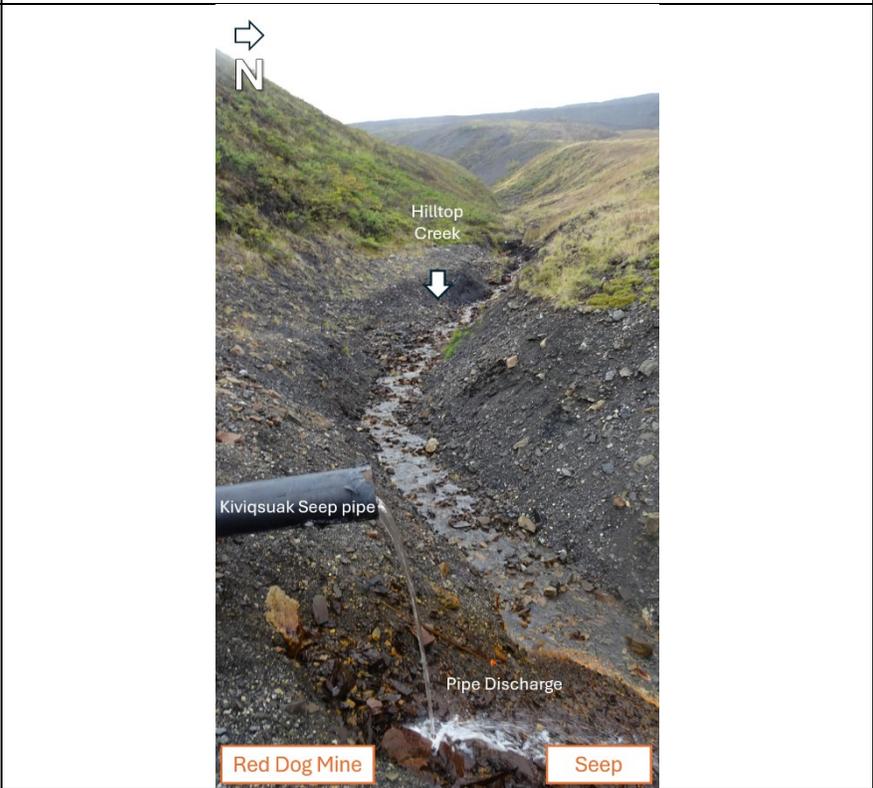
- 2.2. The Kivisauk seep originates from a rivulet on the backside of Qanaiyaq South Pit and now is collected and piped to Hilltop Creek (Photos 20 and 21), which is part of the water management and treatment system. DNR staff did not go to Kivisauk seep's collection point, it was only viewed at the discharge point. Current water flow volumes sampled exiting the Kivisauk Seep fill a 5-gallon bucket in approximately 45 seconds. Zinc oxide precipitates are visible just below the diversion pipeline outfall and is the result of natural background mineralization. Teck staff indicated that no chemical signature to show mine contact was found with monitoring. The diversion pipeline has been in place for approximately 5 years, and TAK is proposing that it be disconnected to allow seep water to flow back into its natural drainage.

Photo 20: Kiviqsuak Seep pipe and discharge into Hilltop Creek. Flows to Middle Fork Red Dog Creek diversion pipeline and mine water treatment system

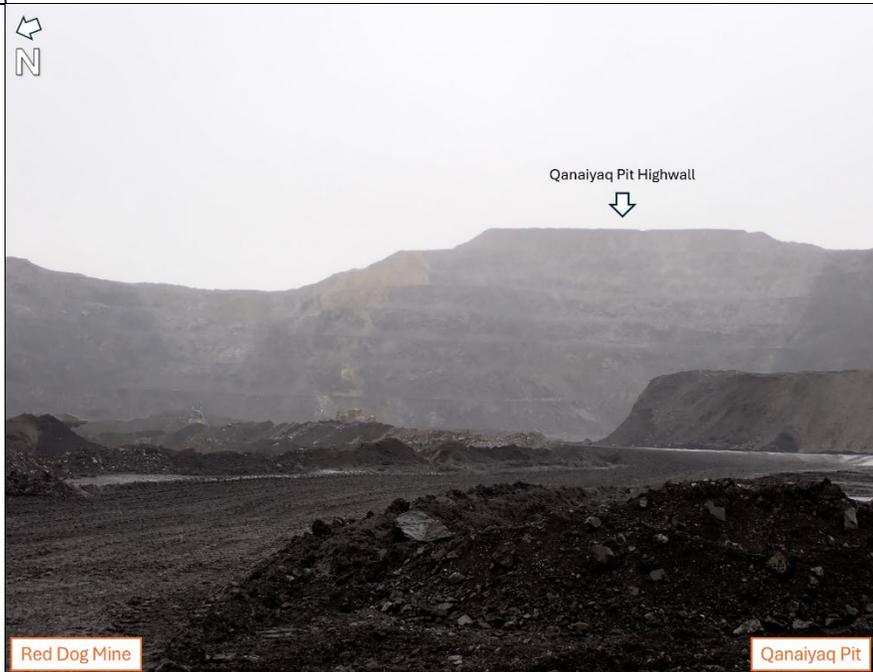
- 1.2. Active haul truck activity was underway within the Qanaiyaq Pit (Photo 24). DNR staff only observed the area from its periphery which is currently being filled with waste rock. Most of the pit has already been filled and graded in preparation for closure. The remaining high walls will be stabilized and left in place as part of the final reclamation for the site. DNR staff could not visit the Qanaiyaq South Pit area during this inspection due to slick and muddied access road conditions.

Photo 24: Qanaiyaq Pit highwall and active construction (deposition of waste rock).

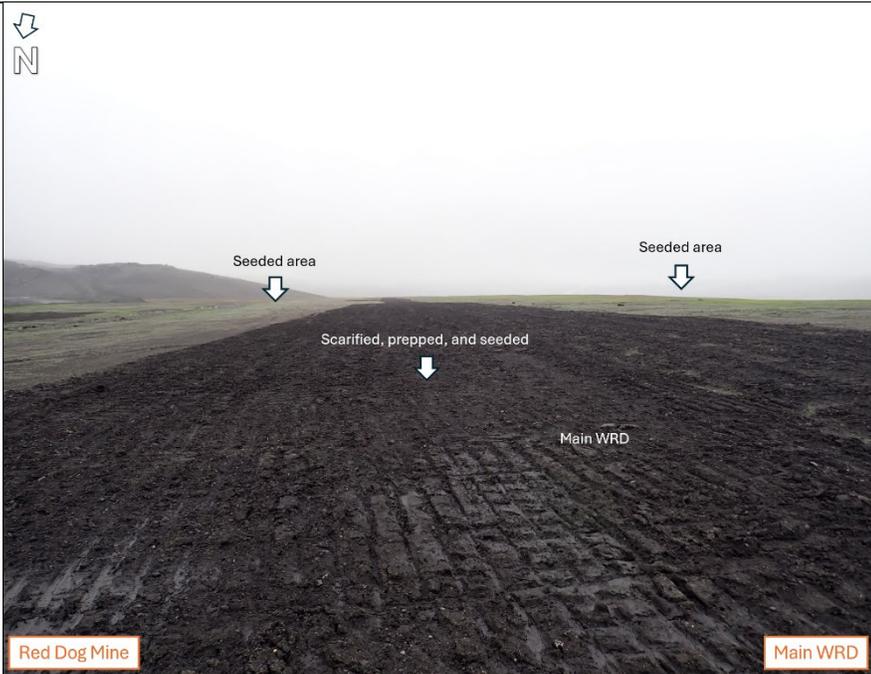
Photo 25: Top of the Main Waste Rock Dump (WRD) and old access road.

- 1.3. DNR staff arrived at the top of the WRD and observed the progress of reclamation activities from the previous year. Since last year, the access road and surrounding areas have been ripped, graded, scarified, and recently seeded adjacent to a lined drainage ditch, which was in good condition. Most seeding efforts occurred in the spring with aerial seeding efforts taking place the previous fall. Early aerial seeding covered the western extent of the Main WRD and the entirety of the northern and western slopes. Vegetative growth looks well established on the western end of the WRD; however, good vegetative cover is sparse on the WRD slopes. Sprouts were just beginning to surface on all areas of recent scarifying.

This area has been scarified, prepped, and seeded.

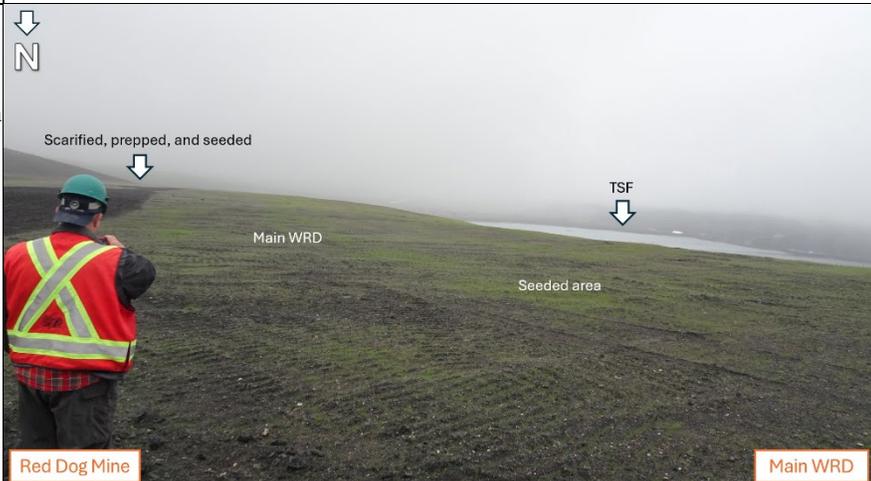
Photo 26: Top of the Main WRD exhibiting seed growth. Partial view of the old access road that has been scarified, prepped, and seeded.

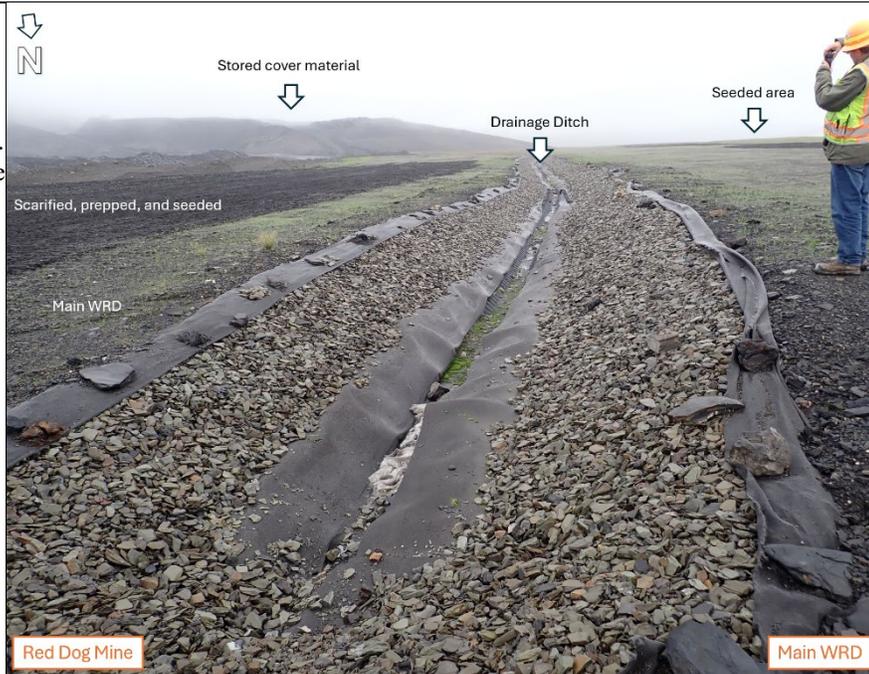
Photo 27: Top of the Main WRD, drainage ditch, and seed growth. Scarified, prepped, and seeded area to the left of the drainage ditch. Slopes in the background are stored cover material.

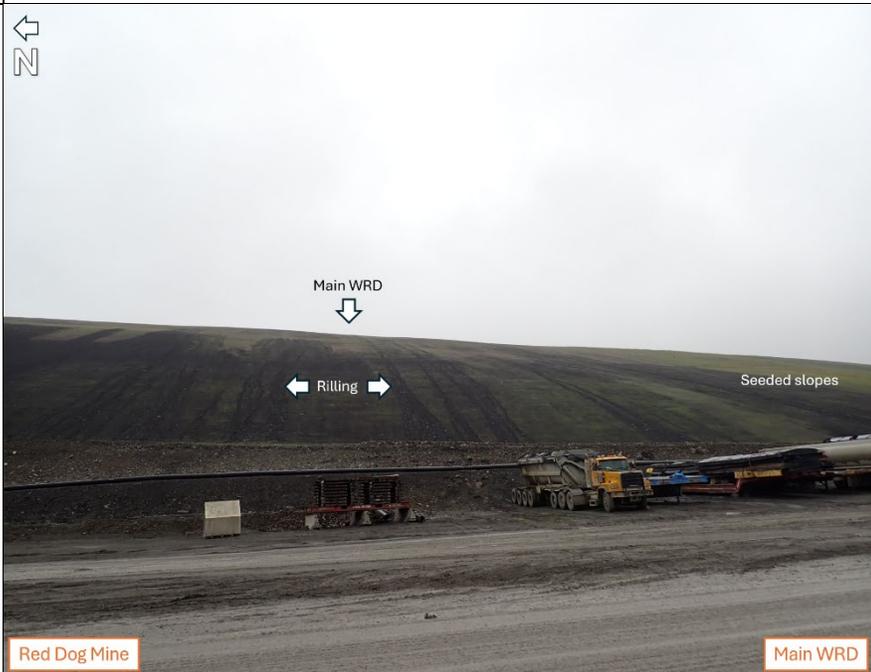
Photo 32: Graded and seeded west facing slope of the Main WRD.

During the previous year, rilling was prevalent along the slopes of the WRD due to a large rain event. Rills were found along most of the extent of the WRD slopes washing away seeds and causing enlarging furrows running downslope within graded areas of top cover. Large amounts of material were found within the ditch that runs the length along the base of the WRD slopes from erosion. Since then, TAK has used best management practices to correct these erosional issues. Re-grading of rilled areas was undertaken and seeds were sewn by hand to reestablish soil stability. Care was taken when re-grading as to not compact the top cover so seeds can more easily take root. Below the Main WRD along the main access road to the mine, a plot was fertilized to test if it would promote a faster germination for slope stabilization. This area resides next to a successful 17-acre vegetative test plot that was originally established in 2017. Rilling still persists in some areas after it was tracked by a dozer, no ripping occurred. DNR has noted that TAK has made significant progress in remediating these erosional issues and will continue to

Various stages of vegetative germination and growth, along with rilling and erosion are visible on the WRD slope.

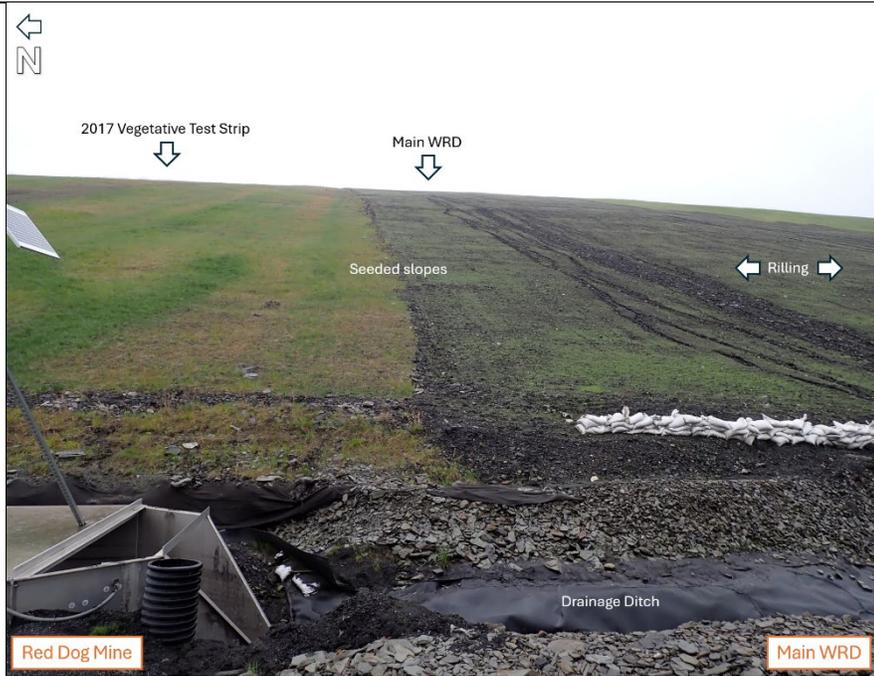
Photo 33: Graded and seeded west facing slope of the Main WRD. Lined drainage ditch in the foreground.

Various stages of vegetative germination and growth, along with rilling and erosion are visible on the WRD slope.

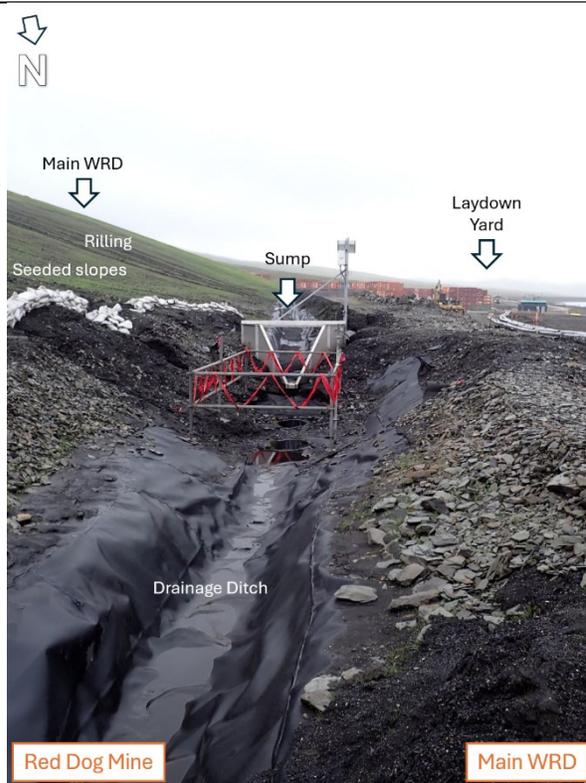
Photo 35: Another view of the lined drainage ditch at the base of the Main WRD. Note no top cover material has flowed into lined ditch. This area is just below the well-established vegetative test plot from 2017. Soil is stable and prevents erosion.

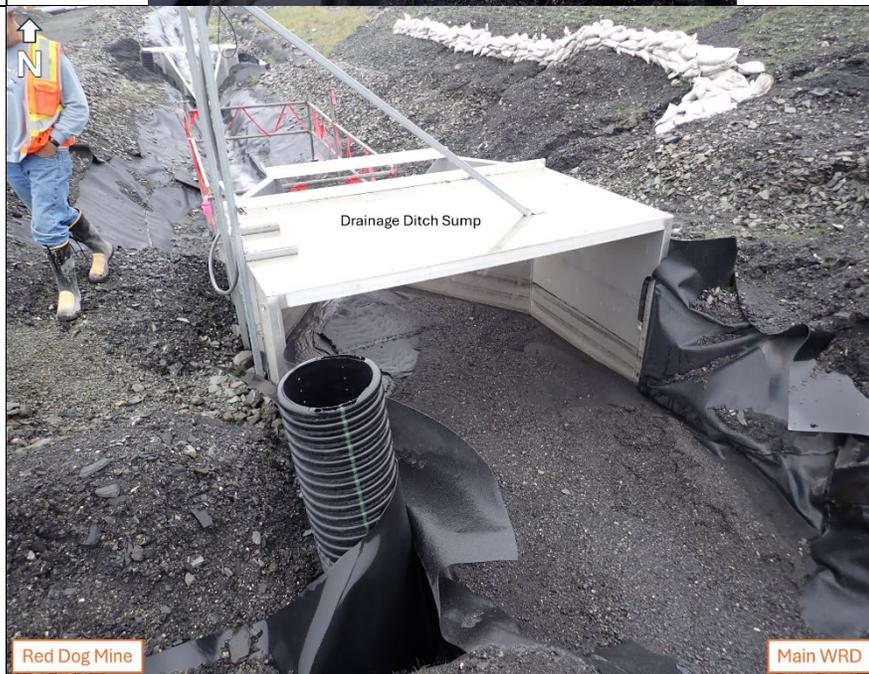
A small storage yard was in place at the base of the WRD along the main mine access road. At time of inspection, TAK was moving Conex storage containers from a yard adjacent to the TSF. This area will become inundated with water as the TSF fills. The new storage yard resides at the base of the Main WRD. Here, DNR staff were able to photograph the lined ditch that runs the length of the WRD. The ditch still had top cover material that continues to wash into it from areas that have not yet been stabilized.

Photo 36: Another view of the lined drainage ditch at the base of the Main WRD. Ongoing rilling allows material to flow into this section of the lined ditch.

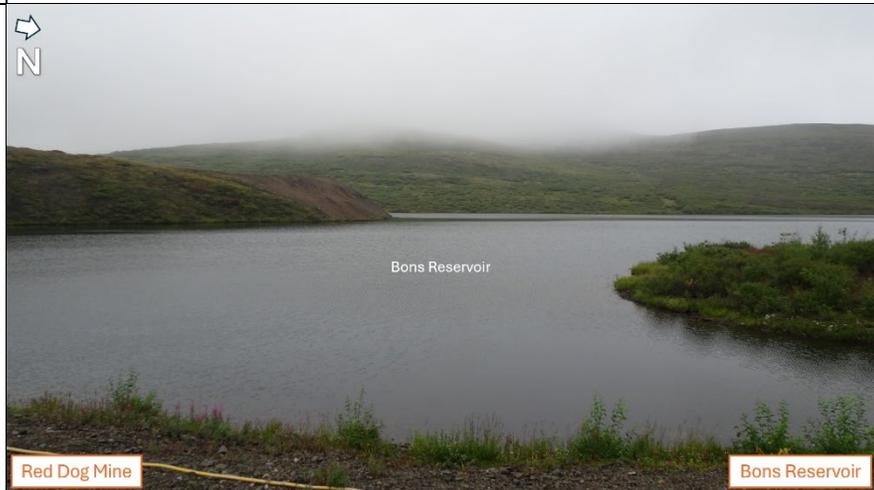
Photo 40: Bons Reservoir.

- 2.4. DNR staff stopped at Bons Reservoir to take some photographs of the freshwater supply for the mine. The reservoir was free of visible debris, and everything was in good working order. (See photos 40 and 41)
