Field Inspection Report Red Dog Mine Tailings Storage Facility and Dams

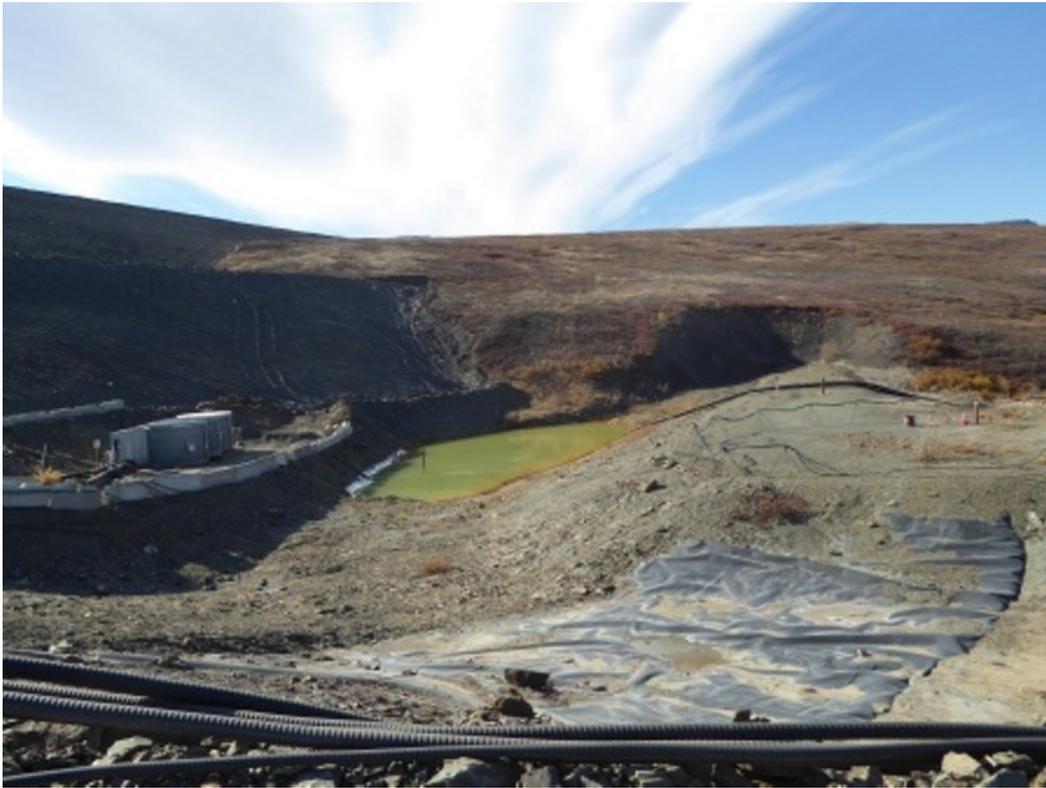
Figure 1 Seepage Collection Pond, pump-back wells, and part of the buttress near the toe of the downstream face of the Main Dam. Looking West.

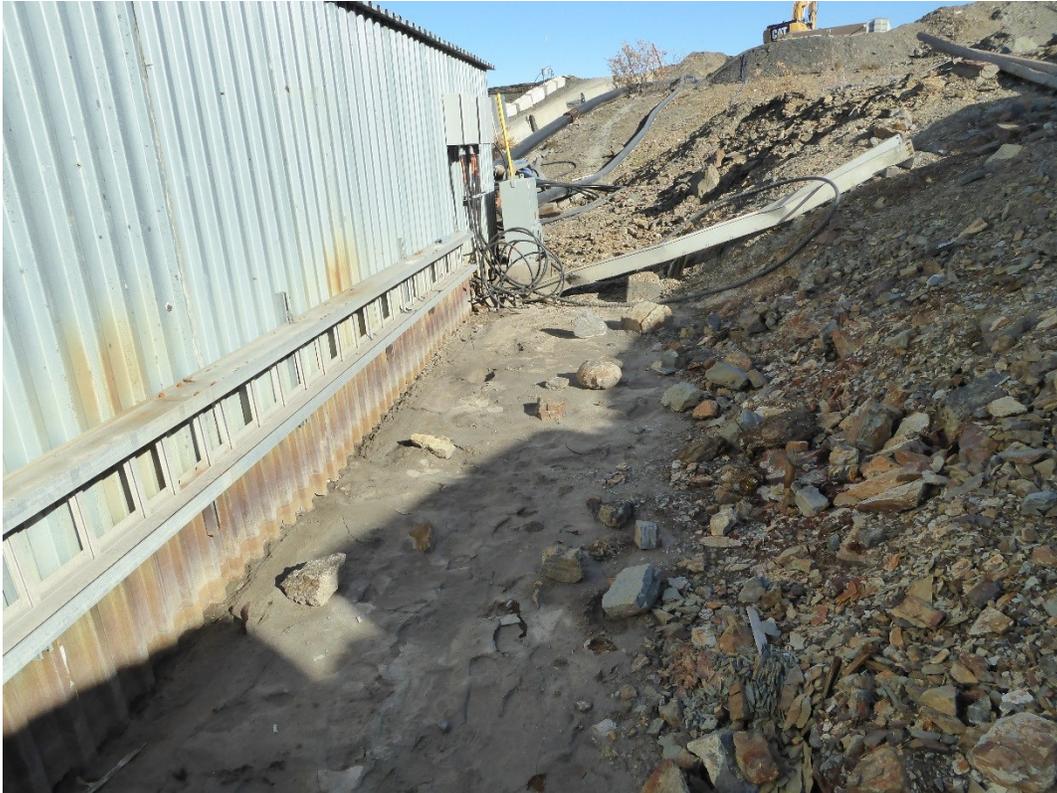
Figure 2 The ground behind the seepage pump-back wells was mostly dry, with no standing water. The soil had a small amount of moisture in it and deformed slightly under-foot. Looking East.

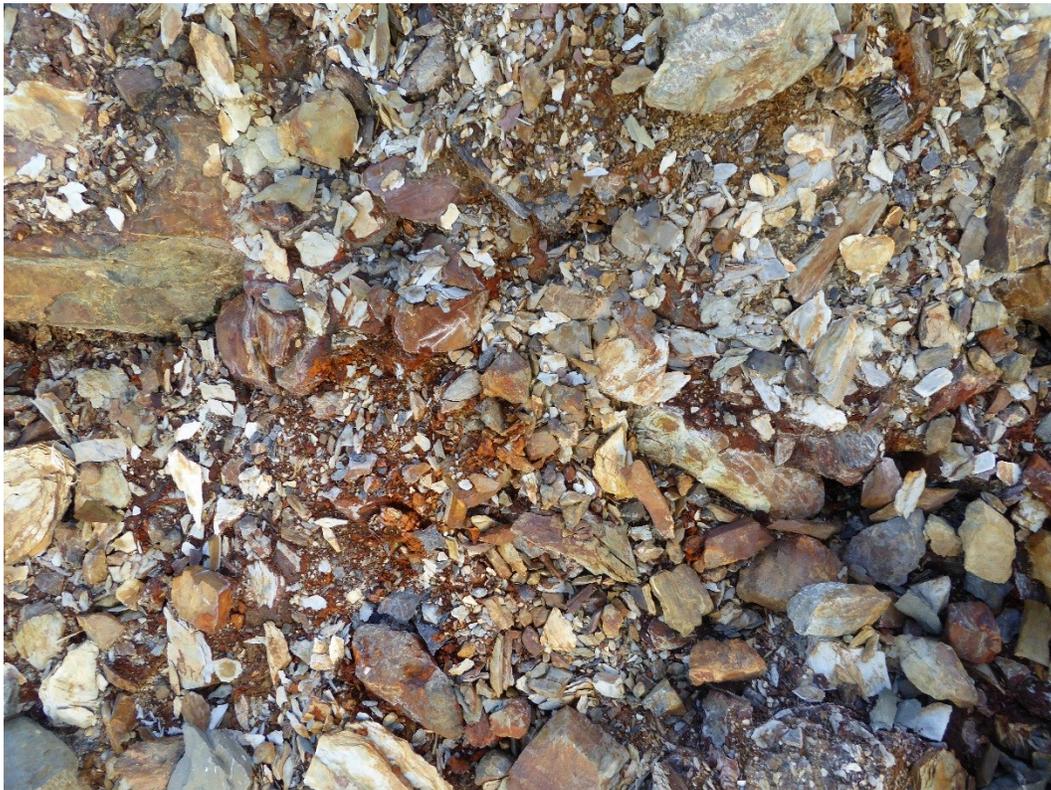
Figure 3 "Ferrocrete" at the toe of the downstream face of the Main Dam. According to a Teck representative, the deposits are caused by a historic seep of acidic water from the Tailings Facility. The surrounding area was dry during the inspection. Looking South.

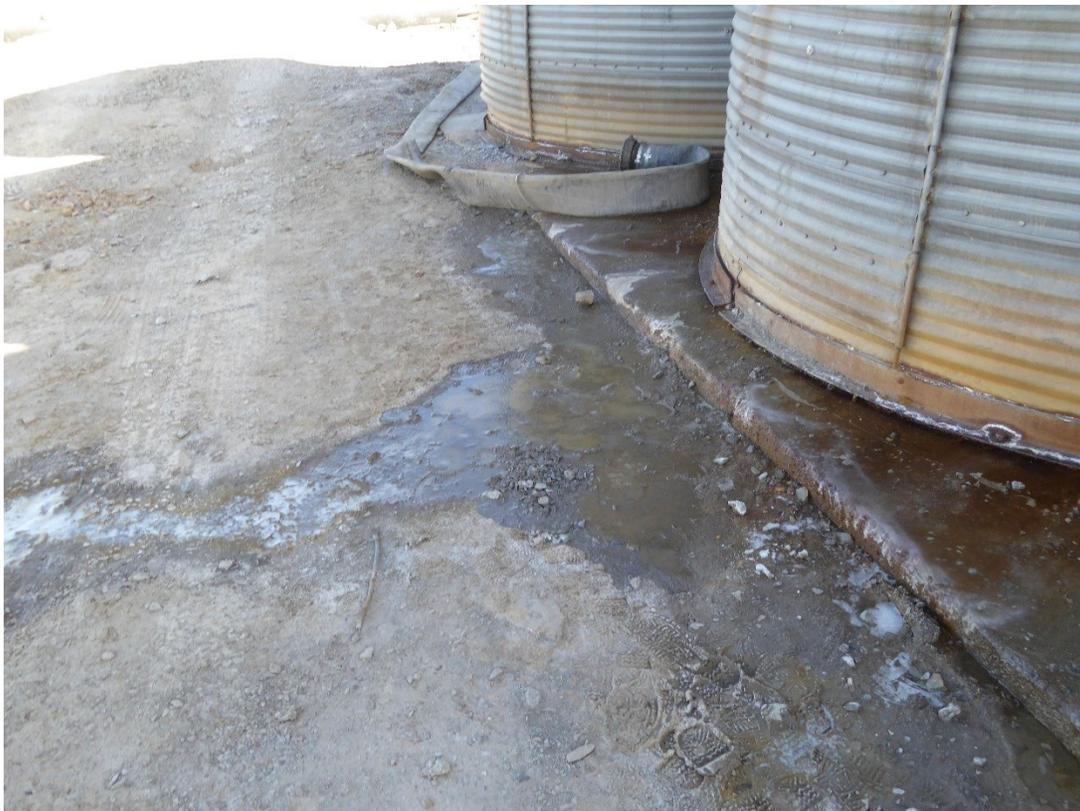
Figure 4 Surface water and ice near the middle pump-back well. The water was observed to be leaking from the top of the center well's pump. The water reports to the Seepage Collection Pond. Looking east.

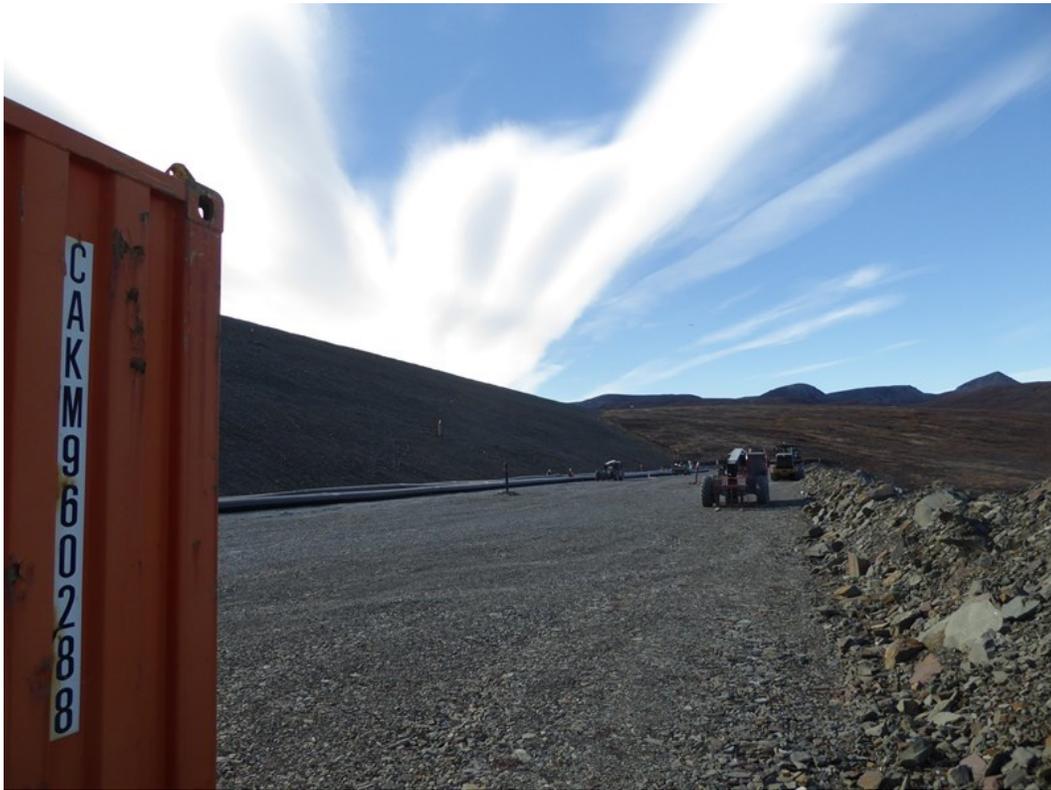
Figure 5 Oblique View of the Main Dam and Buttress. Looking West.

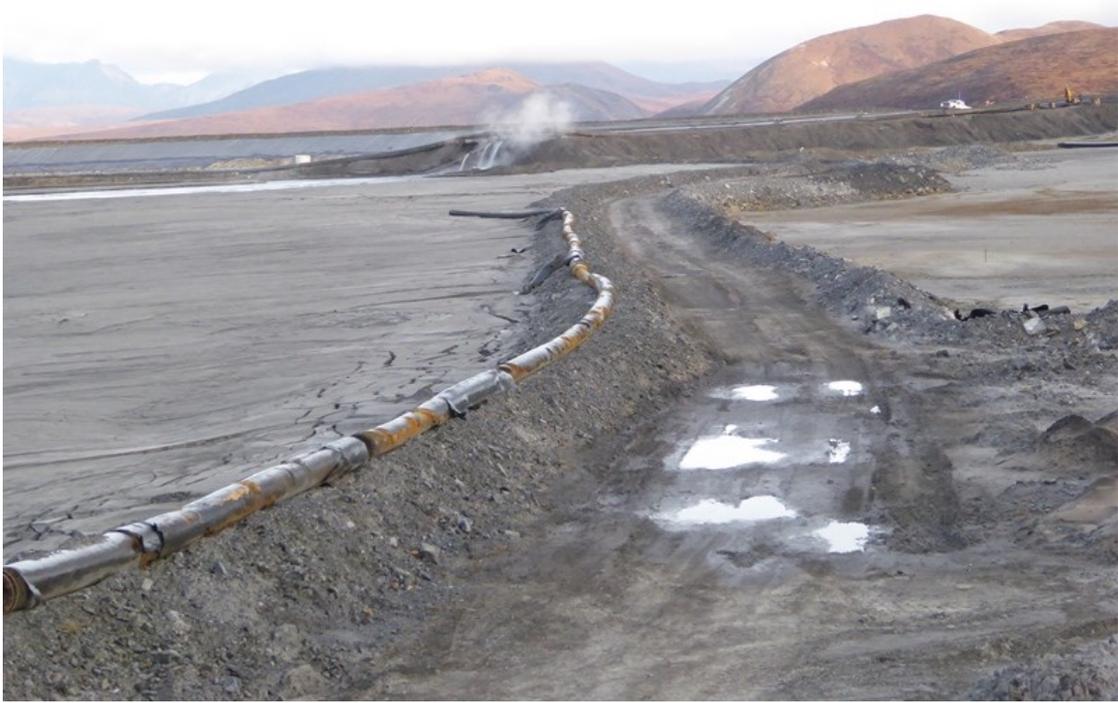
Figure 17 A tailings deposition pipeline. Looking north along the tailings beach causeway.

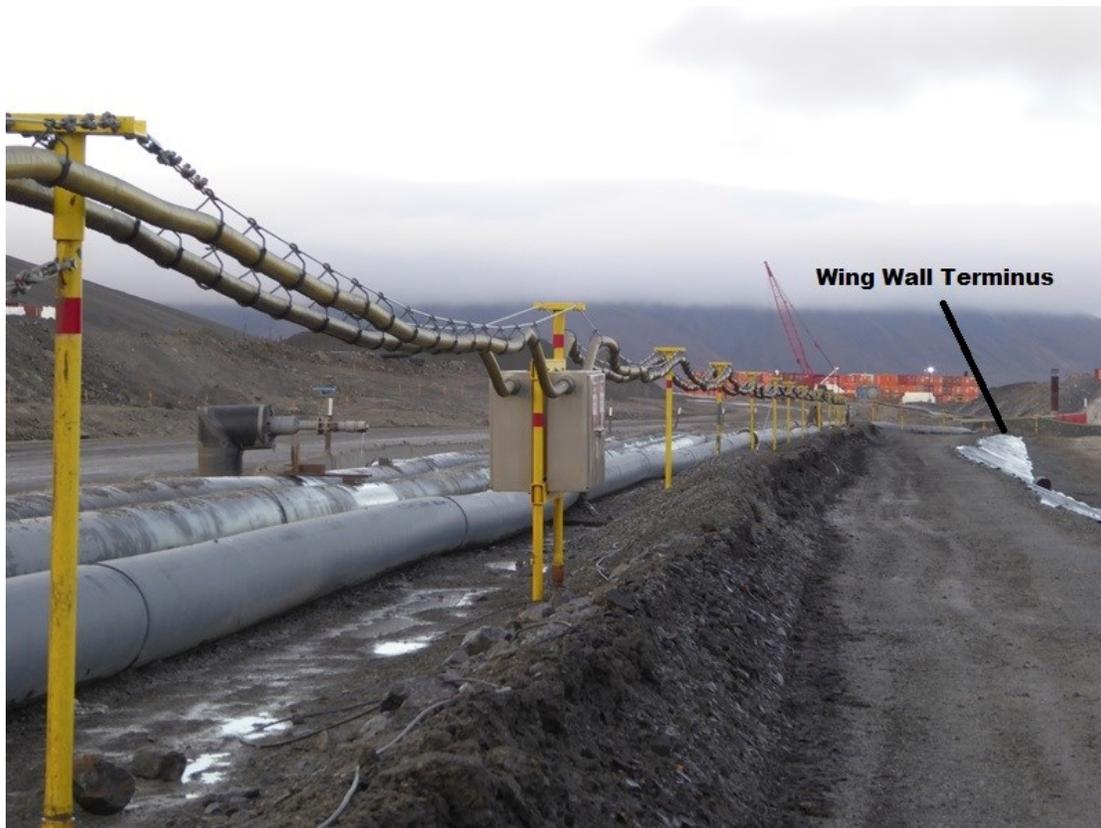
Figure 18 Pipe corridor running along the south end of the Wing Wall. Looking South.

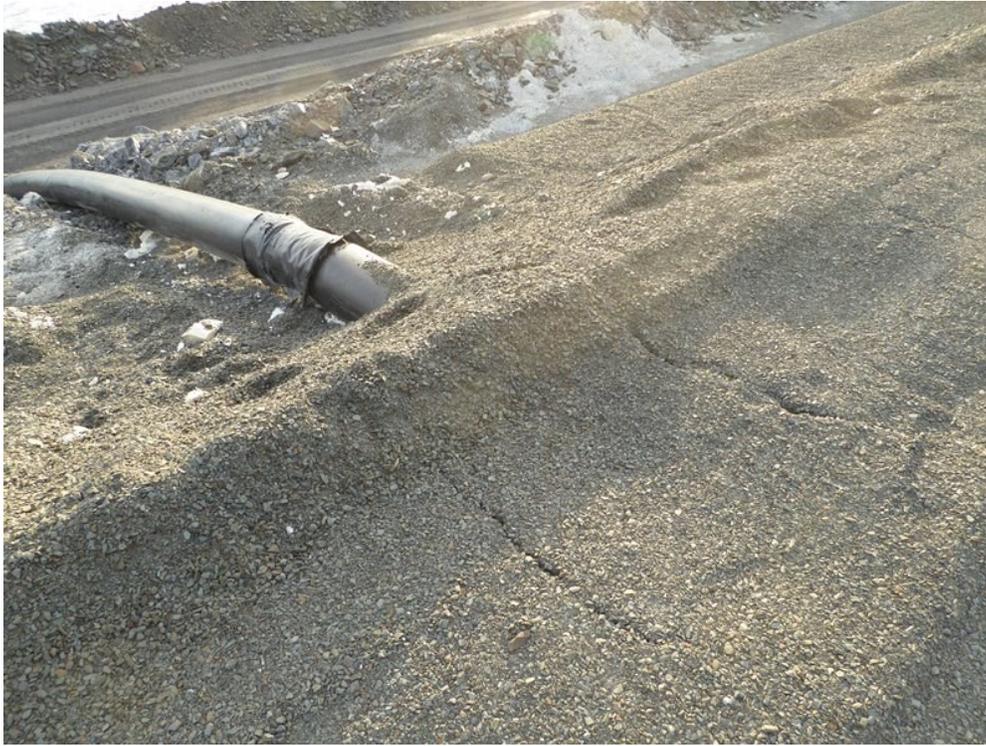
Figure 23 Cracks in the gravel where a pipeline was buried under the roadway/frost protection layer on the crest of the Back Dam. The cracks were apparent in the road bed/frost protection layer fill only, and did not extend into the dam structure itself. Looking northeast.

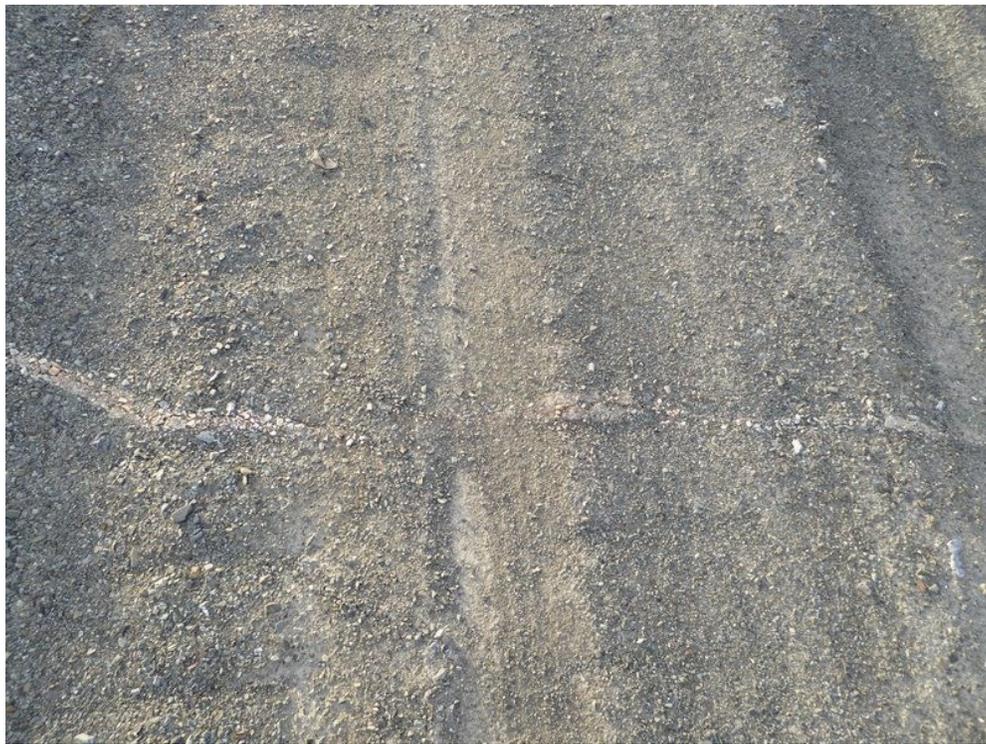
Figure 24 Paint highlighting a crack on the crest of the Back Dam. The cracks were very thin and difficult to trace, but did not appear to extend past the frost protection layer. Looking down.

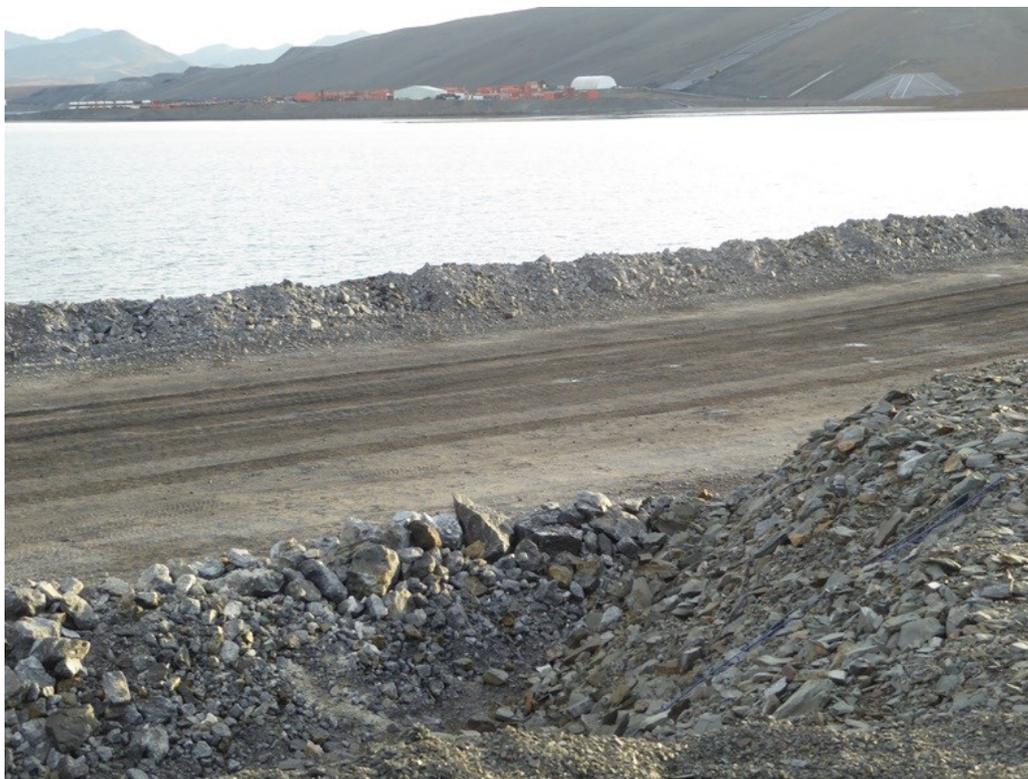
Figure 25 Fill placed on the tailings side of the Back Dam used to maintain haul truck access to the DD2 rock quarry. Haul trucks cannot travel on the crest of the Back Dam due to the possibility of damaging the insulating panels buried under the roadway. Looking northeast.

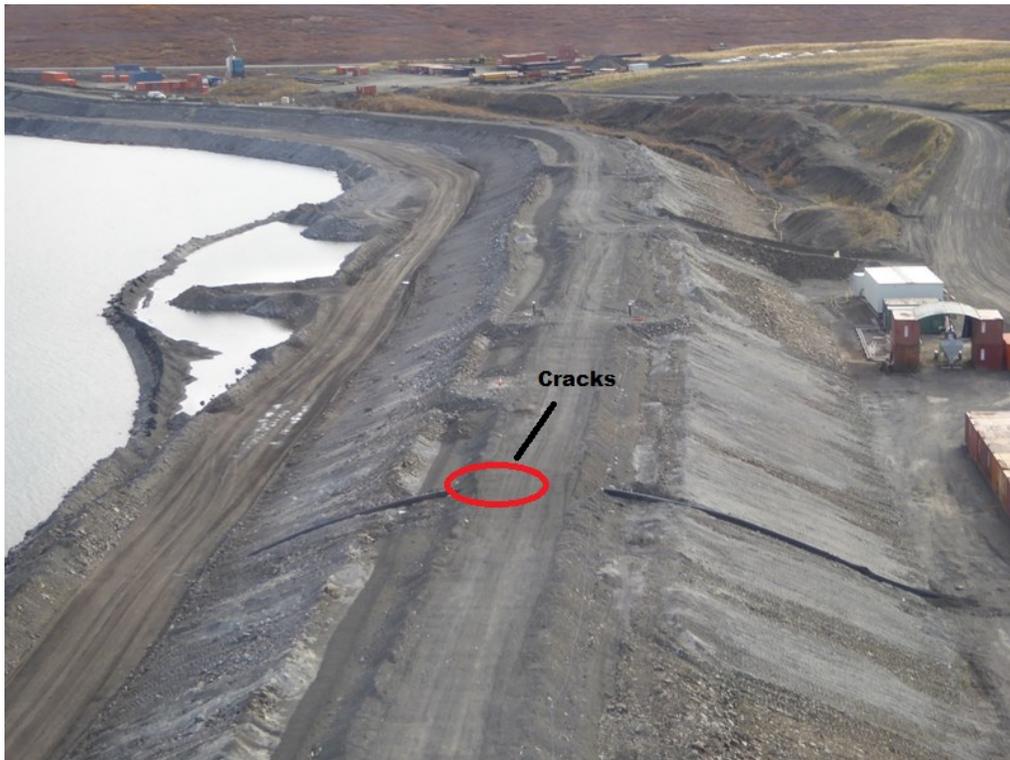
Figure 36 Back Dam showing the area of cracks shown in Figure 23. Looking east from the air.

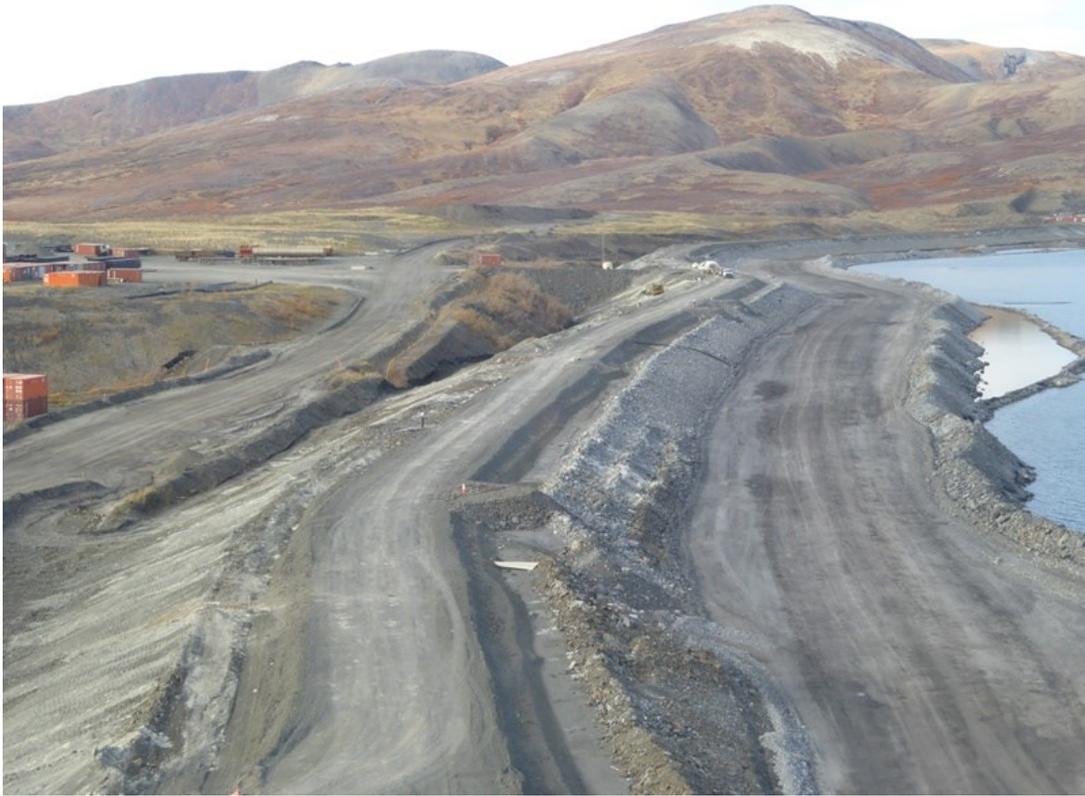
Figure 37 Oblique view of the Back Dam. Looking west from the air.

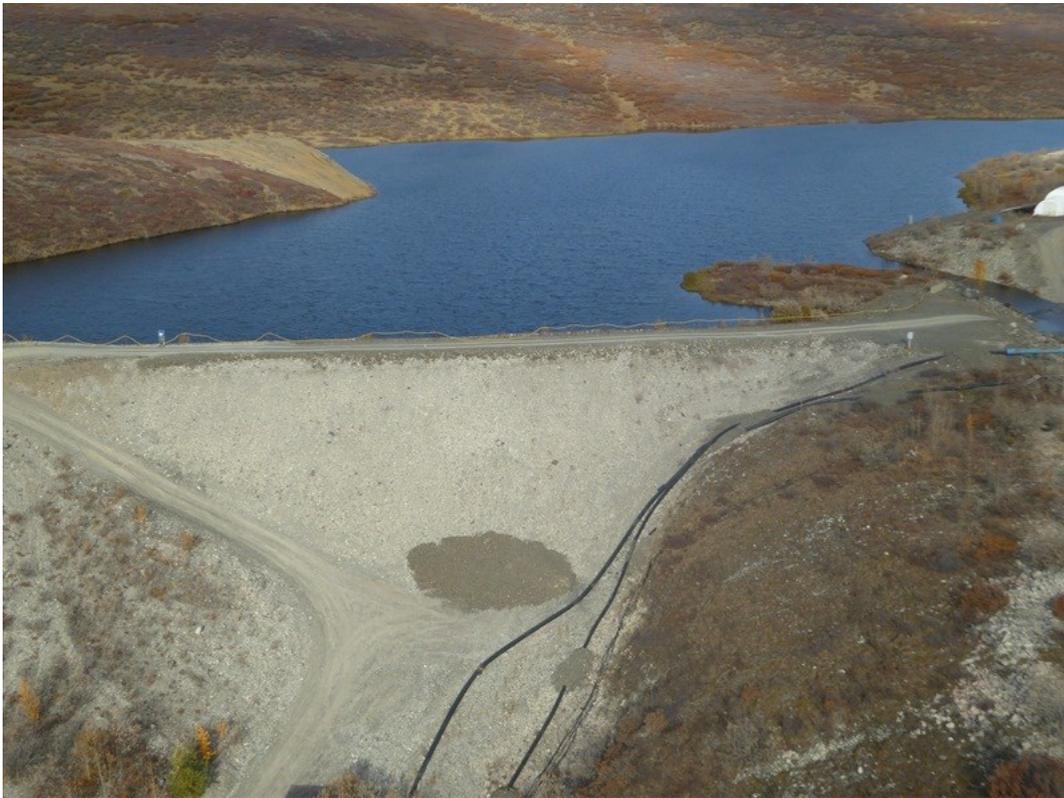
Figure 38 Downstream face of the Freshwater Reservoir Dam. The dark area at the bottom of the dam is an unauthorized repair to the dam. Looking north from the air.

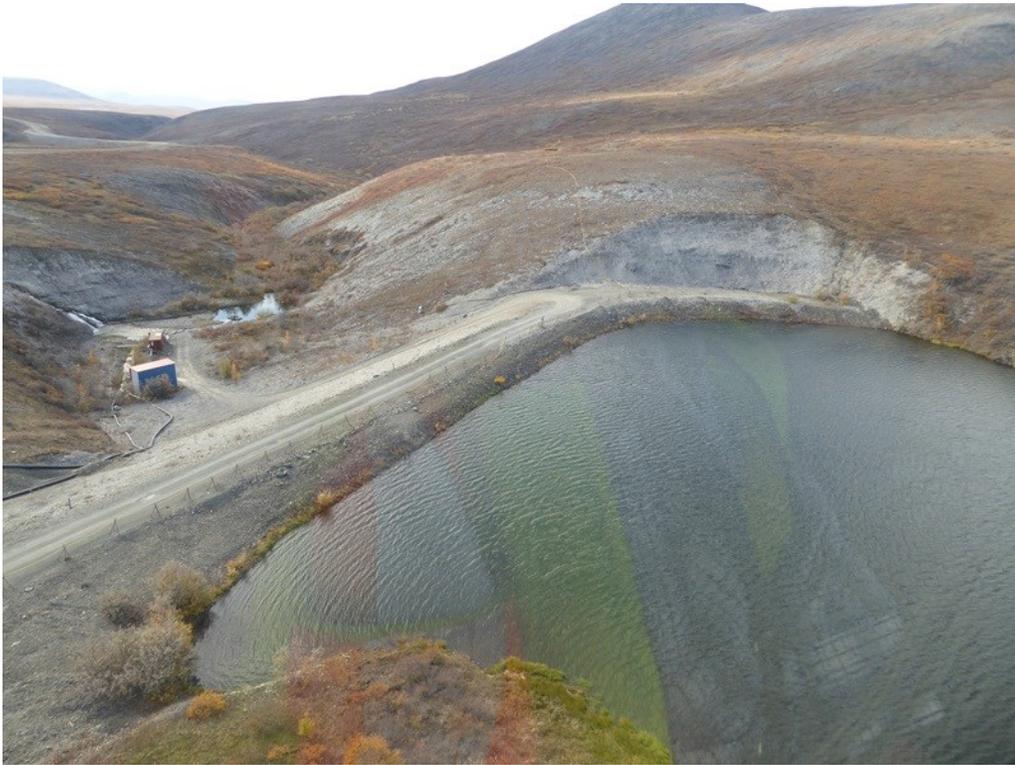
Figure 39 Freshwater Reservoir Dam. Looking southwest from the air.
