## RED DOG MINE INSPECTION REPORT

<b>Inspection Date:</b>	July 25 through July 27, 2016
<b>Weather:</b>	July 25: Sunny-overcast, 69 °F; July 26: sunny, overcast 66 °F; July 27: rain, wind 53 °F
<b>Time of Inspection:</b>	July 25 1:30PM to July 27 noon
<b>Operator Contact:</b>	Chris Eckert (Teck Alaska Incorporated)
<b>Agency Personnel:</b>	ADNR – Carolyn Curley
<b>Inspection Objectives:</b>	General Site Inspection and observation of construction activities.
<b>Documentation:</b>	Photos and field book notes may be reviewed at the Northern Regional Office of ADNR

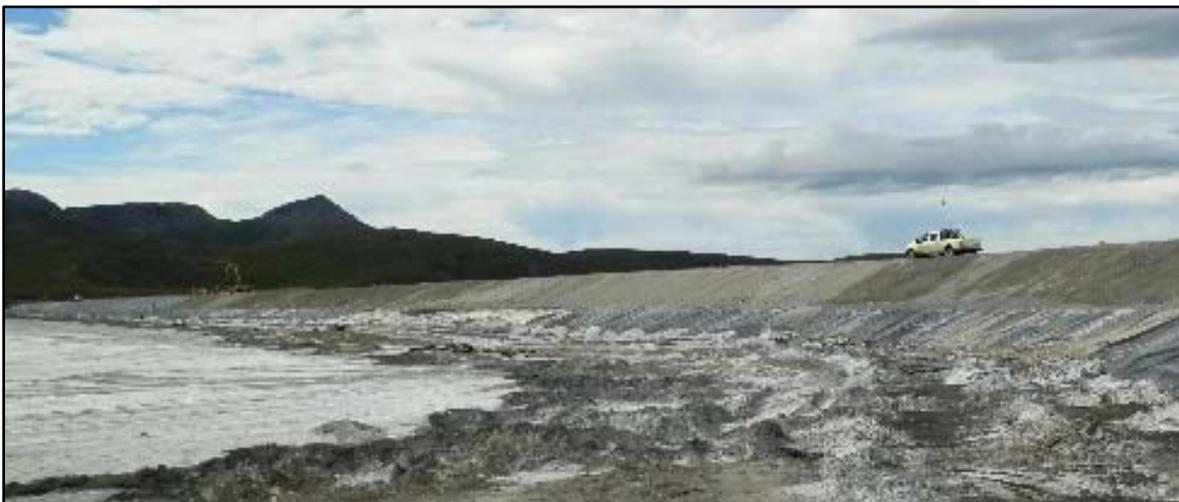
Figure 1: View of liner installation progress on upstream face of main dam, looking west from pipe crossing.

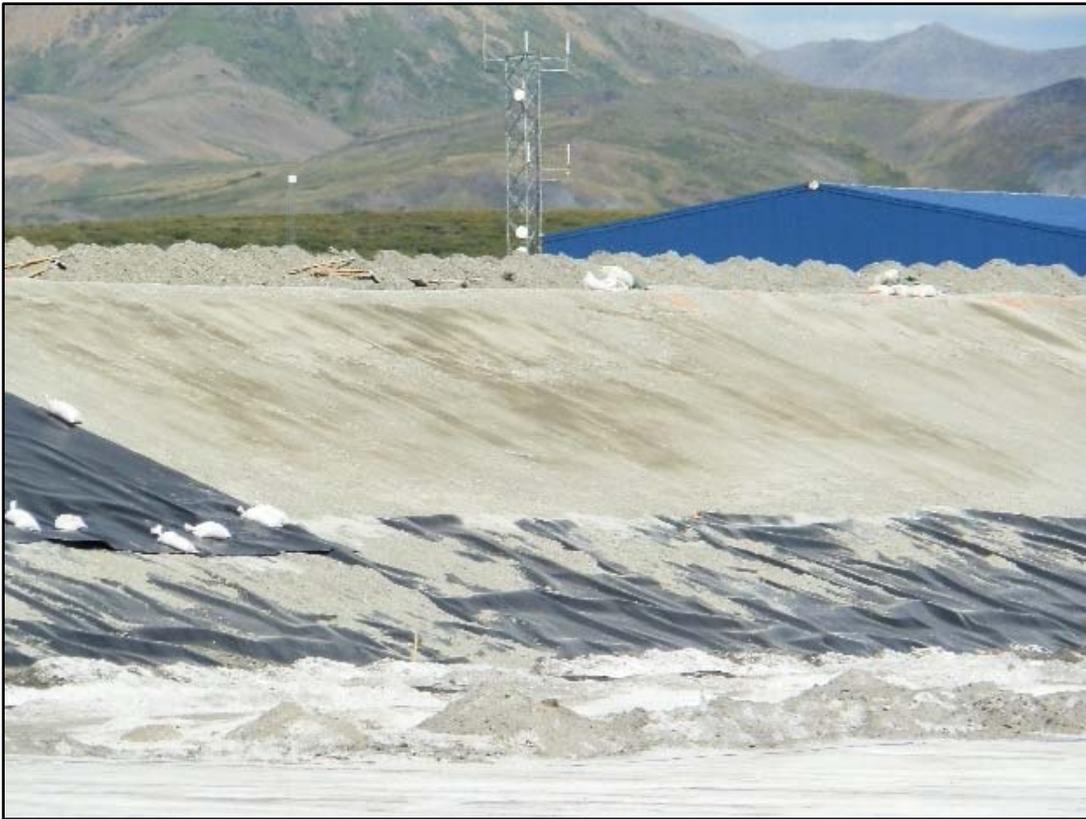
Figure 2: Upstream face of Red Dog Mine Tailings Main Dam showing compacted material before liner placement.

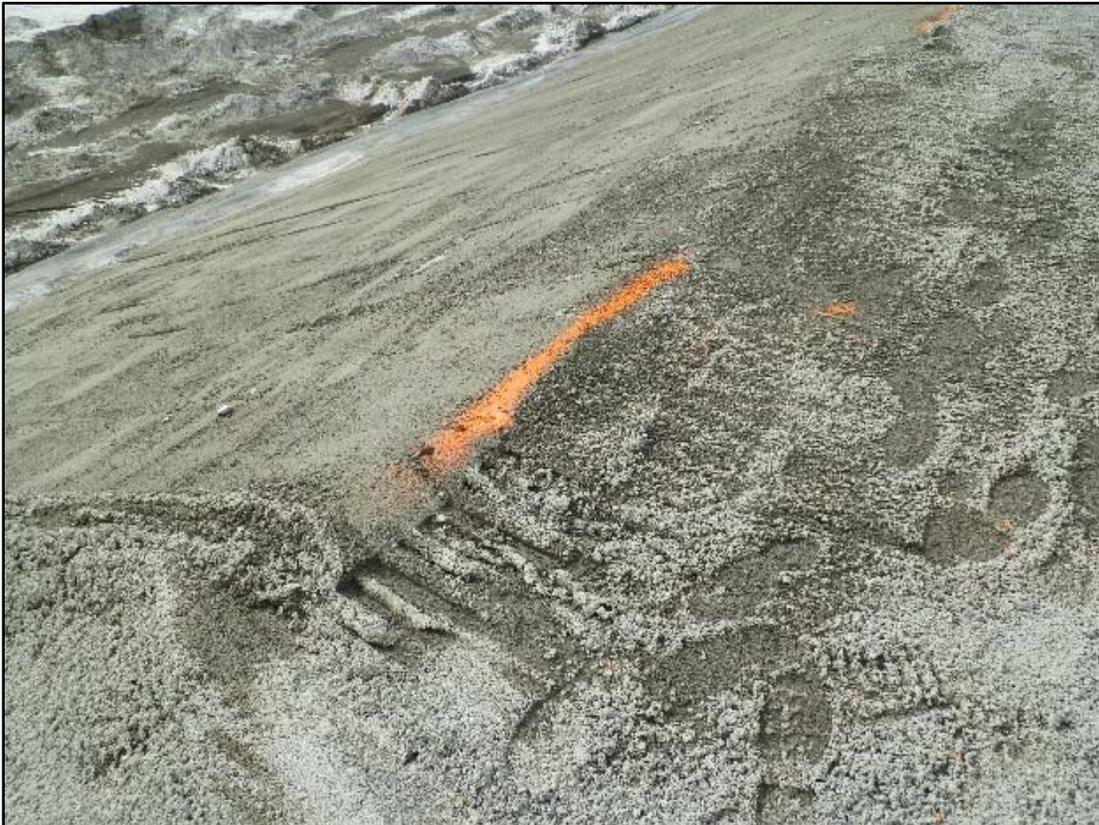
Figure 3: Crest of Red Dog Mine Tailings Main Dam looking down the upstream face.

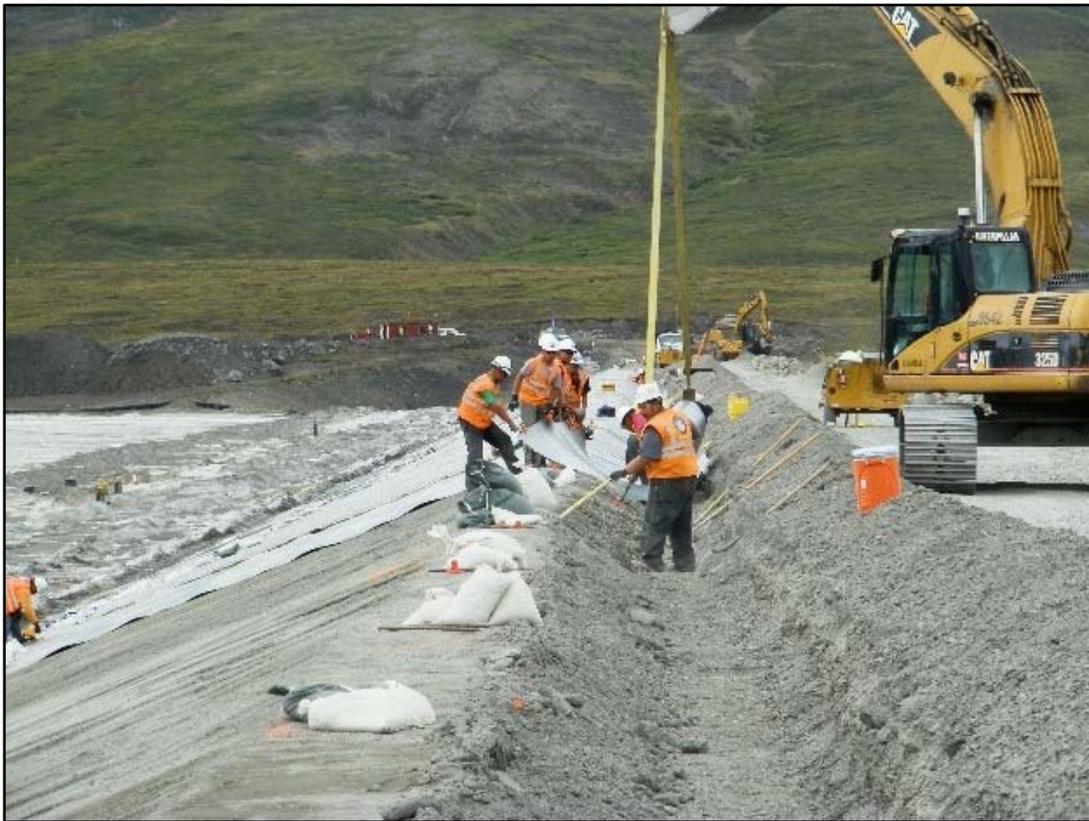
Figure 6: Crew placing liner panel.

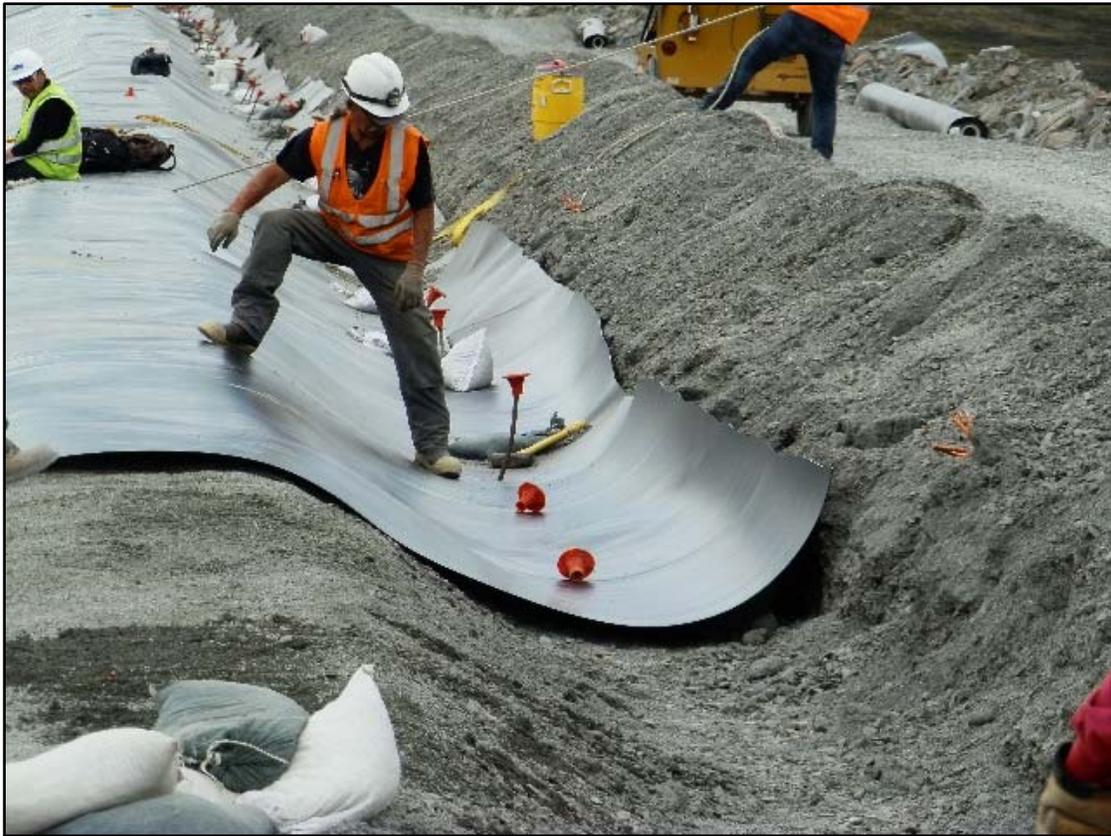
Figure 7: Placement of the liner panel end in the anchor trench.

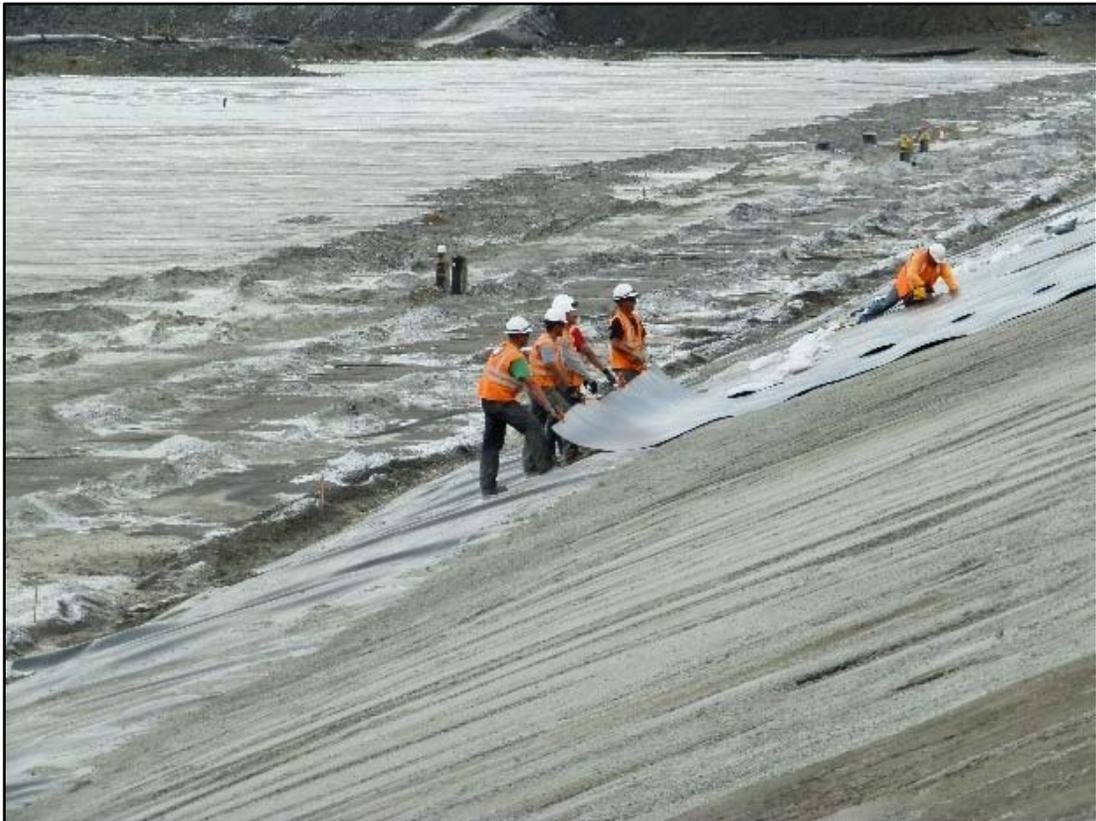
Figure 8: Crew placing liner panel on upstream face of Red Dog Mine Tailings Main Dam.

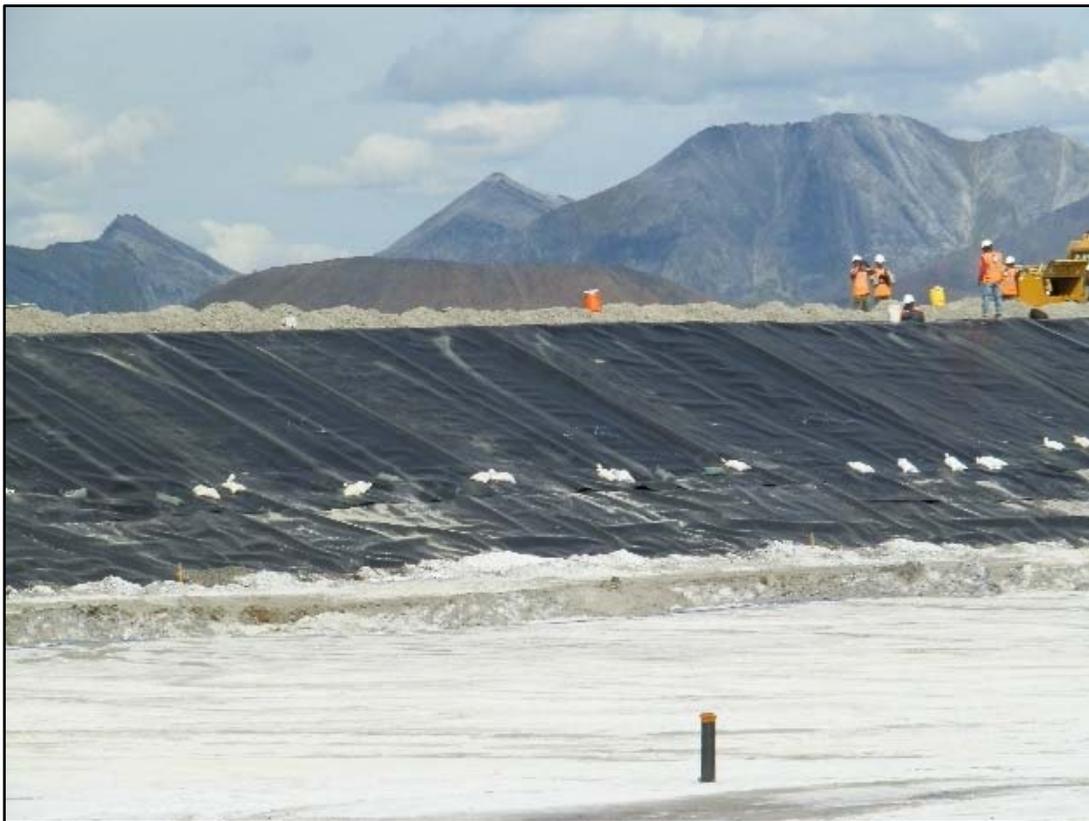
Figure 9: View of panels 139 to 143 in place on upstream face of Red Dog Mine Tailings Main Dam.

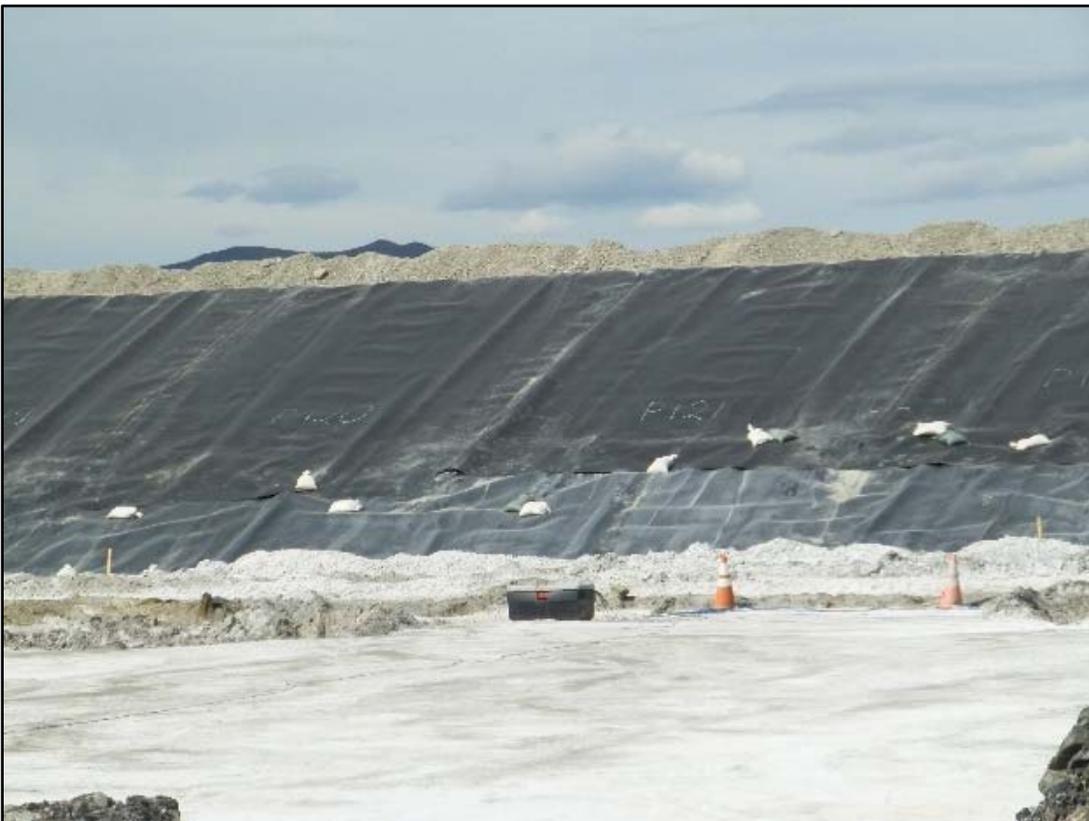
Figure 10: View of panels 119 to 122 on upstream face of Red Dog Mine Tailings Main Dam after seam fusion welding.

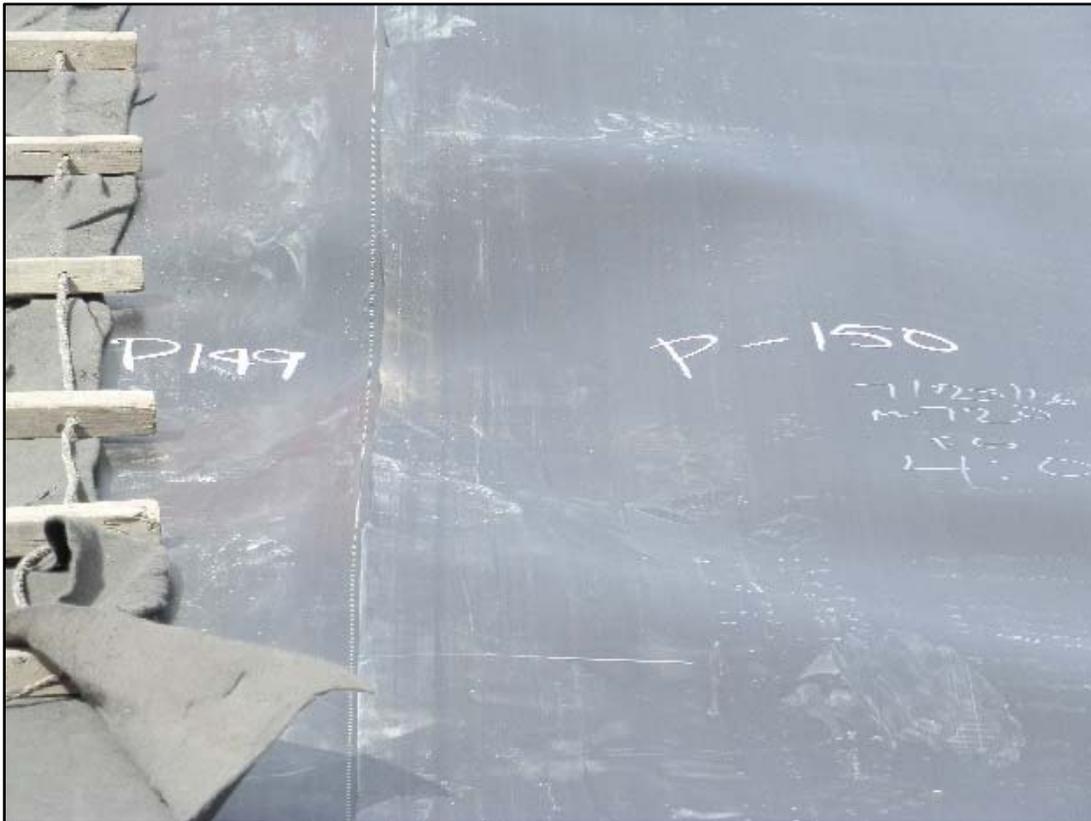
Figure 13: Completed seam fusion weld of panels 149 and 150.

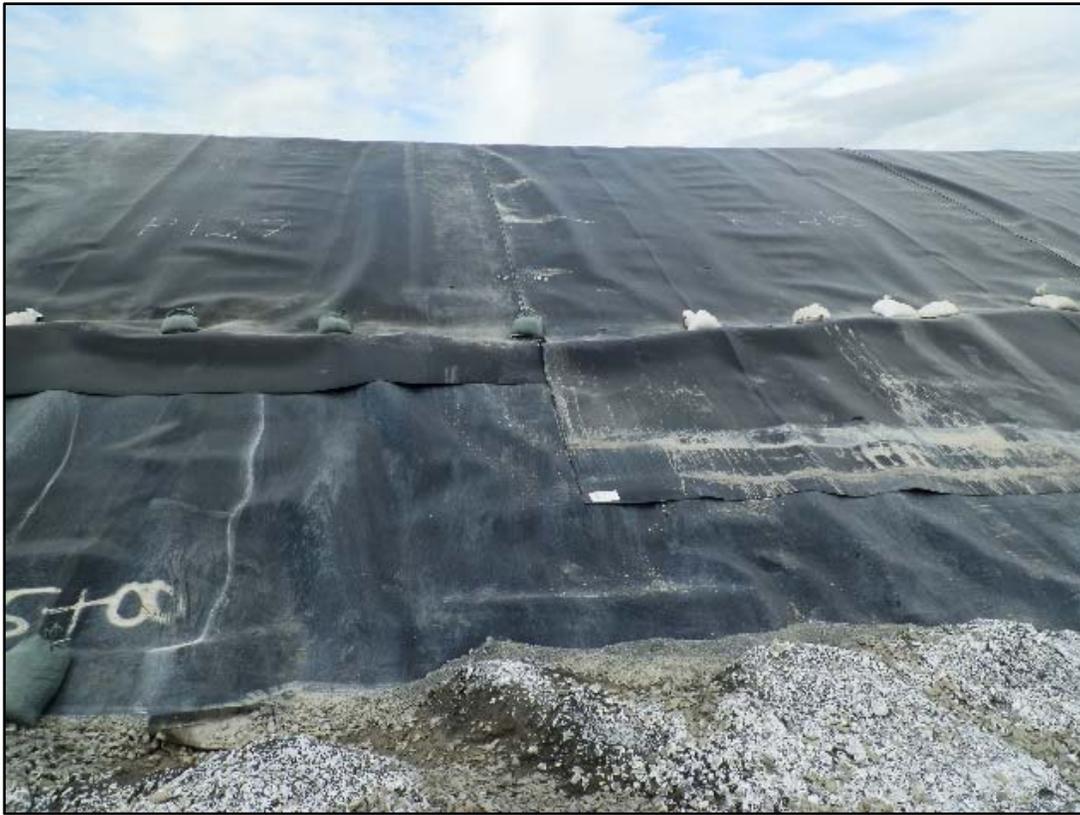
Figure 14: Panel 127 trimmed in preparation for extrusion weld.

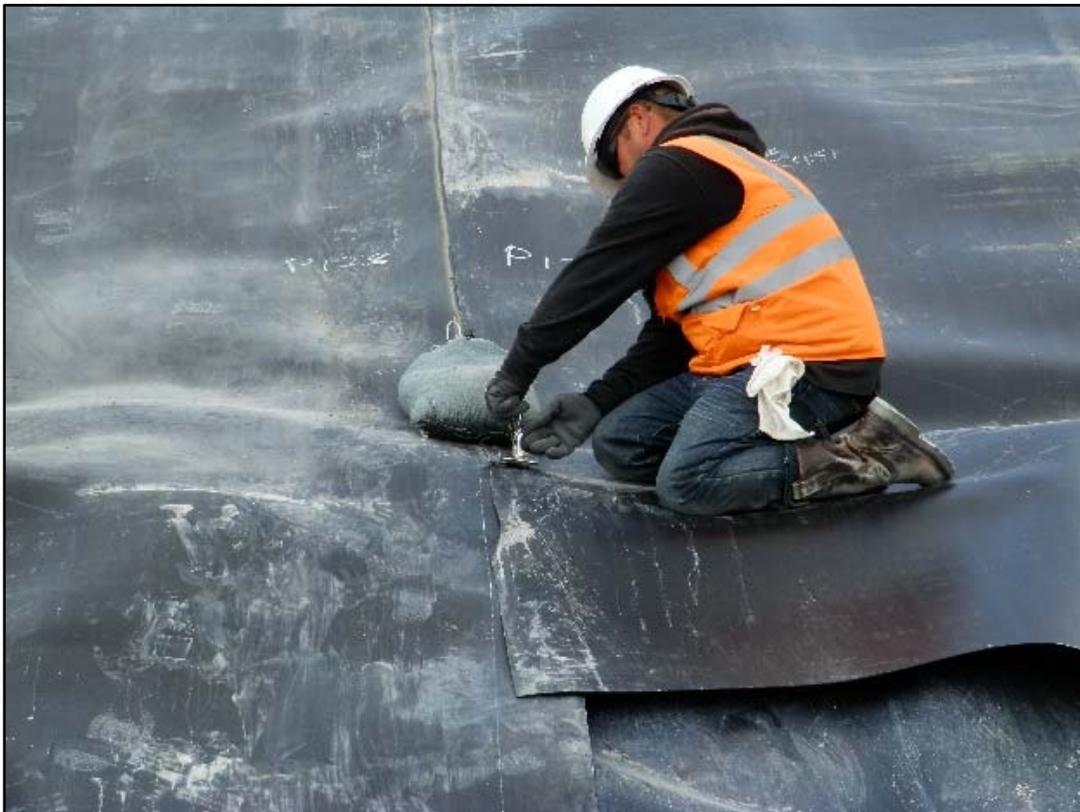
Figure 15: Crew extrusion welding at panels 128 and 129.

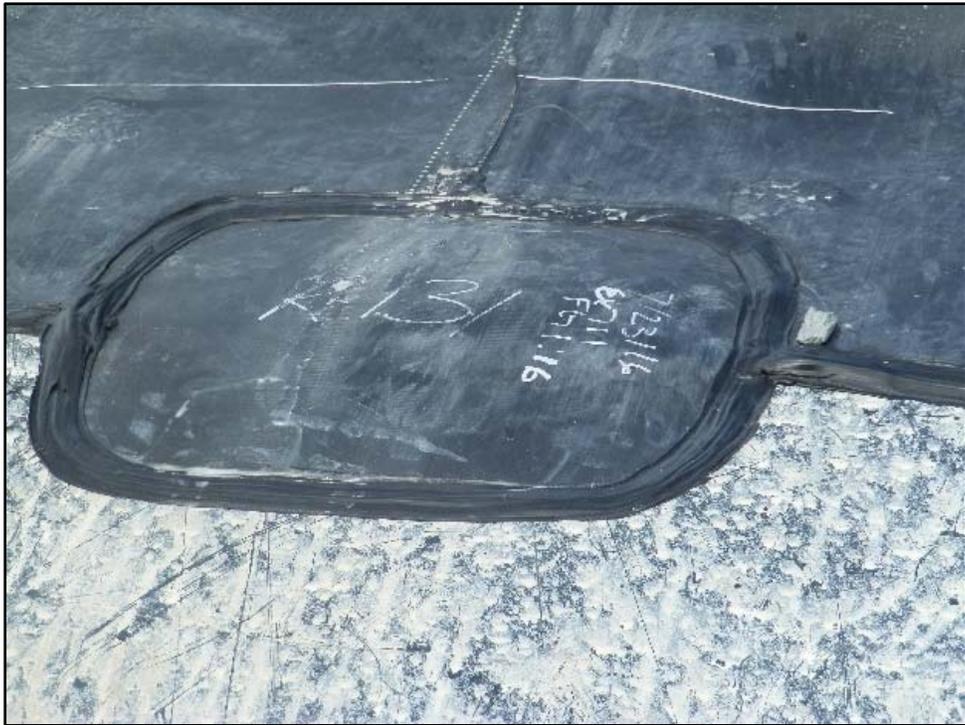
Figure 16: Patch at intersection of existing liner, panel 104 and panel 103.

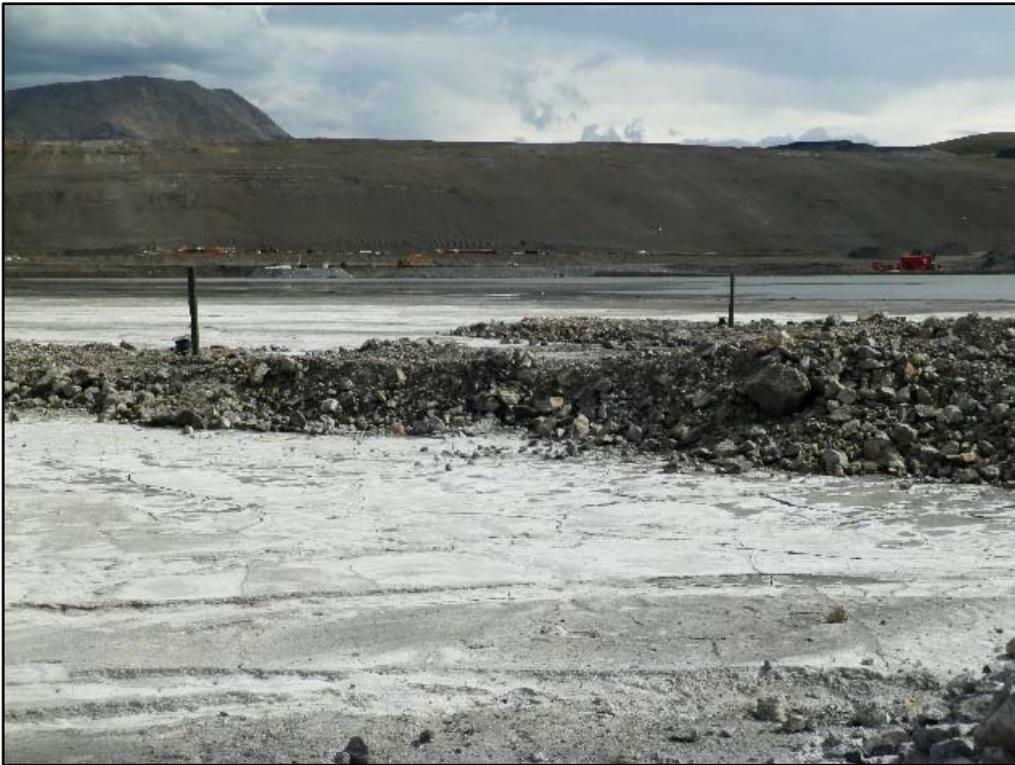
Figure 18: Piezometers SS-5-16 (Left) and SS-10-16 (Right) installed in Tailings Storage Facility.

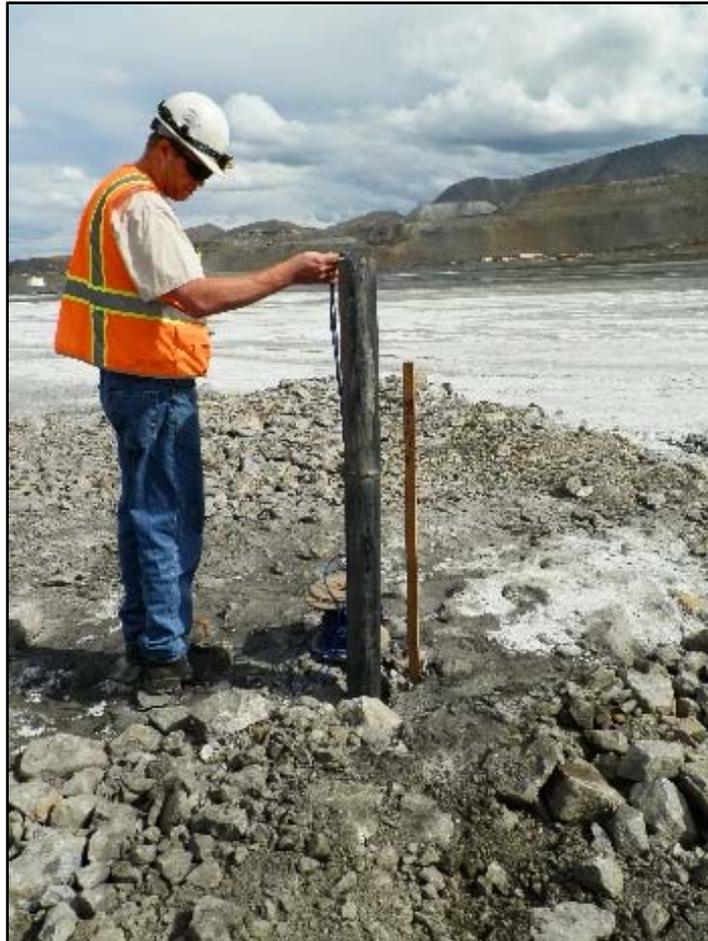
Figure 19: Piezometer SS-10-16 installed. Equipment to be hooked up to power supply.

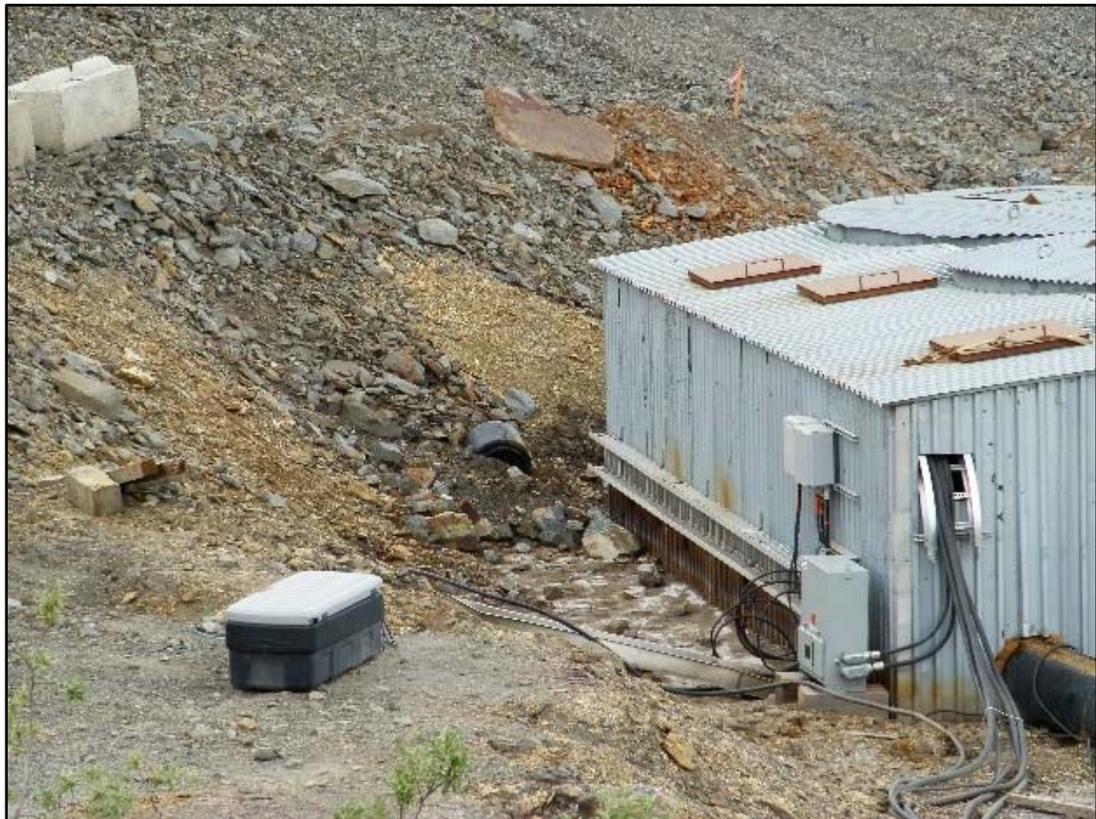
Figure 21: No visible seepage on the Red Dog Mine Tailings Main Dam downstream face behind seepage pumpback system building.

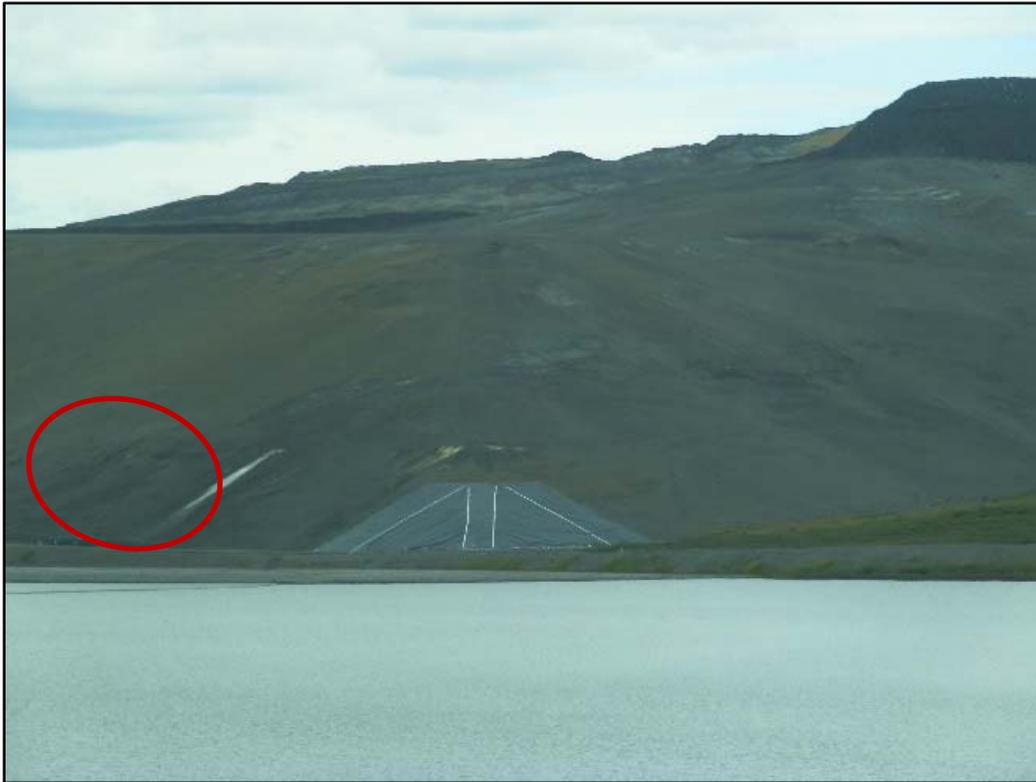
Initial cover test on southwest corner of the Main Waste Dump was abandoned. Location of new cover test will be to the north of the abandoned cover test, near Material Site 15 (MS-15).

Figure 26: View of Main Waste Dump, southwest corner. Approximate location for new cover test is shown.

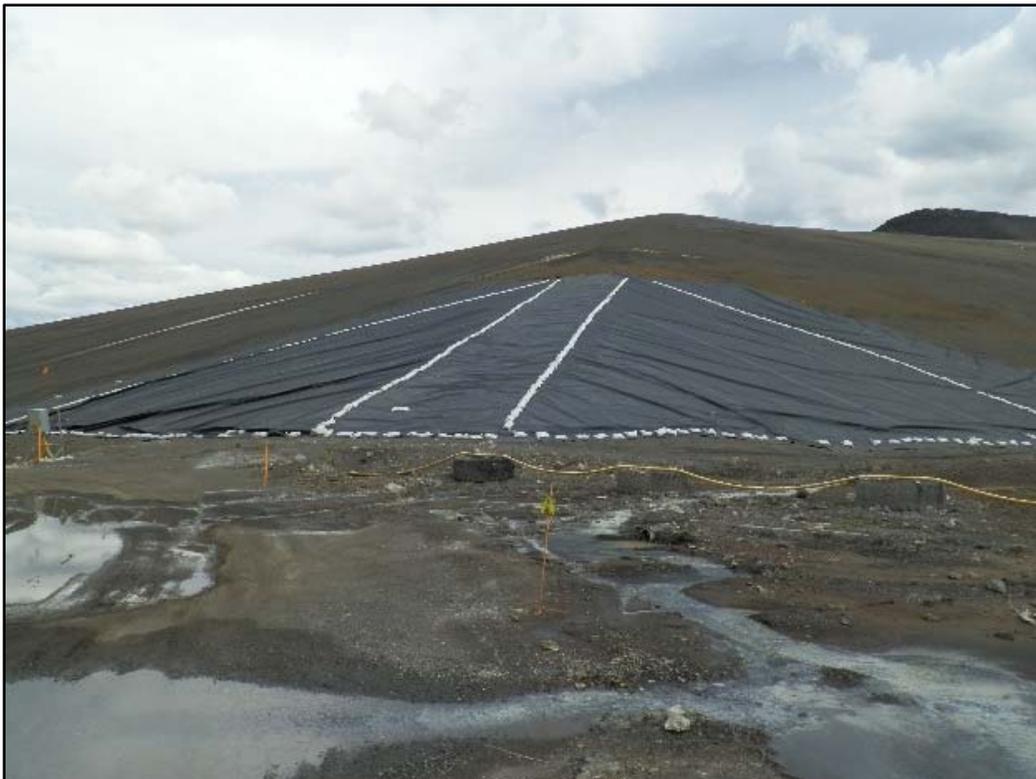
Figure 27: Abandoned cover test southwest corner of main waste dump.

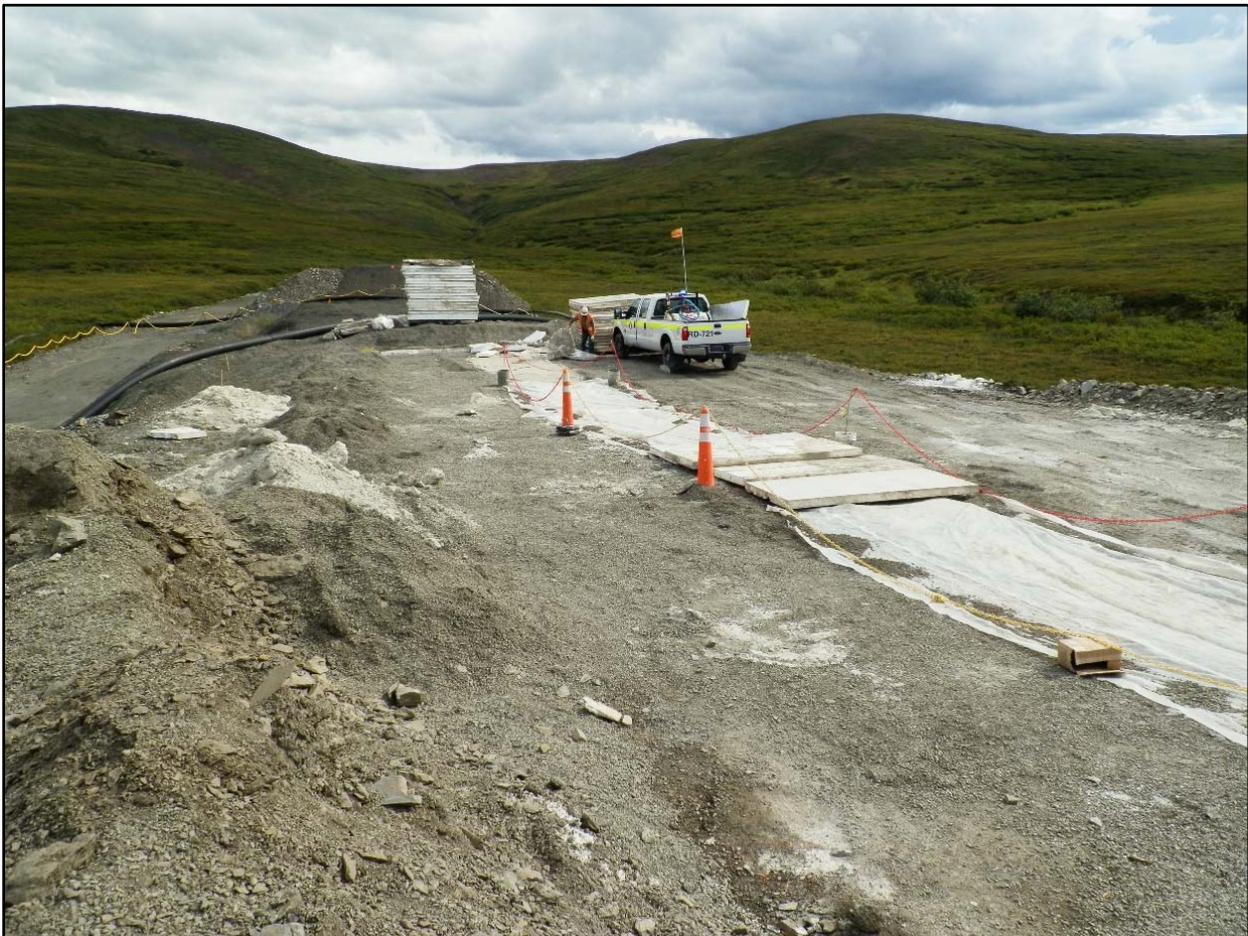
Figure 34: Cement was protected with plastic while curing.

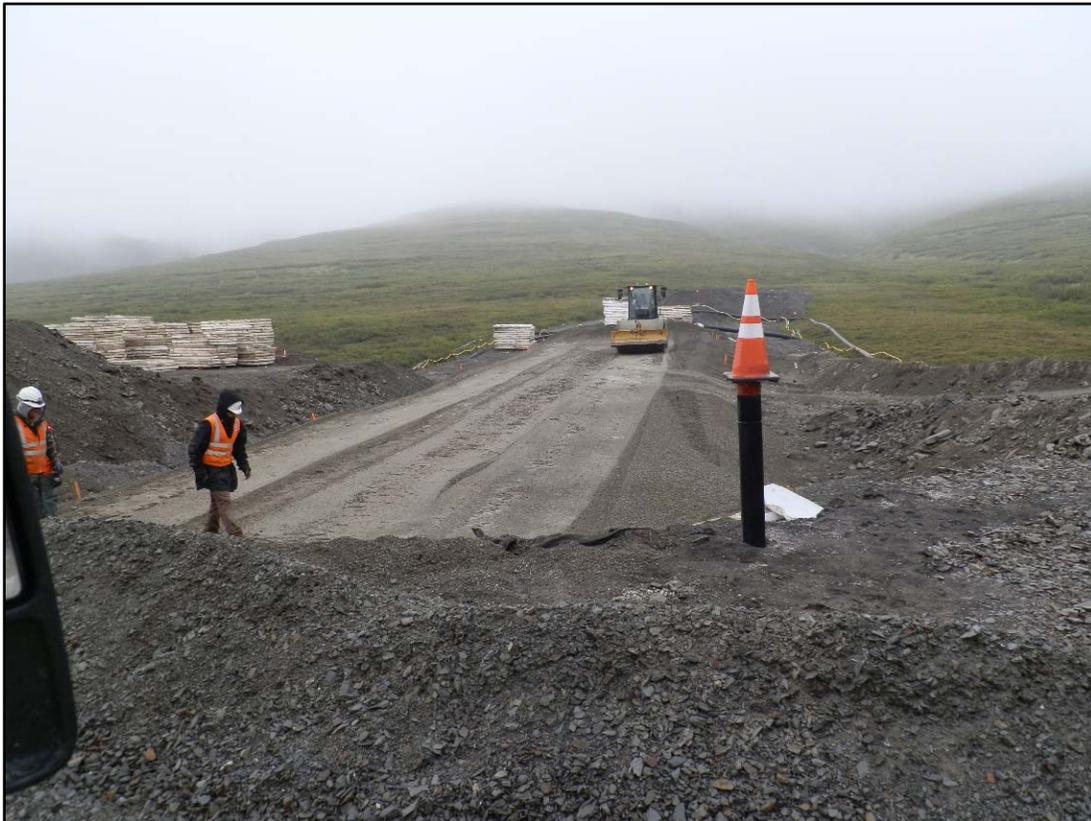
Figure 36 Insulation placed. Frost cap installation in process.

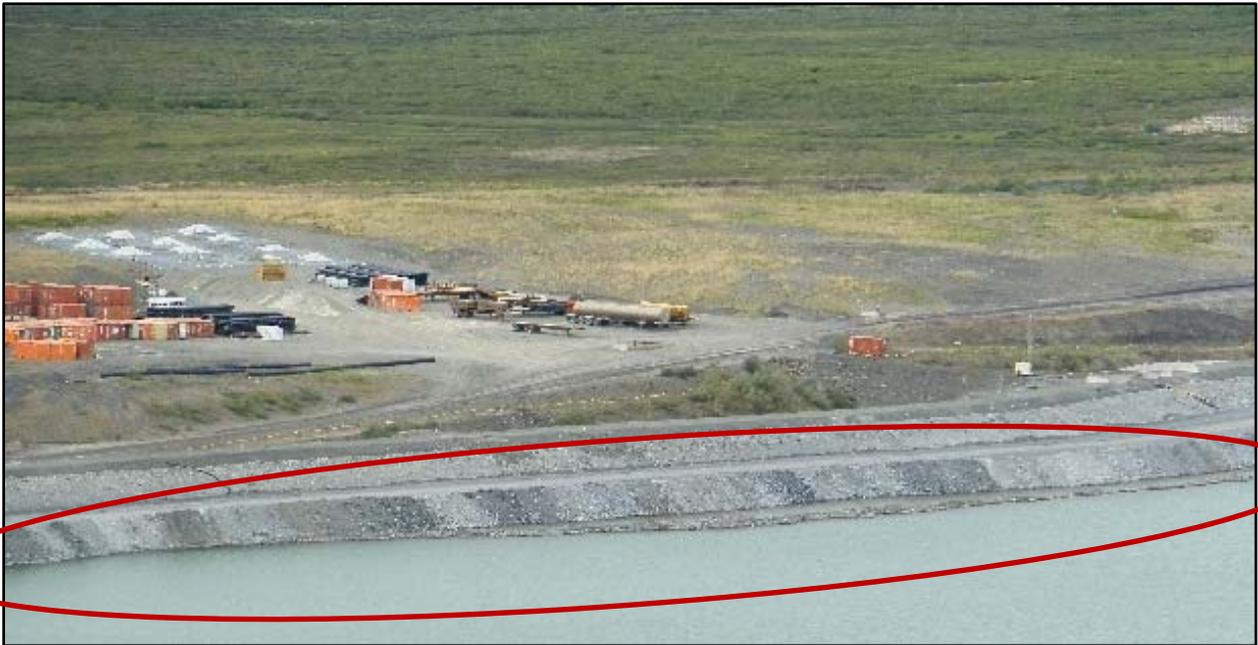
Figure 37: Northeast side of Red Dog Tailings Back Dam with area of fill circled.

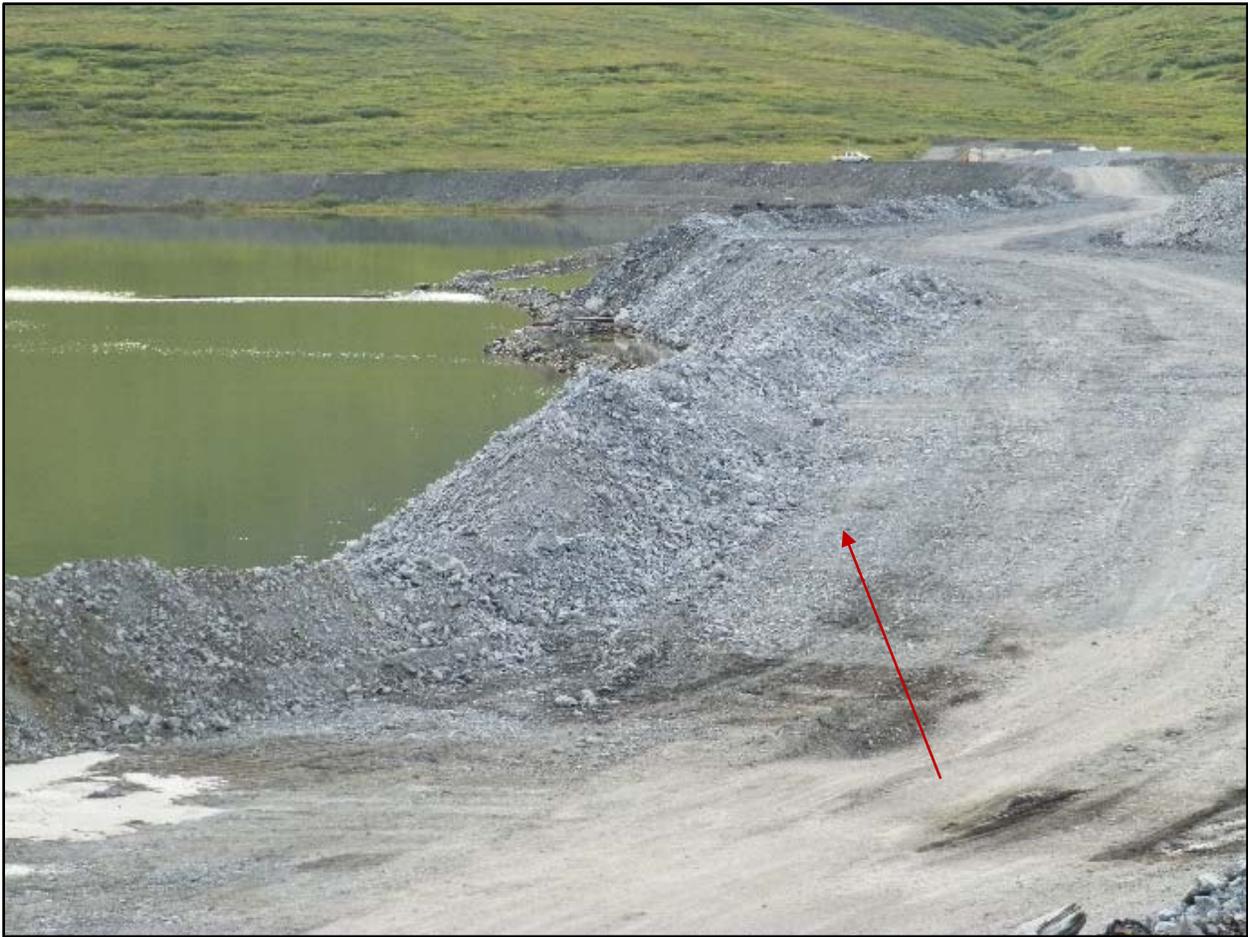
Figure 39: View from center of Red Dog Tailings Back Dam looking east along the north side. Note the elevation change of the road along the north face of the Back Dam.

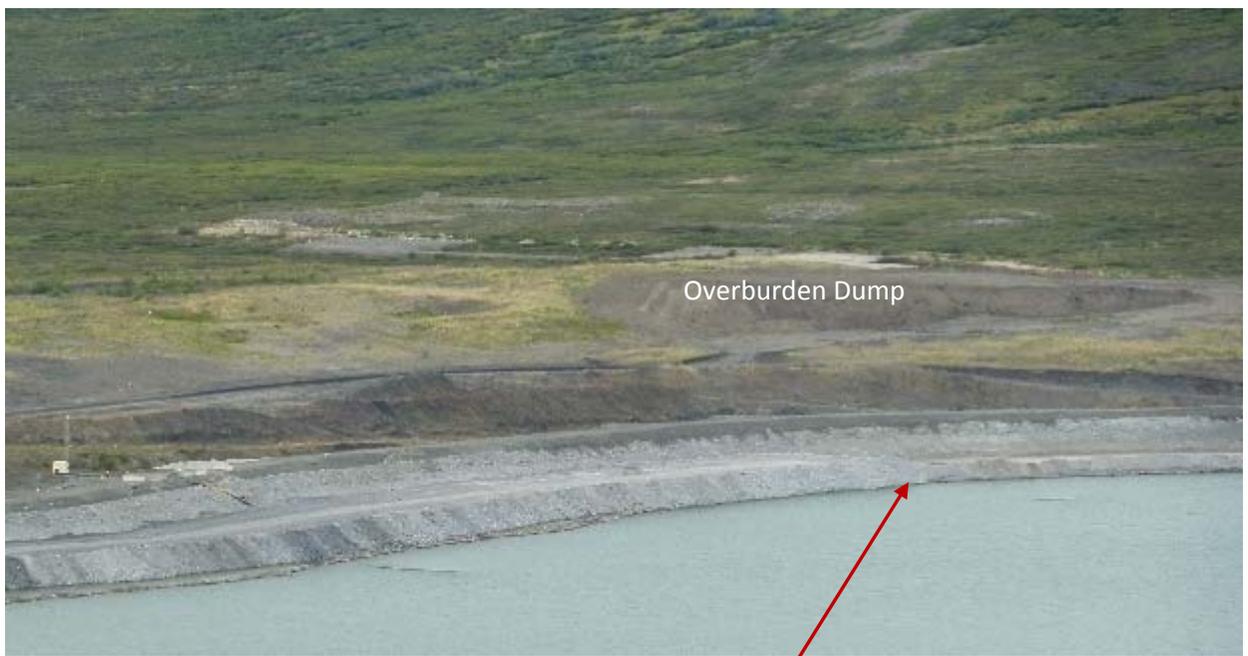
Figure 40: Center of Red Dog Tailings Back Dam as viewed from the Main Waste Dump. Note elevation change of road on north side of the dam. The Overburden Dump is visible in the background.

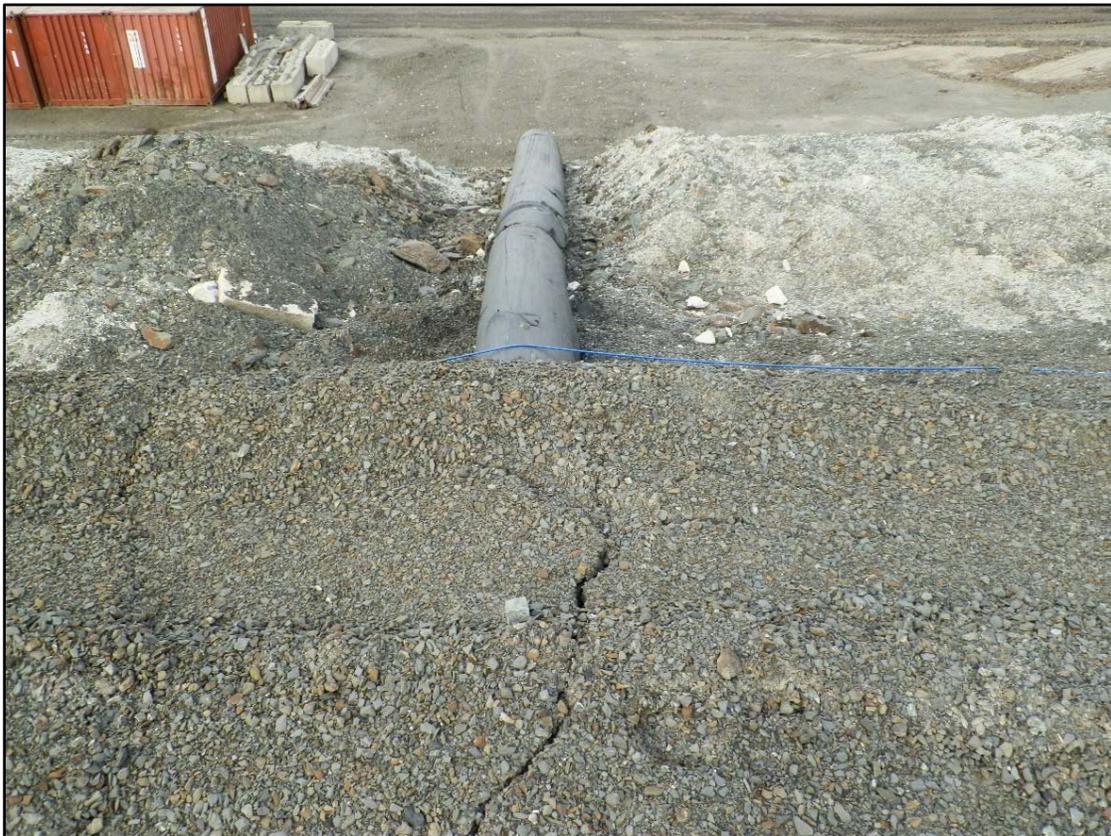
Figure 46: Example of surface crack in the frost cap associated with culvert.

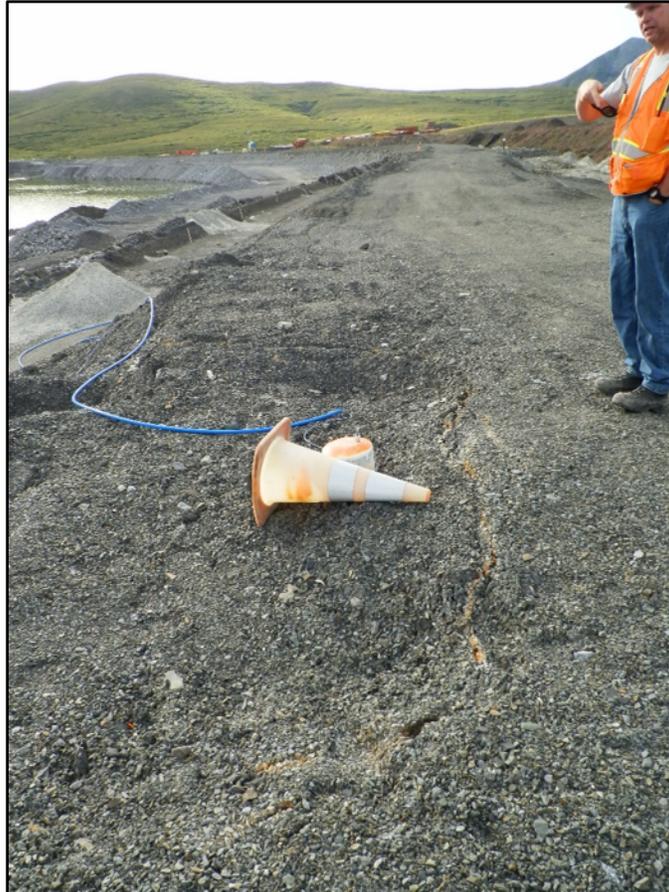
Figure 48: Subsidence at instrument near west end on the back dam. This was noted in previous inspections by Dam Safety.

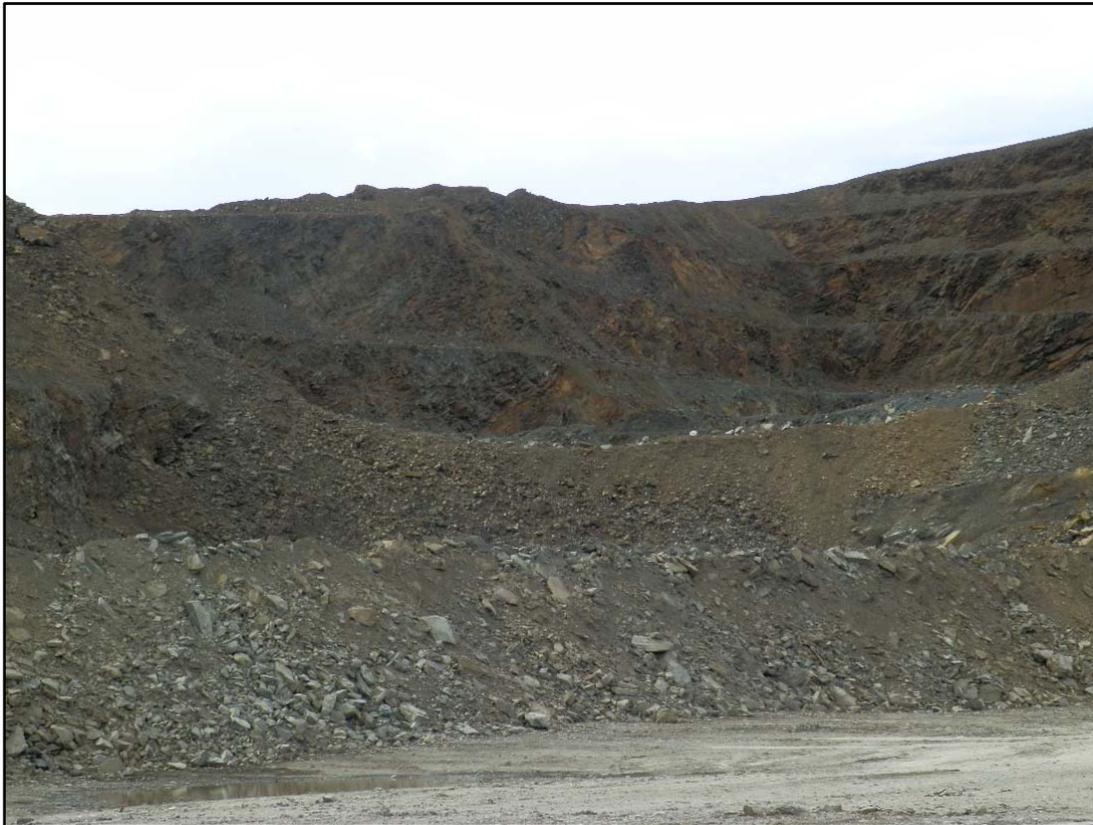
Figure 52: South face in fault zone of DD2 Quarry. Material did not meet specifications for use in projects on site.

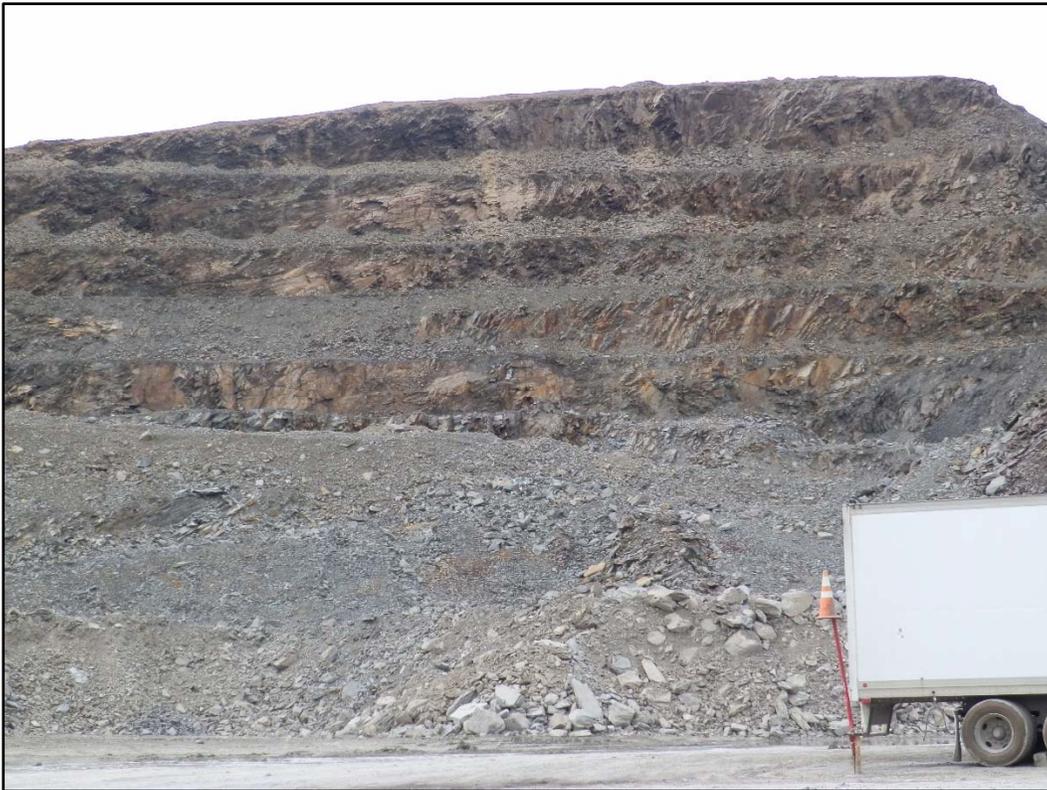
Figure 53: West face of DD2 Quarry with competent material.
