## RED DOG MINE INSPECTION REPORT:

<b>Inspection Date:</b>	July 23 to 25, 2014
<b>Weather:</b>	Overcast and windy with light drizzle to sunny and windy, Approximately 50 degrees
<b>Time of Inspection:</b>	8:00 am to 5:30 pm
<b>Operator Contact:</b>	Chris Menefee (Teck)
<b>Agency Personnel:</b>	ADNR – Brent Martellaro, Stephanie Lovell DEC – Tim Pilon, Neil Lehner, Will Collingwood
<b>Inspection Objectives:</b>	General Inspection of the Red Dog Mine site.

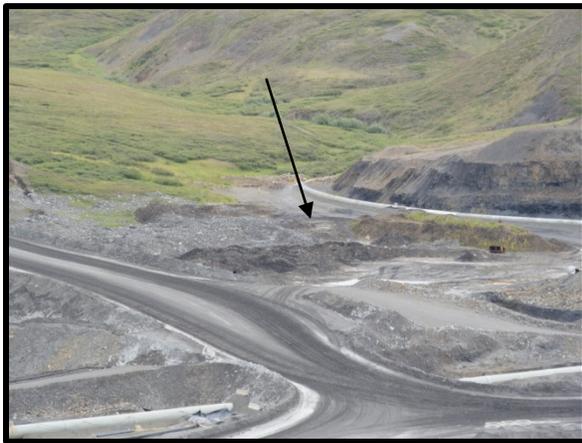
The inspection commenced at the Main Pit Overlook where the Main Pit, Aqqaluk Pit, Tailings Storage Facility, and Crusher operations were viewed. From this location the organic stockpiles in the Shelley Creek area (Figure 1) and the Oxide Stockpile above the Main Waste Stockpile (Figure 2) were visible. A dozer worked the Main Pit 840 (ft) Bench pushing waste rock into the Main Pit Lake (Figure 3). The water level of the Main Pit Lake and progress in the Aqqaluk Pit were observed (Figure 5). The locations of the primary gyratory crusher (blue building) and the secondary jaw crusher (red and white building) were pointed out (Figure 4). Teck noted that due to harder rock in the Aqqaluk Pit and an interest in increasing the mill's throughput capacity, the company was considering building a larger gyratory crusher for primary use, and using the current gyratory crusher as the secondary in lieu of the jaw crusher, which would be decommissioned and demolished. The need to blend ore for crusher feed was discussed.

Figure 1: Shelley Creek Organic Stockpile

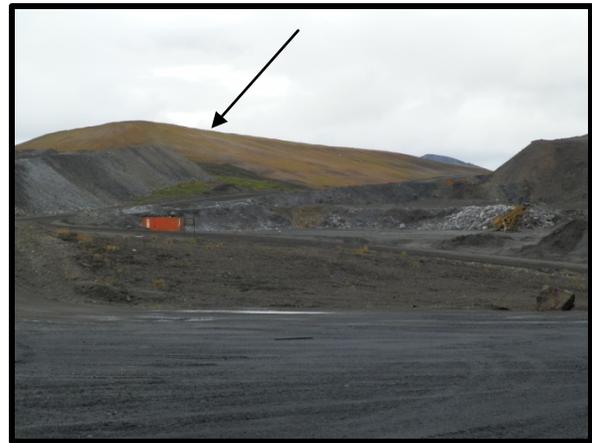
Figure 2: Oxide Stockpile

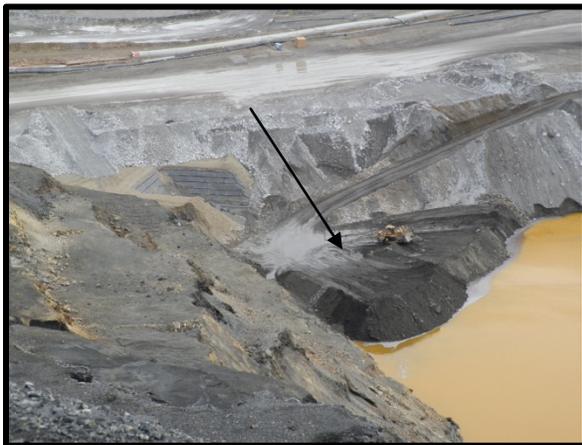
Figure 3: 840 Bench Waste Rock Dumping Platform

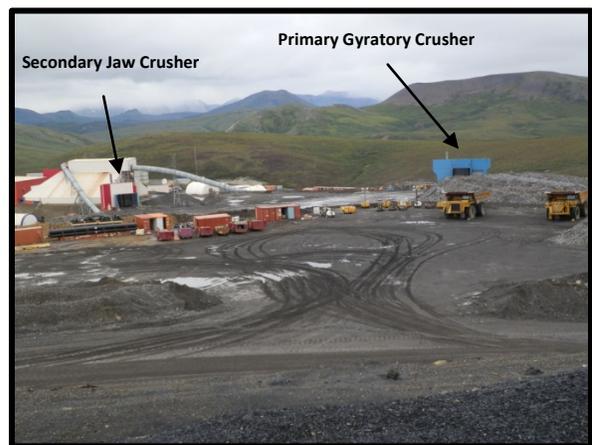
Figure 4: Crusher Area

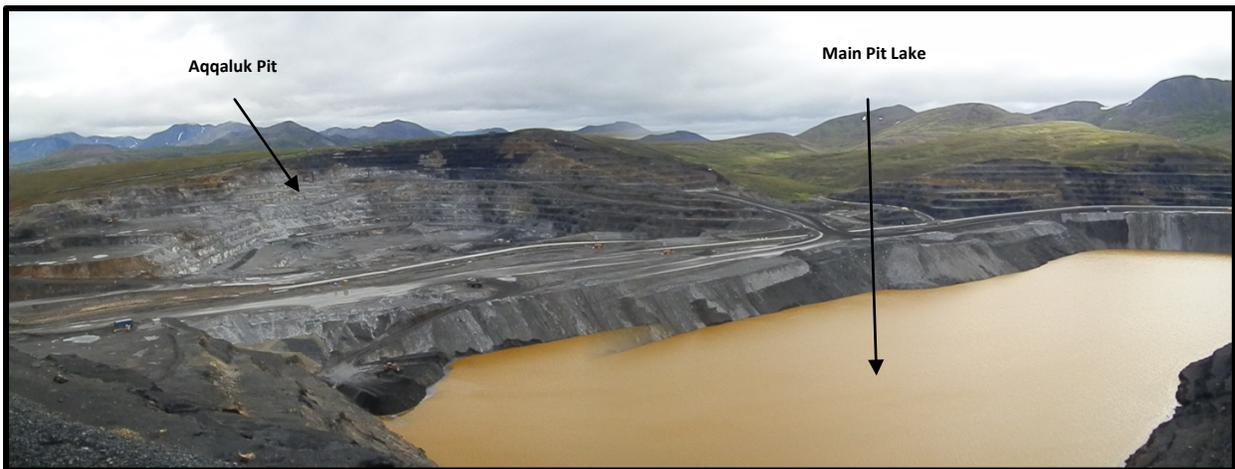
Figure 5: Aqqaluk and Main Pit Lake (NOTE: photo is panoramic from spliced images and displays some offsets)

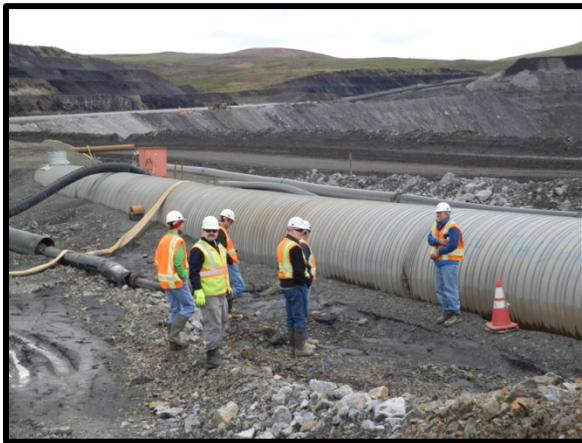
After breaking for lunch, the inspection continued. The team examined the Red Dog Creek diversion pipeline area, where during May 28 and 29, 2014 ice temporarily plugged the culvert causing an overflow of the non-contact water out of the culvert's man holes (Figure 6).

Figure 6: Overflow Area

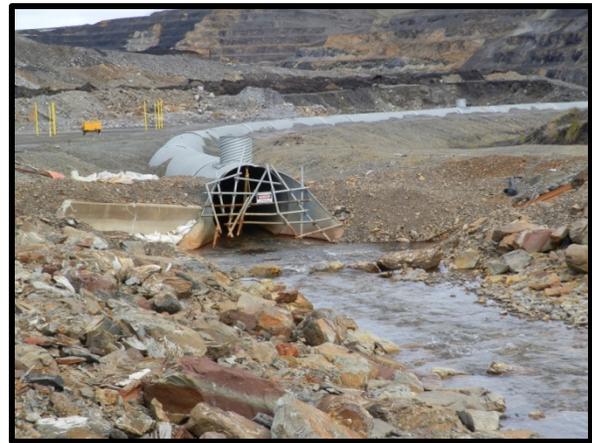
Figure 7: Non-contact Water Collection Point

The diversion pipeline route was observed up to the collection point of the non-contact water just below the confluence of Rachael Creek and the Lisa Creek (Figure 7 above). Along the route, ADNR noted areas where natural colonizing of vegetation was occurring along the Main Pit's upper benches, particularly in the Kivalina Formation (Figures 8 and 9). In benches below Rachael Creek, natural colonizing was also visible in similar looking shale (Kayak or Kivalina Formations) (Figure 10). A young Spruce tree growing above this area was unexpected (Figure 11).

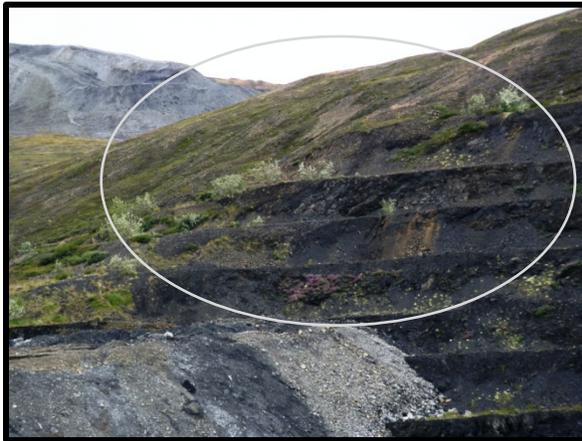
Figure 8: Upper Benches Main Pit Natural Vegetation

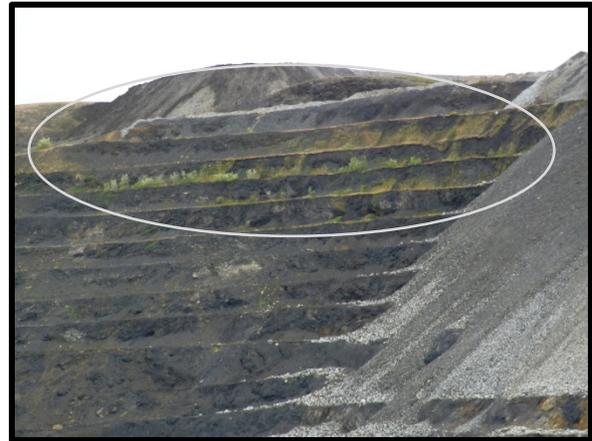
Figure 9: Upper Benches Main Pit Natural Vegetation

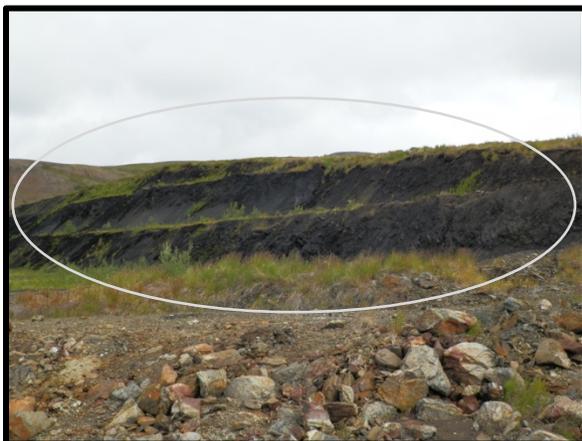
Figure 10: Natural Vegetation below Rachael Creek

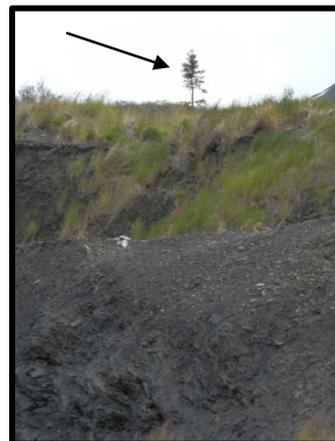
Figure 11: Spruce Tree

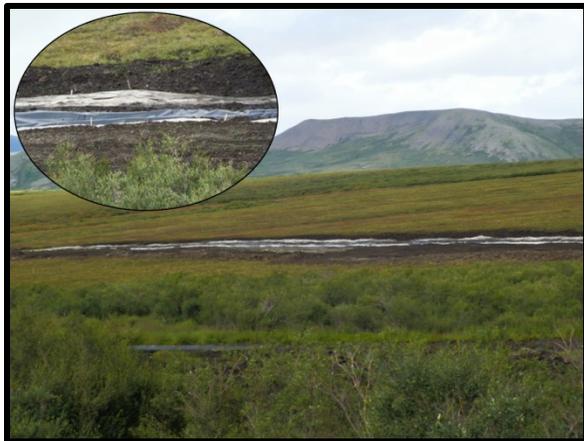
The inspection proceeded to the Aqqaluk Pit, where the new storm water diversion channel was observed (Figure 12, Inset shows enlargement). Also of note, an exploration drill rig was operating just north of the Aqqaluk Pit (Figure 13). This exploration project was helicopter supported, utilizing a sling to mobilize the equipment to drilling locations, rather than building roads and creating additional disturbance (Figure 13 Inset).

Figure 12: New Storm Water Diversion Channel

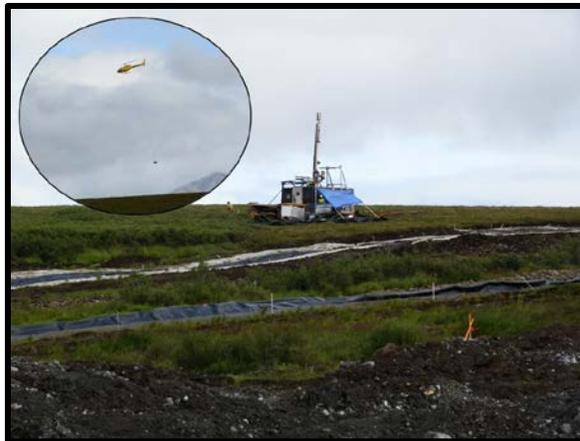
Figure 13: Helicopter Supported Exploration Drill Rig

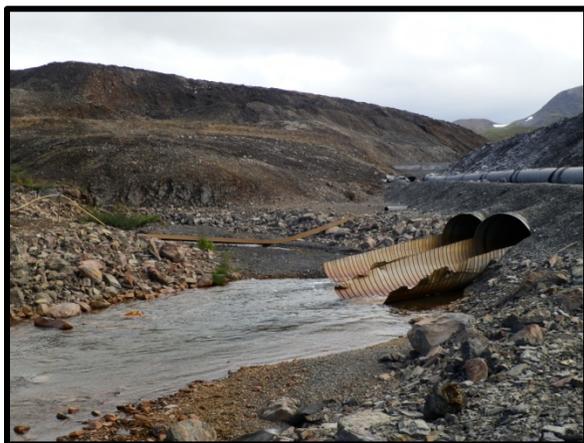
Figure 14: Red Dog Creek Diversion Terminus

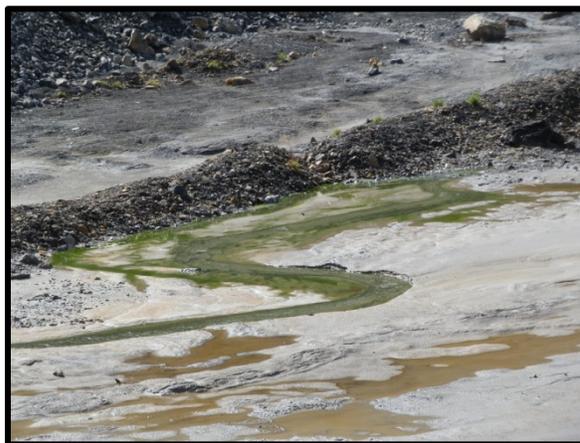
The Red Dog Creek diversion terminus was observed (Figure 14). At the Mine Drainage Dam for contact water, algae were observed growing (Figure 15). The inspection continued to the Seepage Collection area below the Main Dam (Figure 16). The ferricrete removal appears effective in stopping the seeps previously observed and restoring the designed function of the Seepage Collection System. Vegetation along the northwest abutment of the Main Dam had been cleared in preparation for construction of the dam raise (Figure 17).

Figure 15: Algae Growth at Mine Drainage Sump

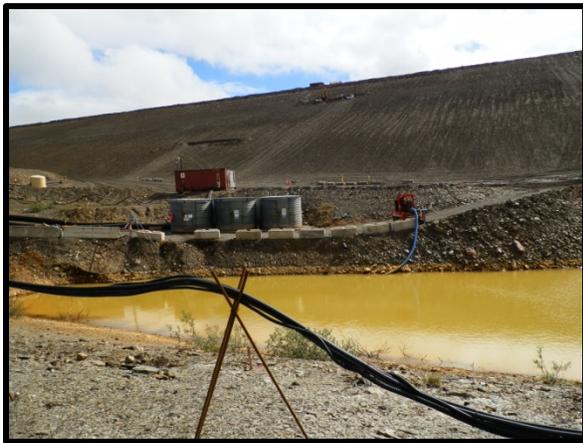
Figure 16: Seepage Collection Area

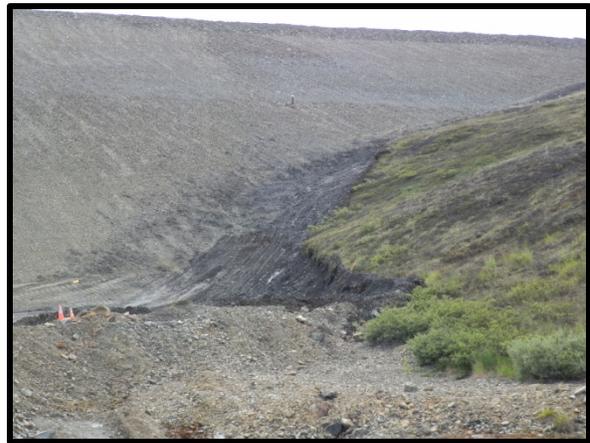
Figure 17: Vegetation Clearing for Dam Raise

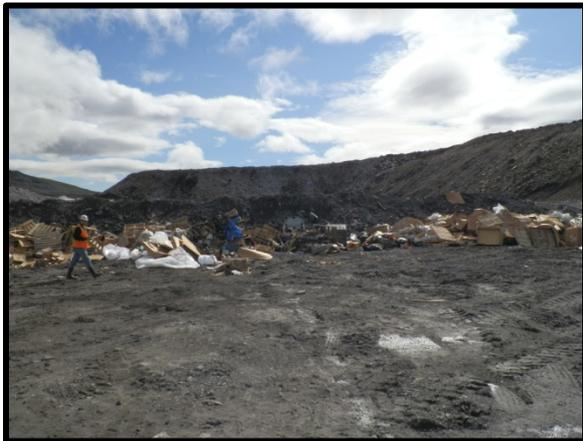
Figure 18: Landfill

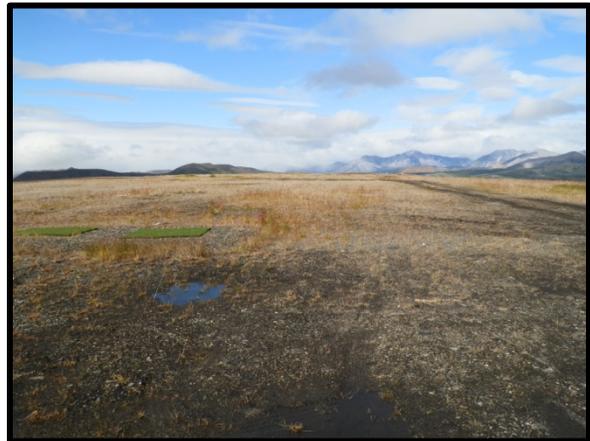
The Landfill located on the Main Waste Stockpile was visited (Figure 18). The inspection proceeded to the Oxide Stockpile where the cover system was observed (Figure 19). The reseeded cover area was stabilized by vegetation displaying natural colonizing of moss species (Figures 20 & 21) and Chrysanthemum species (Figure 22). The team observed Musk Ox tracks along the top of the Oxide Stockpile (Figure 23).

Figure 19: Oxide Stockpile

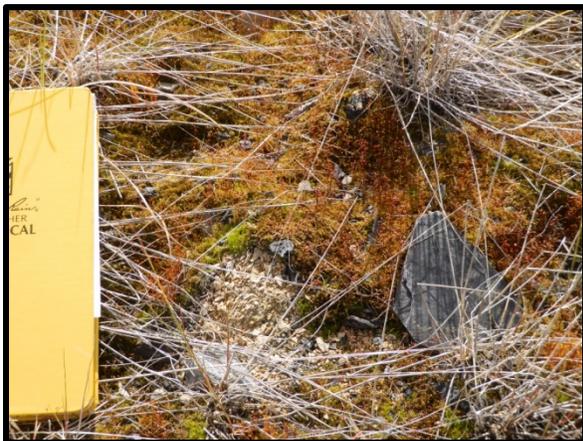
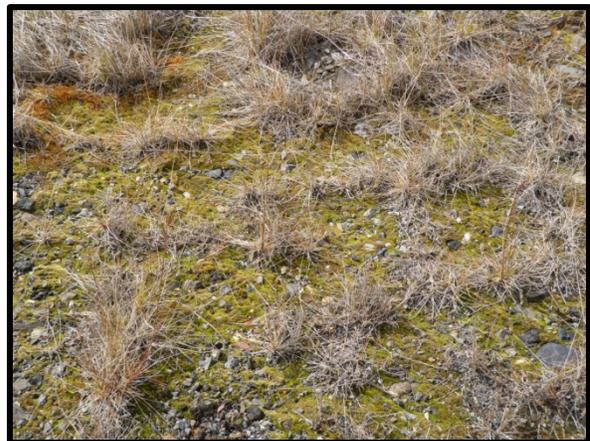
Figure 20: Moss on Oxide Stockpile

Figure 21: Moss on Oxide Stockpile

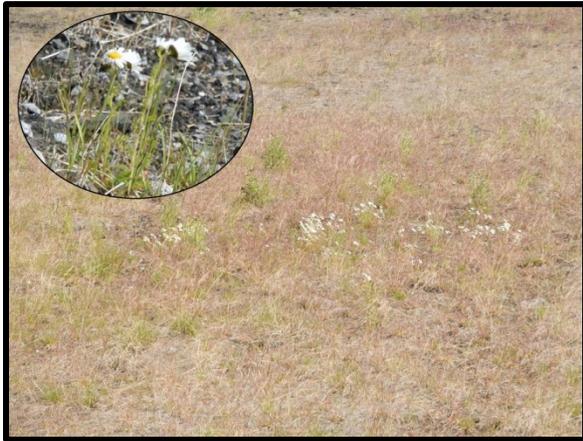
Figure 22: Chrysanthemums on Oxide Stockpile

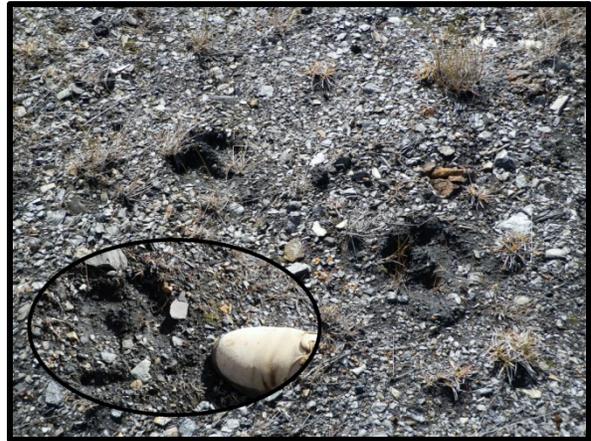
Figure 23: Musk Ox Tracks on Oxide Stockpile

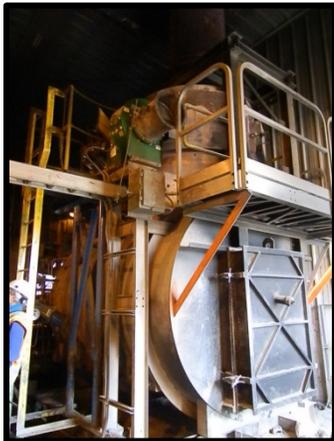
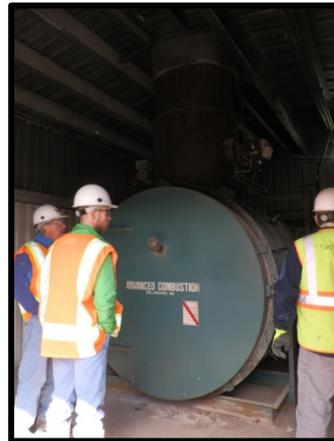
Figure 24: Incinerator

Figure 25: Incinerator

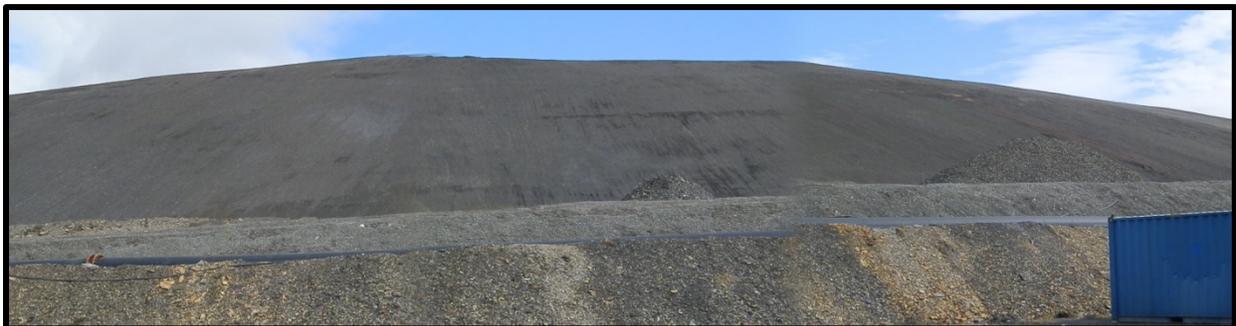
From the Oxide Stockpile, the inspection proceeded to the Incinerator Buildings (Figures 24 & 25). From this location the regrading of the Main Waste Stockpile, which had been completed over the last two years, was visible (Figure 26). Natural vegetation was noted near the Incinerator Building area (Figure 27). The truck wash station was also observed (Figure 28). The inspection concluded for the day, and the team returned to the PAC.

Figure 26: Main Waste Stockpile Regrading (NOTE: photo is panoramic from spliced images and displays some offsets)

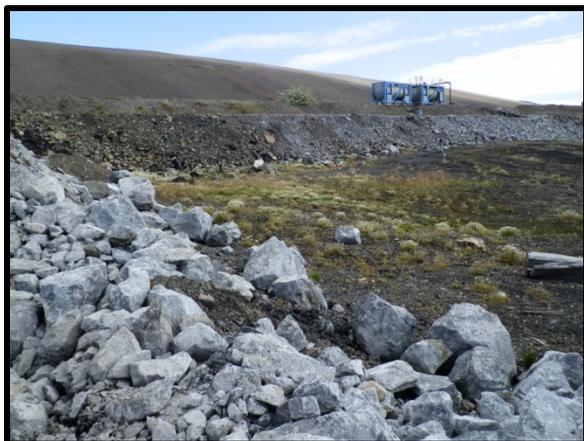
Figure 27: Natural Vegetation near the Incinerators

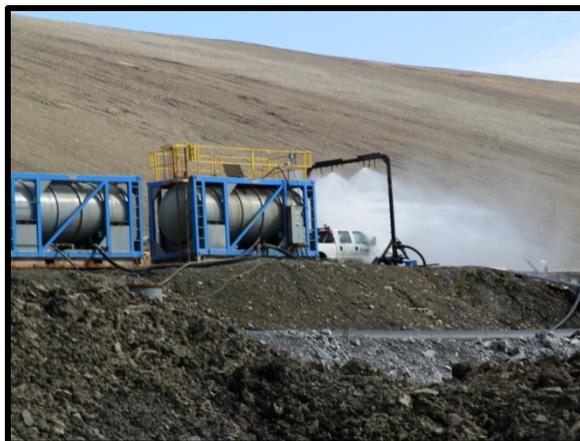
Figure 28: Truck Wash Station

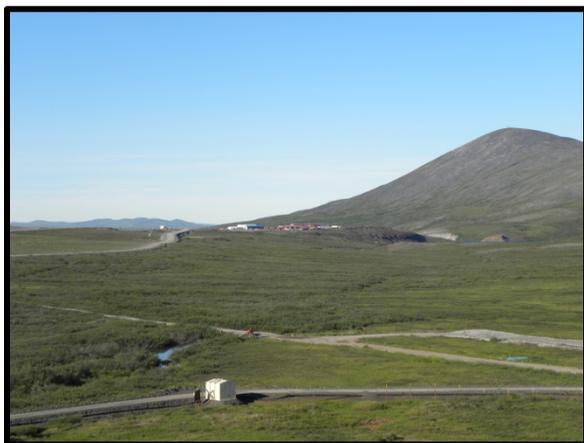
Figure 29: Bons Creek Bypass & Pump back Area

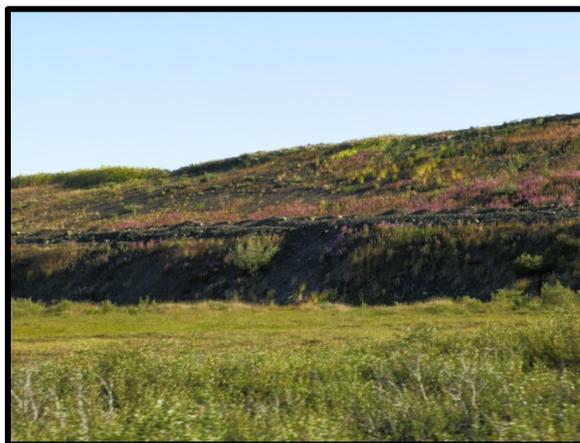
Figure 30: Overburden Stockpile from Pumpback Road

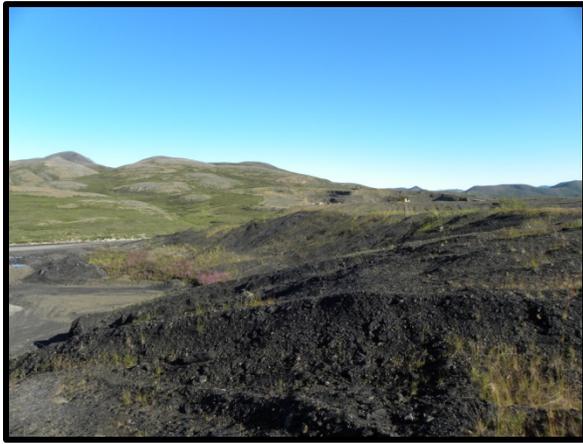
**Figure 31: Corner Removed for Oxide Cover Material**

Teck should provide in the renewal plans an update that addresses the availability of cover material and any potential for material deficits.

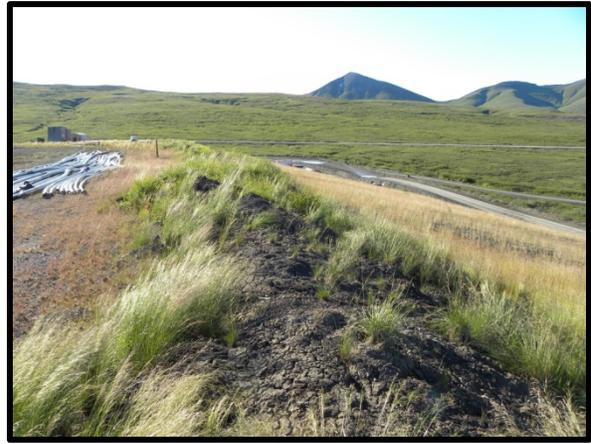
**Figure 32: Revegetation of Grasses**

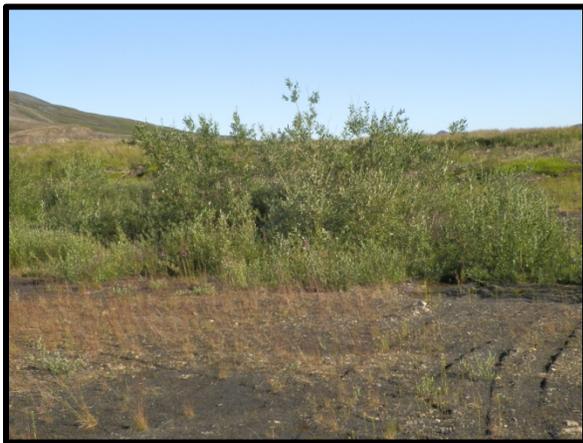
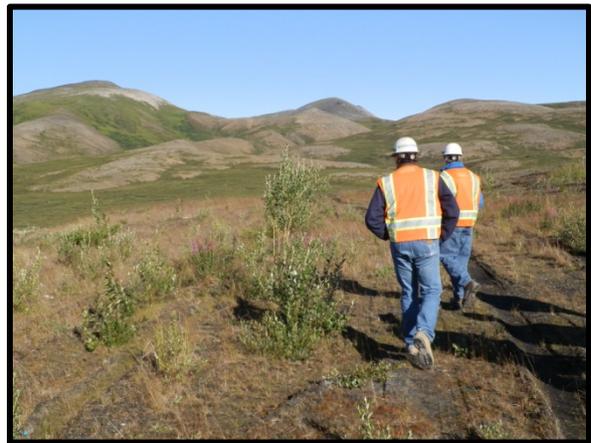
**Figure 33: Revegetation of Woody Species**

**Figure 34: Revegetation of Woody Species**

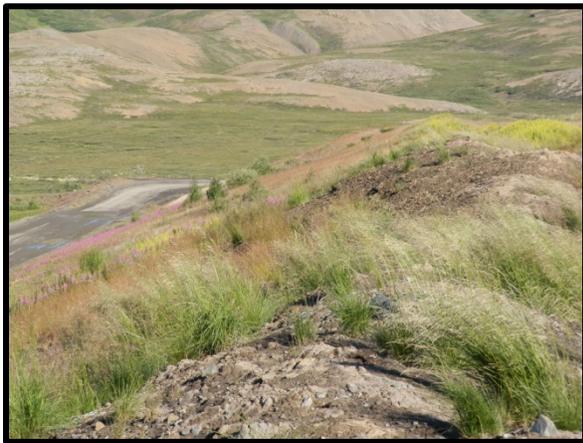
**Figure 35: Grasses & Woody Species**

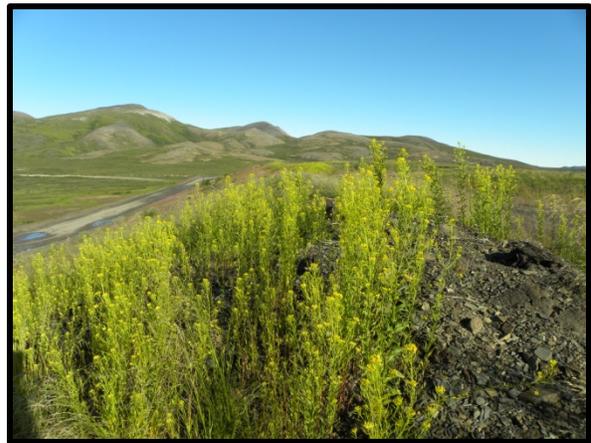
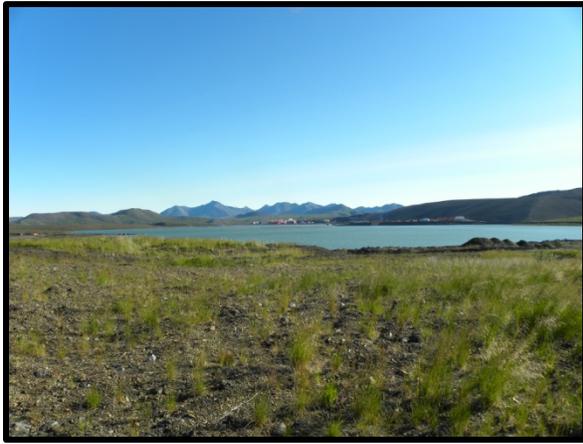
**Figure 36: Vegetation Cover**

Figure 37: Vegetation Cover

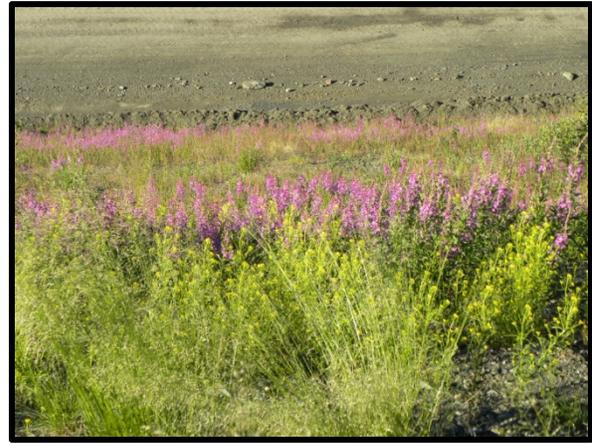
Figure 38: Natural Colonization of Fireweed

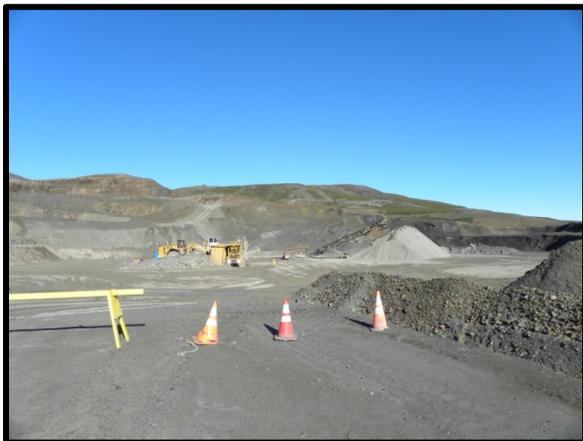
Figure 39: DD-2 State Material Site

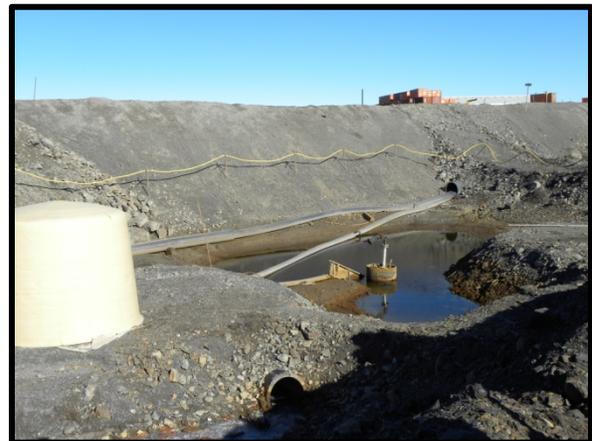
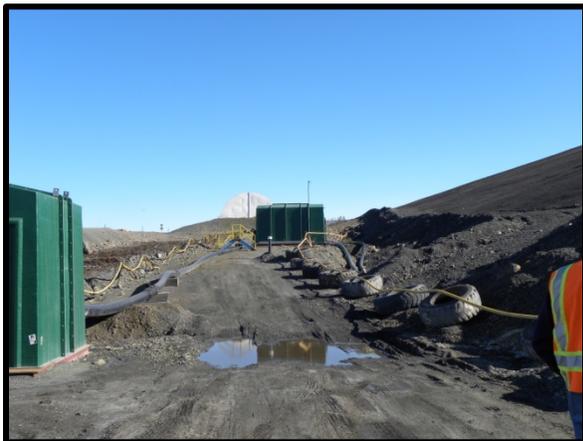
Figure 40: ARD Seepage Collection Pump

Figure 41: ARD Seepage Collection Pumps

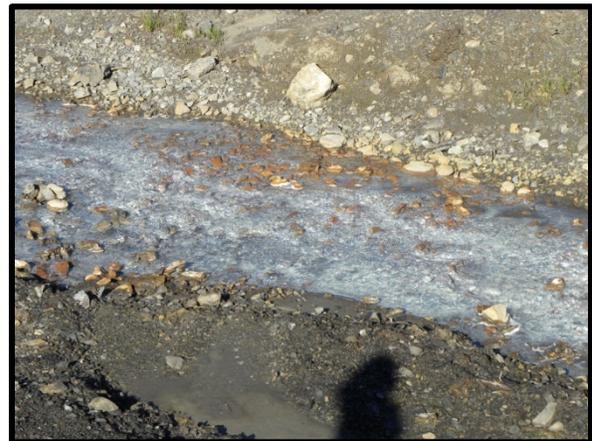
From the Overburden Stockpile, the team proceeded to the DD-2 State Material Site (Figure 39). The inspection continued to the Main Waste Stockpile ARD Seepage Collection Pumps (Figures 40 & 41). Aluminum precipitate was visible in the seepage water (Figure 42). Lastly, the team proceeded to the crest of the Main Dam (Figures 43 & 44).

Figure 42: Aluminum Hydroxide Precipitate in White

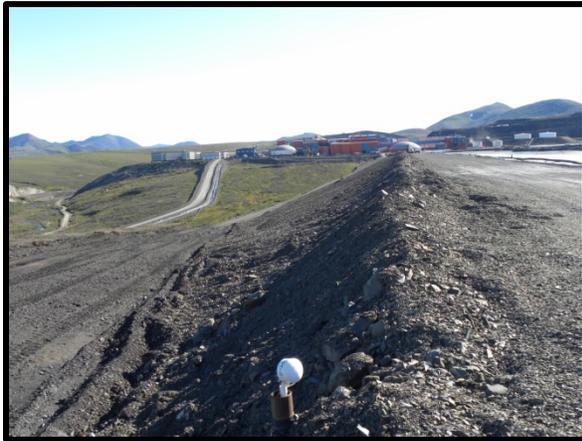
Figure 43: Downstream View from Top of Dam

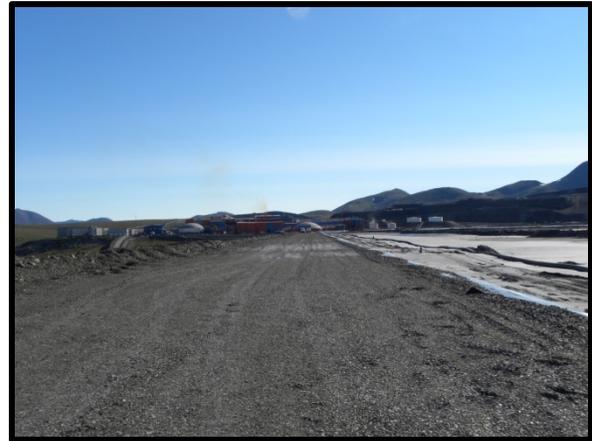
Figure 44: Top of Dam
