Red Dog Mine Inspection Report

Inspection Date: August 16, 2023 and August 17, 2023
Weather: Rainy, Foggy, Variable Wind, 45°F to 58°F
Time of Inspection: 10:00 AM to 4:00 PM
Operator Contact: Frank Bendrick and Emily Hart
Agency Personnel: William Groom, Carolyn Curley, and Michael Ladouceur (Mining)
Ben Wagner (Dam Safety), DMLW Director Christianna Colles, and
OPMP Project Coordinator Sylvia Kreel

Inspection Objectives

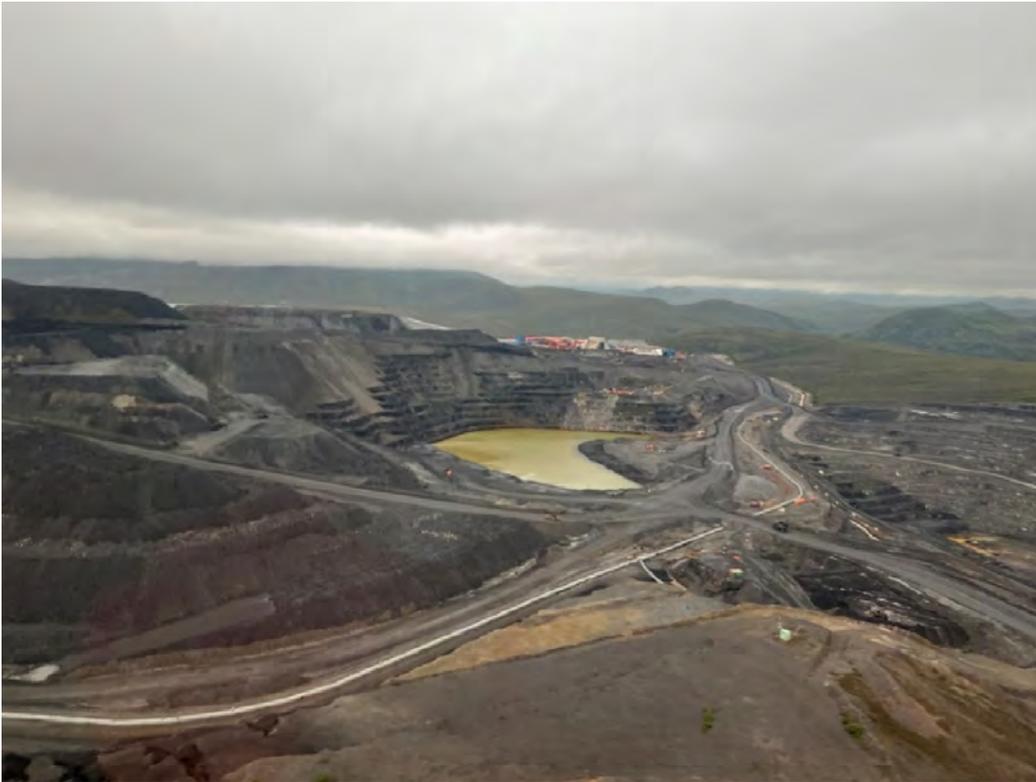
Photo 1: View of Main Pit looking toward the northwest as taken from a helicopter.

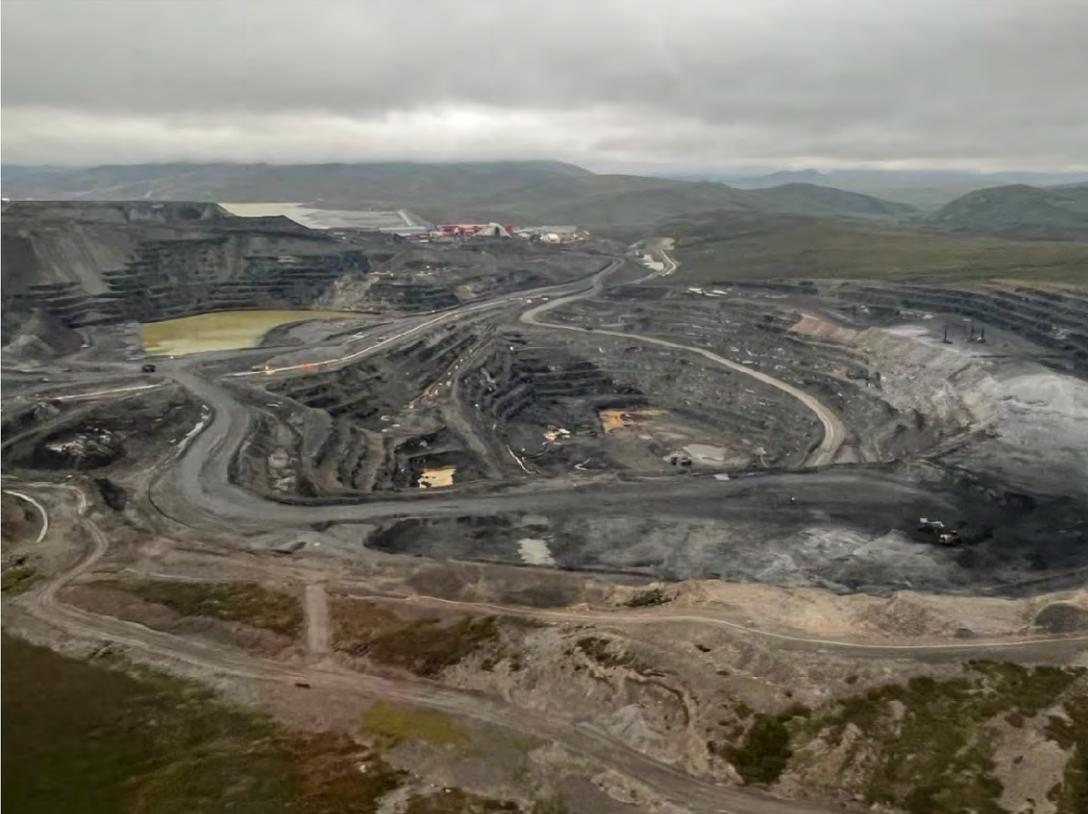
Photo 2: Aqqaluk Pit in the foreground.

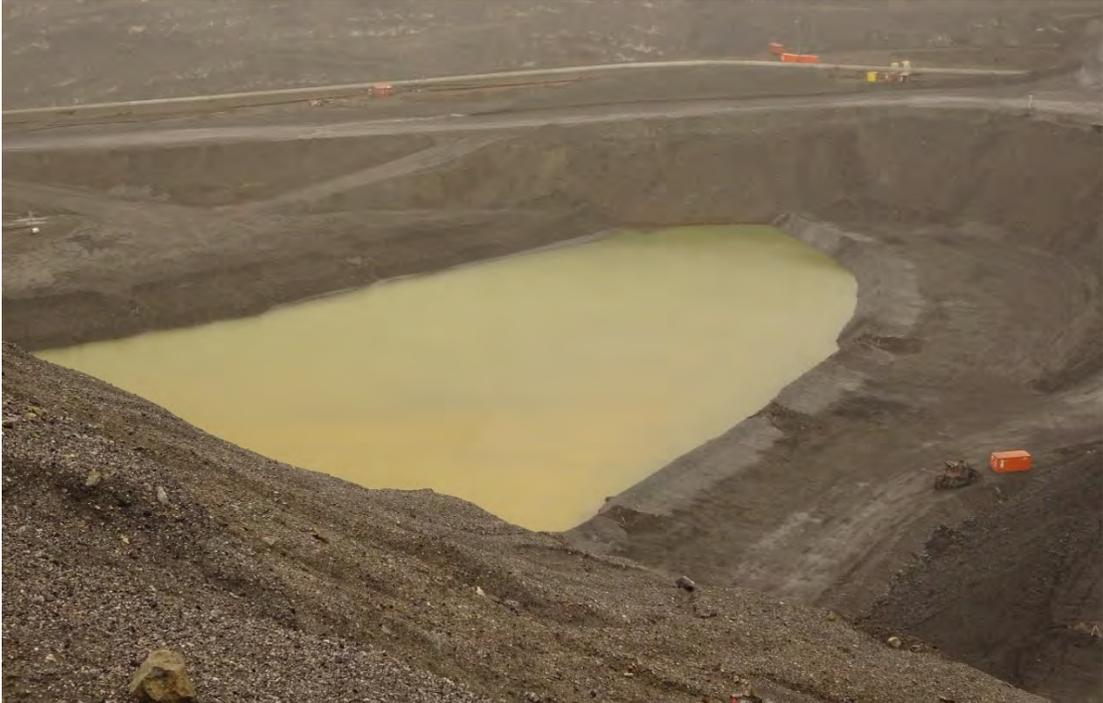
Mining in the Main Pit was completed in 2011. Currently the Main Pit is being backfilled with waste rock from the Aqqaluk and Qanaiyaq pits. Photos 1-3 show activities at the Main and Aqqaluk pits.

Photo 3: Main Pit backfill in progress.

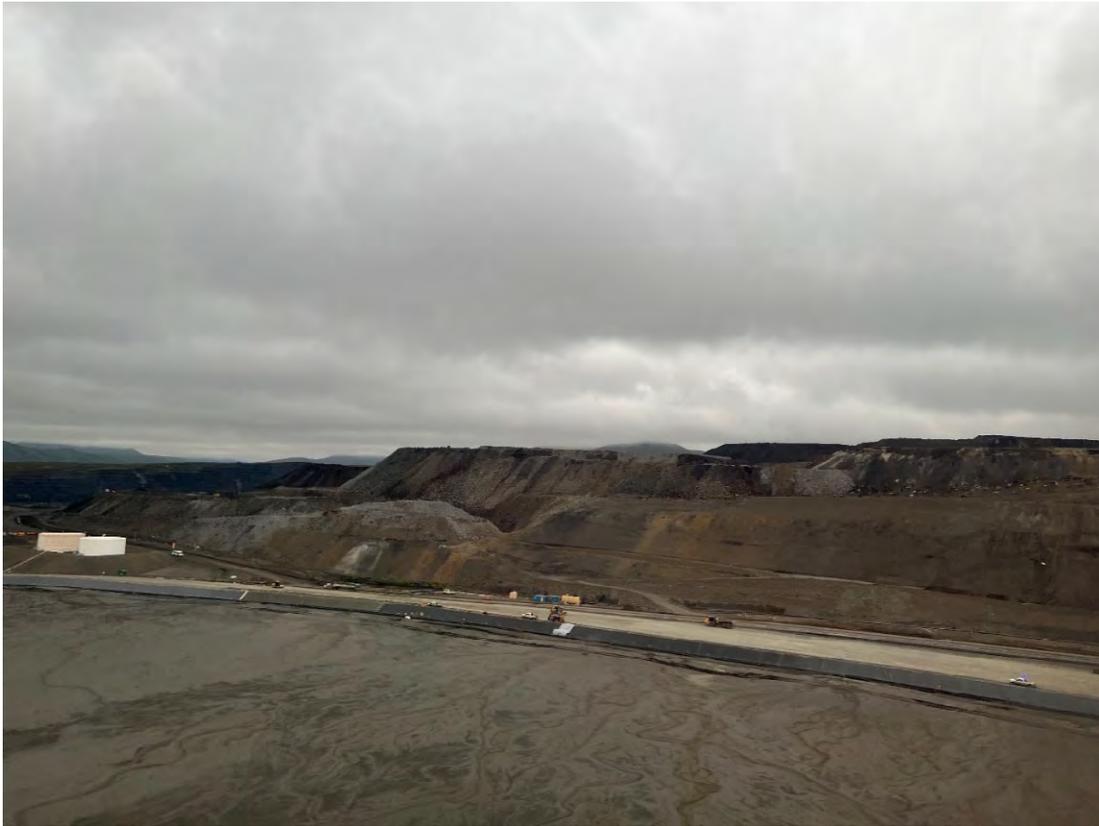
Photo 4: Low Grade Ore Stockpile, Oxide Stockpile, and MWD.

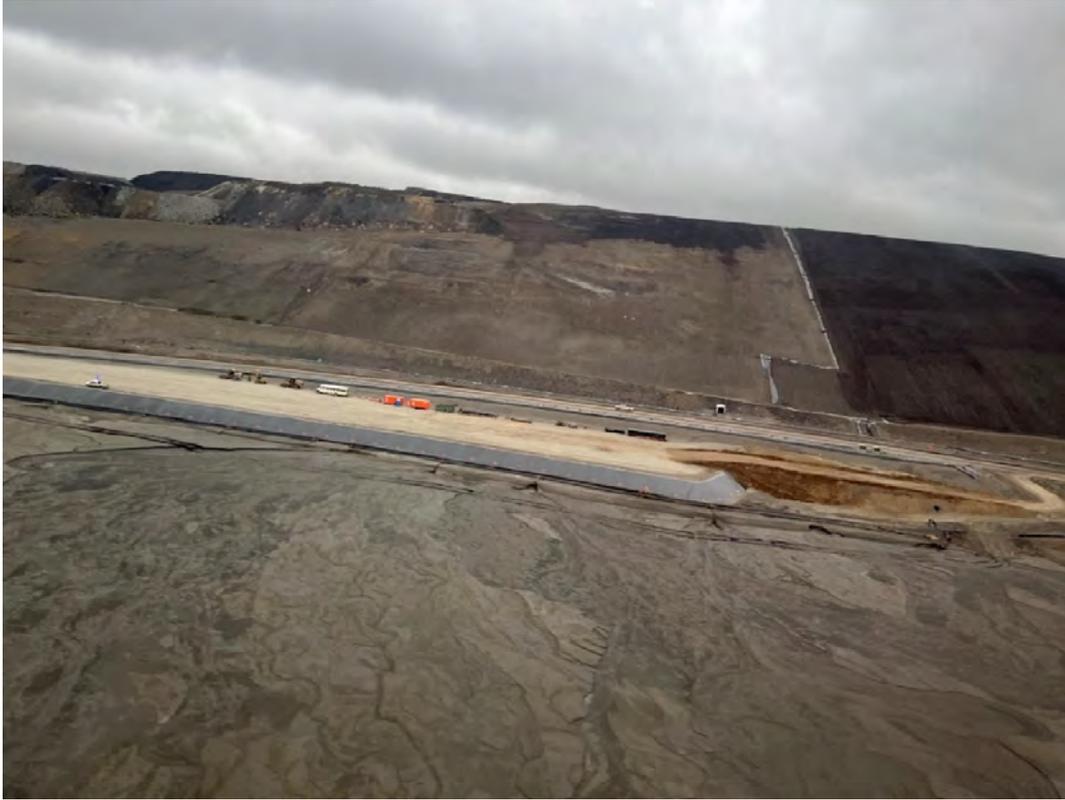
Photo 5: Oxide Stockpile and MWD.

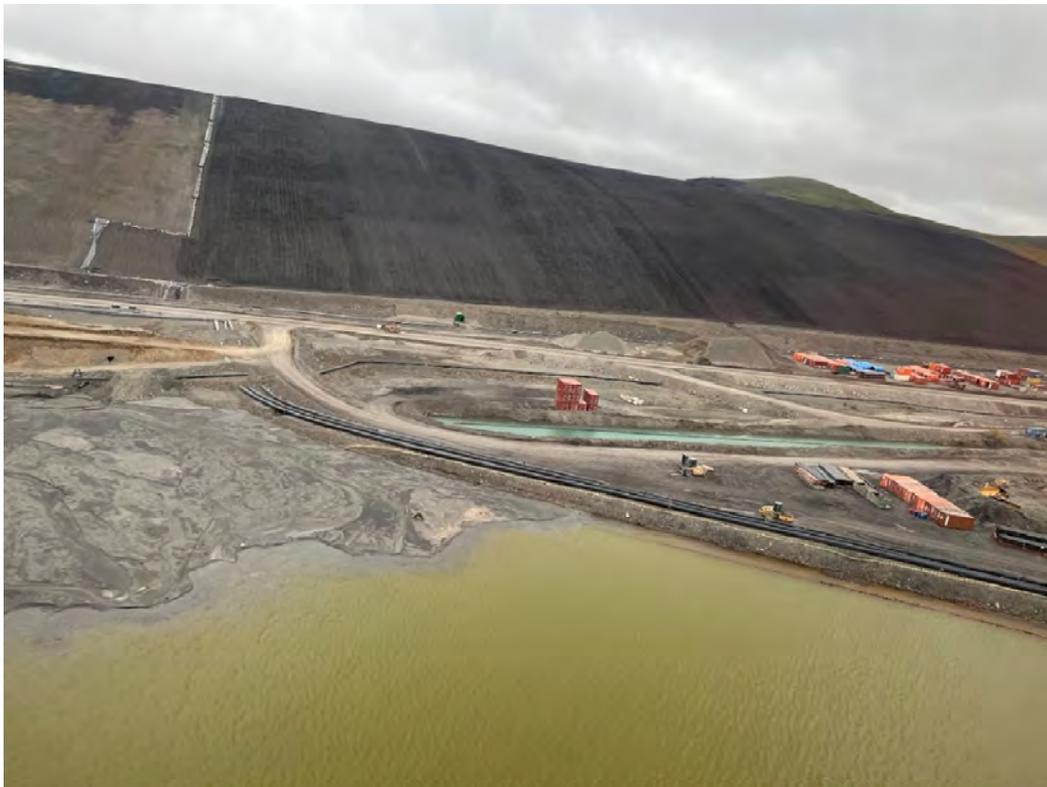
Photo 6: Prior reclamation on the southwest side of the MWD.

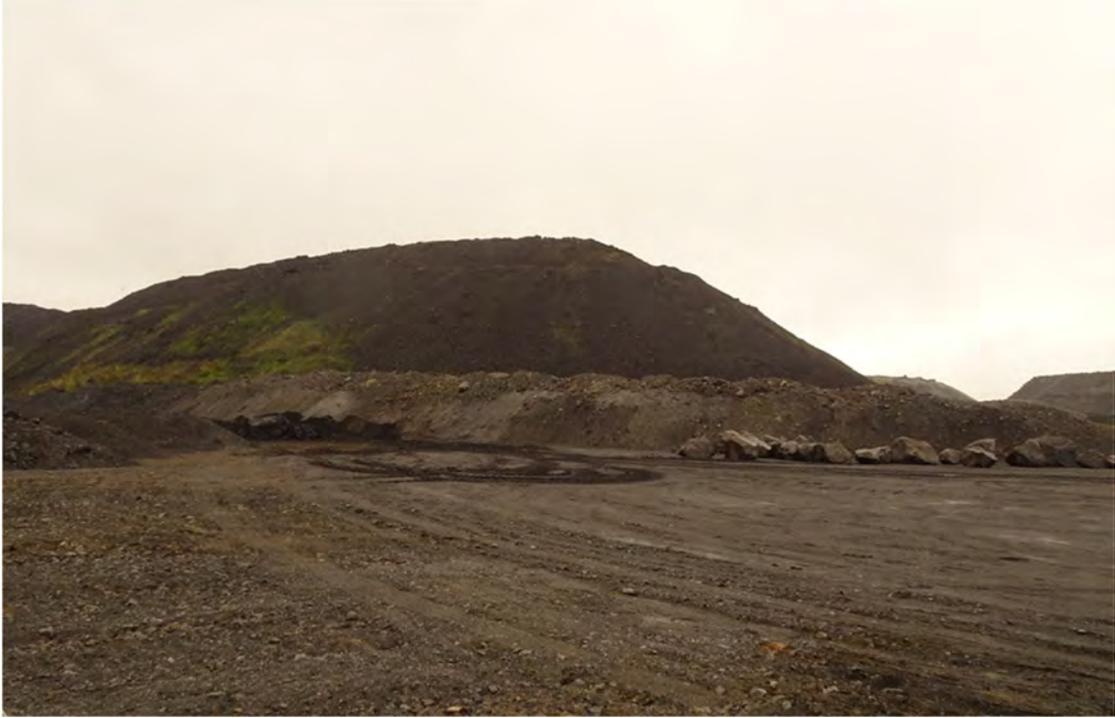
Photo 7: Cover Material Stockpile on MWD.

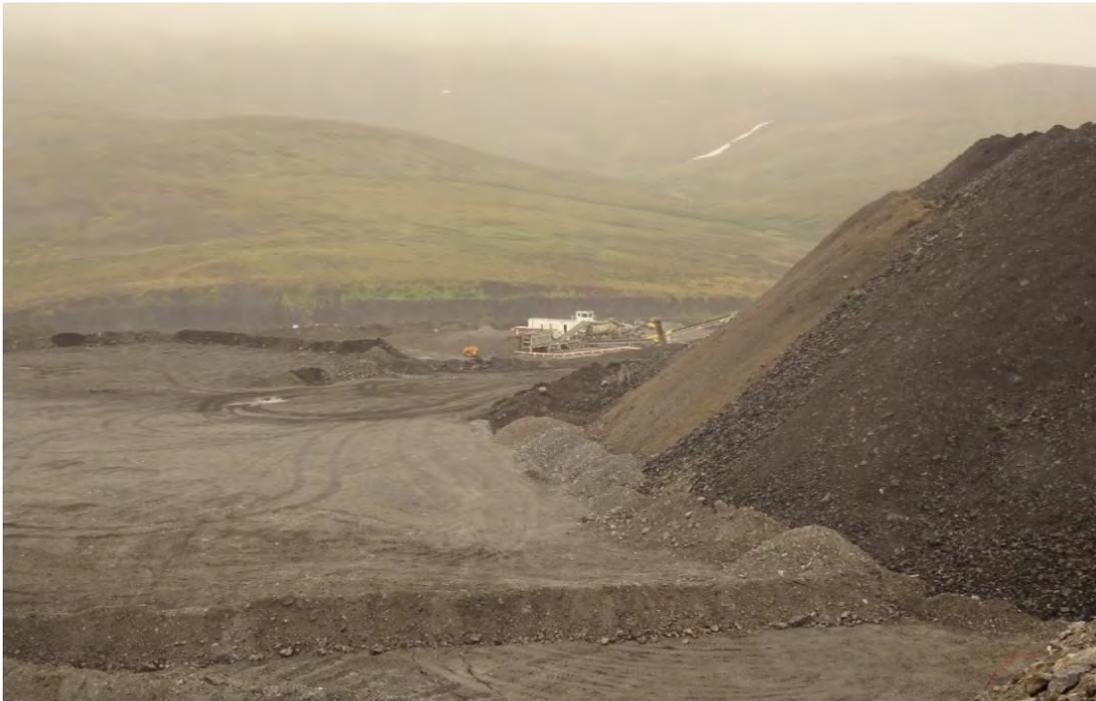
Photo 8: Screen plant for cover material.

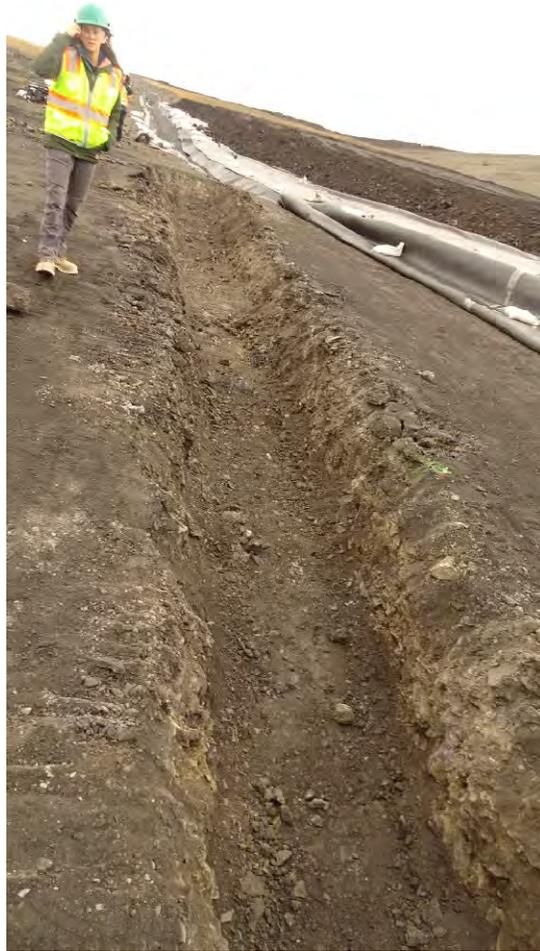
Photo 9: Drainage ditch on MWD.

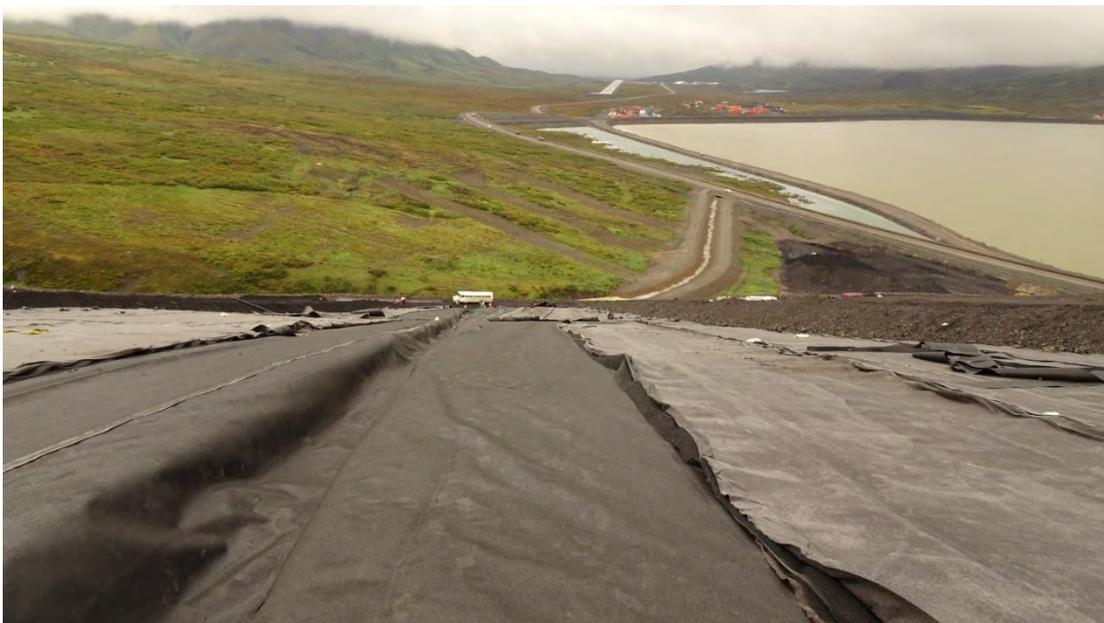
Photo 10: Drainage ditch on south side of the MWD. Liner has been placed. Back Dam and facilities are in the background.

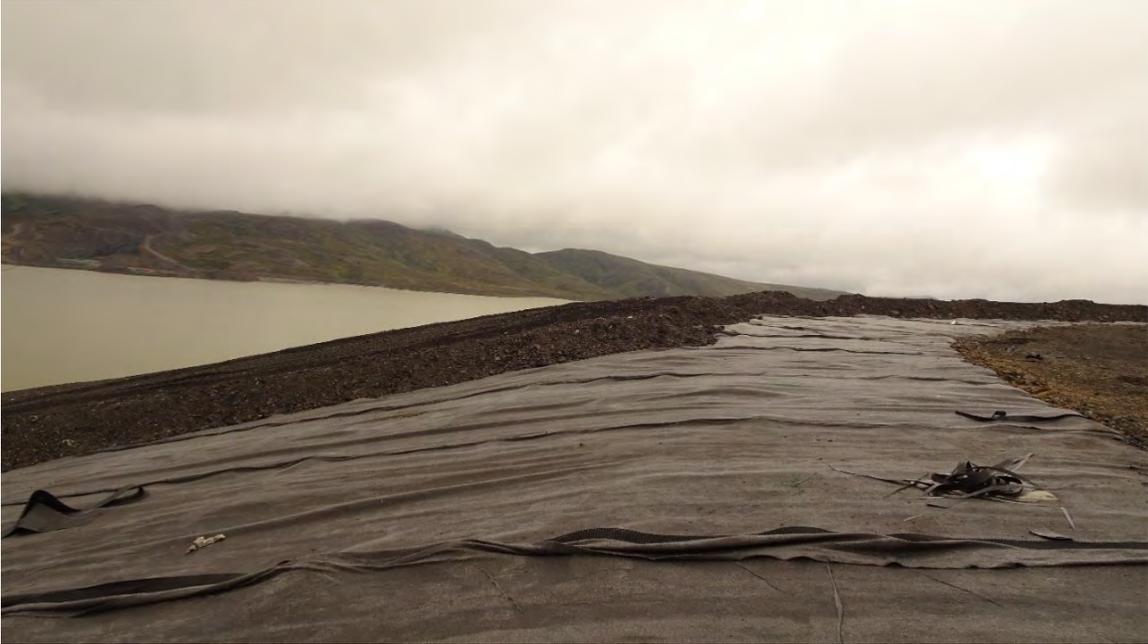
Photo 11: MWD reclamation progress showing liner with cover material placed.

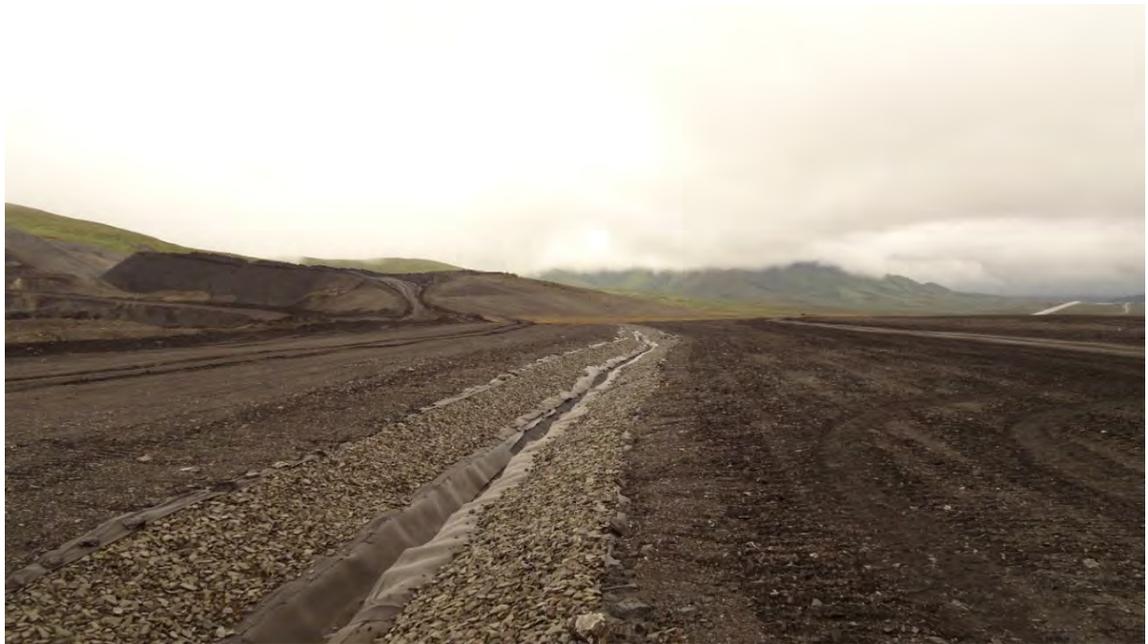
Photo 12: MWD drainage ditch, lined and graveled. Cover material placed on the liner adjacent to the ditch.

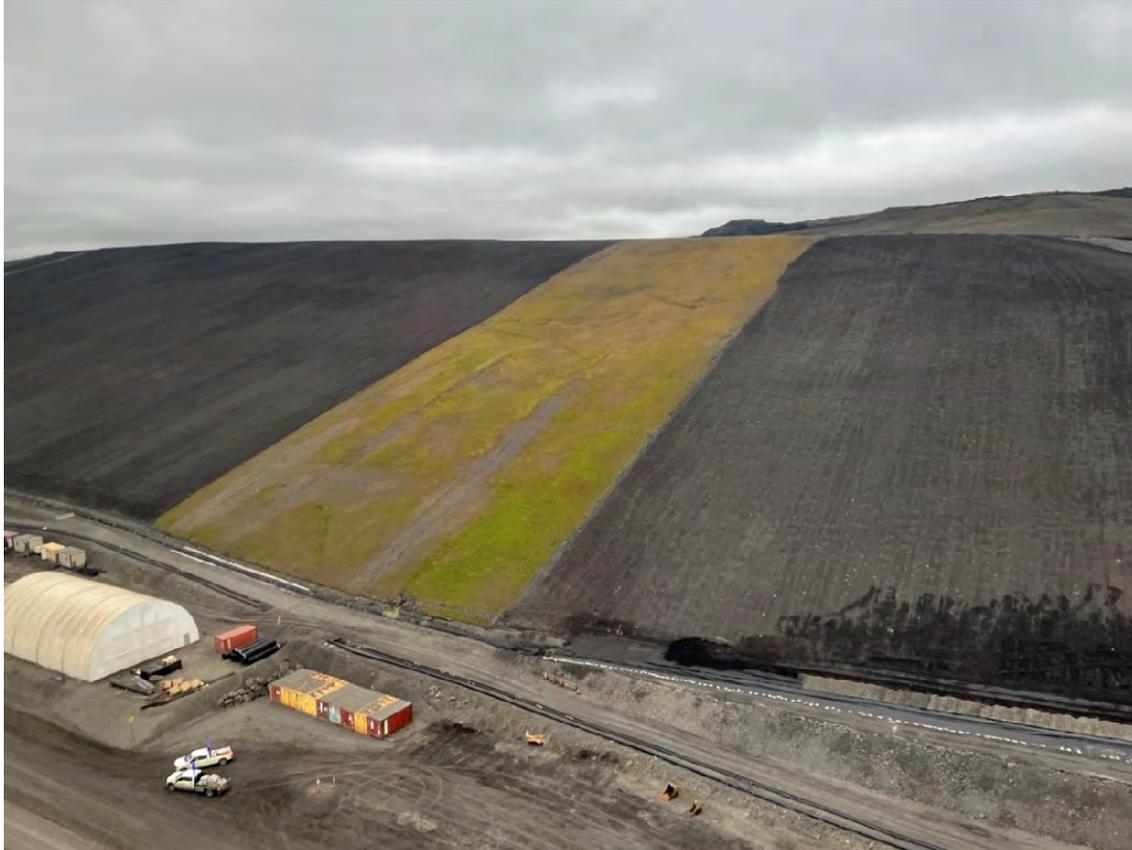
Photo 13: MWD reclamation revegetation test plot.

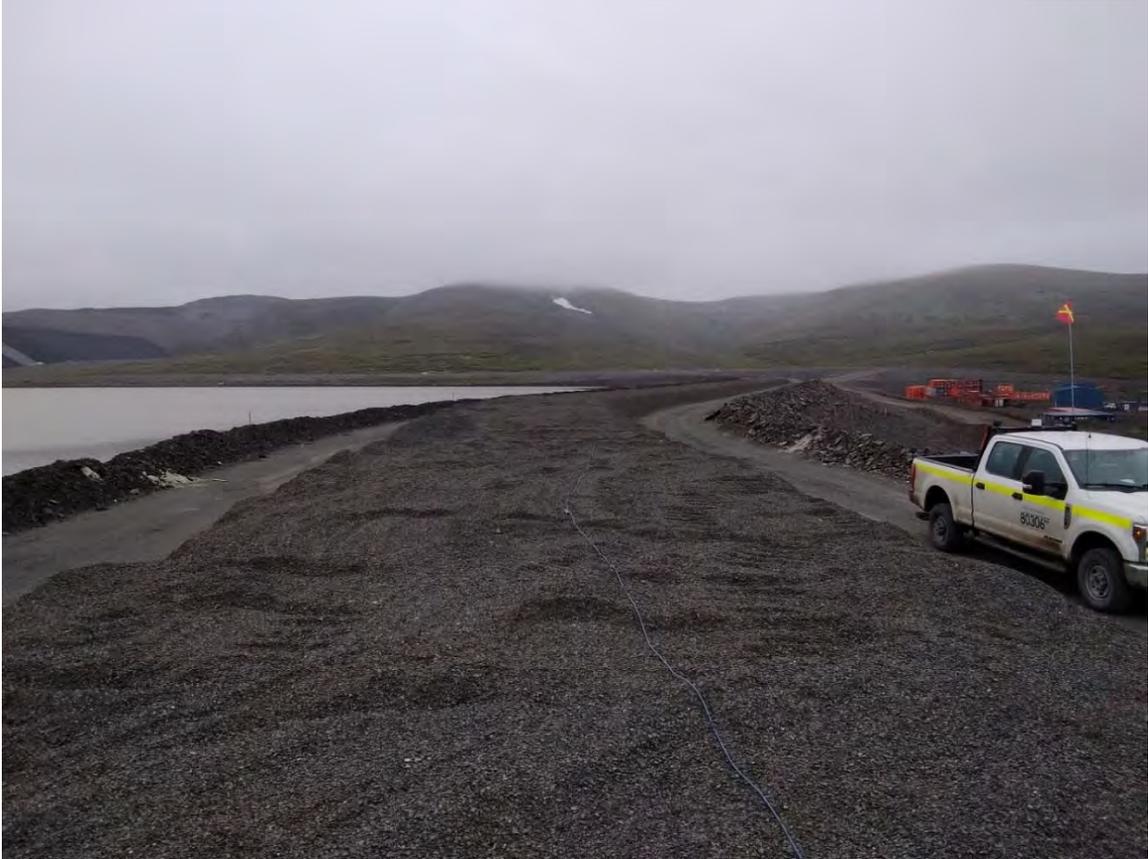
The Back Dam has been raised to an elevation of 996'. Photos 17 and 18 show views of the Back Dam toward the east and to the west.

Photo 17: Back Dam looking east from the crest of the dam.

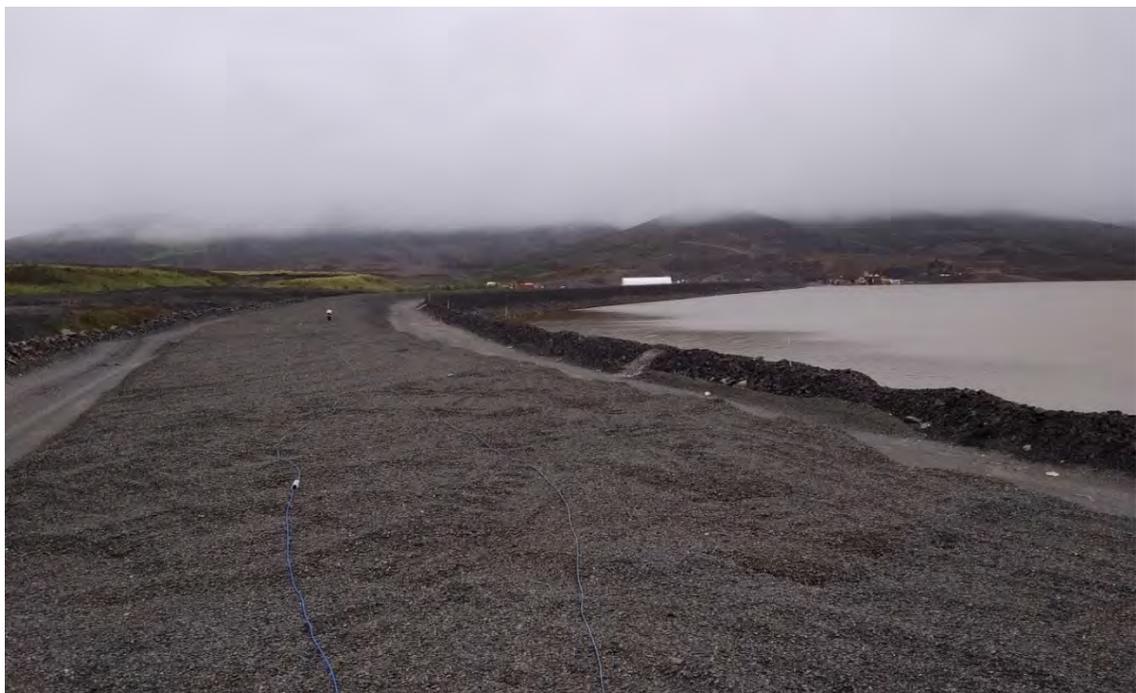
Photo 18: The view looking approximately west along the crest of the Back Dam.

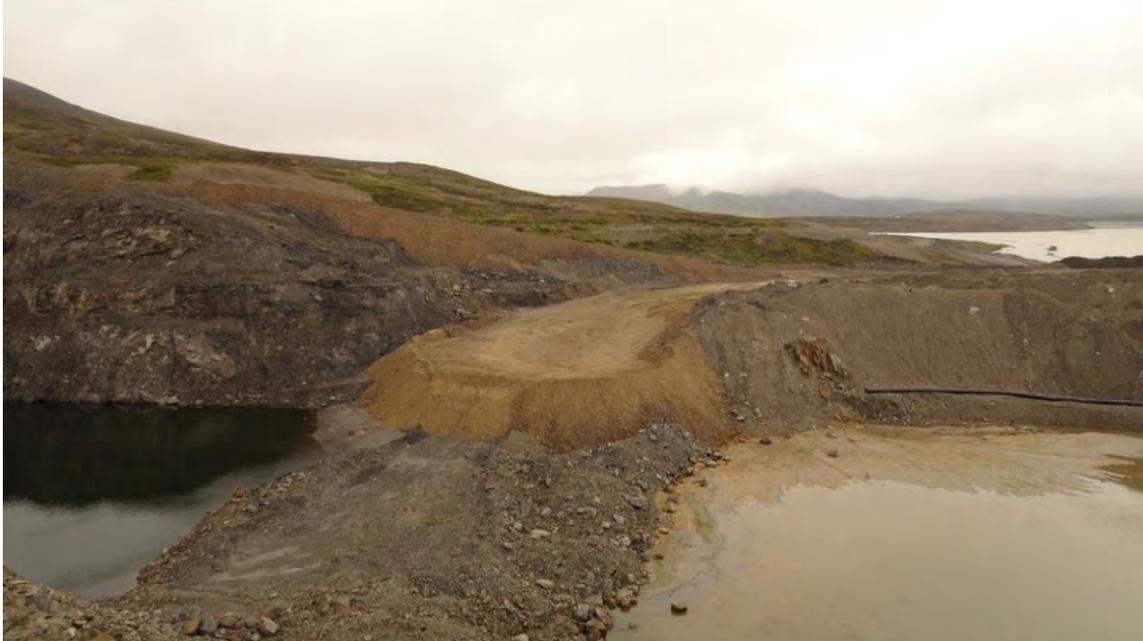
Photo 19: Work at DD-2 for tails storage.

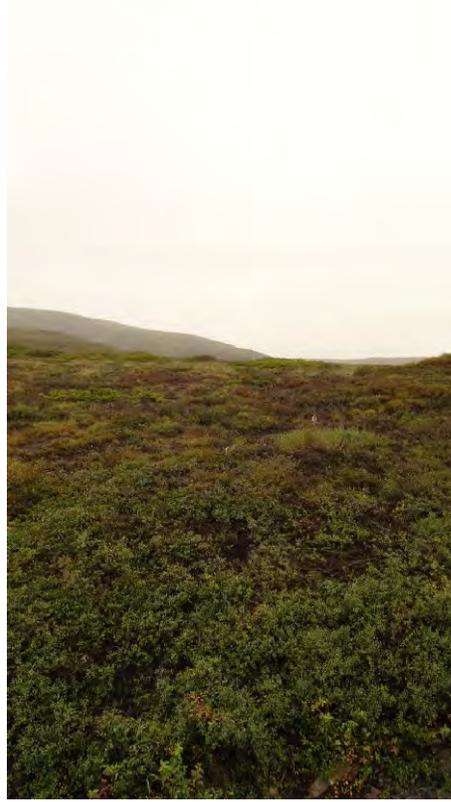
Photo 22: Potential closure spillway location.

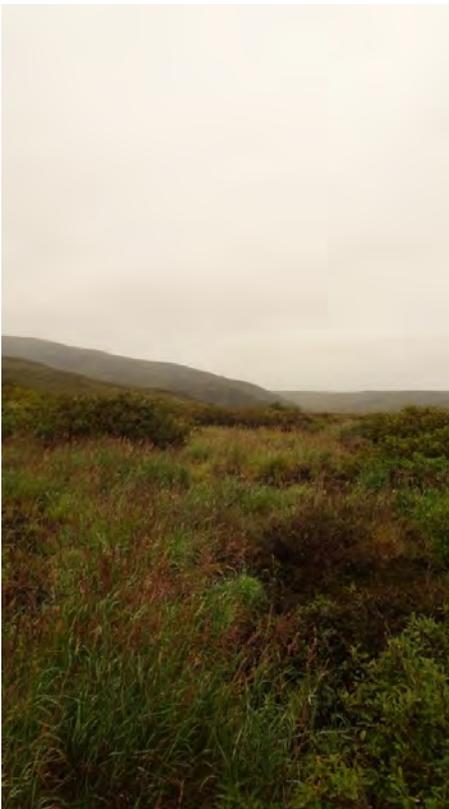
Photo 23: Potential closure spillway location.

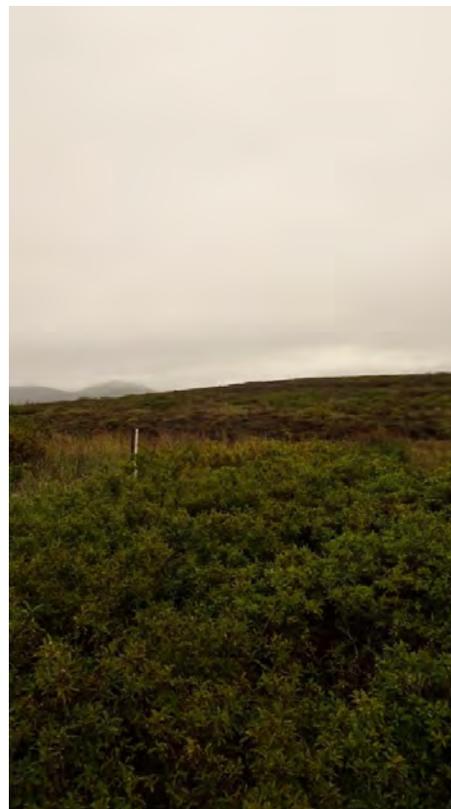
Photo 24: Stakes for closure spillway.

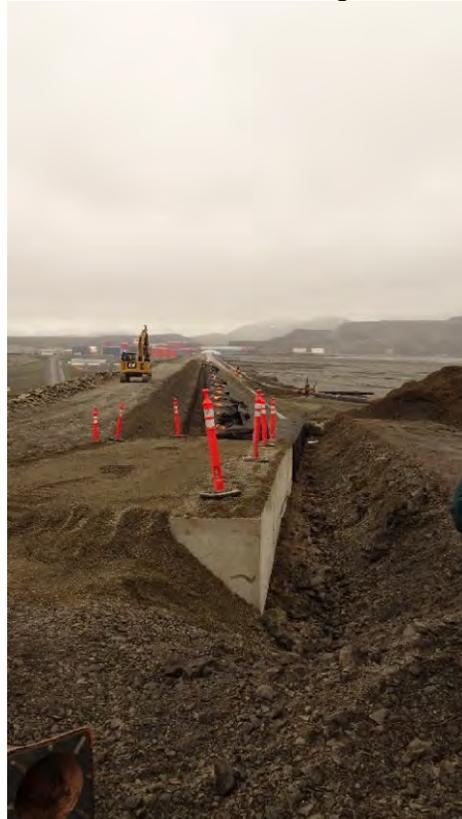
Photo 2: Ongoing work at the Main Dam raise.

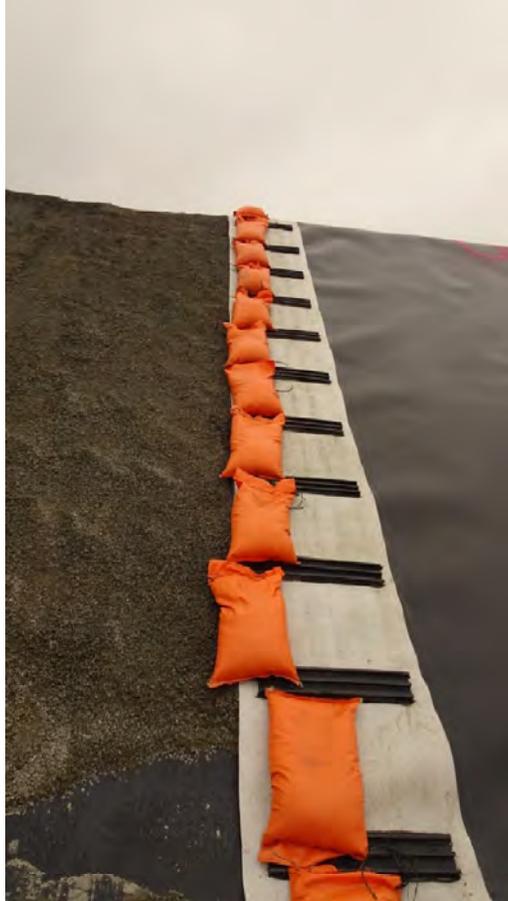
Photo 4: Liner and cover installation at liner seam location

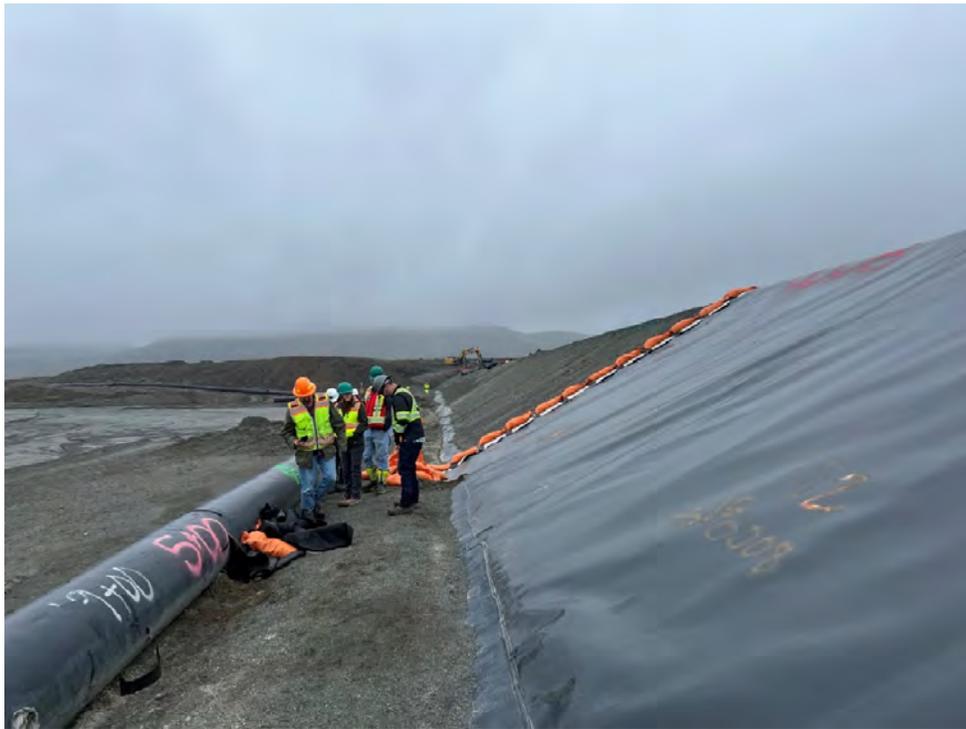
Photo 5: Progress on the Main Dam raise. The view is in a westerly direction.

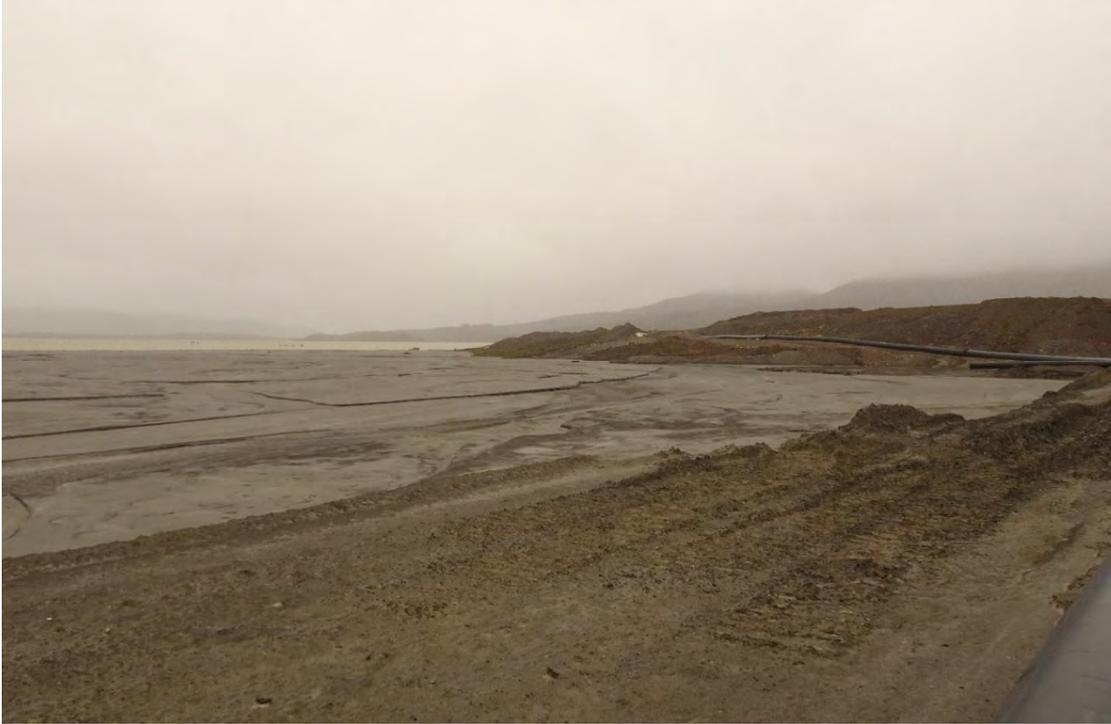
Photo 29: West side of the tails beach.

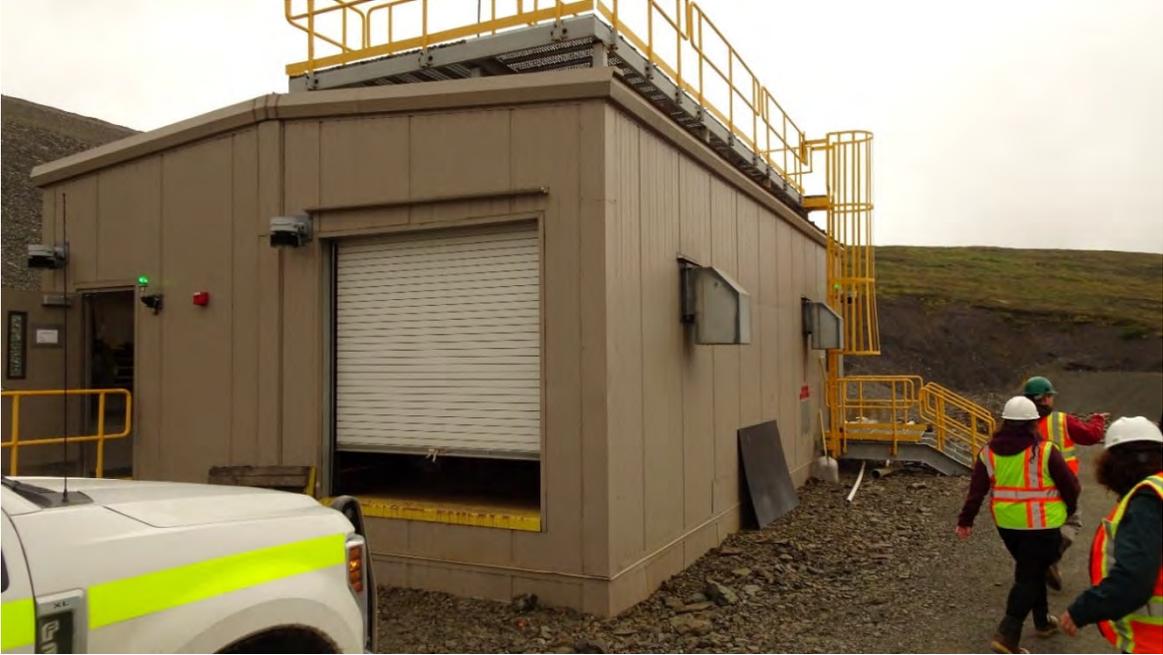
Photo 34: Main Dam seepage pump house.

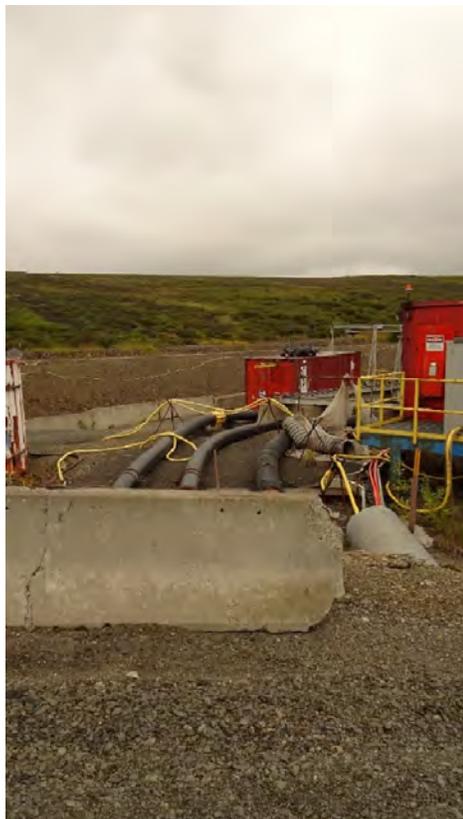
Photo 40: Seepage collection pipes for the Diversion Dam.

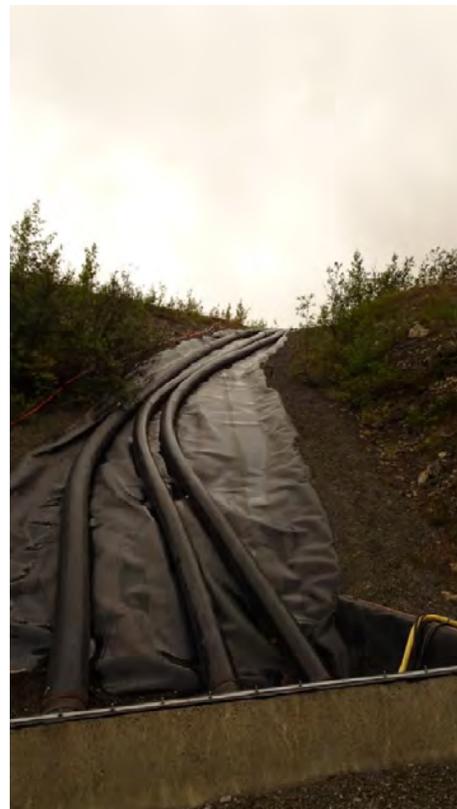
Photo 41: Seepage collection pipes pumping water for treatment.

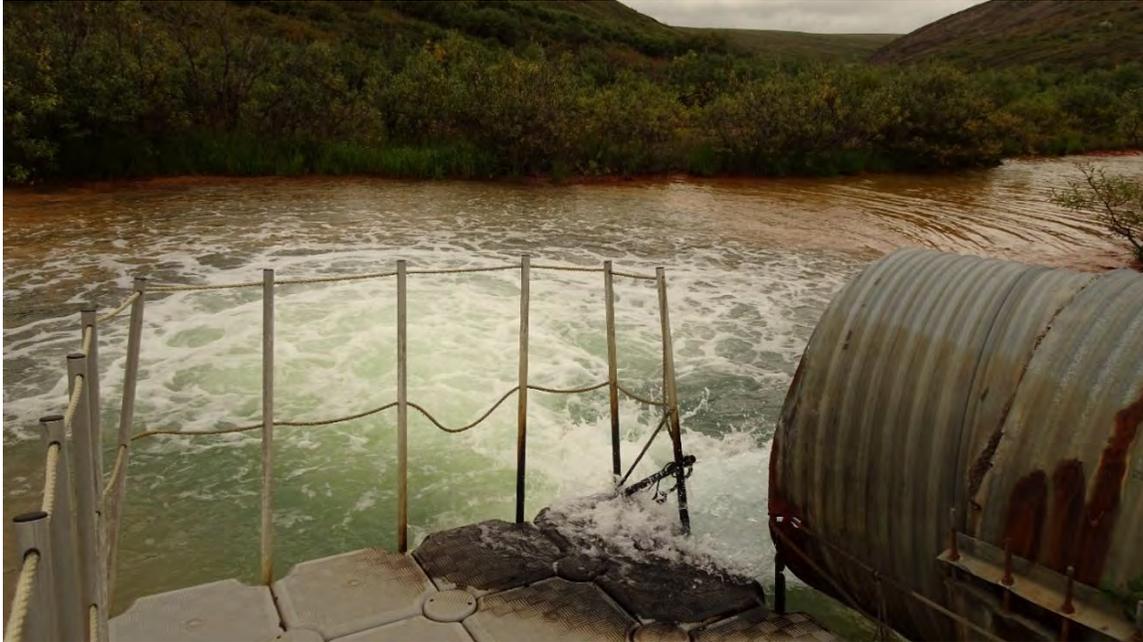
Photo 46: Treated water discharging into Red Dog Creek at Outfall 001.

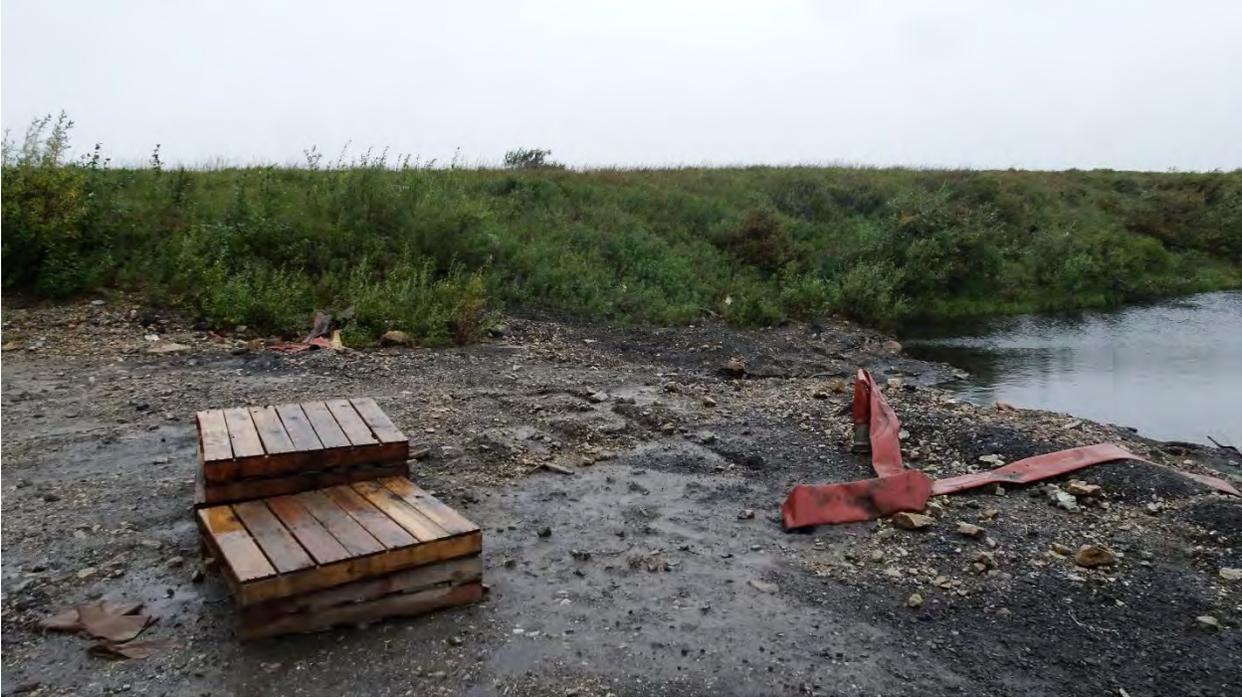
Photo 59: Pallets and debris at MS 10

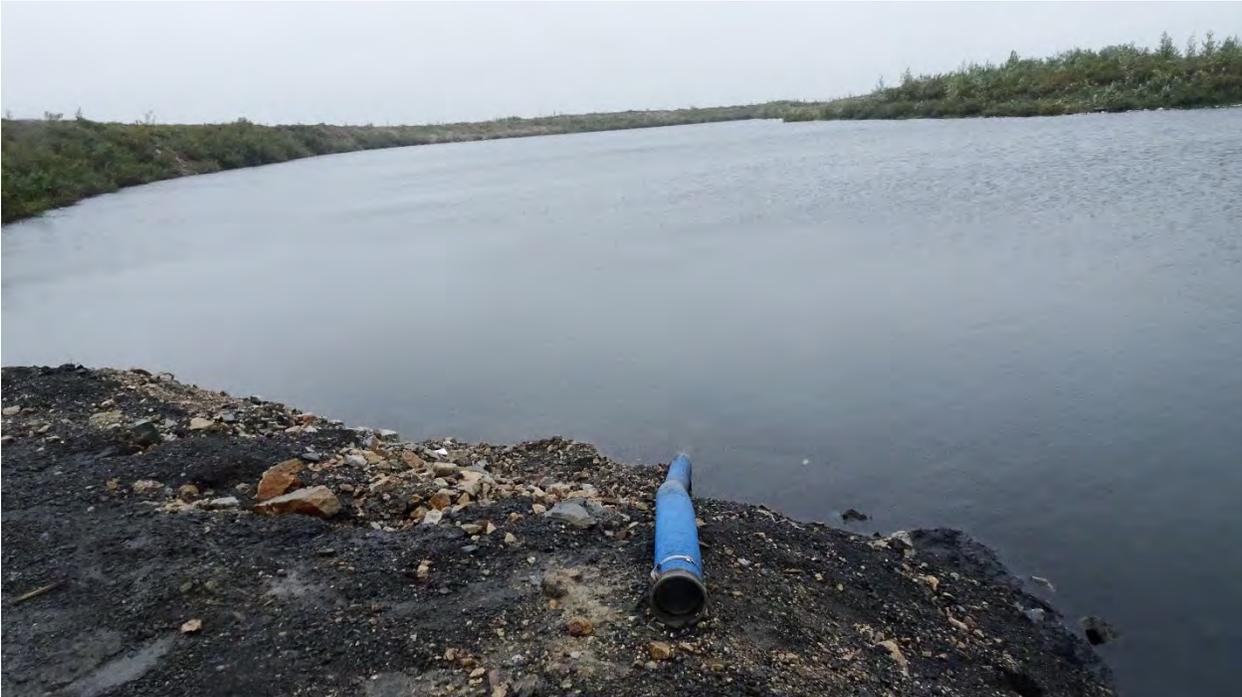
Photo 60: Hose line in the water at MS 10
