Department of Natural Resources

Red Dog Mine Inspection Report

Inspection Date: July 9, 2019 thru July 11, 2019

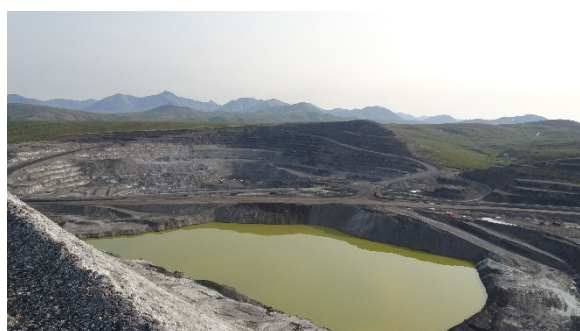
Red Dog Main Pit & Aqqaluk Pit

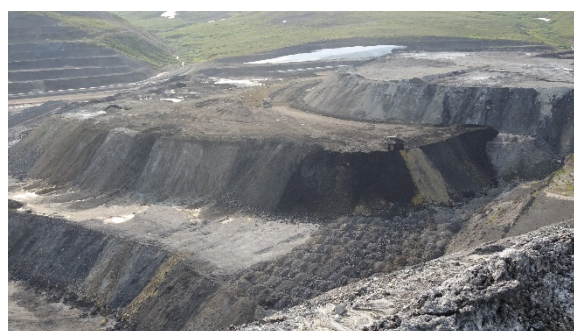
Back filling of Red Dog Main Pit

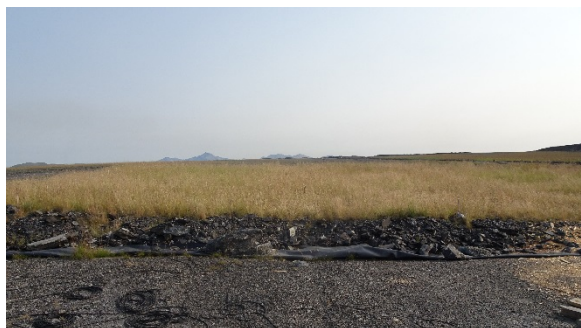
Revegetation test plot on Main Waste Dump

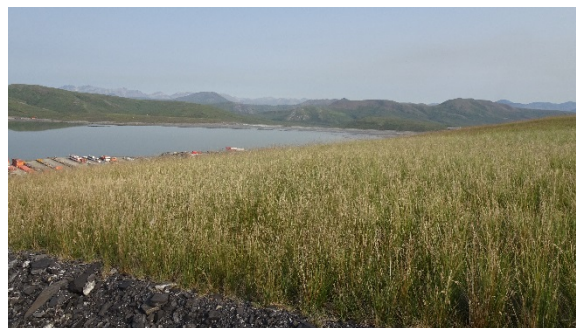
Revegetation test plot on Main Waste Dump

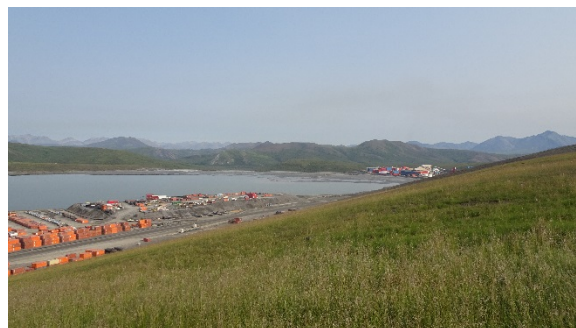
Revegetation test plot on Main Waste Dump

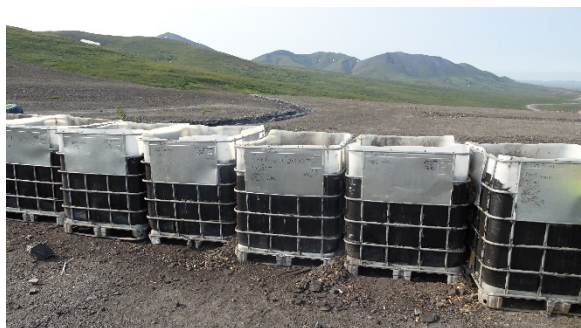
Wood chip revegetation test cells

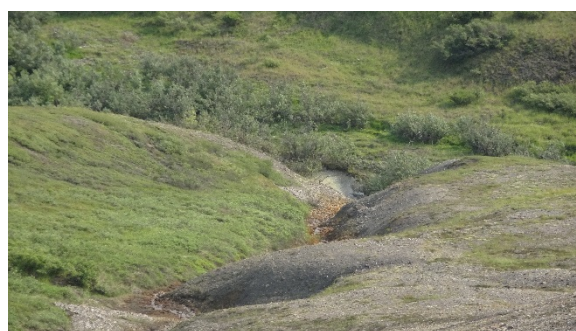
Seep near Qanaiyaq Pit

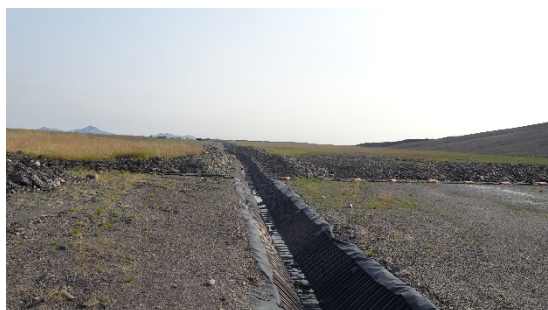
Water collection ditch on Main Waste Dump

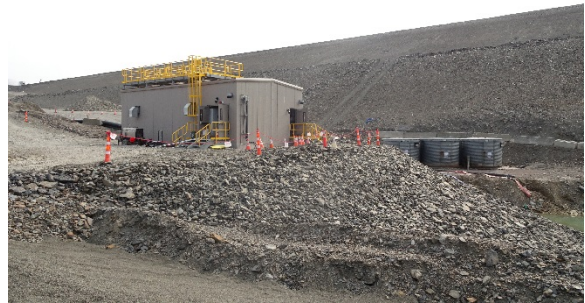
New Seepage Collection system below downstream face of the Main Dam

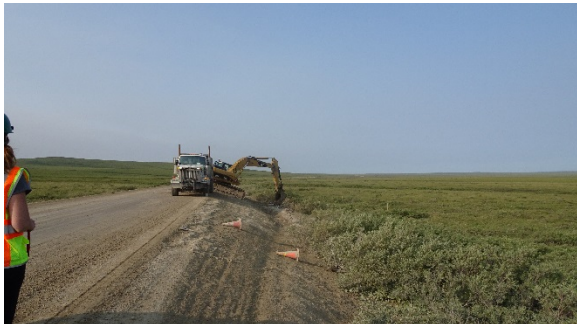
Cleanup of Zinc Concentrate Spill @ approx. MP 29 DMTS

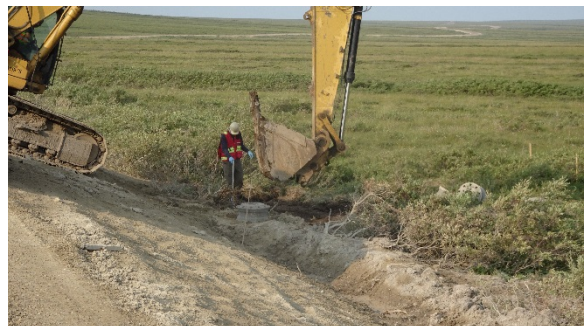
Contractor measuring soil metals with mobile XRF

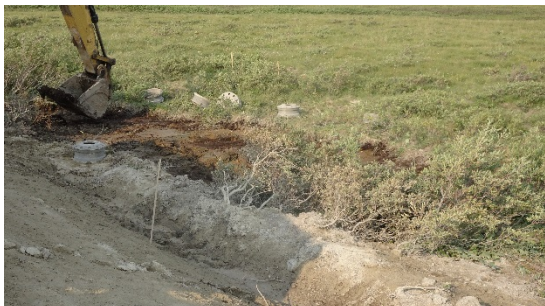
Excavator cleanup at approx. MP 29 DMTS

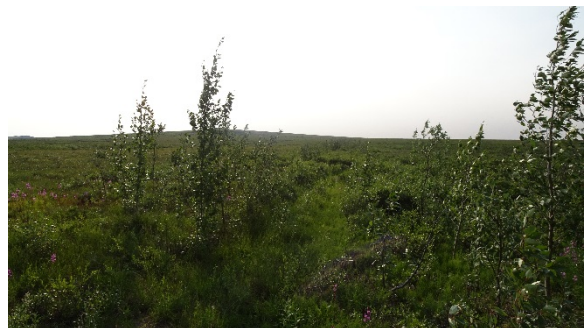
Old Material Site that is being examined for future water point for road watering work.

2. To ensure that all State permits are timely identified and received, Teck should coordinate with DNR/DMLW-Northern Region Office concerning the reopening of a closed Material Site along the DMTS to serve as a water collection site.

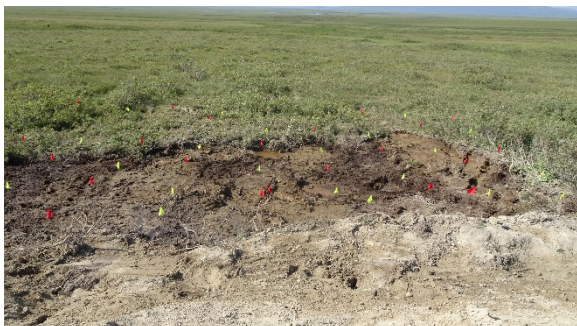
MP 29 Spill after excavator work.

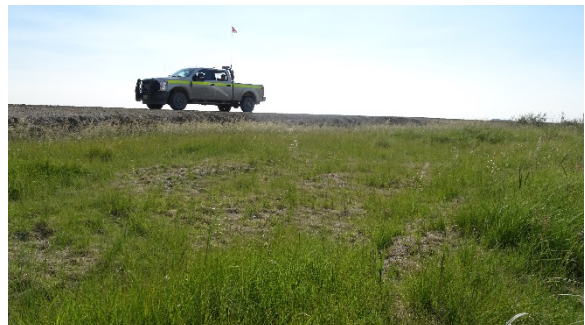
Reclamation condition at the MP 35.2 spill from 2012.

1. Teck and the Agencies need to work better in coordinating a unified method of locating and documenting the old spill sites along the DMTS for follow-up inspections to ensure that sites are properly revegetating and not presenting any long-term issues.

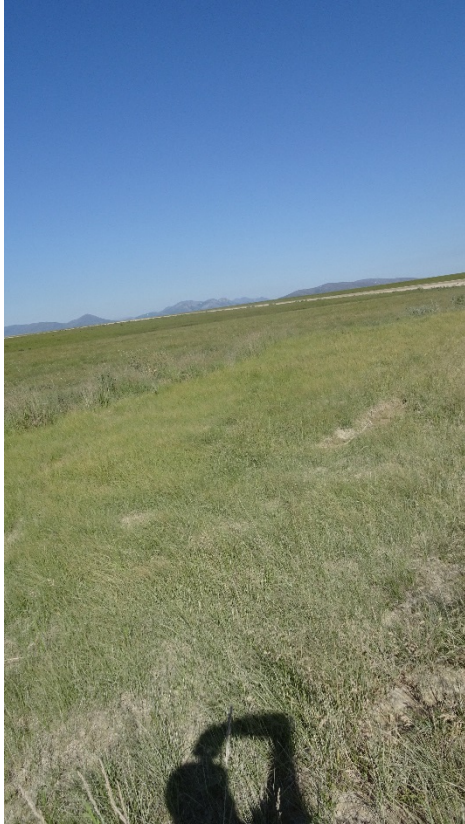
Vegetative regrowth at 2012 Concentrate Spill

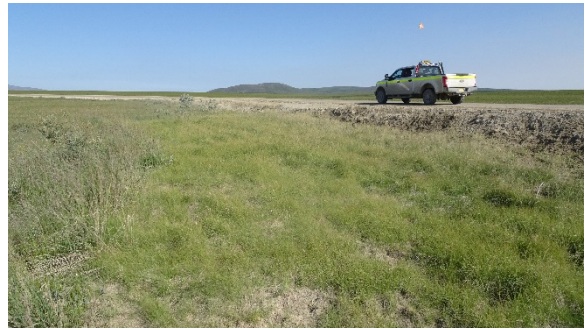
Vegetative regrowth at 2012 Concentrate Spill

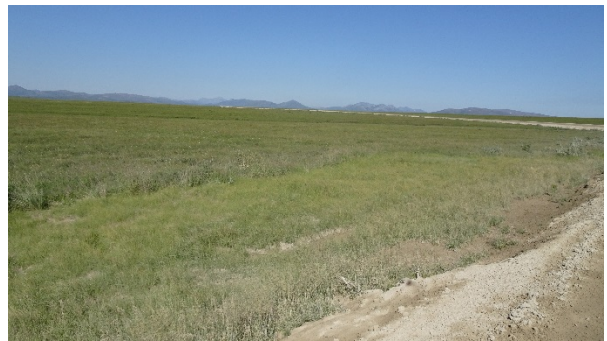
Vegetative regrowth at 2012 Concentrate Spill

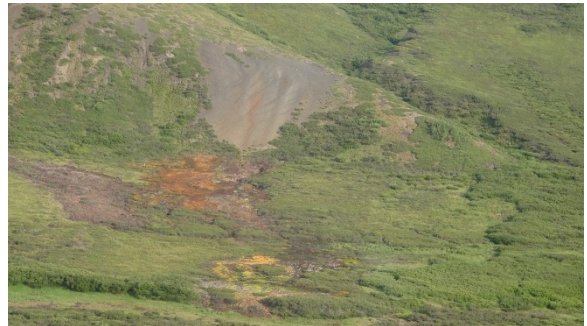
Natural Mineral Seep along Ikalukrok Creek
