**Red Dog Mine  
Closure and Reclamation Plan**

**SD C3: Dam History Report, Red Dog Tailings  
Main Dam, Future Raises to Closure  
(URS, 2007)**

**DAM HISTORY REPORT  
RED DOG TAILINGS MAIN DAM  
FUTURE RAISES TO CLOSURE  
RED DOG MINE, ALASKA**

**TECK COMINCO ALASKA, INC.  
URS JOB NO. 33757098  
September 14, 2007**

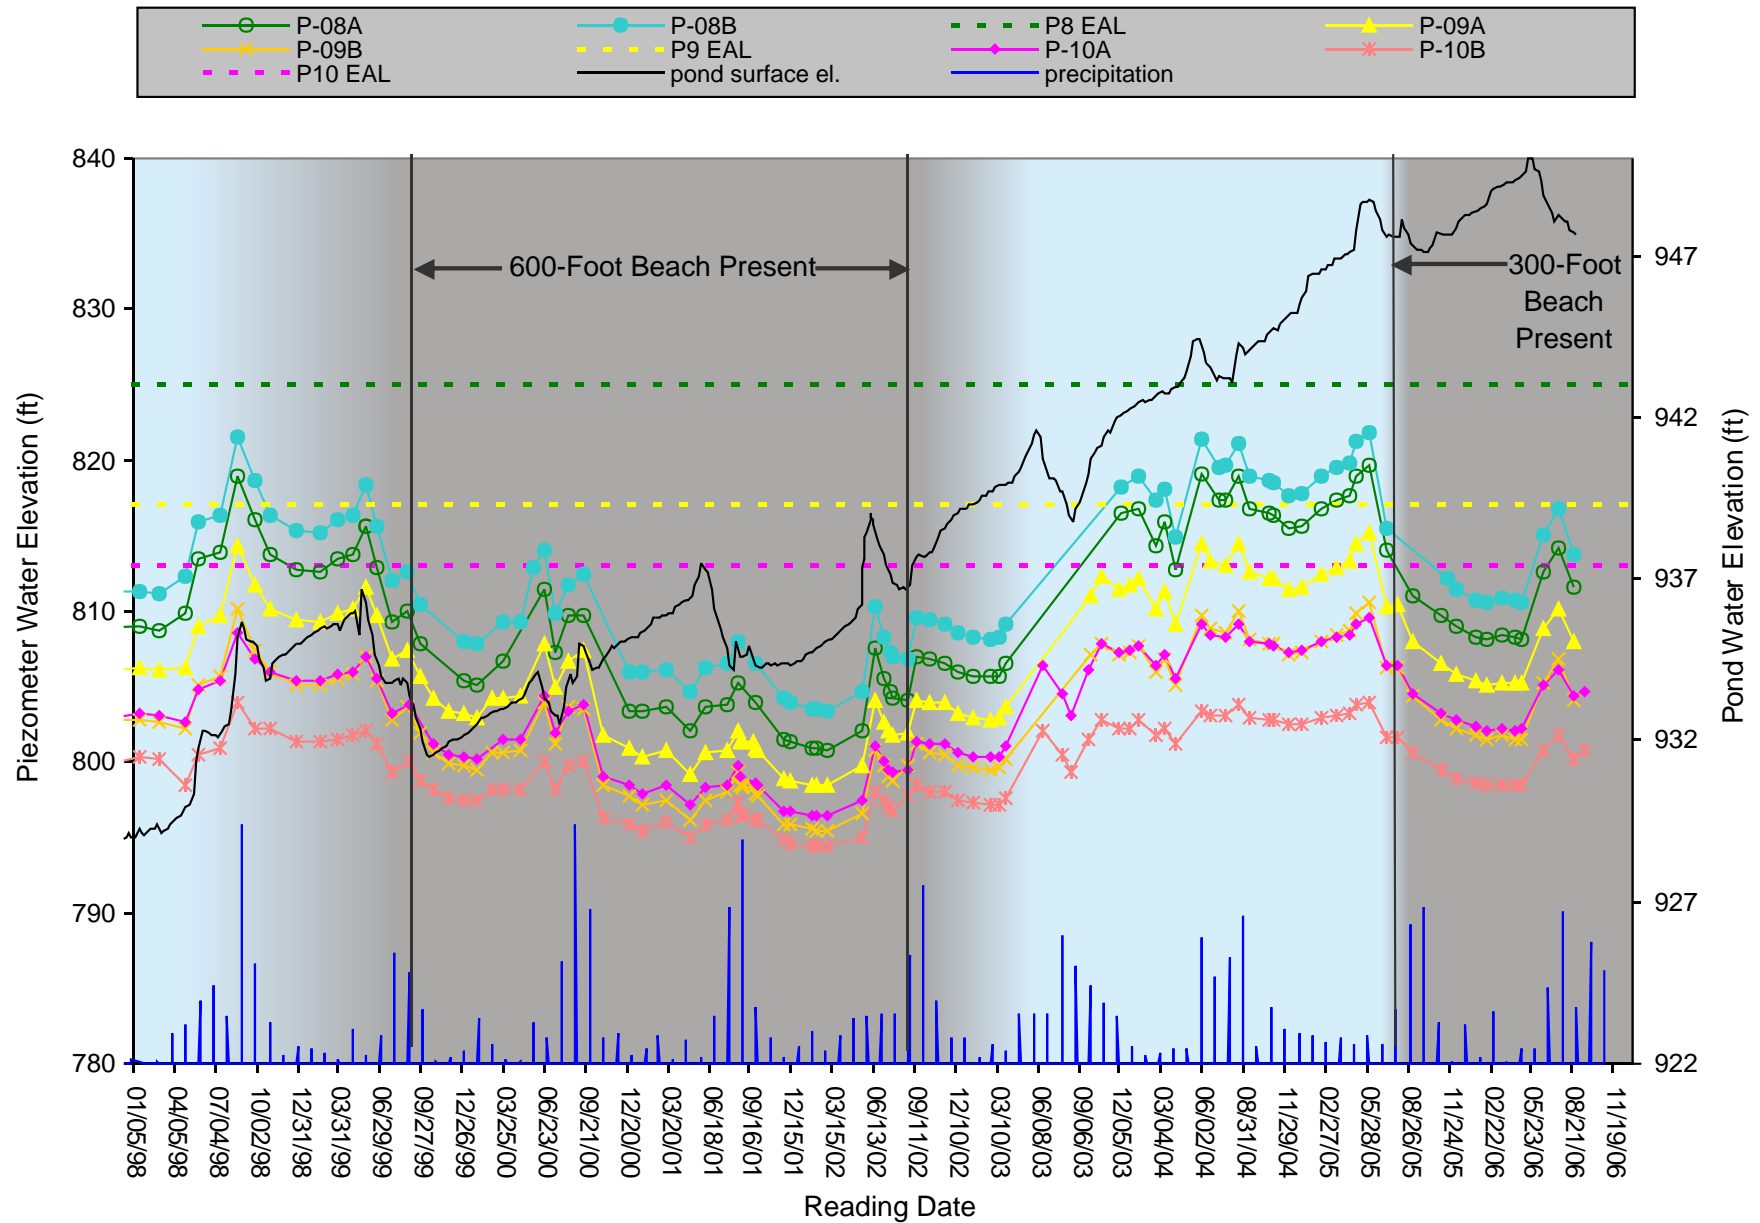
Figure 11  
**Underdrain Piezometers with EALs**

Piezometric readings are plotted for the record period along with the recommended EALs for P-10, P-09 and P-08 as shown on Figure 11. None of the readings for these piezometers has exceeded the EAL levels.

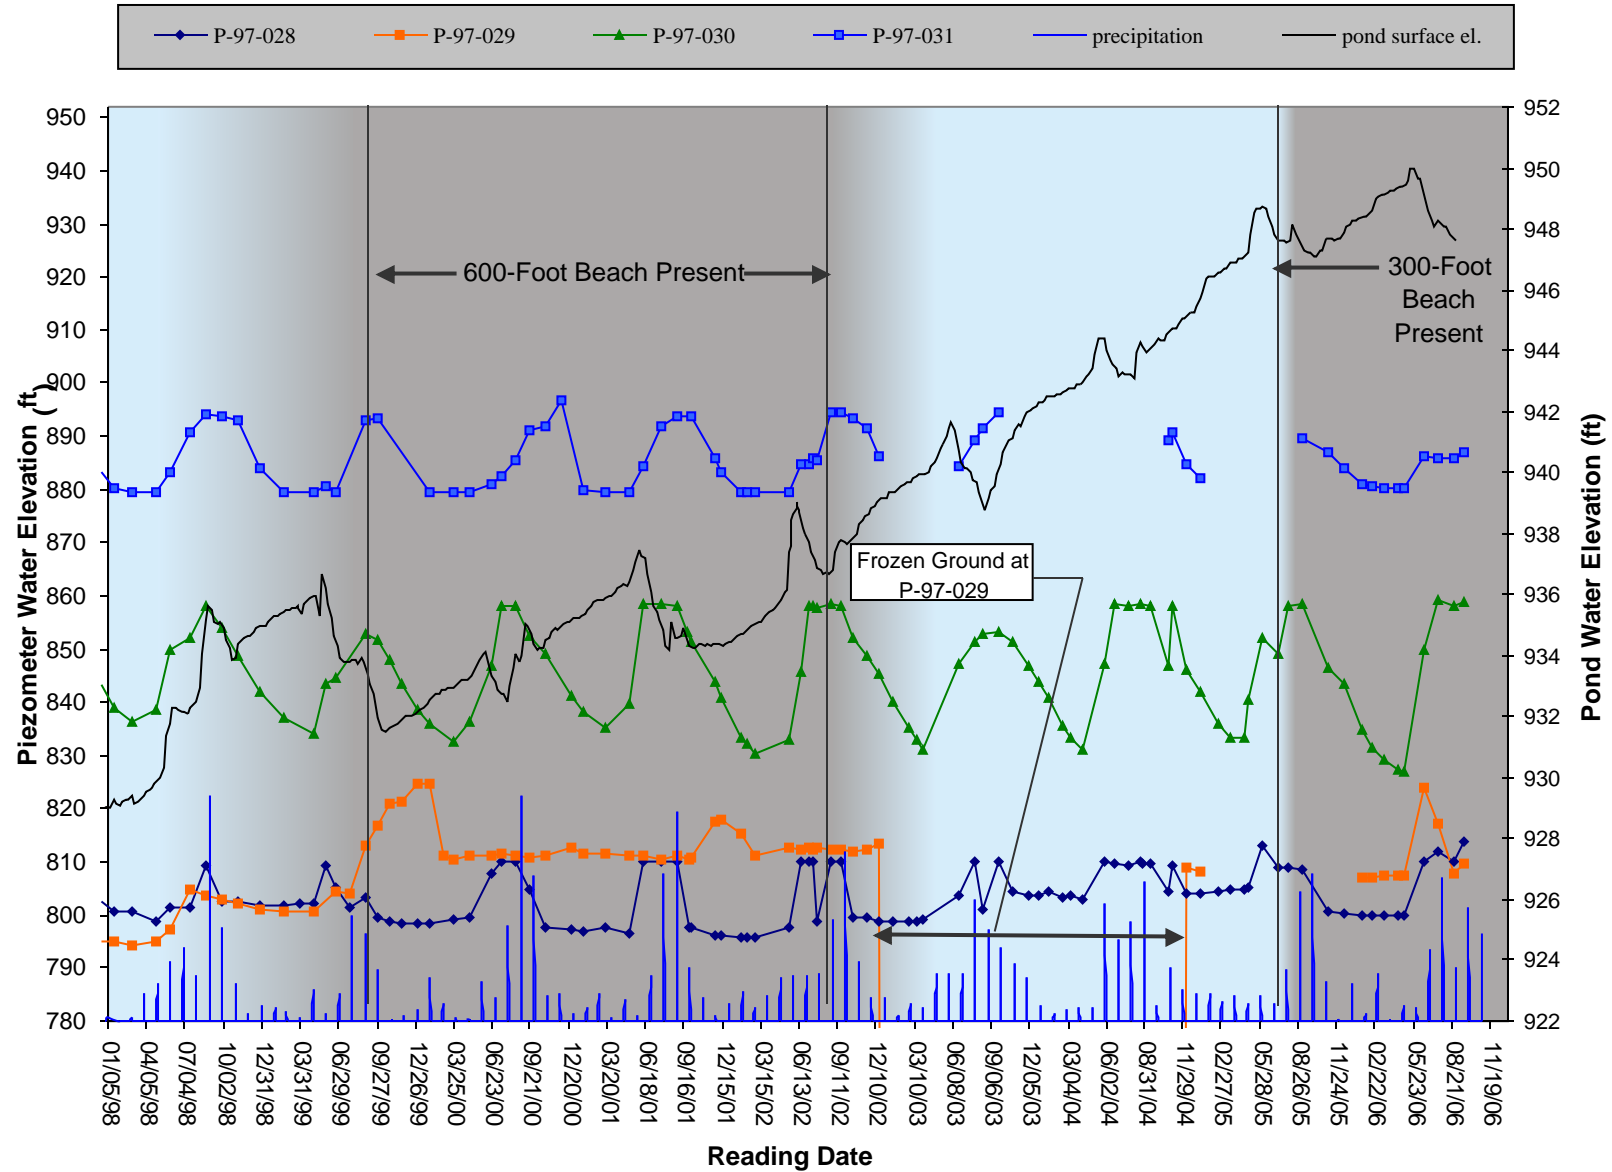
Figure 13  
**Buttress Piezometers**

Four piezometers are located along the rockfill buttress as shown in Figure 13. Except for P-97-031 which terminates in dam fill, the buttress piezometers are located in the foundation beneath the dam. Buttress piezometers P-97-028, P-97-029, P-97-030 and P-97-031 were installed in the rock fill buttress in 1997 as part of a Phase II hydrologic characterization (Water Management Consultants, 1999).

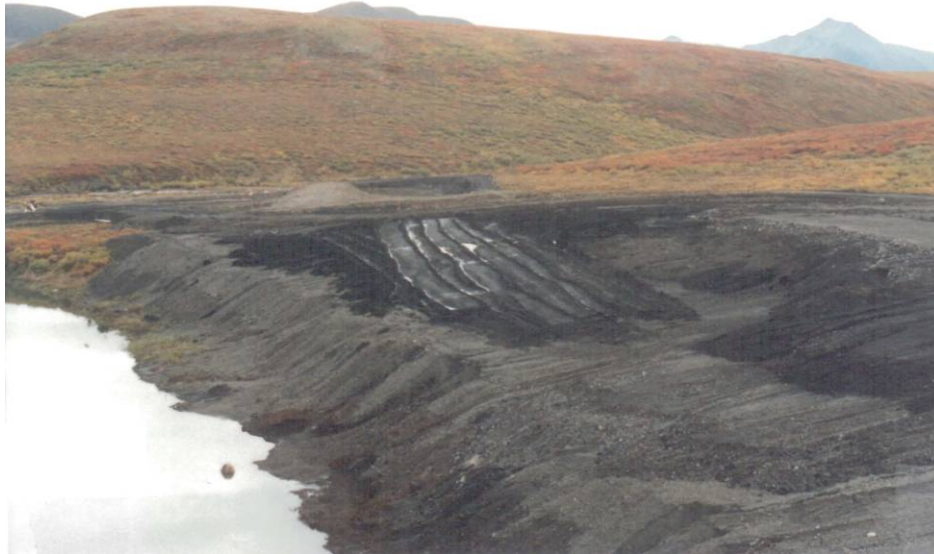
Left shoulder of Starter Dam Sta. 9+00 looking to the north. Polishing pond in top part of photo. Observe standing water on top of Stage 2 material.

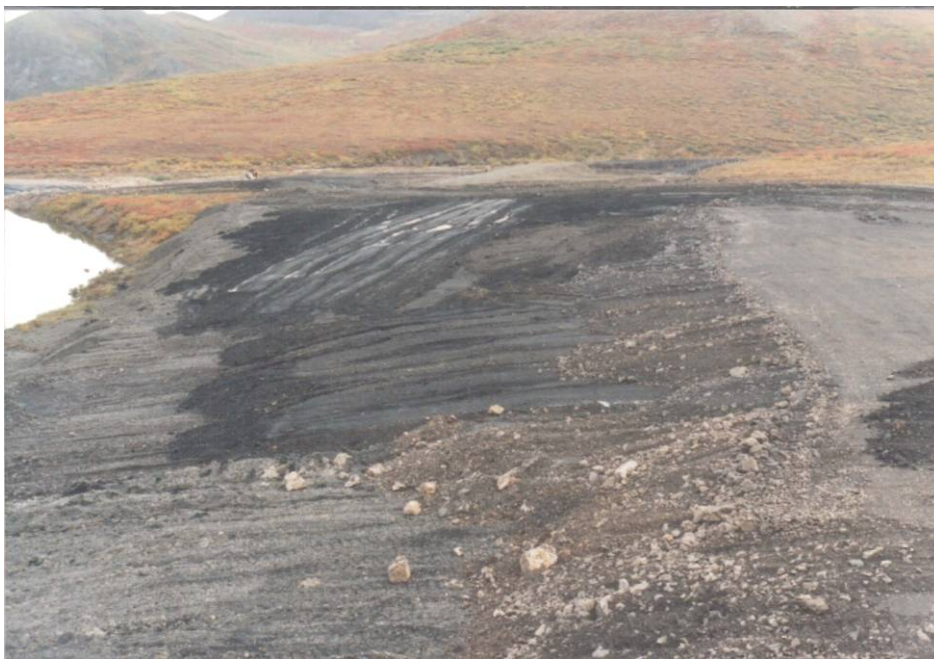
Left shoulder of Starter Dam Sta. 11+00 looking to the north. Edge of lift placed August 16 and 17, random rock from millsite.

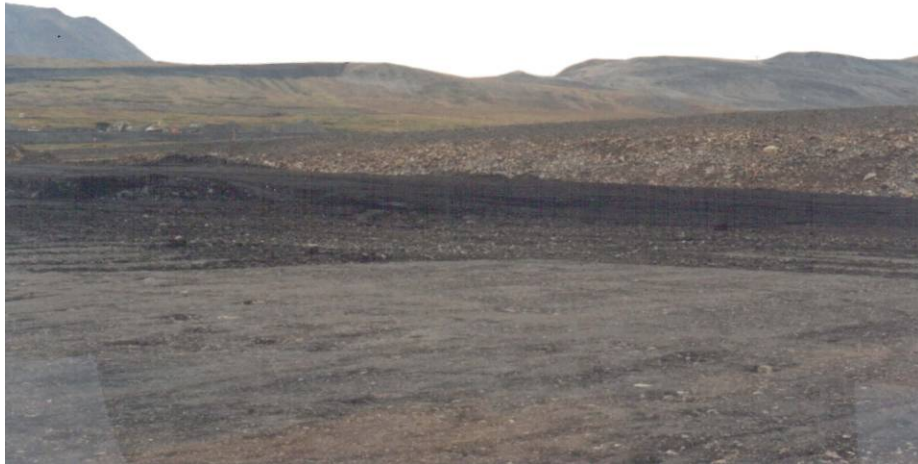
Fill material placed August 20, from millsite excavation (highly weathered/high moisture content).

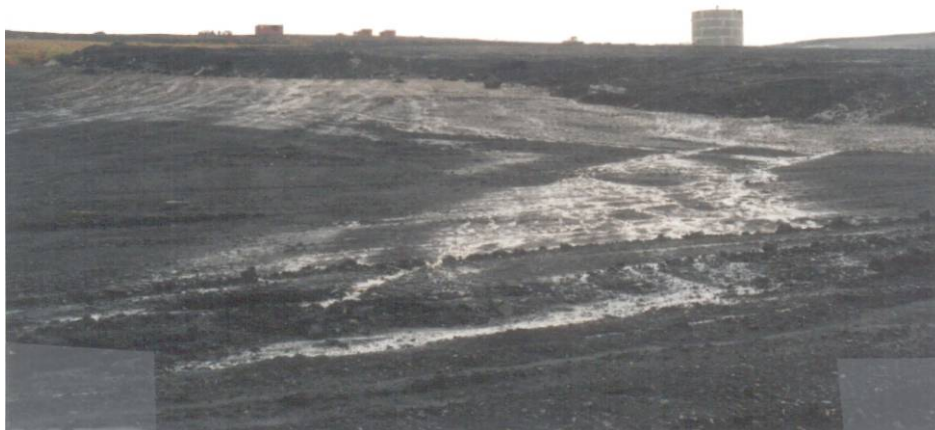
Taken from the seepage dam access road looking towards the east. Lift is estimated to be approximately 5 to 6 feet thick in the middle and tapered on the edges. Noticeable drainage from under lift.

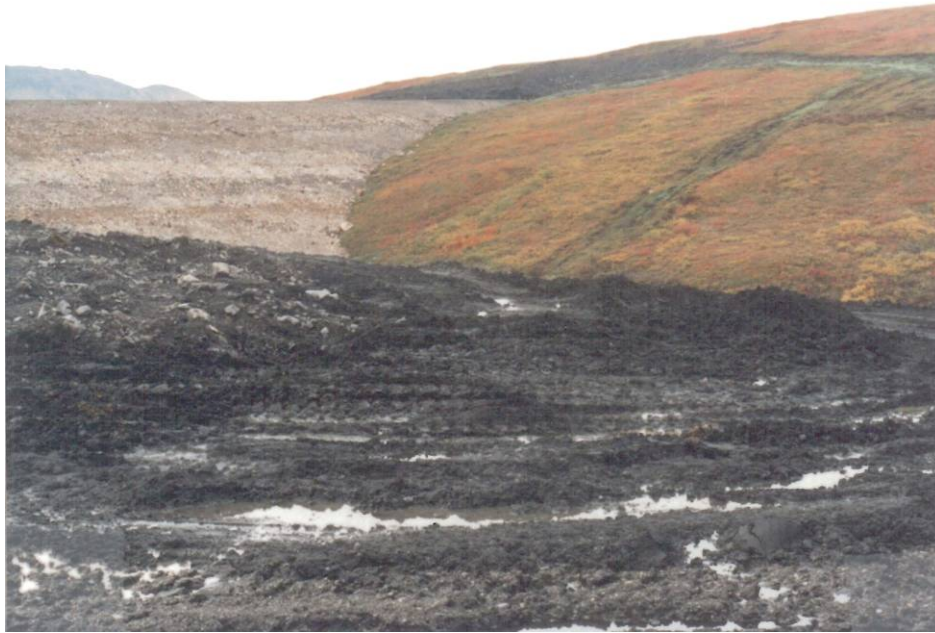
Taken from the seepage dam access road looking towards the starter dam. Area where D6 got stuck. Random rock fill placed over very soft and wet silty material.

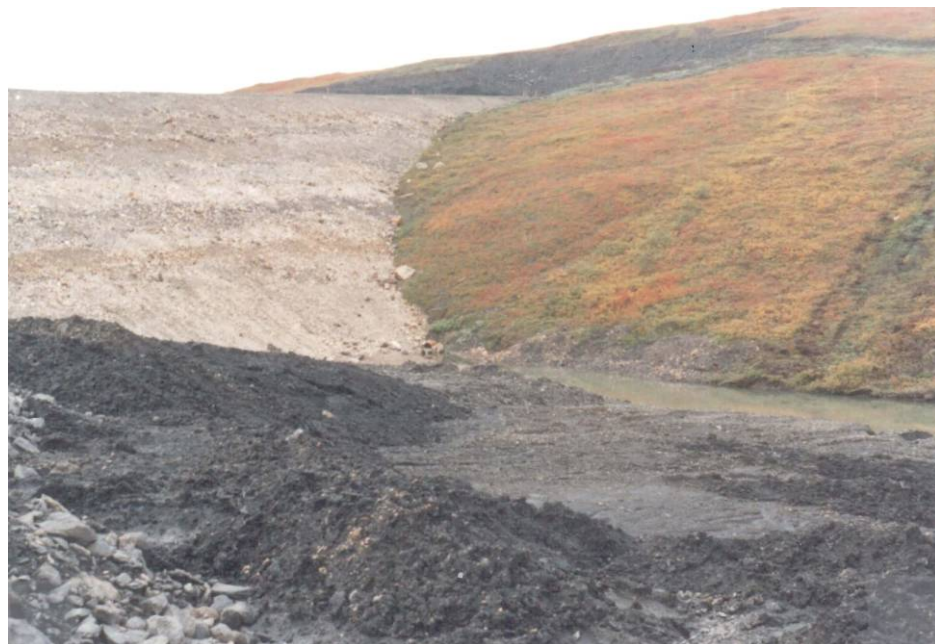
Edge of random rock fill looking towards starter dam. Very soft material approximately 6 to 7 feet thick.

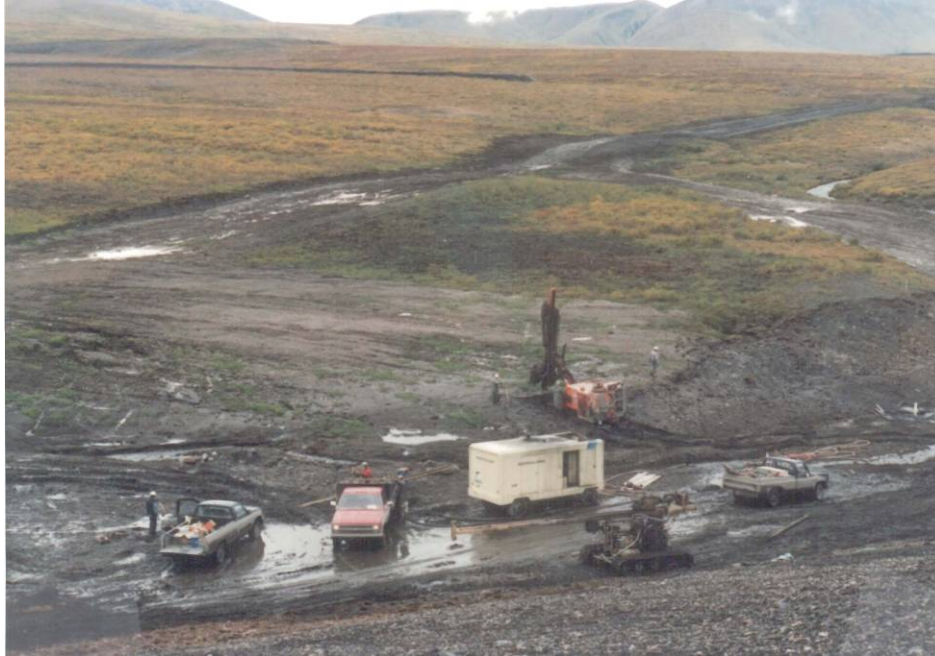
Right shoulder of starter dam. Crest, thermistor locations; T-11 to right of the black pickup in right corner, individual placing string; T-10 in the area of the Tamrock; T-9 left corner of photo with white PVC above ground.

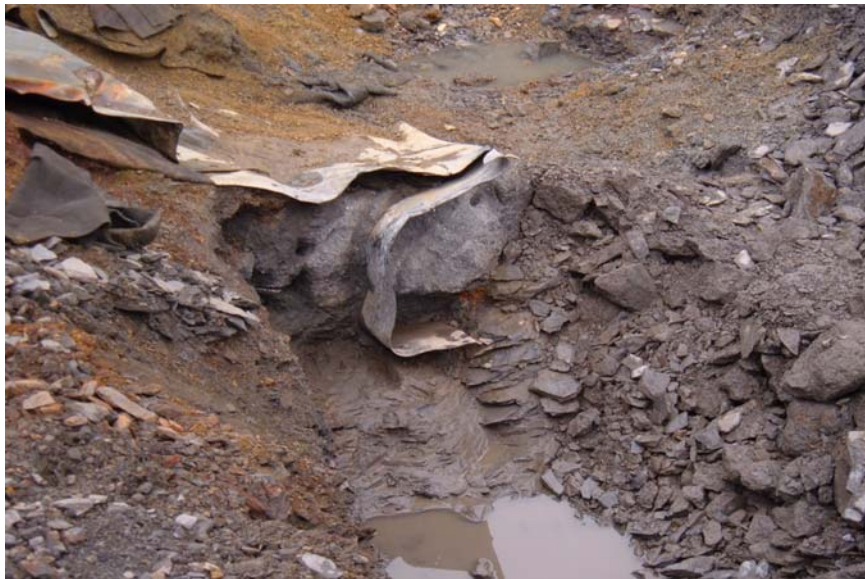
Exposed End of Stage IV Cutoff Wall

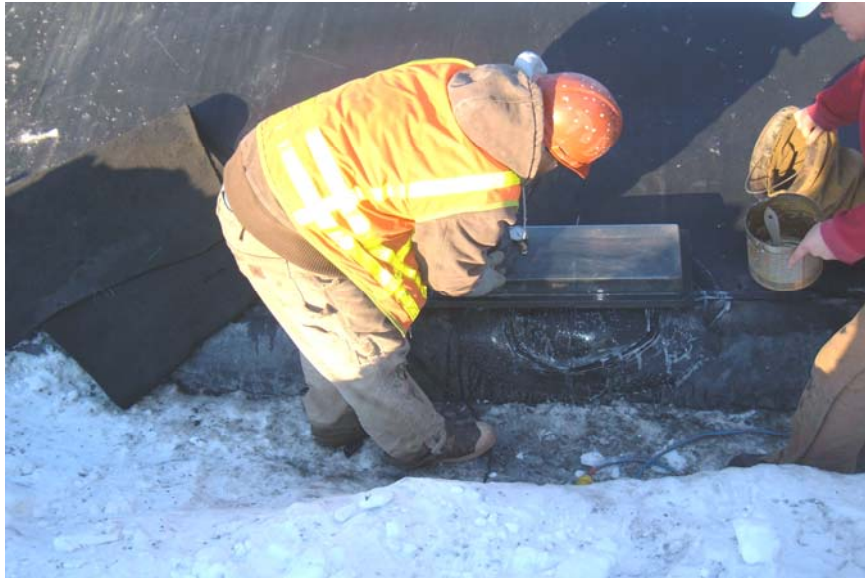
The geomembrane panels were seamed by fusion and extrusion welding. All welds were tested for leaks by either air pressure or vacuum test methods. CQA and CQC personnel inspected the testing and watched for pressure losses or bubbles that would indicate leaks in the seam. Any leaks that were found were repaired.

Non-Destructive Vacuum Test of Welds
