Greens Creek Mine Inspection Report

Agency Personnel: Operator Contacts: Inspection Objectives: September 12, 2024 7:00AM to 4:00PM Overcast, frequent scattered showers occasionally heavy. Wind gusts to 35mph. 50°F. Jesse Garnett White, William Groom, and Carolyn Curley Paula Lillesve Site Inspection

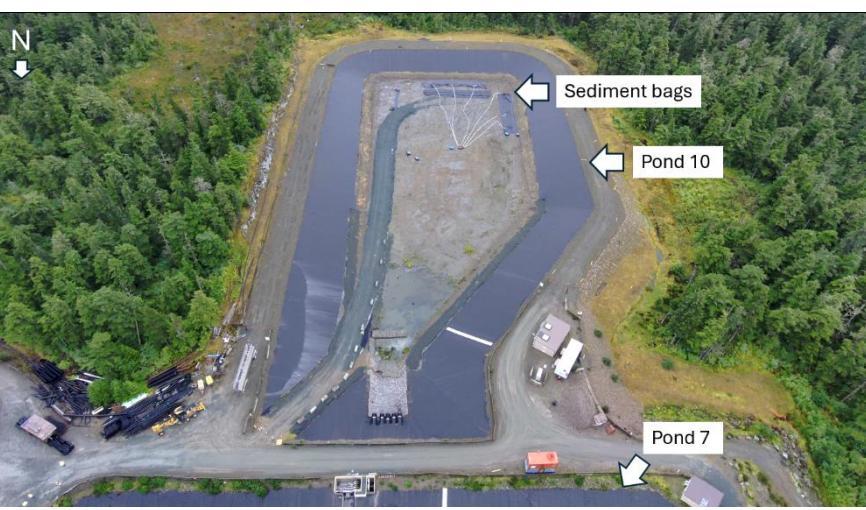
Photo 1: Pond 10. Pond 10 is a backup pond to provide additional surge protection and was essentially devoid of water at the time of inspection. The liner appeared well maintained. Note the sediment bags and hoses in the upper right of Pond 10. When the pond is dredged to remove sediment, that sediment is pumped to the bags and dewatered. The dry tails are removed from the bags and placed on the TDF.

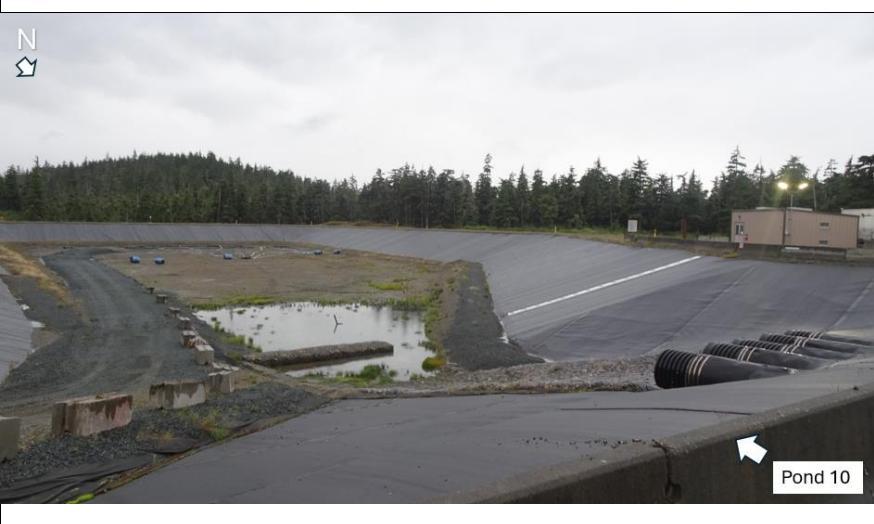
Photo 2: A different view of Pond 10 exhibiting the minor amount of water in the basin, liner, and gabion inlet spillway. Note that Pond 10 was prepped but had not yet been dredged at the time of inspection.
