TRIP REPORT

State of Alaska
Department of Fish and Game

Field Date(s): September 15-18, 2025
Location(s): Johnson Tract – West Cook Inlet
Objective(s): Fish surveys along proposed port road
Participant(s): J. Brekken and B. Evers
Weather: Mixed
Access: Fixed wing charter and helicopter

Johnson Tract Fish Survey 2025

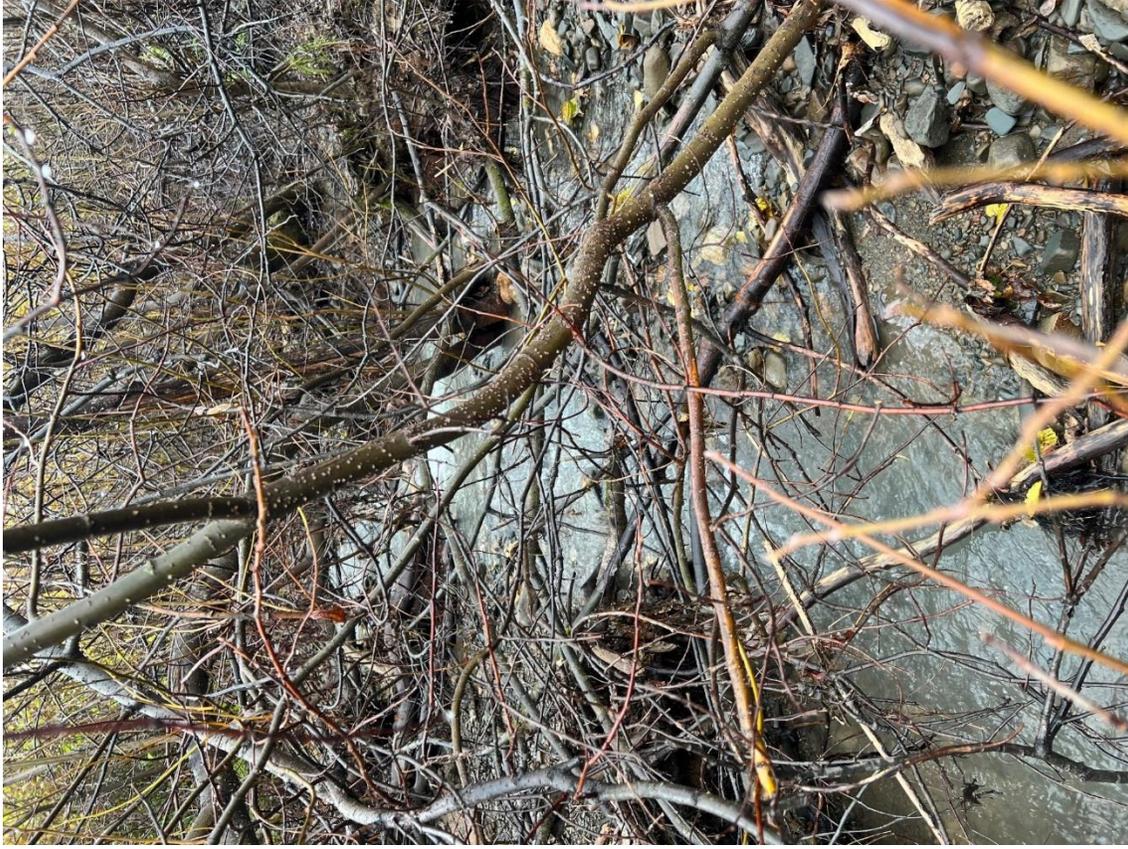
Crossing No. 47 looking upstream (downstream of No. 48).

Crossing	Elevation (m)	Latitude	Longitude	Fish Results	Habitat Notes	Fish Present	Notes on Fish Presence
47	64.3	60.109058	-152.73483	No fish captured or observed	3' wide, 4" deep, gravel/cobble substrate, thick willows, channel appears to move around - currently cutting through small trees/shrubs, looks like it should support fish, and point is just downstream of #48	Possible	Suitable habitat, close to Bear Creek with no barriers present, stream course appears to move around
48	65.9	60.109320	-152.73530	No fish captured or observed	3' wide, 4" deep, gravel/cobble substrate, thick willows, channel appears to move around - currently cutting through small trees/shrubs	Possible	Suitable habitat, close to Bear Creek with no barriers present, stream course appears to move around
49	68.5	60.108655	-152.73818	No fish - dry channel	Vegetated swale, alders/ferns, no recent evidence of flows	No	Dry, doesn't appear to hold water very often

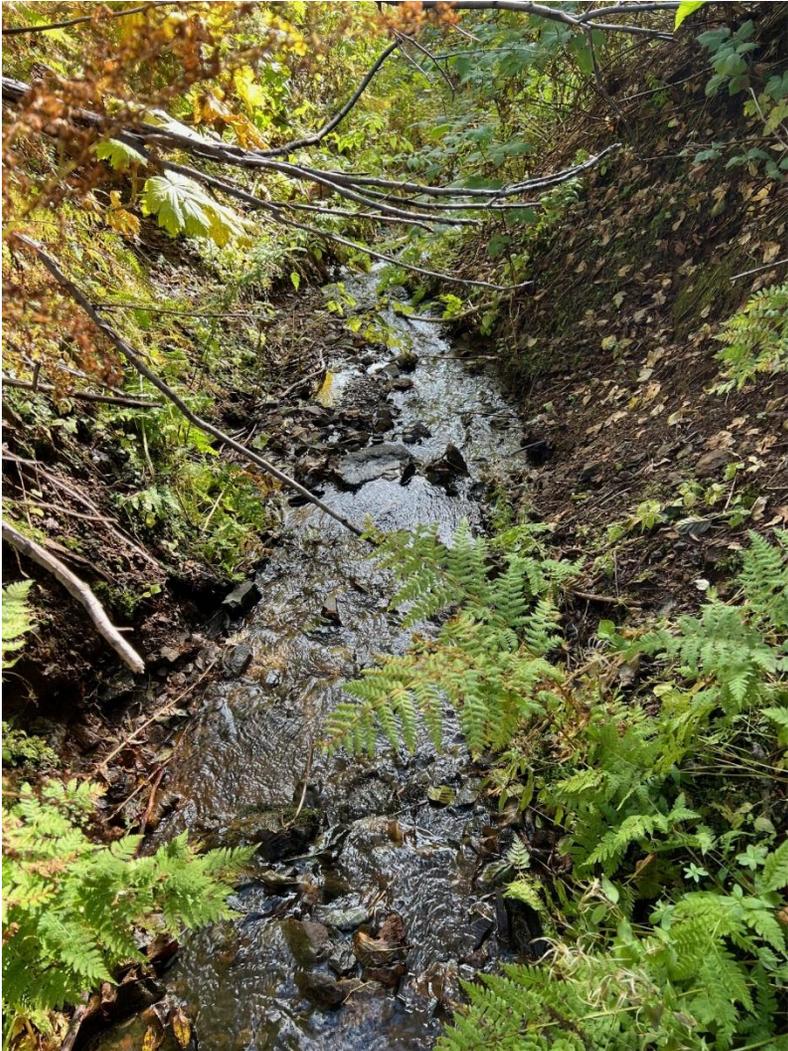
Crossing No. 62.

Crossing	Elevation (m)	Latitude	Longitude	Fish Results	Habitat Notes	Fish Present	Notes on Fish Presence
62	176.5	60.098955	-152.76466	No fish captured or observed	small and steep stream, 5% slope, 2' wide, 2" deep, incised/canyon like, bedrock/cobble/gravel substrate, alder/salmonberry veg., cascade nature	No	Steep with very little drainage area, likely dry or frozen in winter
63	59.2	60.079006	-152.76634	DV: 400 (male), 350 (female) - in spawning condition; juveniles captured (FL 65-180 mm)	10-15' wide, 6"-2' deep, riffle character, alder banks, cobble/gravel substrate, 1-2% slope	Yes	Dolly Varden present, crossing likely in a spawning reach
64	39.3	60.07529	-152.77608	2 coho salmon (spawning); multiple juvenile coho salmon captured (FL 49-65 mm), DV present	2' wide, 8-10" deep, incised channel, grass/willow riparian, sand/gravel substrate, medium gradient (+1%), drains from remnant beaver pond (fish observed in pond)	Yes	Dolly Varden and coho salmon present

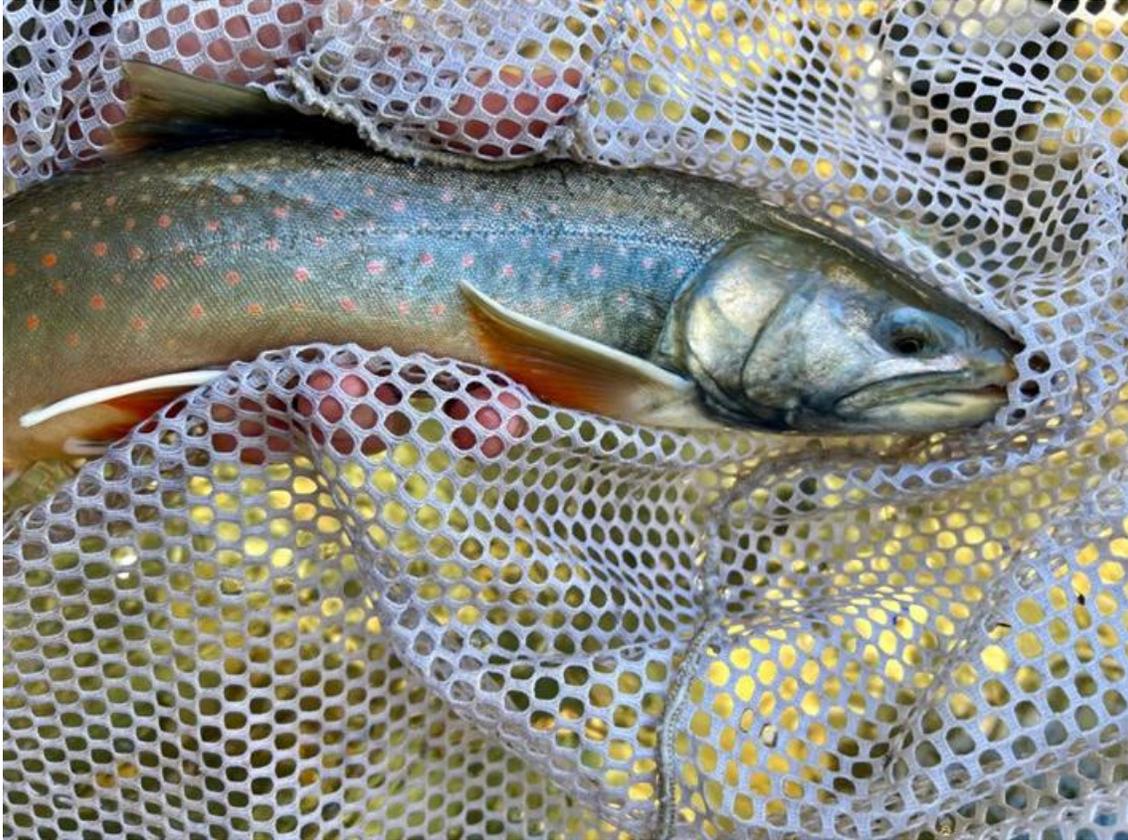
Dolly Varden at Crossing No. 63.

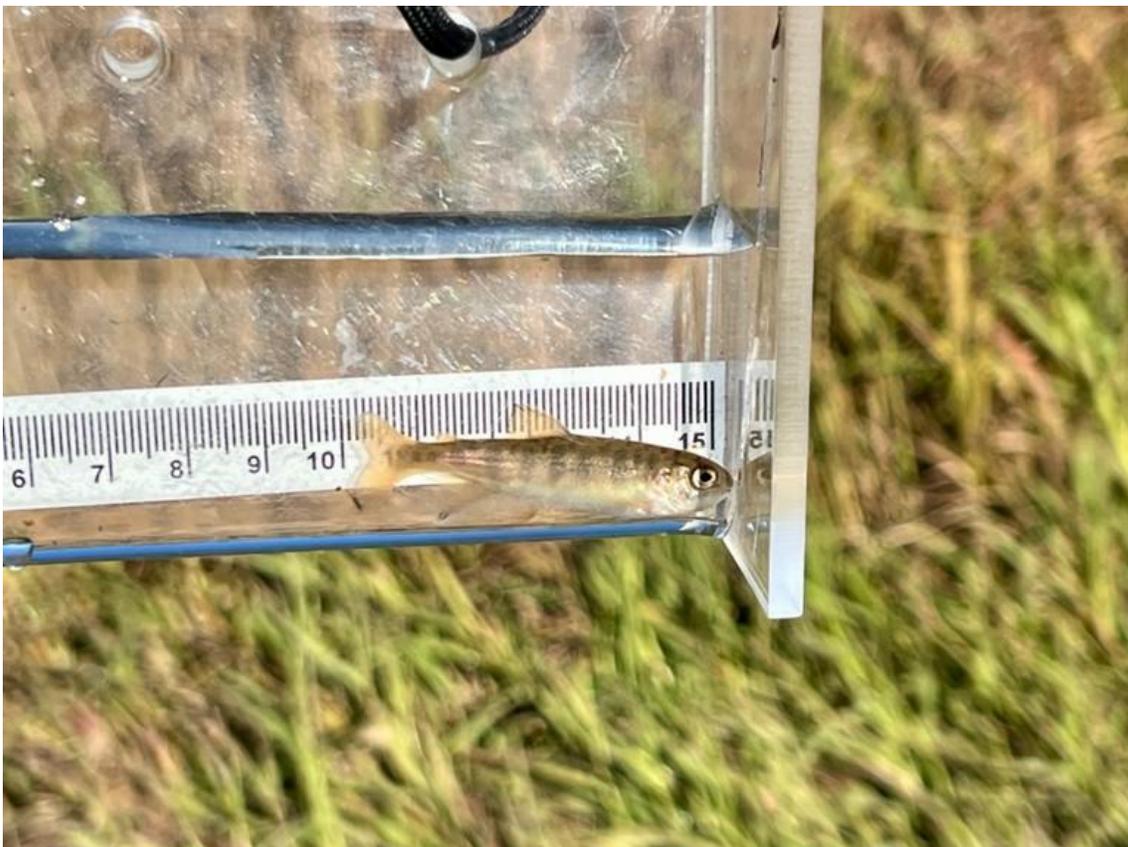
Coho salmon at Crossing No. 64.

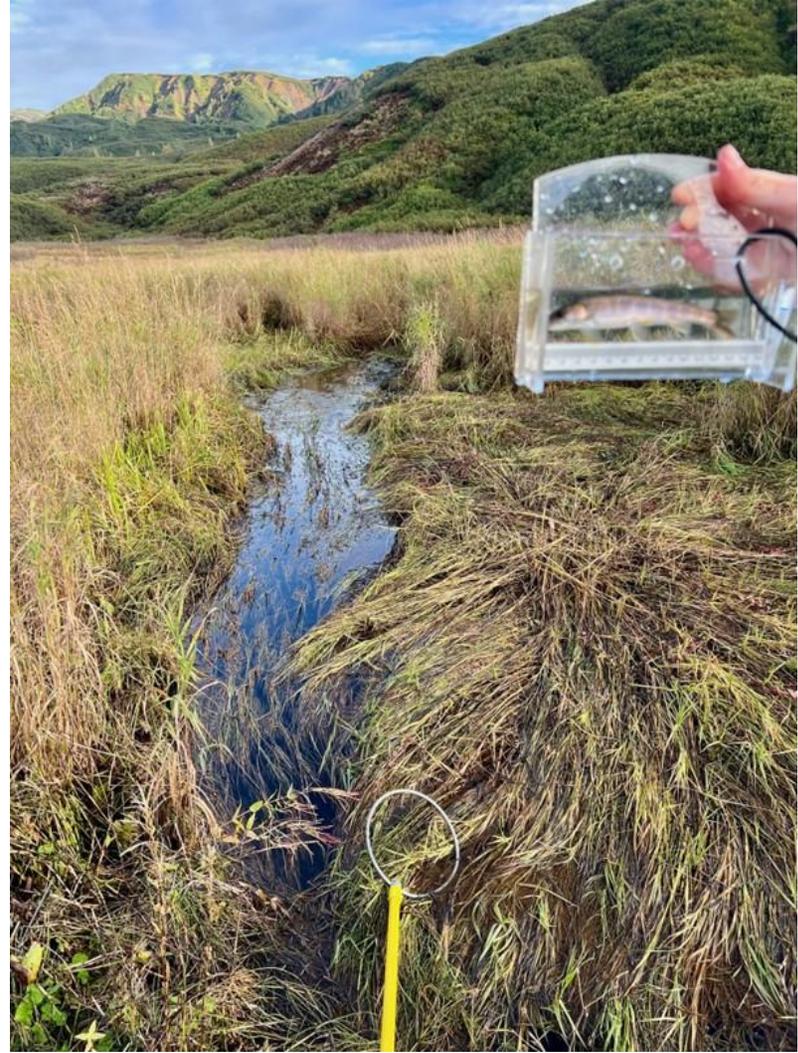
65	39.2	60.076562	-152.78152	DV: 122	3' wide, 1' deep, sand/gravel/silt substrate, drains remnant beaver pond through dam breach, low gradient	Yes	Dolly Varden present, high quality rearing habitat
66	40.4	60.077168	-152.78592	No fish captured or observed	Marshy area, multiple channels in the area (flats), low gradient, lots of iron flocculant, aquatic vegetation and sedges, surveyed channel was 2' wide, 8" deep	Unlikely	Water quality may be an issue for fish habitat at this site; would be helpful to collect water quality parameters (specifically pH)
67	66.1	60.081155	-152.79458	No survey	Drainage evident but we did not observe water (could have been obscured by vegetation)	Likely	Likely suitable habitat based on similarities to #64 and #65
68	69.1	60.082870	-152.79810	No survey	Drainage evident but we did not observe water (could have been obscured by vegetation)	Likely	Likely suitable habitat based on similarities to #64 and #65

Crossing No. 65 and Dolly Varden.

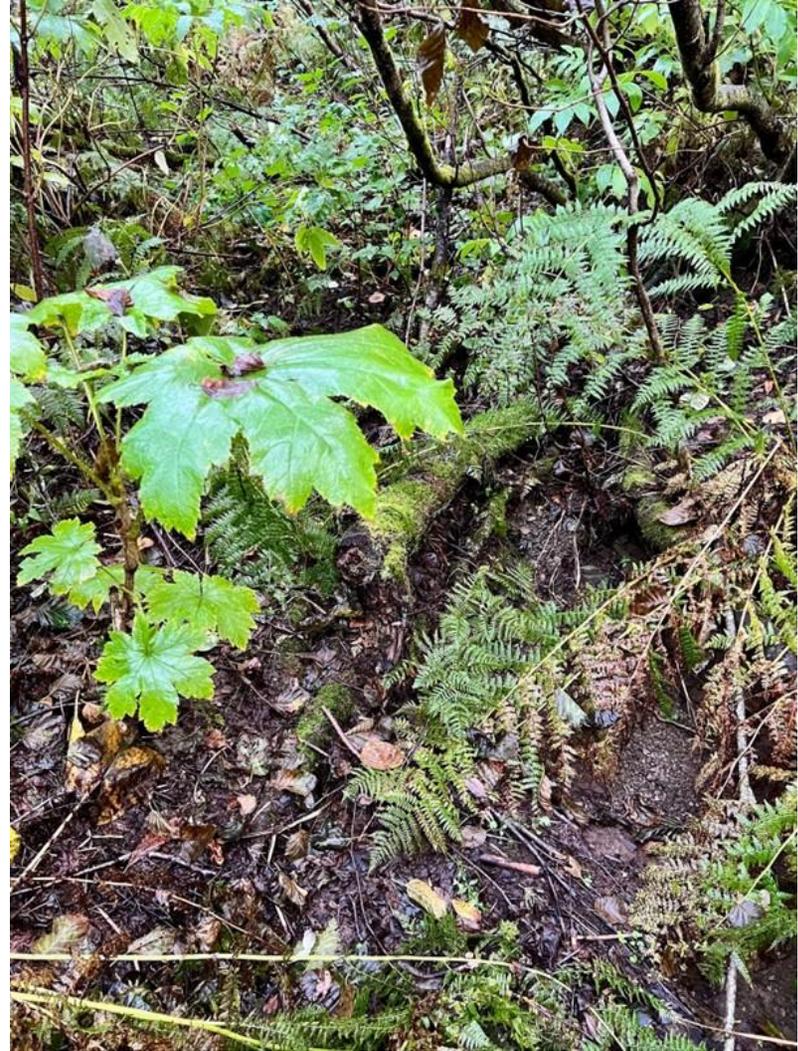
Crossing No. 69.

69	73.0	60.084413	-152.80127	No fish/dry channel	vegetated swale (alders), not much evidence of flow	No	Very small catchment at this location
70	80.4	60.085447	-152.80391	No fish/dry channel	Dry, cobble and gravel substrate, evidence of high flow, split channel, ~50' wide channel	At times	Site was dry during our visit, stream is a distributary/split of #71 and #72, water present at times with direct connection to #72
71	81.4	60.085655	-152.80496	No fish captured or observed	4' wide, 4" deep, ~2% slope, cobble and gravel substrate, evidence of high flows, split channel, estimated bankfull width of 25 feet	At times	No fish captured, stream is a distributary/split of #70 and #72, water present at times with direct connection to #72
72	82.8	60.085786	-152.80576	DV: 350, 325 mm	~20' wide, 8" deep, cobble/gravel substrate, 2-3% slope, braided/flowing through alders (newer channel)	Yes	Dolly Varden present, crossing possibly in a spawning reach

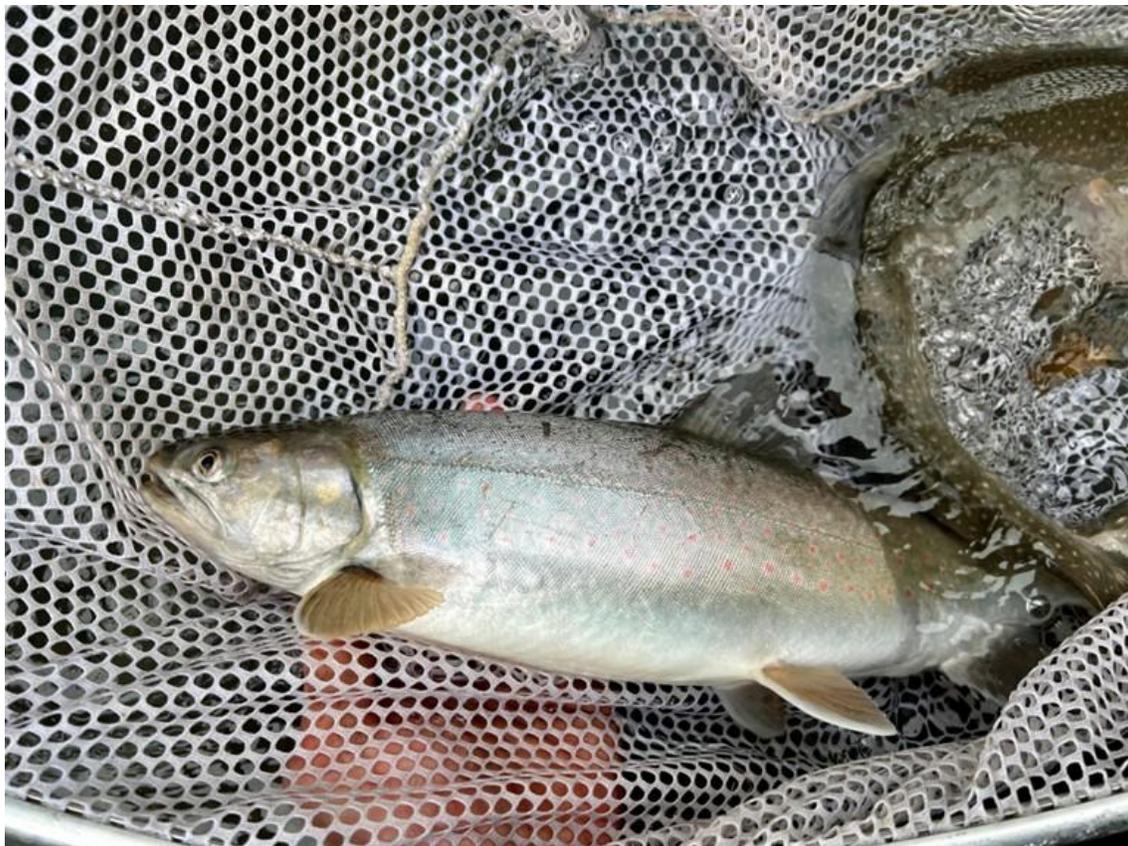
Dolly Varden at Crossing No. 72.

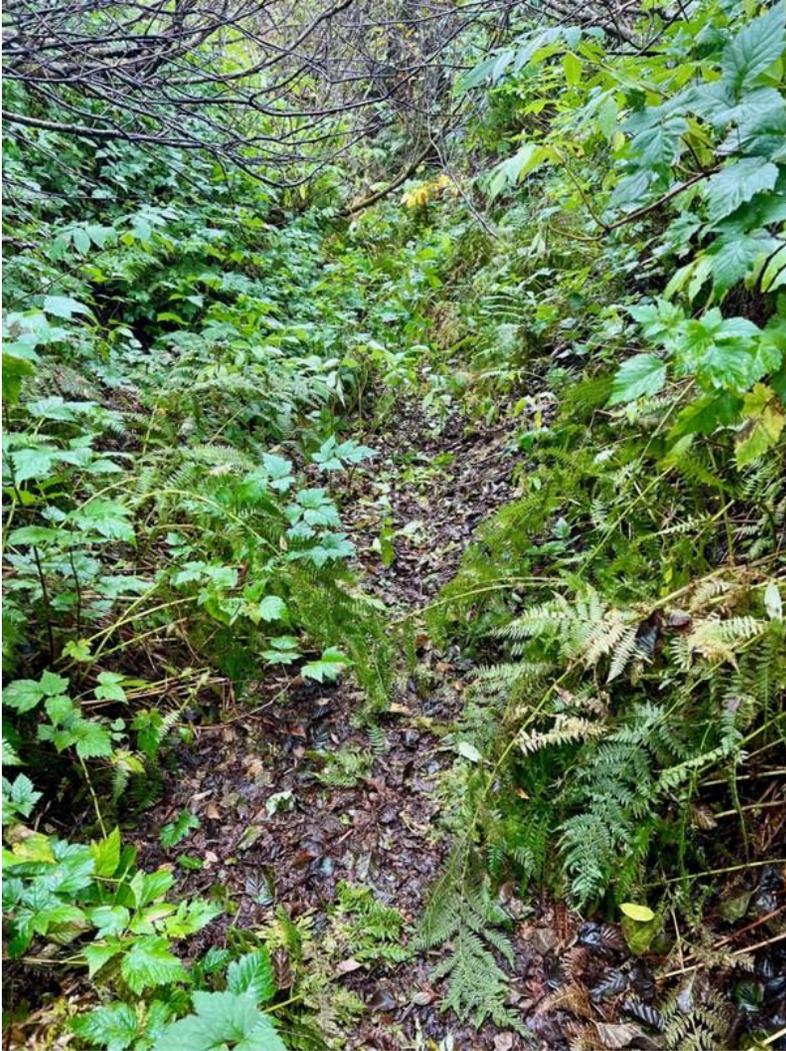
Crossing No. 74.

73	79.8	60.086854	-152.81224	No survey	Thick alder vegetation, drainage path observed	Likely	Habitat appears suitable
74	66.1	60.087815	-152.81807	No fish/dry channel	Dry channel, drainage path evident but no evidence of recent flow, alder/salmonberry/fern vegetation, 3' wide channel, overgrown gravel substrate	No	
75	68.5	60.088727	-152.82360	No Survey	Small drainage area upstream, no stream observed from air, steep gradient, unlikely to provide fish habitat based on conditions found at #74 which has similar drainage area and setting	Unlikely	Did not appear to contain water
76	69.1	60.088834	-152.82425	No Survey	Small drainage area upstream, no stream observed from air, steep gradient, unlikely to provide fish habitat based on conditions found at #74 which has similar drainage area and setting	Unlikely	Did not appear to contain water
77	66.6	60.089621	-152.82903	No fish captured or observed	Same stream as 78 and 79. Decent volume stream that drains flooded area/shallow pond, 5' wide, 8" deep, alder/willow veg., ~1% slope	Possible	Habitat appears suitable

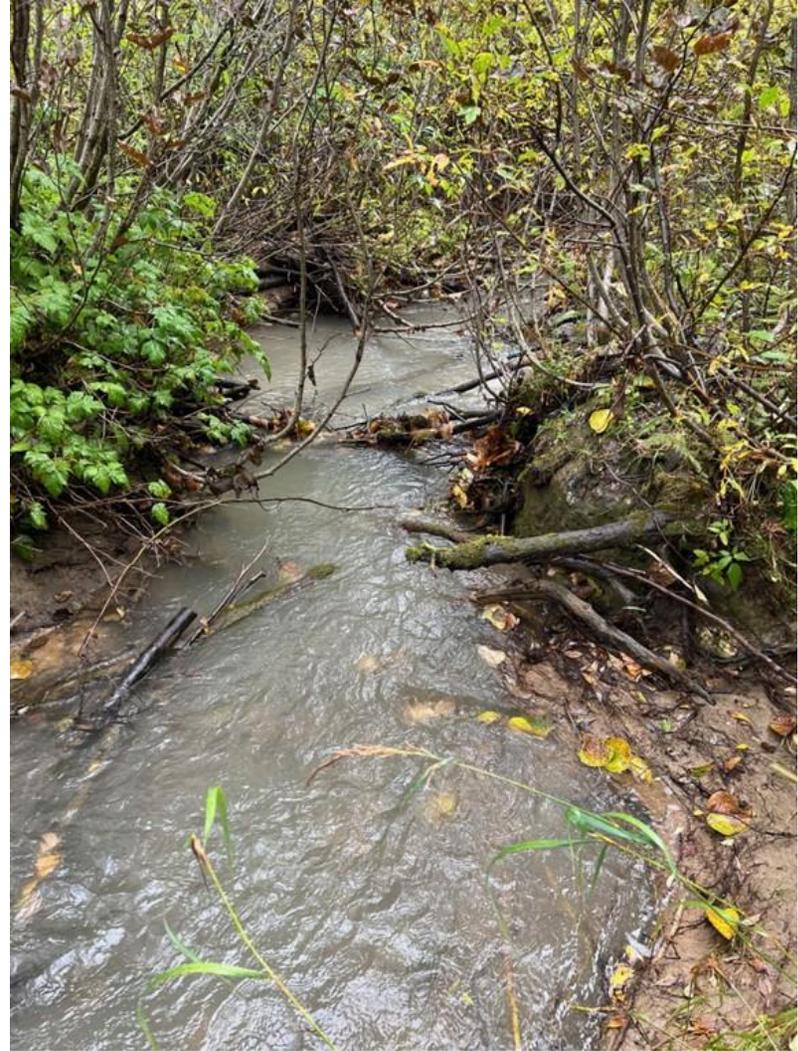
Crossing No. 77 (just downstream of No. 78 and 79).

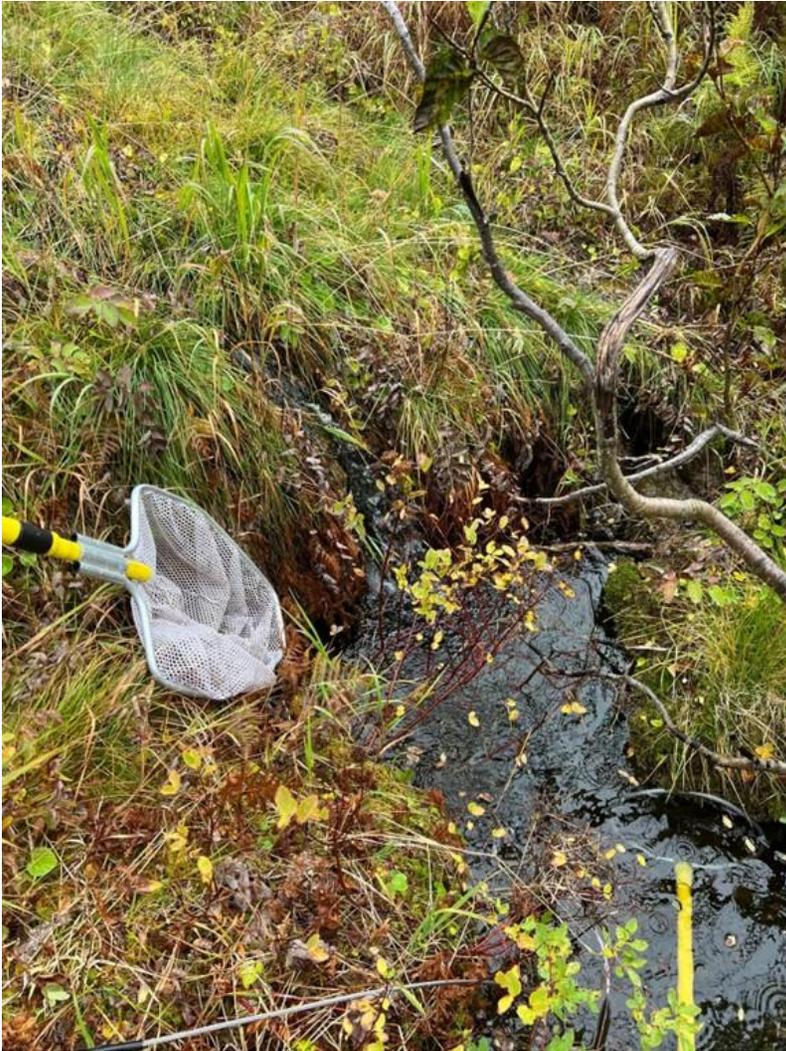
Crossing No. 82.

82	90.0	60.091880	-152.8415	No fish captured or observed	1-2' wide, 4-8" deep, organic substrate, low gradient stream on bench above Johnson River, barriers between site and Johnson	No	Very small catchment at this location
83	87.3	60.092552	-152.84476	DV: 78, 65 mm	5-6' wide, 2-6" deep, cobble/gravel substrate, ~2% gradient	Yes	Dolly Varden present
84	84.7	60.092670	-152.84675	No fish - dry channel	gravel substrate, well-established flow path but no water present, ~5' wide channel, riparian veg: alders	No	Dry
85	90.1	60.092742	-152.85303	No fish - dry channel	dry channel in a small canyon (~6' wide), alder/salmonberry veg., gravel/cobble substrate (slightly overgrown)	No	Dry, doesn't appear to hold water very often
86	86.0	60.092553	-152.854005	DV: 75, 80 mm	Side channel of Johnson River, mixed substrate (sand to boulder), located above set of rapids	Yes	Side channel habitat in large and swift river system

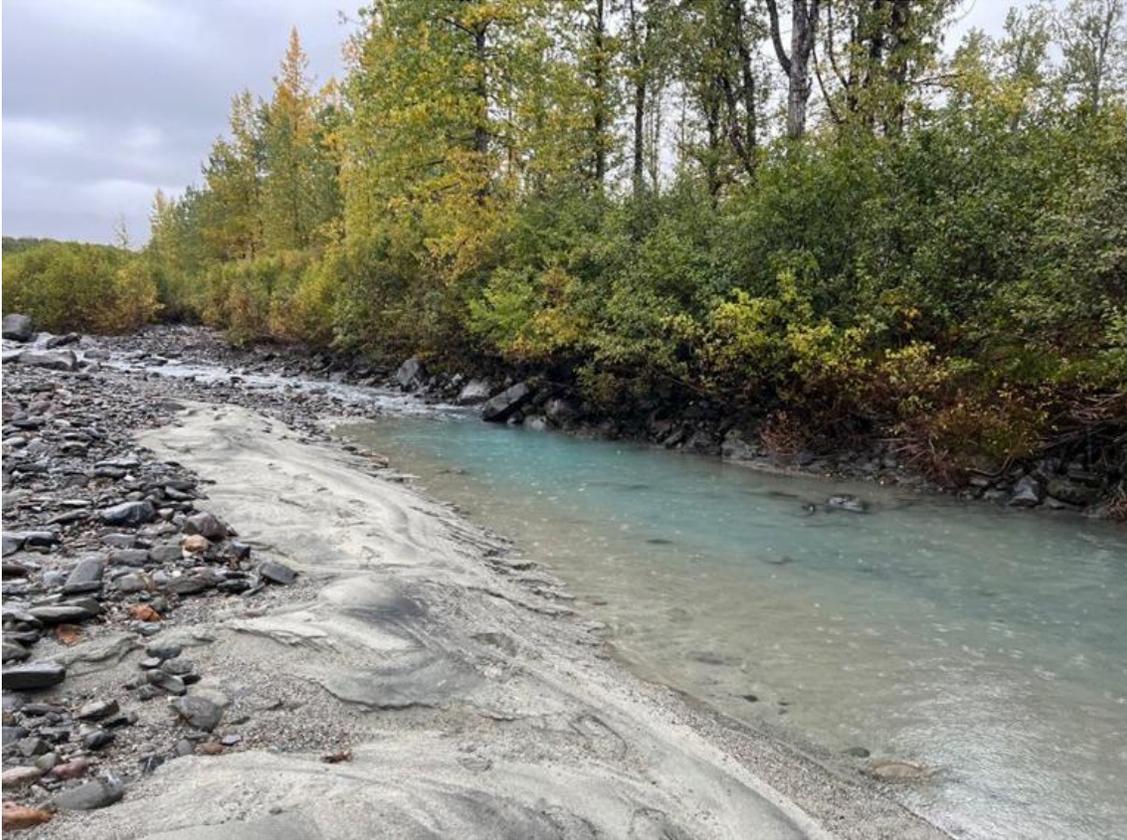
Side channel at Crossing No. 86.

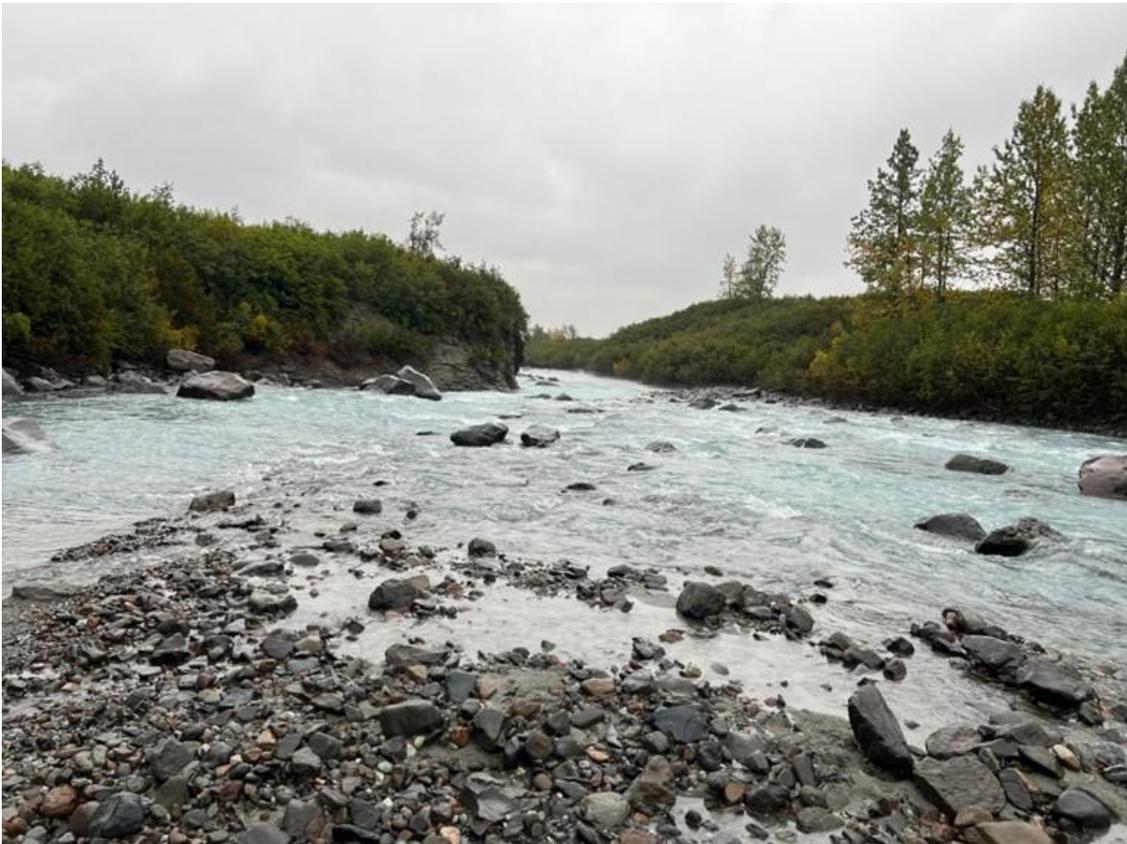
Johnson River (Crossing No. 86).

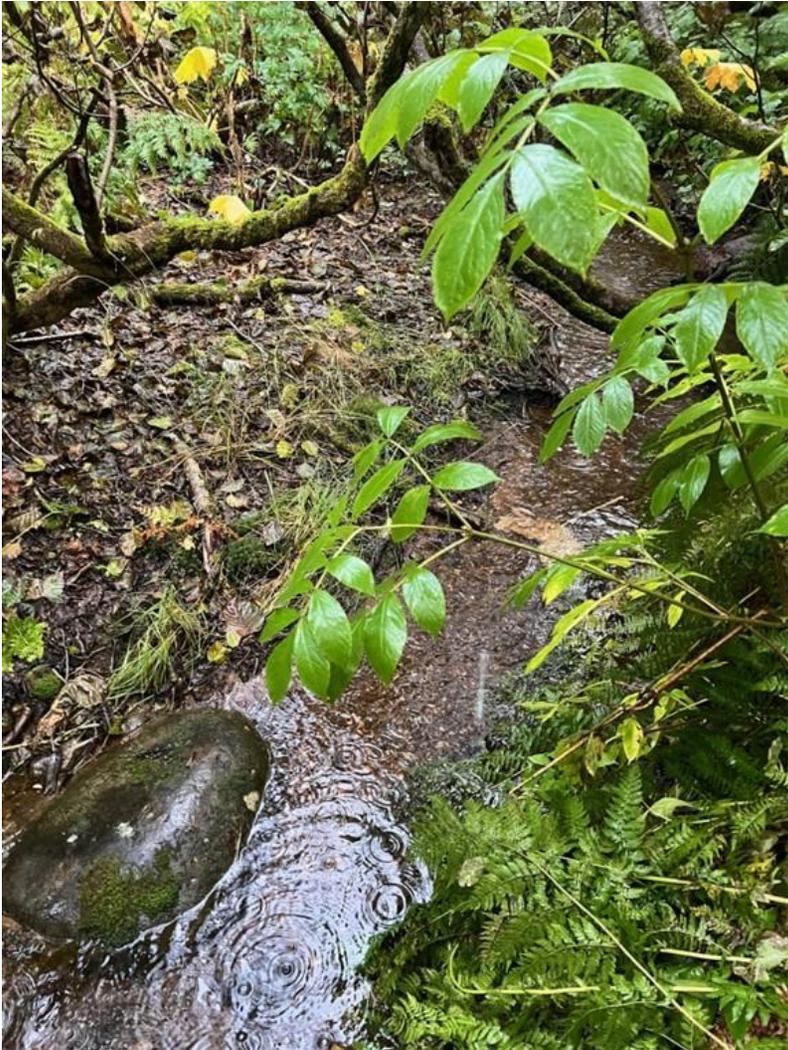
Crossing No. 87.

87	100.5	60.093402	-152.861895	No fish captured or observed	1.5' wide, 3" deep, sand/gravel substrate, low gradient, small amount of flowing water, small drainage area	No	Very little water
88	119.1	60.093309	-152.888399	No fish captured or observed	2' wide, 2-8" deep, gravel/cobble substrate, small creek that drains beaver pond, cascade character with multiple 2-3' drops	No	Very steep with lots of passage barriers
89	126.3	60.0931895	-152.893969	No fish captured or observed	2.5' wide, 3-6" deep, sand/organic substrate, very little flow, dry or subsurface in some reaches, feeds into small pond	No	Very little water, small catchment area
90	145.3	60.091375	-152.91007	DV: 115, 85, 72 mm CO: 70 mm	12' wide, 5" deep (outside of beaver impoundments), 1-2% gradient, active beaver activity/beaver pond system (small ponds in line with cascading/riffle stream, large substrate (cobble, gravel, organics), willow/alder banks	Yes	Excellent rearing habitat
