STATE OF ALASKA

DEPARTMENT OF NATURAL RESOURCES DIVISION OF MINING, LAND and WATER SEAN PARNELL GOVERNOR

POGO INSPECTION REPORT

October 6, 2011 Clear, 26 degrees F morning, 40 afternoon. 9:00 am to 2:00 pm Makoto Umedera, Julia Andoe – Sumitomo Pogo; Mika Mack -Mappa Brent Martellaro – ADNR Observe the Geotechnical Monitoring of the Dry stack Shell Construction

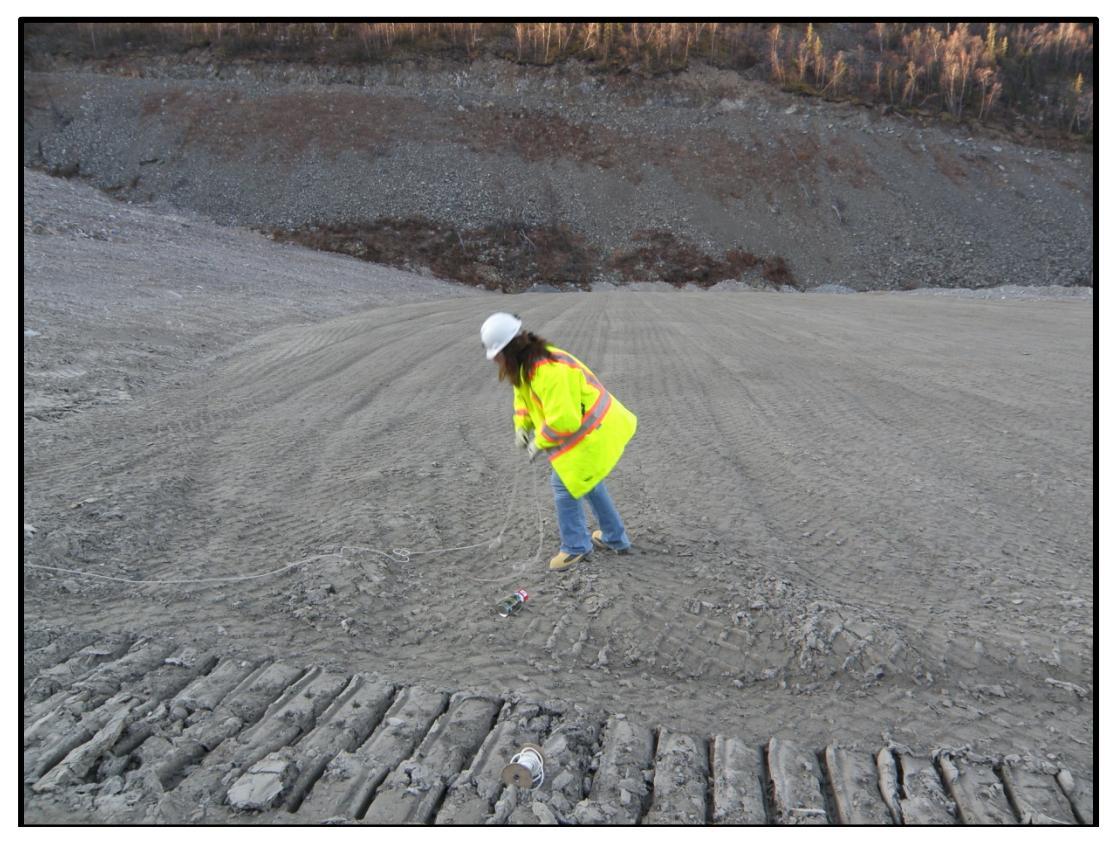
A 30-foot grid, 3 rows of 12 monitoring locations, was delineated on shell 2, and 3 rows of 7 monitoring locations on shell 3. This resulted in 36 monitoring points on shell 2, and 21 on shell 3. These points were tested with a nuclear density gauge or densometer. Additionally, material for three Proctor tests was collected on each of the shells.

Measuring Out the Grid on Shell 2

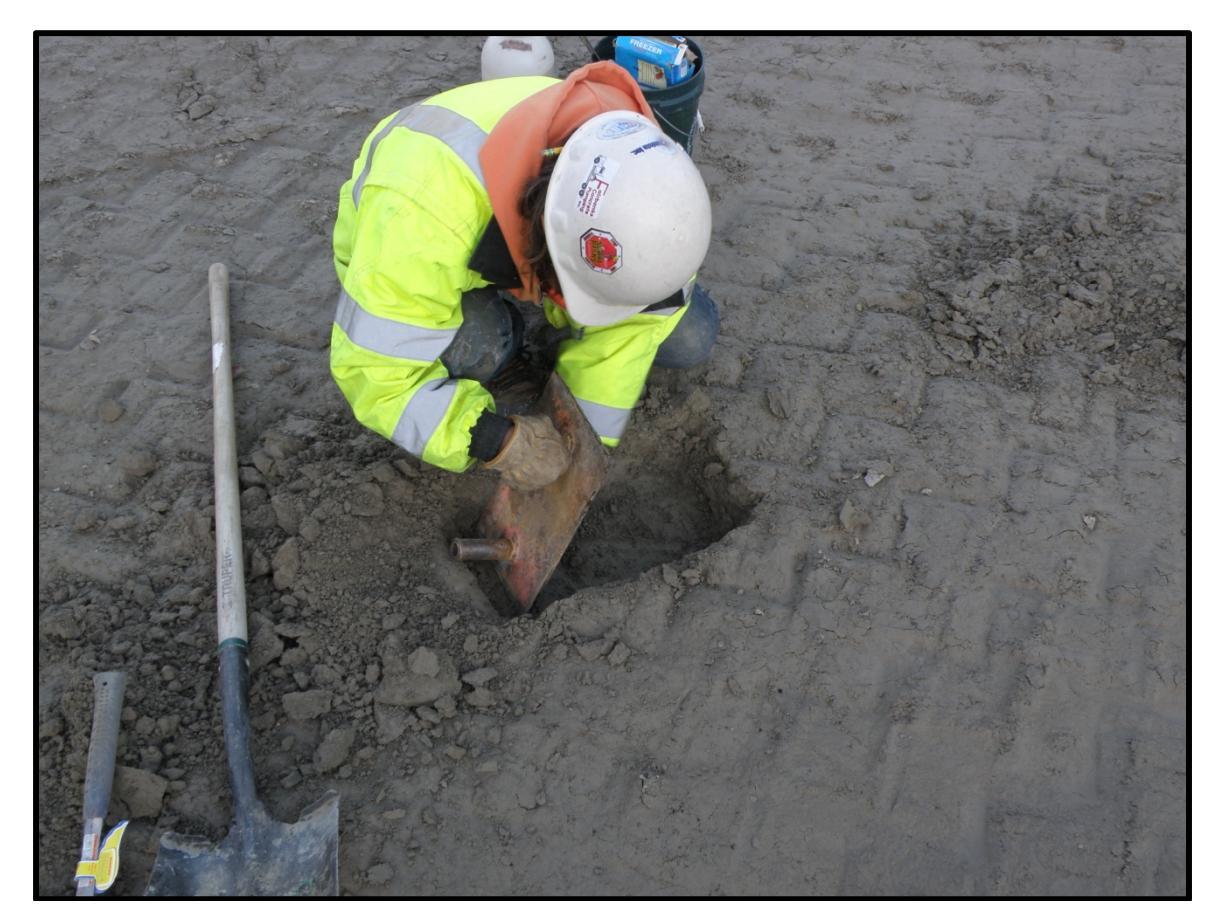
Because of the partially frozen conditions, the top 3 to 4 inches of material was scraped off to provide a flat, ice-free surface for the nuclear densometer.

Preparing Surface for Nuclear Gauge

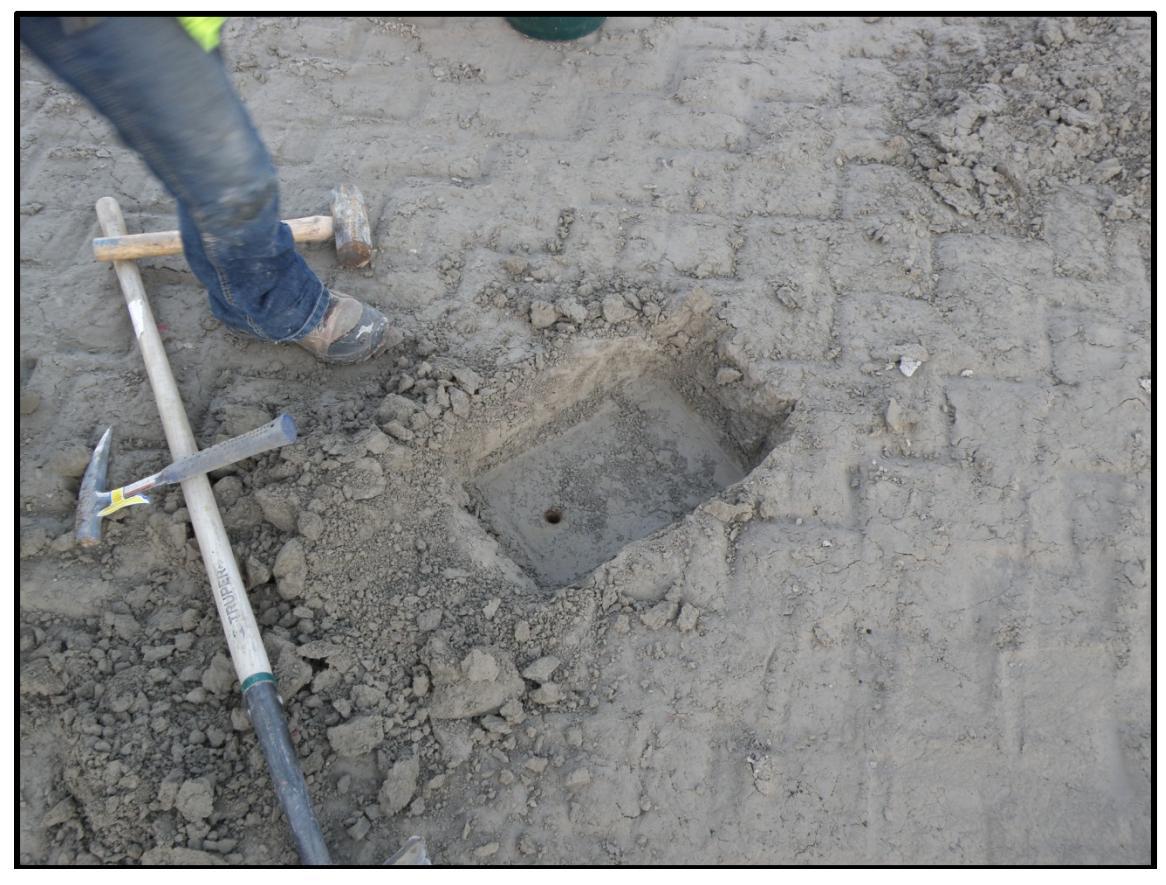
Surface and Probe Hole Prepared for Nuclear Gauge

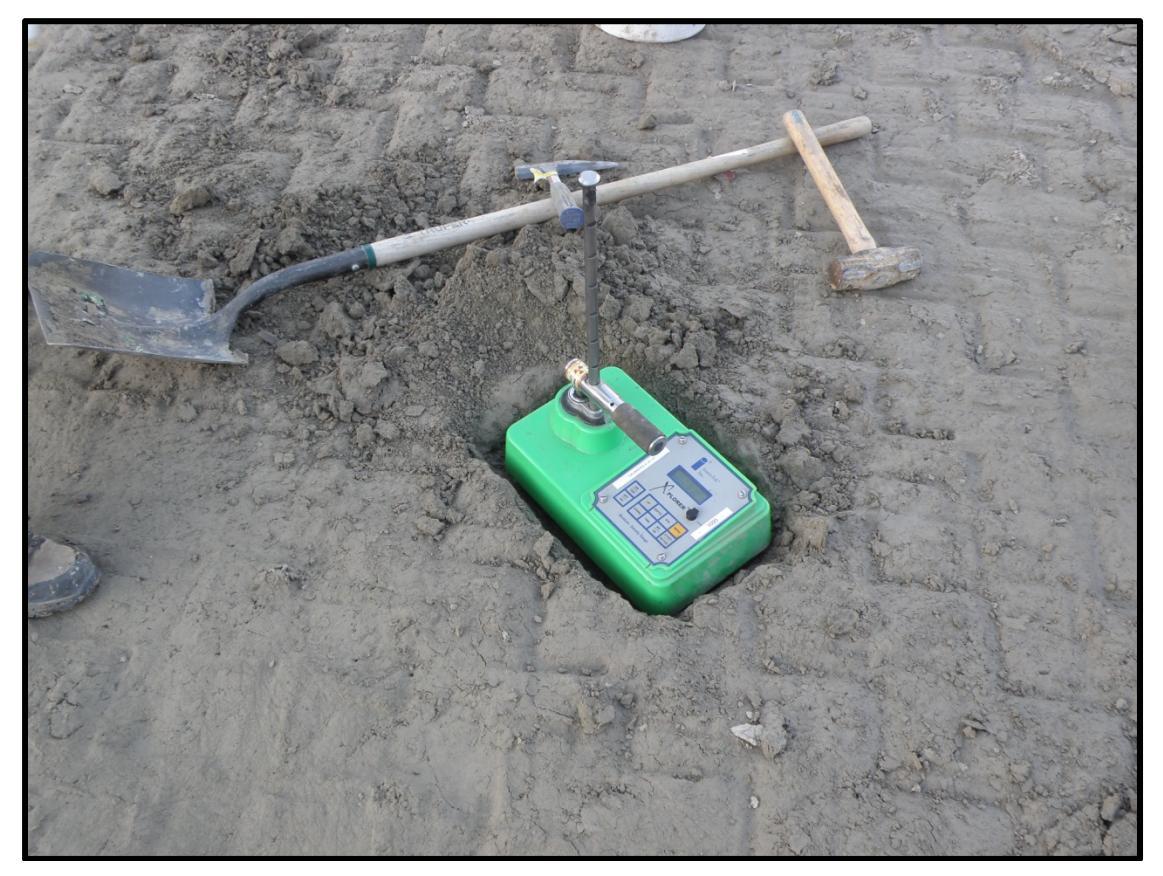
Nuclear Gauge or "Densometer"

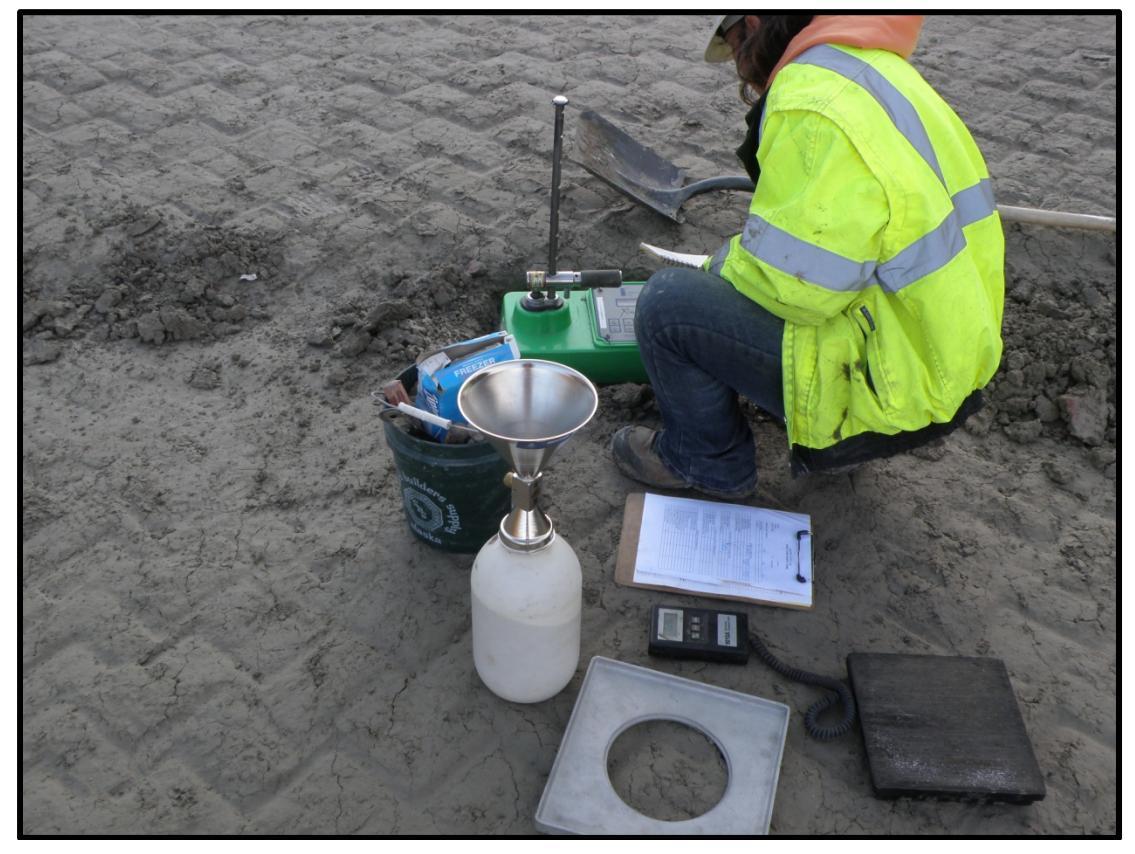
The monitoring plan schedule calls for sand cone testing to be conducted every 80,000 tons of material placed in each shell. On this day, three sand cone tests were conducted on Shell 2 but none were required on shell 3.

Sand Cone Testing Materials

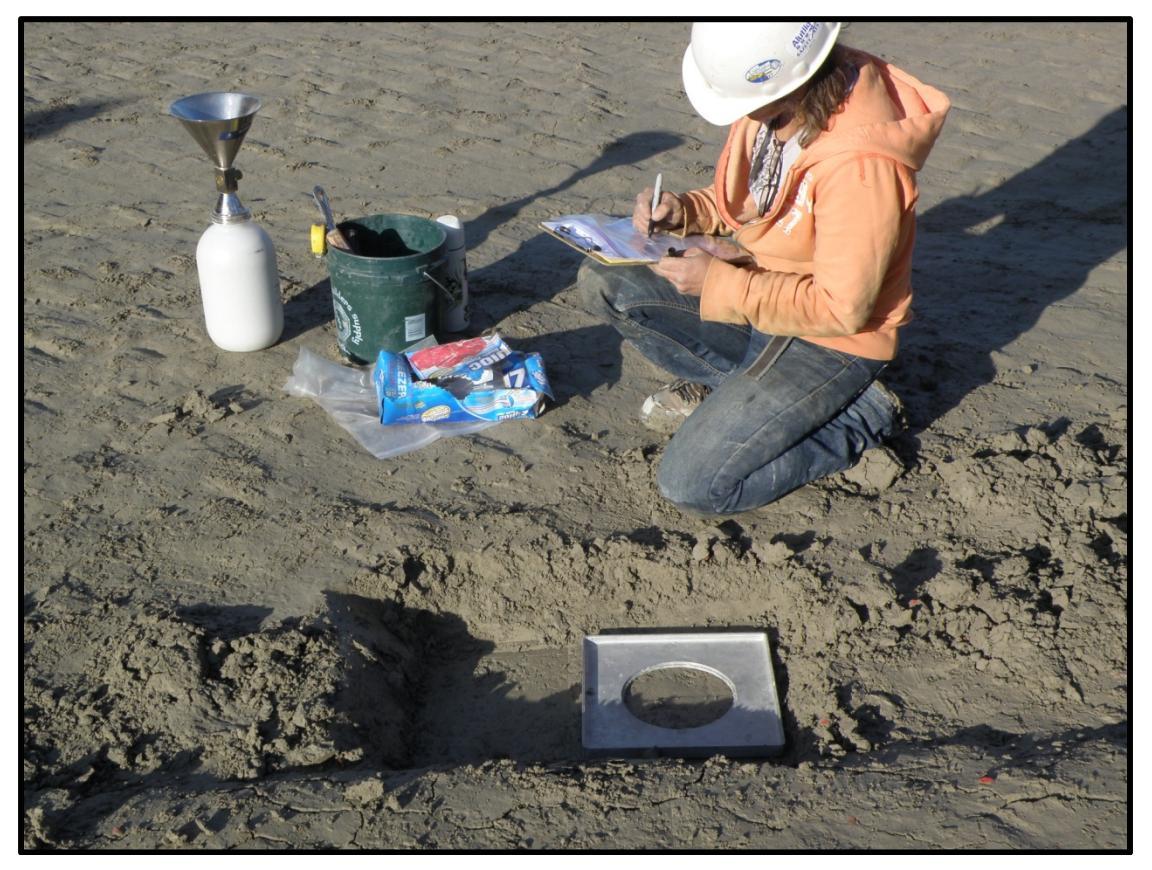
Sand Cone Test Plate

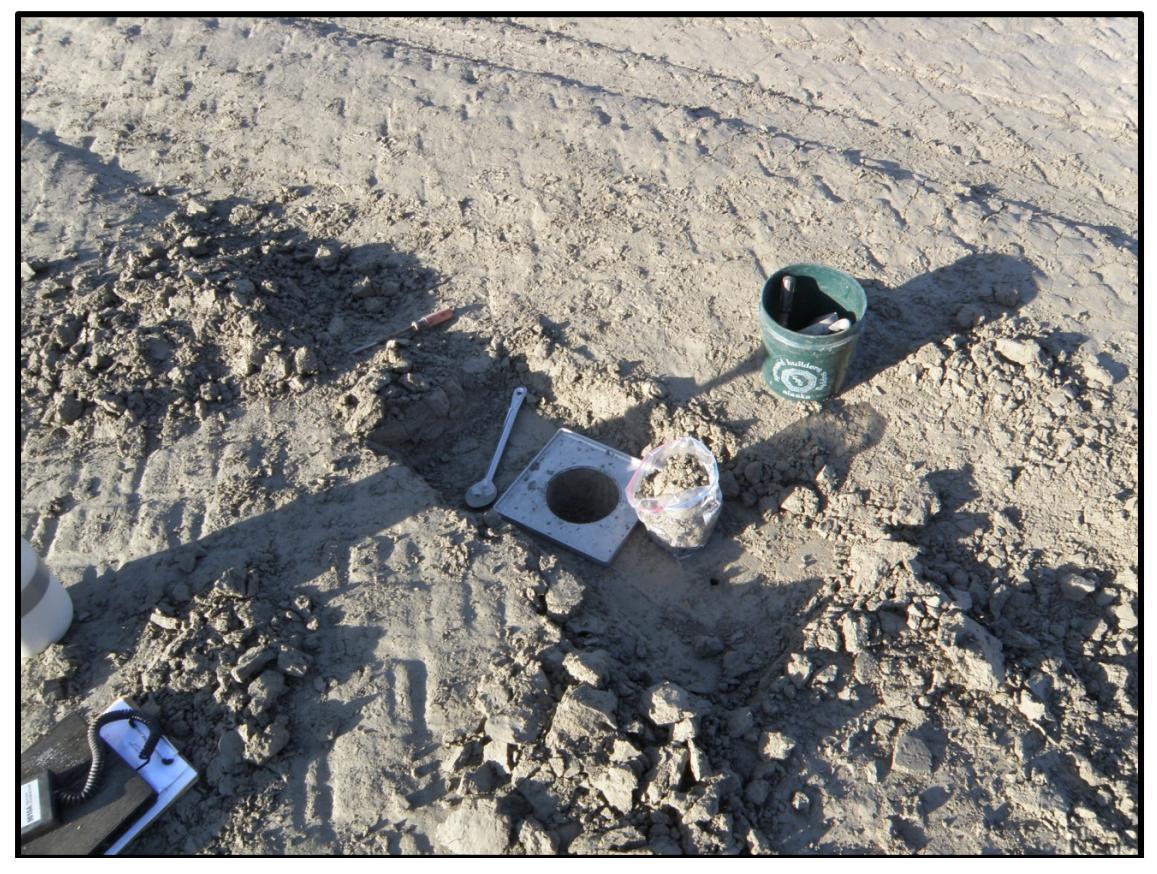
Sand Cone Material Collection

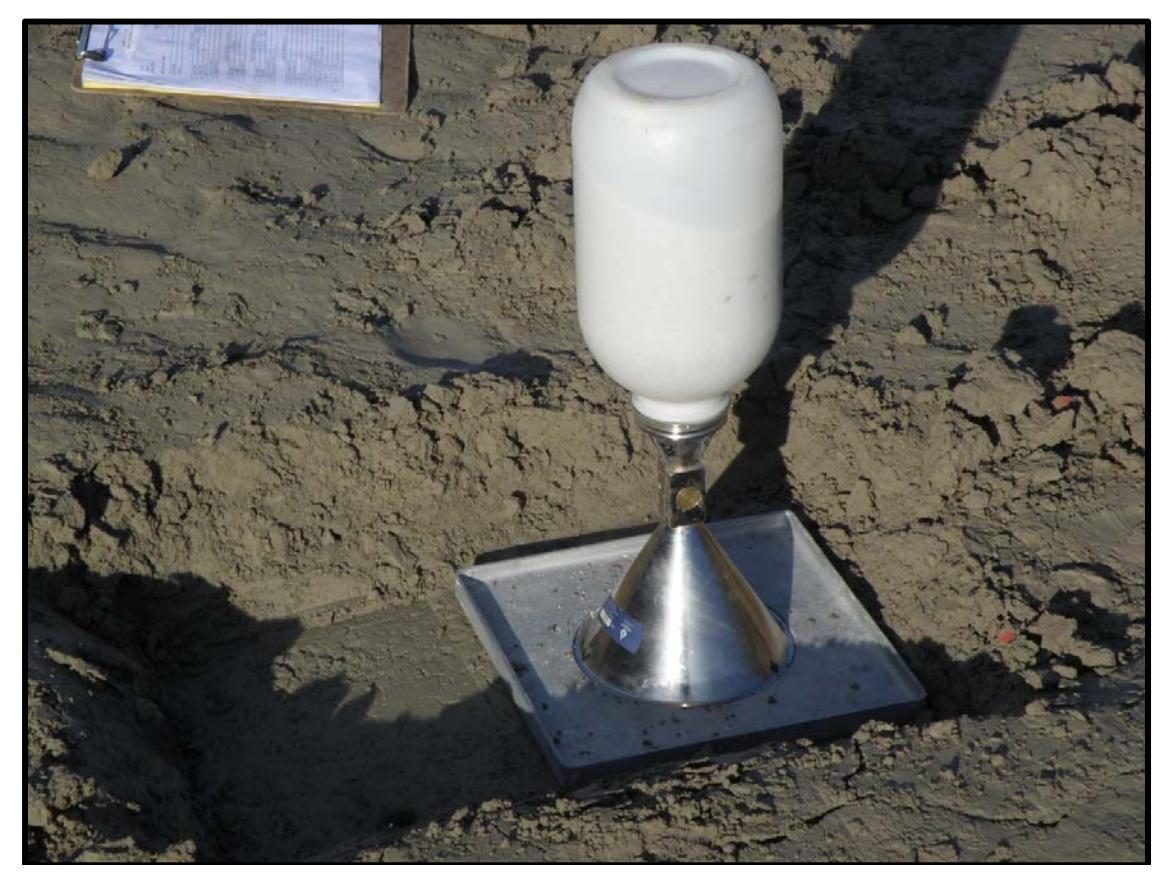
Sand Cone Test - Sand Flows into Hole and Cone

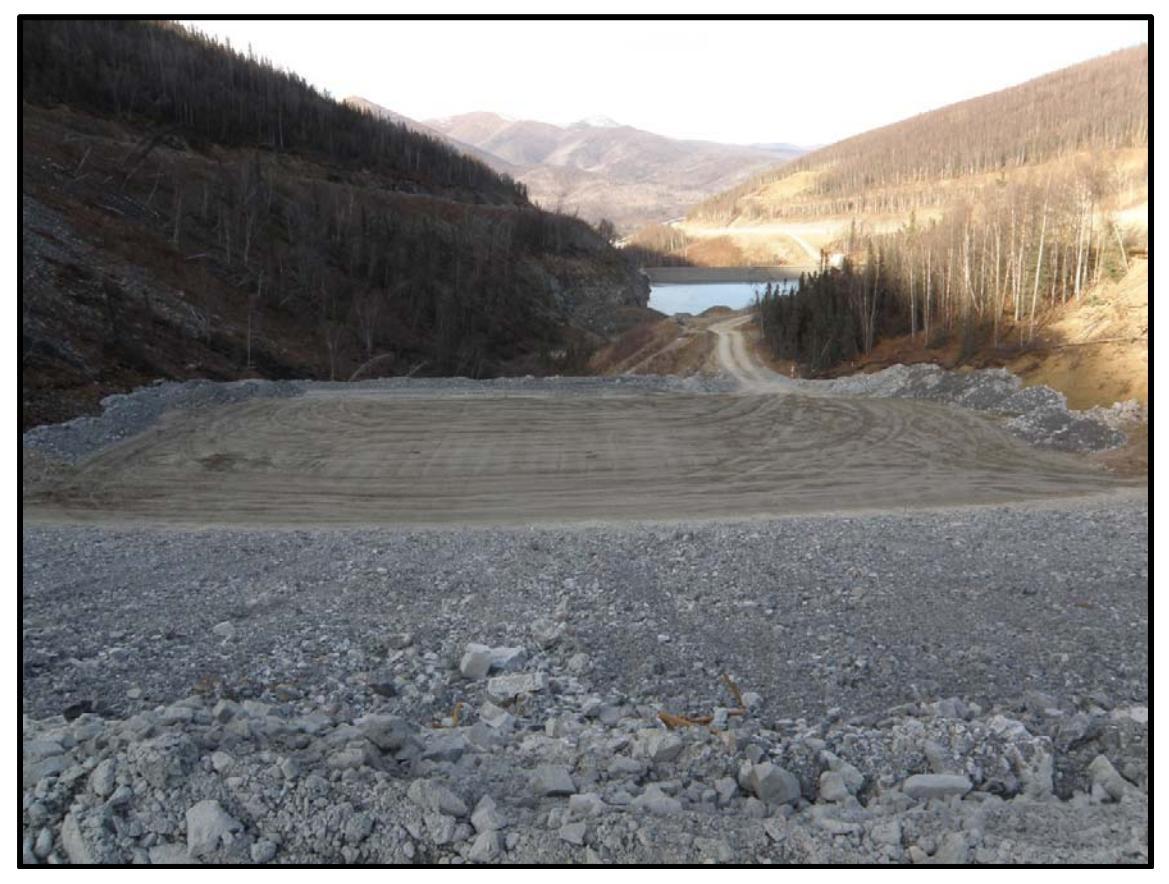
I arrived at the Pogo mine site at 9:00 a.m. Makoto explained that material in Shell 2 and 3 had been placed and compacted as recent as the day before. The temperature was below freezing. The top 2 inches of dry stack appeared partially frozen. The Shell 2 surface appeared smoother and drier than Shell 3. Large tire ruts up to one foot deep were visible on Shell 3.

Shell 3 Viewed from Shell 2

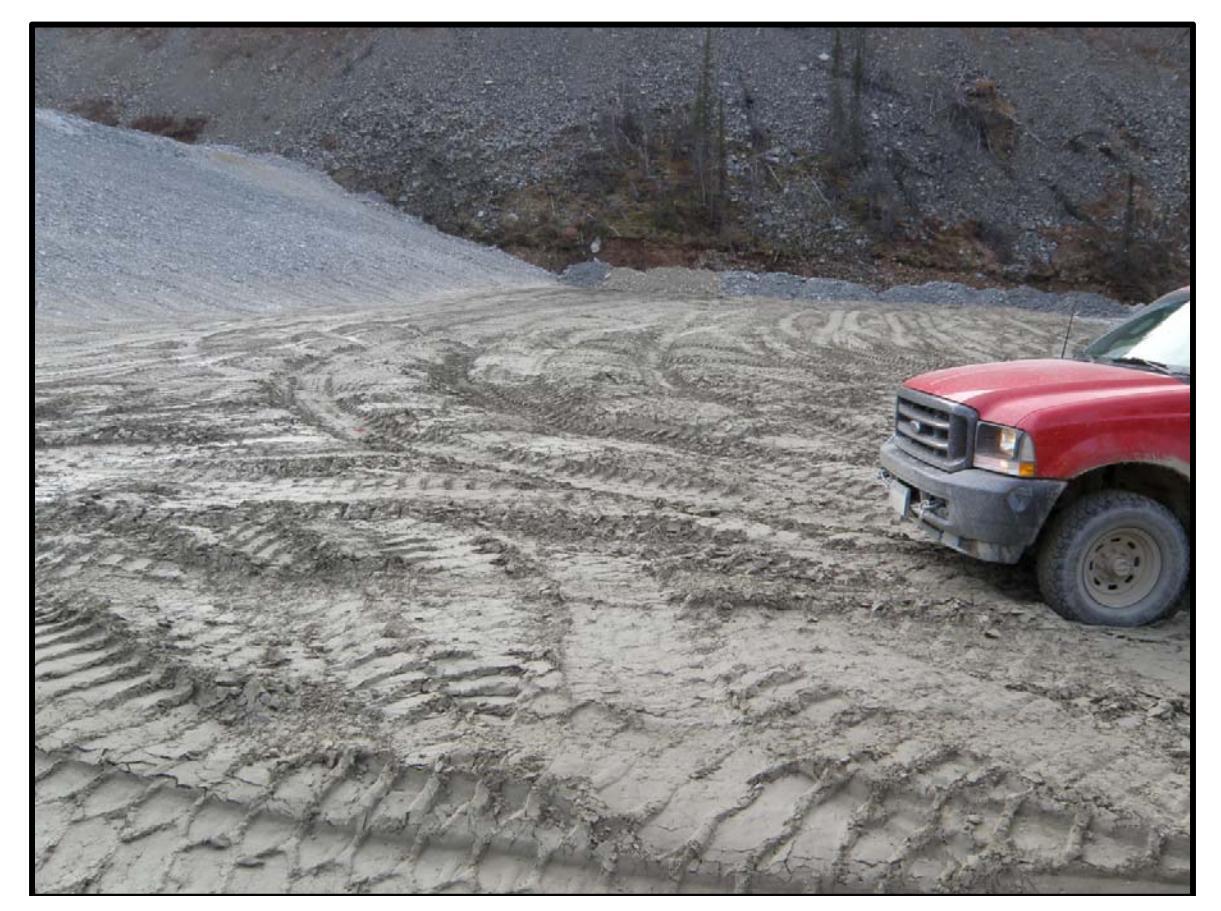
Shell Three Tire Tracks and Ruts
