**Phase I and Limited Phase II
Environmental Site Assessment
25951 Williamson Lane
Kasilof, Alaska**

November 2014

Submitted To:
Alaska Department Transportation & Public Facilities
2200 East 42nd Avenue
Anchorage, Alaska 99508

32-1-17687

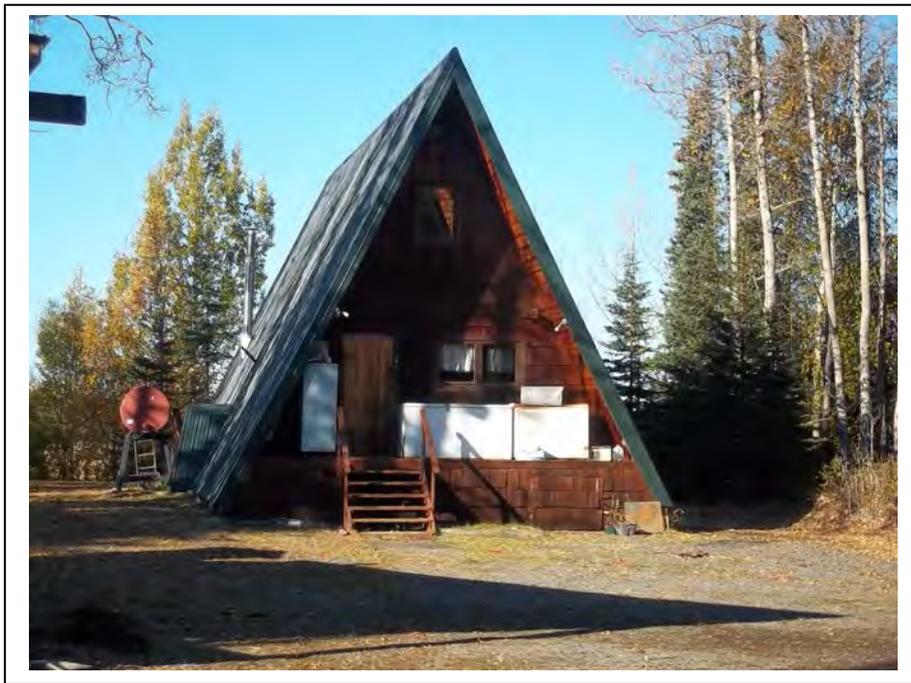
A two-story, A-frame structure is currently located on the Property (Photo 1). The first floor of the structure is comprised of a kitchen, utility closet (Photo 2), and living room. General household cleaning supplies were observed in the kitchen. The second floor of the structure

Photo 1: Exterior of the Property's residential structure; looking west. (September 30, 2014)

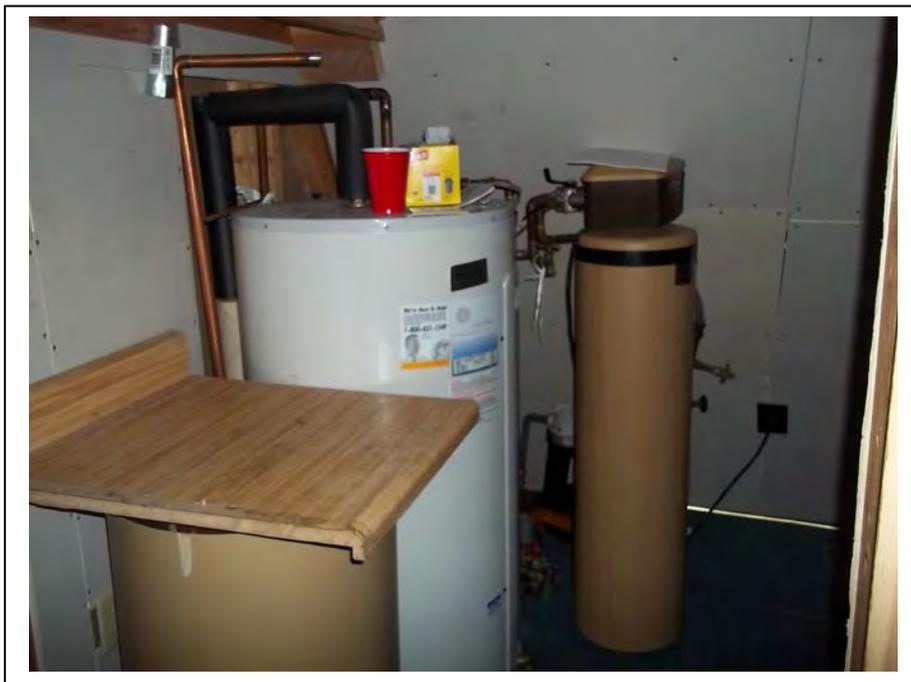
Photo 2: Utility closet in the residential structure. (September 30, 2014)

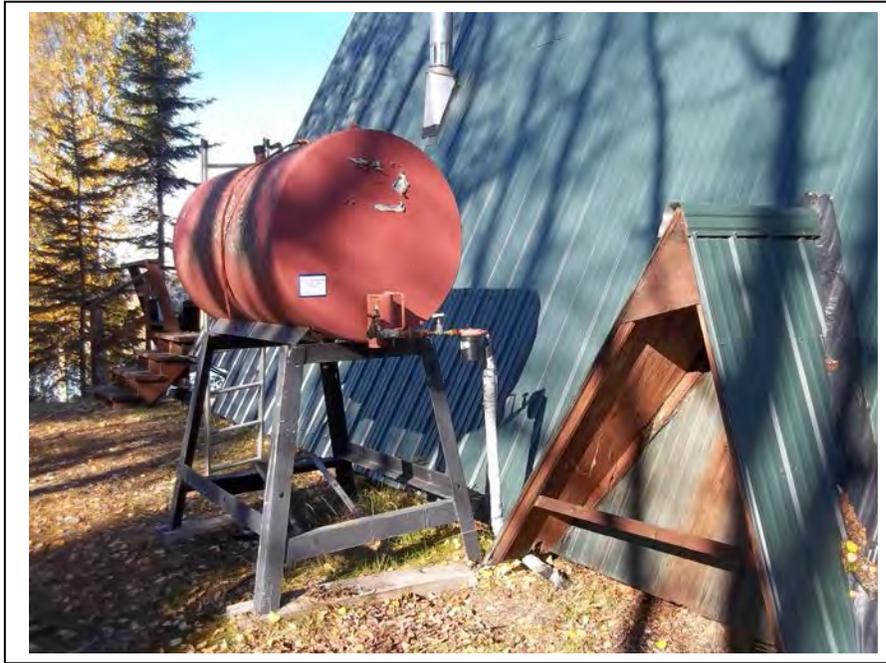
The residential structure is serviced by a 300-gallon aboveground storage tank (AST) located adjacent to the south side of the structure (Photo 3). Evidence of leaks and/or spills associated with the AST was not observed during the September 30, 2014 site visit.

Photo 3: The Property's residential structure is serviced by heating oil stored in an aboveground storage tank; looking northwest. (September 30, 2014)

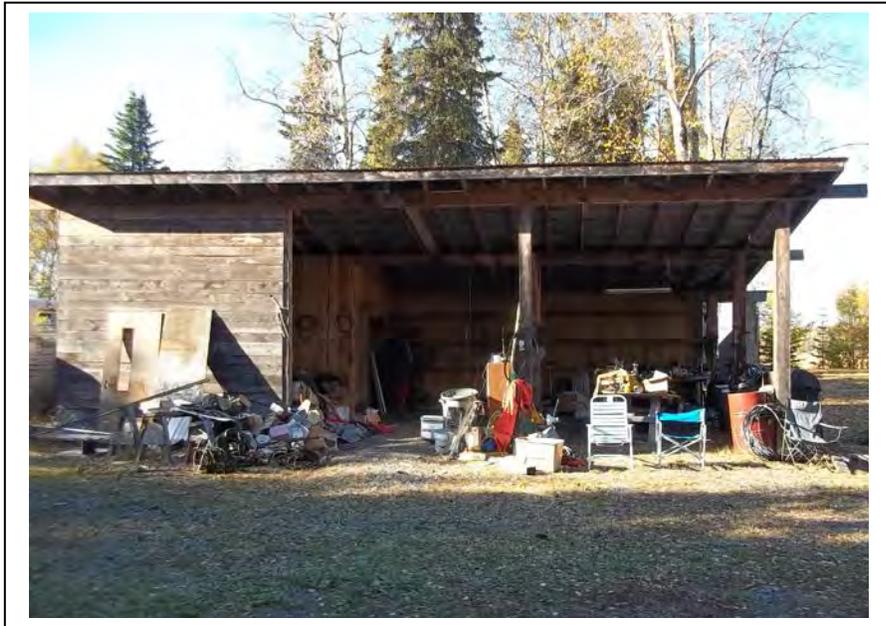
An outbuilding/shed is located southeast of the residential structure (Photo 4). This structure has walls on the west and south sides while the other two sides are open. An enclosed room with a wooden floor is located in the southwest portion of the structure. Small containers (less than one gallon each) containing wood finishes and mechanical fluids, including lube oil and starter fluid, were observed in the enclosed portion of the structure (Photo 5). Multiple empty 5-gallon fuel containers and three 55-gallon drums (Photo 6) were also observed in the outbuilding/shed. Two of the 55-gallon drums appeared to be empty, and one drum, labeled "2-cycle oil", appeared to contain liquid. Surface stains were visible underneath several empty fuel containers which were located adjacent to the drum labeled "2-cycle oil" (Photo 7). Evidence of leaks and spills in the vicinity of the two empty 55-gallon drums was not observed during the site visit; however, multiple surface stains were observed throughout the outbuilding/shed on the wooden floor (Photo 8) and gravel surfaces (Photos 9 and 10). Note that due to the amount of items stored within the outbuilding/shed, the entire floor/ground surface could not be observed (Photo 11).

Photo 4: An outbuilding/shed is located southeast of the Property's residential structure; looking west. Boring EB1 was advanced outside this structure approximately 5 feet from the orange drum. (September 30, 2014)

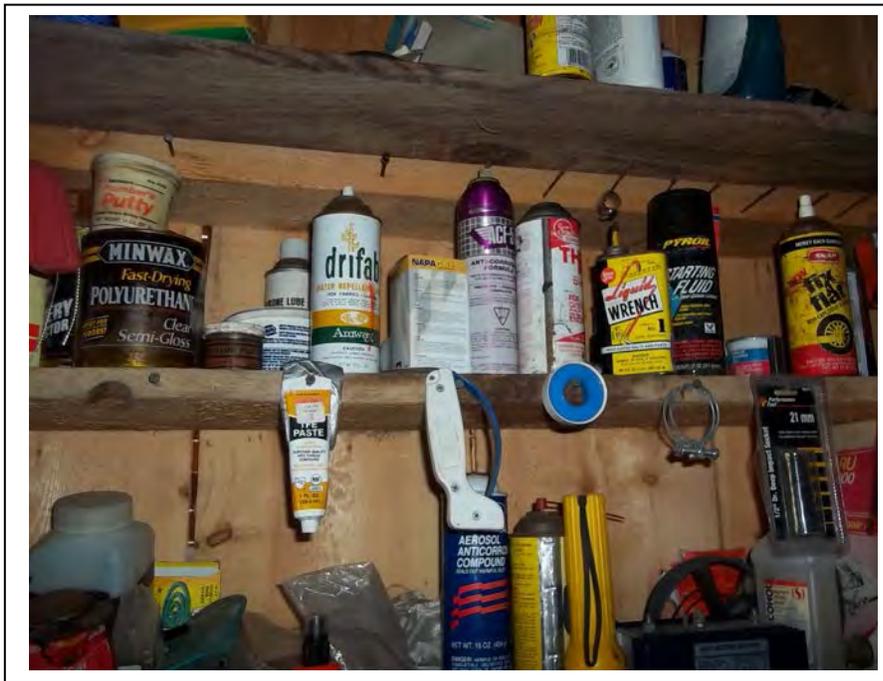
Photo 5: Wood finishes and mechanical fluids, including lube oil and starter fluid, stored in the outbuilding/shed. (September 30, 2014)

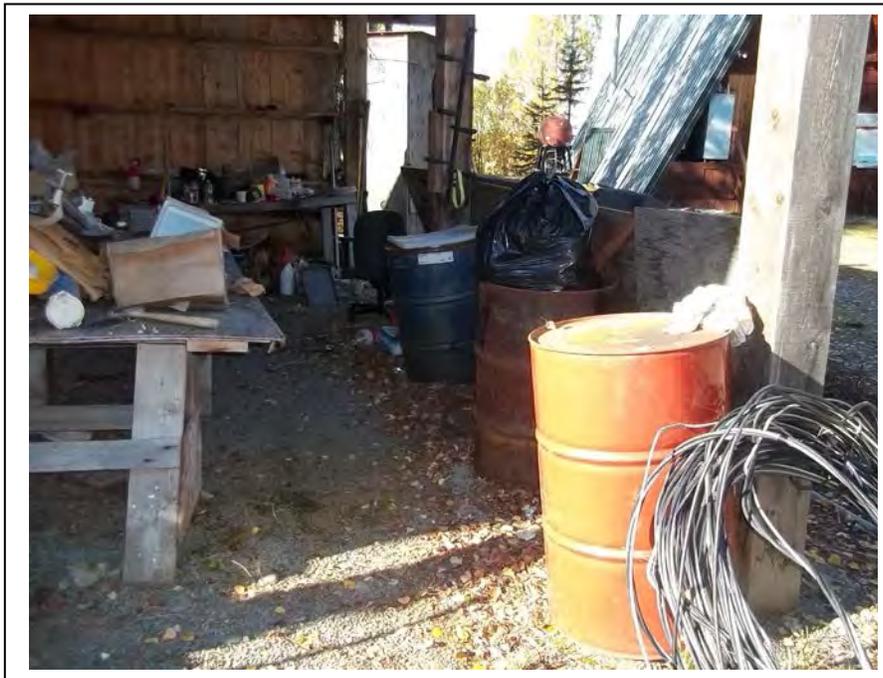
Photo 6: Three 55-gallon drums were observed in the outbuilding/shed. (September 30, 2014)

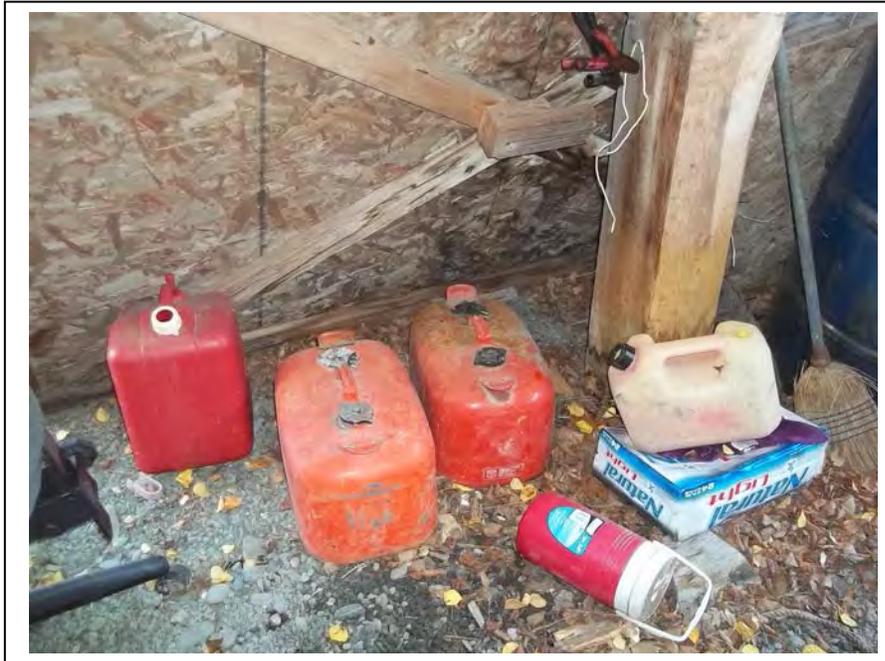
Surface stains were observed in an outbuilding/shed in the vicinity of a drum that appeared to contain fluid and was labeled “2-cycle oil.” Several empty 5-gallon fuel containers

were also observed in this vicinity. Additional surface stains were observed on a wooden floor in the outbuilding/shed and on the ground surface at various locations throughout the Property.

Photo 7: Surface stains observed near the empty gas cans and drum labeled “2-cycle oil” in the outbuilding/shed. Surface soil Sample SS3 was collected from this area. (September 30, 2014)

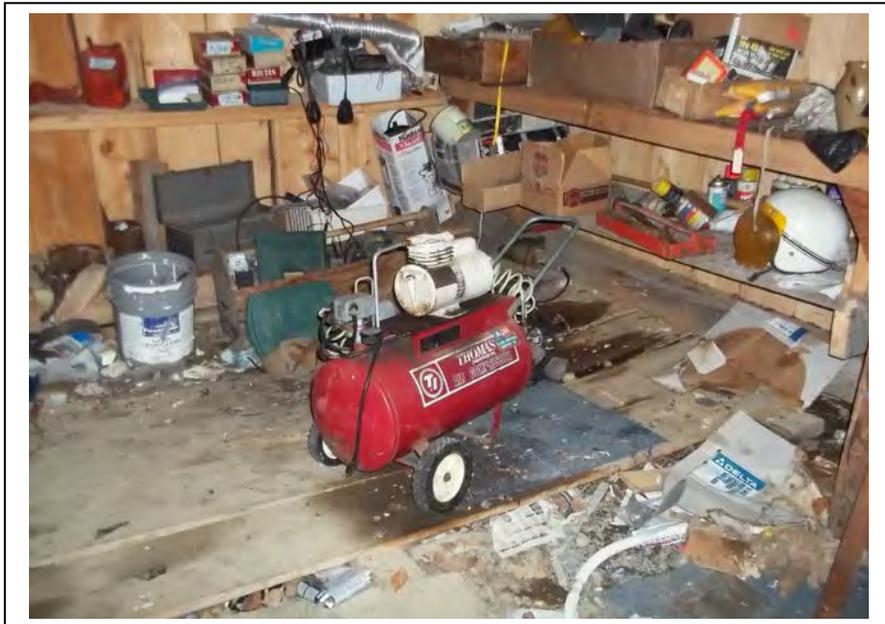
Photo 8: Surface stains were observed on a wood surface in the outbuilding/shed. (September 30, 2014)

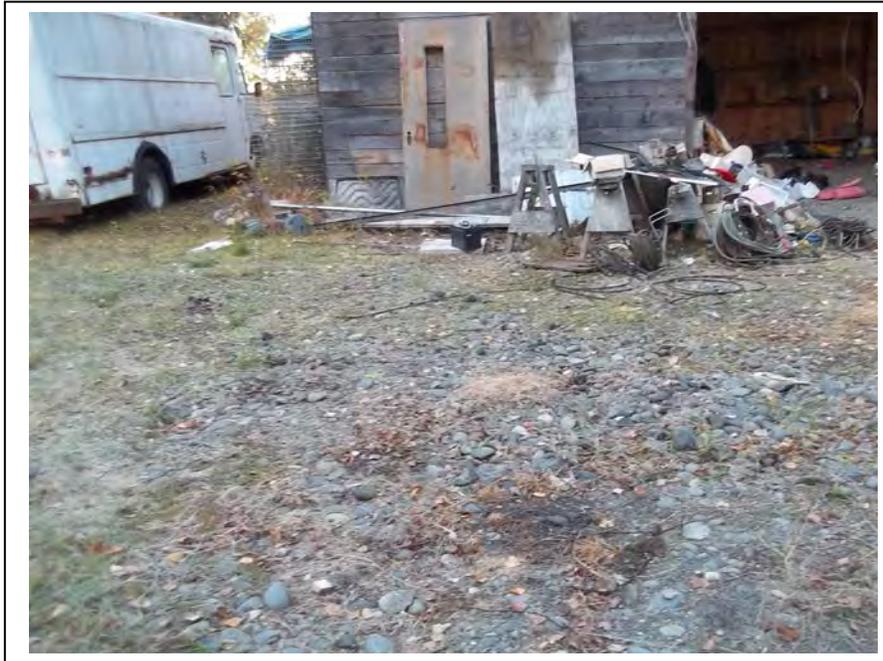
Photo 9: Surface stains observed on the unpaved surfaces in and around the outbuilding/shed; looking west. (September 30, 2014)

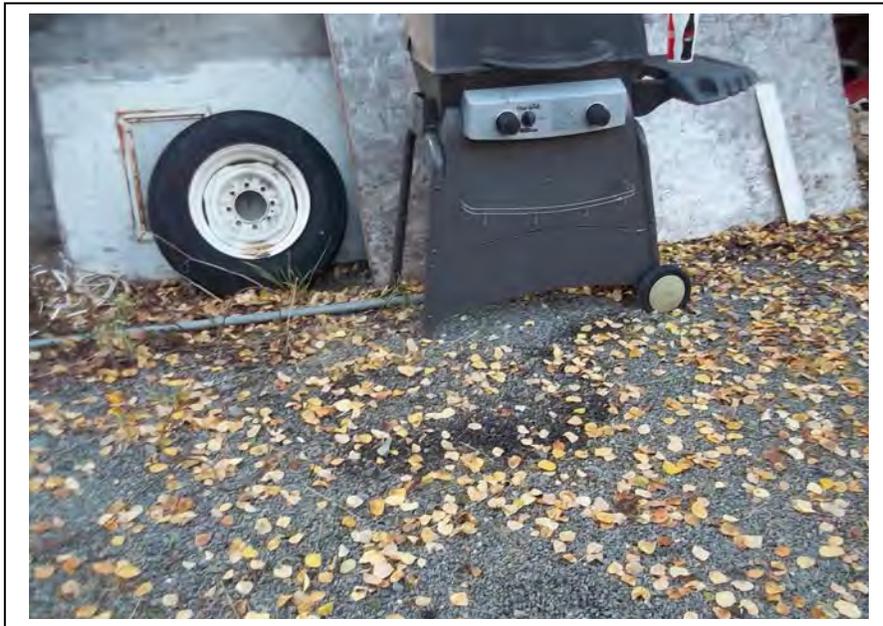
Photo 10: Surface stains observed on the unpaved surfaces in and around the outbuilding/shed; looking south. (September 30, 2014)

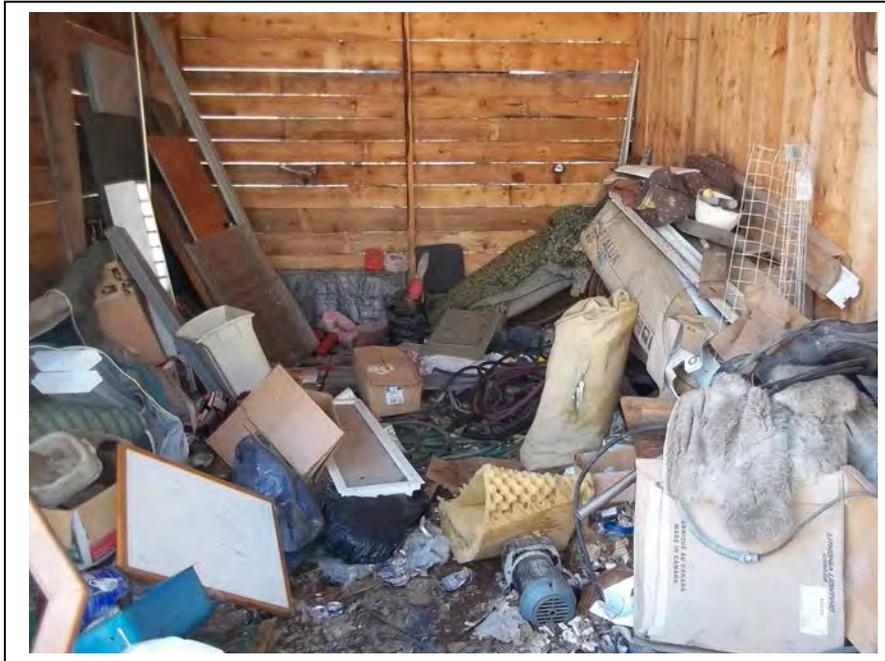
Photo 11: Due to the amount of items stored within the outbuilding/shed, the entire ground surface could not be assessed. (September 30, 2014)

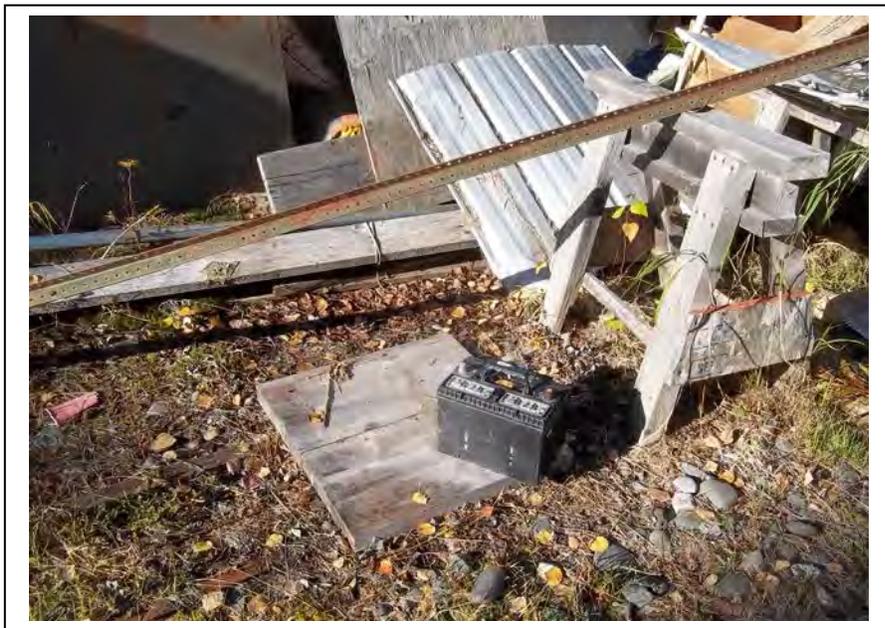
Eleven vehicle batteries were observed in a storage area adjacent east of the outbuilding/shed during the July 18, 2012 site visit, although only one battery was observed during the September 30, 2014 site visit. There is a potential that weathered and corroded batteries could impact the Property's soil and/or groundwater.

Outside the outbuilding/shed, eleven vehicle batteries were observed in a storage area adjacent east of the outbuilding/shed during the July 18, 2012 site visit. During the September 30, 2014 site visit, only one vehicle battery was observed in this area (Photo 12). Evidence of corrosion and weathering of the batteries was not observed during the July 18, 2012 or September 30, 2014 site visits. In addition, two empty, overturned, unlabeled 55-gallon drums were observed west of the outbuilding/shed (Photo 13) during the July 18, 2012 and September 30, 2014 site visits. Evidence of leaks and spills associated with these drums was not observed.

Photo 12: Looking west, eleven vehicle batteries were observed in a storage area adjacent east of the outbuilding/shed during the July 18, 2012 site visit. During the September 30, 2014 site visit, one battery was stored in this area. (September 30, 2014).

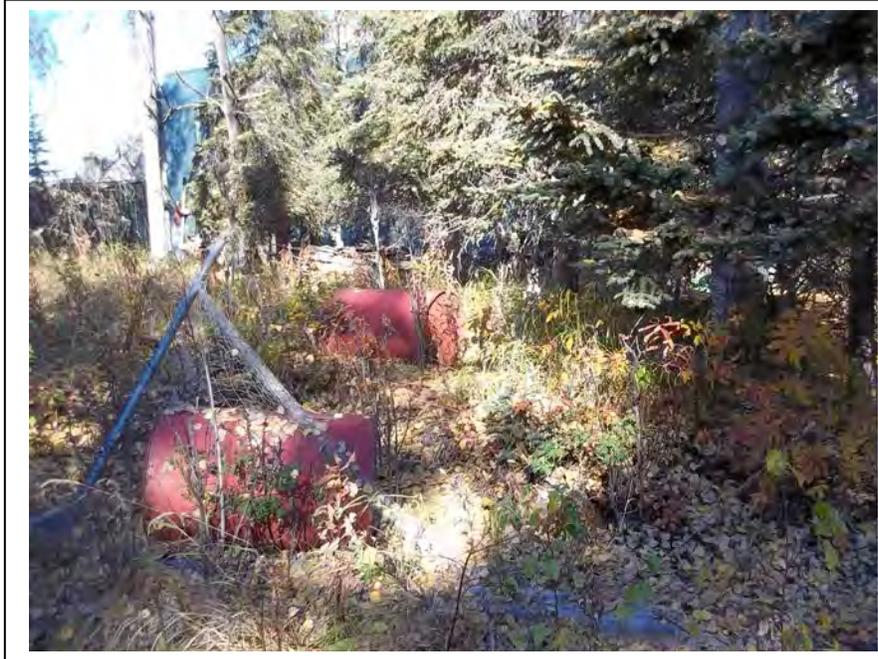
Photo 13: Two overturned, empty 55-gallon drums were observed west of the outbuilding/shed; looking northwest. (September 30, 2014)

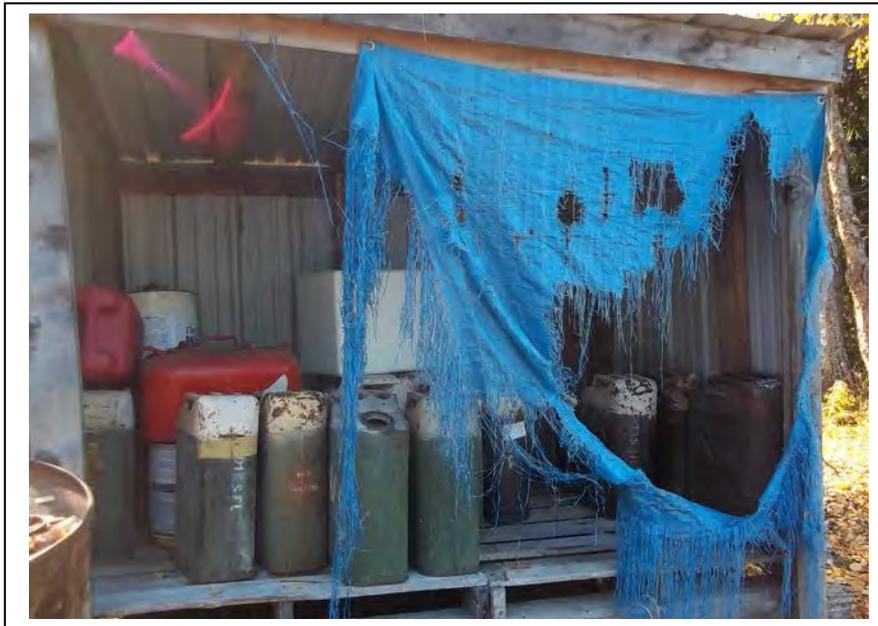
A storage shed containing approximately 25 empty fuel containers (each with a capacity of 5 gallons or less) is located south of the residential structure and west of the outbuilding/shed (Photo 14). An empty 55-gallon drum was observed adjacent to the storage shed. Evidence of leaks and spills associated with the fuel containers and drum was not observed.

Photo 14: A storage shed containing approximately 25 fuel containers is located south of the residential structure. (September 30, 2014)

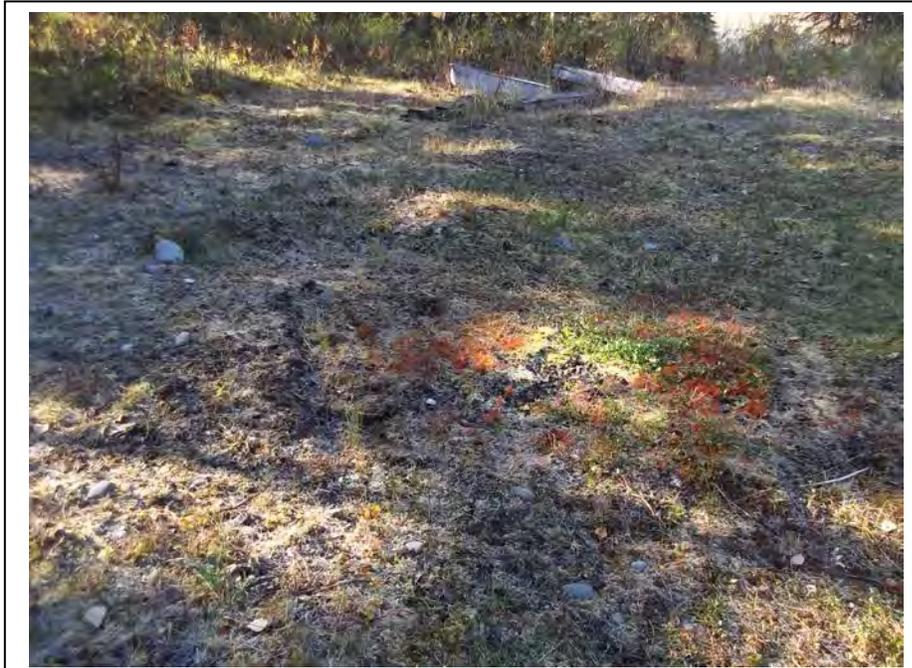
A burn area is located south of the outbuilding/shed. Burn areas could pose environmental risk as petroleum hydrocarbons are often used to ignite the contents of the burn material and may impact the ground surface. In addition, combustion by-products and residuals may include hazardous materials.

A burn area and a vehicle are located south of the outbuilding/shed (Photos 15 and 16). Overturned containers of fuel and oil and surface staining observed southeast of the

Photo 15: A burn area is located south of the outbuilding/shed; looking west. Surface soil Sample SS1 was collected from the burn area. (September 30, 2014)

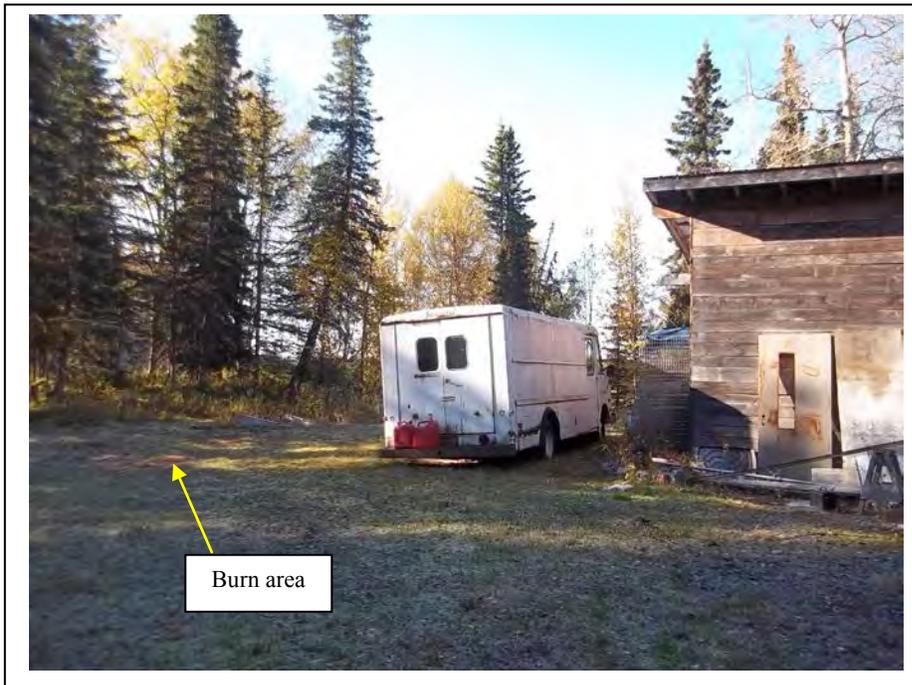
Photo 16: An unused vehicle is located between the outbuilding/shed and the burn area; looking southwest. (September 30, 2014)

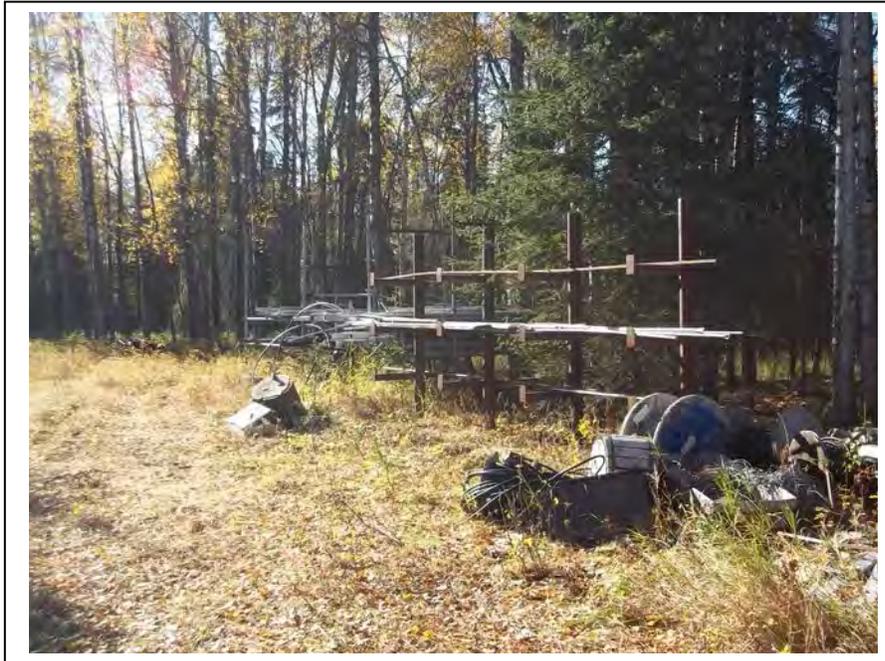
- Discarded materials that may be classified as solid waste per state and federal environmental regulations were observed on the Property. Among the miscellaneous items scattered throughout the Property, potential sources of contamination include but are not limited to vehicles and equipment, mechanical fluid containers, and home appliances.

The remainder of the Property is forested, with the exception of a clearing in the east central portion and a grassy area in the northwest corner, adjacent to the boat launch and parking area located on the parcel north of the Property. Discarded materials (including boat parts, a refrigerator, and miscellaneous wooden and metal items) were observed throughout the Property, mostly in the cleared areas (Photos 17 and 18).

Photo 17: Looking southwest at various discarded materials stored on the east-central portion of the Property. Boring EB2 was advanced in the foreground of the photo. (September 30, 2014)

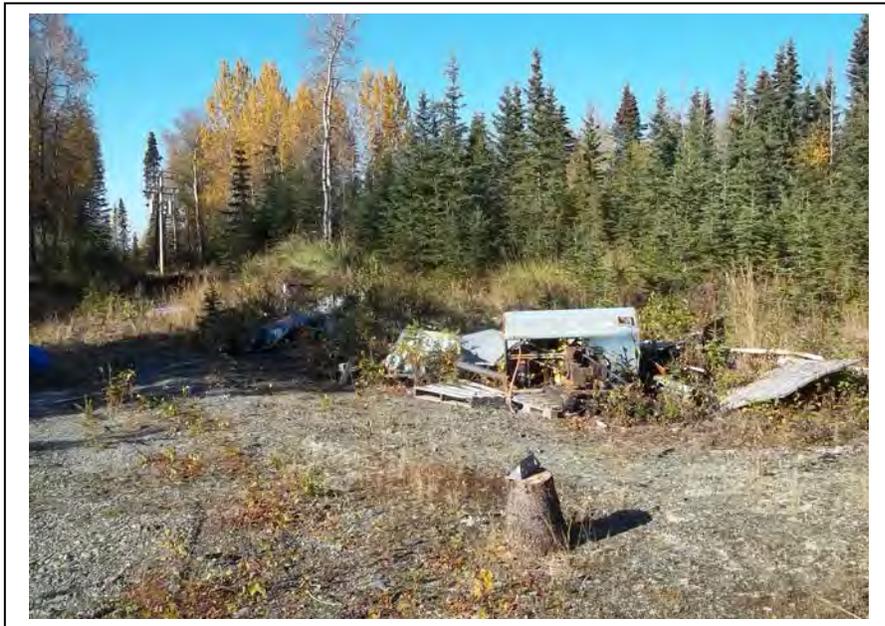
Photo 18: Looking west at various discarded materials stored on the northeast portion of the Property. Boring EB4 was advanced in this vicinity (September 30, 2014)

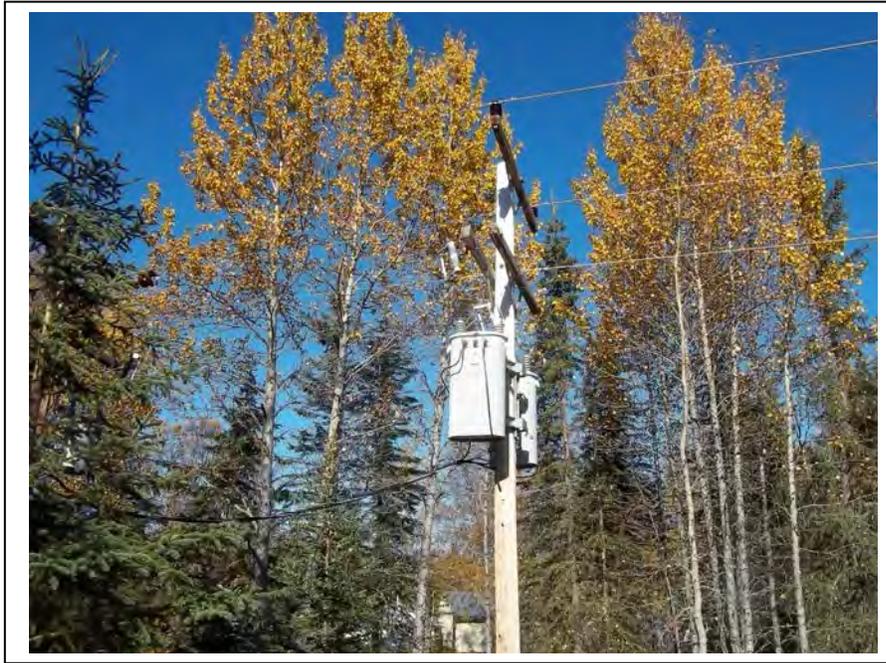
- Five pole-mounted transformers were observed along the northern Property boundary). The pole-mounted transformers did not contain stickers indicating that they had been tested for polychlorinated biphenyls (PCBs), and a representative of HEA could not say for certain whether the transformers contain oil with less than one part per million PCBs. No evidence of releases from the transformers was observed during the site visit. It is noted that the electric utility is typically responsible for releases from their transformers or equipment.

Photo 19: Five pole-mounted transformers are located along the northern Property boundary; looking north. (September 30, 2014)

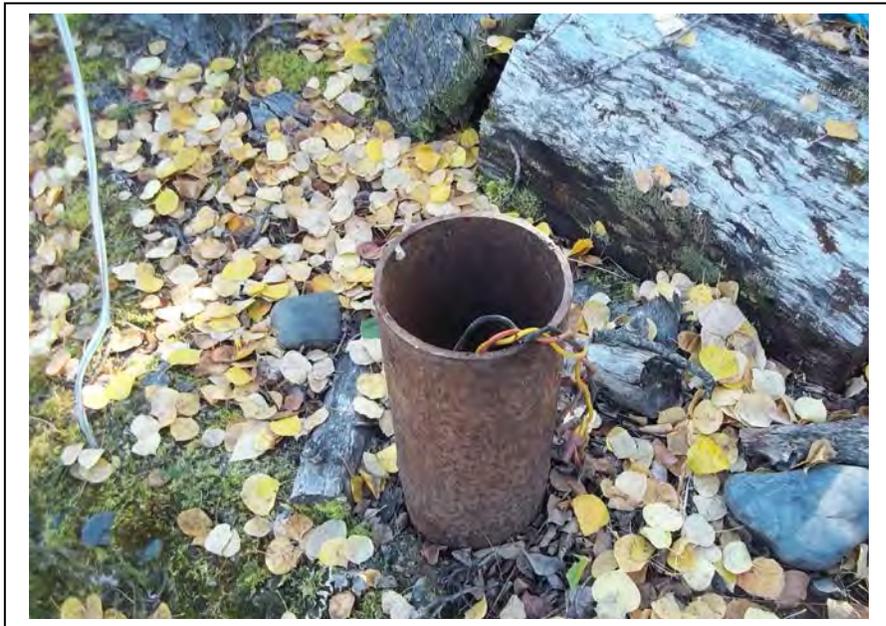
The State of Alaska Well Log Tracking System (WELTS) was researched to provide information about drinking water wells on or near the Property. The WELTS database, reviewed on September 15, 2014, does not identify drinking water wells on the Property. However, according to Ms. Ann Kimbrough, part owner of the Property, the Property is serviced by a drinking water well. The well was observed during our September 30, 2014 site visit. The approximate location of the well is shown on Figure 2 and in Photo 20.

Photo 20: The Property is serviced by a private drinking water well. (September 30, 2014)

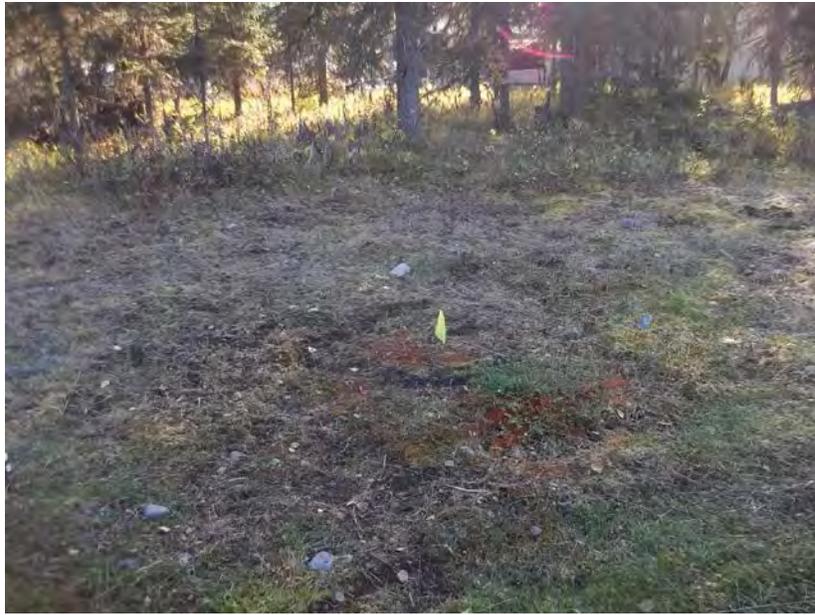
Photo 21: Looking south, Sample SS1 was collected from the burn area. (September 30, 2014)

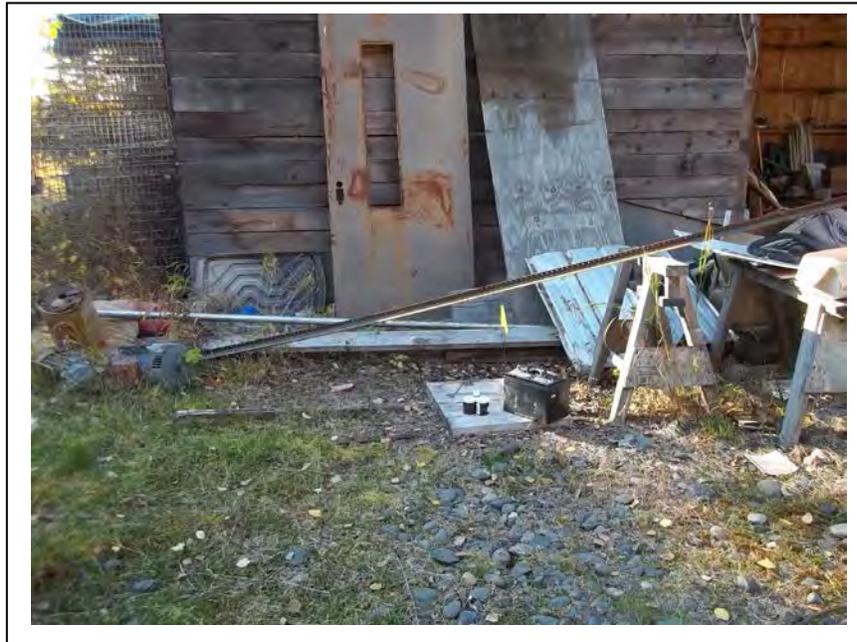
Photo 22: Looking west, Sample SS2 was collected from the battery storage area identified in the 2012 Phase I ESA. (September 30, 2014)

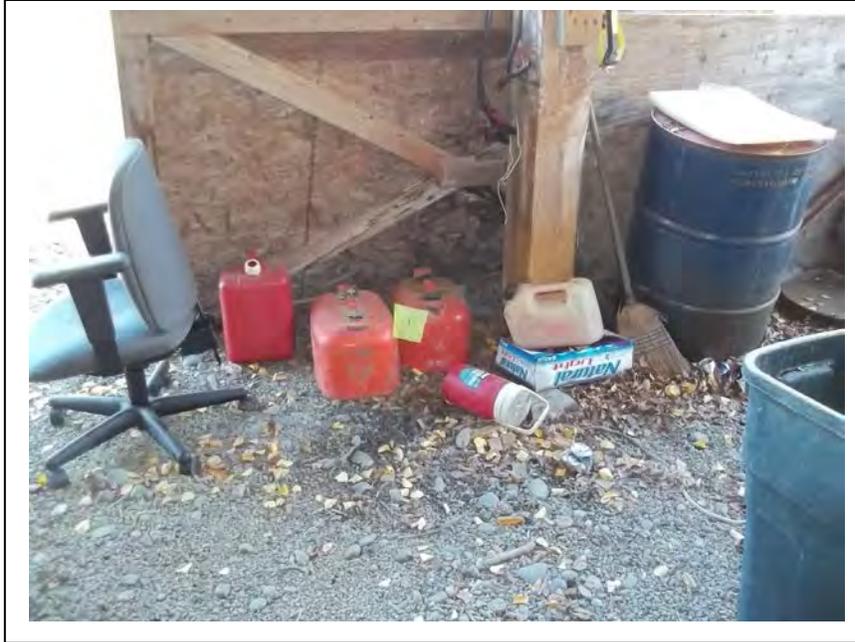
Photo 23: Looking north, Sample SS3 was collected from surface staining observed near the 55-gallon drums and empty fuel containers in the outbuilding/shed. (September 30, 2014)

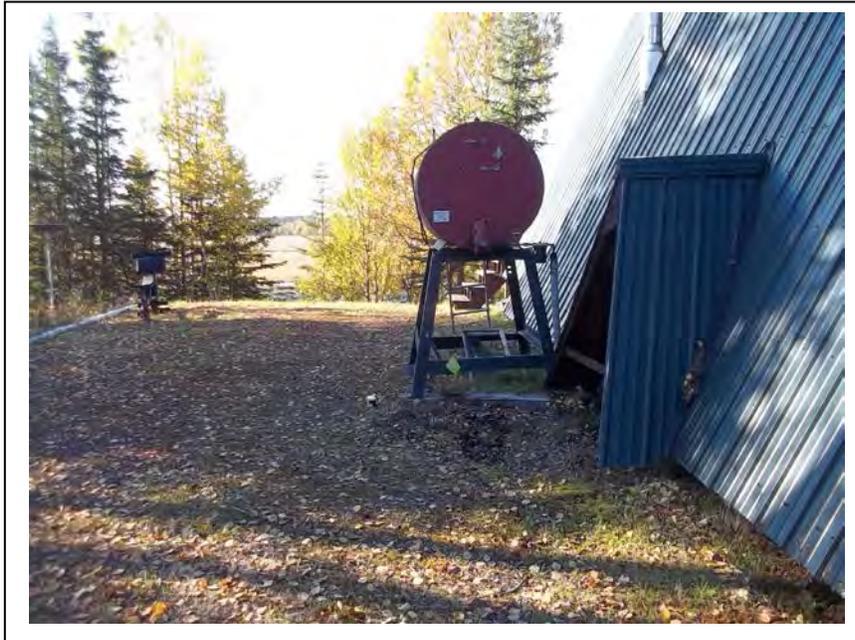
Photo 24: Looking west, Sample SS4 was collected from beneath the east end of the AST. Boring EB3 was advanced approximately three feet south of Sample SS4. (September 30, 2014)

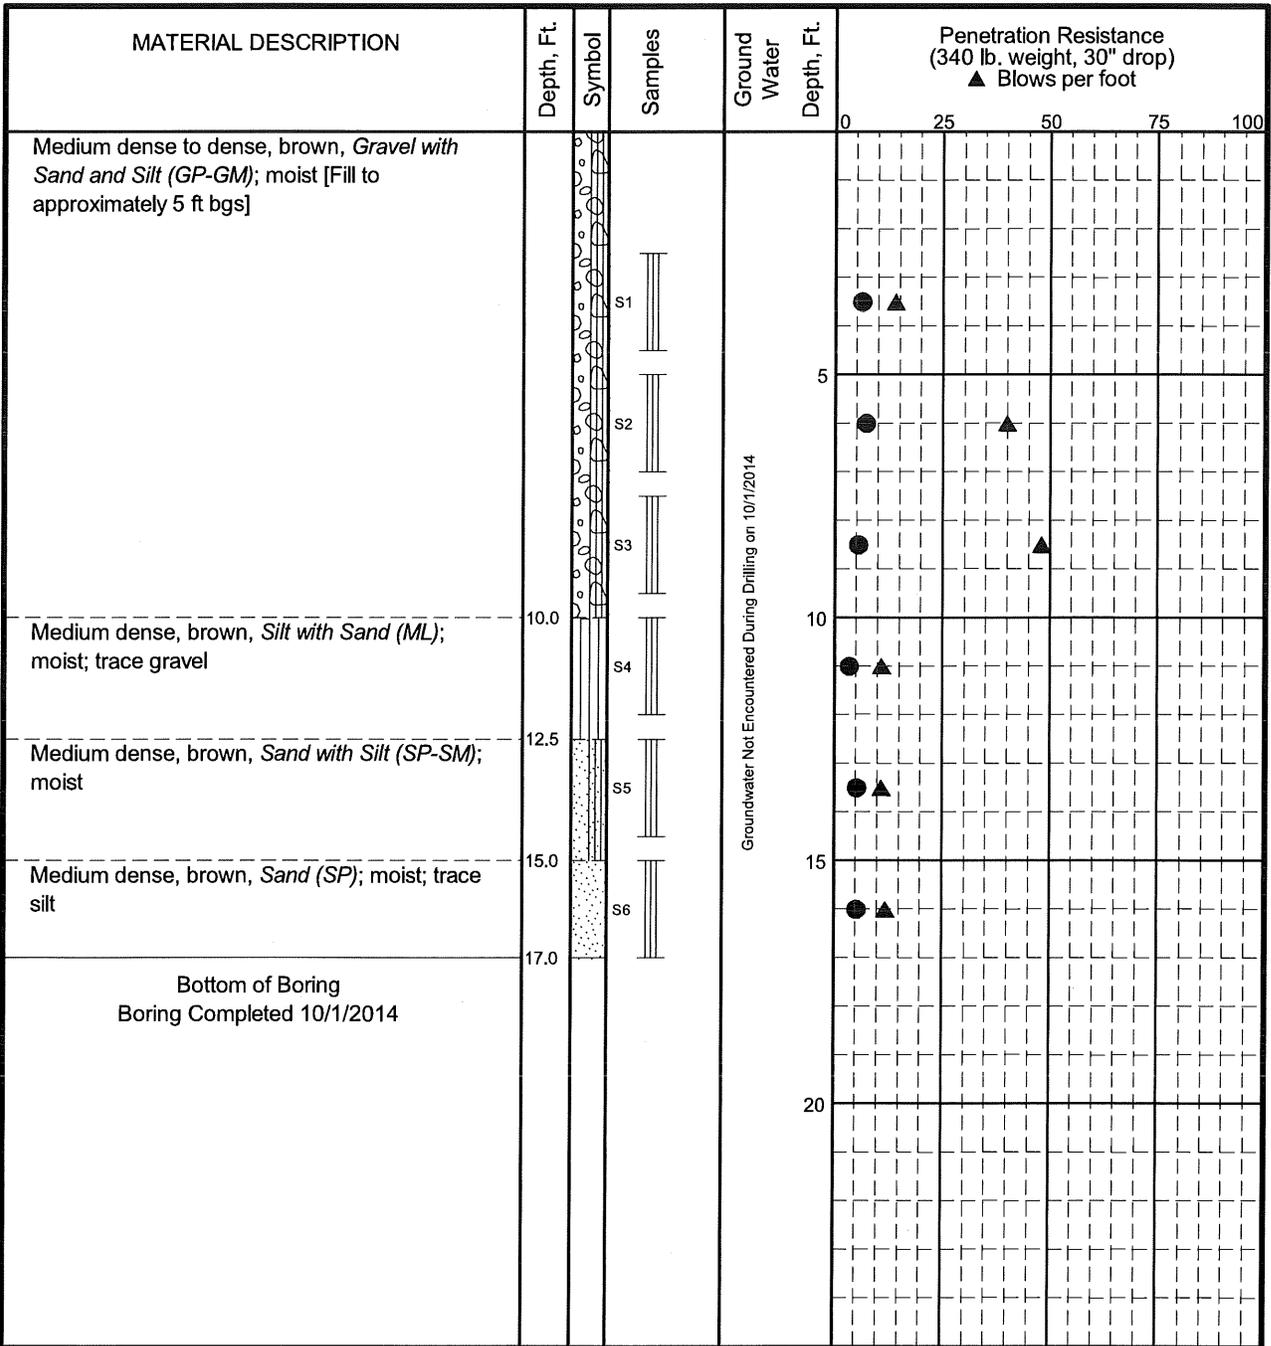
25951 Williamson Lane Kasilof, Alaska	
LOG OF BORING EB1	
November 2014	32-1-17687
SHANNON & WILSON, INC. Geotechnical and Environmental Consultants	Fig. D-1

Groundwater Not Encountered During Drilling on 10/1/2014
