**Chistochina River Wetland Restoration
Tok Cutoff 30E Project
One Year Evaluation**

January 18, 2008

**Prepared By:
Andrew Nolen
Agronomist
State of Alaska
Department of Natural Resources
Division of Agriculture
Plant Materials Center**

**Prepared For:
State of Alaska
Department of Transportation and Public Facilities**

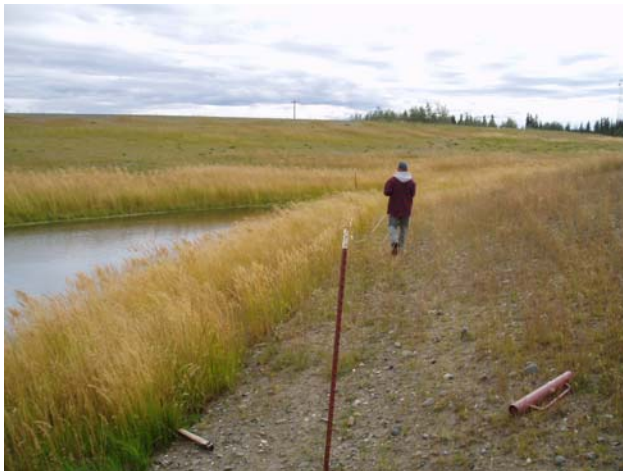
Photo 1. Installing Permanent Transect

A permanent transect was installed across a representative area in the northwest wetland to evaluate plant cover and diversity. (Photo 1) The 100 foot long transect documented what was present on 6 inch intervals, thus 200 total hit points were recorded. Table 1 presents the data indicating plant cover at 66.5% of the total area.

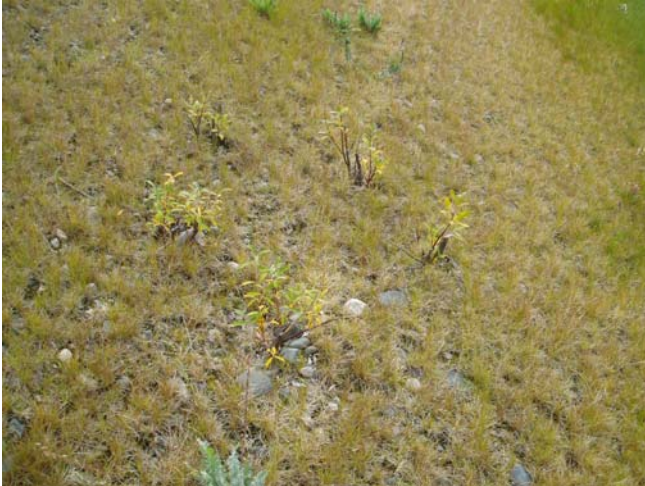
Photo 2. High Survival Rate for Planted Dormant Cuttings

It is estimated that 80% of the dormant willow cuttings planted on the project have survived. (Photo 2) The only area with low survival was near the top of the rip rap dike of the northwest wetland. This area had compacted, highly porous soils giving the cuttings little access to moisture.

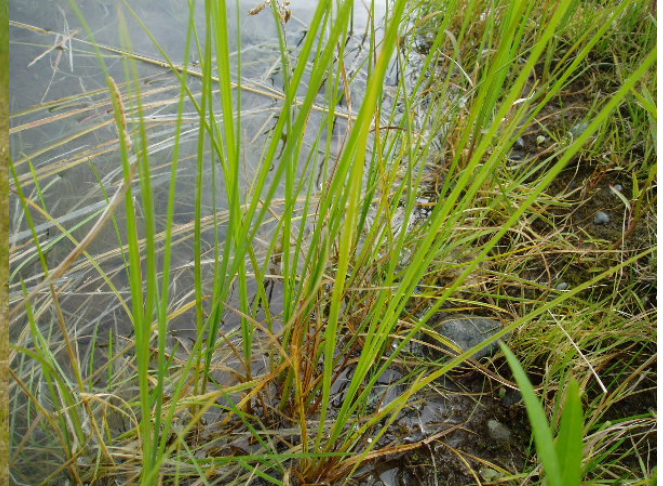
Photo 3. Thriving Sedge Transplant

Most of the planted species were observed to be established and thriving on the site with the exception of the seeded ‘Alyeska’ polargrass and *Carex pachystachya*. The transplanted *Carex aquatilis* and *Carex utriculata*, and bluejoint (*Calamagrostis canadensis*) were thriving (Photo 3). ‘Gruening’ alpine bluegrass, ‘Nortran’ tufted hairgrass, ‘Egan’ American sloughgrass and ‘Wainwright’ slender wheatgrass were all observed to have full seed heads and naturally dispersing seed.

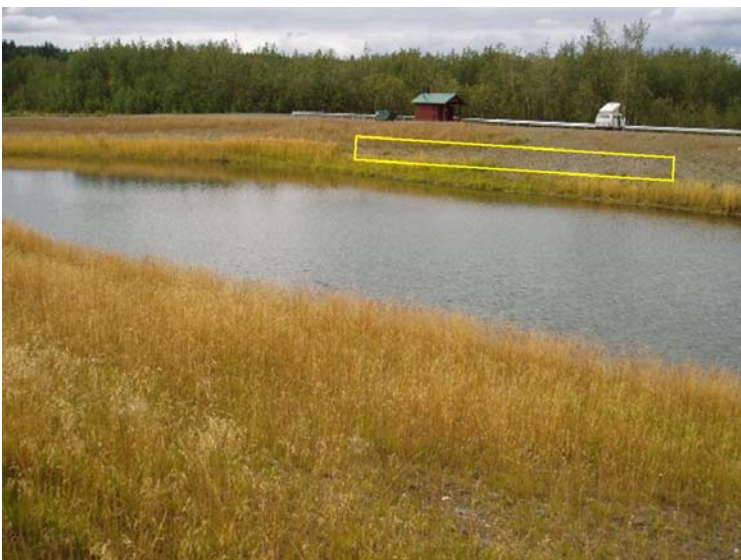
Photo 4. Approximation of the special treatment areas with less vegetation than adjacent areas.

could not be determined. In general, the entire special treatment area appeared to have lower overall plant cover than the other areas of the project that received the standard treatments. (Photo 4) It is expected that vegetation will occupy this area over time. It will be interesting if the species diversity and plant density in the special treatment areas is significantly different five years after implementation of the revegetation efforts.
