**Abandon Mine Land Reclamation:
Jonesville Mine, Sutton Alaska
Phases 3 and 4**

**Prepared By:
Andrew Nolen
Agronomist
State of Alaska**

**Prepared For:
State of Alaska
Department of Natural Resources
Division of Mining, Land, and Water**

May 9, 2007

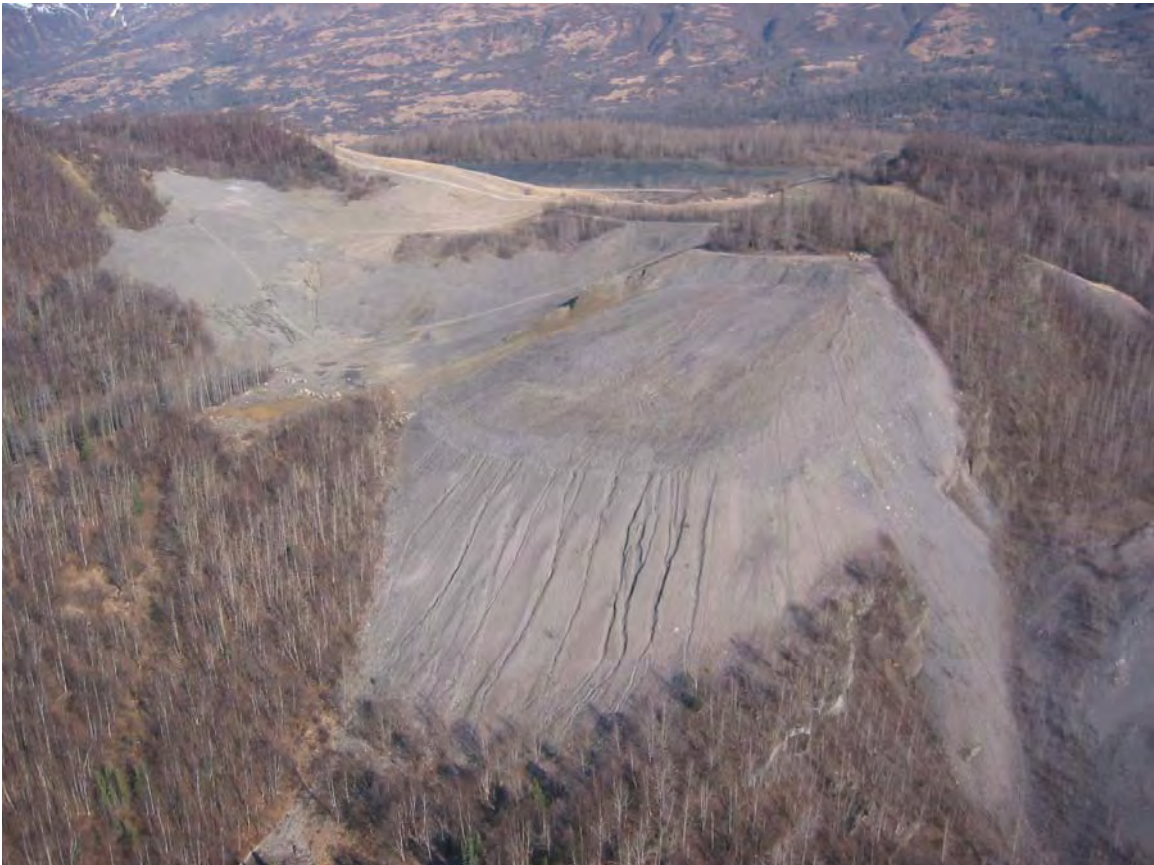
Photo 1. Aerial View of Jonesville Phases III and IV Prior to Restoration

Several years of collaboration between the Alaska Plant Materials Center (PMC) and the Division of Mining, Land and Water Abandon Mine Land (AML) program culminated in 2003 with the implementation of revegetation activities at phases III and IV of the Jonesville coal mine near Sutton, Alaska (Photo 1). The PMC was responsible for the revegetation planning aspects of the reclamation effort. Previous experience with other phases of the Jonesville mine and the Knob Creek mine aided in the development of the revegetation plan for this last remaining disturbance.

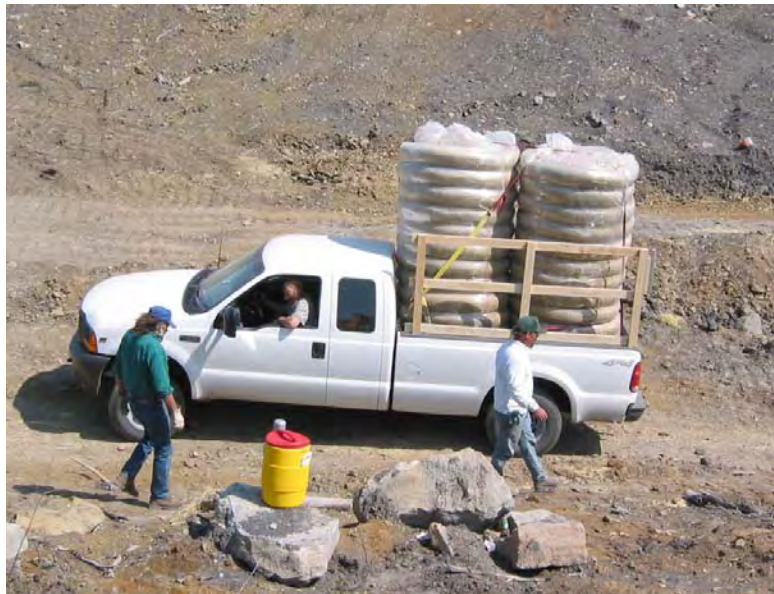
Photo 2. Delivery of Straw Wattle

Mobilization to the site began on May 27, 2003. A hired crew of five laborers converged on the site to aid two PMC agronomists. Straw wattle installation was the initial task. The PMC staff used a pickup to transport two pallets at a time from the PMC to the site. (Photo 2) The laborers trenched along the contour of the steep faces of phases III and IV (Photo 3). The wattles were installed at three steep locations of the project spaced at intervals of 15 feet of elevation (Photo 4). Wood stakes were used to secure the wattle in the trenches (Photo 5).

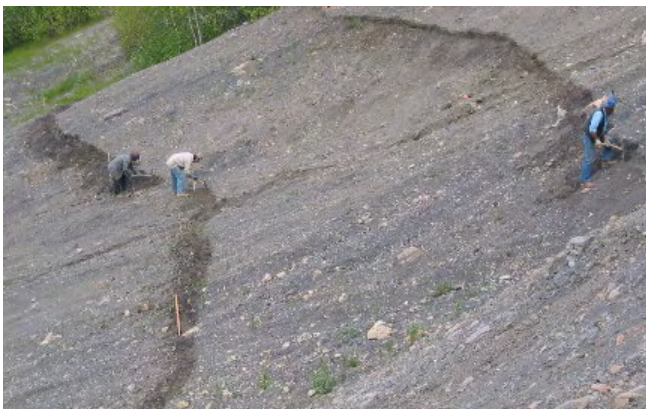
Photo 3. Contour Trenching for Wattle installations

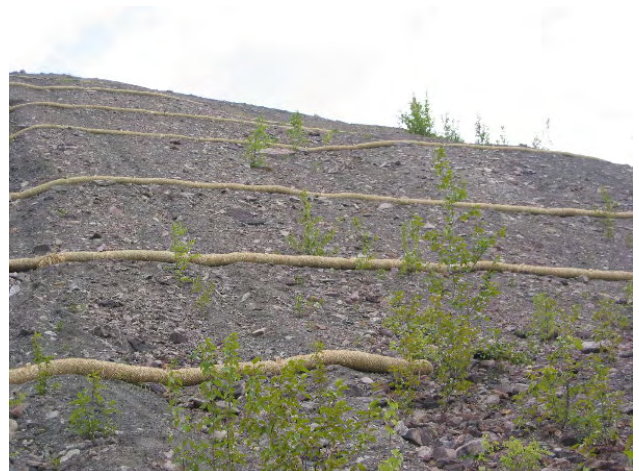
Photo 4. Wattle Space on 15-foot Intervals

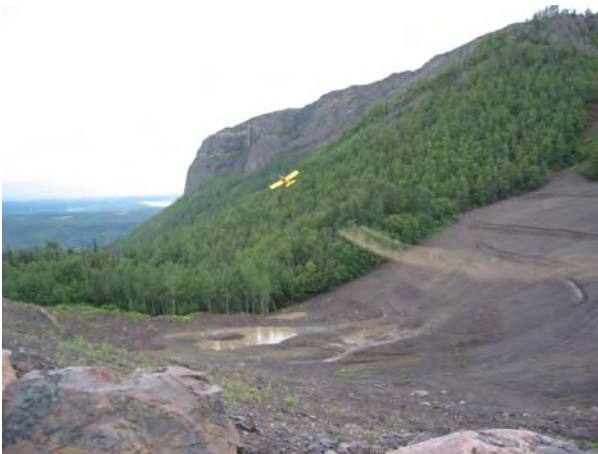
Photo 5. Aerial Application

Aerial applications of seed and fertilizer occurred July 30, 2003 (Photo 5). The seed was applied first because wind at the site, which could drift the light weight mix, tended to be calm in the morning hours. The application appeared to be very uniform with few light areas (Photo 6). The fertilizer application was also very uniform. The plane was not loaded to capacity due to the highly variable terrain of the site and risk of adverse weather conditions. All of the applications were complete in the early afternoon.

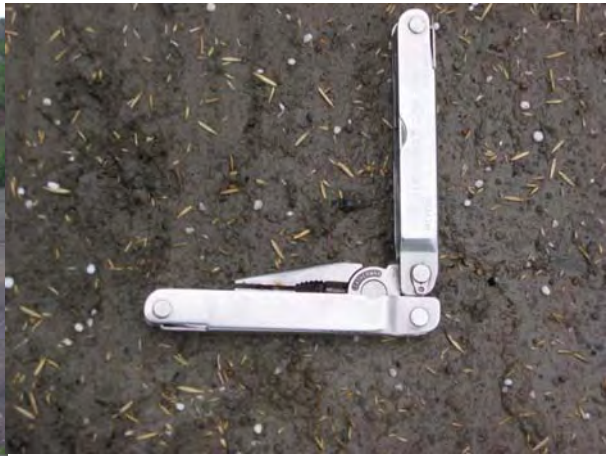
Photo 6. Uniform coverage of seed and fertilizer

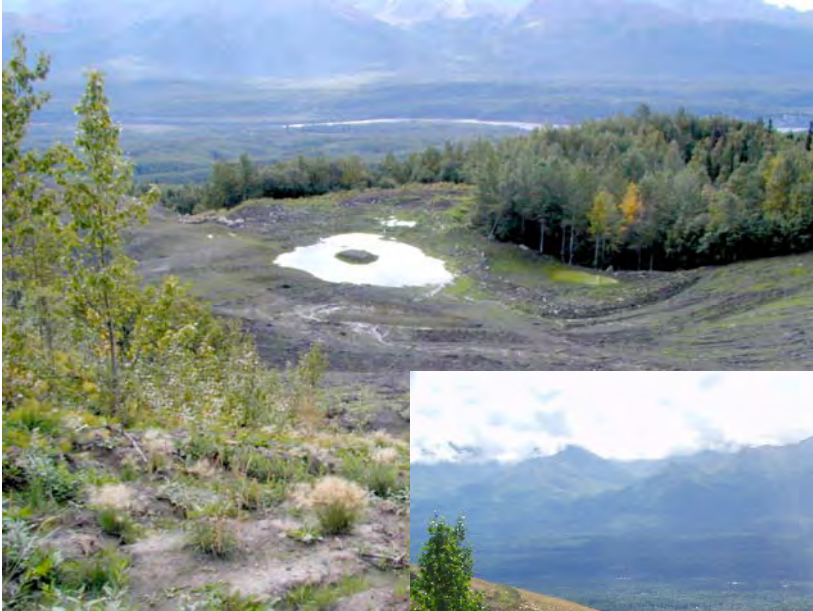
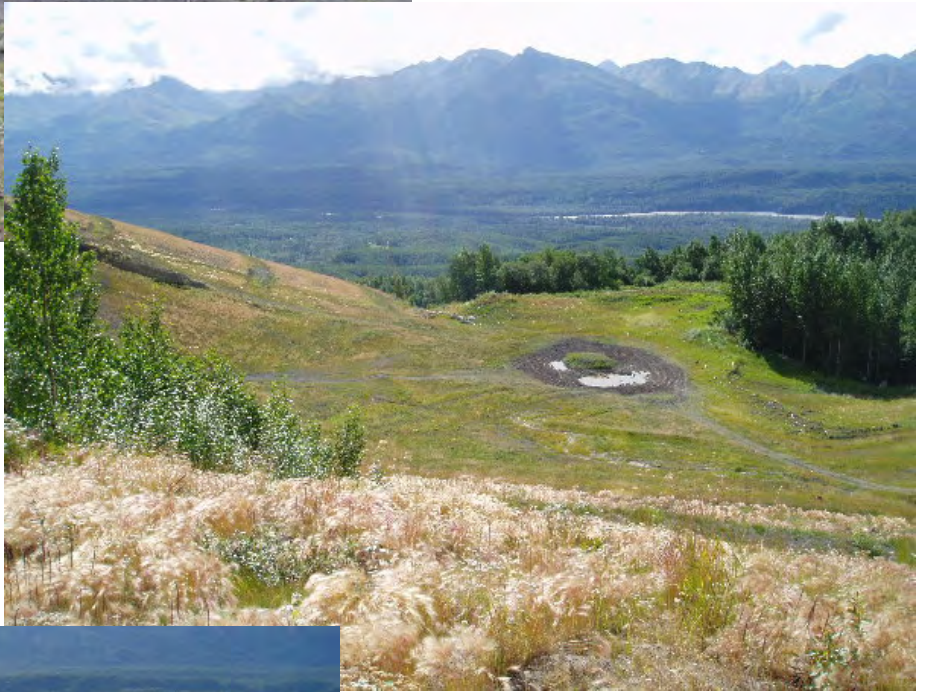
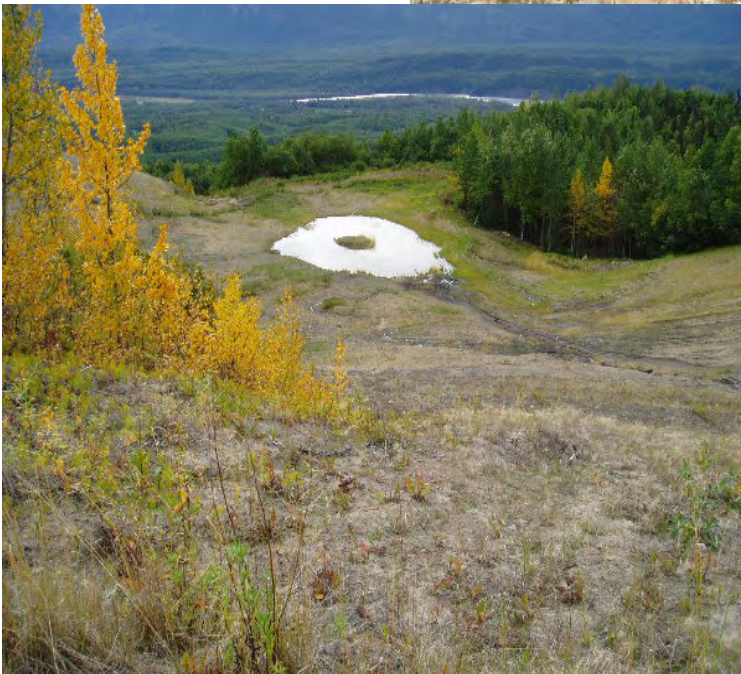
Photo Point 1: N 61° 44' 19.7" W 148° 56' 29.8"

9-7-03

7-21-04

9-6-06

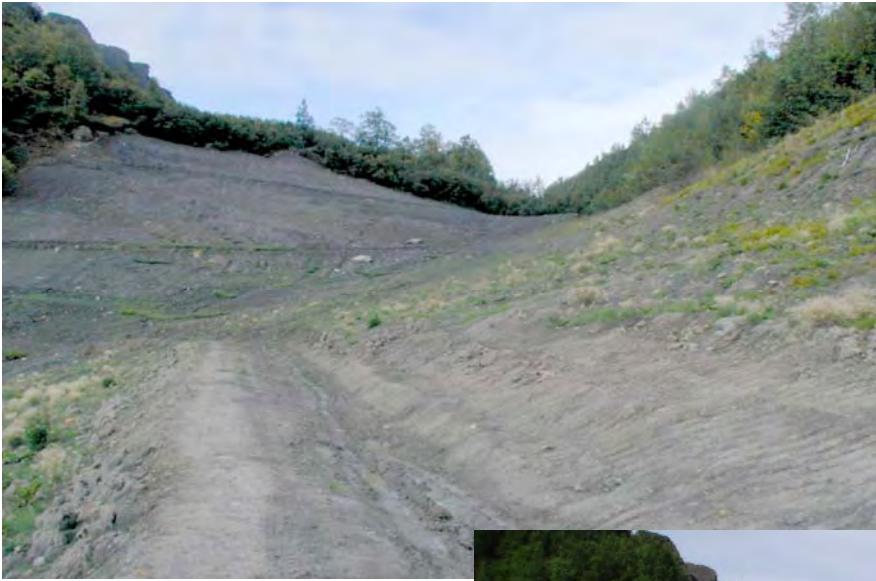
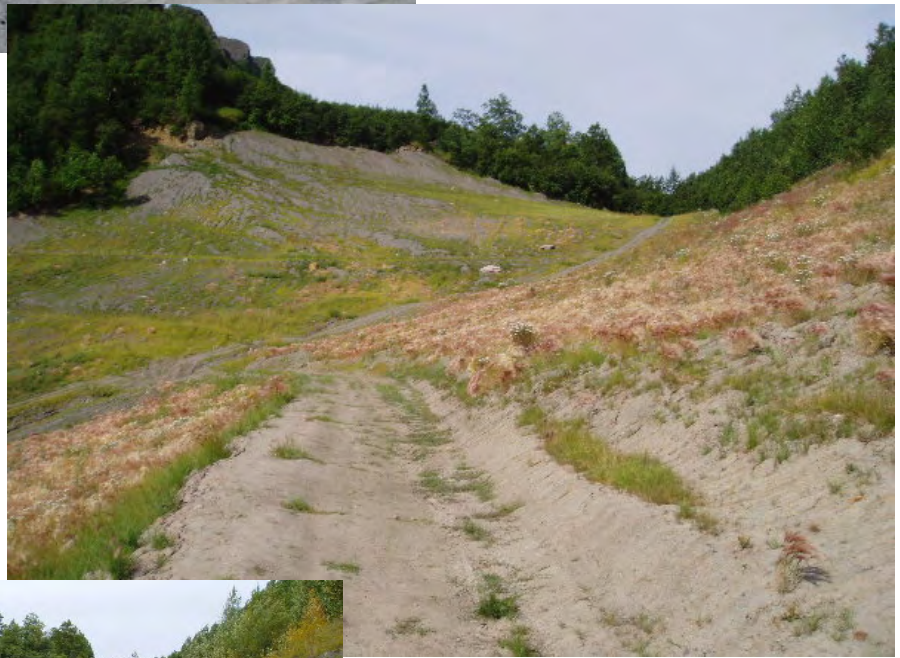
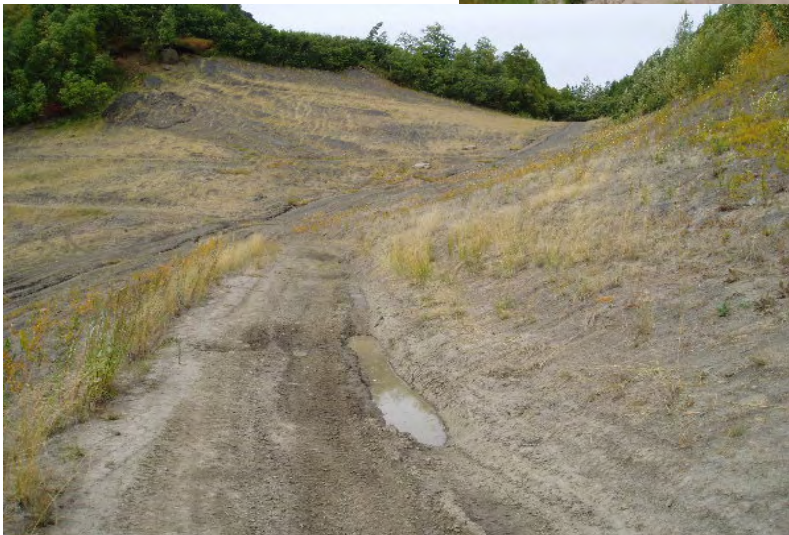
Photo Point 2: N 61° 44' 19.7" W 148° 56' 29.8"

9-4-03

7-21-04

9-6-06

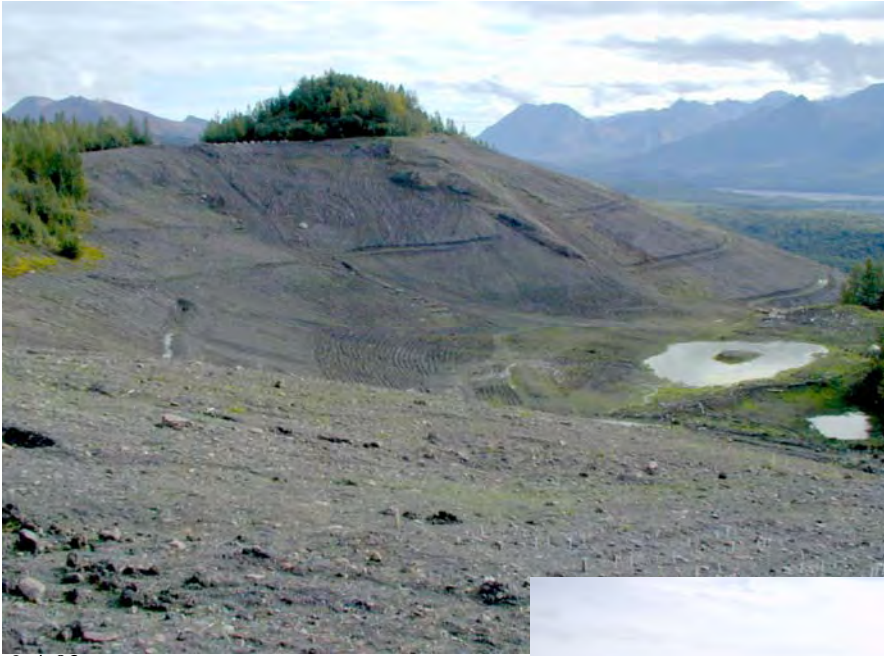
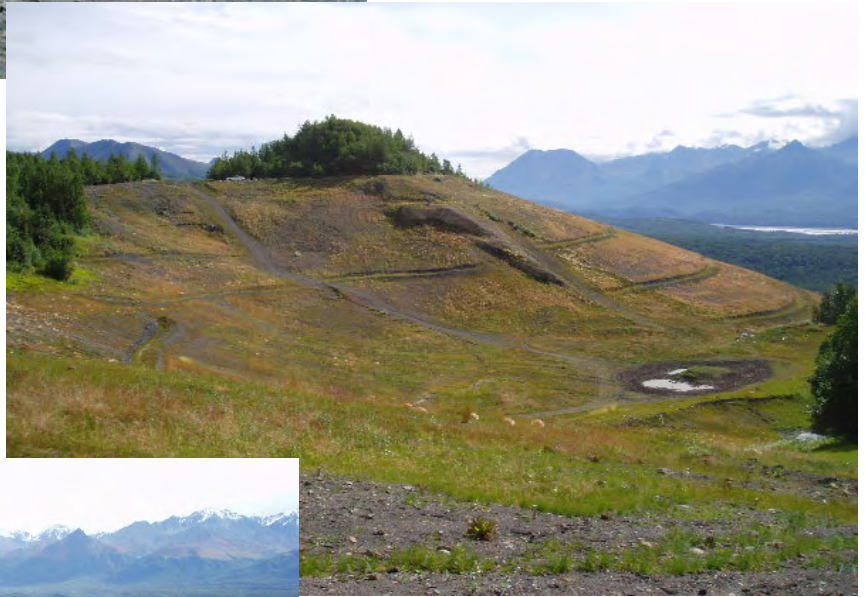
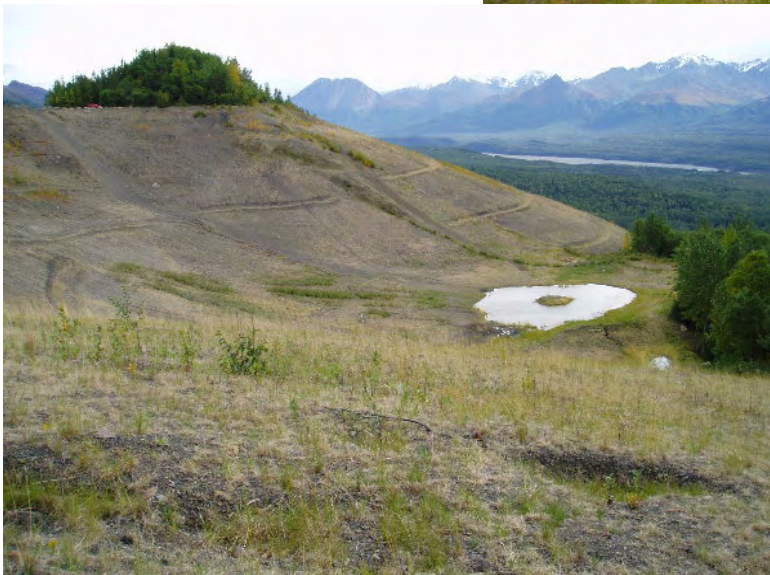
Photo Point 3: N 61° 44' 19.7" W 148° 56' 36.5"

9-4-03

7-21-04

9-6-06

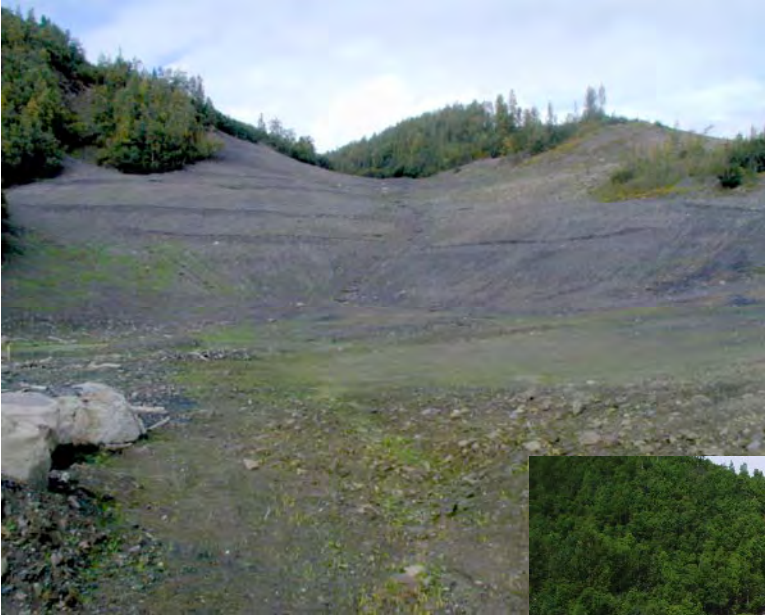
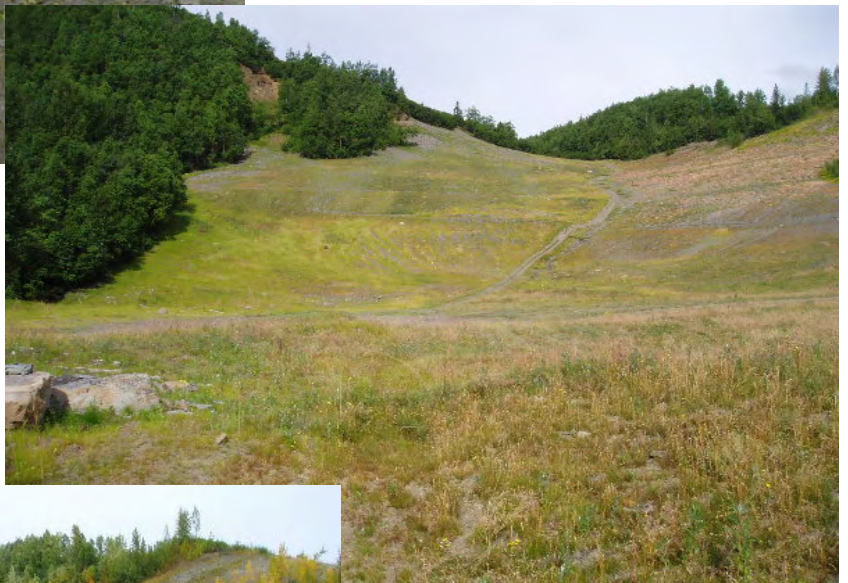
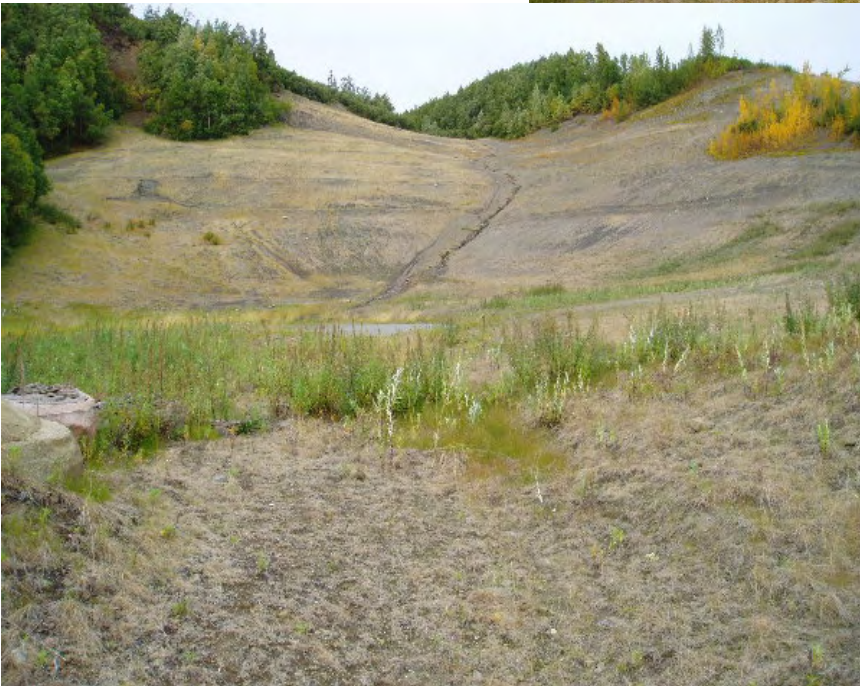
Photo Point 4: N 61° 44' 15.2" W 148° 56' 21.5"

9-4-03

7-21-04

9-6-06

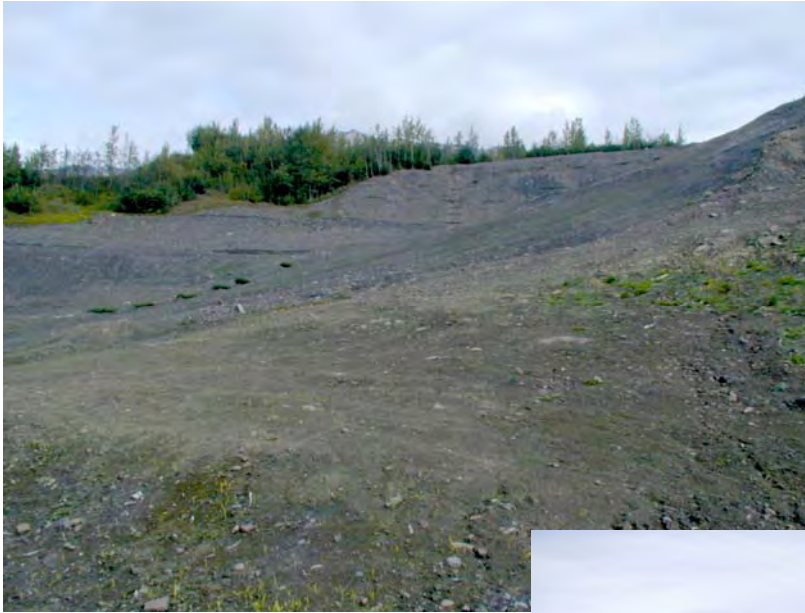
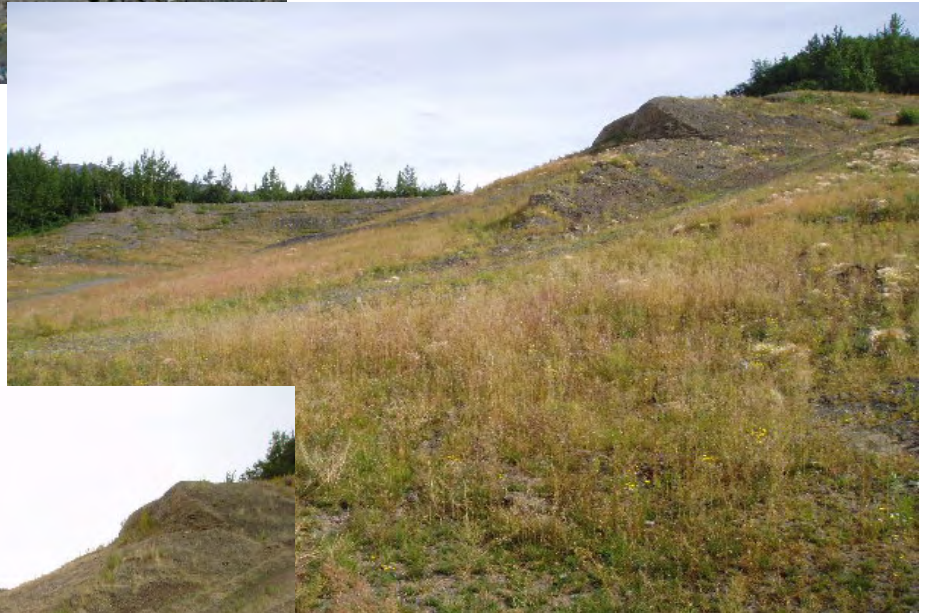
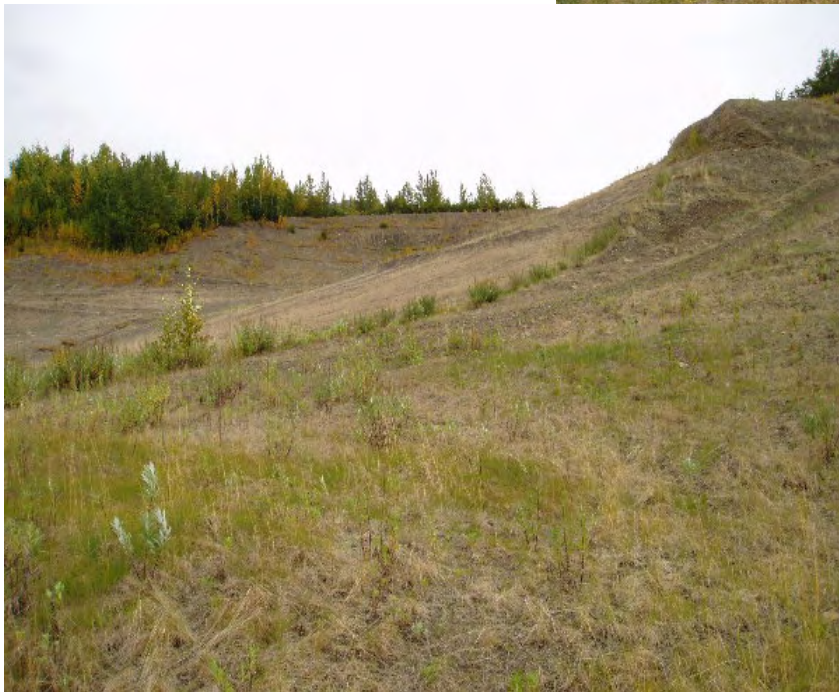
Photo Point 5: N 61° 44' 15.2" W 148° 56' 21.5"

9-4-03

7-21-04

9-6-06

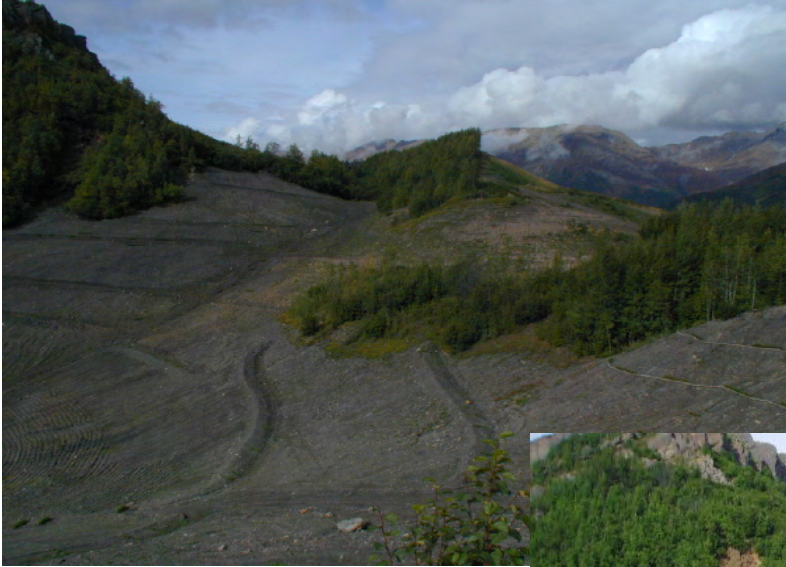
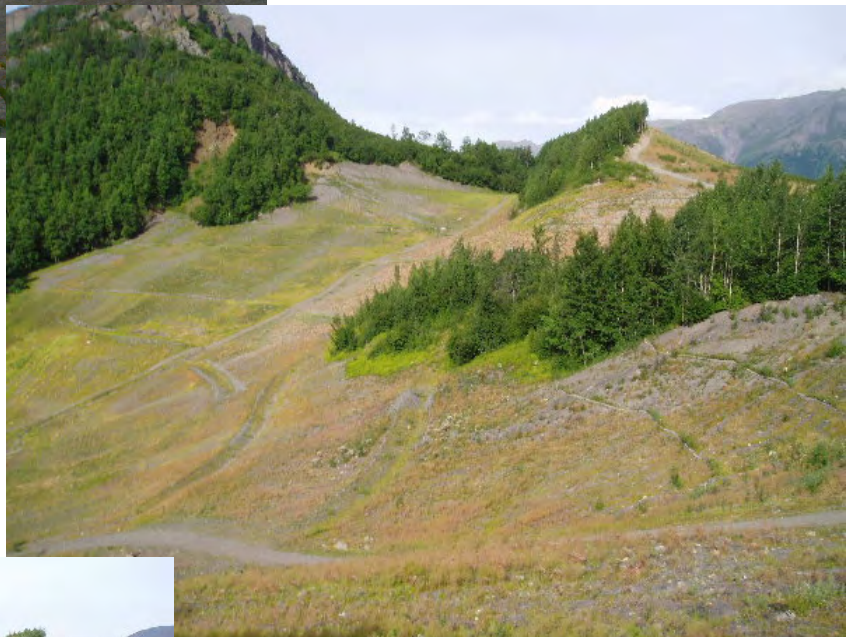
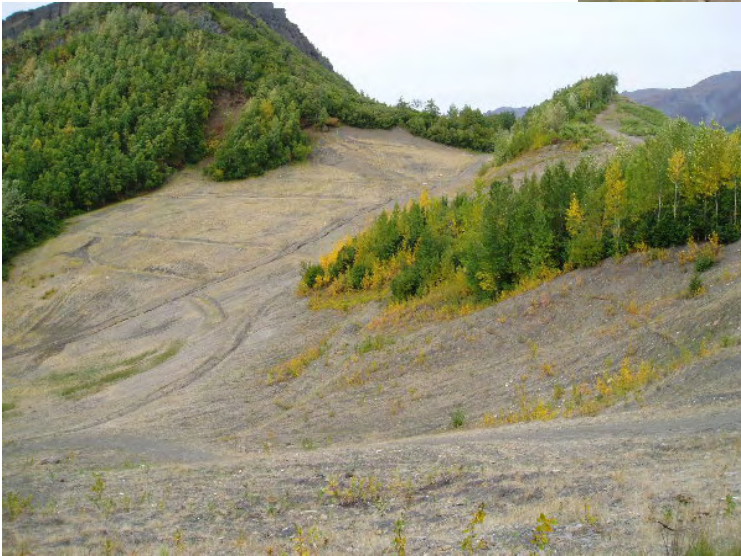
Photo Point 6: N 61° 44' 18.4" W 148° 56' 16.4"

9-4-03

7-21-04

9-6-06
