**Chitina Cemetery Road  
Proposal to Identify as a  
RS 2477 Right of Way**

State of Alaska  
Department of Natural Resources  
Division of Mining, Land and Water  
Public Access Defense Unit  
March 2010

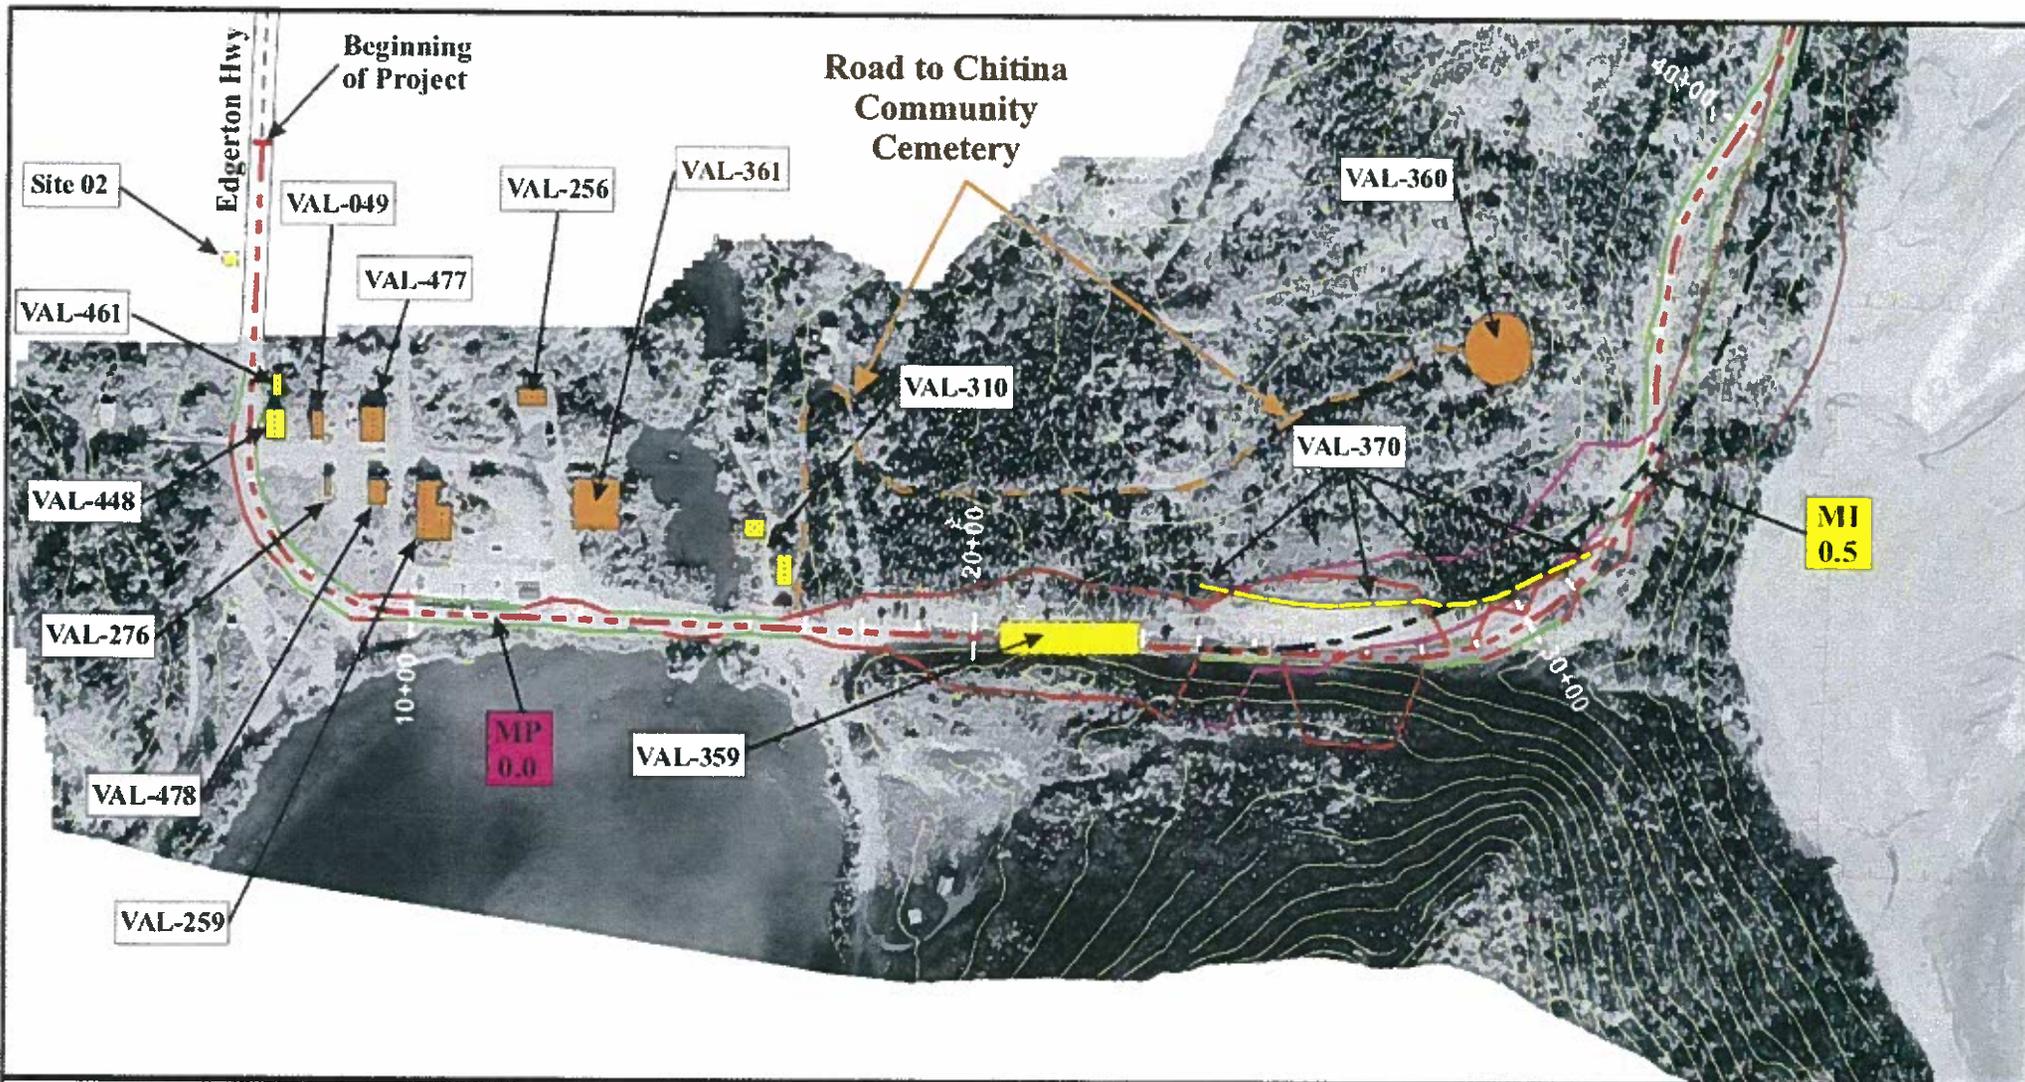
**Figure 3. Cultural resource sites in the Chitina area from Mile 0.0 to Mile 0.5 of the existing and proposed realignments of McCarthy Road.**

McCarthy Road Improvement Project, Cultural Resource Survey, September 2003; Created by ADOT&PF in 2005. The historic sites were based on the work of Rolfe Buzzell as described in the work above. This version has the Chitina Cemetery Road delineated by Rolfe Buzzell in 2009.

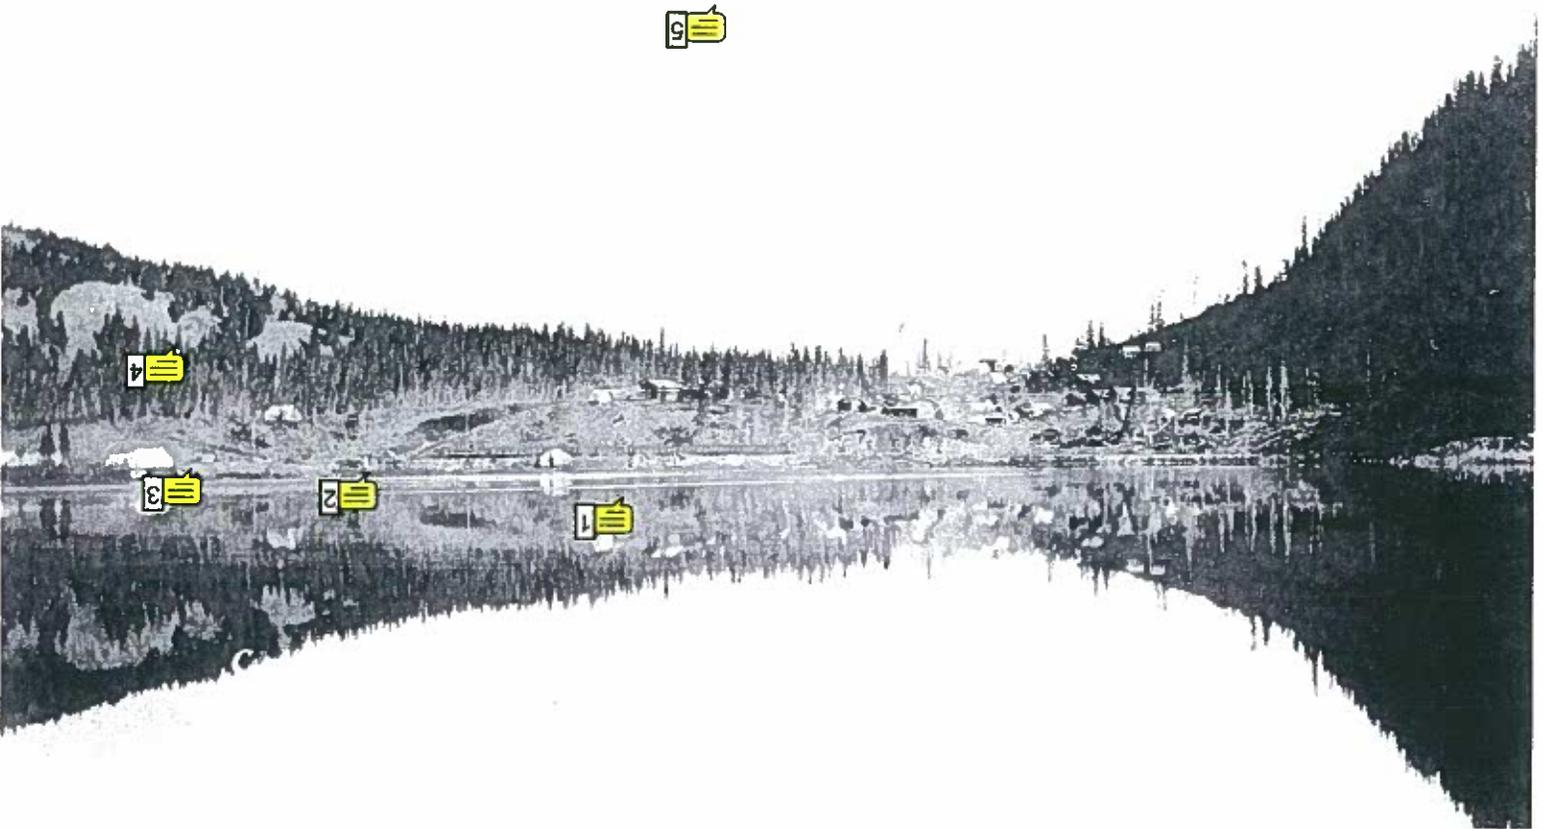
Railroad cars on track along Trout Lake. The RR first reached Chitina September 12, 1910. The tunnel was complete by January 7, 1911.

Tunnel begun, but no maintenance building which shows this photo predates photo #2

Little cabin along road

Road is visible note the cut along hillside

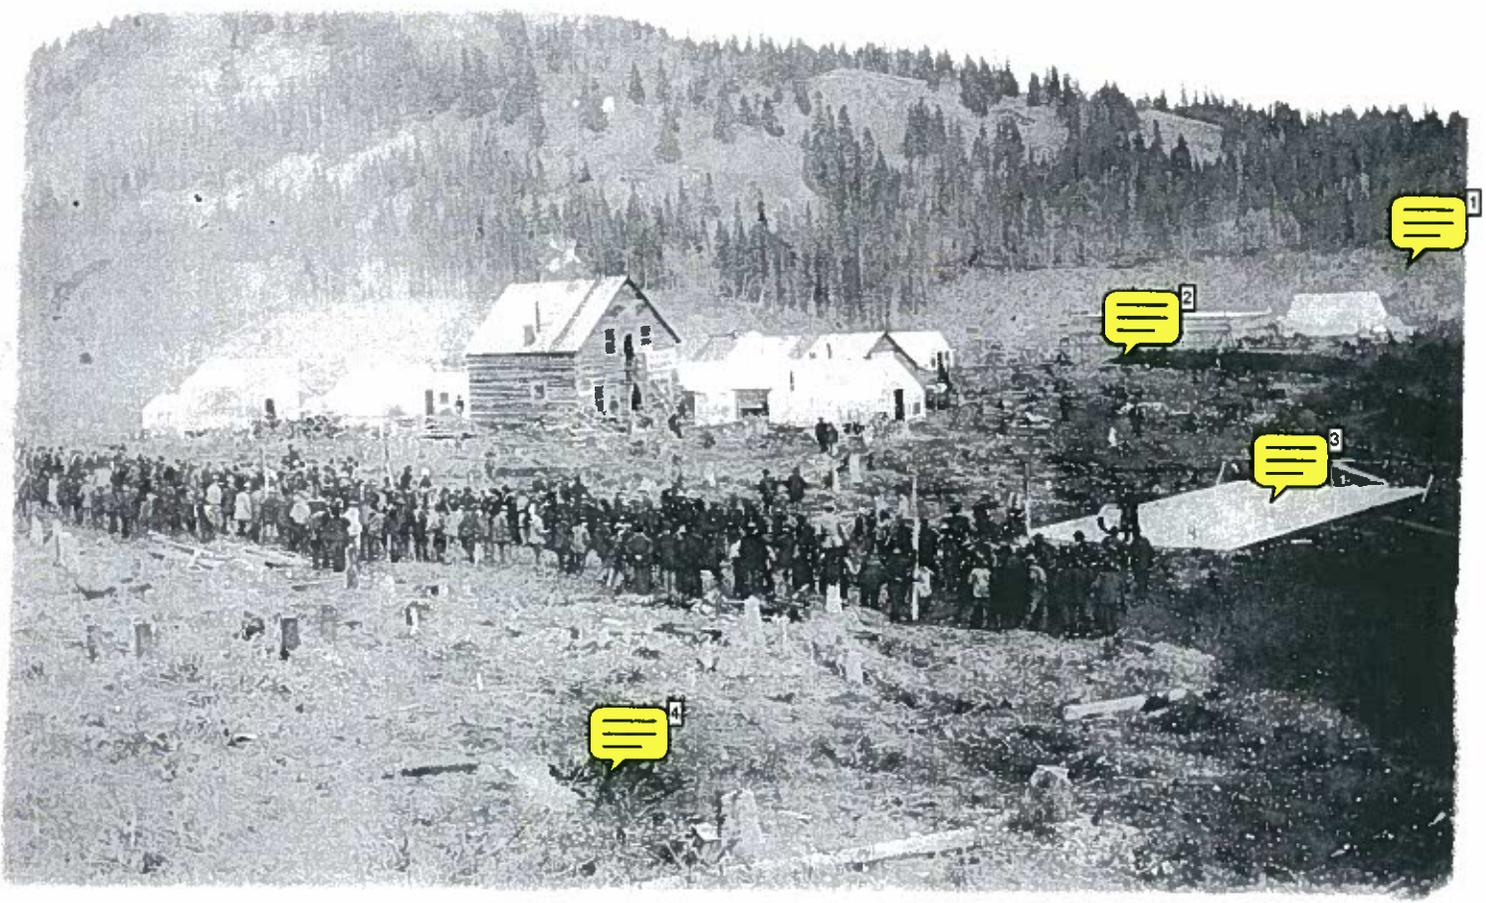
High point of trail? May need to enlarge

Hotel is under construction

Construction beginning on RR Station

"Railroad Day" September 25, 1910 123 people came from Cordova for a day of celebration, which was the first passenger train to Chitina. See Chitina Leader October 11, 1910 and September 24, 1910

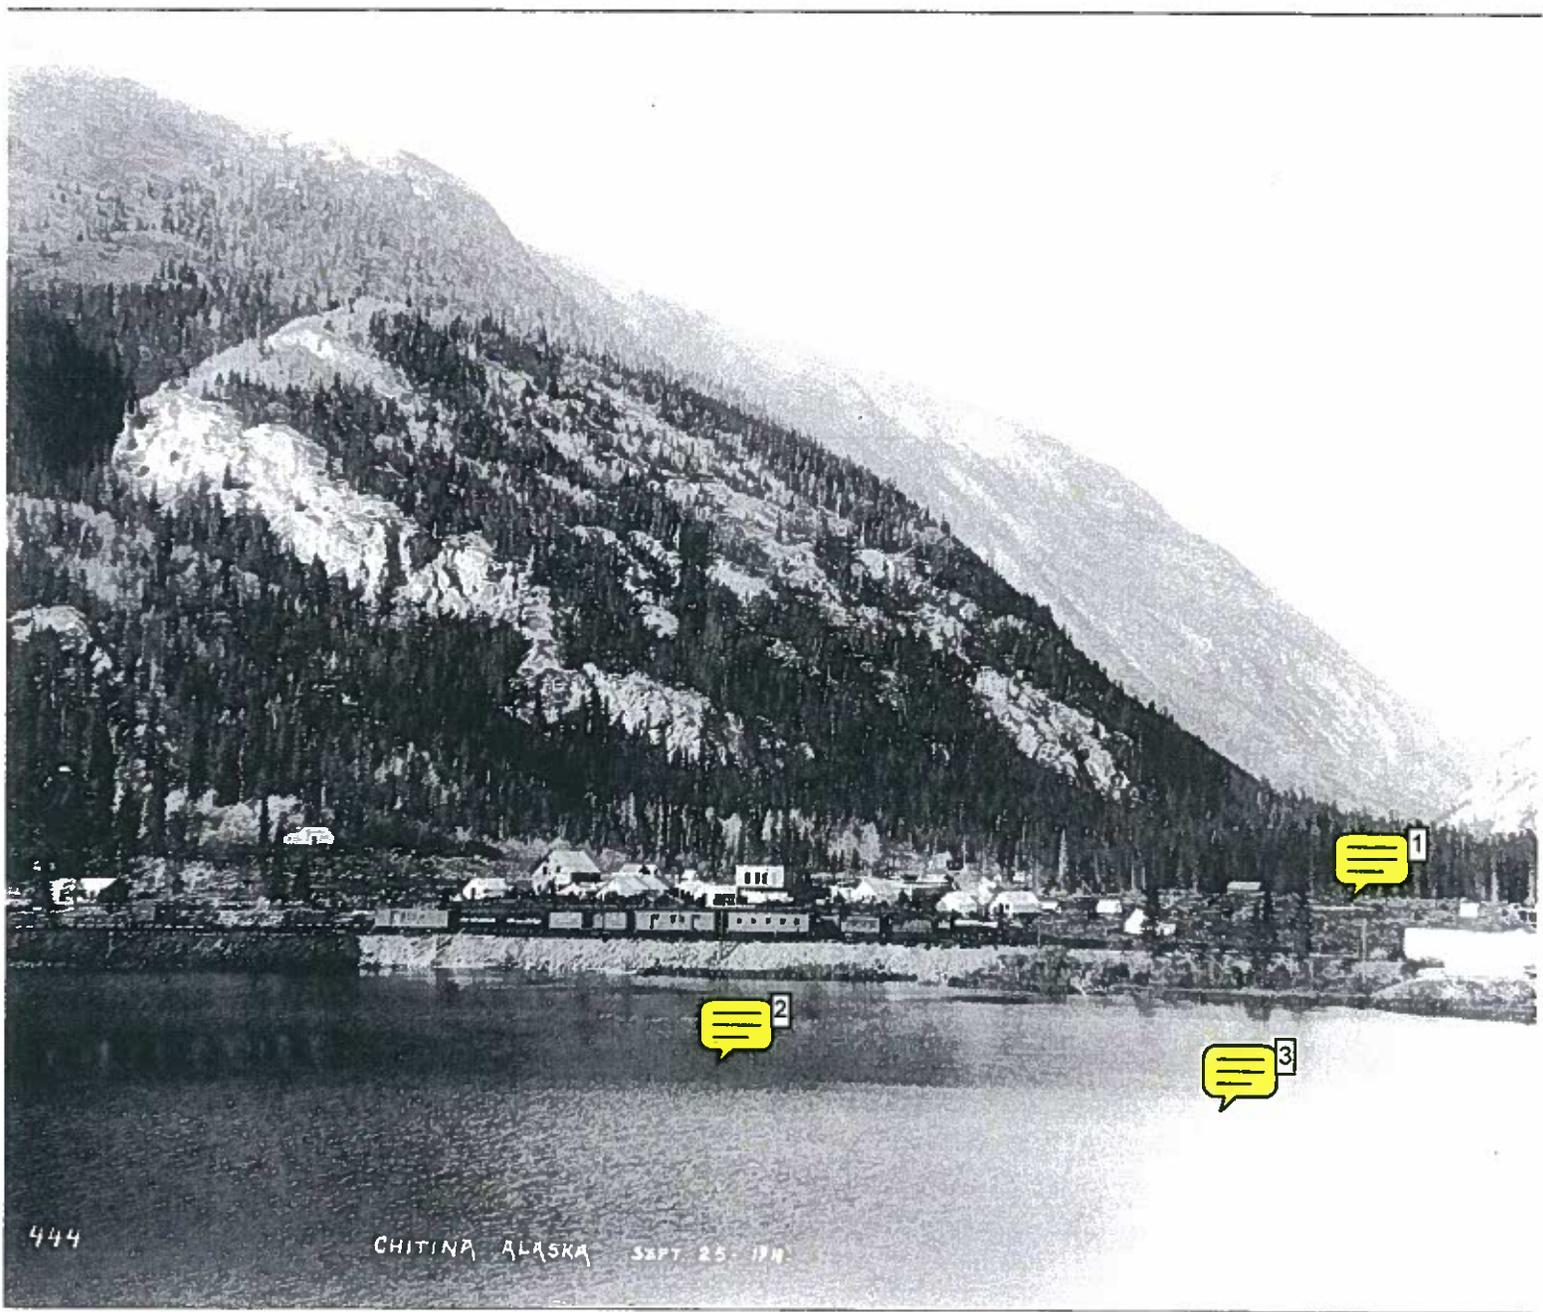
CHITINA ALASKA SEPT. 25. 1911

No Hotel

RR is to Chitina, it first arrived September 12, 1911

No RR Station

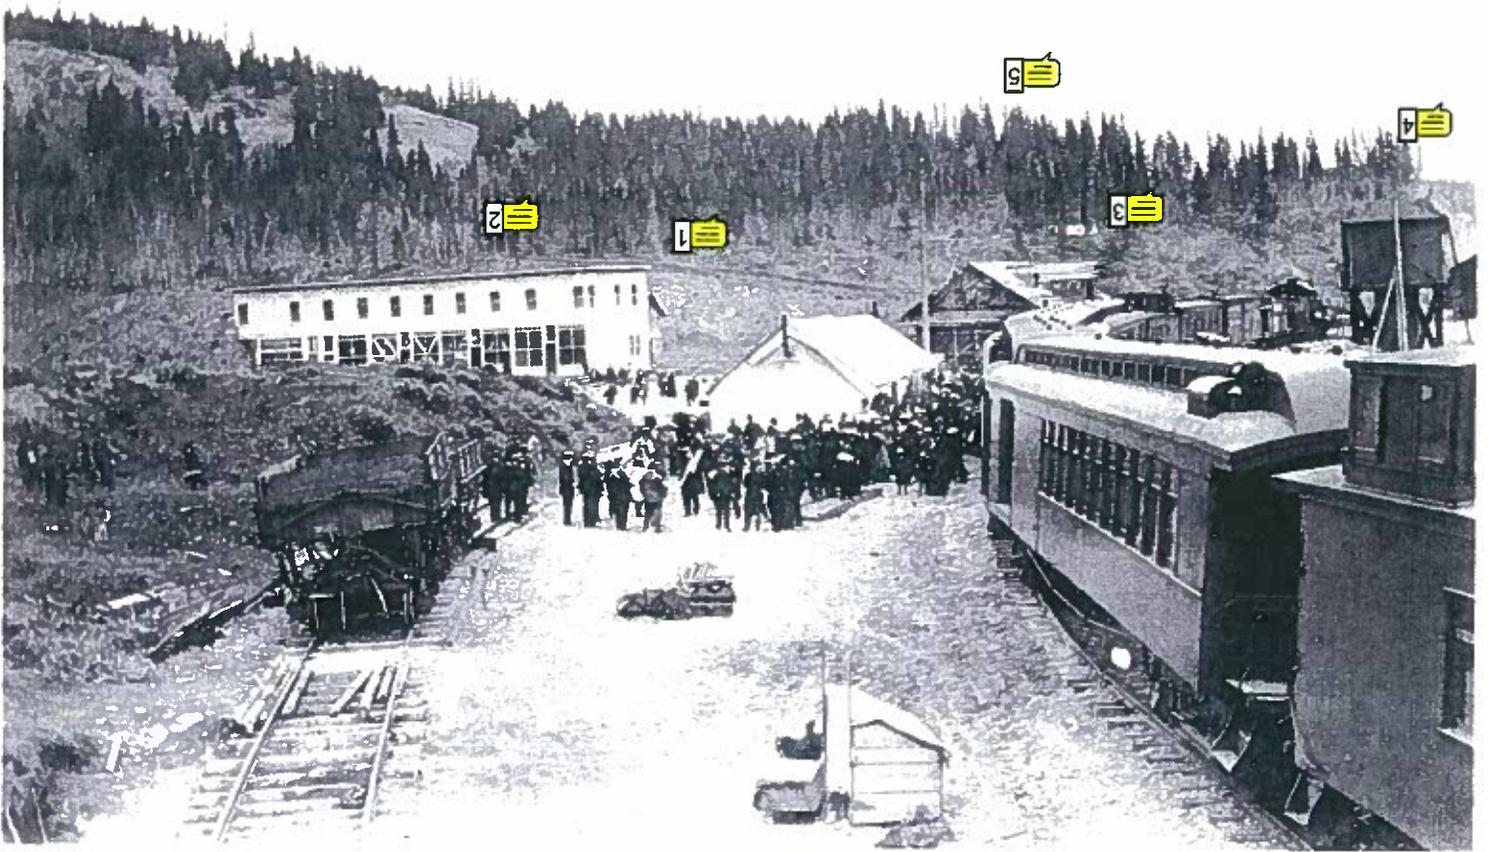
road visible

Hotel is in use. It opened November 26, 1910

dwelling

maintenance Building in place

Station under construction, secondary building is a temporary structure

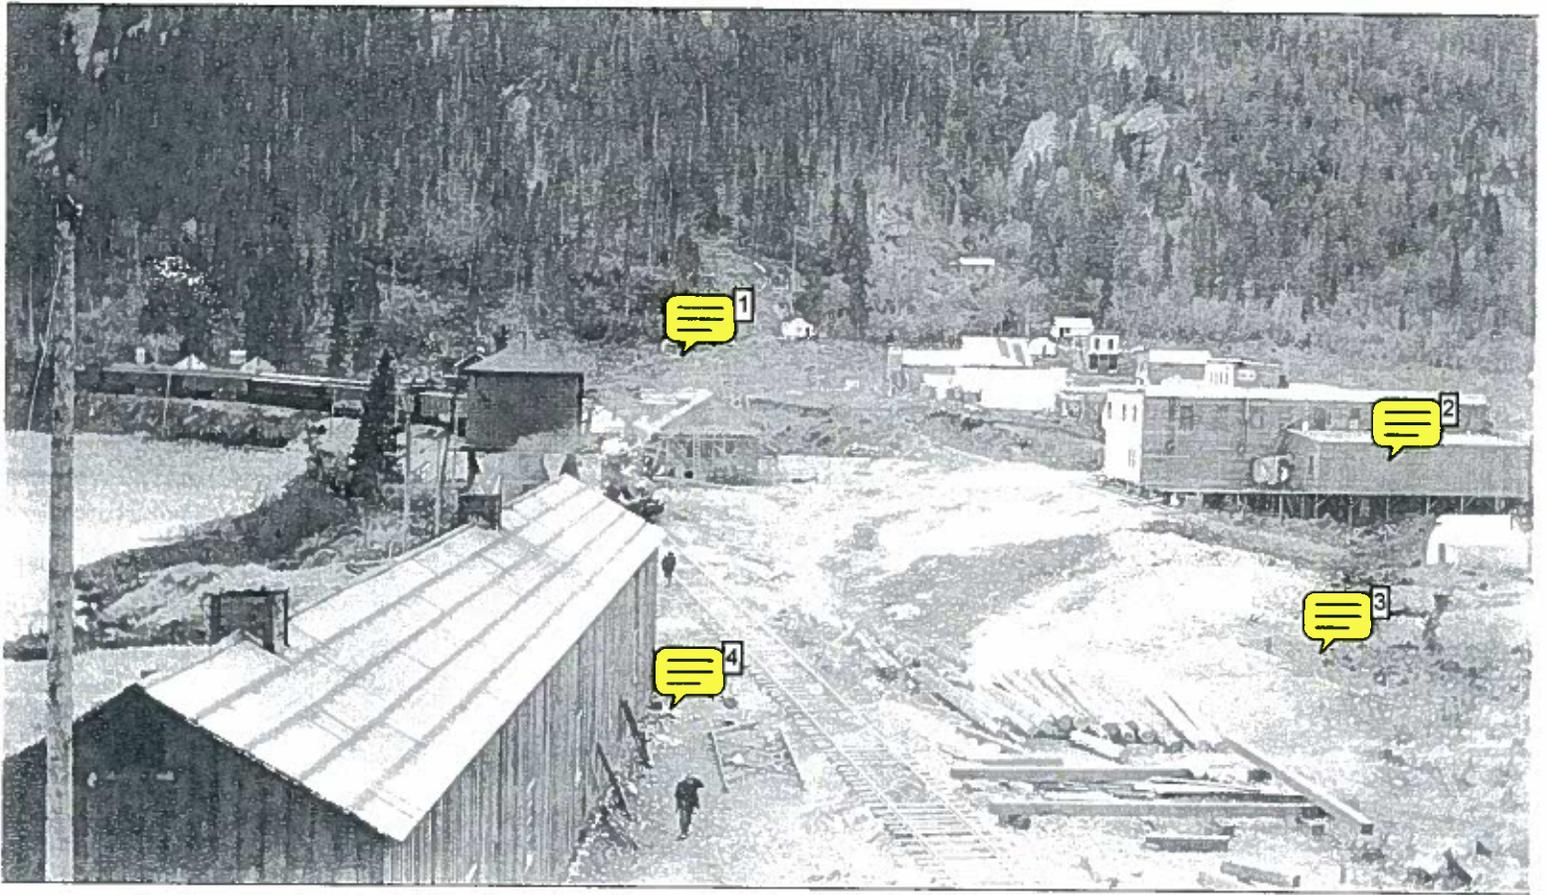
RR Station is under construction. Chitina Leader mentions depot on 11/12/10

Hotel opened 11/26/10

Beginning of trail.

Maintenance Building is build

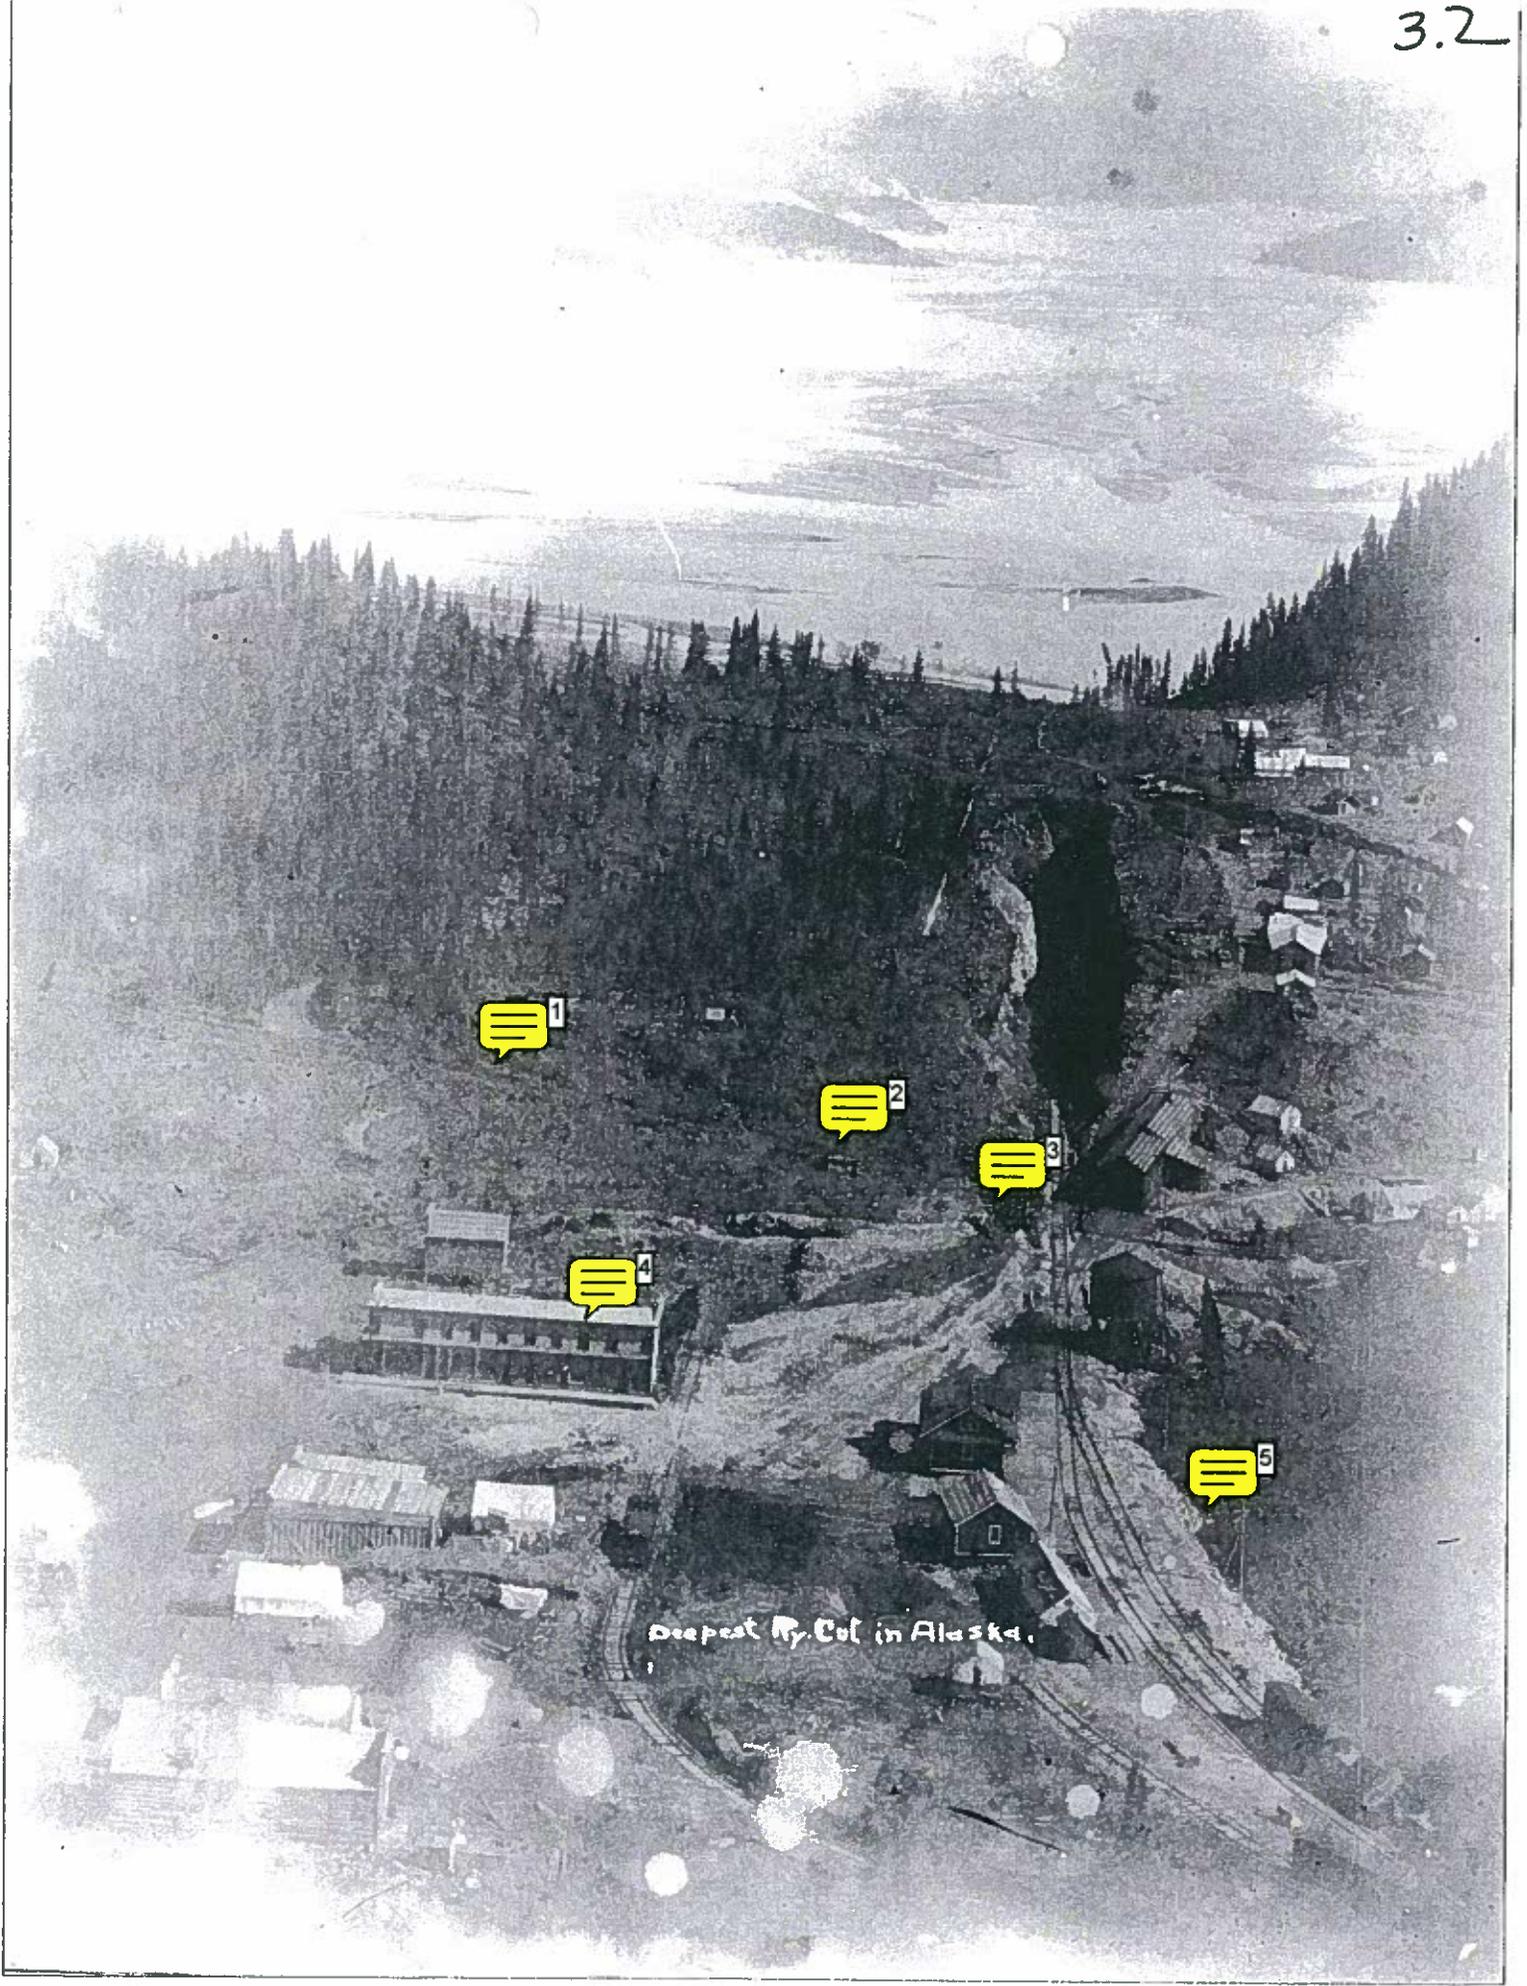
Deepest Ry. Cut in Alaska.

Trail

Small cabin by trail. Could possible belong to Way Bowker. The Chitina Leader reported he was one of Chitina's earliest residents and his cabin burned down in February 1911

Trail leads to what appears to be a staging area for timbers along the RR track at the mouth of the cut. It seems to indicate that the trail has some kind of role in the ongoing construction.

Hotel opened 11/16/10

RR Station

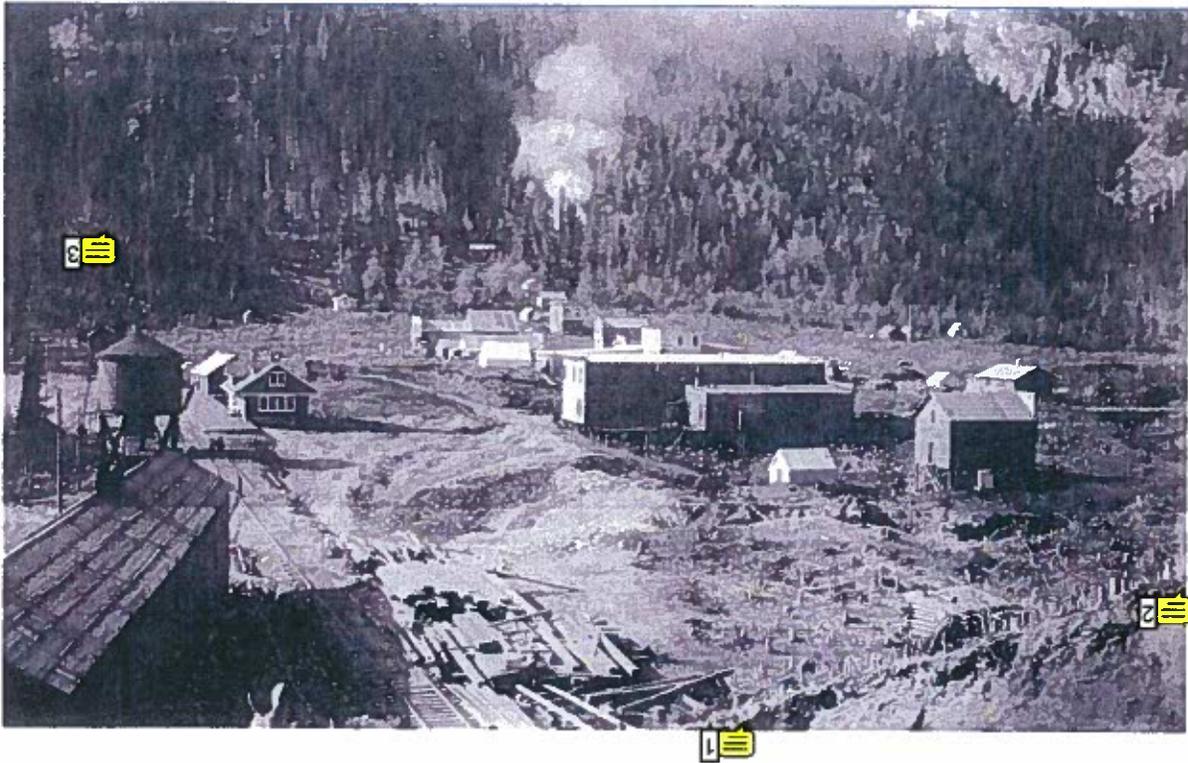
road is not visible, but staging area is, this is basically the other end view of Photo 3.2.

log cabin of unknown origin in same location as bunkhouse. Obscure object in photo #1 and 2 is likely this cabin. It could have belonged to Way Bowker which burned down.see Chitina Leader 2/18/11

Station and secondary building complete

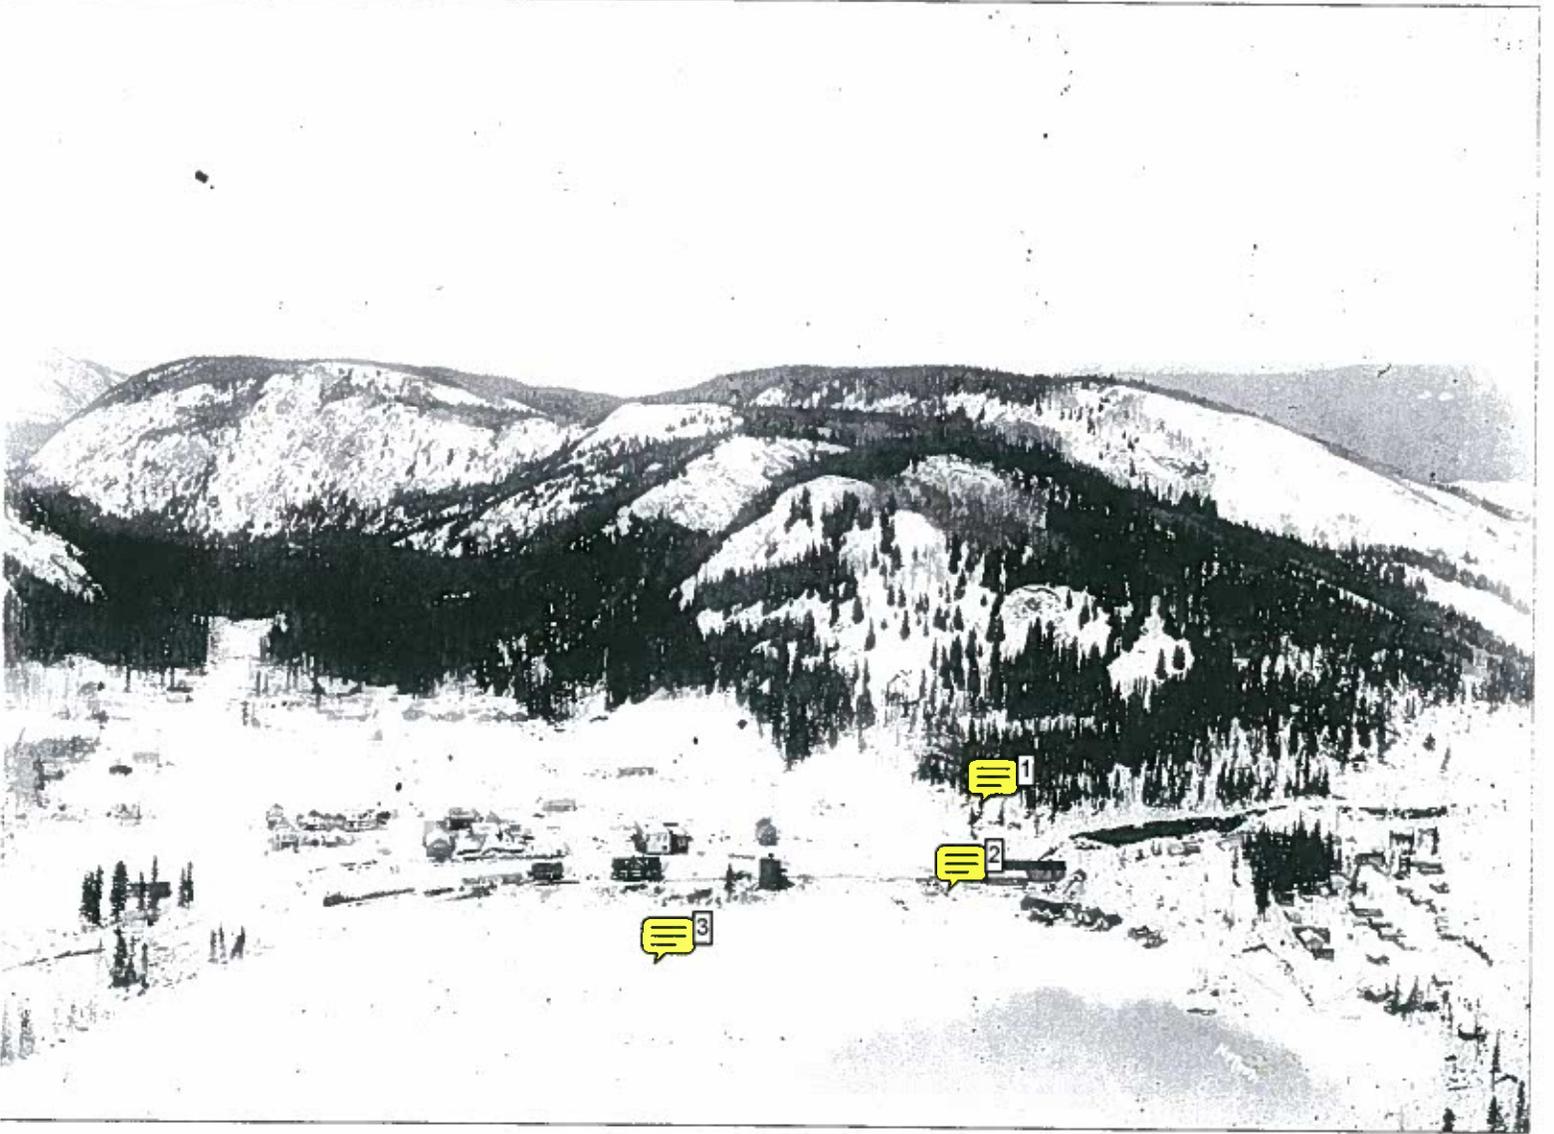
Faint outline of Trail is visible. May need to enlarge.

Small cabin along Trail is gone.

RR Station is complete

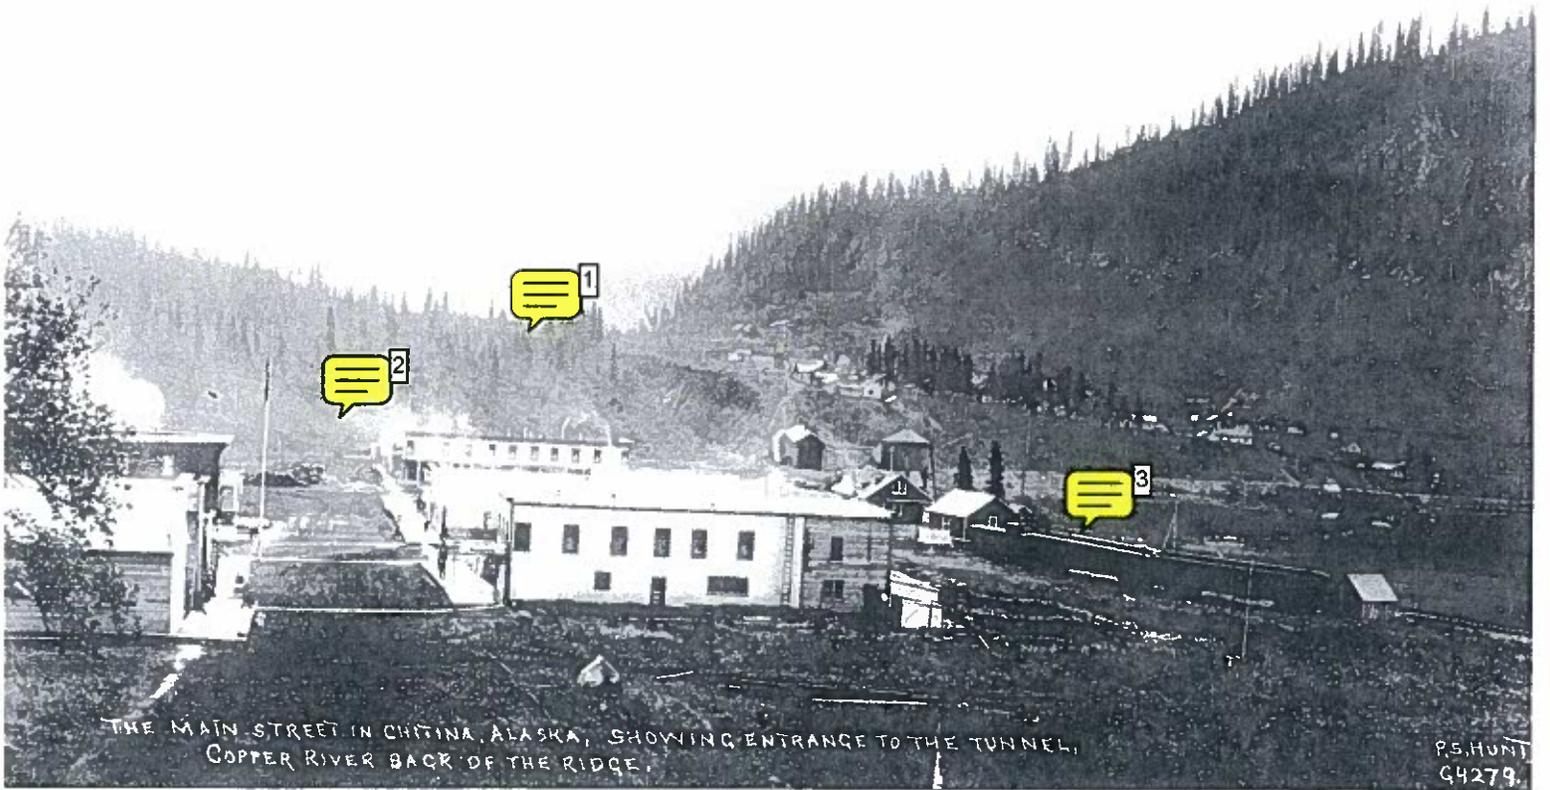
THE MAIN STREET IN CHITINA, ALASKA, SHOWING ENTRANCE TO THE TUNNEL,  
COPPER RIVER BACK OF THE RIDGE.

No Bunkhouse

Trail is visible

Old Old Maintenance Building

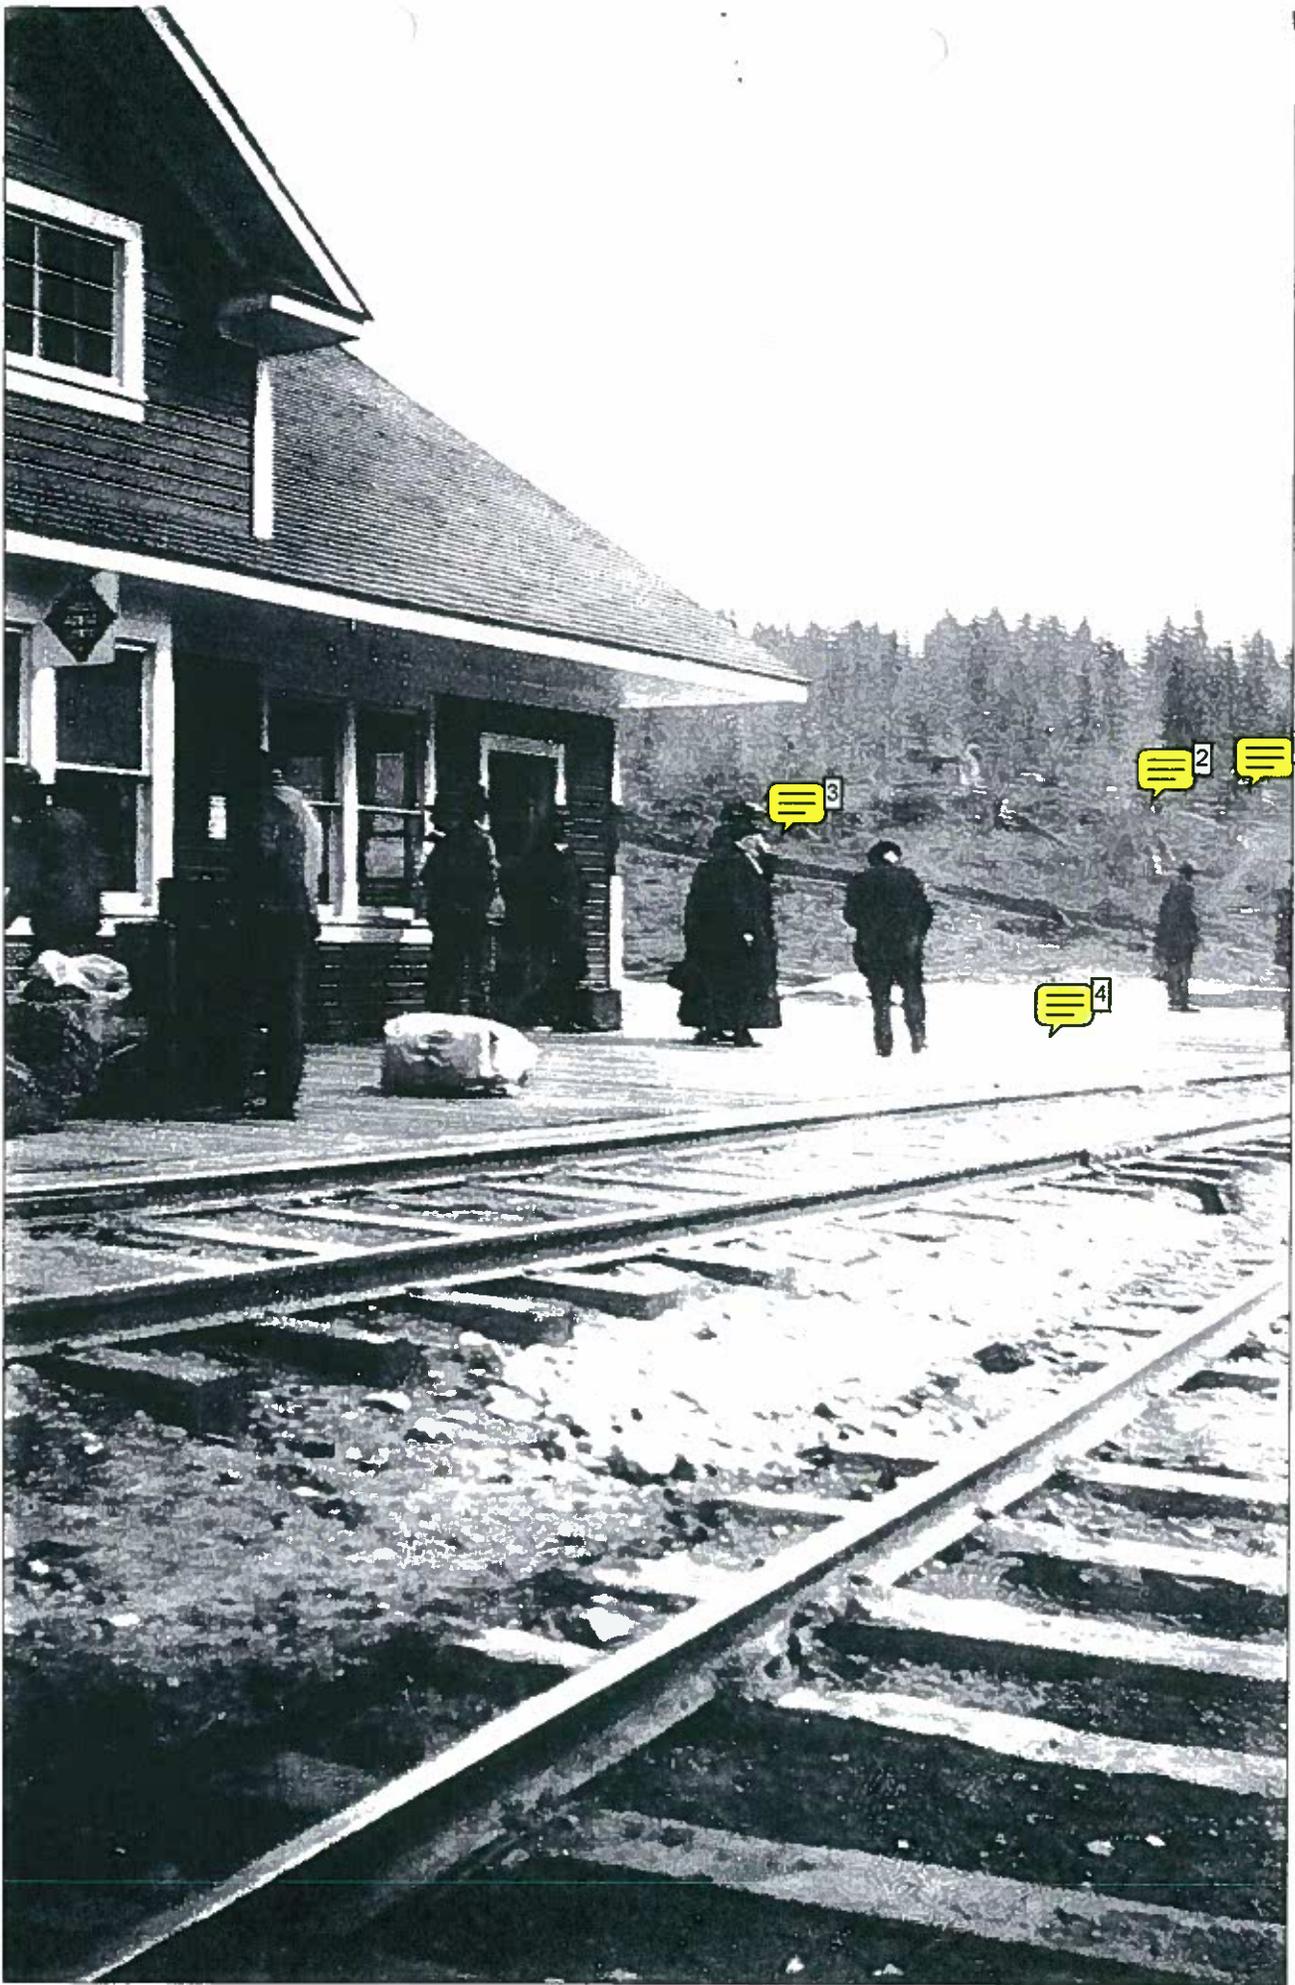
No Bunkhouse

Trail from Road to dwellings

Road visible, can see that it was mechanically constructed

Little Cabin gone

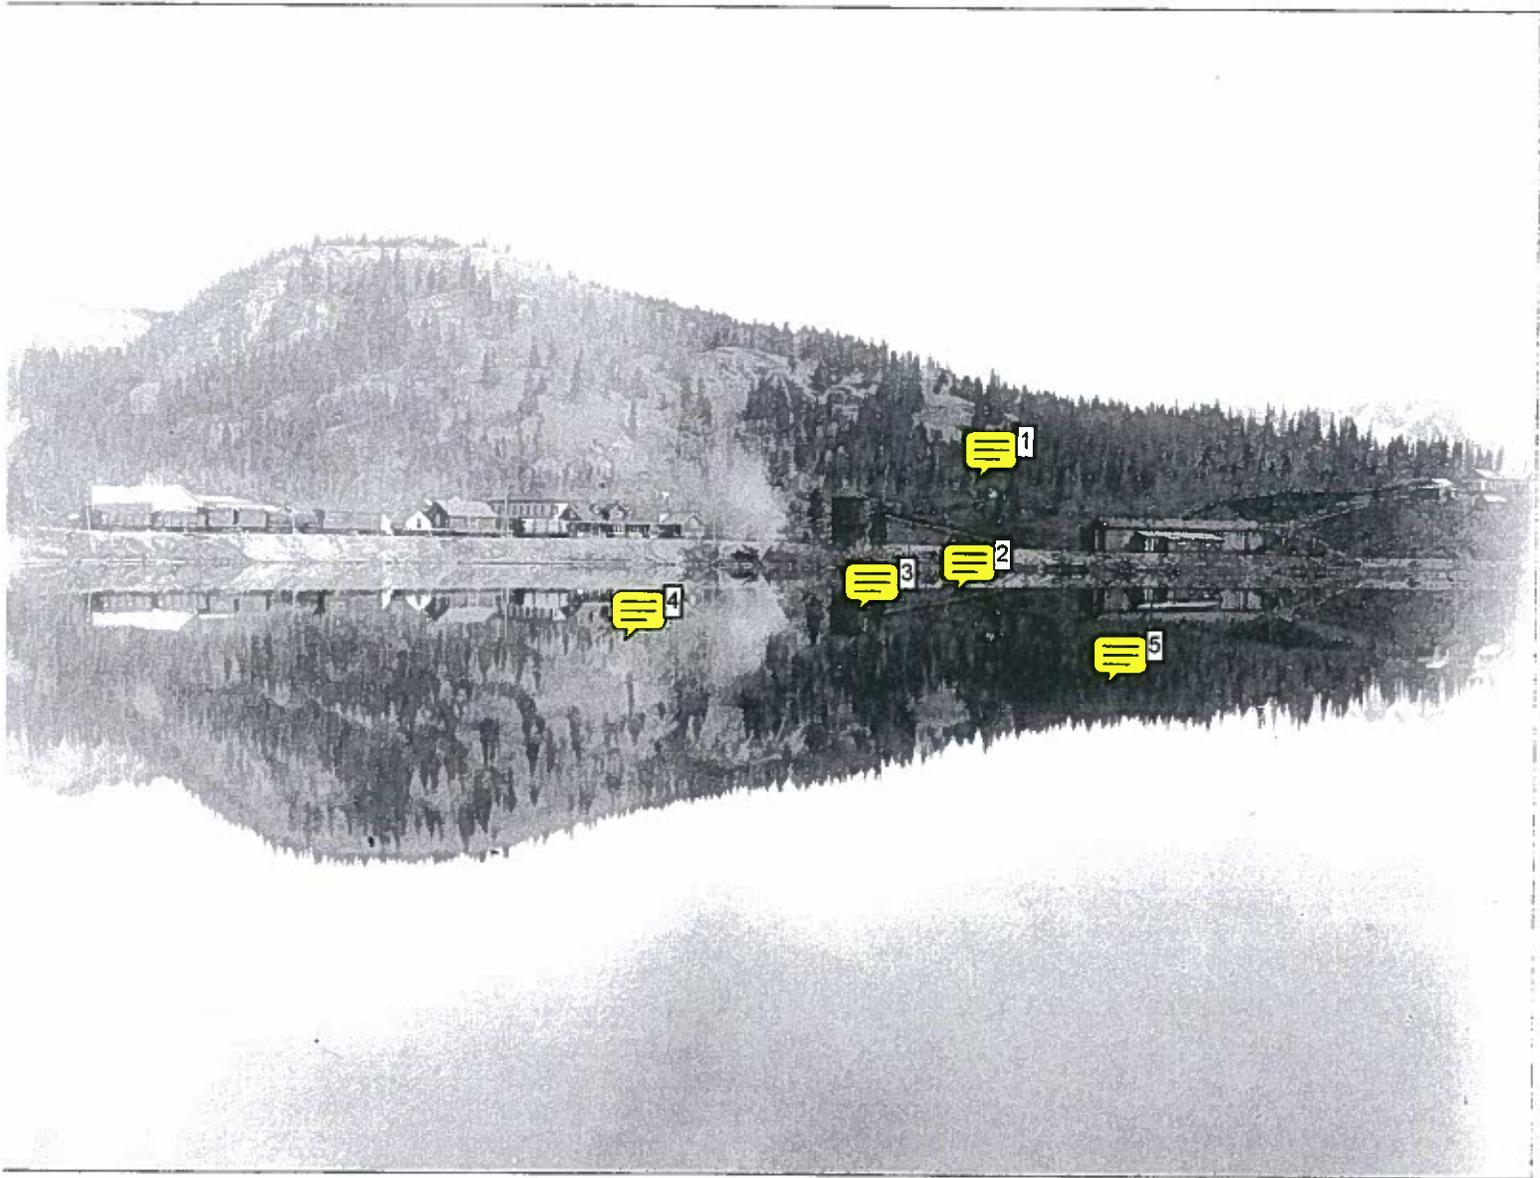
Trail is visible

Small Cabin is gone

Spruce Trees by Watertower

RR Station

Old Maintenance Building

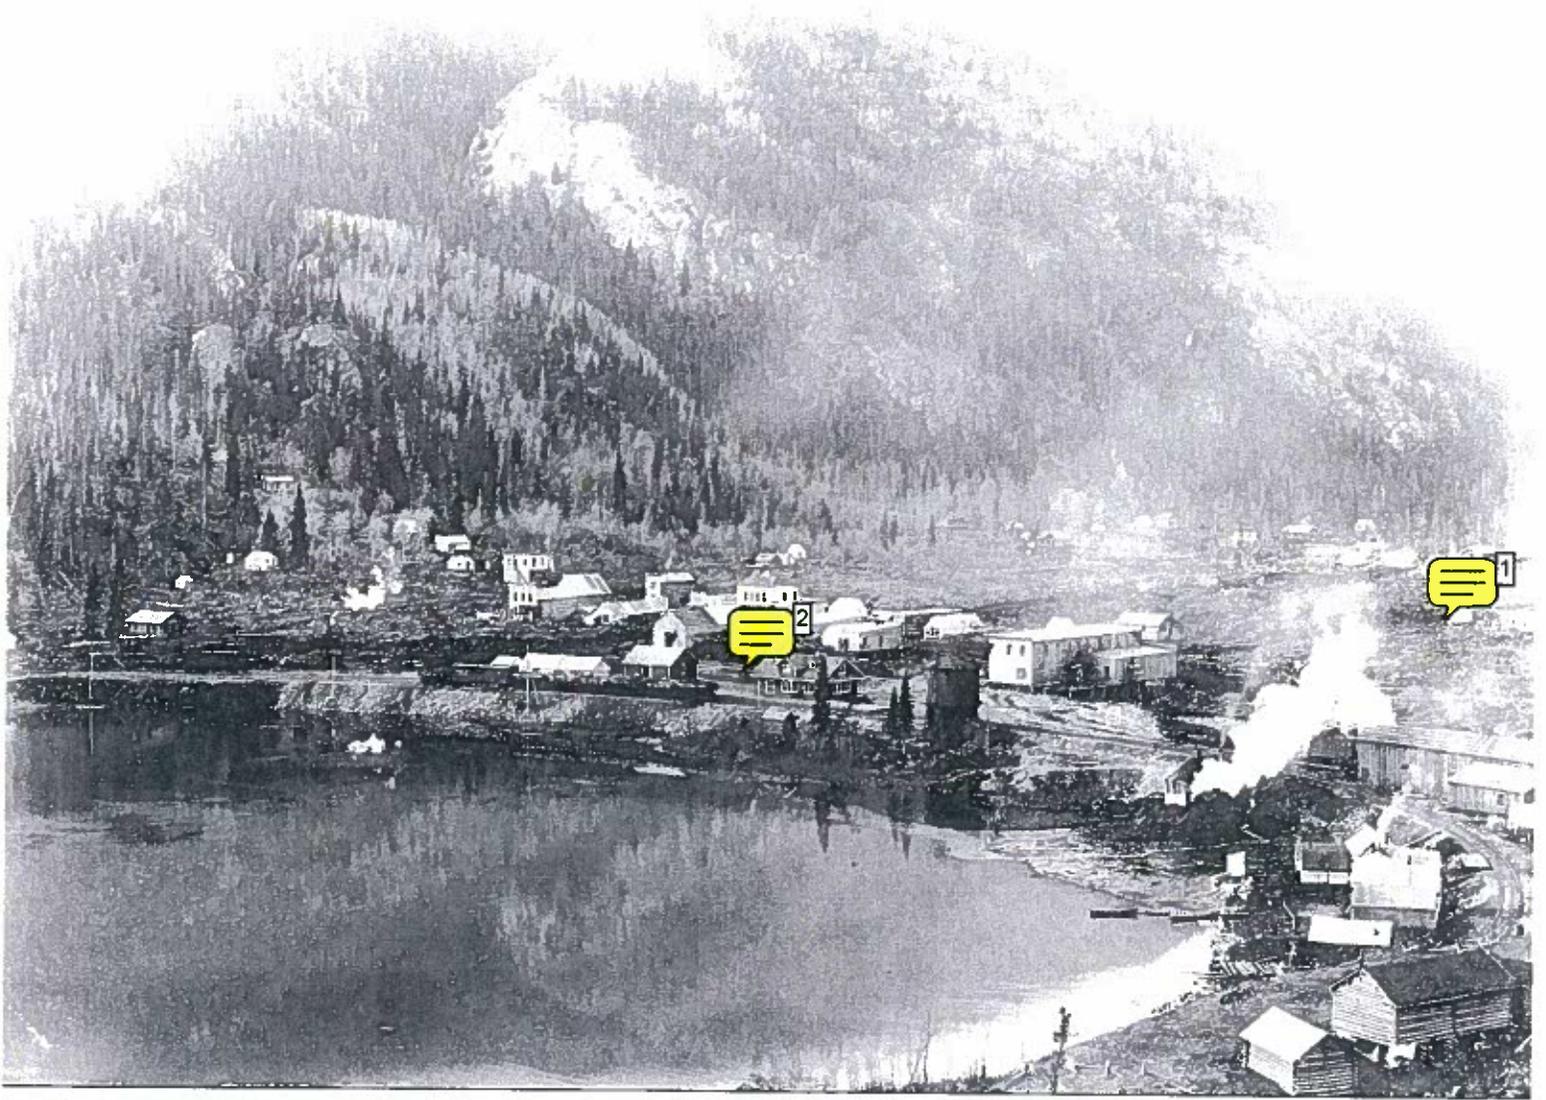
Road not visible

This bldg's roof is partially done, it was complete by 3/1/1912
