**Chitina Cemetery Road  
Proposal to Identify as a  
RS 2477 Right of Way**

State of Alaska  
Department of Natural Resources  
Division of Mining, Land and Water  
Public Access Defense Unit  
March 2010

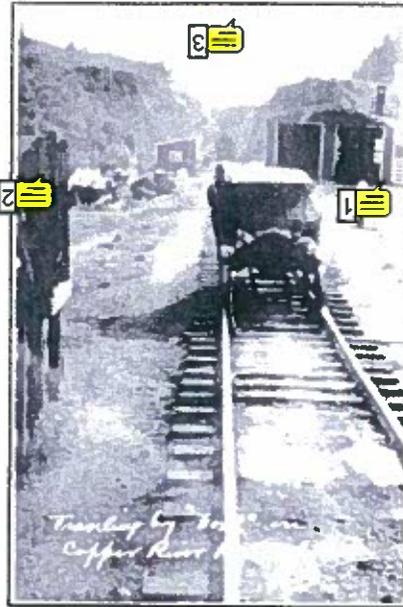
Figure 31. A CR&NW speeder, Chitina, after traveling through the tunnel (background), early 1910s. Photo courtesy of Cliff Collins, Cordova.

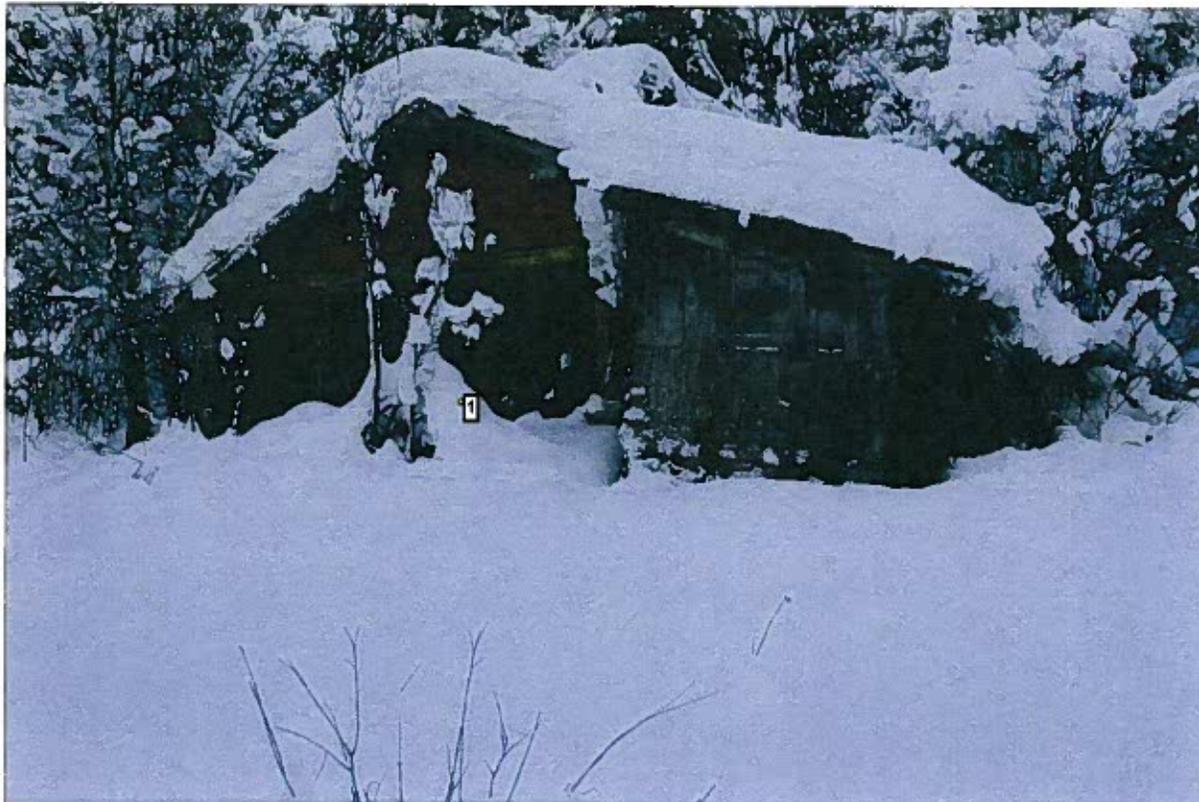
This small abandon house almost certainly dates to the early Chitna development. The house is approximately thirty feet from the road and would have used the road for access. This house is not apparent in other photos in index. This photo was taken January 22, 2010.

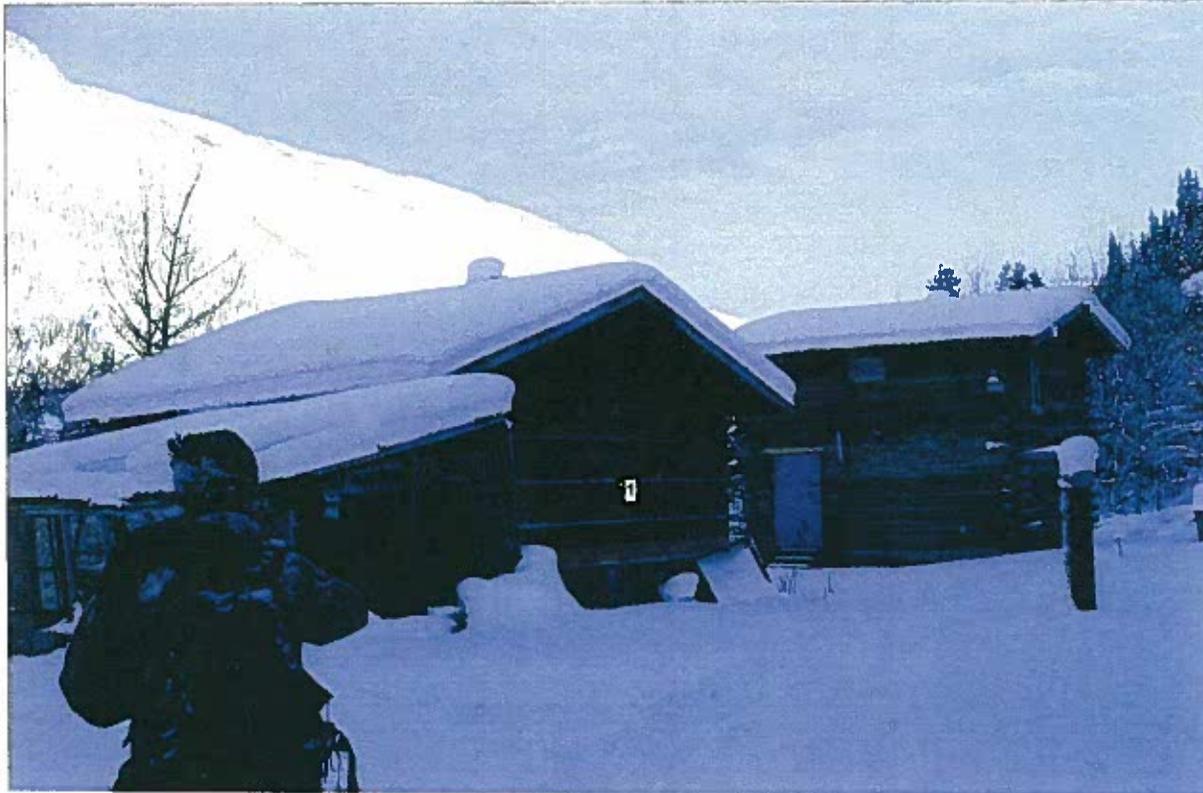
This is the homesite with multiple buildings at the bend in the road. This homesite is visible in earlier photos. The building in the foreground is probably newer and not in early photos.

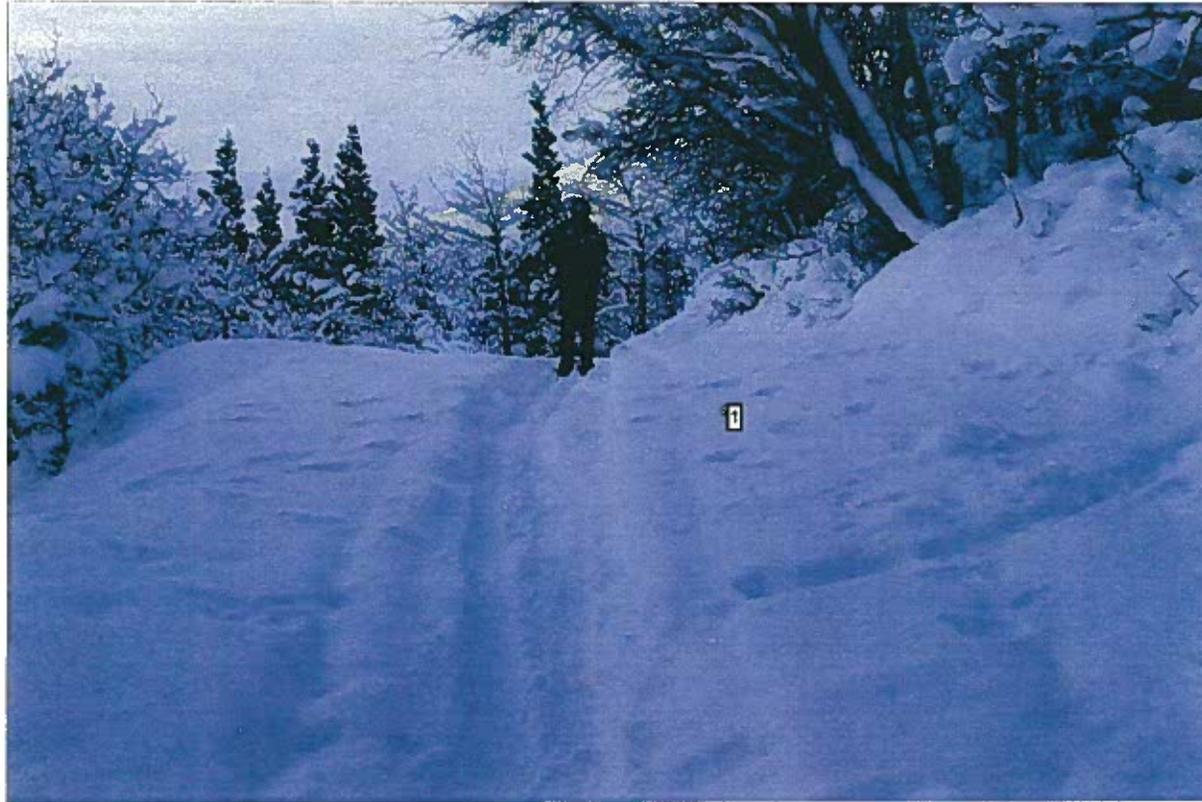
Road shows signs of mechanized blade construction. This photo taken January 22, 2010 in the upper portion not far from the cemetery.

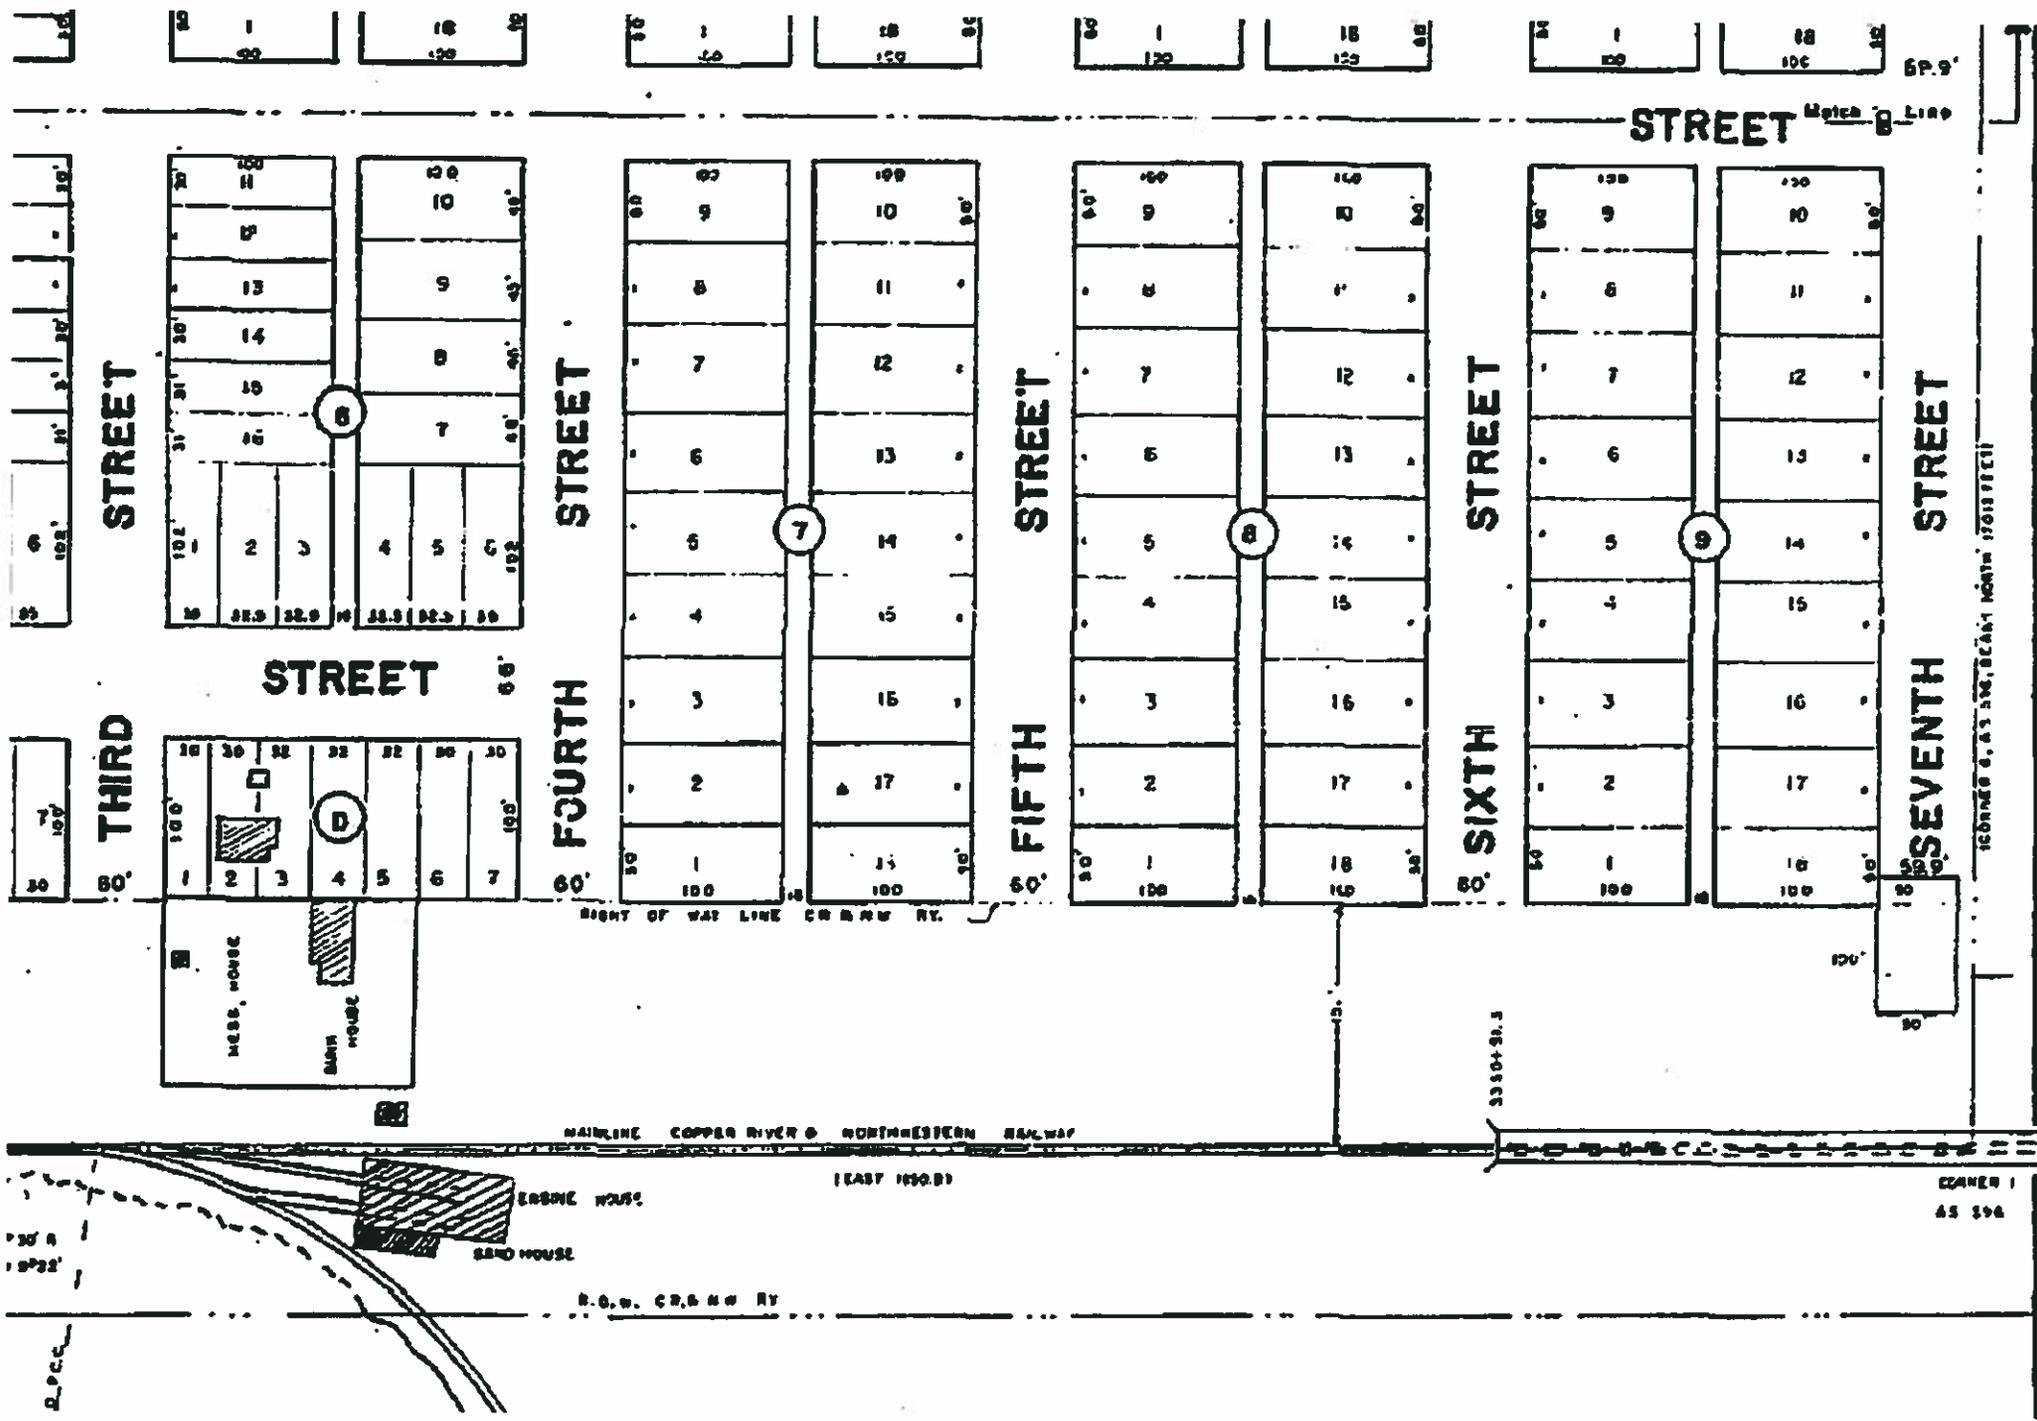
The Alaska Development & Mineral Company, a corporation organized under the laws of the State of New York, surveyed, laid out, and platted all of the lands within U. S. Nos. 264, 585, 702, and the southerly and easterly portions of U. S. No. 597, as the "Chitina Town Site" in 1919. Easements and right-of-ways within this area were dedicated to the public at that time.

Chitina Townsite Plat; The Alaska Development and Mineral Company, 1919, copy of trace from original 1923.
