SOLID WASTE PROGRAM

FIELD INSPECTION REPORT HECLA GREENS CREEK MINING COMPANY (HGCMC)

Inspection Date: April 29, 2010, Thursday
Report Date: May 6, 2010
Report Written By: Ed Emswiler, ADEC Solid Waste Program
Weather: 45 degrees F., 0.38 inches precip., wind 5.2 mph ESE, some light rain, mostly clear (reported at Juneau Airport)

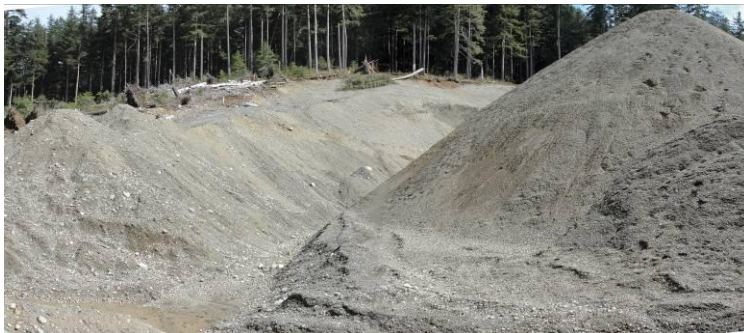
The Sand Pit on the A-Road was visited. There were no flows leaving the site. HGCMC mentioned they plan to expand the site from 5 to 15 acres to meet the demand for this material. The upper overburden layer from the expansion will be stored at Pit 7 for use at closure. A Forest Service Environmental Assessment has been completed for the 10 acre expansion. HGCMC reported some of the sand from the project would be tested using the newly developed Standard Operating Procedure for the Characterization of Construction Rock (SOP). The SOP was mainly developed for material to be used outside of containment. Most of the material from the sand pit will be used to provide the bedding and service layers for geosynthetic liner systems within containment.

Sand Pit on the A Road

4. A representative quantity of the material from the sand pit should be sampled according to the newly developed Standard Operating Procedure for the Characterization of Construction Rock.

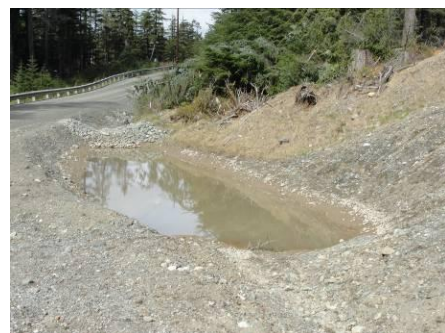
**Settling Pond and Check Dam
for Sediment Control**

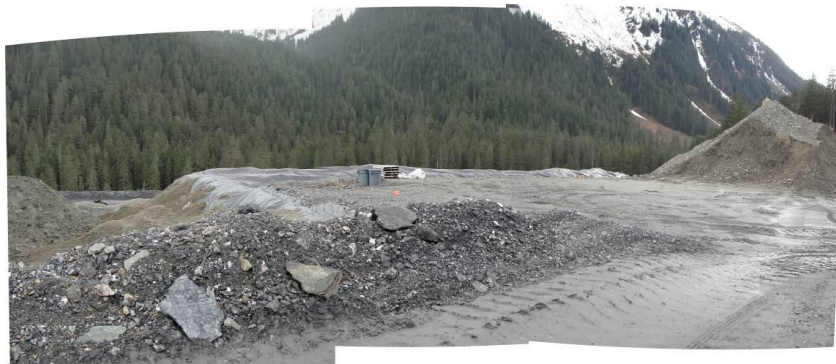
The upper surface of Site 23 was well compacted to decrease sediment run-off, graded and sloped to prevent excessive ponding and provide adequate drainage. The lined temporary storage pad within the facility contains production rock from the removal of the downgradient berms at

both B and D Ponds. This rock has varying metals leaching and acid producing properties. The plan is to co-dispose this rock into the tailings disposal facility this spring according to a plan submitted to ADEC on February 8, 2010, which was approved on March 1, 2010. This will make the pad available to receive production rock from Site 1350 this summer. Site 1350 is often unreachable during the late fall, winter, and early spring due to snow accumulation at that altitude. Staging this material at the temporary storage pad at Site 23 will allow winter co-disposal operations to occur, as co-disposal of production rock from Site E will take priority over the Site 23 temporary pad material during the summer months. Work to excavate and co-dispose other inactive production rock sites is planned and will be on-going throughout the life of the mine.

Site 23 Lined Temporary Production Rock Storage Site

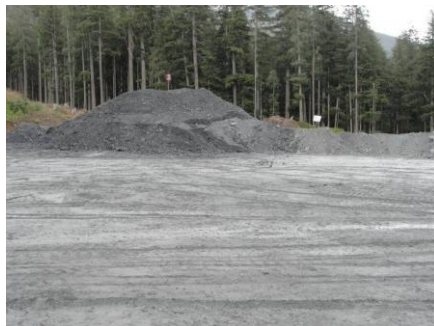
**Site 23 - Note: Upper Surface Compacted and Sloped to Drain
(no ponding present)**

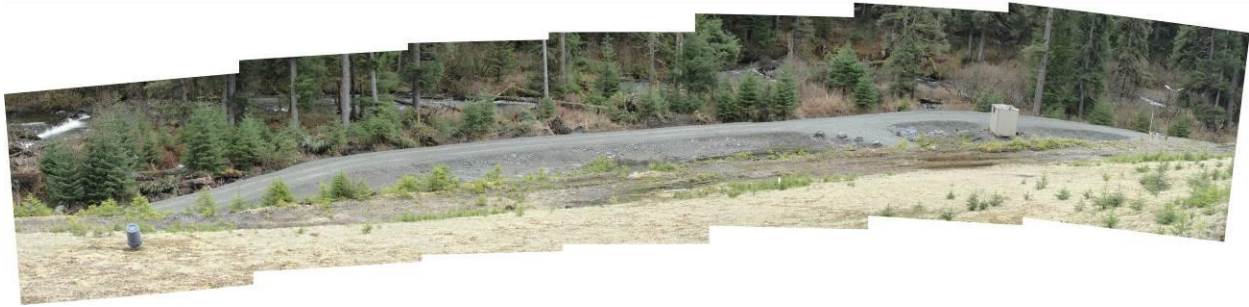
The outstanding feature at Site D was the newly constructed berm that replaced the previous one which contained pyritic material. The new berm was constructed using material from the Site 23 backslope. D Pond was empty of water at the time of this inspection. The newly installed pump at Pond D had not been tested under high flow conditions at the time of this inspection because of low flows. HGCMC has not yet provided an as-built showing the full build-out of this structure as per ADEC approval of this plan dated July 24, 2009. Both as-built site plan and cross-sections are action items to this report.

Site“D Pond and Berm Replacement

5. HGCMC must provide as-built plans and drawings showing the build-out of the Site D berm reconstruction structure as per ADEC approval of this plan dated July 24, 2009.

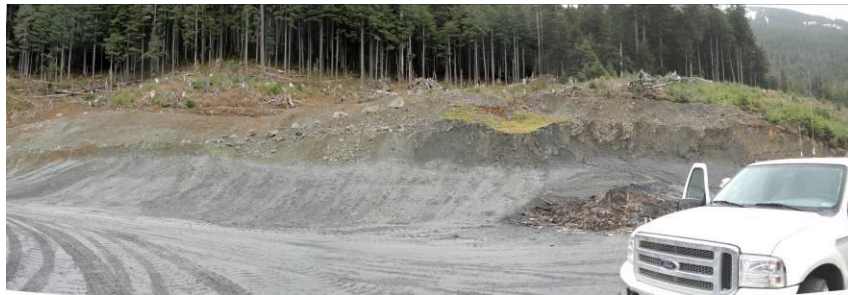
Site 23 Backslope

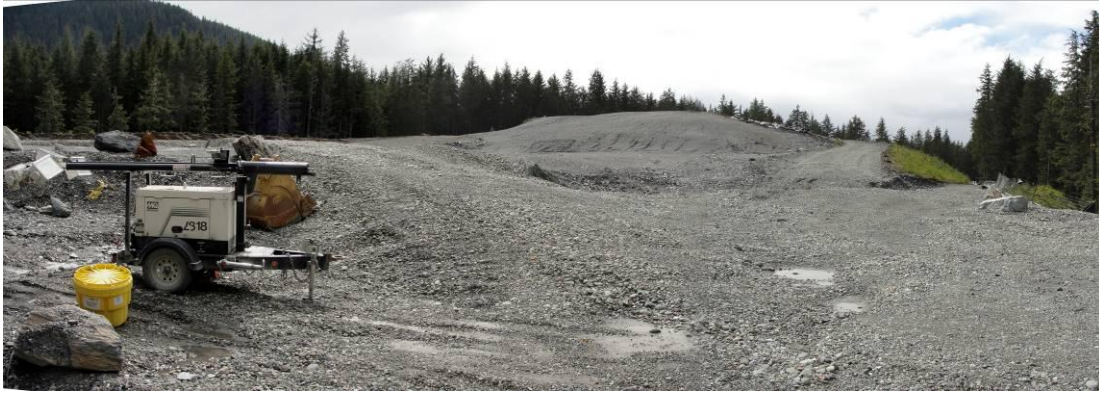
Site E Southwest Aspect at B-Road Entrance

The plan at Site E this year is to install a stormwater collection pond located at the northeast aspect of the footprint (see Section 7, Mapsheets, Sheet 2 of 3 of April 14, 2009 approved plan entitled “Site E Removal and Waste Rock/Tailings Co-Disposal Plan). This pond will collect stormwater from the entire site and transmit it to the B-Road pipeline. Construction of the lined collection pond is slated to begin within the next two weeks.

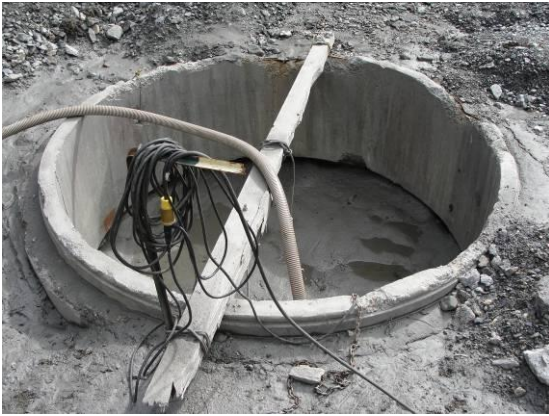
The sump at Site E was empty. However, the pump in this sump was installed and ready for use when needed. The HGCMC Environmental Manager showed how the system worked in providing a conduit for captured contact water to the B-Road pipeline that transmits water from the mill area to the treatment plant at the tailings disposal site. She also showed how water that over-topped the sump travels through a series of settling ponds and rock check dams to remove sediment prior to its discharge into the adjacent woods.

Sump at Site E

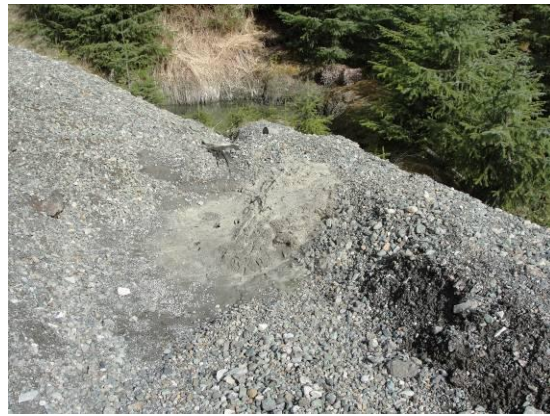
Settling Pond at Site E

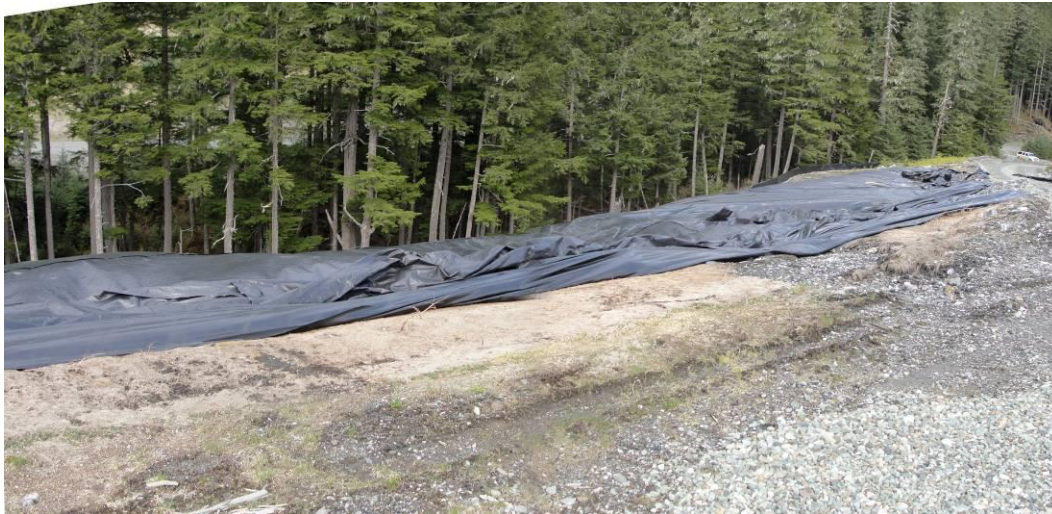
Several areas of the site continue to be covered by geosynthetic material even though ADEC approved its removal to prevent the build-up of salts while covered. The HGCMC Environmental Manager reported the cover would likely be removed as excavation is completed in that area.

Geosynthetic Cover at Site E

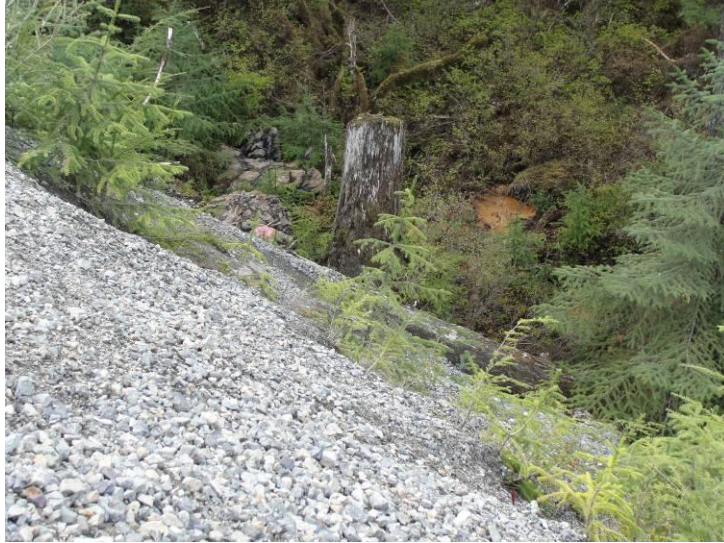
HGCMC identified a seep with orange-staining at the toe of a pull-out at 1.8 Mile on the B Road. This pull out was constructed from rock blasted from the road cut at Mile 2.5 on the B Road. The road cut was later found to have ARD and metals leaching potential and can be easily

visualized while driving up the B Road. The seep at Mile 1.8 is reported to have elevated levels of iron and manganese and somewhat lower zinc and copper concentrations. This material is also acid producing. The flow from this seep is low and the distance to the nearest tributary of Tributary Creek is approximately 200 feet. A low priority has been given to removing the material because of this.

Mile 1.8 Pullout – Note Seepage at Toe of Slope

6. The material from the lay-down area at Mile 1.8 B Road should be removed as soon as practicable and be replaced with clean fill material.
7. The Tailings Disposal Facility Stage 3 Proposed Expansion Project should be coordinated between HGCMC and the USDA Forest Service NEPA/EIS and ADEC.

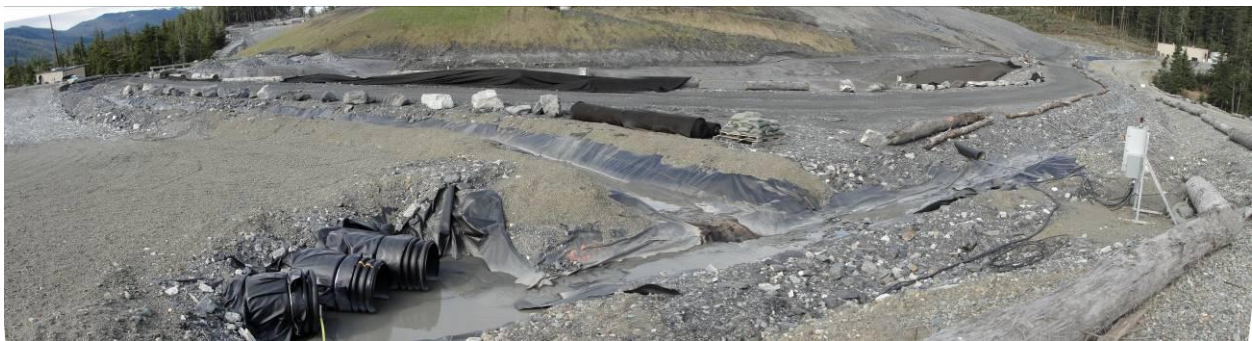
Stormwater collection ditches at the Tailings Disposal Facility were clear and able to transmit water freely from the southern end of the facility that included the truckwash area as well as the western aspects. This stormwater is transmitted to a new degritting basin near the water treatment plant where sediment is dropped out before entering Pond 7. This allows Pond 7 to remain as sediment free as possible to minimize the need to dredge the bottom of the pond.

Southwest Tailings Facility Near Water Treatment Plant Showing Stormwater Collection and Controls

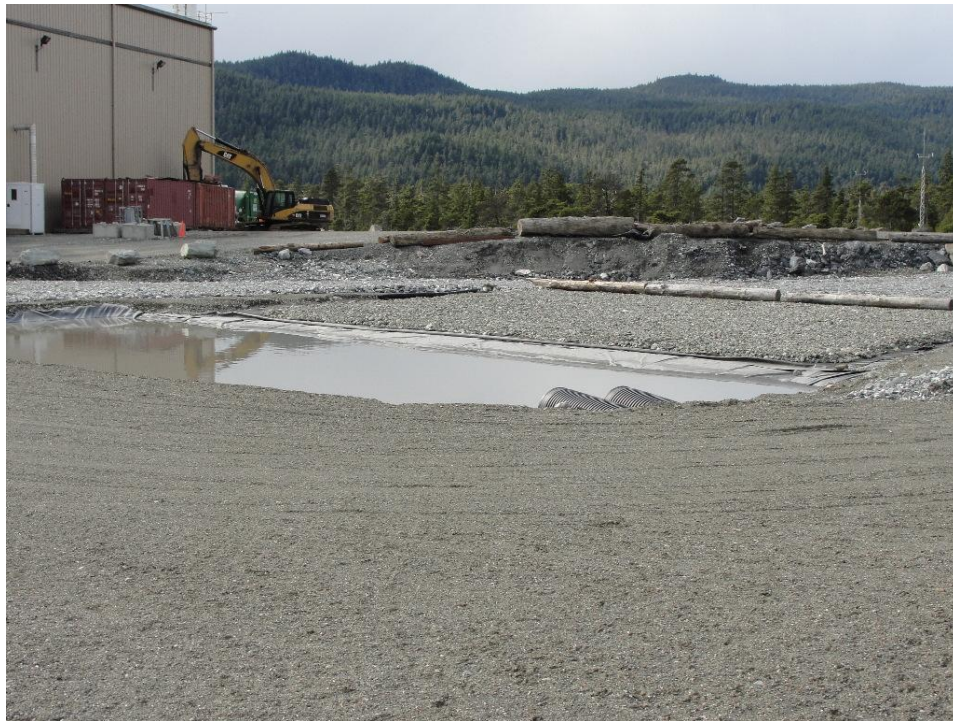
Tailings Disposal Site – Degritting Basin Near Water Treatment Plant

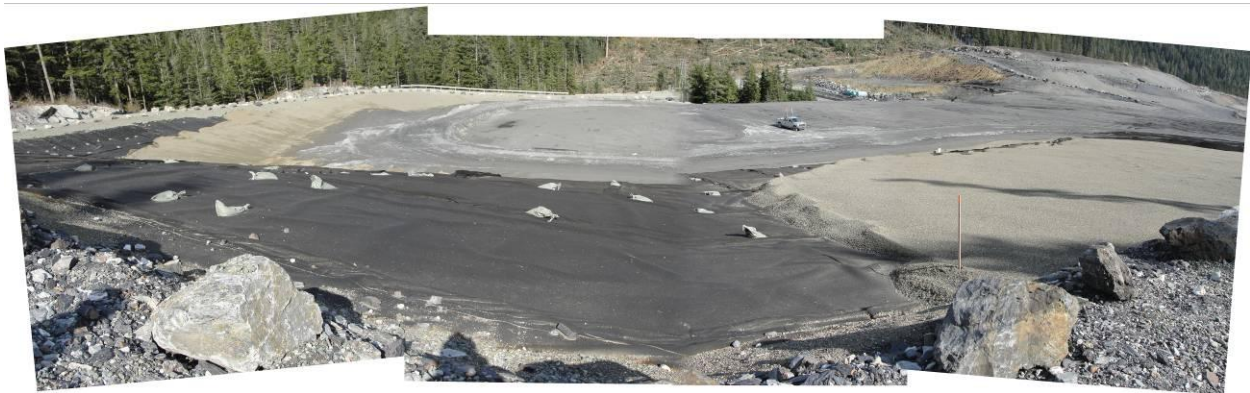
Co-disposal practices at the TDF were not observed. Tailings were actively being disposed into the northwest Pit 5 area of the facility and there were areas where the sand and geotextile layers were exposed. These areas would need a sufficient amount tailings placement (approximately 5-feet) and proper distance away from the outside edges of the facility before co-disposal of waste rock can take place. Some off-site rock was observed in the road construction within containment. This was reported to come from the Hoonah area.

Tailings Disposal in the Northwest Pit 5 Area – Note: Sand Layer and Geotextile

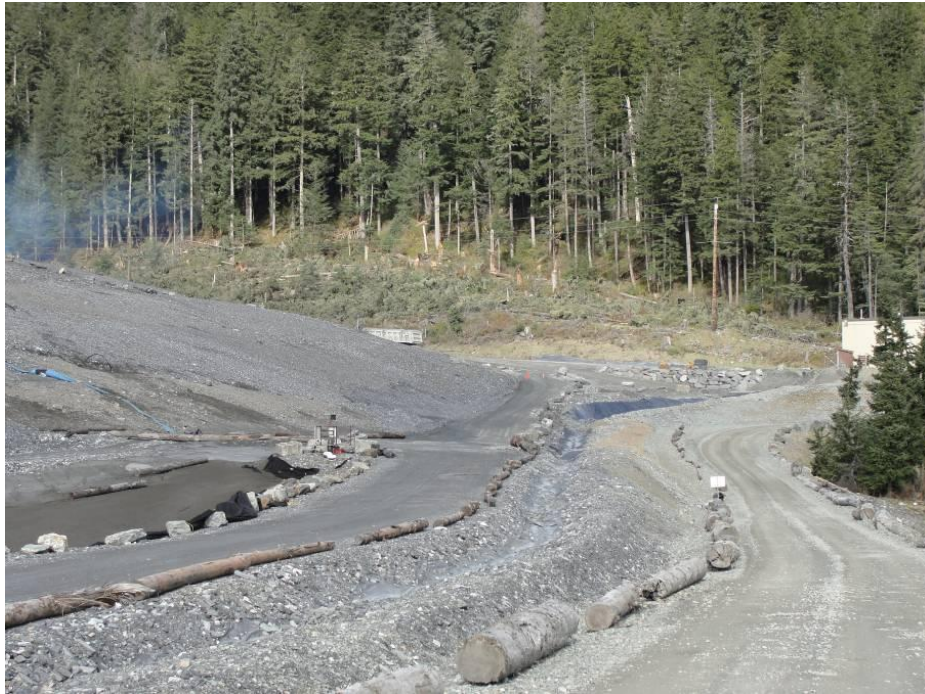
Trees have been cut down in the permitted East Ridge area of the landfill in preparation for hydrologic and geotechnical studies that will form the basis of a design. A geosynthetic liner used in this area of the landfill has not been confirmed although it is assumed one will be needed. Approval to construct will be given by ADEC after sufficient operation and design information is available. The construction of the East Ridge area is projected to take place during the 2011 or 2012 construction season.

**East Ridge Expansion at Tailings (Background)
Stormwater Controls at South Tailings (Foreground)**

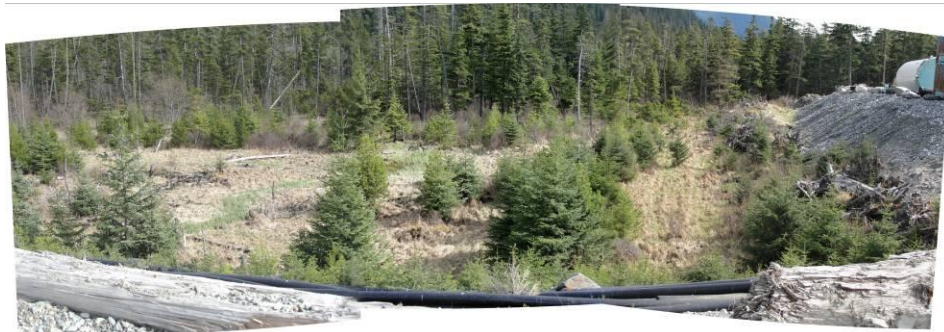
HGCMC is proposing a large expansion project to the south of the tailings disposal site in the Tributary Creek Drainage (see attachment at the end of this report). The “Stage 3 Tailings Expansion Project” will nearly double the size of the existing footprint. The expansion was not approved as part of the current Waste Management Permit and will likely involve a permit modification in concert with an Environmental Impact Statement (EIS) under the National Environmental Protection Act (NEPA) as coordinated by the USDA Forest Service.

**South of Tailings Facility in Tributary Creek Drainage
Site of Proposed Future Tailings Expansion Project**
