GREENS CREEK

# 2009 Annual Report

Site 23/D

June 8, 2010

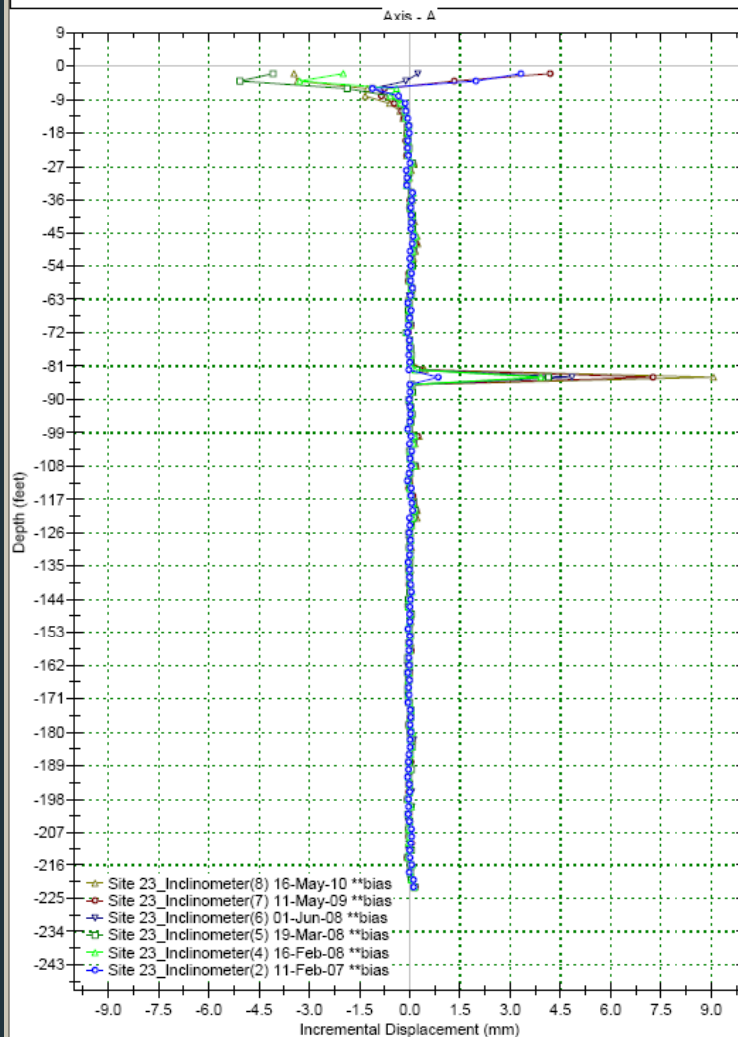
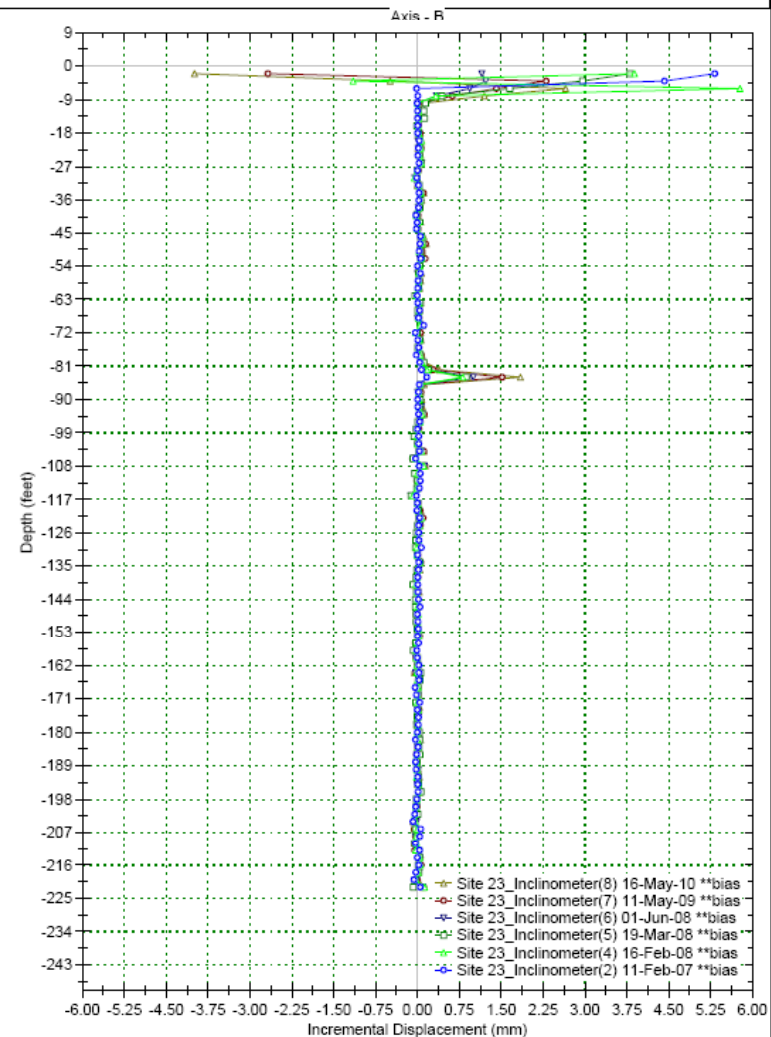
# Figure 3.30 Inclinerometer Incremental Displacement

INCREMENTAL DISPLACEMENT

Borehole : Inclinerometer  
Project : Site 23  
Location :  
Northing :  
Easting :

Spiral Correction : N/A  
Collar Elevation :  
Borehole Total Depth : 222.0 feet  
North Groove Azimuth :  
Base Reading : 2006 Oct 07 10:28

- Compaction
  - Method specification includes spreading in less than 24" lifts with at least one pass with bulldozer and four passes with vibratory compactor
- Inspections
  - Results of operator, engineering, environmental and regulatory inspections revealed no visible signs of instability
  - No issues of non-compliance were noted in 12 USFS and 5 ADEC/ADNR inspections
- Slope monitoring
  - 12 survey hubs monitored with GPS
    - No large movements were identified
  - Inclinator readings
    - Minor creep at 85' (~3mm/yr)

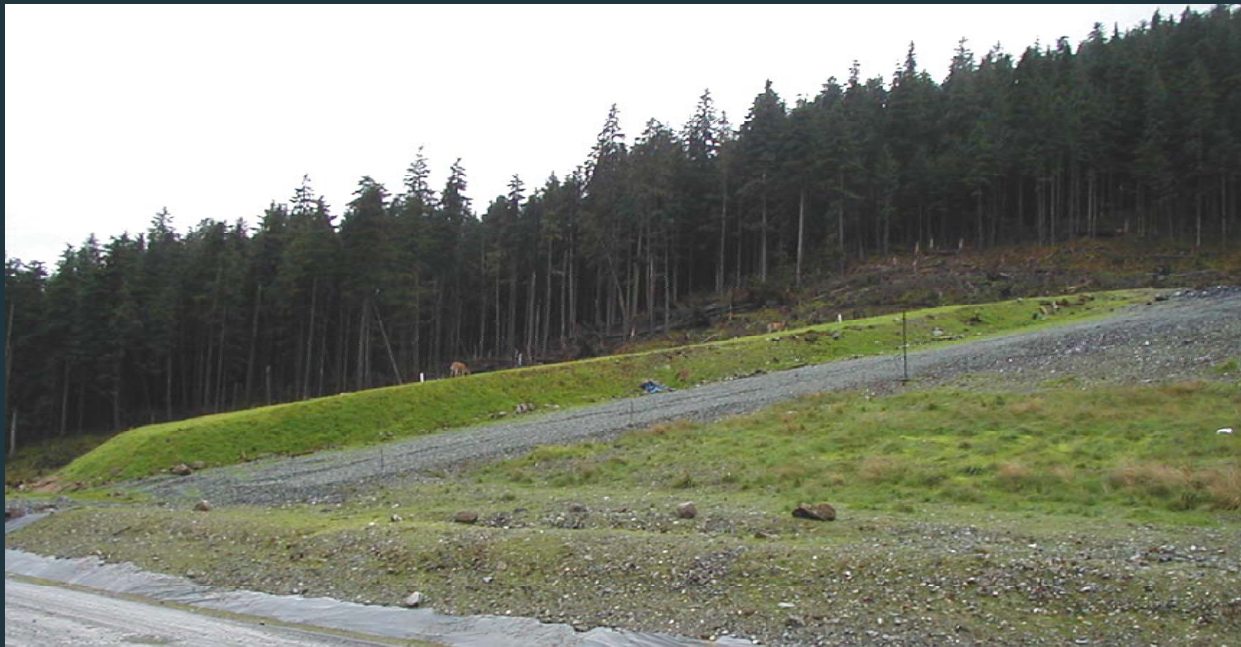
# Cover Design

Growth Medium

Capillary Break

Barrier Layer

2 meters

- Greater than 85% water saturation in barrier layer minimizes oxygen ingress
- Water percolation through barrier layer 15-20% of annual precipitation
- Barrier layer does not freeze during the winter
- About 85% of the water collected in the chalet trench system reported via the upper capillary break, 15% from growth medium.
- The lag time between peak precipitation and peak trench flow is about 6 hours for dry conditions and 2 hours for wet conditions
- Modeling with Hydrus-2D/3D software compares favorably with field results
- Numerical modeling of alternative cover designs indicates that the upper capillary break is necessary to maximize lateral flow and prevent buildup of head pressures in the growth medium and barrier layer
- OSU vegetation assessment expected 2010
