GREENS CREEK

2009 Annual Tailings Report

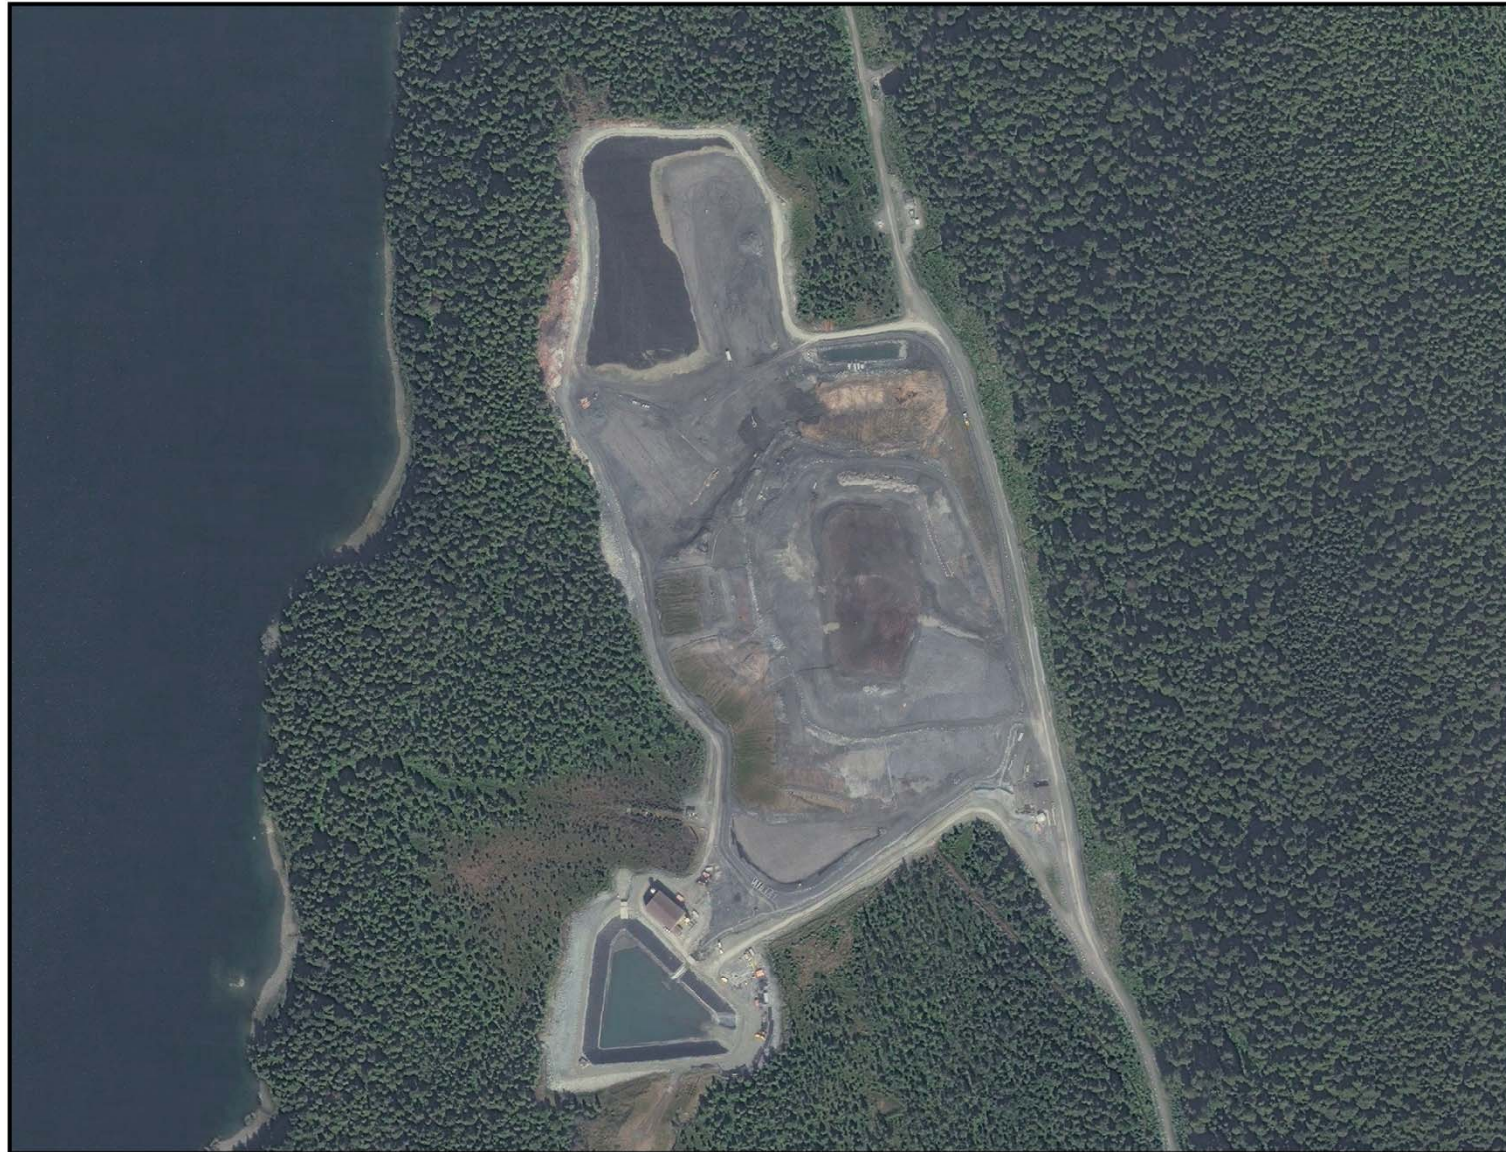
2009 Satellite Photo

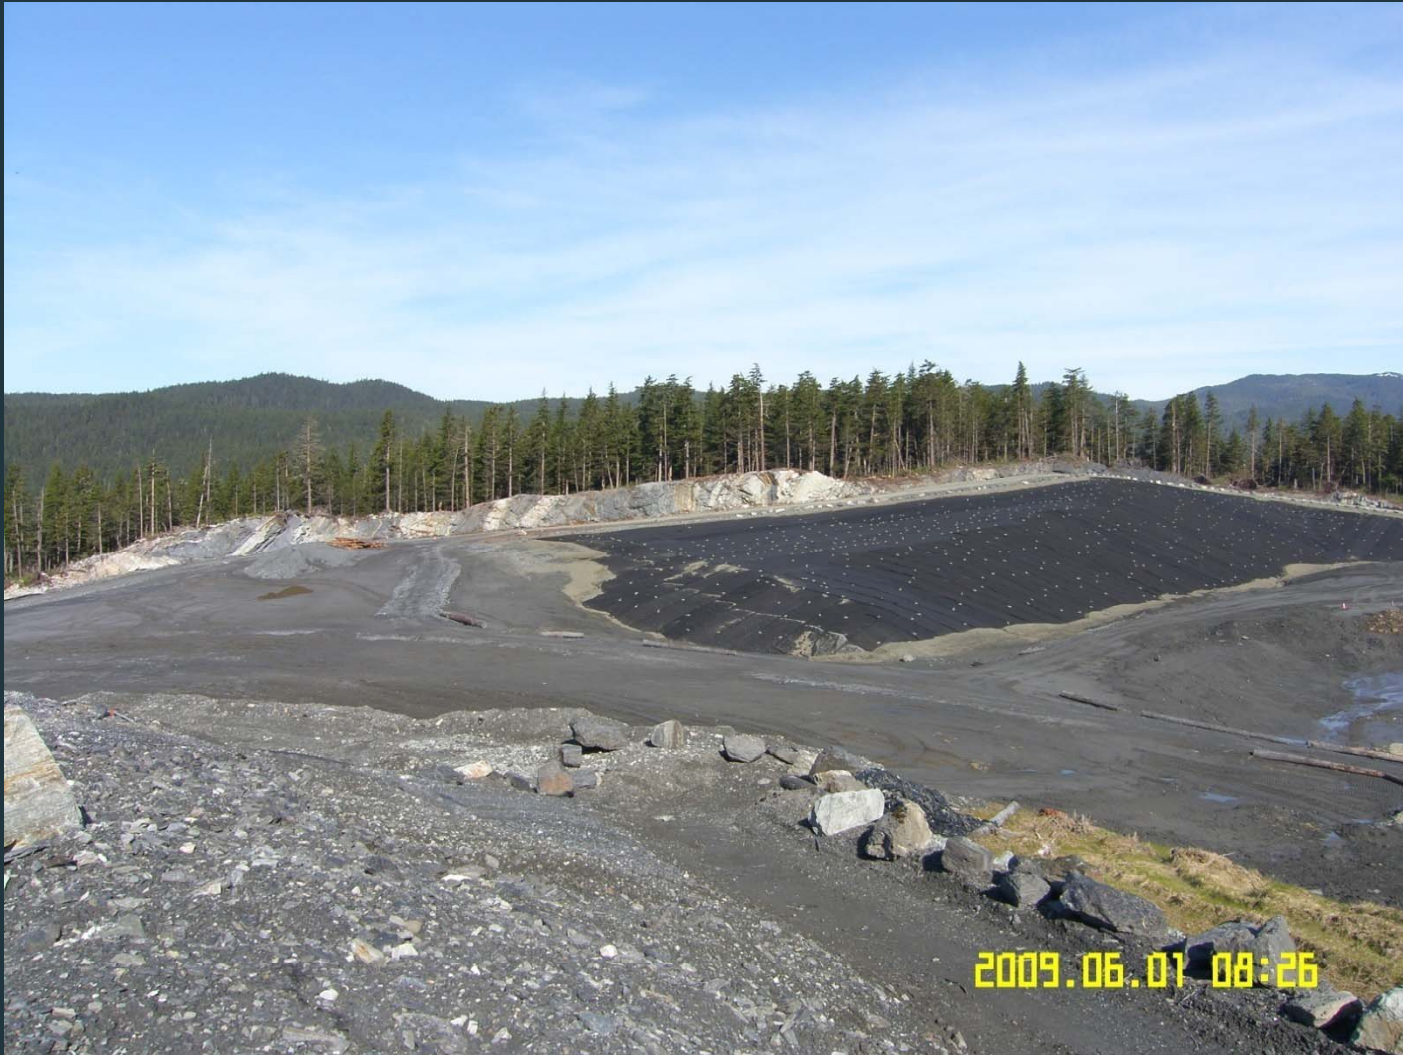
2009 Pit 5 Looking Northwest

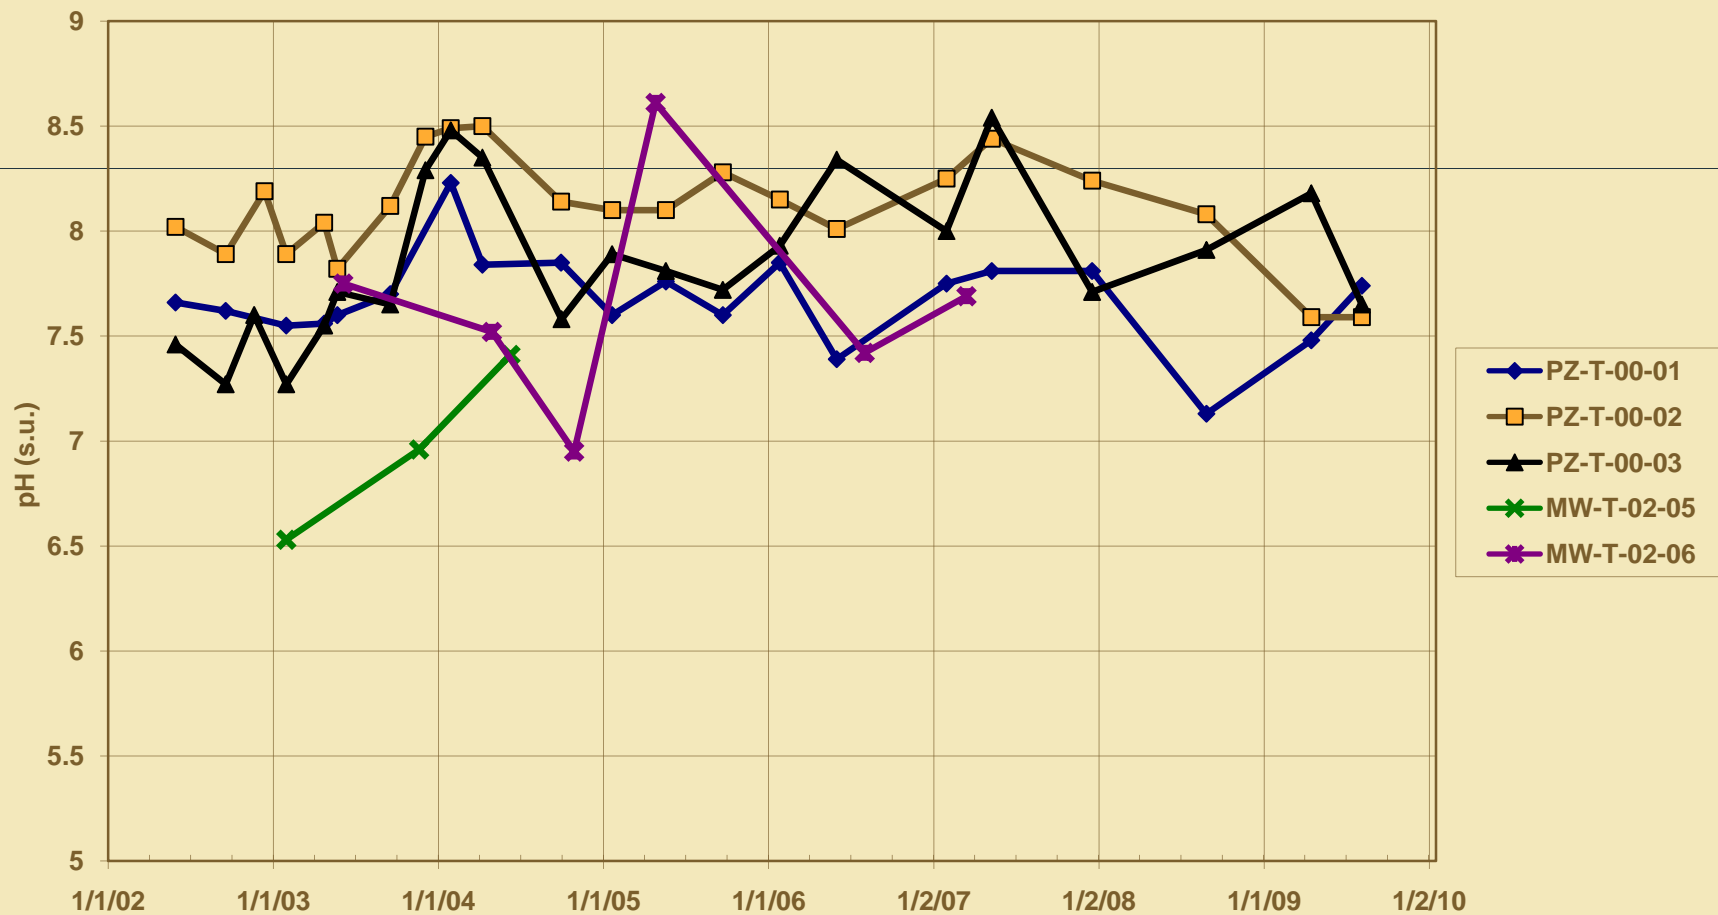
Tailings Area Internal Sites pH Figure 2.20b

FIGURE 2.20b GREENS CREEK TAILINGS INTERNAL MONITORING SITES:
TAILINGS COMPLETIONS - pH DATA

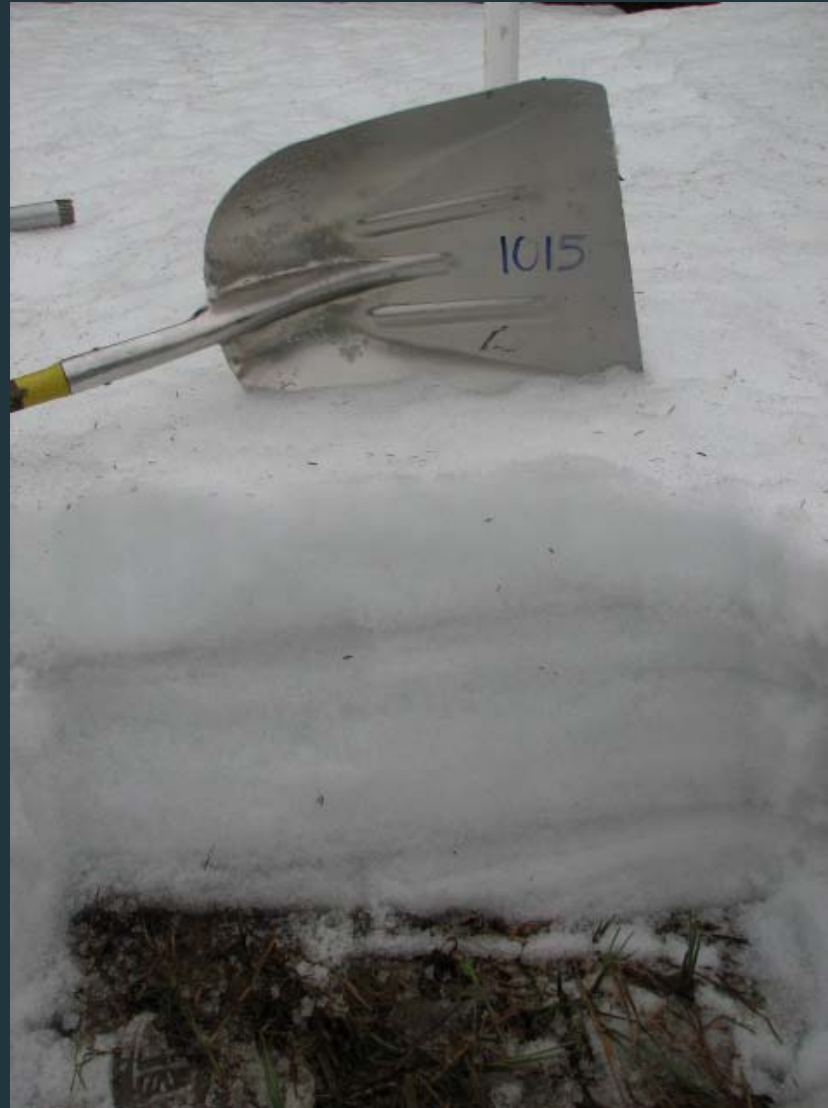
Tails Snow Dust Sampling

- Mitigation
 - Snow Fences
 - Eco Blocks
 - Snow removal only in active placement area
- Lead levels in water do not directly correlate to lead loading values
- Observable up to approximately 1700 feet away
- Significant decrease in lead load over the past three years
