**INACTIVE PRODUCTION ROCK SITES AND QUARRIES
2013 ANNUAL REPORT**

Hecla Greens Creek Mining Company

April 15, 2014

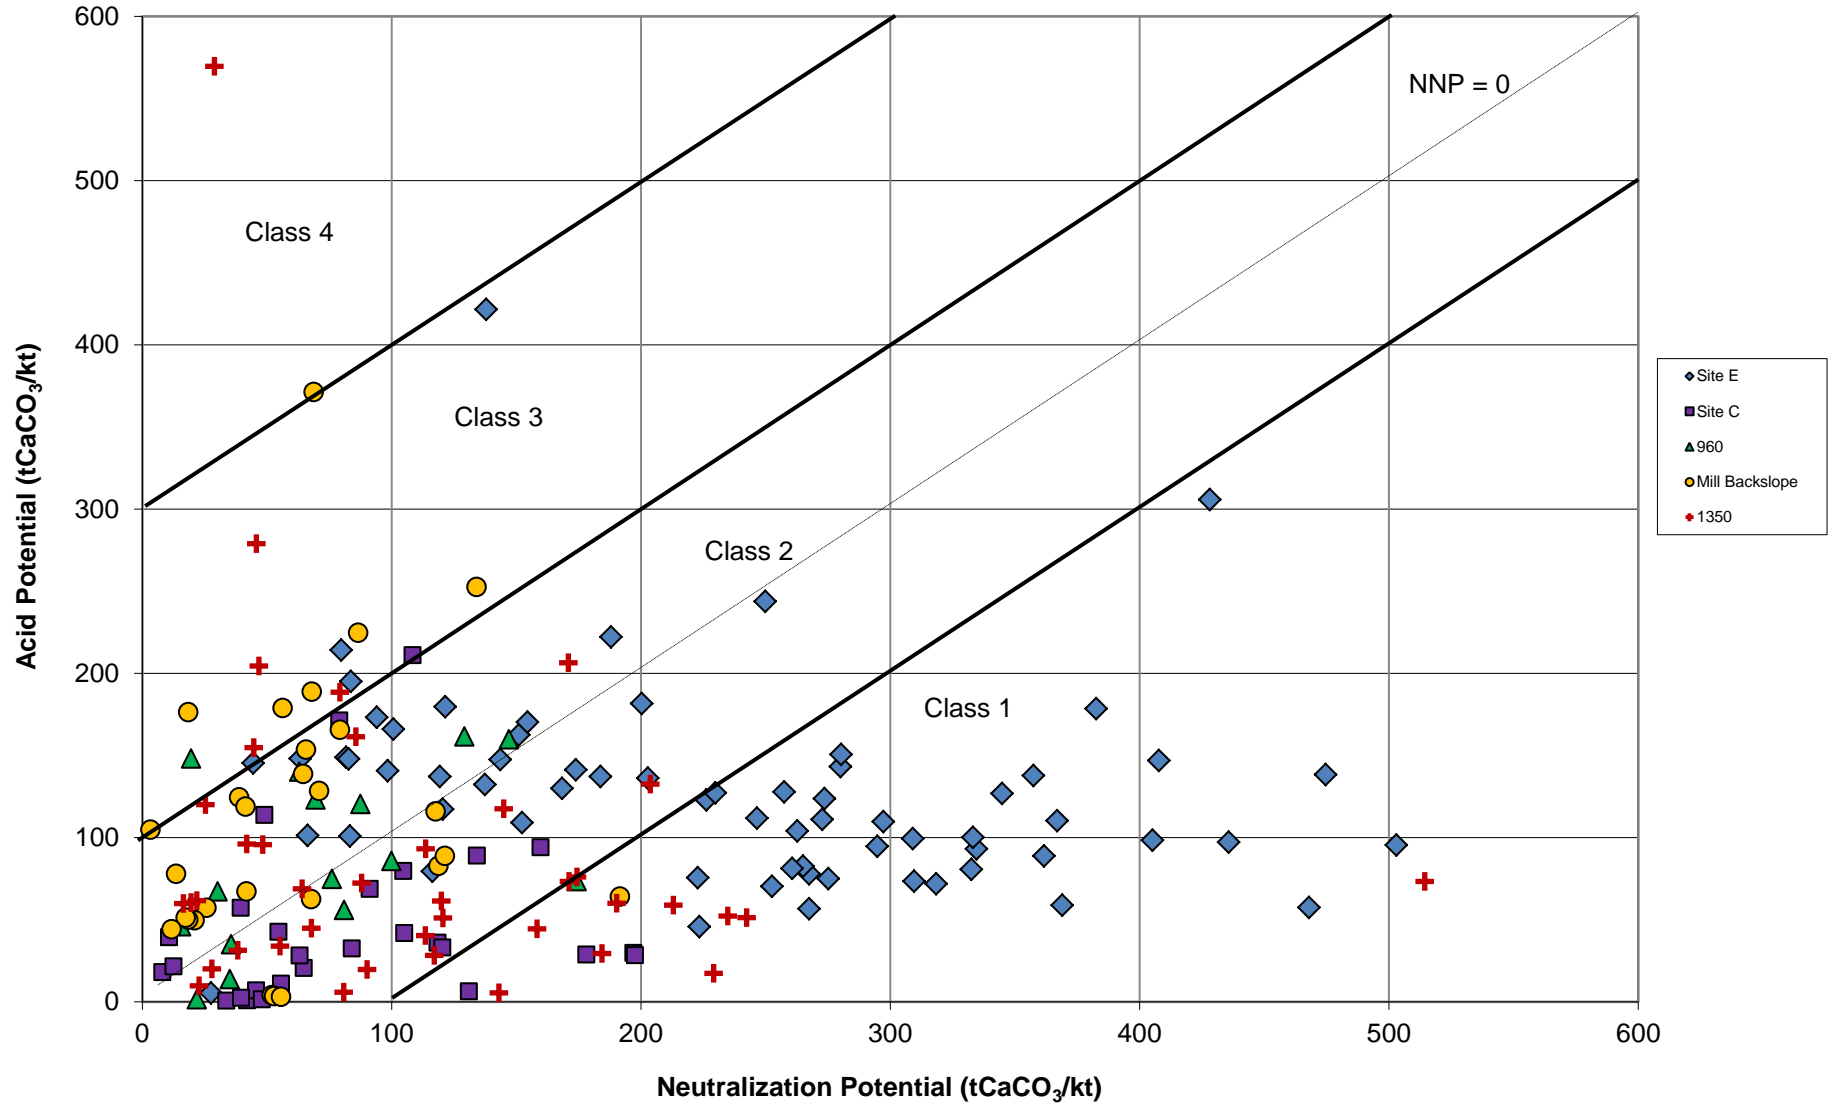
FIGURE 2.3 2002-2013 INACTIVE SITE ABA DATA

Figure 2.3 compares acid potential (AP) with neutralization potential (NP) for samples collected from the surface of the inactive sites. The sites were constructed prior to development of the classification protocol that HGCMC currently uses for segregation of production rock. Symbols in Figure 2.3 represent actual laboratory data points. Lines indicating the currently utilized production rock classes are shown on Figure 2.3 for reference only. Figure 2.3 shows the distribution of potentially acid generating (upper left half of figure) and potentially acid neutralizing (lower right half of figure) samples. Many samples from Site E have more neutralization potential than those from other sites, reflecting a greater proportion of argillite in the material. Samples from the Mill Backslope and the 1350 Site generally have a higher acid generation potential than those from the other sites. Reclamation activities at the 960, 1350 and Site E have removed significant quantities of potentially acid generating material from these sites.

A total of 28 ABA samples have been collected from the Mill Backslope rock cover and access road since 2002, including three samples collected in 2013. The results from this sampling (Figures 2.3 and 2.4) indicates that the majority of the rock is acid generating and has elevated sulfide content and low carbonate content. The low carbonate content is likely a combination of deficient initial composition and depletion of carbonate from the fines fraction through weathering.

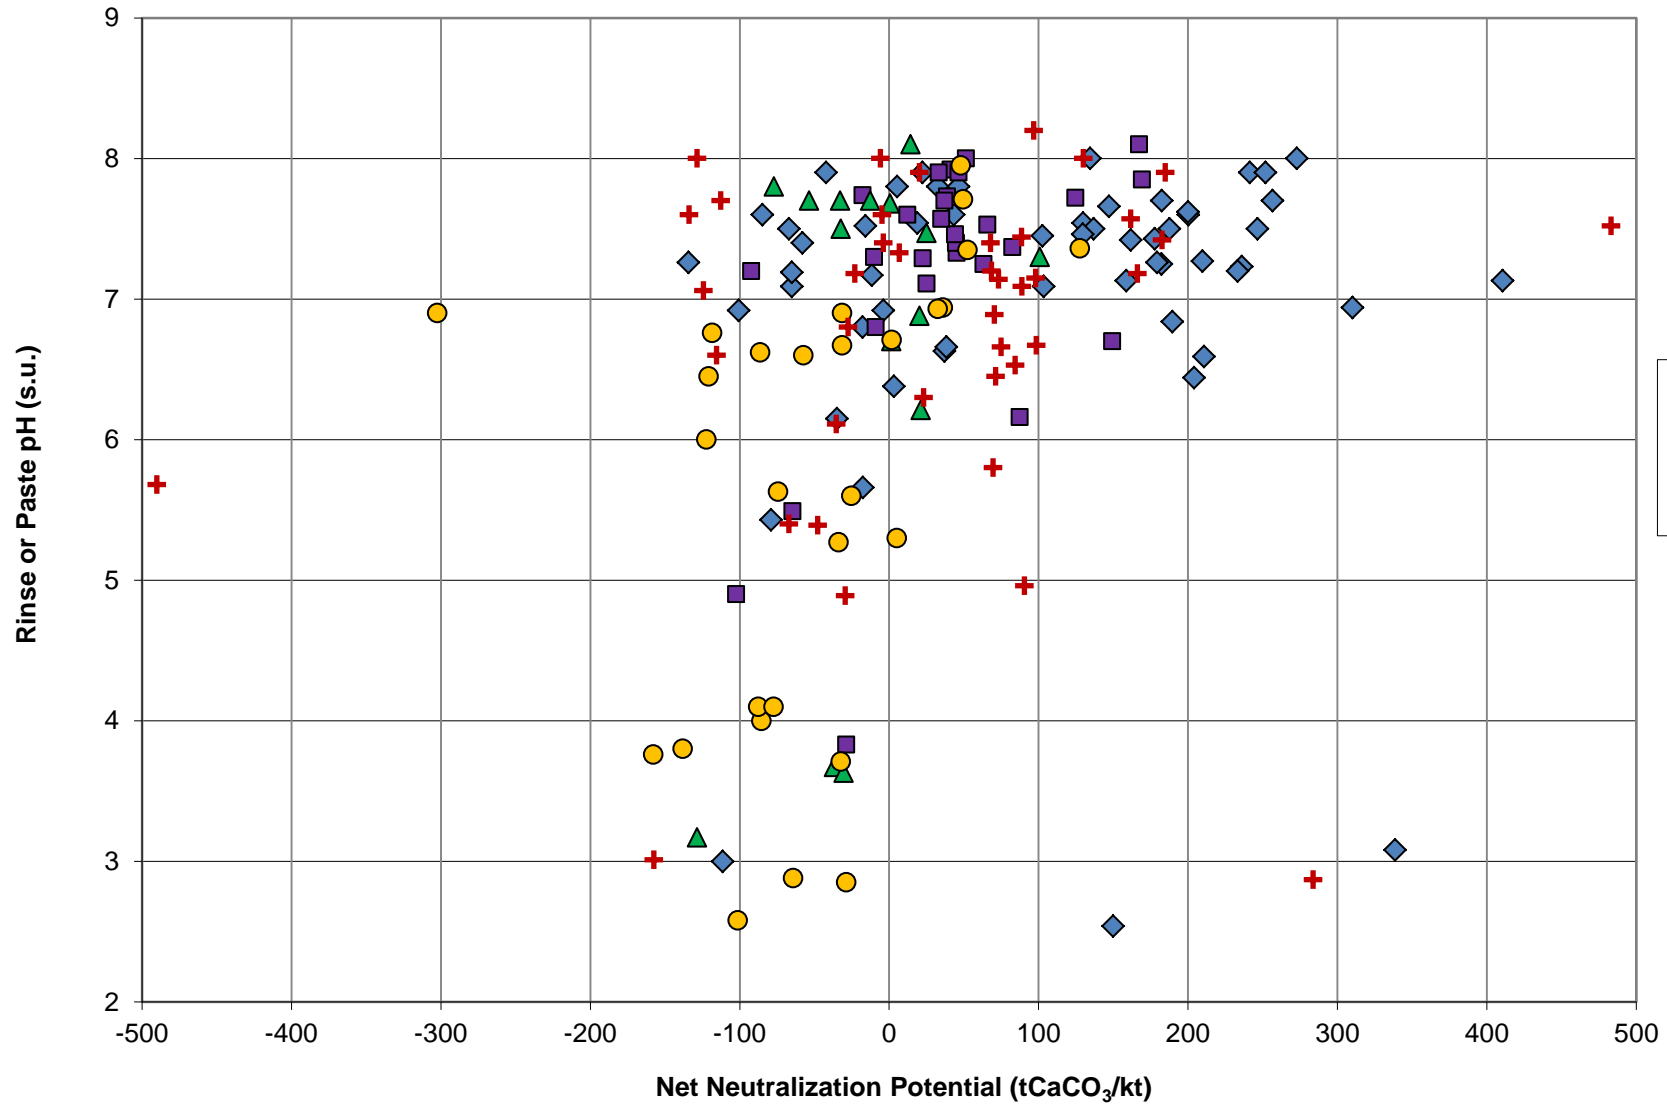
FIGURE 2.4 2002-2013 INACTIVE SITE ABA DATA (NNP vs pH)

Figure 2.4 shows the results of rinse pH relative to net neutralization potential (NNP) for the five inactive sites. Most samples produced a rinse pH greater than 6.0; however, each site has produced at least two samples with rinse pH values less than 5.0. This is consistent with the distribution of NNP values and the duration of waste rock exposure. ABA sampling occurs at the surface of the piles where oxidation rates are greatest. Drainage from the inactive sites remains near neutral because the bulk of the material in the piles contains sufficient carbonate to neutralize the acidity formed by pyrite oxidation near the pile surface. There are a few cases where samples produced a low rinse pH and high NNP. This is likely a result of accumulated acidic oxidation products in the fines fraction of the sample and remaining carbonate minerals in the coarse fraction.

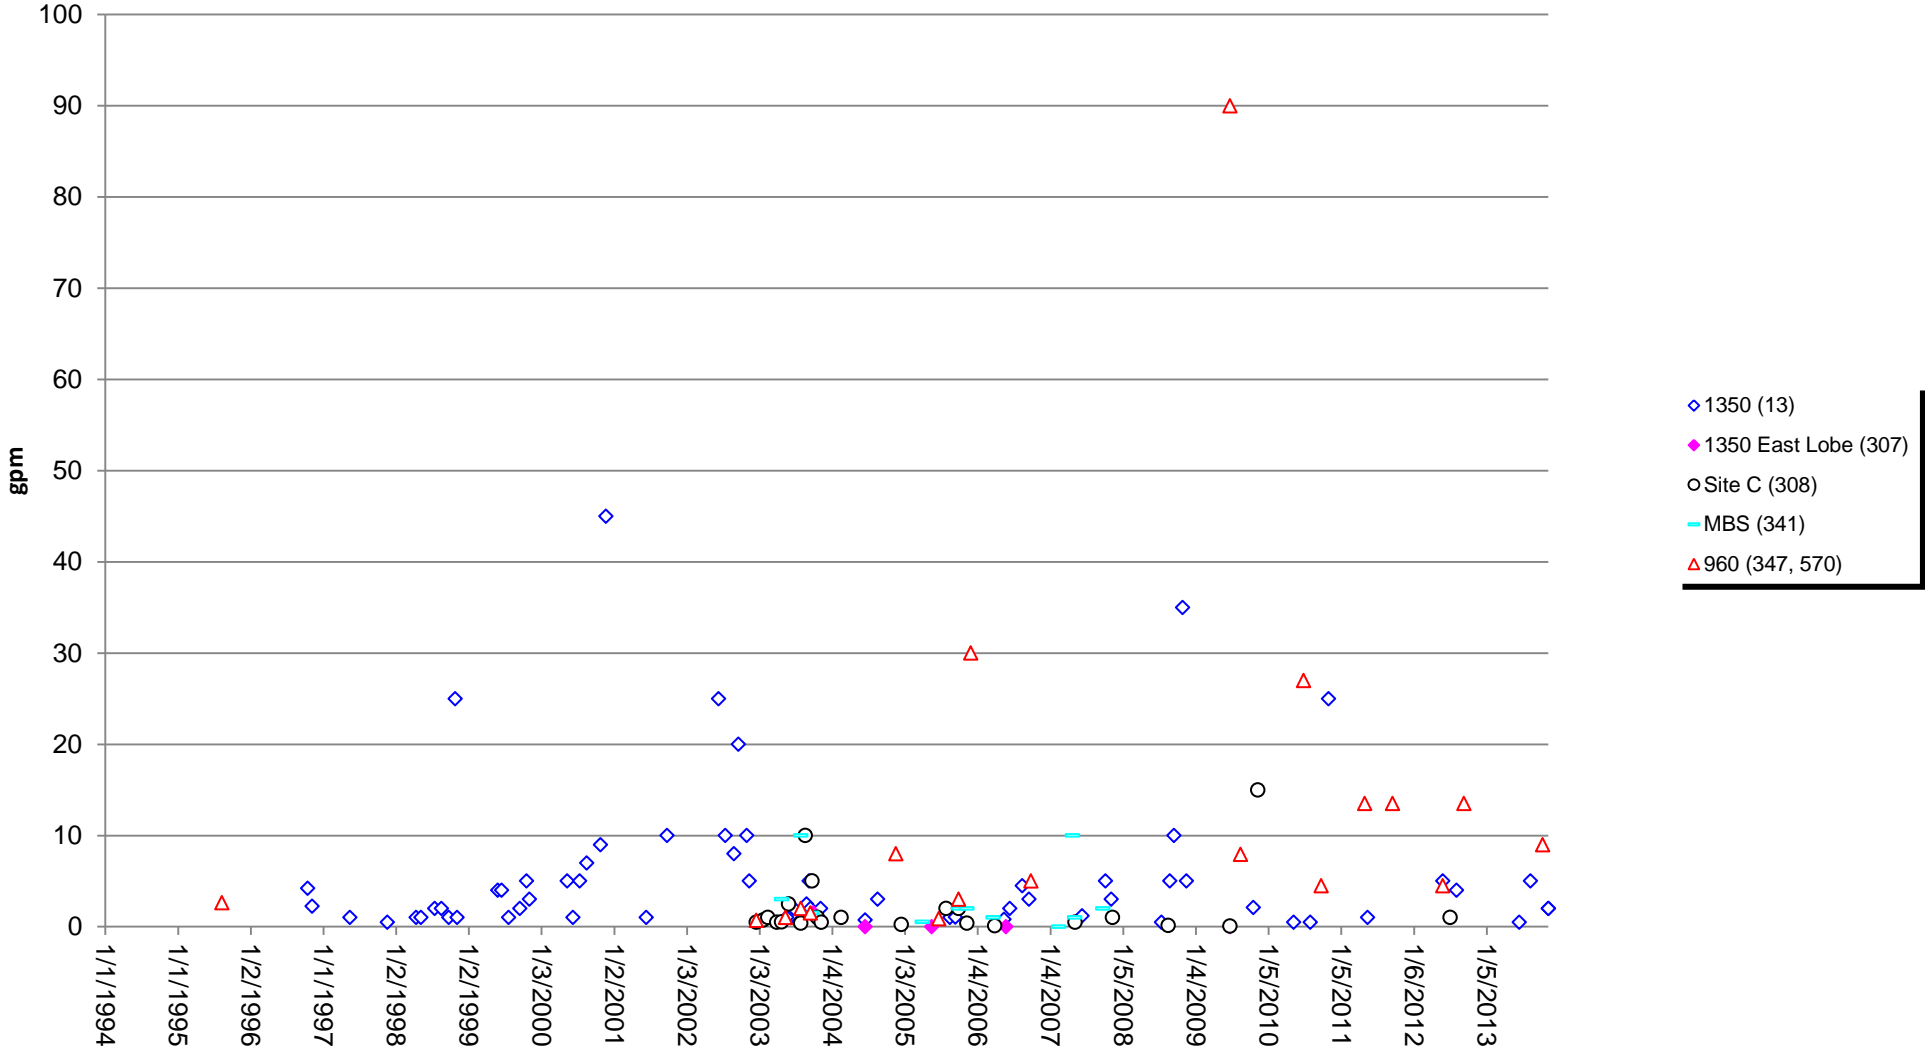
Figure 2.5 INACTIVE PRODUCTION ROCK SITE FLOW DATA

Flow data presented in Figures 2.5 and 2.20 show that flows at most of the sample locations are generally low (less than 10 gpm) with the exception of Site E. Some of the flow data were collected as part of the APDES stormwater monitoring program. Collected during or following storm events, flow data from these locations (e.g. Site E, 356; 960 Site, 347 and 570) represent short-term maximum flow values in response to relatively large precipitation events. Lack of significant flow from inactive sites is a positive characteristic because it reflects minimization of potential off-site impacts.

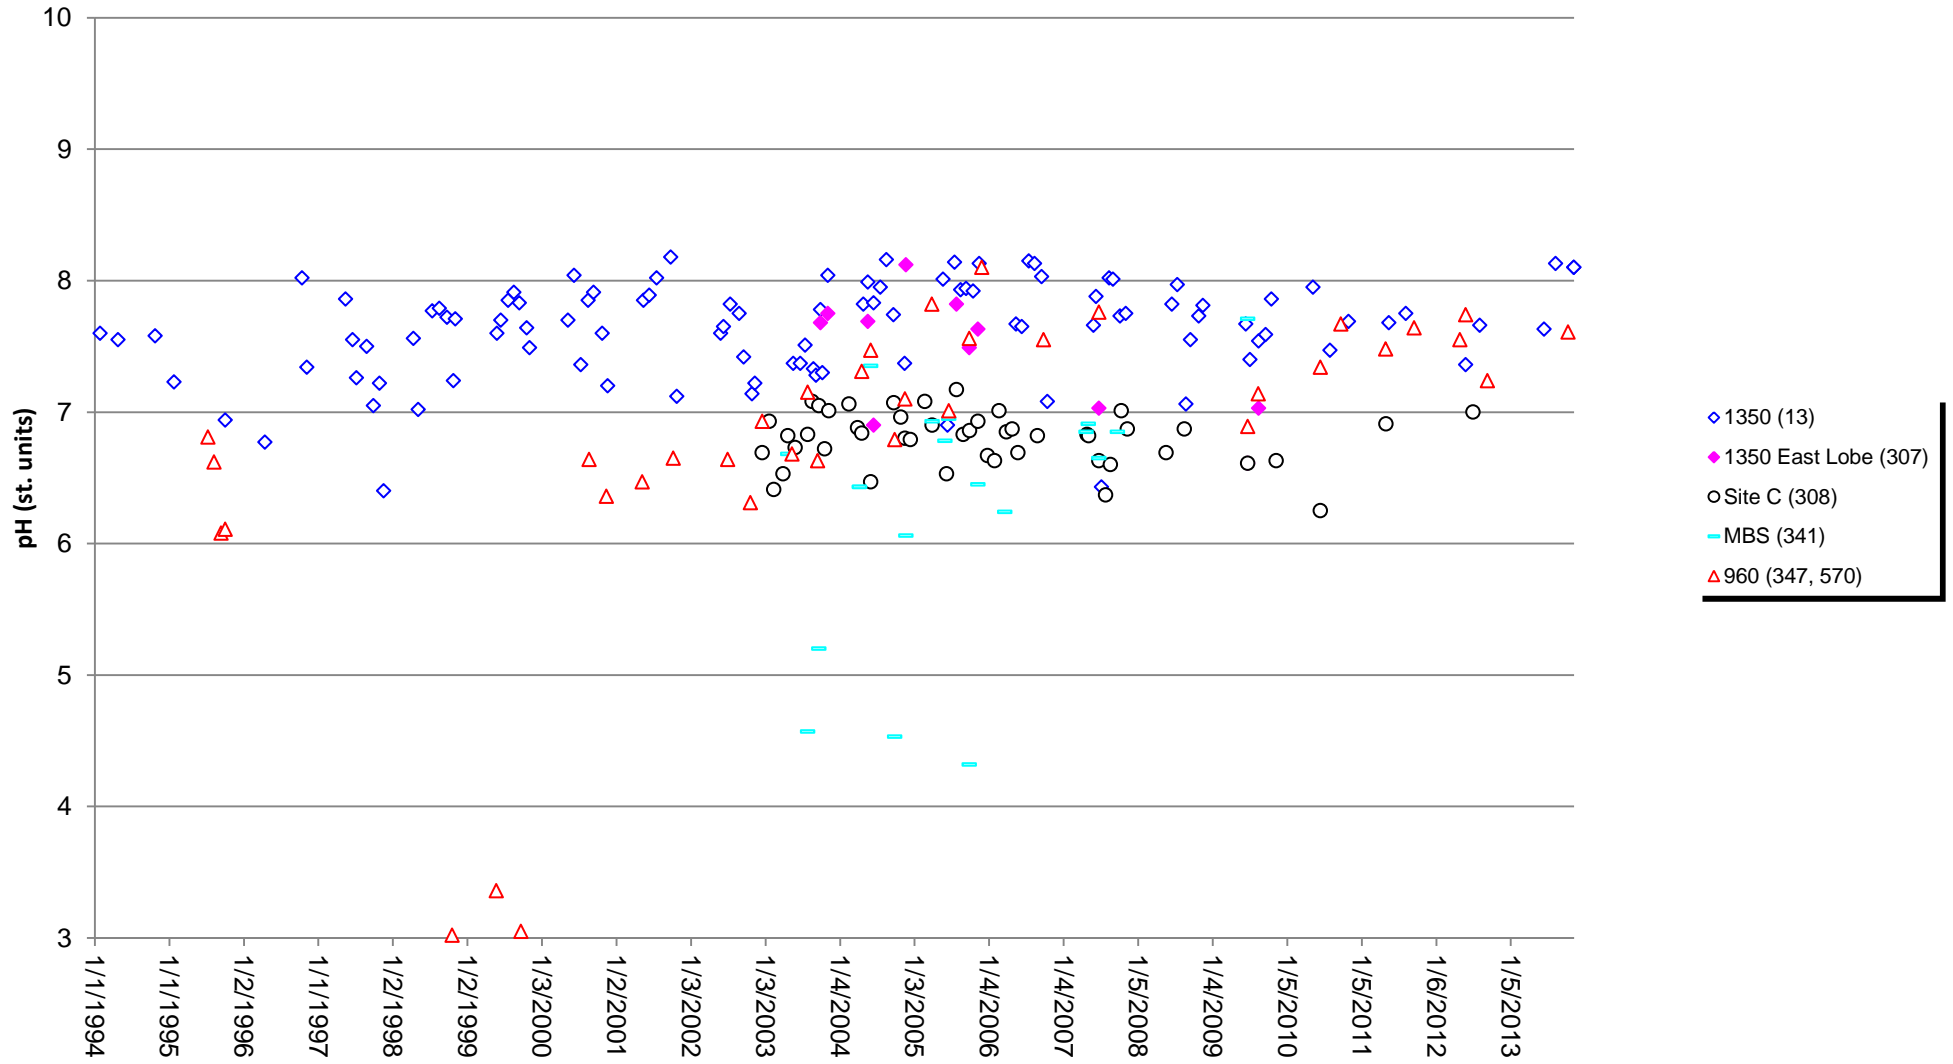
Figure 2.6 INACTIVE PRODUCTION ROCK SITE pH DATA

Figures 2.6 and 2.21 show pH data from sampling locations associated with the inactive sites. Lower pH values can represent influences from pyrite oxidation and/or organic acids from muskeg and forest soils. The data show that the vast majority of the site drainage remains above pH 6.0. Drainage from the Mill Backslope consistently shows the lowest pH due to the quantity of pyritic rock. The drainage from this area is collected and routed to water treatment facilities prior to discharge at the permitted outfall. For a brief period in 1998 and 1999, acidic conditions began developing at the 960 (sites 347 and 570). Hecla's predecessor Kennecott Greens Creek Mining Company (KGCMC) applied lime and removed approximately 1,000 cubic yards of oxidized pyritic rock from the site in 2000. The pH of the drainage quickly rebounded and has remained near-neutral since 2000. Removal of additional Site 960 material in 2003, 2004 and 2005 is discussed below in Section 2.3. The material removal activities may also be responsible for the pH of 8.1 measured at the 960 site in 2005. This is the highest recorded for this site. Fresh

carbonate mineral surfaces exposed during the excavation and the placement of the toe buttress may have contributed to the higher pH values observed. Alkalinity data presented in Figures 2.7 and 2.22 are consistent with the pH results in Figures 2.6 and 2.21. Drainage from the inactive sites continues to maintain measurable alkalinity provided by dissolution of carbonate minerals.

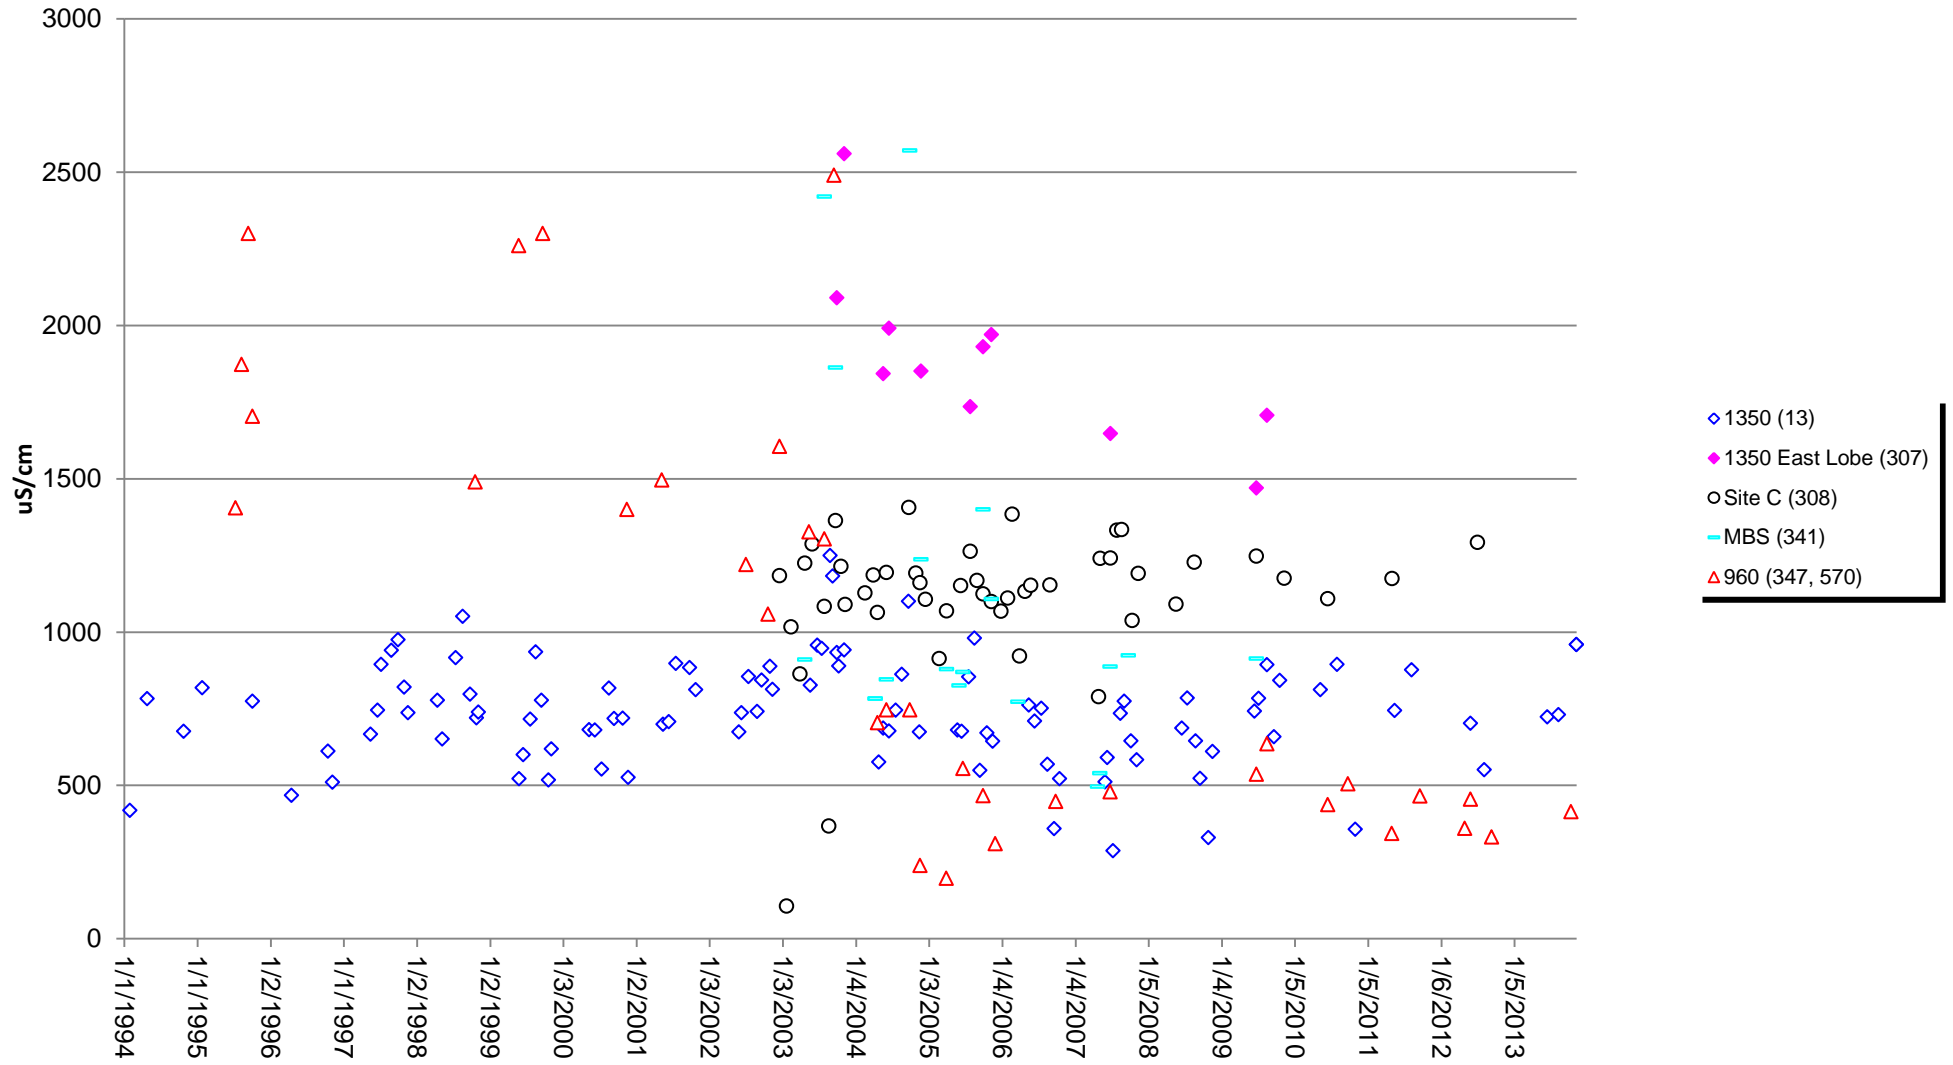
Figure 2.8 INACTIVE PRODUCTION ROCK SITE CONDUCTIVITY DATA

Conductivity data are shown in Figures 2.8 and 2.23. Conductivity indicates the amount of dissolved constituents in the water. Samples showing higher conductivity values usually have elevated sulfate, calcium and magnesium (hardness) concentrations, reflecting influences from sulfide oxidation and carbonate mineral dissolution. Water that has contacted production rock is expected to have higher conductivity values than background waters. Drainage from the 960 (Sites 347 and 570) shows a substantial decrease in conductivity following removal of the production rock. The decreasing trends apparent in Figures 2.8 and 2.23 are the result of decreasing reactive surface area available for oxidation and dissolution. The reactive surface area decreases as reactants are consumed and mineral surfaces become coated with oxidation products. The results for sulfate, magnesium and hardness, shown in Figures 2.9 and 2.24, 2.10 and 2.25, and 2.11 and 2.26, respectively, correlate with conductivity results and are consistent with the concept of generally decreasing or static reactive surface area.

The benefits of the removal activities are evident in the monitoring data for Site 307, which showed a decreasing trend in conductivity and sulfate concentrations (Figures 2.8 and 2.9). An improvement has also been seen in the water quality at Site 13, but to a lesser extent. This is likely due to production rock up-gradient of this site that has not yet been removed. The goal for 2014 is to remove an additional 11,400 cy of material, the majority of which is directly up-gradient of Site 13. After 2014 removal activities, it is estimated that approximately 13,500 cy of production rock will remain. This material will not be available for removal until final closure of the mine due to the need to retain access to the Raise Bore that is a key component of the mine ventilation system.

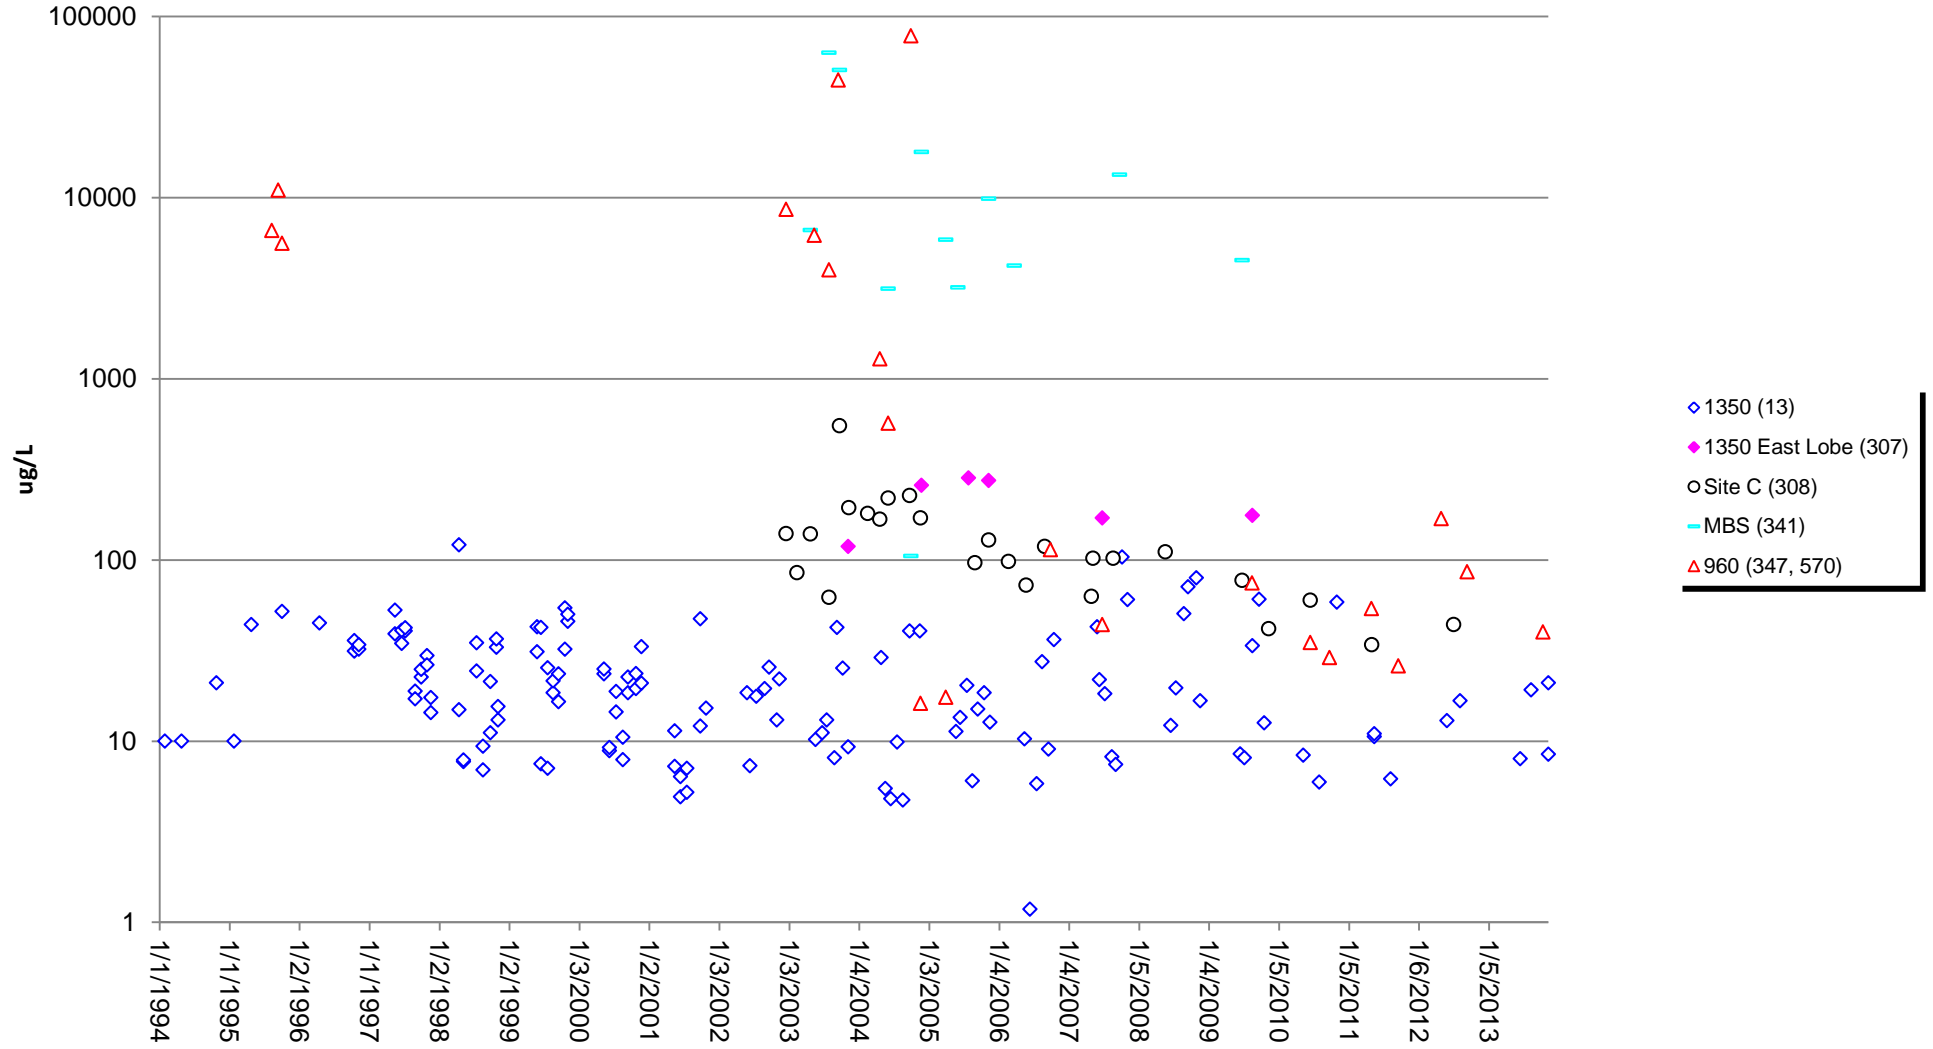
Figure 2.12 INACTIVE PRODUCTION ROCK SITE ZINC DATA

The data for zinc, copper, lead, cadmium, nickel, arsenic, iron and manganese are presented in Figures 2.12 to 2.19 and Figures 2.27 to 2.34. Sample results that were less than the detection limit are plotted at one half the detection limit value. While this allows the results to be plotted on a logarithmic scale, it causes non-detect results with high detection levels to appear more concentrated than they actually are. Detection limits have varied with time and are often evident on the graphs as horizontal groupings of symbols. The results for metals generally correlate with conductivity values. Zinc concentrations reflect the higher solubility of this element relative to the other metals at near-neutral pH conditions. Manganese concentrations are elevated at most of the inactive sites, indicating the generation of secondary products from localized redox and buffering reactions as well as this metal's higher solubility in the prevailing pH conditions. Metal loads from inactive sites have either remained relatively constant or decreased with time. The decrease in metal loading is attributed to the reduction of reactive surface area discussed above. Site 960 showed elevated copper, zinc and cadmium concentrations in 2004. This was likely due to the removal of production rock from the area, which exposed additional production rock materials in the base of the road, and rerouted additional water sources into the sampling area, confounding comparative water sampling with pre-removal data. Post removal Site 960 data in 2005-2011 have shown a decrease in most metal concentrations, with close to an order of magnitude decrease in cadmium, nickel, manganese and zinc.

The 960 Site showed some elevated copper, zinc and cadmium concentrations in 2003 and 2004 (Figures 2.12, 2.13 and 2.15). This was likely due to the removal activities, which exposed some additional production rock materials in the base of the road and altered drainage patterns. Comparison of pre- and post-removal monitoring data (Table 2.2) demonstrates that water quality of drainage from the 960 Site has improved considerably.

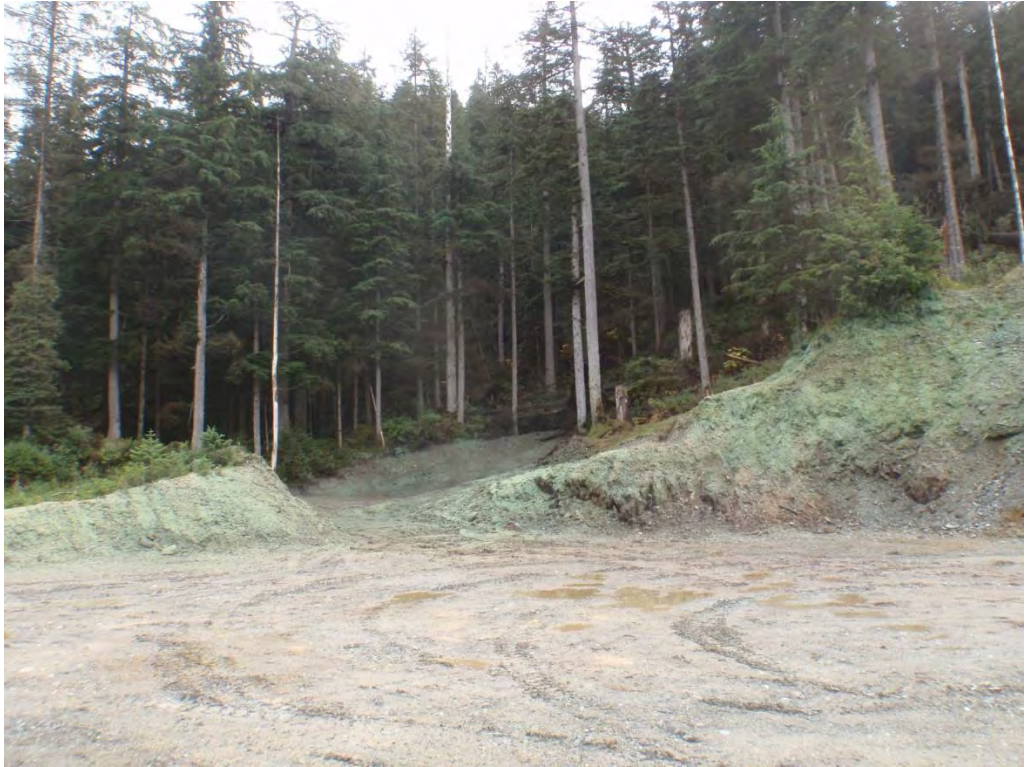
Figure 2.35: 1350 Site - 2013 Production Rock Removal Area

After evaluating reclamation alternatives for the 1350 Site, it was determined that removal of the production rock for disposal in the underground mine as backfill was the best option to achieve closure of the site. Removal activities commenced in 2005 and have continued on an intermittent basis. Removal is performed during the drier summer months to minimize erosion and sediment production from the excavation and haulage activities. There was no removal in 2006, 2009 or 2012 due to limited availability of space underground and/or at the temporary storage pad at Site 23. From 2005 through 2013, a total surveyed quantity of 39,473 bcy of material has been removed from the 1350 Site. Of this total, approximately 5,645 bcy was removed in 2013. A photograph of the area where the 2013 removal activities occurred is presented as Figure 2.35.

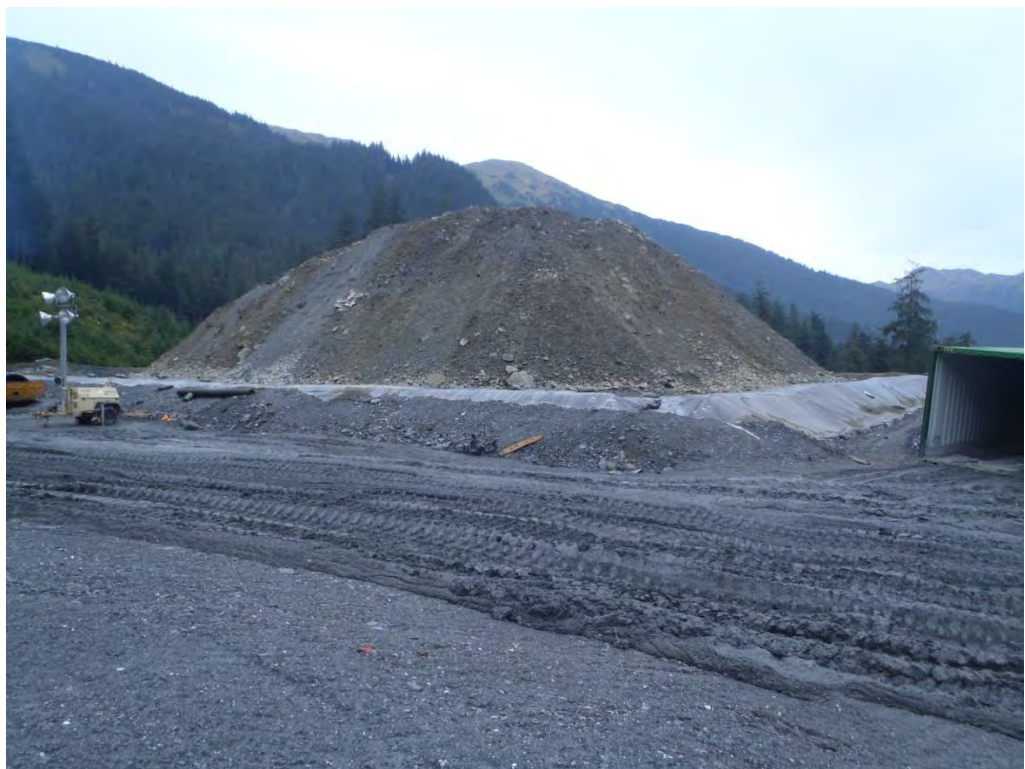
Figure 2.36: Site 23 Temporary Storage Pad for 1350 Material

A temporary storage pad for the 1350 material was constructed at Site 23 in 2008. Prior to building this facility, the 920 remuck area was used as the temporary storage area before hauling underground as backfill. The remuck area has a limited capacity of 700 cy and is available only on a seasonal basis. The temporary storage pad at Site 23 allows material to be hauled underground on a year-round basis, thus expediting the 1350 removal process. The temporary storage pad was lined to provide containment of storm water drainage, which is routed to water treatment facilities prior to discharge at the permitted outfall. The 1350 material is also blended with lime during placement on the storage pad to ensure neutralization of acidic oxidation products.

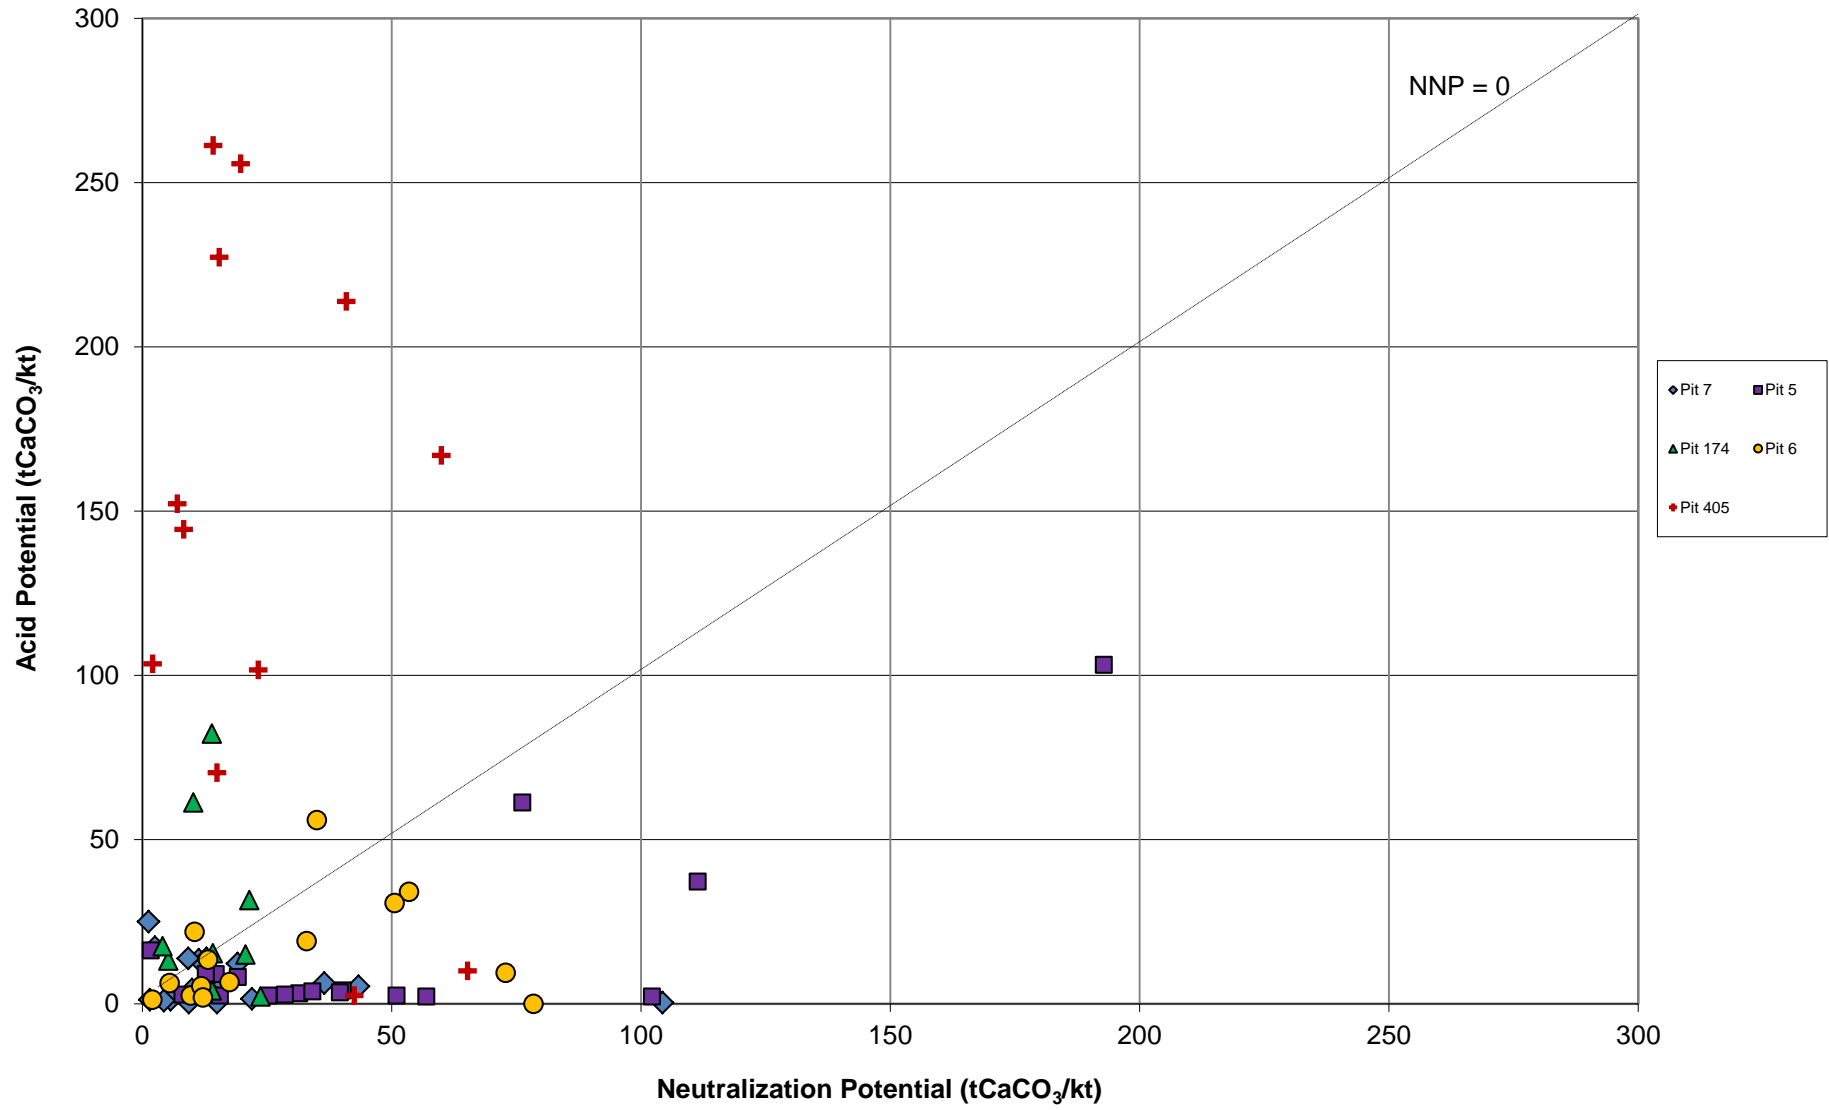
FIGURE 3.16 2002-2013 QUARRY SITE ABA DATA

Acid Base Accounting data collected from 2002 to 2013 are summarized in Figures 3.16 and 3.17. Pit 405 and Pit 174 have significant exposures of potentially acid generating rock and produced several samples with acidic rinse pH. Pit 6 and Pit 7 produced samples showing a broad distribution of NNP and rinse pH, and Pit 5 generally produced acid neutralizing samples with alkaline rinse pH. Buildup of oxidation products (salts) on overhanging quarry walls was noted at each of the five quarry sites and may have contributed to the lower rinse pH readings for several samples.
