**TAILINGS AND PRODUCTION ROCK SITE  
2001 ANNUAL REPORT**

**Kennecott Greens Creek Mining Company**

**April 2002**

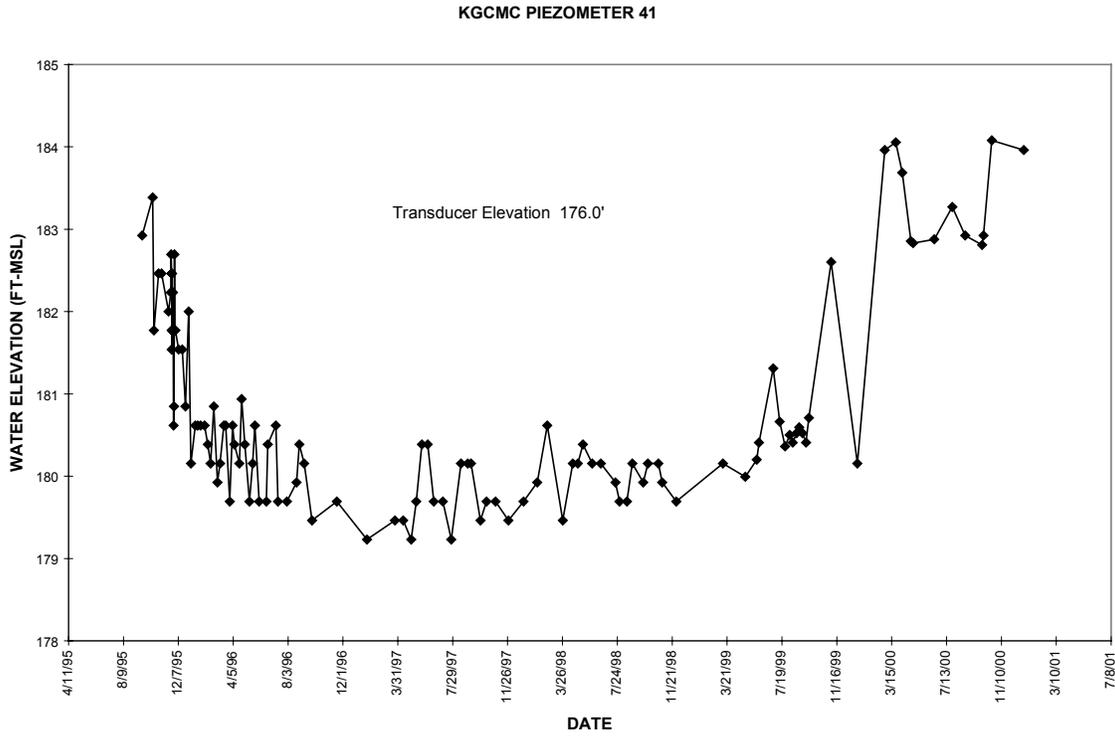
Figure 2.1 Water Level Data for Piezometer 41

Pneumatic piezometer and well water level data for the tailings site are presented in Figures 2.1 to 2.22. Well and piezometer locations and water level cross sections are shown on the tailing facility as-built (Appendix 1). Water levels remained relatively constant throughout the report period. Some piezometers (e.g. 41, 44, and 46 in Figures 2.1, 2.4, 2.5) showed a slight decrease in the latter half of the year, which is consistent with the drier than average conditions during the monitoring period. Section CC of the Tailings Facility as-built shows the inferred water table in the tailings pile. The maximum saturated thickness (approximately 42 feet) occurs near MW-T-B2 (Figure 2.14) in the center of the main portion of the pile. However, the elevated water table does not extend close to the down-slope toes of the pile. The foundation of the West Buttress and southern portion of the pile is well drained, as indicated by unsaturated conditions in the blanket drains (MW-T-00-05A, Figure 2.18) and at the base of the West Buttress (piezometers 74, 75, 76 in Figures 2.11, 2.12, 2.13). Low head elevations near the pile toe maximize the pile's geotechnical stability.

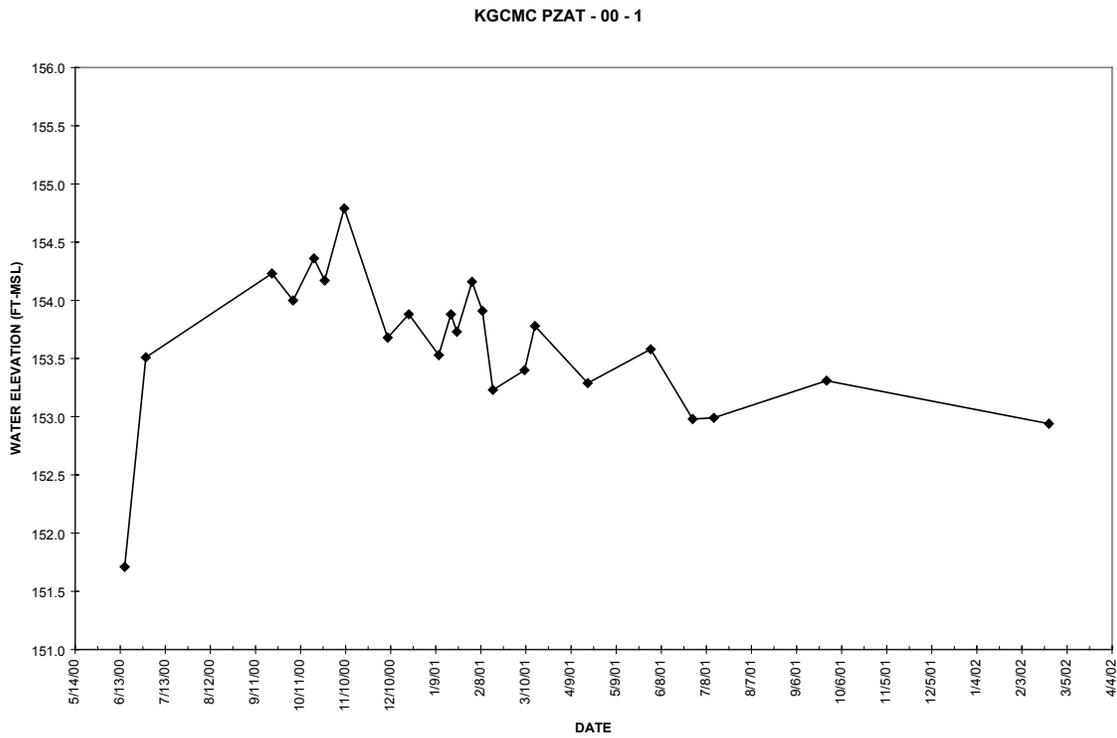
Figure 2.15 Water Level Data for Standpipe Piezometer PZ-T-00-01

The data from standpipe piezometers completed above the blanket drain (PZ-T-00-01, PZ-T-00-02, PZ-T-00-03 in Figures 2.15, 2.16, 2.17) indicate that the water perches above the unsaturated underdrains to a thickness of approximately 12 feet. This is consistent with the low permeability of the tailings and the un-capped condition of the pile. Covering the pile will help minimize the saturated zone in the pile. This was demonstrated by the 10+ foot decrease in the water table that occurred from 1995 to 1997 when the pile was covered (see Figures 2.1 to 2.9 and 2.14).

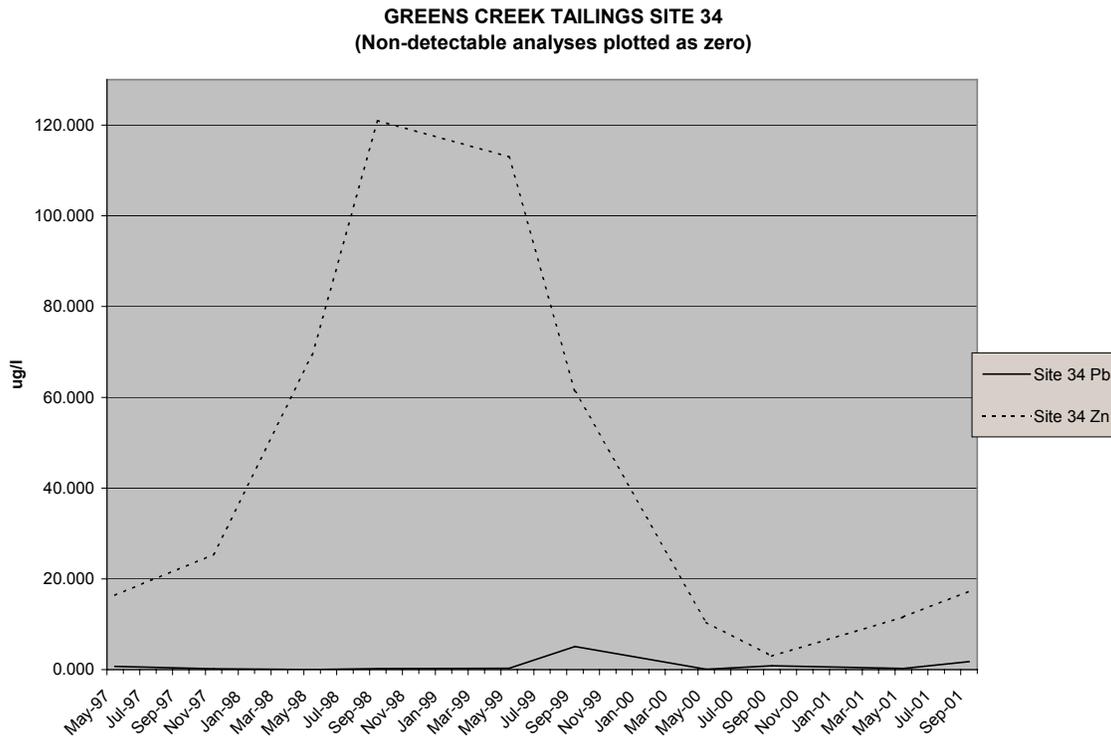
Figure 2.24 FWMP Site 34 Lead and Zinc Data

The year 2001 sampling continues to show no evidence of contamination from the facility at the compliance points around the KGCMC surface Tailings facility. Prior analyses had shown high levels of zinc at Site 34, the Seepage Control Structure below the Pond 6 dam. These results were attributed to the disintegration of a corrugated metal standpipe in the sample pool. This rusting metal piece was removed in late 1998. Zinc levels have dropped steadily since then, returning to earlier levels, well below Alaska Water Quality Standard FWMP target level of 45.6 for surface water (Figure 2.24). As can also be seen from this figure, lead levels have remained low and stable through this period. These results help to substantiate the source of the high zinc results as not being from the tailings facility.

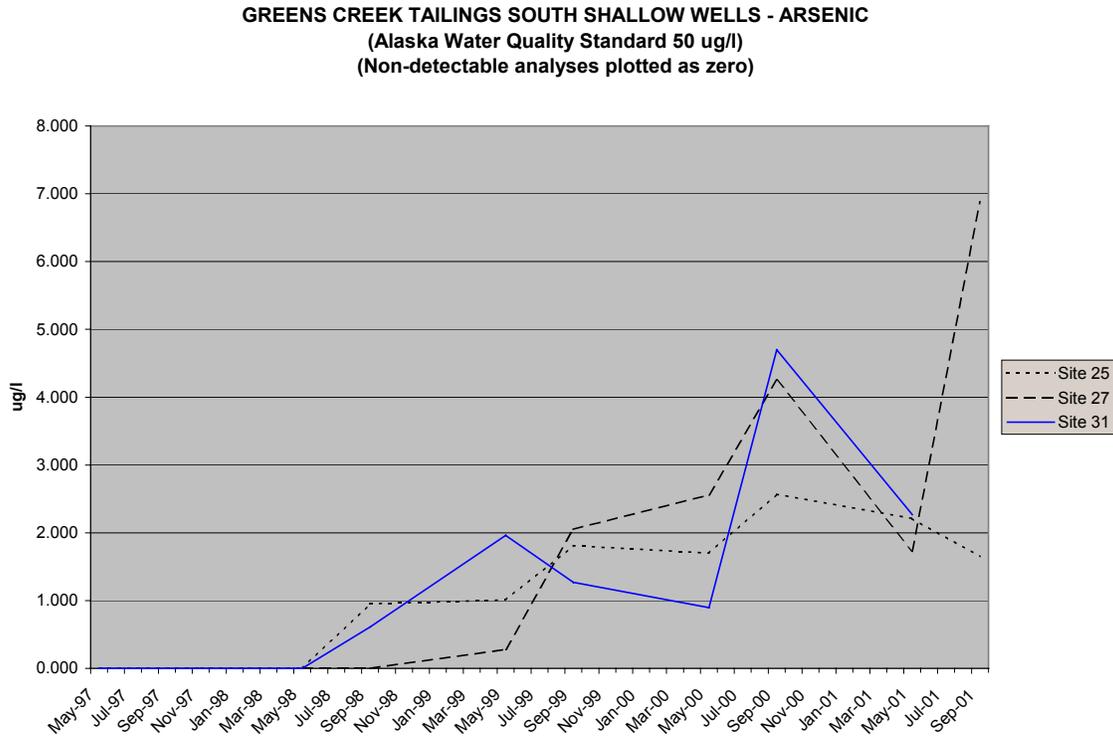
Figure 2.25 FWMP Sites 25, 27 and 31 Arsenic Data

Arsenic results of the downgradient wells and the upgradient well appear to interchange in a random manner over time (Figure 2.25). However the magnitude of these fluctuations are quite small, some 5 micrograms per liter. These wells' arsenic levels remain far below the Alaska Water Quality Standard FWMP target level of 50 ug/l.

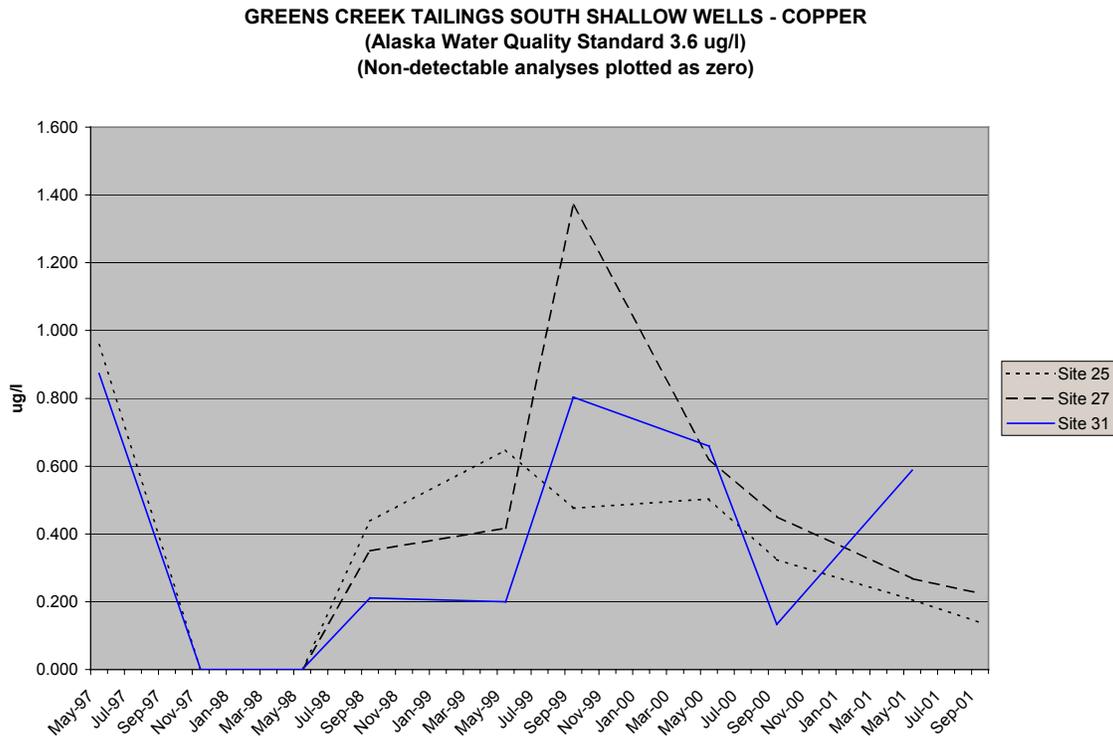
Figure 2.26 FWMP Sites 25, 27 and 31 Copper Data

Copper results show consistency over the 5-year period, generally fluctuating between 0.2 and 0.8 ug/l (Figure 2.26). As with arsenic, results of the up- and down-gradient wells do not present consistent comparative results. An apparent spike in September 1999 analytical results at Site 27 was followed by subsequent analyses dropping back into line with prior years' results. Site 31 shows evidence of the encroaching tailings pile with a spike of copper showing up in the Spring 2001 sample. Also as with the arsenic results, these copper results remain well below the Alaska Water Quality Standard FWMP target level of 3.6 ug/l.

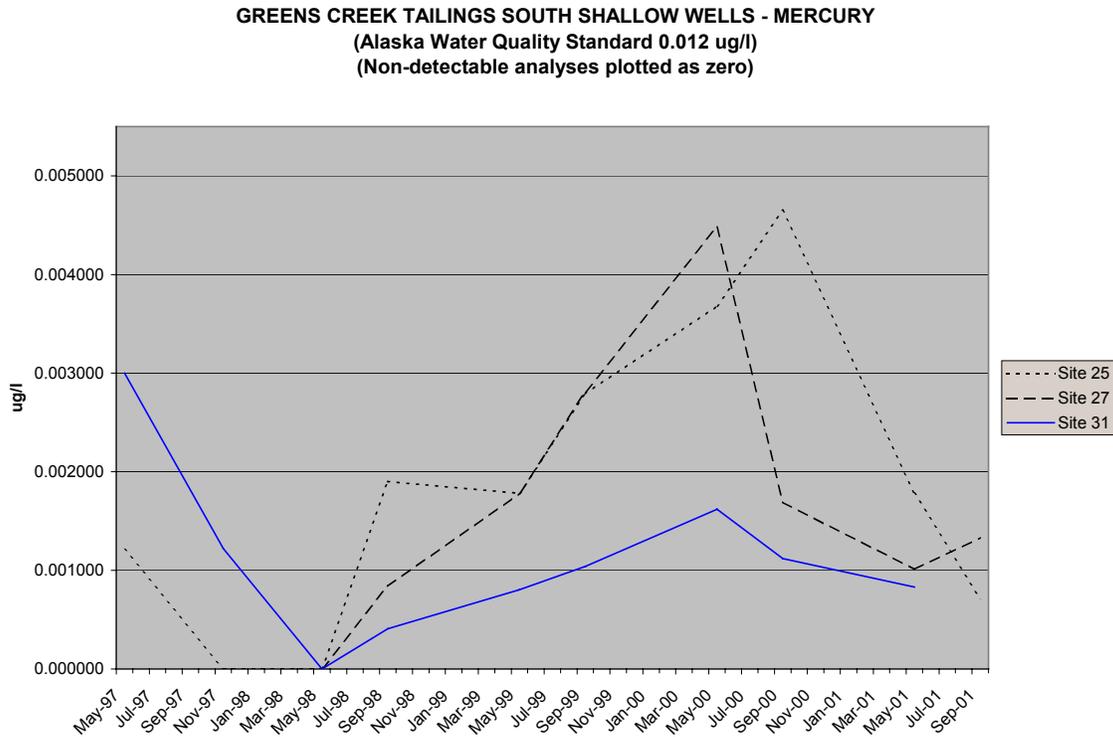
Figure 2.27 FWMP Sites 25, 27 and 31 Mercury Data

Mercury results, as with the above constituents, remain far below the Alaska Water Quality Standard FWMP target level of 0.012 ug/l (Figure 2.27). For mercury however, even though the magnitude of difference is small (0.0005 to 0.003 ug/l), the upgradient well results consistently remain below the downgradient well results. The downgradient wells showed higher analytical results in late 1999 and early 2000 monitoring, but have since returned to levels below 0.0015 ug/l.

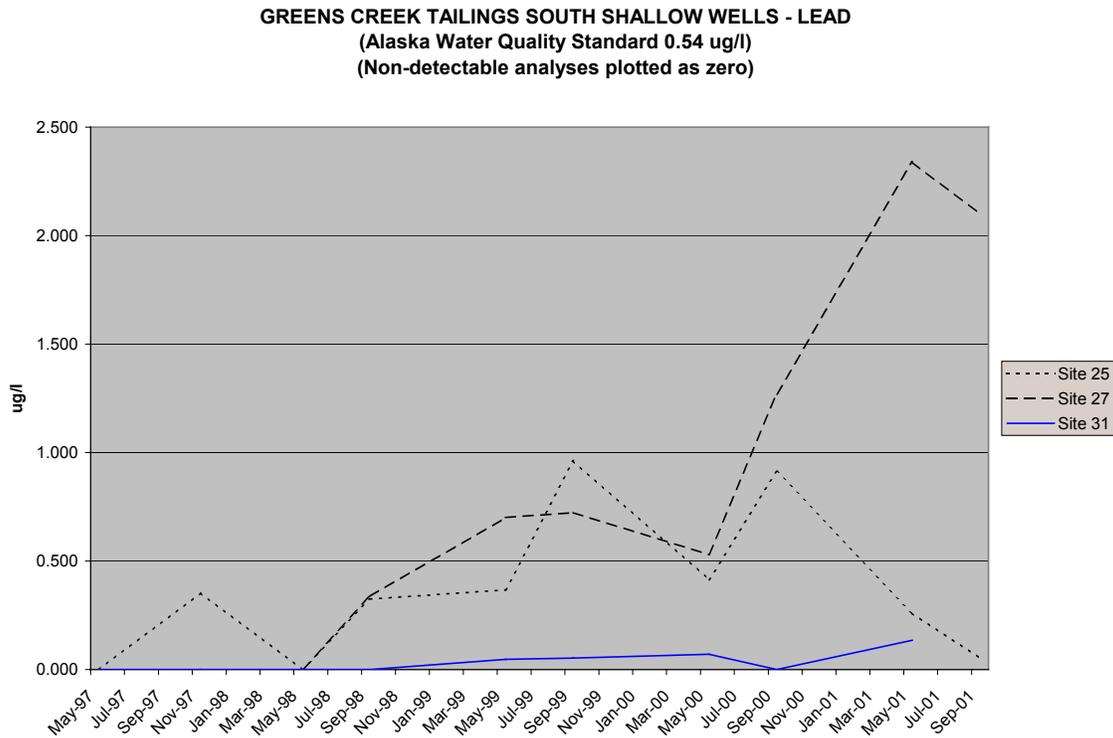
Figure 2.28 FWMP Sites 25, 27 and 31 Lead Data

Lead results show an interesting increase at Site 27 during the Fall 2000 and Spring 2001 analyses, the furthest site from the Tailings facility (Figure 2.28). The Fall 2001 results show the level having peaked, and beginning to drop back with the other well results. As with Mercury, the upgradient well results consistently remain below the downgradient well results. Both Southern shallow wells' lead analytical results have generally been above the Alaska Water Quality Standard FWMP target level of 0.54 ug/l. Site 31 analytical lead results remain stable and well below the Alaska Water Quality Standard FWMP target level of 0.54 ug/l.

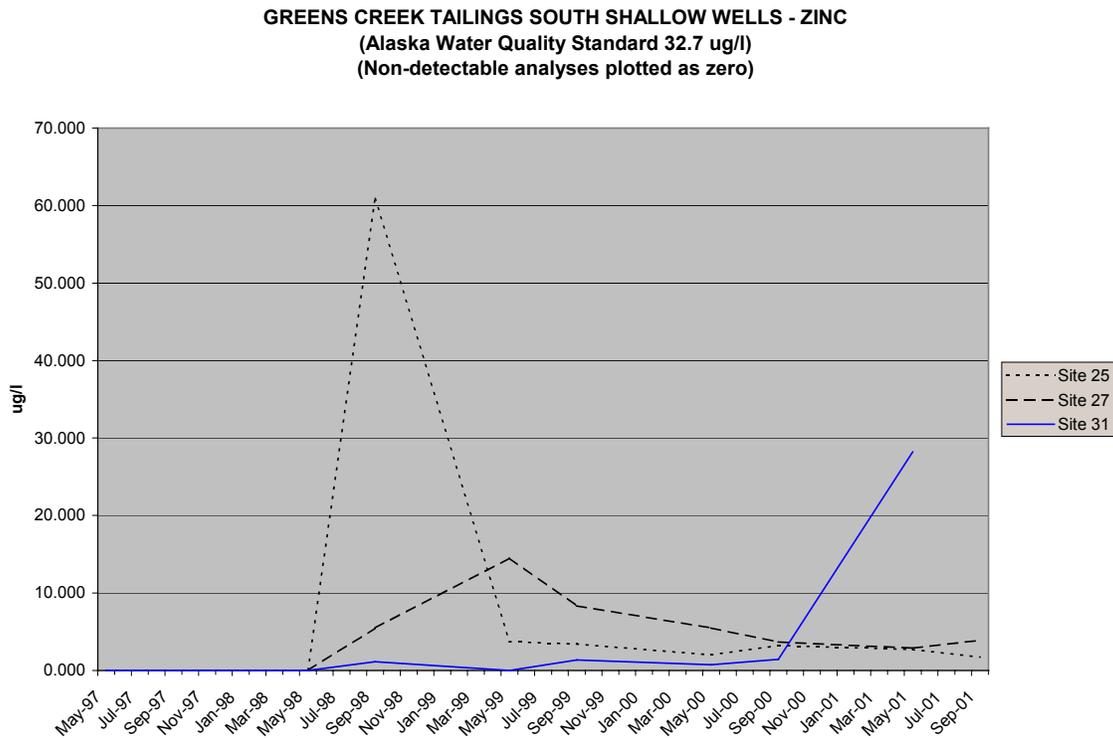
Figure 2.29 FWMP Sites 25, 27 and 31 Zinc Data

Zinc results also show consistent, or explainable analytical results (Figure 2.29). The upgradient well results generally remain lower than the downgradient well results. As with the copper analytical results, zinc shows a response to the encroaching tailings pile expansion to the east with a Spring 2001 analytical result increase appearing at Site 31. The Fall 1998 zinc result from Site 25 has proven to be anomalous, with the subsequent years' results showing consistent low levels. Undoubtedly this result was an artifact of the previous pumping method, a method changed in the above referenced FWMP revision. For zinc, as with the above constituents, analytical results remain well below the Alaska Water Quality Standard FWMP target level of 32.7 ug/l.

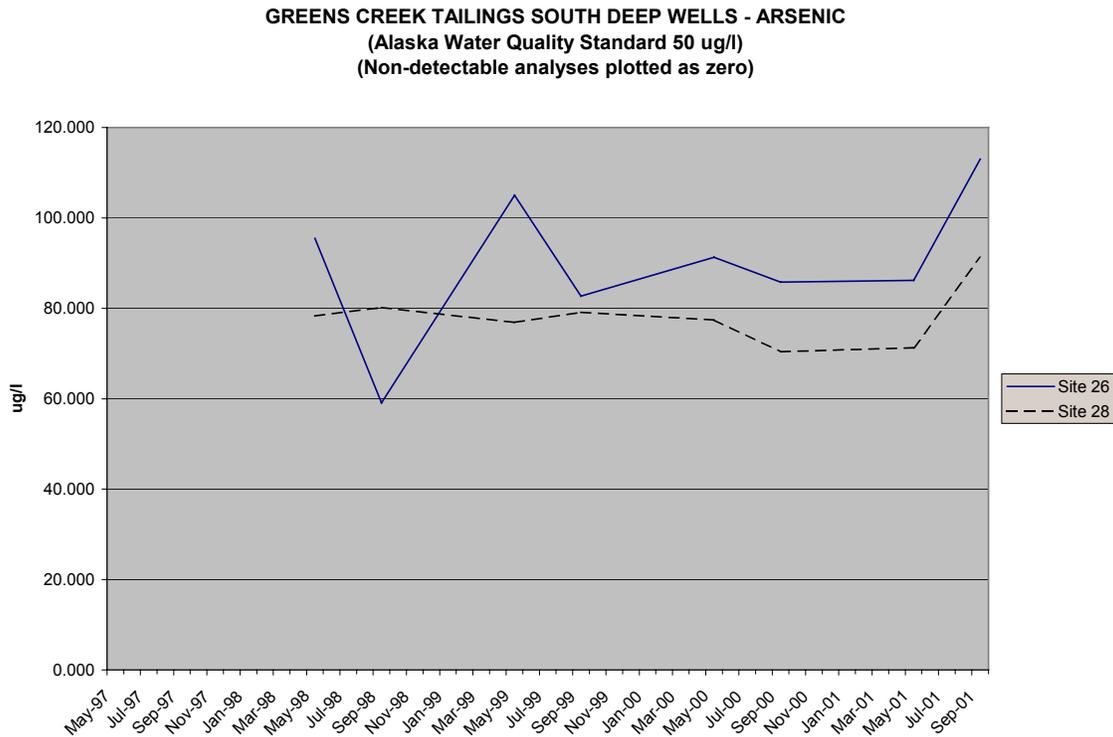
Figure 2.30 FWMP Sites 26 and 28 Arsenic Data

Arsenic analytical levels in the Southern deep wells are distinctly different than those in the co-located shallow aquifer wells, averaging some 20 times greater analytical results (Figure 2.30). However, these sites' analytical results have remained consistent, and relatively stable throughout the over ten years of monitoring. The site closer to the Tailings facility generally has produced the lower analytic result. Arsenic analytical results for the Southern deep wells remain well above the Alaska Water Quality Standard FWMP target level of 50 ug/l.

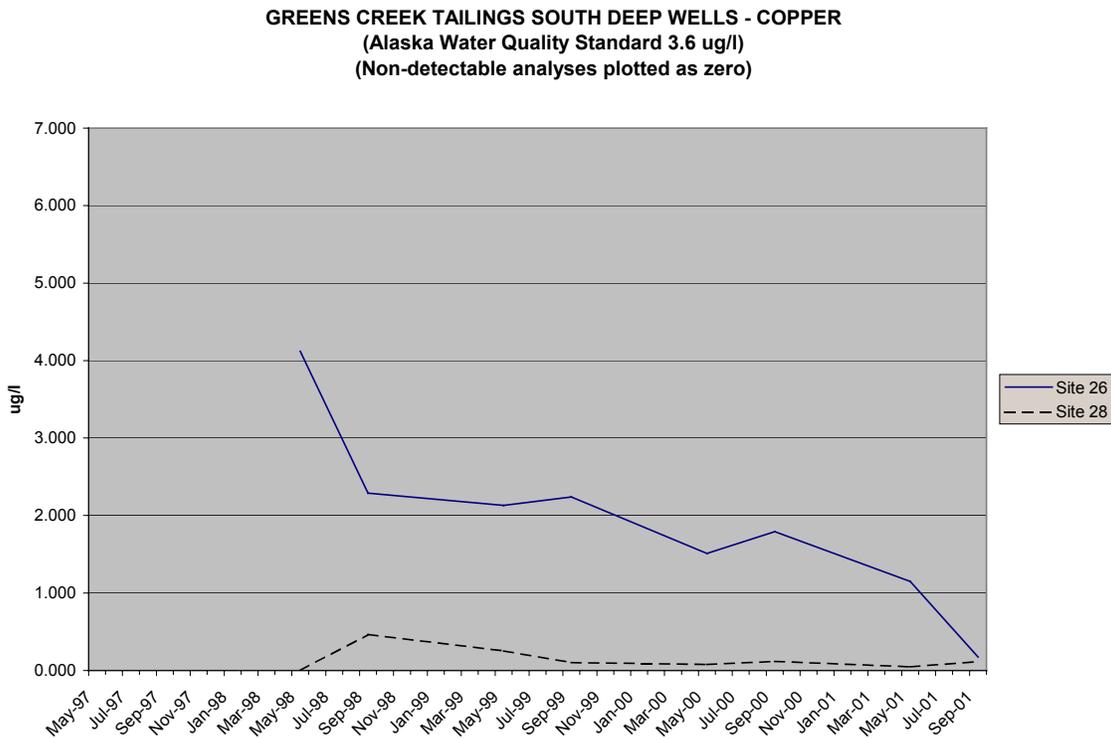
Figure 2.31 FWMP Sites 26 and 28 Copper Data

Copper results for the Southern deep wells show a different comparative result from their arsenic results (Figure 2.31). That is, one well (Site 28) consistently produces results similar to the co-located shallow wells. Conversely, Site 26 has traditionally produced copper levels some ten times higher than the co-located shallow wells. Over the last two years' monitoring Site 26 copper analytical results have been dropping down into the range of these other three wells' results. Since 1998 all copper analytical results for these Southern deep wells have been well below the Alaska Water Quality Standard FWMP target level of 3.6 ug/l.

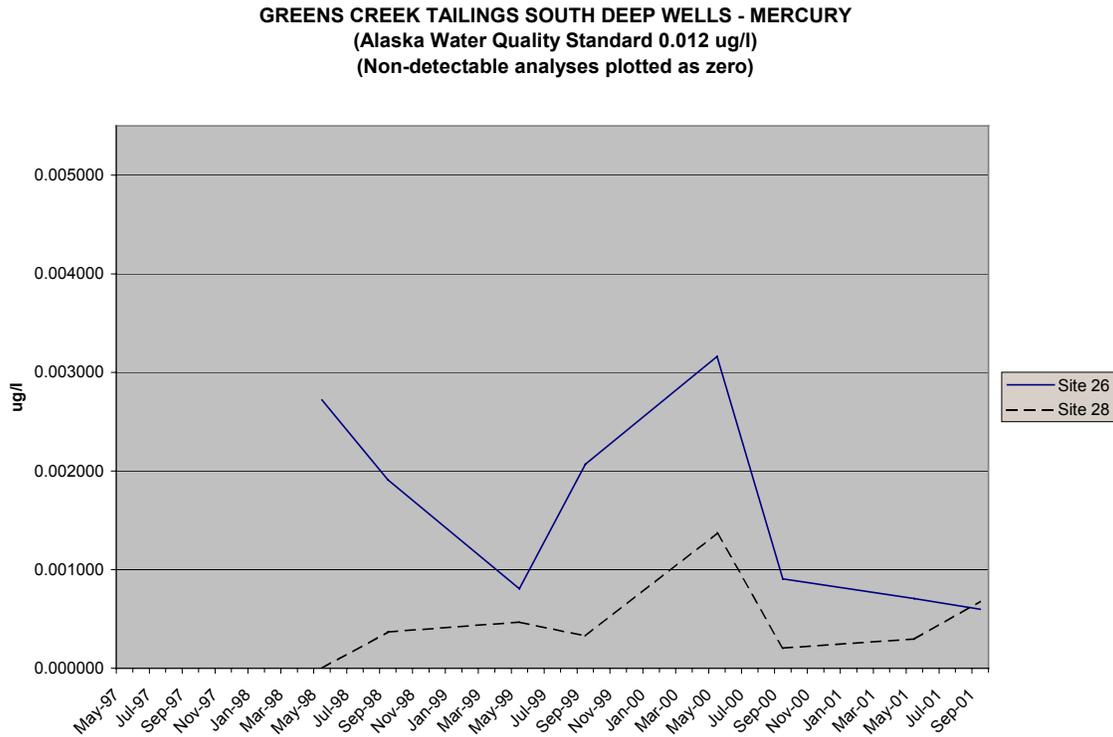
Figure 2.32 FWMP Sites 26 and 28 Mercury Data

Mercury results for the Southern deep wells remain generally below the co-located shallow well's results (Figure 2.32). All southern well's mercury analytical results remain stable and well below the Alaska Water Quality Standard FWMP target level of 0.012 ug/l.

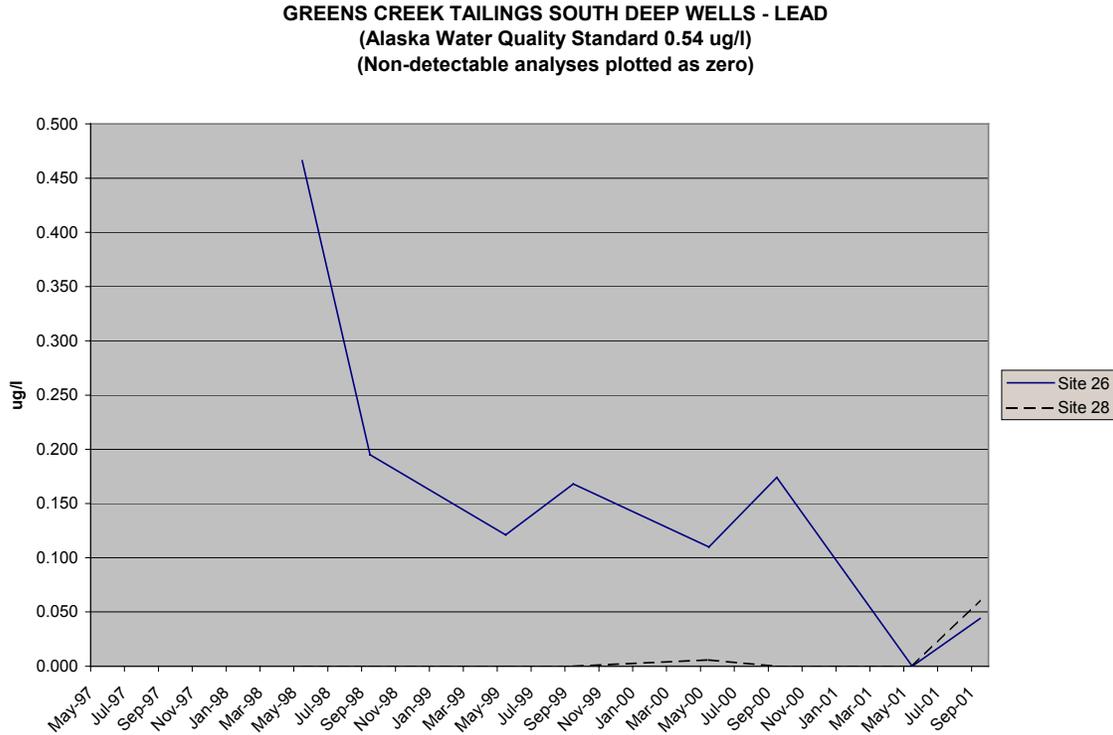
Figure 2.33 FWMP Sites 26 and 28 Lead Data

Lead results for the Southern deep wells show disparity between their comparisons to the shallow co-located well results (Figure 2.33). As with the copper results, Site 26 has produced analytical results consistently above the shallow wells, but demonstrating a steady decline over time. Conversely, Site 28 has produced analytical results consistently below the shallow wells, generally still below the laboratory detection levels. Both Southern deep wells have recently produce results below the Alaska Water Quality Standard FWMP target level of 0.012 ug/l.

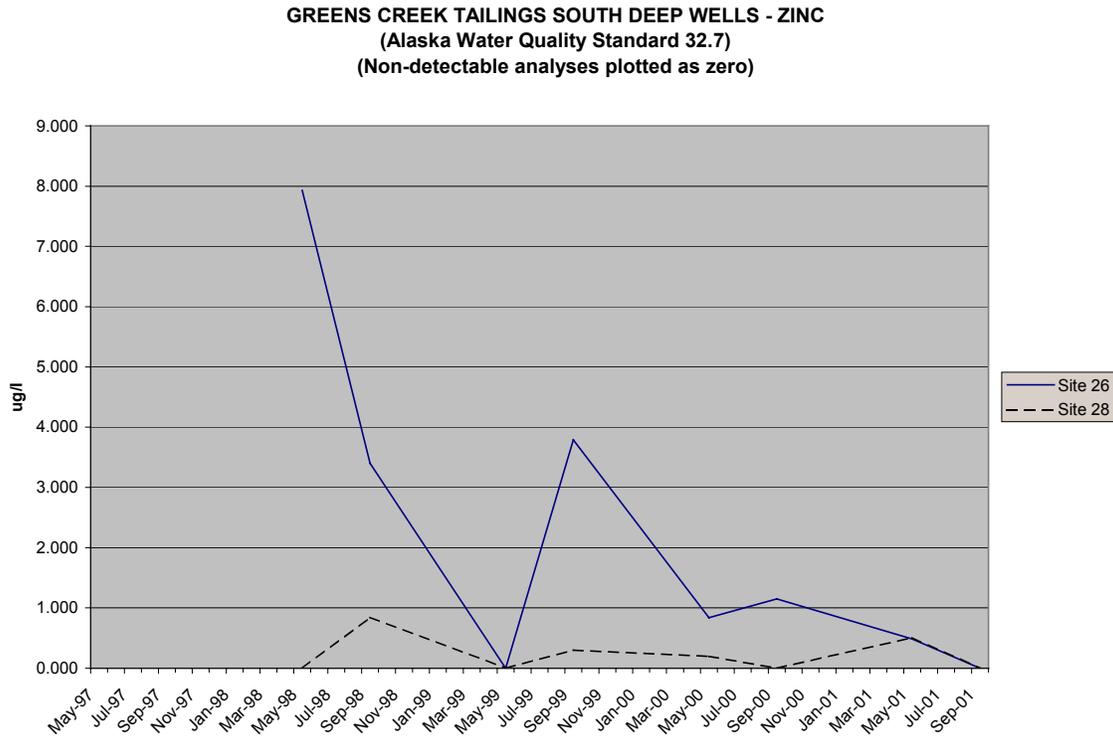
Figure 2.34 FWMP Sites 26 and 28 Zinc Data

Zinc results for the Southern deep wells generally track with their co-located shallow wells' analytical results (Figure 2.34). All southern wells' zinc analytical results remain stable and well below the Alaska Water Quality Standard FWMP target level of 32.7 ug/l.

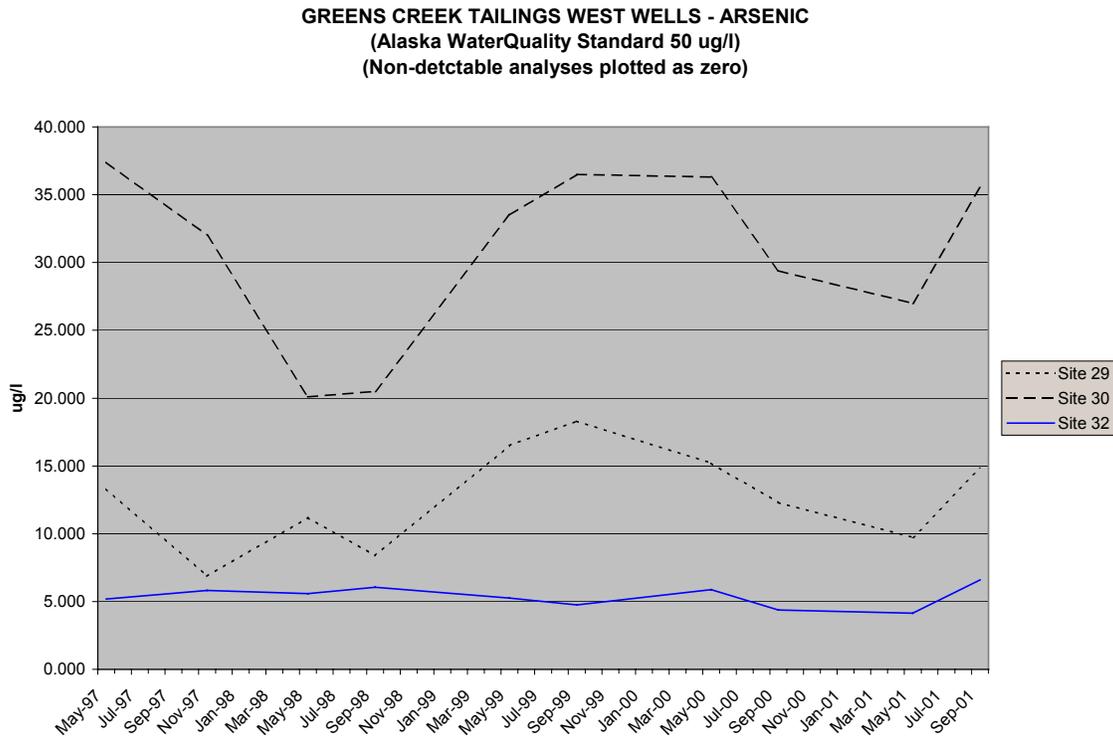
Figure 2.35 FWMP Sites 29, 30 and 32 Arsenic Data

Arsenic results for these three West wells show three distinct and relatively stable sets of analyses (Figure 2.35). The two shallow wells show the highest and lowest results while the deep well results consistently falls between. While Site 29 remains below the Alaska Water Quality Standard FWMP target level of 50 ug/l, it has traditionally fluctuated in the 30-40 ug/l range. Sites 30 and 32 analytical results remain stable and well below that Alaska Water Quality Standard FWMP target level of 50 ug/l.

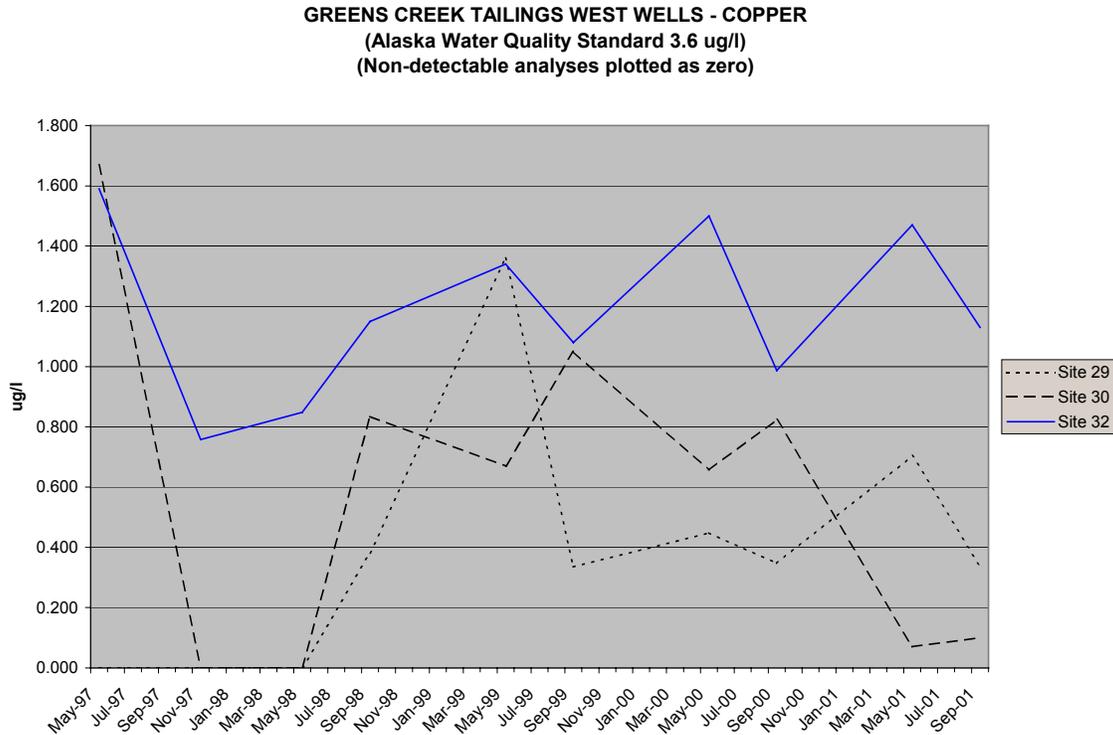
Figure 2.36 FWMP Sites 29, 30 and 32 Copper Data

Copper results for the West wells show fluctuating analytical results (Figure 2.36). Site 32 generally produces highest analytical results while the other shallow well (Site 29) results are generally the lowest copper levels. The West wells' copper analytical results tend to mimic the Southern shallow well results, that is fluctuating at or below 1 ug/l. All West wells' copper analytical results remain well below the Alaska Water Quality Standard FWMP target level of 3.6 ug/l.

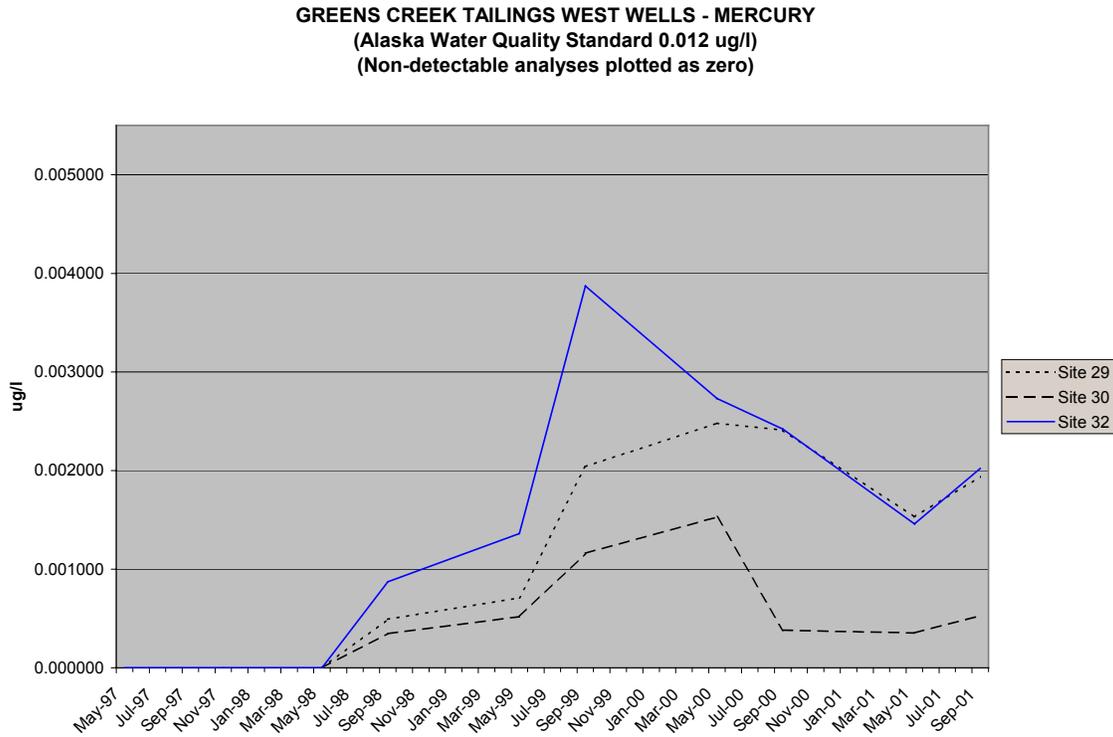
Figure 2.37 FWMP Sites 29, 30 and 32 Mercury Data

Mercury results for the West wells show the deep well (Site 32) generally producing the highest analytical results (Figure 2.37). However, as with the Southern shallow and deep wells, the West well mercury analytical results predominantly remain below 0.003 ug/l, well below the Alaska Water Quality Standard FWMP target level of 0.012 ug/l.

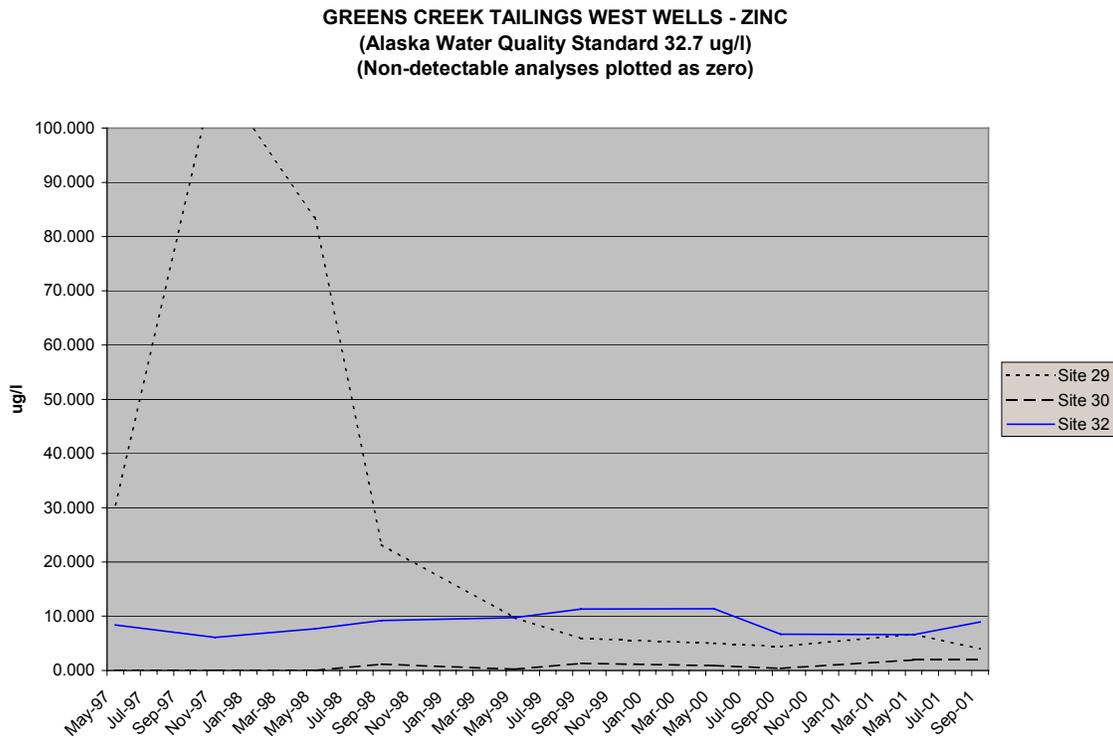
Figure 2.39 FWMP Sites 29, 30 and 32 Zinc Data

Zinc results for the West wells show very consistent analytical results over the course of the past three and one-half years (Figure 2.39). The two co-located West wells (Sites 29 & 30) produce the lowest results, with the deep well (Site 30) consistently producing the lowest zinc analytical results. The separate West shallow well (Site 32) consistently has produced the higher zinc analytical result for this three-well grouping. The anomalous 1997-8 high zinc levels found from Site 29 have since stabilized back to levels between the other two West wells. The 1997-8 analytical results for Site 29 are likely a result of the pumping technique of that time producing excessive sediments. Over the past three and one-half years all of the West well zinc analytical results remain well below the Alaska Water Quality Standard FWMP target level of 32.7 ug/l.

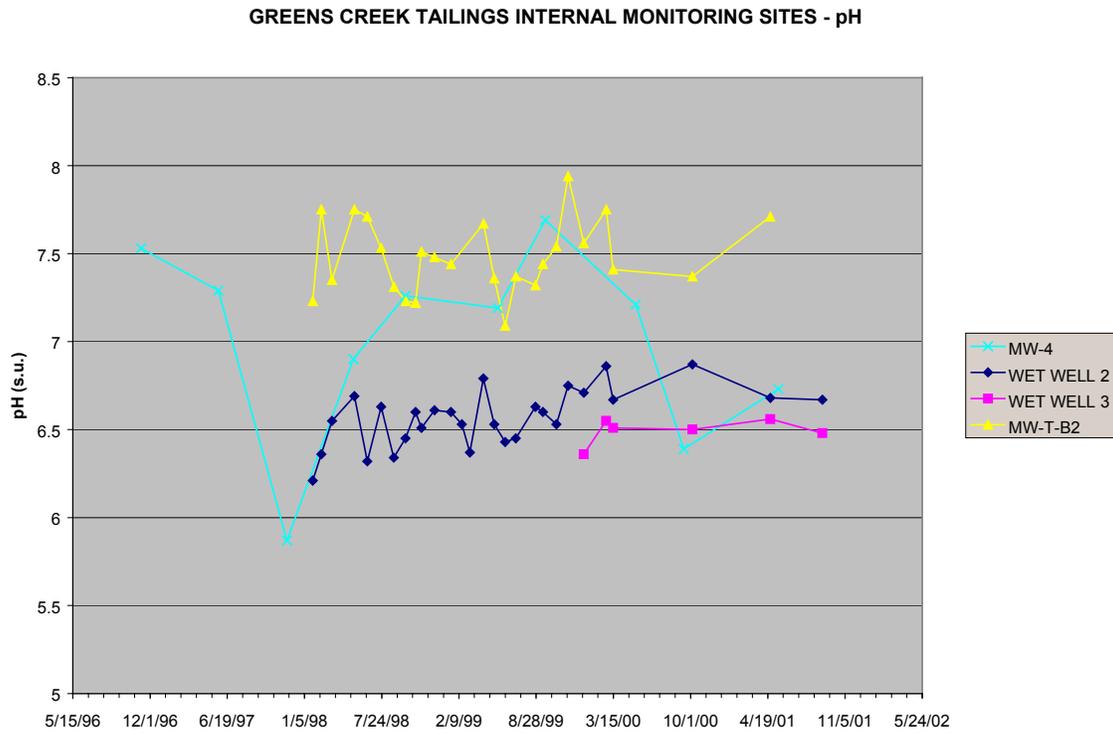
Figure 2.40 Tailings Area Internal Monitoring Plan Sites - pH Data

Values of pH were between 6 and 8 for all internal monitoring site samples in 2001. MW-T-B2, which screens the lower ten feet of tailings in the oldest portion of the pile, has the highest pH of the four internal monitoring sites. This is likely a result of microbial sulfate reduction and equilibration with carbonate in the saturated zone of the pile. The wet wells and MW-4 produce water with slightly lower pH (generally between 6.5 and 7), reflecting minor influences from groundwater (organic acids) and oxidized surface waters (acidity from thiosalt, sulfide and iron oxidation). The fact that these internal waters are near-neutral to alkaline indicates that the buffering capacity of the tailings is sufficient to prevent acidification of site drainage in the near-term (tens of years).

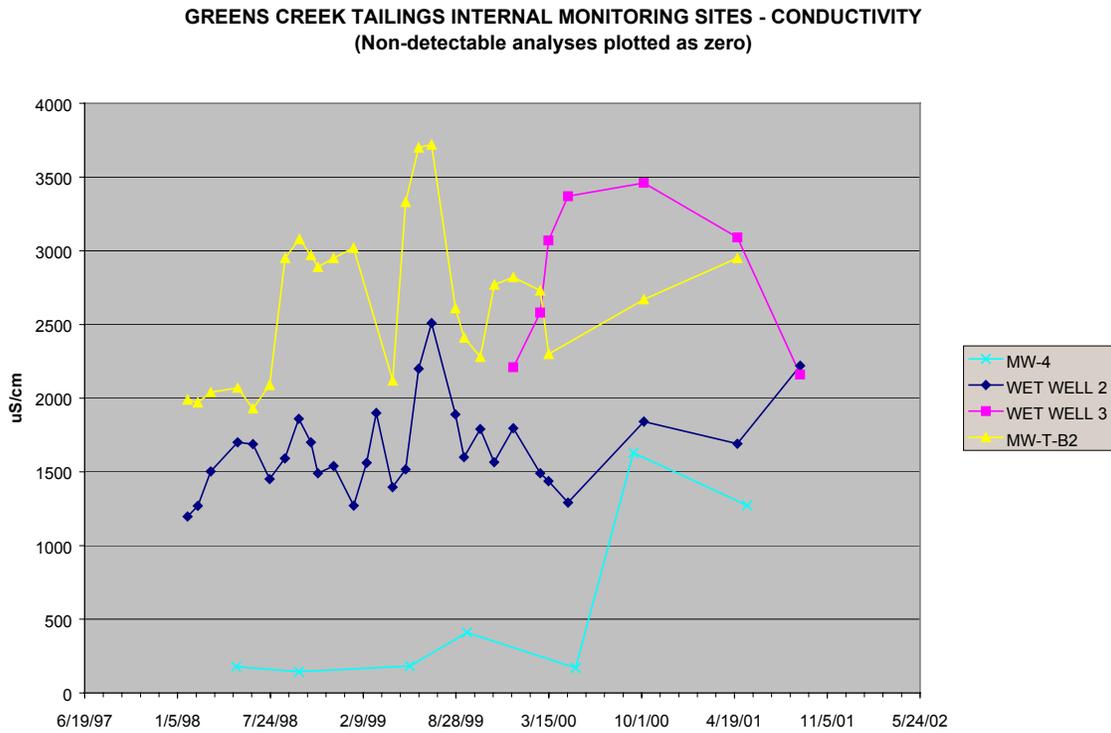
Figure 2.41 Tailings Area Internal Monitoring Plan Sites – Conductivity Data

The higher conductivity of the site contact waters reflects a larger dissolved load caused by weathering of the tailings. Pyrite oxidation and carbonate dissolution contribute dissolved ions such as sulfate, bicarbonate, calcium and magnesium to the contact waters, increasing their conductivity. Wet Well 2 generally has a lower conductivity than MW-T-B2 because it has a greater contribution from groundwater. However, both waters show similar responses to seasonal loading/flushing cycles. Wet Well 3 has a different capture area and shows a different pattern with respect to conductivity. The changes in conductivity observed in Wet Well 3 probably reflect changes in the relative contributions from runoff, infiltration and groundwater as the West Buttress was constructed.

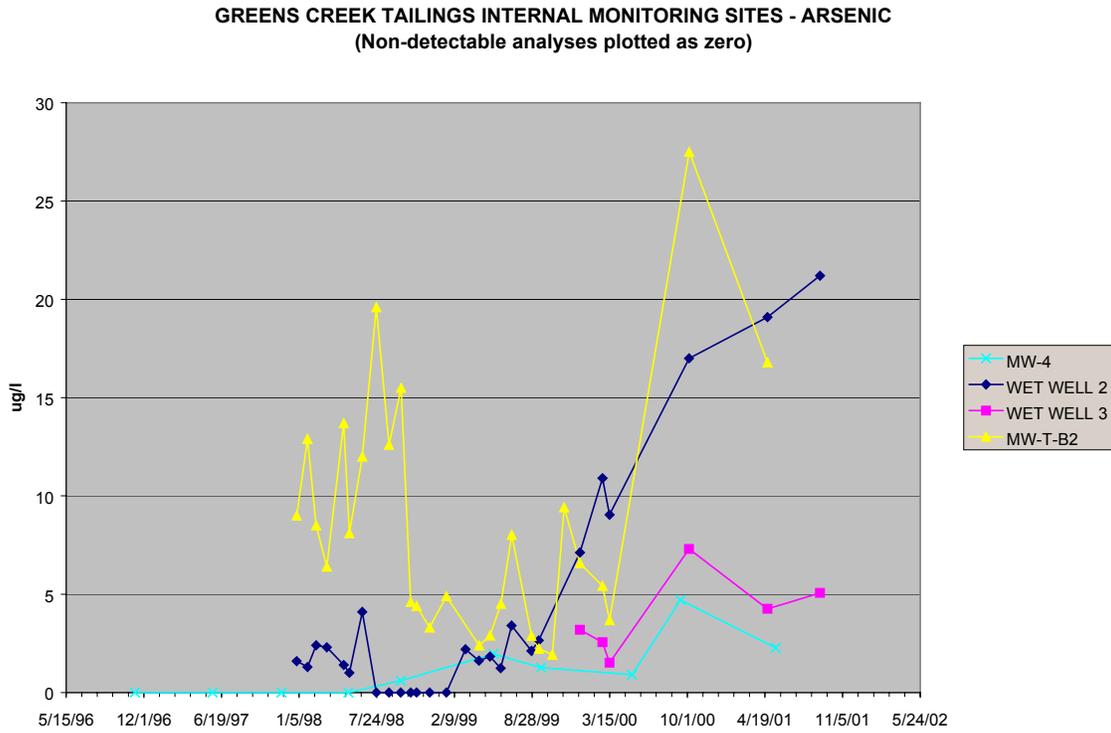
Figure 2.42 Tailings Area Internal Monitoring Plan Sites – Arsenic Data

Arsenic data are presented in Figure 2.42. The data for Wet Well 2 (and other sites to a lesser extent) show a distinct increasing trend. The data for MW-T-B2 appears to be cyclical. As arsenic-bearing minerals such as arsenopyrite and tetrahedrite/tennantite weather, the arsenic that is produced is typically co-precipitated with iron oxy-hydroxides. As the pile grows, reducing conditions overtake areas that were once oxidizing. This was particularly true as the water table rose following removal of the temporary PVC cover that was placed on the pile in 1995 (removal began in 1997). Dissolution of oxyhydroxides (and possibly sulfates) should occur as the waters respond to the changing redox conditions. This will contribute arsenic (and iron) to the drainage water. Arsenic concentrations in the drainage will decrease when redox conditions in the pile stabilize.

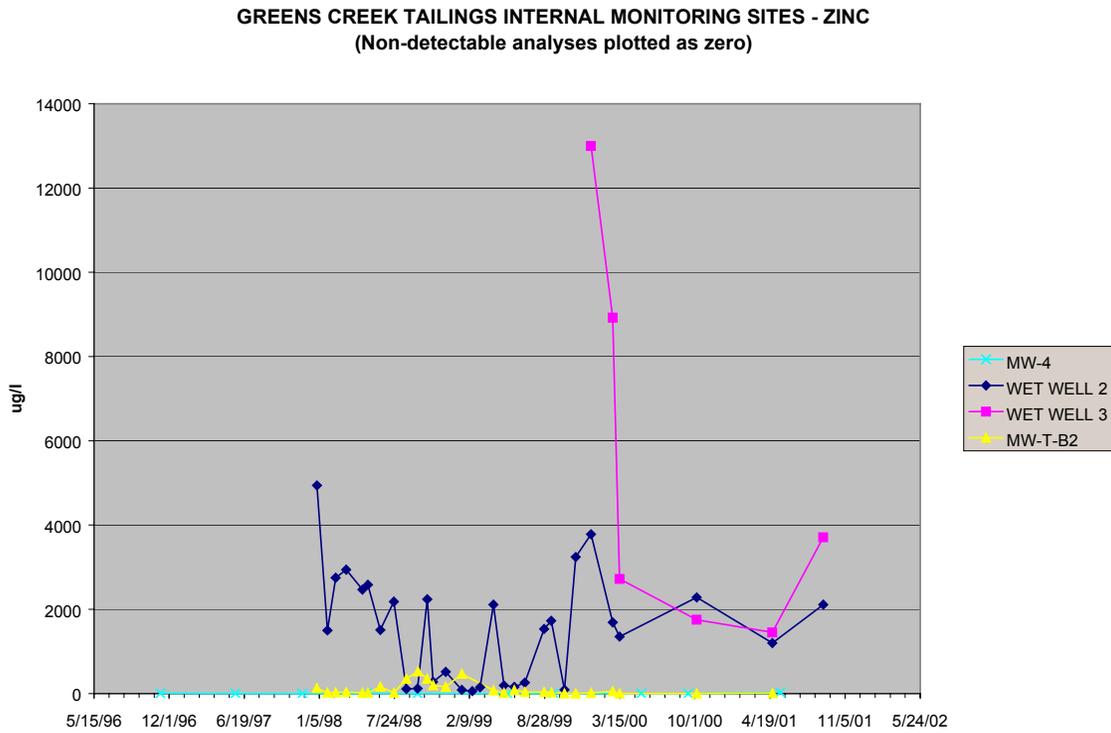
Figure 2.43 Tailings Area Internal Monitoring Plan Sites – Zinc Data

Figure 2.43 shows the concentration of zinc in the four internal monitoring sites. Zinc levels remained relatively constant in 2001. The initially high zinc concentrations in Wet Well 3 in 1999-2000 were a result of flushing of argillite used in the early construction of the West Buttress. The wet well system also received a greater component of zinc-bearing runoff during early stages of development. The low concentration of zinc in MW-T-B2 is caused by sulfate reduction, which promotes zinc sulfide precipitation. The same processes may be keeping the zinc concentrations in MW-4 low as well, despite the fact that the conductivity of the water in the shallow sand has increased with the construction of East Tailings. In contrast, the wet wells receive a significant component of oxidized near-surface water that has higher zinc concentrations.

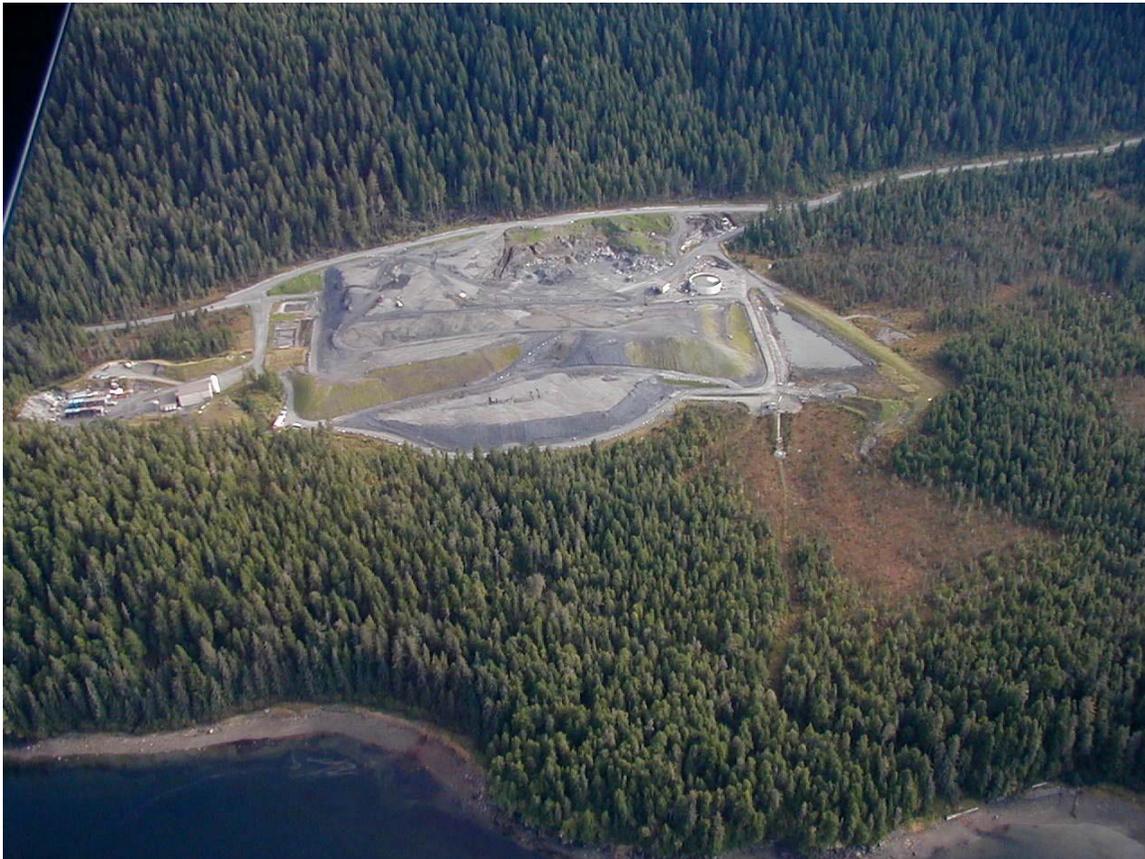
Figure 2.46 Aerial Photograph of Tailings Facility 2001

This aerial view of the Tailings Facility shows the West Buttriss (foreground), Pit 5 water treatment facility (left, north), East Tailings placement area and B Road (back), Tank 6 and Pond 6 (right, south), and NPDES outfall pipeline (foreground right).
