**TAILINGS AND PRODUCTION ROCK SITE  
2001 ANNUAL REPORT**

**Kennecott Greens Creek Mining Company**

**April 2002**

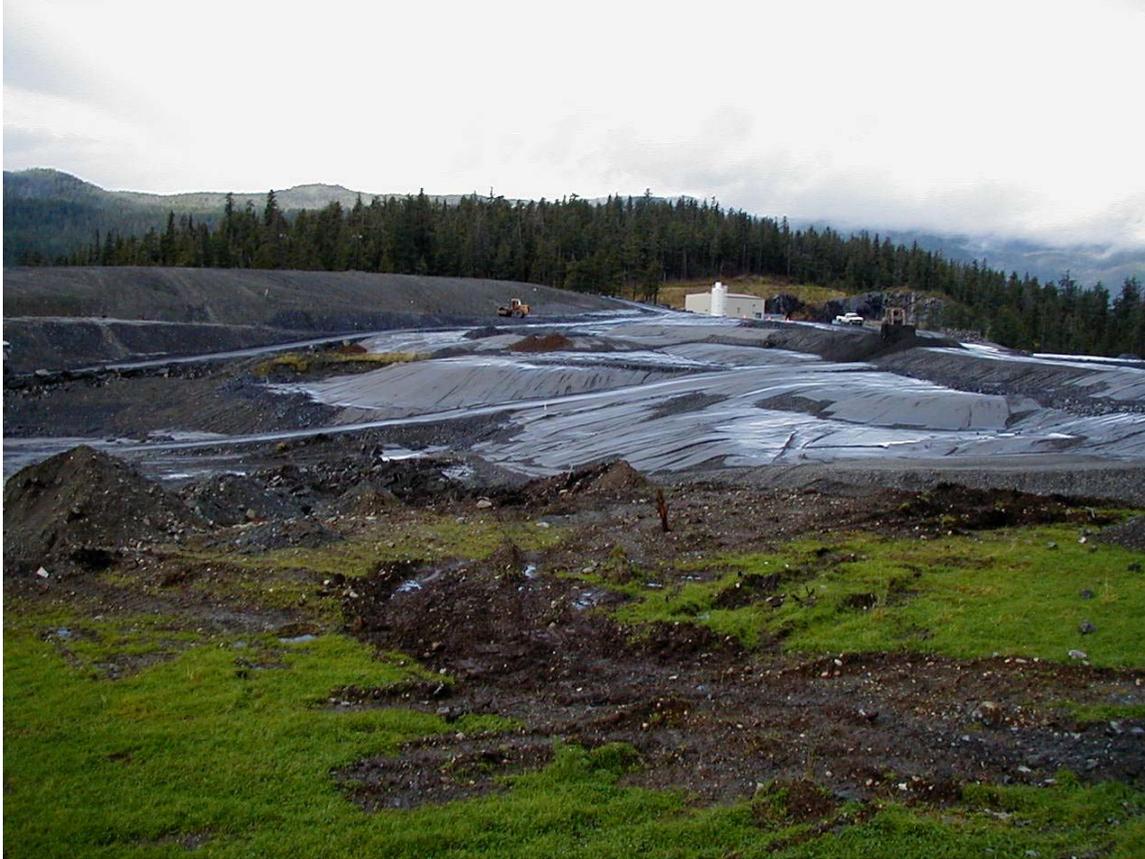
Figure 2.47 Photograph of East Tailings Placement Area

This photograph shows wet weather cellular tailings placement in the East Tailings placement area. Tailings are spread in thin lifts with a bulldozer (right) and compacted with a vibratory roller. Disturbed areas are hydroseeded to minimize erosion (foreground). The Pit 5 water treatment facility is visible in the background. Ramps (center) provide access to the wheel wash located near Tank 6 (Figure 2.46).

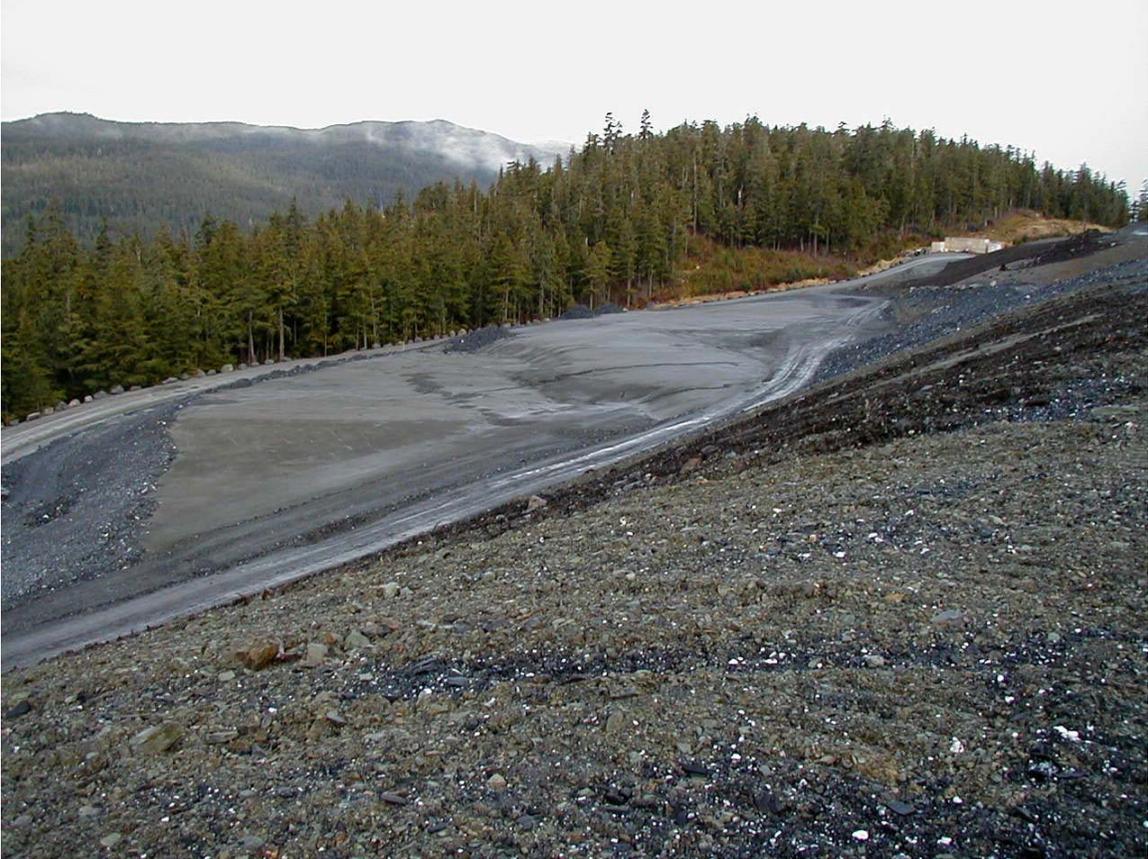
Figure 2.48 Photograph of West Buttrass Tailings Placement Area

This photograph is a view of the West Buttrass placement area from the South Tailings placement area. Tailings are placed in cells and the 3H:1V outer slope is covered with Class 1 production rock or native materials to minimize erosion.

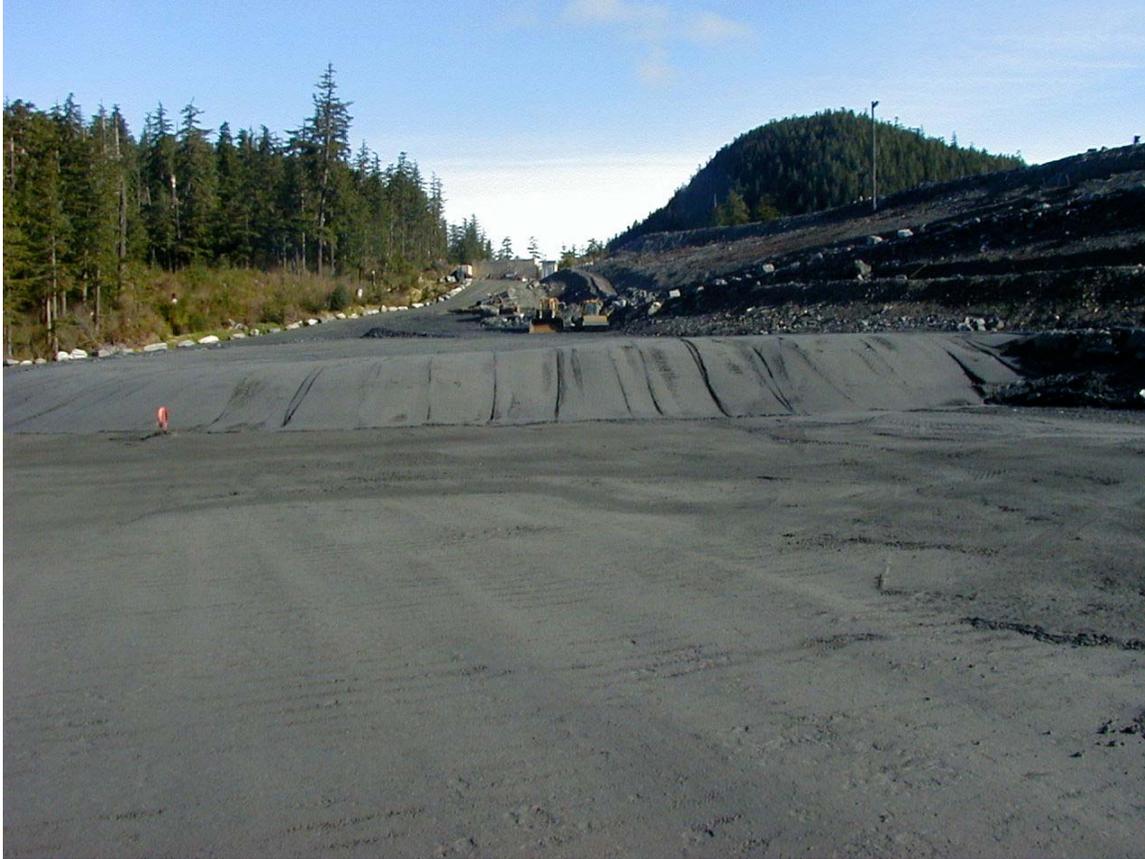
Figure 2.49 Photograph of Compacted West Buttress Tailings

This photograph is a view of compacted tailings in the West Buttress placement area. The tailings are spread and compacted in thin, inclined lifts in a cell that has an overall thickness of approximately five feet. This promotes drainage and dissipation of pore pressures that rise as the material is compacted.

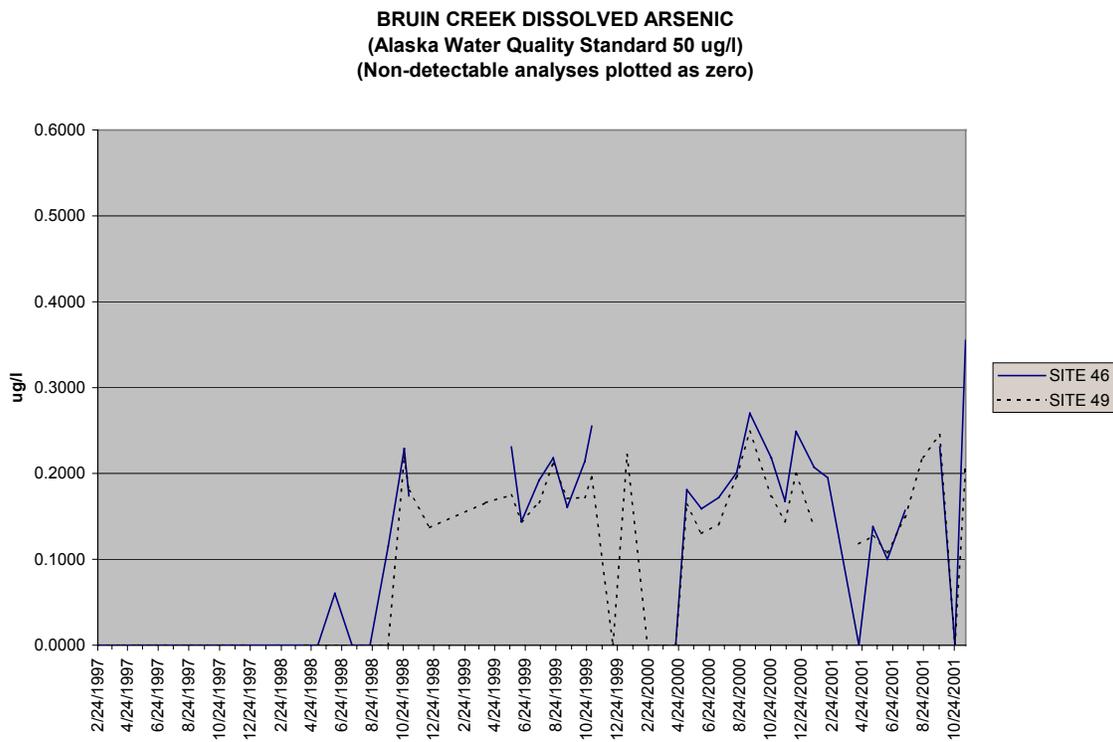
Figure 3.14 FWMP Sites 46 and 49 Arsenic Data

Arsenic results at the Bruin Creek sites show fluctuations over a very tight range from 0.1 to 0.27 ug/l (Figure 3.14). In general the upstream (Site 46) produces slightly higher arsenic levels than the downstream (Site 49). Both Bruin Creek sites' analytical results remain far below the Alaska Water Quality Standard FWMP target arsenic level of 50 ug/l.

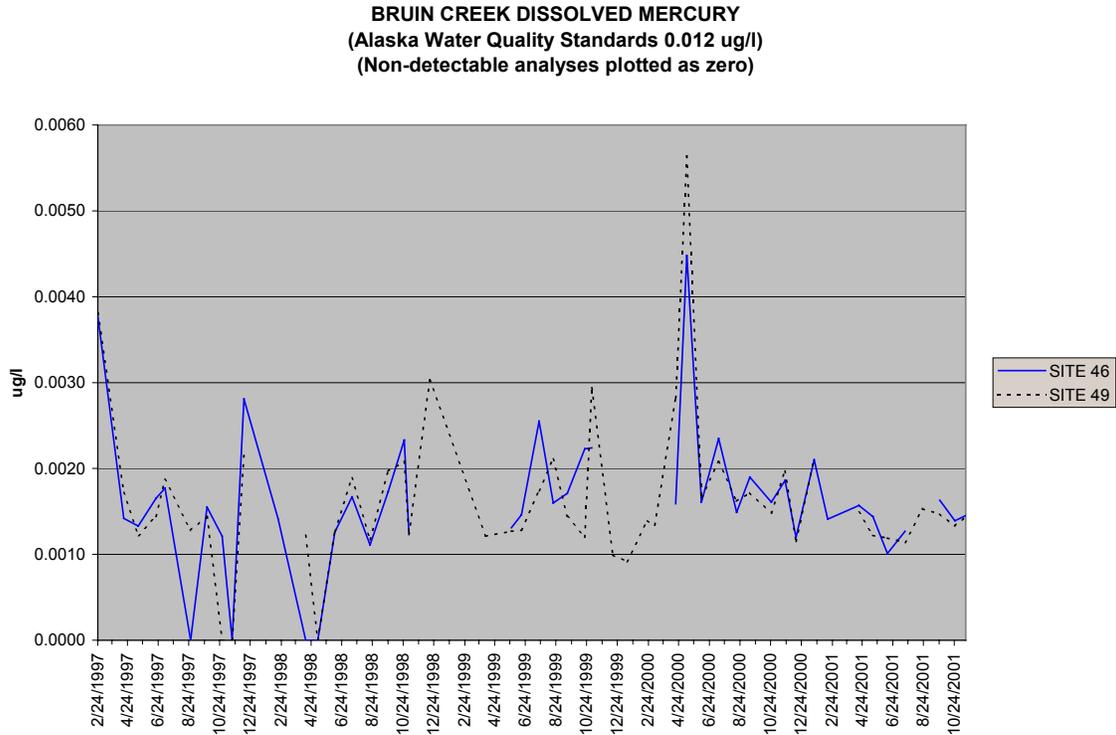
Figure 3.16 FWMP Sites 46 and 49 Mercury Data

Mercury results at the Bruin Creek sites follow the same pattern as the above arsenic and copper results. Fluctuations generally find the mercury level between 0.001 and 0.003 ug/l (Figure 3.16), again with the upstream (Site 46) generally producing slightly higher mercury levels than the downstream (Site 49). A spike in both sites' analytical results in April 2000 was still well below the Alaska Water Quality Standard FWMP mercury target level of 0.012 ug/l. These results then dropped right back into the normal range with the following analyses, and have remained in this low range since. Both Bruin Creek sites' analytical results remain far below the Alaska Water Quality Standard FWMP mercury target level of 0.012 ug/l.

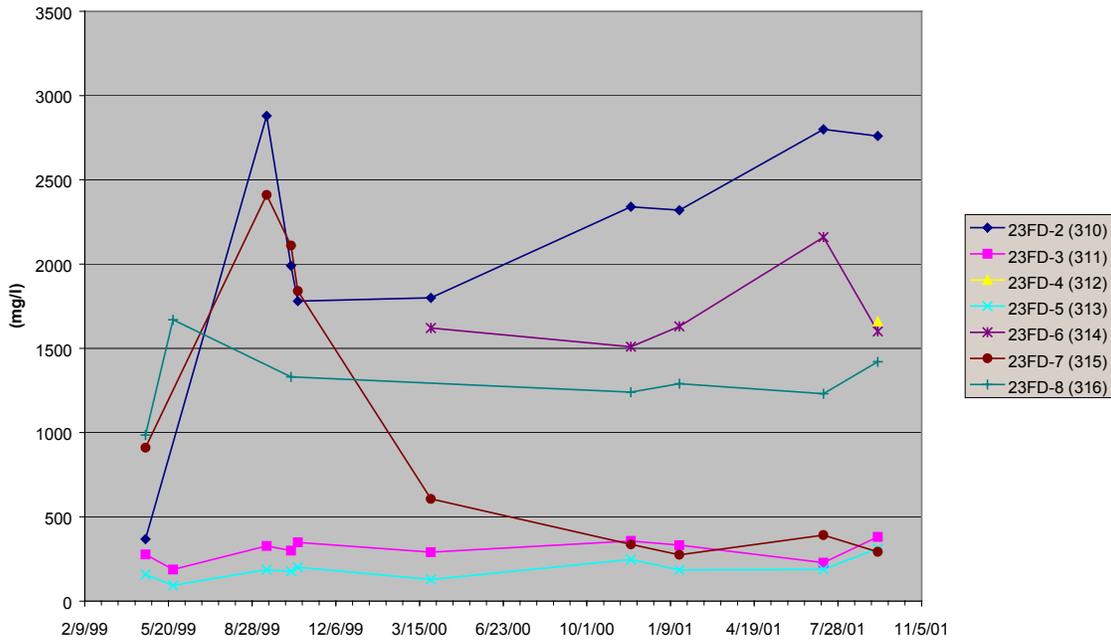
Figure 3.26 Site 23/D Internal Monitoring Plan Sites – Sulfate Data

The fact that MW-D3 does not show signs of a contribution from contact water suggests that an upward hydrologic gradient may exist beneath Site D. Finger Drain FD-2 has the highest conductivity but consistently low flow, suggesting no significant influence from groundwater. This drain may also be influenced by runoff that infiltrates along the access ramp to the site. The higher conductivity of the site contact waters reflects a larger dissolved load caused by weathering of the production rock. As with tailings, pyrite oxidation and carbonate dissolution contribute dissolved ions such as sulfate, bicarbonate, calcium and magnesium to the contact waters, increasing their conductivity. Sulfate concentrations for the finger drains are plotted in Figure 3.26 and match closely the values of conductivity.

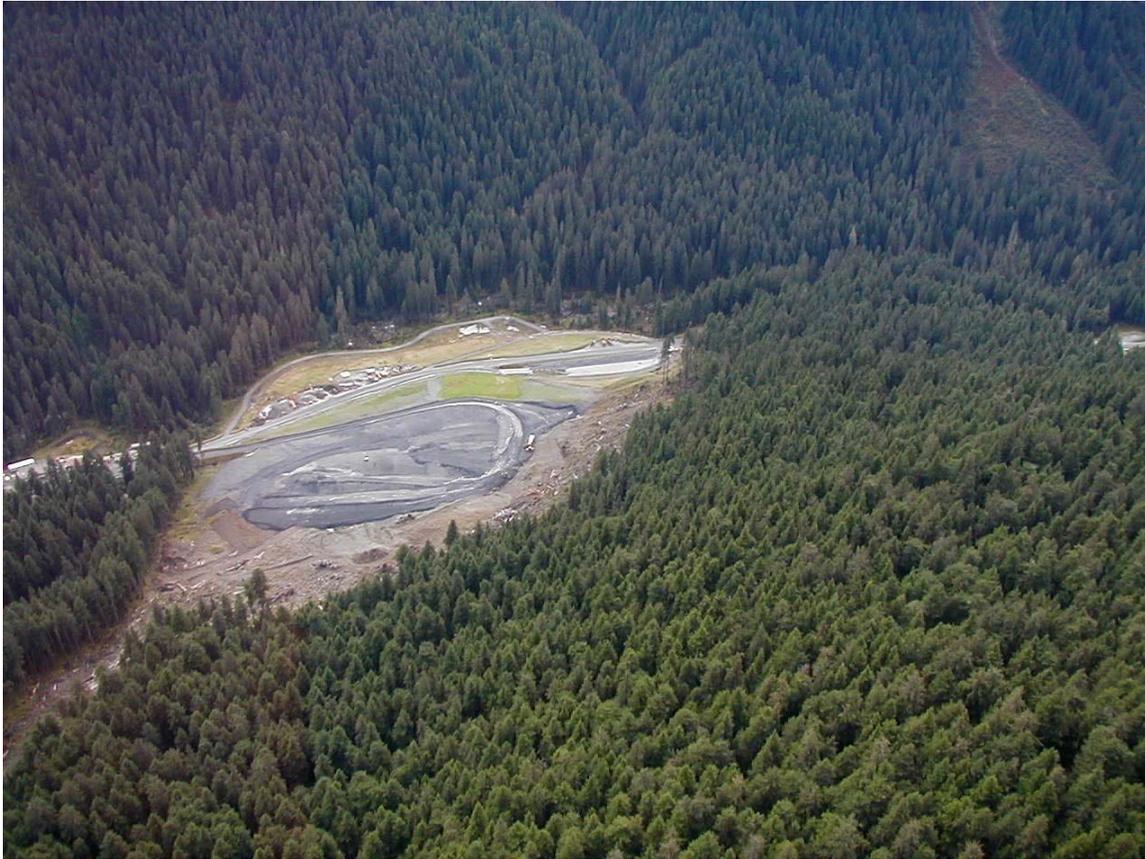
This photograph shows Site 23 (foreground) and Site D (separated from Site 23 by the B Road). The composite soil cover plot (green) is visible on the lower slope of Site 23. Pond 23 and Pond D are visible on the southwest (right) perimeters of their respective sites. Reclamation materials have been removed from the slope above Site 23 (below tree line, foreground).

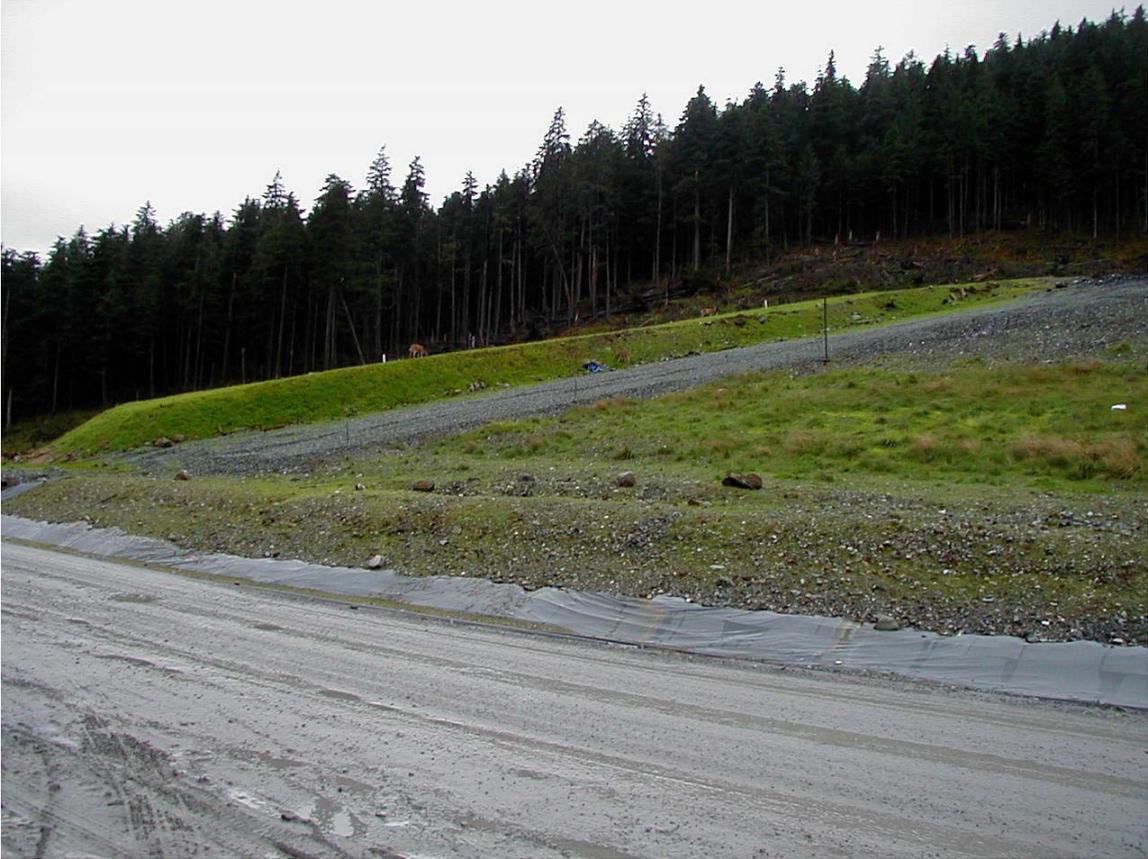
The photograph shows the recently seeded composite soil cover placed on the lower slope of Site 23. A portion of the lower capillary break is visible below the seeded growth layer. The B Road and lined ditch that brings surface waters to Pond 23 are visible in the foreground.

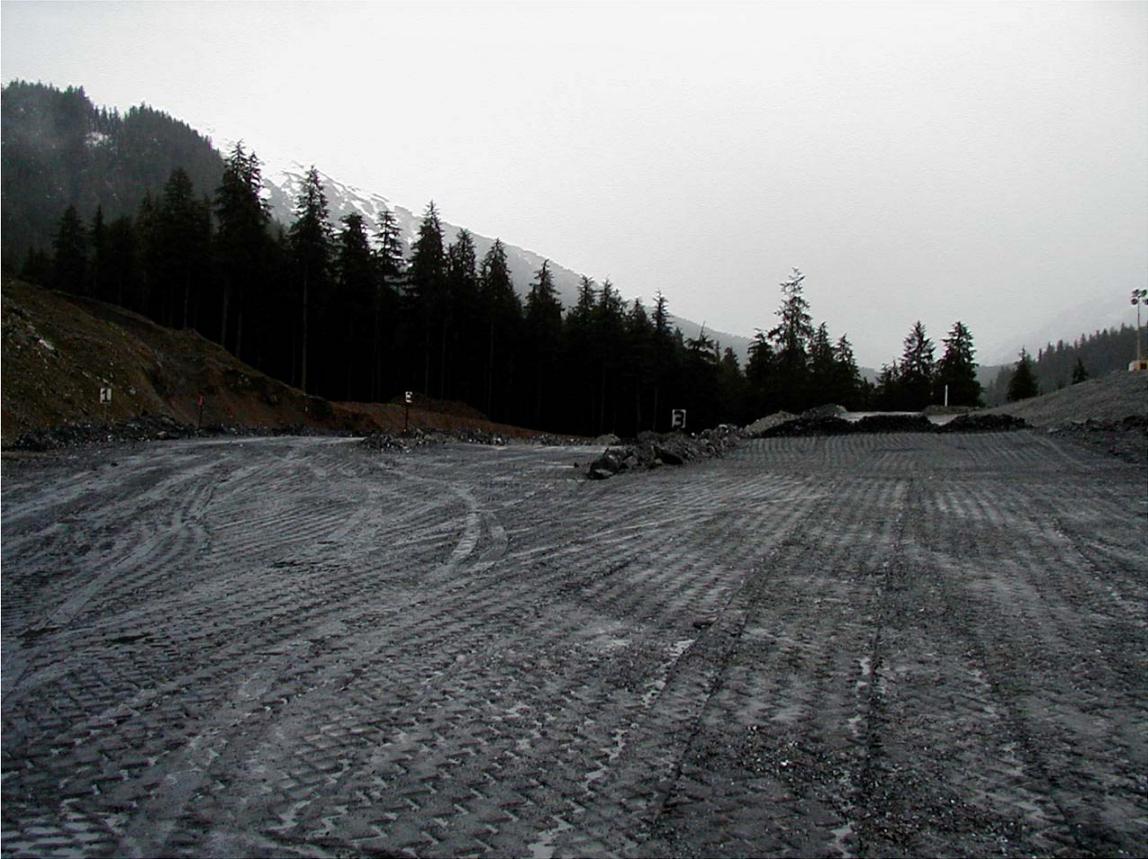
The photograph shows the designated placement zones (Class 1, left; Class 2, center; Class 3, right). Marks from the grid roller are visible on the recently spread and compacted production rock surface. The view is looking east.

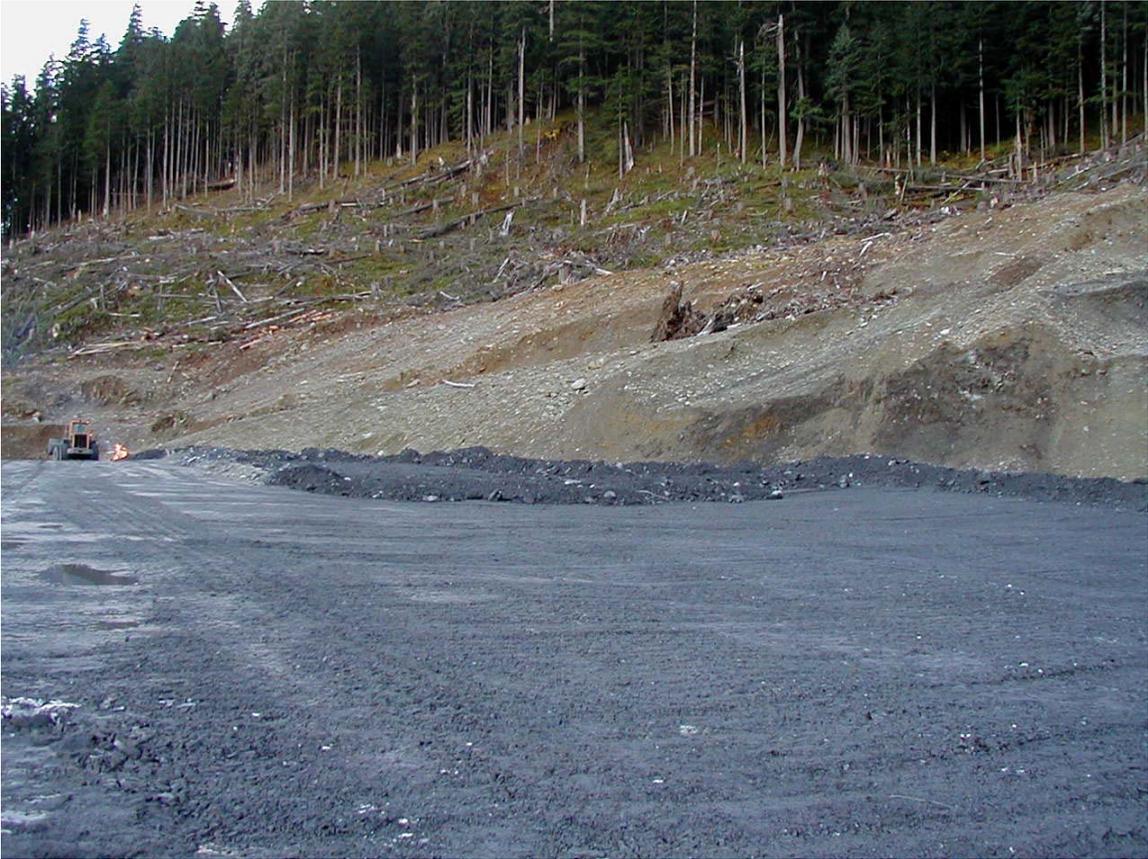
Figure 3.45 Photograph of Site 23 Foundation Preparation

This photograph shows construction of base of the pile. Native rock and sediments are removed from the back slope and stockpiled for use in future reclamation projects. Finger drains (not visible) are extended over the prepared surface and a five-foot thickness of Class 1 production rock are placed prior to placement of other classes.

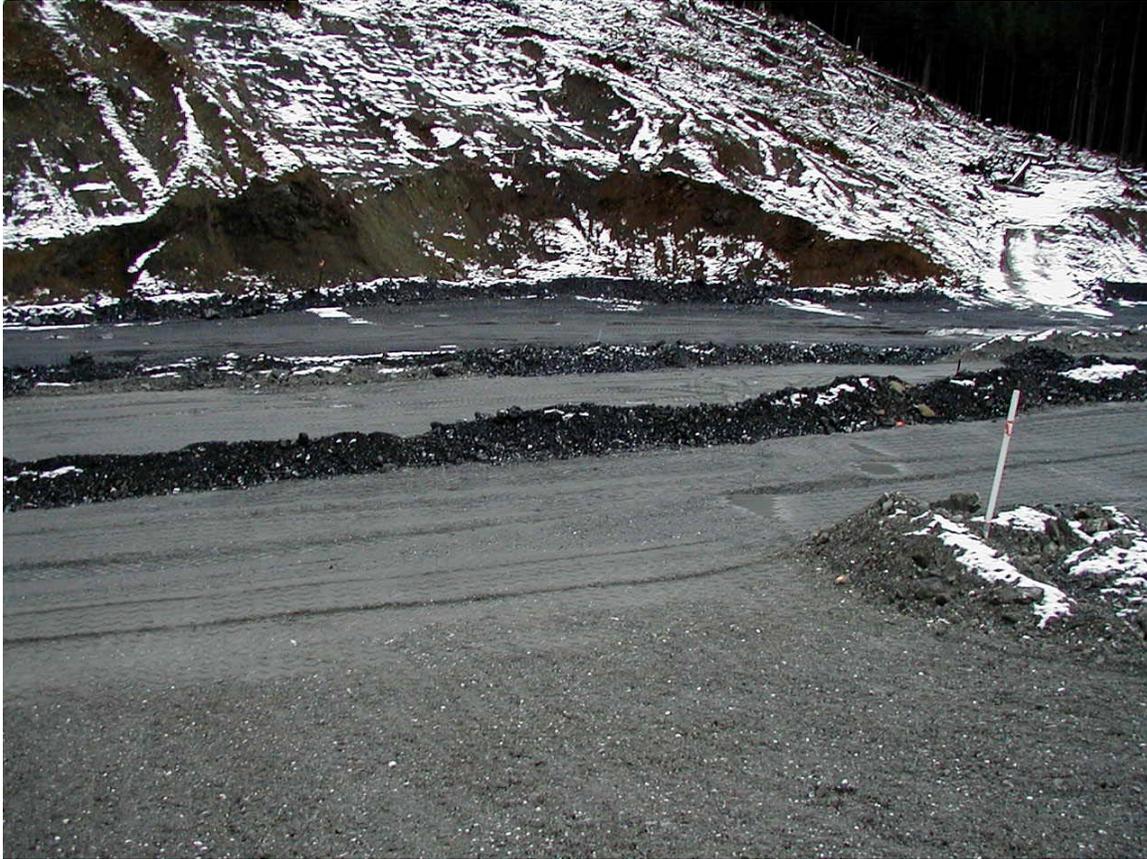
The three designated placement zones are visible in the lower half of the photograph. Class 3 in the foreground, Class 2 at center and Class 1 at base of backslope. Safety berms are left between the placement zones. Excavated material from the backslope (upper half of photo) will be used for site reclamation. Monitoring well MW-23-98-01 is visible in the foreground (right). The view is oriented north.
