**INACTIVE PRODUCTION ROCK SITES AND QUARRIES
2002 ANNUAL REPORT**

Kennecott Greens Creek Mining Company

August 2003

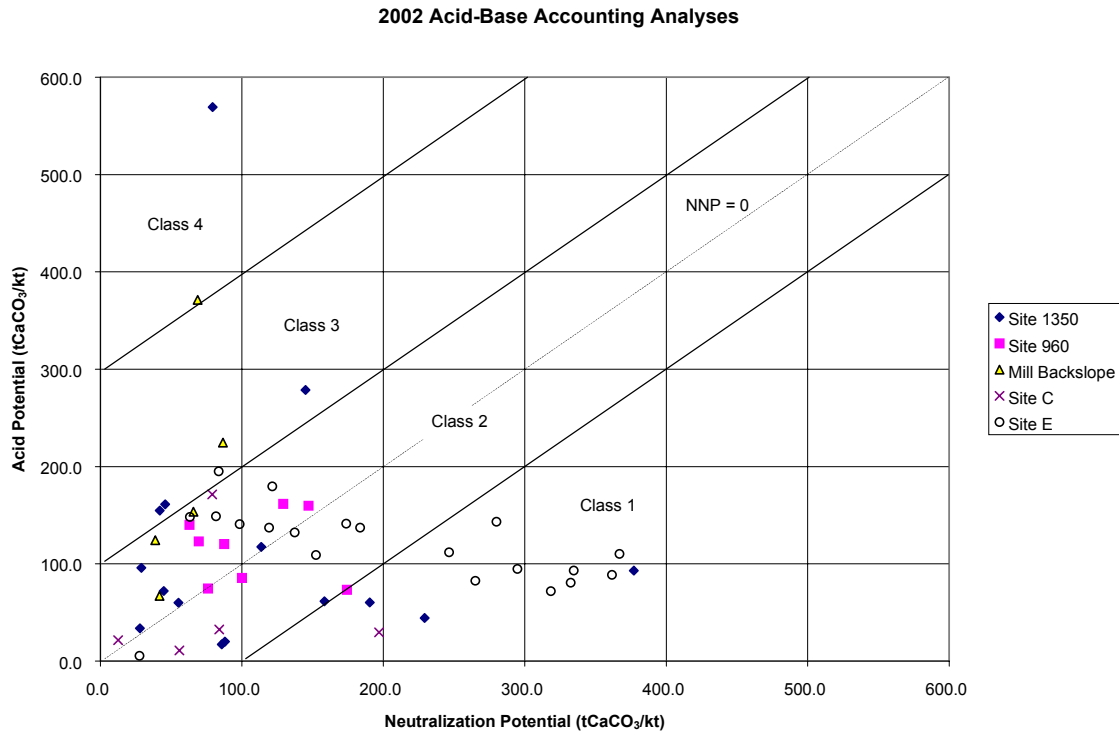
Figure 2.2 2002 Inactive Production Rock Site Acid Base Accounting Analyses

Figure 2.2 compares Acid Potential (AP) with Neutralization Potential (NP) from surface grid samples. The inactive sites were constructed prior to development of the classification protocol that KGCMC currently uses. At the time the inactive piles were constructed KGCMC did not classify or segregate its production rock. Symbols in Figure 2.2 represent actual laboratory data points. Lines indicating the currently utilized production rock classes are shown on Figure 2.2 for

reference only. Figure 2.2 shows a wide distribution of potentially acid generating (upper left half of figure) and potentially acid neutralizing (lower left half of figure) samples. Most of the samples would be classified as Class 2 under the current classification procedure. Regardless of pyrite content, almost all production rock at Greens Creek contains substantial carbonate (5 to 40 %). Although approximately half of the grid samples are potentially acid generating, their carbonate contents indicate that there is a relatively long lag time to potential acid generation for the majority of the samples.

A long lag time to potential acid generation explains why only a few samples show signs of acidification and indicates sufficient time remains available to reclaim the sites, pending availability of backfill space underground or cover material. Figure 2.3 shows the relationship between surface rock grid sample rinse pH and net neutralization potential (NNP). NNP is the balance between NP and AP. A negative NNP typically indicates the sample is potentially acid generating. Rinse pH is a measure of the pH of a one-to-one mixture of “as-received” fines and water. Rinse pH is different than paste pH, which is the pH of the sample after it has been pulverized and moistened. Rinse pH is often lower than paste pH because pulverizing the sample exposes fresh, sometimes alkaline, mineral surfaces. The rinse pH method also uses more water, which can dissolve surface oxidation products, lowering the pH of the solution. The rinse pH data in Figure 2.3 demonstrate that the vast majority of the samples retain enough buffering capacity to maintain pHs above 6.5. Six of the more than 50 samples show evidence of buffering capacity depletion. These six samples are generally very pyritic and lack significant carbonate mineralization. Four of these six samples are from a bench of pyritic rock on the Mill Backslope.

Grid sampling of the Mill Backslope (Figures 2.2 and 2.3) indicates that the rock is acid generating. The average AP for the backslope samples (188 tCaCO₃/kt) is considerably higher than the average AP of other inactive sites, reflecting a higher sulfide content. The lower NP values for these materials relative to other samples are a result of lower carbonate contents in the rock when it was placed and depletion of carbonate from the fines fraction through weathering.

Results of ABA analyses (Figures 2.2 and 2.3) show that two of the five samples are potentially acid generating, however the site drainage remains near-neutral. During construction of the assay lab, glacial till from Site 23 was placed over much of the exposed production rock. The Site 23 material is not potentially acid generating and reduces exposure of the covered production rock to precipitation and oxygen. A network of drains and catchments diverts surface water away from the production rock. Flow from the production rock is low (less than 1gpm), remains near-neutral and has moderate sulfate, zinc, cadmium and iron concentrations. Monitoring in Greens Creek below Site C shows no signs of significant effects from the Site C or other sites up-gradient of the monitoring point.

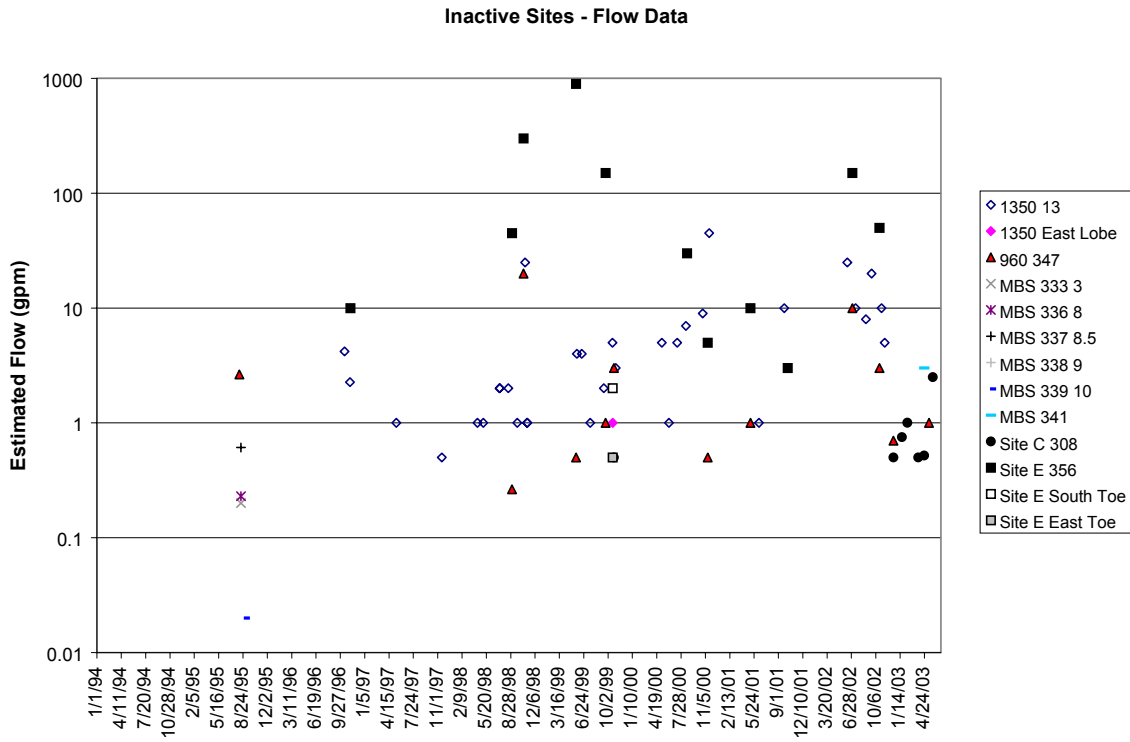
Figure 2.4 Inactive Production Rock Site Flow Data

Flow data presented in Figure 2.4 demonstrate that flows at most of the sample locations are generally low (less than 1 gpm). Much of the flow data were collected as part of the NPDES stormwater monitoring program. Collected during or following storm events, flow data from these locations (e.g. Site E 356, 960 347) represent short-term maximum flow values. Lack of significant flow from inactive sites is a positive characteristic because it reflects minimization of potential off-site impacts.

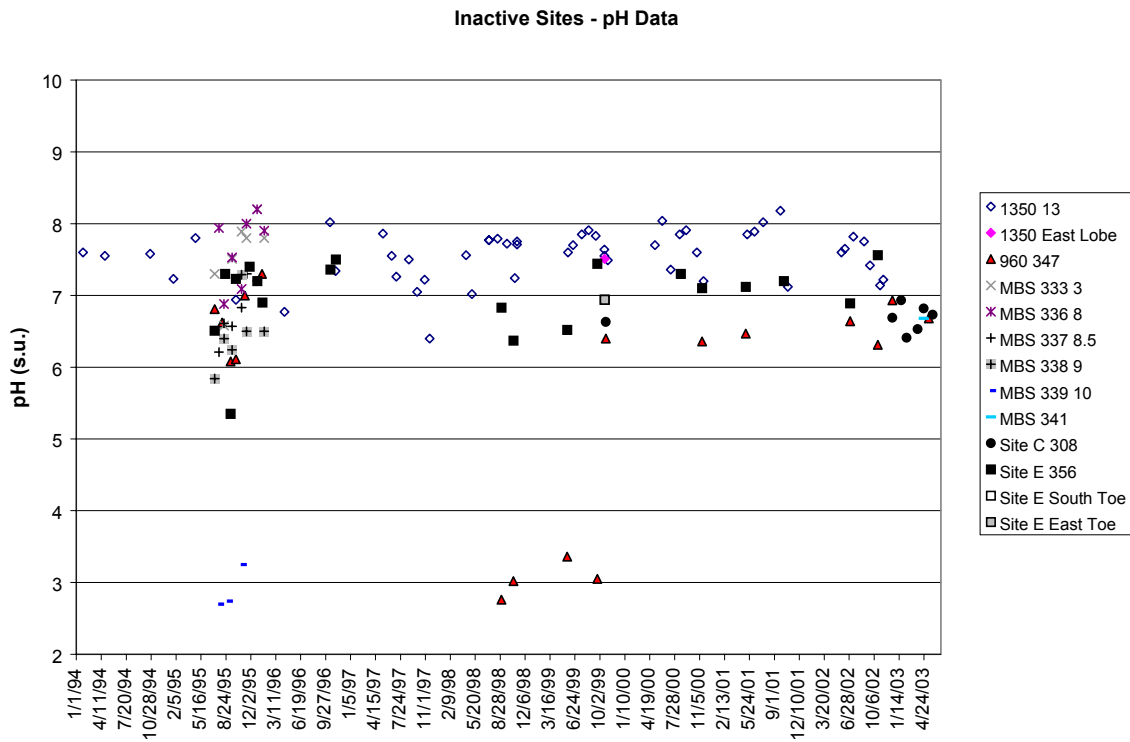
Figure 2.5 Inactive Production Rock Site pH Data

Figure 2.5 shows pH data from inactive site sampling locations. Lower alkalinity values can represent influences from pyrite oxidation and/or organic acids from muskeg and forest soils. The data show that the vast majority of the site drainage remains above pH 6.0. The sample from the mill backslope in 1995 was runoff collected from a bench containing zones of heavily pyritized rock. For a brief period in 1998 and 1999, acidic conditions developed at Site 960 347. KGCMC applied lime and removed 1000 cubic yards of oxidized pyritic rock from the site in 2000. The pH of the drainage quickly rebounded and has remained near-neutral since 2000. Alkalinity data presented in Figure 2.6 are consistent with the pH results in Figures 2.3 and 2.5. Except for the one of the mill backslope sites, all sample locations maintain measurable alkalinity provided by dissolution of carbonate minerals.

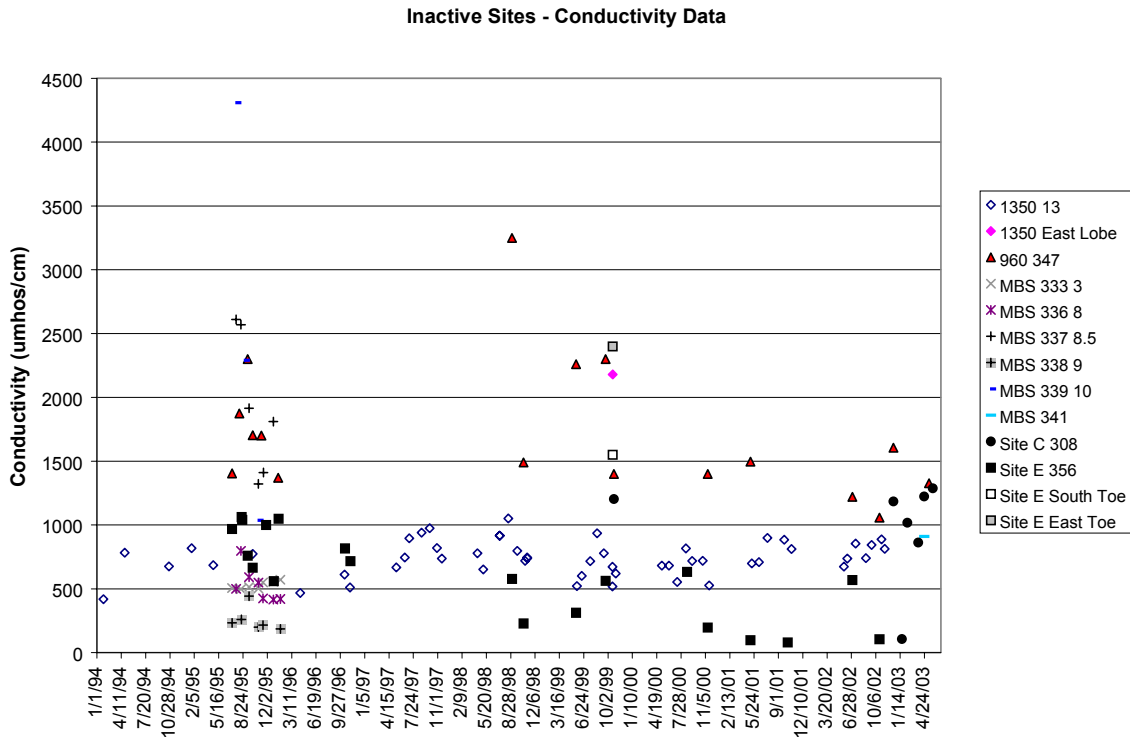
Figure 2.7 Inactive Production Rock Site Conductivity Data

Conductivity data are shown in Figure 2.7. Conductivity indicates the amount of dissolved constituents in the water. KGCMC samples having higher conductivity values usually have higher sulfate, calcium and magnesium (hardness) concentrations, reflecting influences from sulfide oxidation and carbonate mineral dissolution. Water that has contacted production rock is expected to have higher conductivity values than background waters. Site E 356 and 960 347 show an overall decreasing trend in conductivity, and the 1350, Mill Backslope and Site C remain unchanged. The trends apparent in Figure 2.7 are the result of decreasing reactive surface area available for oxidation and dissolution. The reactive surface area decreases as reactants are consumed and mineral surfaces become coated with oxidation products. The results for sulfate, magnesium and hardness, shown in Figures 2.8, 2.9 and 2.10, respectively, correlate with conductivity results and are consistent with the concept of generally decreasing or static reactive surface area discussed above.

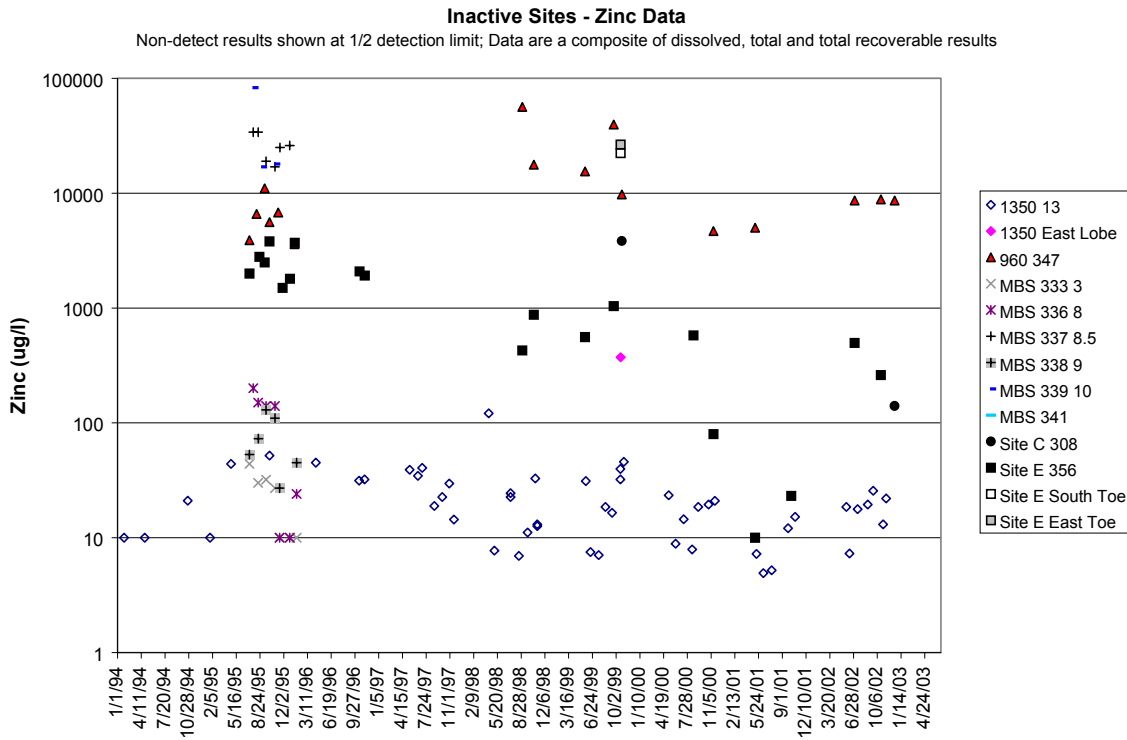
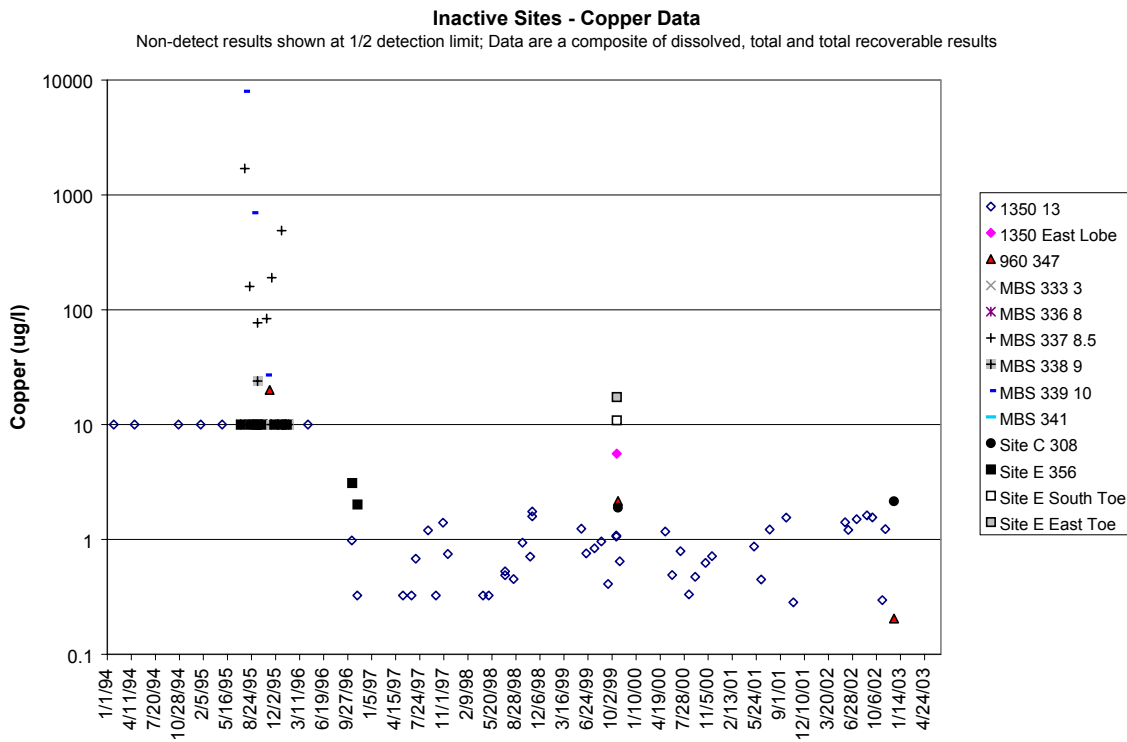
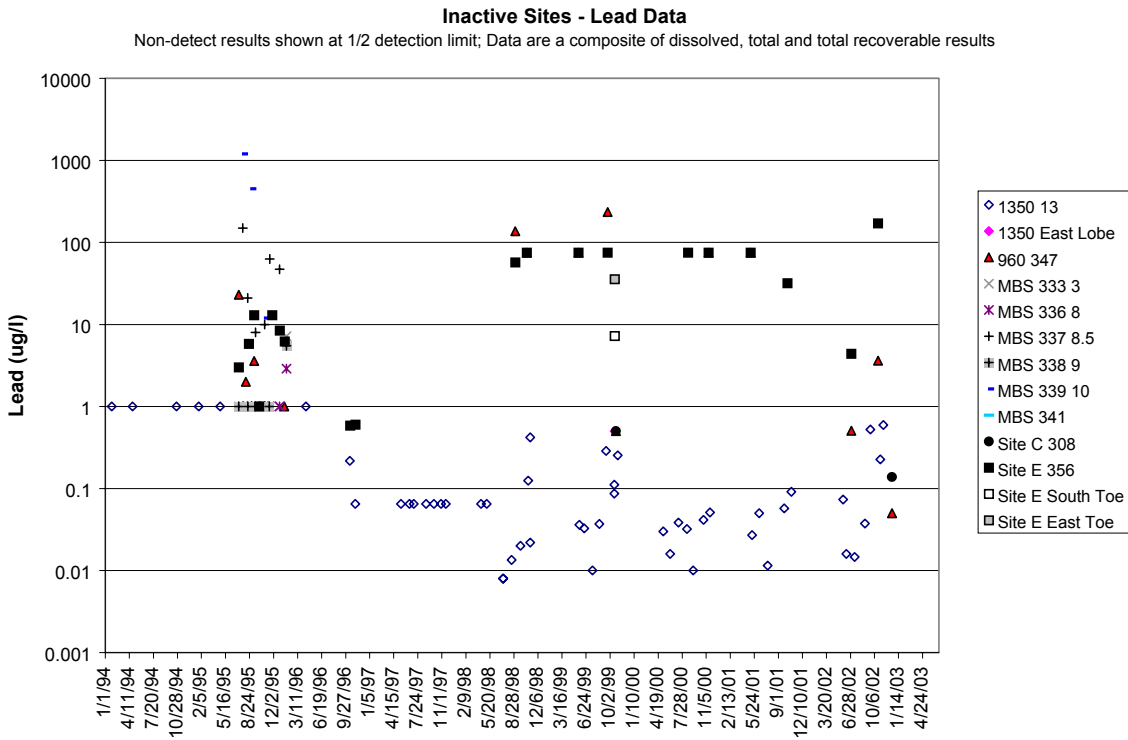
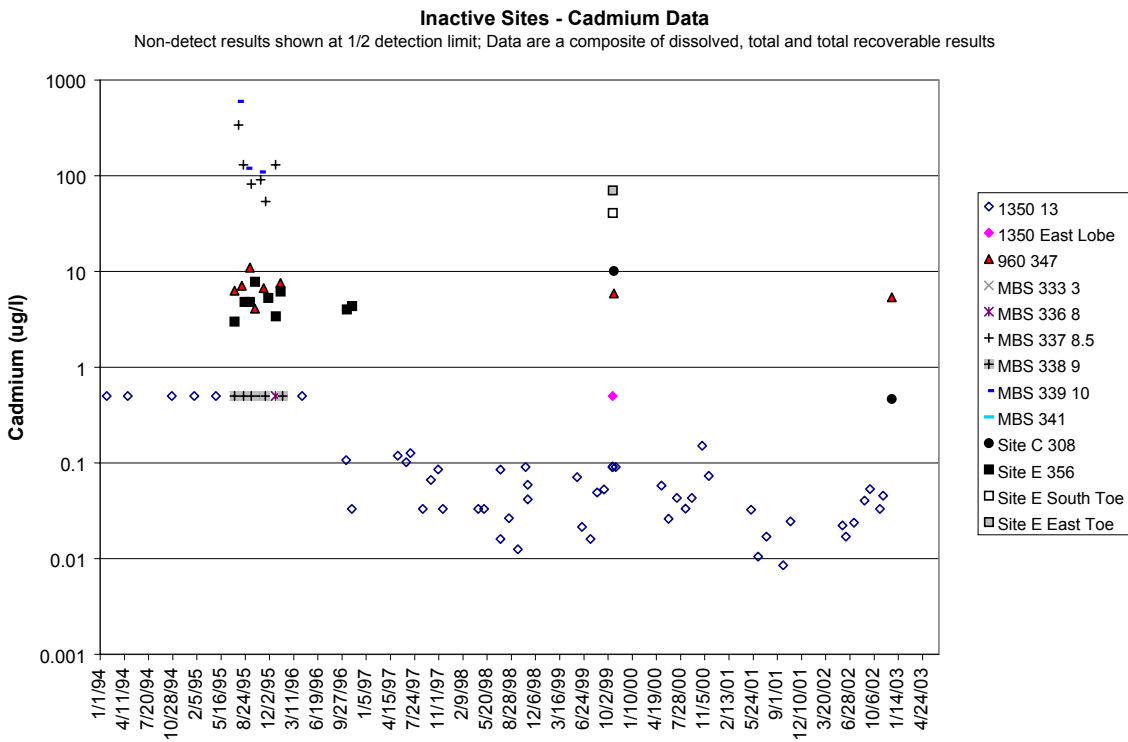
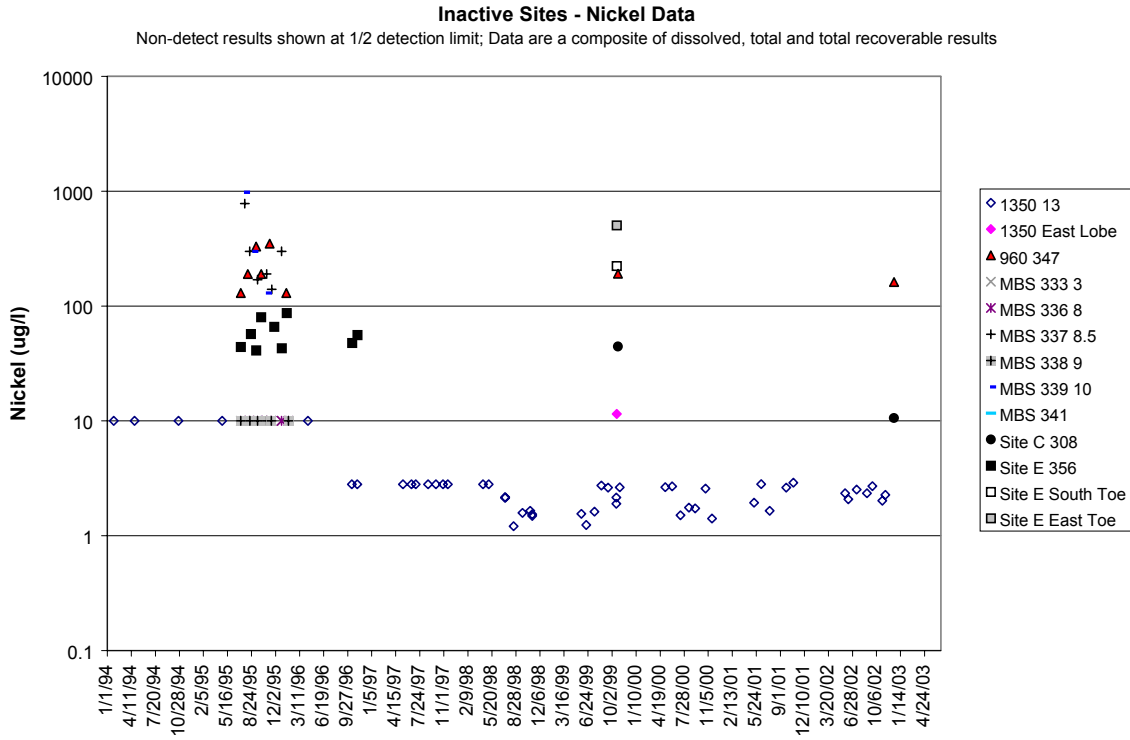
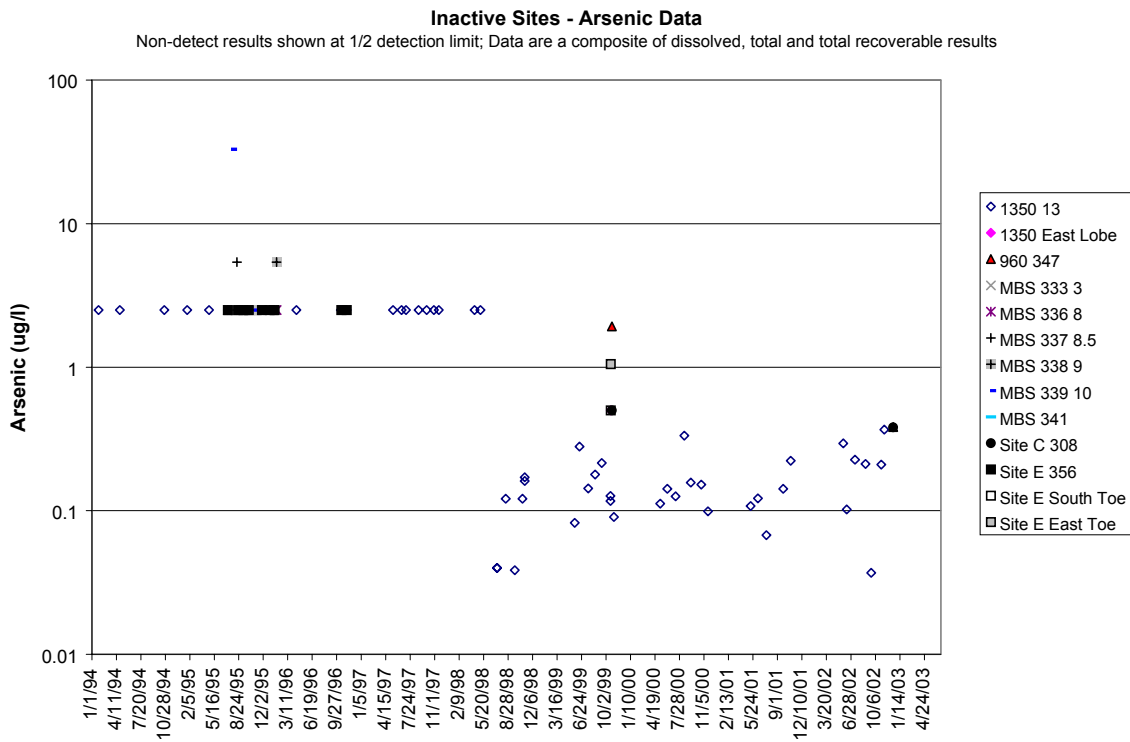
The data for zinc, copper, lead, cadmium, nickel and arsenic are presented in Figures 2.11 to 2.16. Sample results that were less than the detection limit are plotted at one half the limit value. While this allows the results to be plotted on a logarithmic scale, it causes non detect results with high detection levels to appear more concentrated than they actually are. Detection limits have varied with time and are often evident on the graphs as horizontal groupings of symbols. The results for metals generally correlate with conductivity values. Zinc concentrations reflect the higher solubility of this element relative to the others. Metal loads from inactive sites have either remained relatively constant or decreased with time. The decrease in metal loading is attributed to the reduction or reactive surface area discussed above.

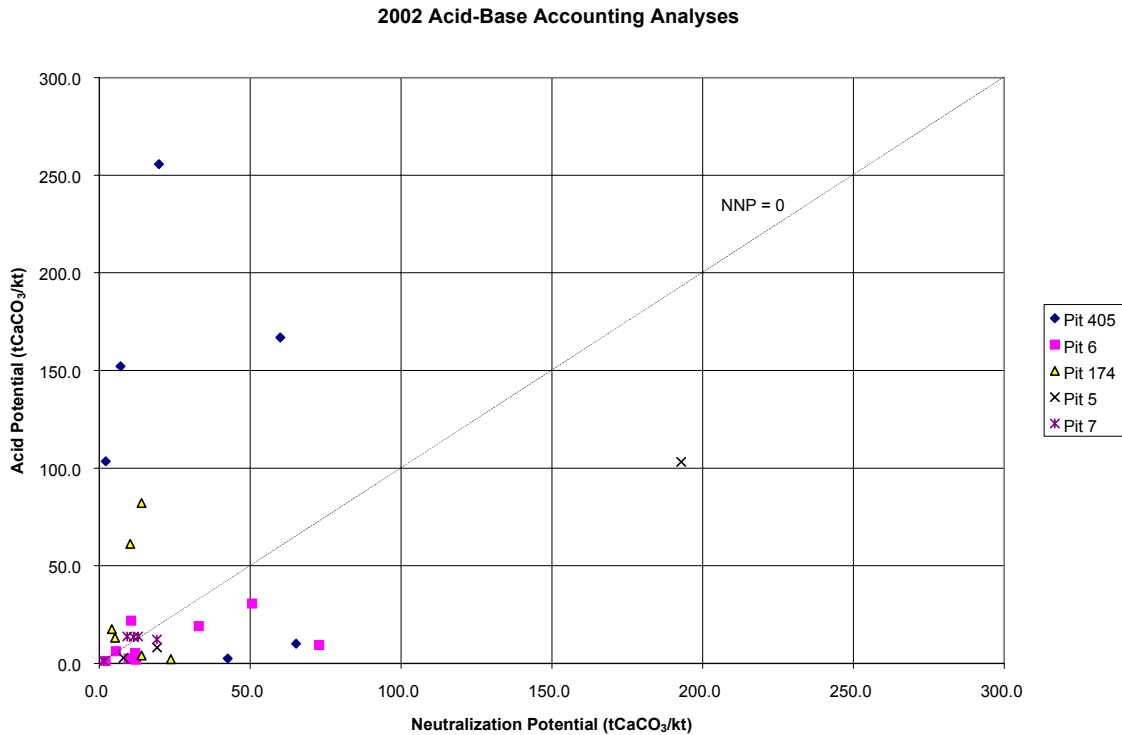
Figure 3.1 2002 Quarry Site Acid Base Accounting Data

Acid Potential (AP) is compared with Neutralization Potential (NP) in Figure 3.1. The distribution of AP and NP values is considerably less than that of inactive production rock sites shown in Figure 2.2. There is typically less pyrite and carbonate in the quarry rock relative to mine production rock. Two of the five quarries (Pit 6, Pit 5) contain little or no potentially acid generating rock. The remaining three quarries (Pit 405, Pit 174 and Pit 7) had multiple samples

of potentially acid generating rock (upper left half of Figure 3.1). One of the potentially acid generating samples from Pit 7 is actually peat, which contains organic acids. This sample does not indicate the potential for acid production from sulfide oxidation. Pit 405 and Pit 174 are the only quarries that have significant zones of potentially acid generating rock.

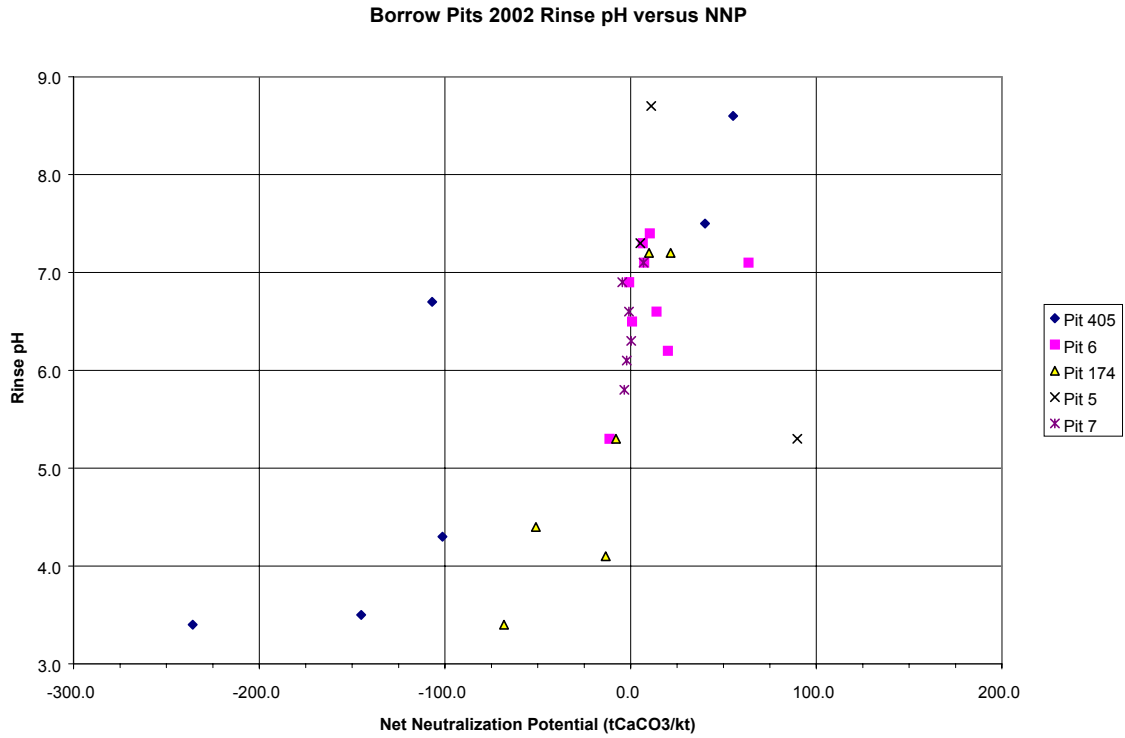
Figure 3.2 2002 Quarry Site Rinse pH Data

Figure 3.2 shows the relationship between rinse pH and net neutralization potential (NNP) for quarry samples. See Section 2.1 for a description of NNP and the differences between rinse pH and paste pH. Twenty of the 30 samples produced a rinse pH greater than 6.0, demonstrating maintenance of buffering capacity. Eight samples from pit walls (mainly Pit 405 and Pit 174) show evidence of buffering capacity depletion. A sample of exploration drill core stored at Pit 5 produced a pH of 5.3, but this sample is not representative of the native rock exposed in the quarry walls. Similarly, a sample of peat stored in Pit 7 produced a pH of 5.8.

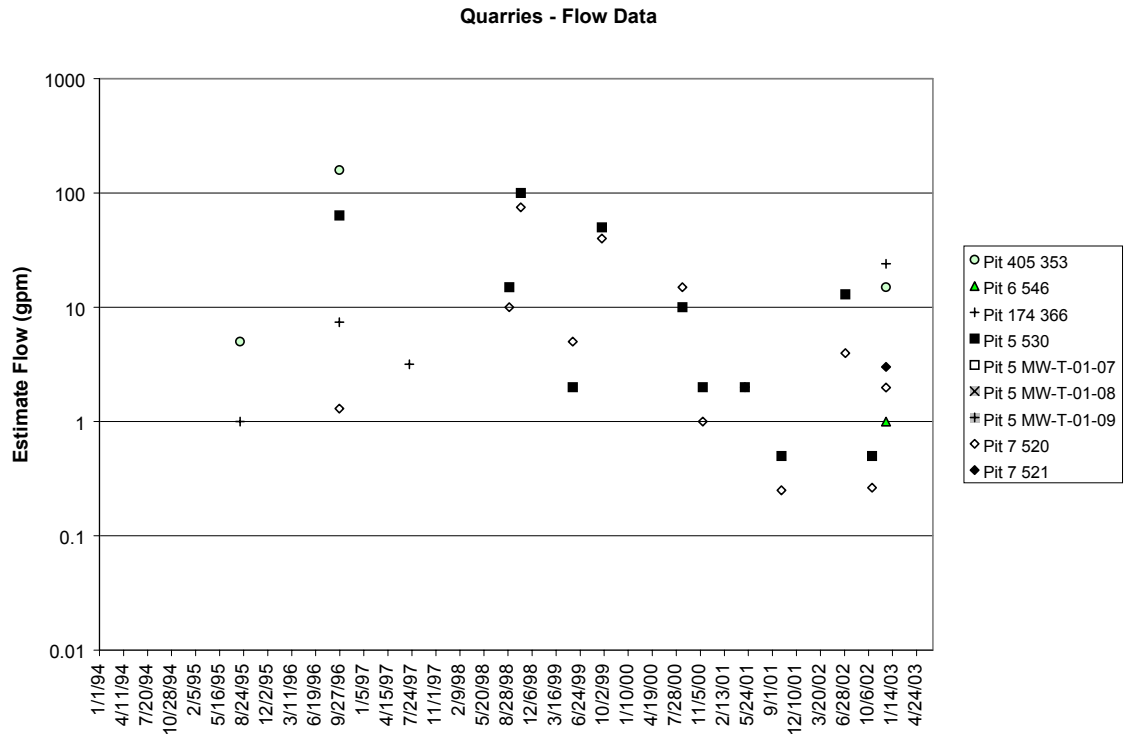
Figure 3.3 Quarry Site Flow Data

Flow data for the quarry sites are presented in Figure 3.3. Much of the flow data was collected during or shortly following storm events and represents maximum flow values. Flow estimates vary from just over 100 gpm to less than 1 gpm with most less than 10 gpm. The bowl-shaped geometry and low permeability of the quarry walls and floors tend to focus flow toward the entrance of the pits.

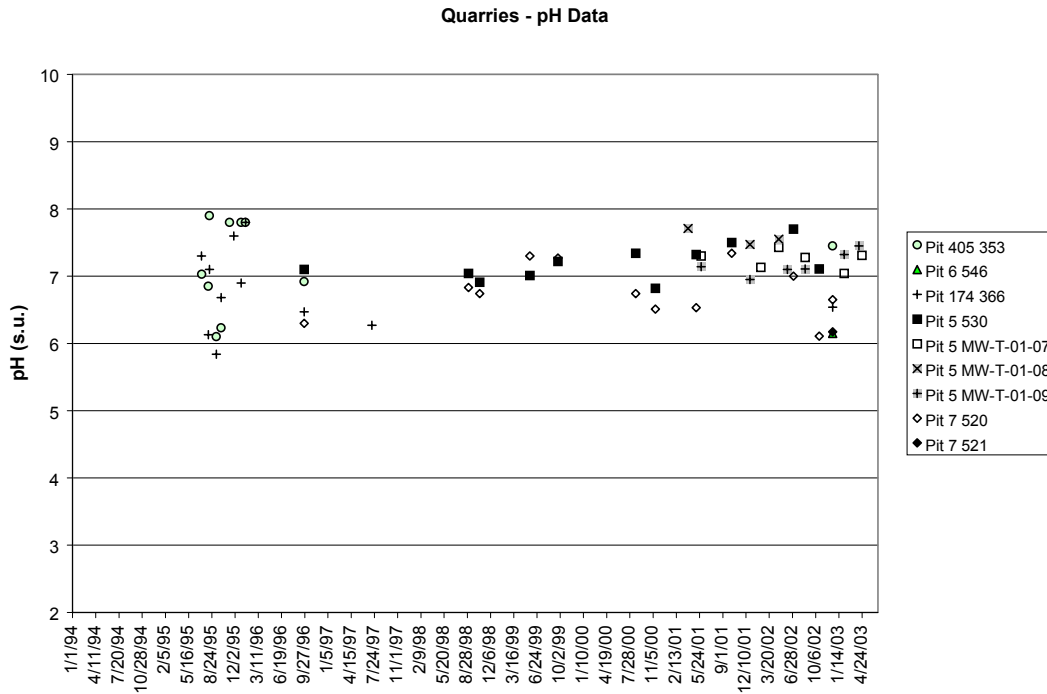
Figure 3.4 Quarry Site pH Data

Figure 3.4 shows pH data from the quarry site sampling locations. Of 61 samples taken since 1995, 60 have pH values between 6.0 and 8.0. A pH of 5.8 was recorded from Pit 174 in 1995, but more recent samples average approximately 6.5. The difference between field drainage pH values in Figure 3.4 and the laboratory rinses pH values in Figure 3.2 is significant. The data show that the limited exposures of stored oxidation products (represented by rinse pH data) do not have a significant effect on the drainage from the sites (field drainage data). Alkalinity data presented in Figure 3.5 are consistent with the pH results, with all sites maintaining measurable alkalinity provided by dissolution of carbonate minerals. The lower alkalinity value from Pit 6 represents influences from organic acids derived from forest soils (note associated low conductivities of Pit 6 samples). Sample sites with the highest alkalinity are groundwater monitoring wells in Pit 5. Pit 5 has the highest carbonate content of the quarries and also may show influences from the water treatment plant located at that site and the continued quarrying activity.

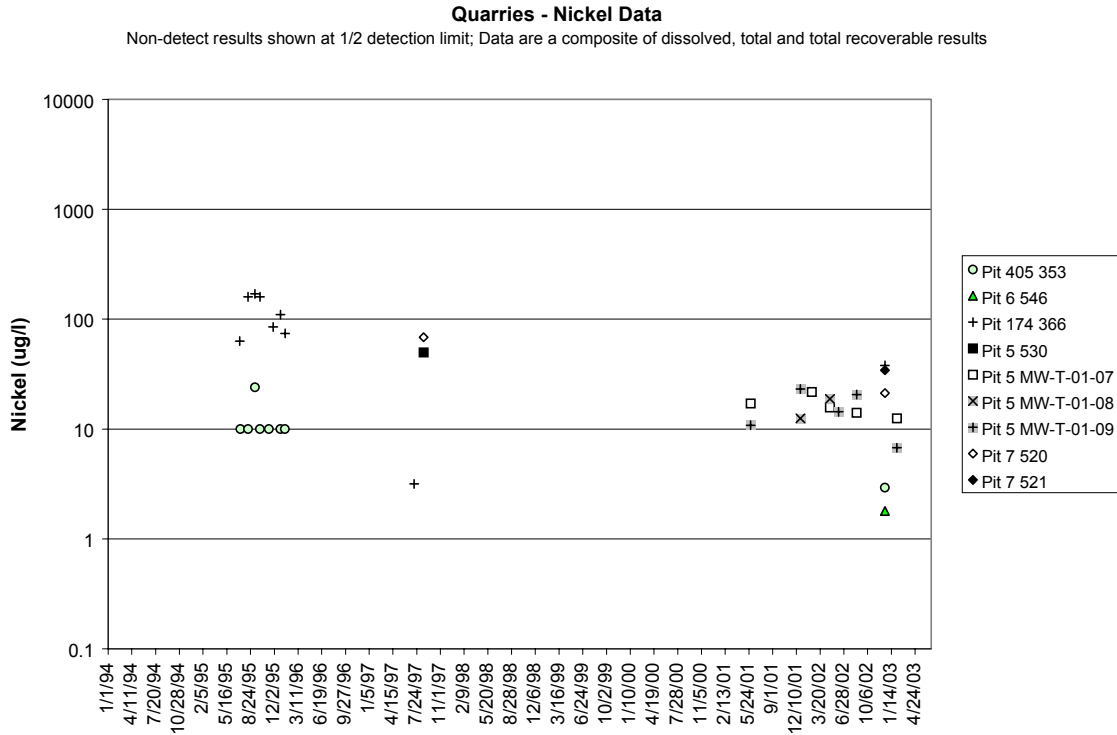
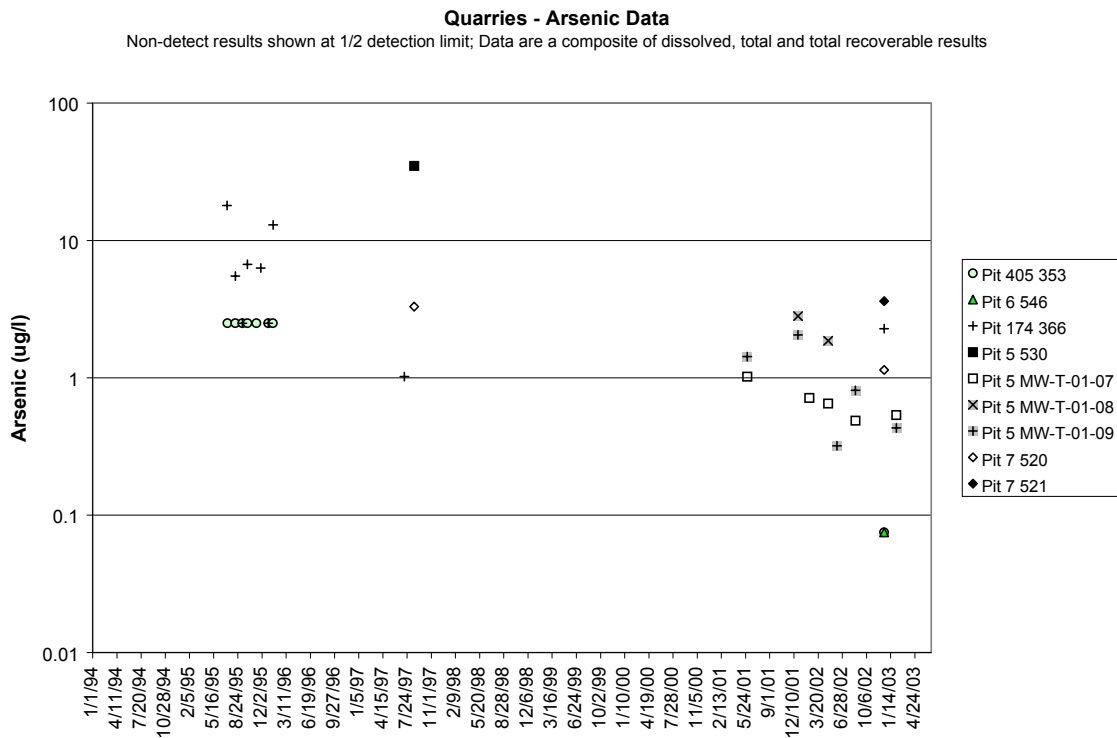
The data for zinc, copper, lead, cadmium, nickel and arsenic are presented in Figures 3.10 to 3.15. Sample results that were less than the detection limit are plotted at one half the limit value. While this allows the results to be plotted on a logarithmic scale, it causes non detect results with high detection levels to appear more concentrated than they actually are. Detection limits have varied with time and are often evident on the graphs as horizontal groupings of symbols. The results for metals generally correlate with conductivity values. Zinc concentrations reflect the higher solubility of this element relative to the others. Metal loads from quarry sites have been consistently relatively low and either remained relatively constant or decreased with time. The decrease in metal loading is attributed to a reduction or reactive surface as reactants are consumed and coatings form on mineral surfaces.

Closure options for pyritic pit walls are relatively limited. Since there are no proven long term surface treatments available, it is best to let naturally occurring coatings that have formed over the past 15 years to continue to form. As the coatings form and the amount of available pyrite decreases, so too will the dissolve load.
