# STORM WATER MONITORING PROGRAM 2018 ANNUAL REPORT

Hecla Greens Creek Mining Company

March 2019

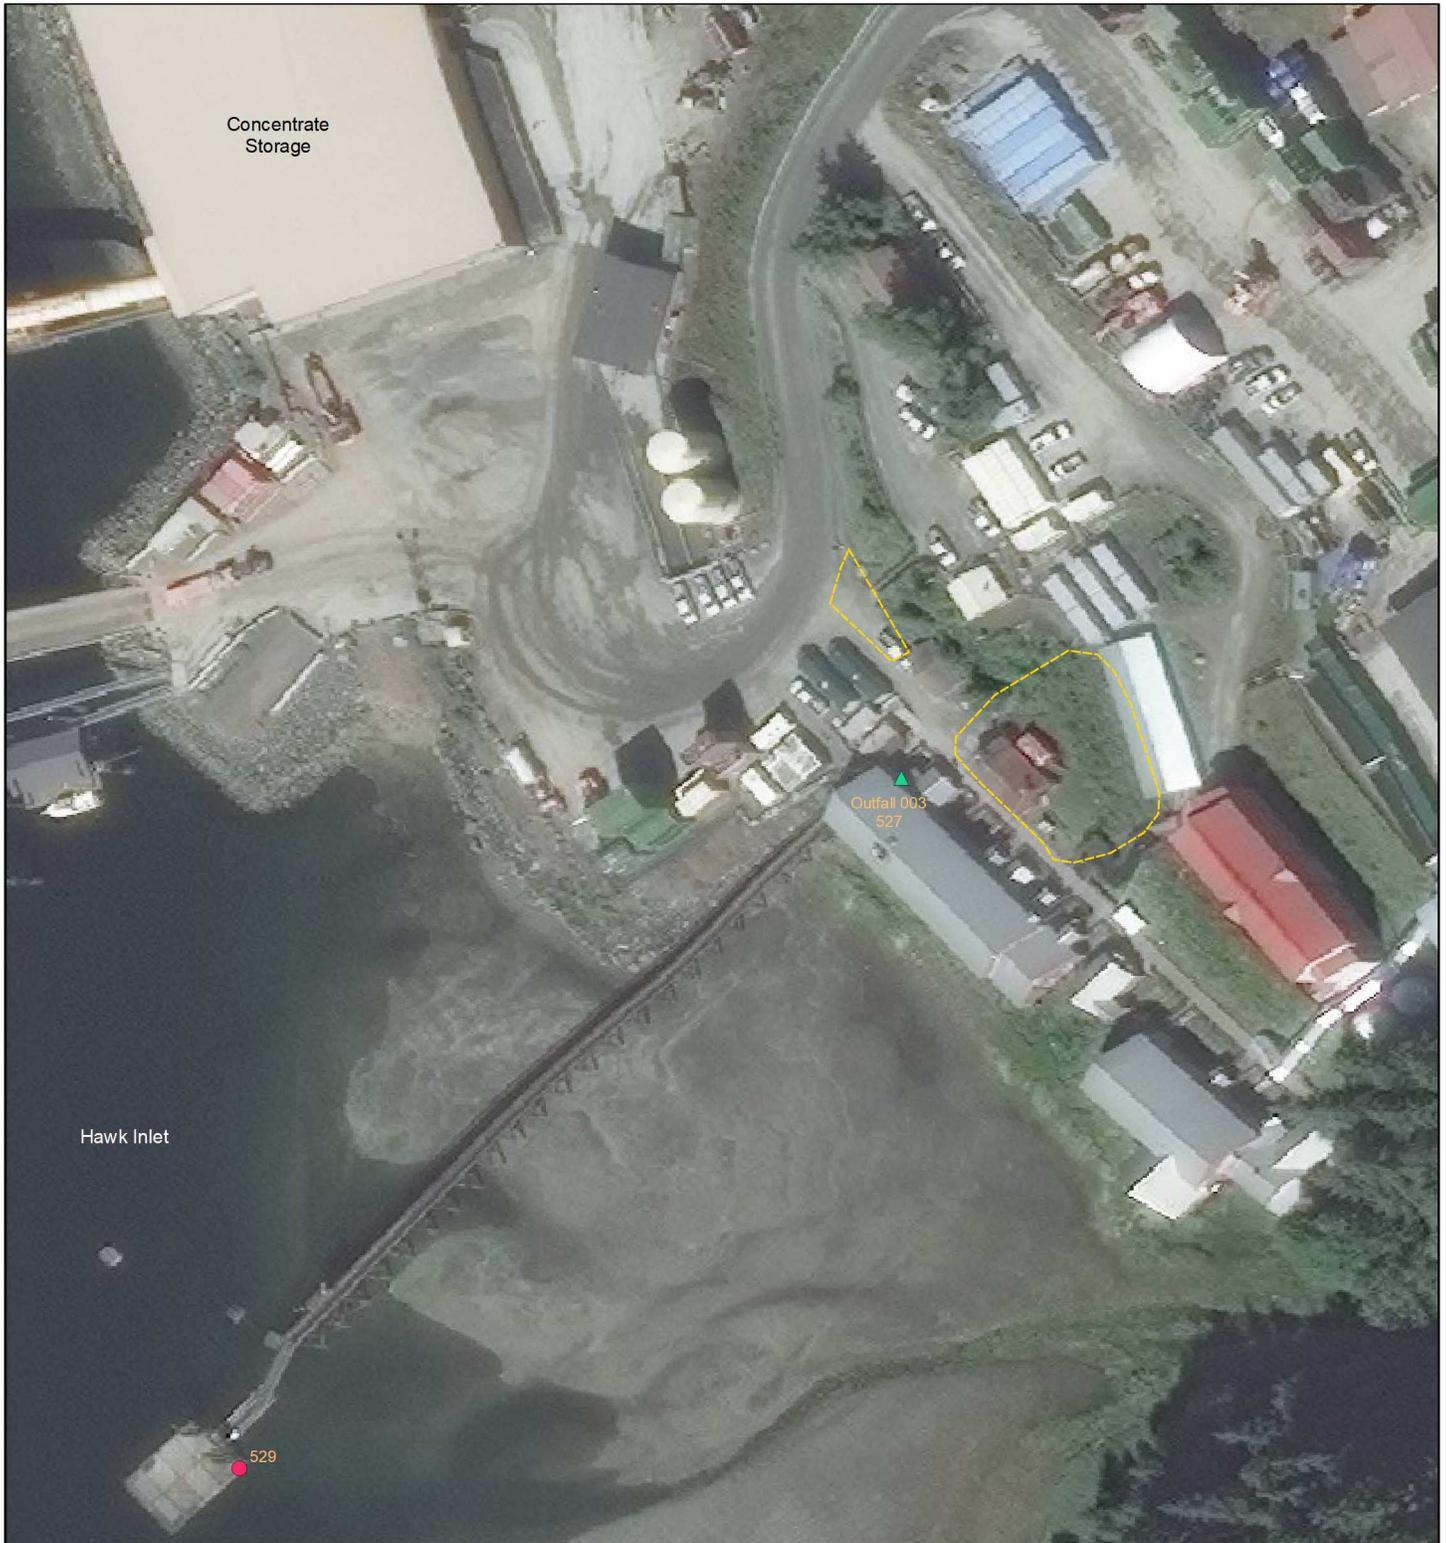
**FIGURE  
2**

Outfall 003, a culvert pipe located adjacent to the North Cannery Building, drains the storm water runoff from a small area approximately 0.2 acres in size (Figure 2). Outfall 003 discharges directly into Hawk Inlet, and therefore there is only one associated receiving water monitoring site (Site 529). The lead concentration in the June sample from the outfall exceeded the chronic AWQS (Table 7) but the lead concentration in the receiving Hawk Inlet water was well below the marine chronic aquatic life criteria due to low discharge rate through the outfall and the immense dilution volume of Hawk Inlet.

**APDES Outfall 003 Monitoring Locations  
Hawk Inlet**

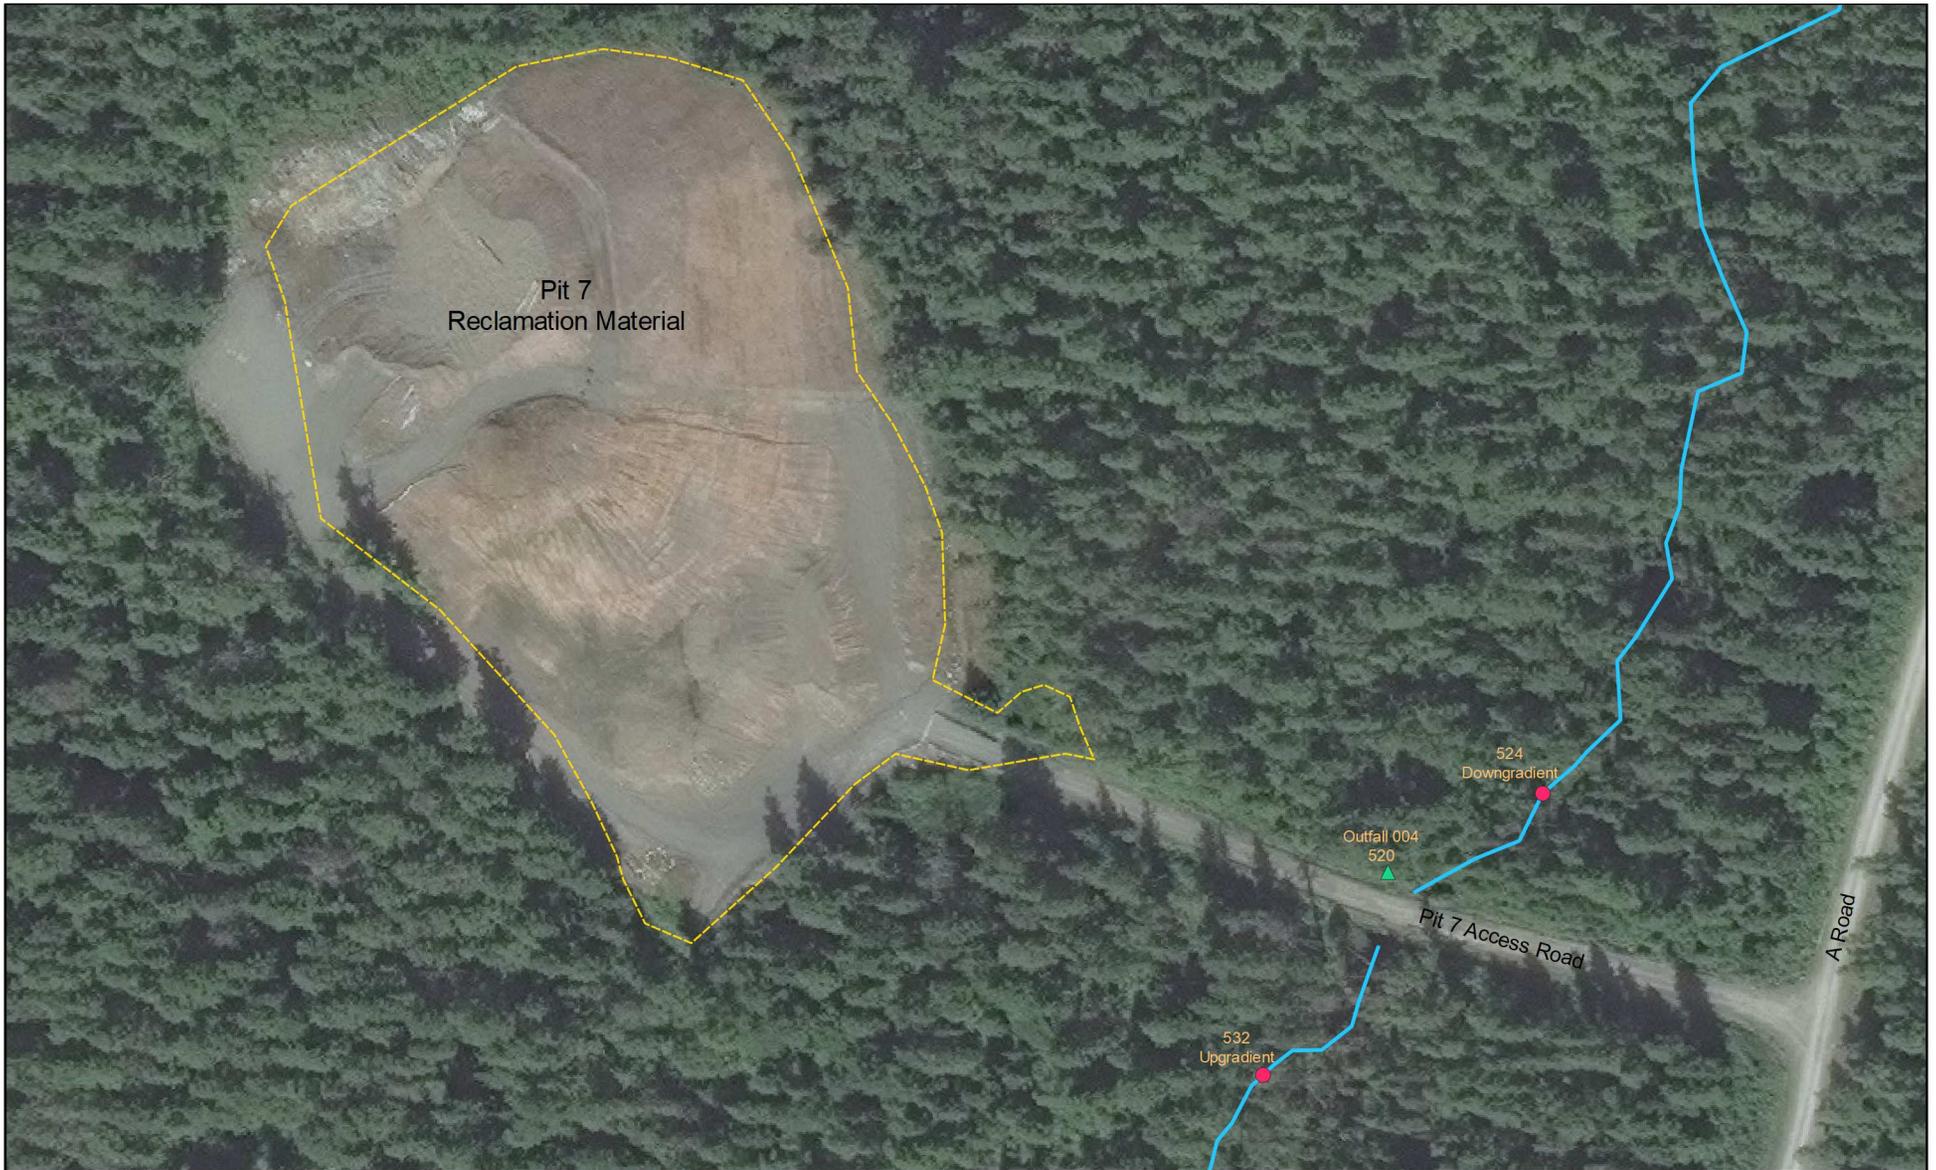
**FIGURE  
3**

Outfall 004 is located downgradient of a constructed wetlands that receives runoff from Pit 7 (Figure 3), which is a former rock quarry and current reclamation material storage pile. Flow has not been observed at this outfall during storm events since 2012, and there was no flow observed during the storm event monitoring conducted during this reporting period. There was no activity at Pit 7 during the reporting period, and no signs of erosion from the reclamation material stockpile.

**APDES Outfall 004 Monitoring Locations  
Pit 7**

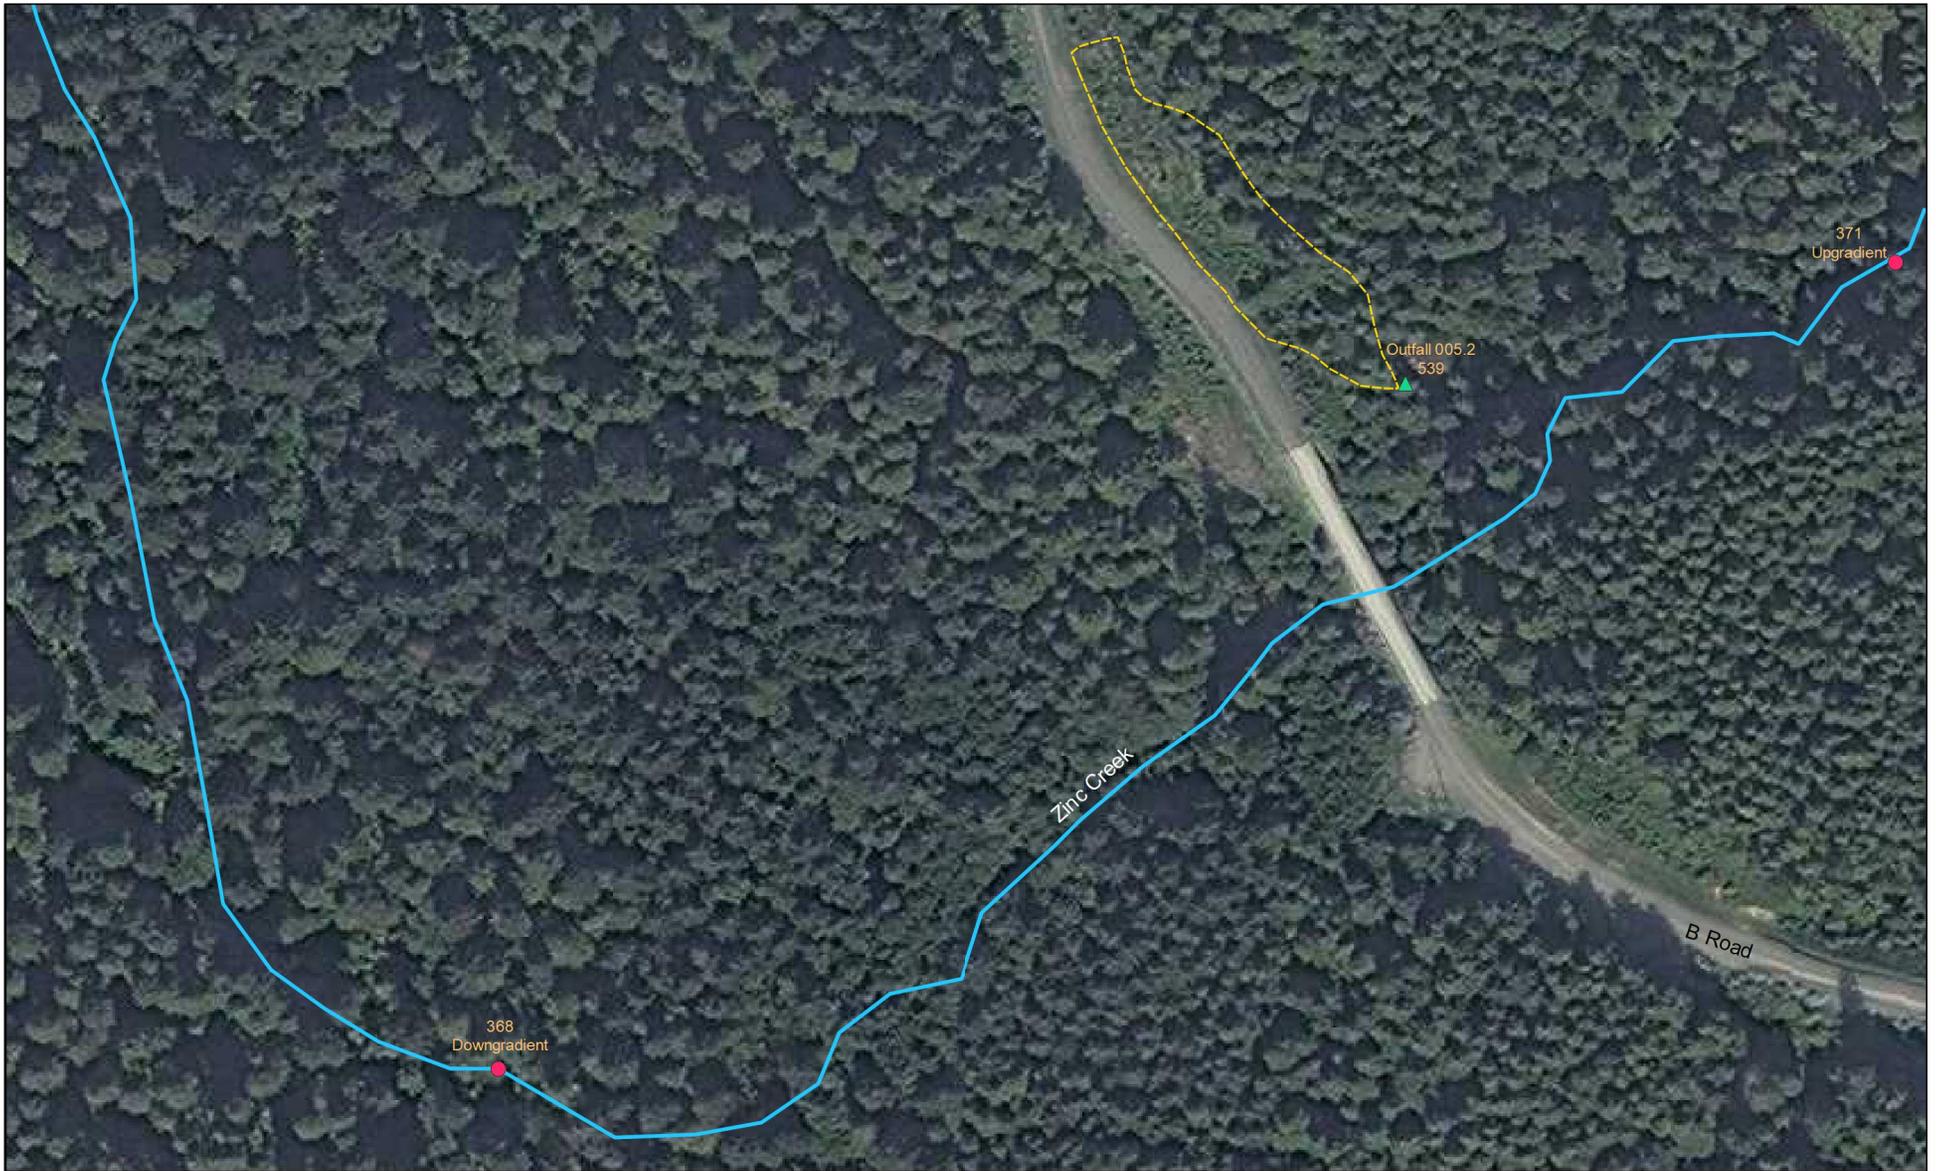
**FIGURE  
4**

Outfall 005.2 is located near the bottom of the north abutment, upstream side, of the Zinc Creek Bridge located at 3.0-mile on the B-Road (Figure 4). The drainage area for this outfall, approximately 0.6 acres in size, captures runoff from a short section of road and a portion of the abutment. Receiving water monitoring is performed at Site 371 (upstream) and Site 368 (downstream) in Zinc Creek.

Storm event monitoring data for 2018 show that the storm water effluent is weakly acidic and contains concentrations of lead and zinc that exceed AWQS (Table 7). In samples collected from the receiving water, pH is near neutral and metal concentrations are below standards. This demonstrates that the low volume of storm water runoff through this outfall is not having an adverse impact on the water quality of Zinc Creek.

**APDES Outfall 005.2 Monitoring Locations  
Zinc Creek Bridge**

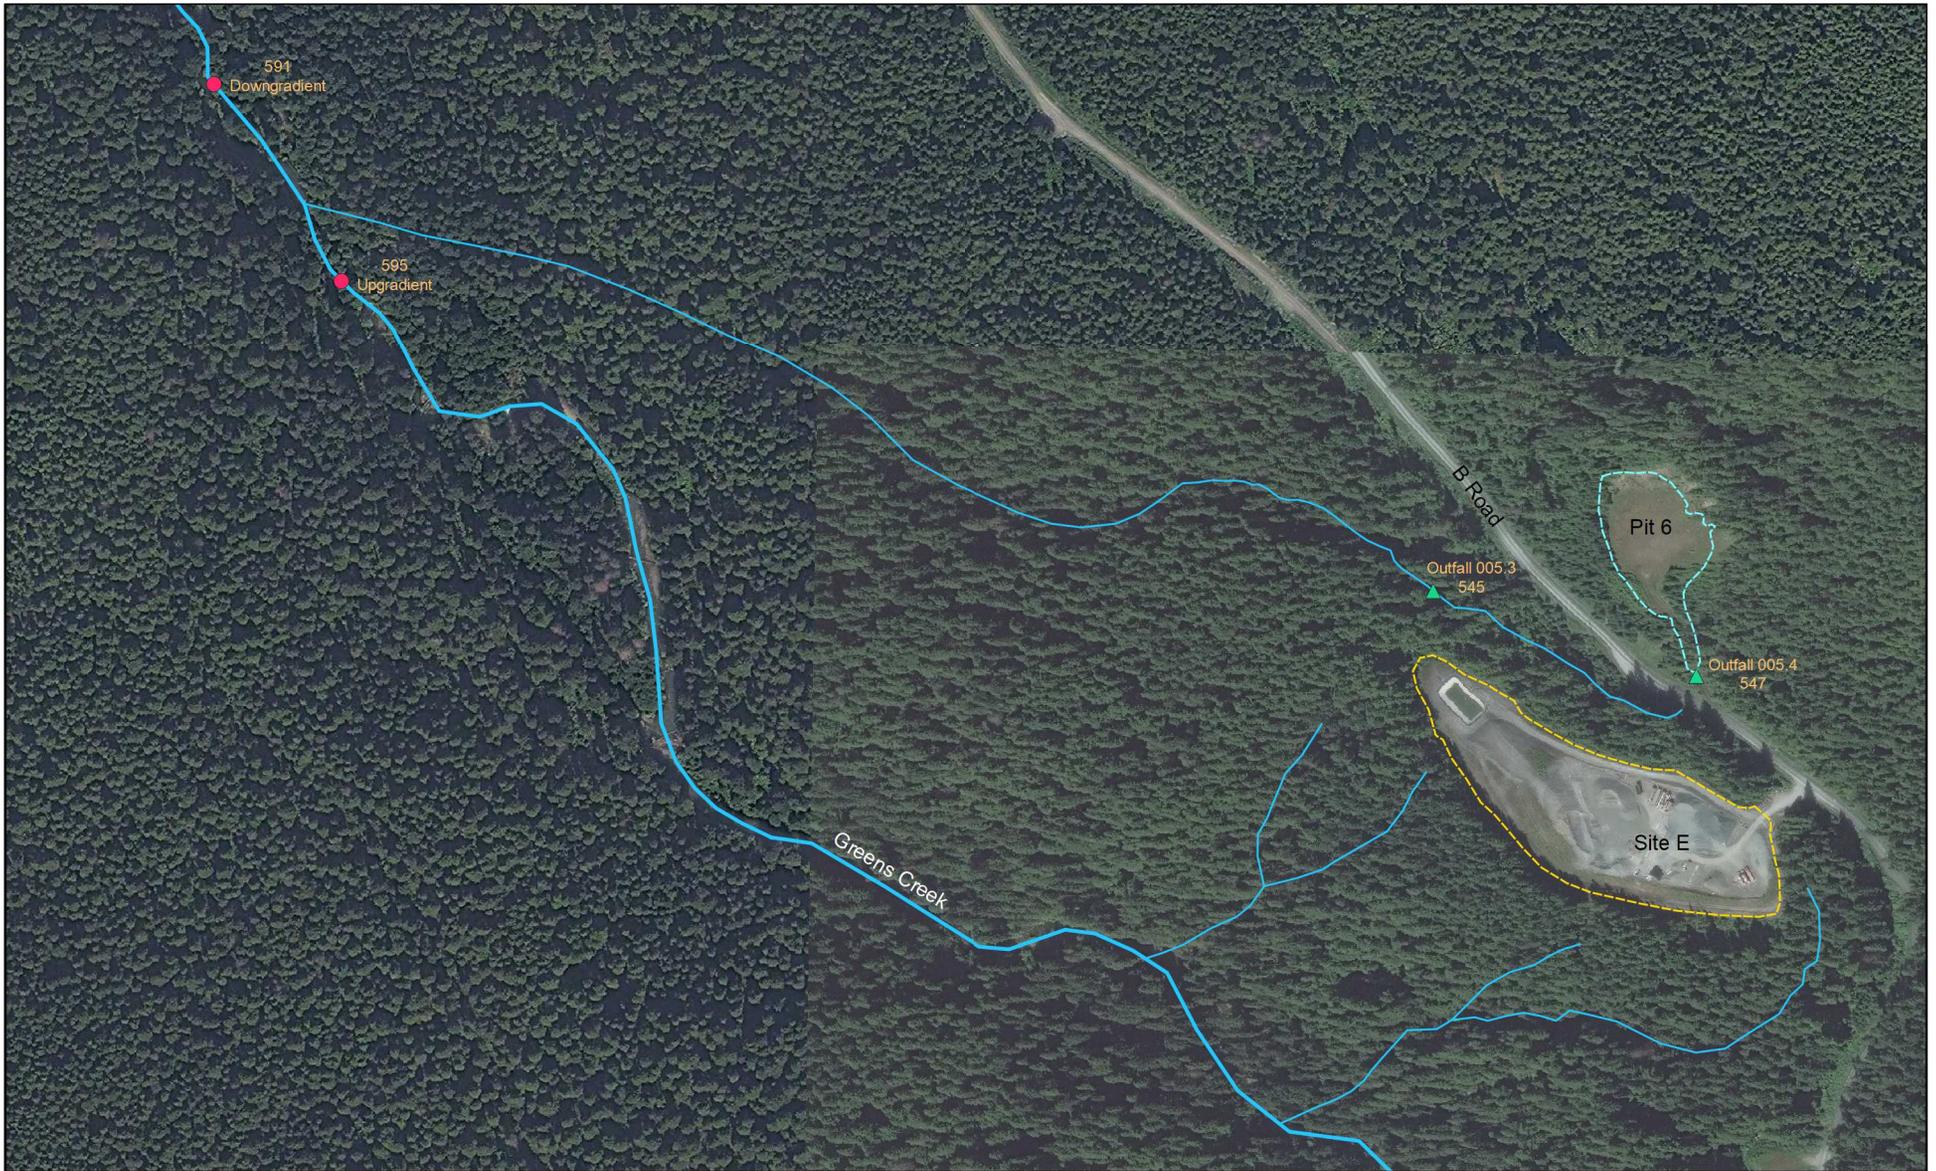
**FIGURE 5**

Outfall 005.3 is located in a small drainage that runs between the B-Road and inactive waste rock Site E (Figure 5). The drainage area contributing to the outfall location is approximately 6.8 acres. The drainage flows into Greens Creek approximately one-half mile from the outfall location. Receiving water monitoring is performed in Greens Creek at Site 595 (upstream) and Site 591 (downstream).

Water quality at the outfall is influenced by the Site E waste rock and has exhibited highly variable lead and zinc concentrations throughout its monitoring history (Attachment A). Samples collected during the reporting period show that monitored constituent concentrations are within the normal range of historical fluctuation, but both lead and zinc exceed AWQS (Table 7). The lead concentration in the upstream receiving water also exceeded the chronic lead standard, but concentrations of lead and zinc were below standards in the downstream receiving water sample.

Outfall 005.4 is the discharge location for runoff from a reclamation material storage area in an old road construction quarry called Pit 6 (Figure 5). The catchment area draining to the outfall is approximately 0.9 acres in size. There has been no activity in Pit 6 since 2009 and the area is stabilized and vegetated. Storm water runoff flows into Greens Creek approximately one-half mile from the outfall location. Receiving water monitoring is performed in Greens Creek at Site 595 (upstream) and Site 591 (downstream).

Water quality at Outfall 005.4 is excellent, with lead and zinc concentrations consistently below the Alaska Water Quality Standards since 2009.

**APDES Outfall 005.3 and 005.4 Monitoring Locations Site E and Pit 6**

In 2008, HGCMC initiated a program of removing Site E waste rock for co-disposal in the tailings facility. Through 2018, over 121,000 cubic yards of material were removed. The water quality at Outfall 005.3 is expected to show gradual improvement as the waste rock removal activities progress.

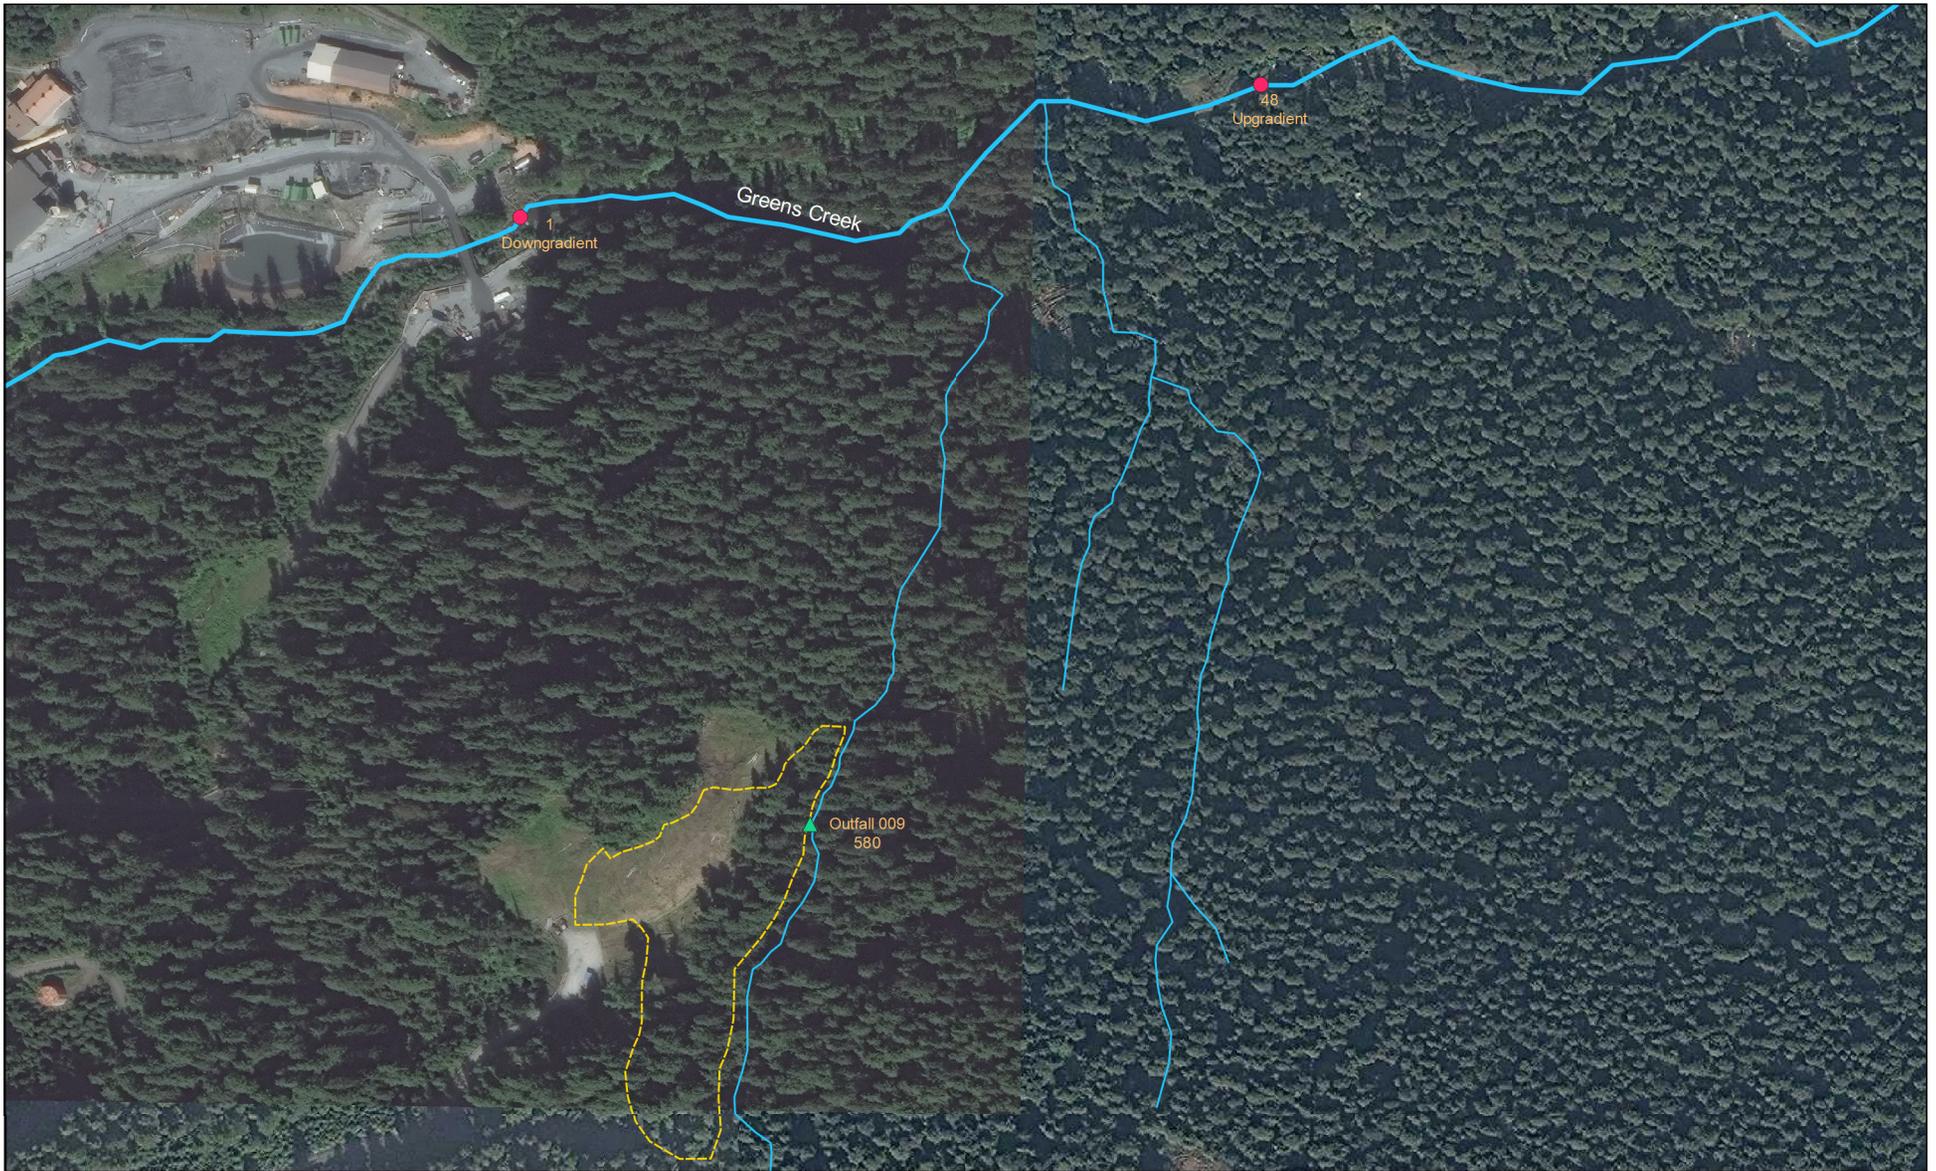
**FIGURE  
9**

Outfall 009 monitors the runoff quality from an inactive waste rock pile that was placed during the development of the 1350 adit (Figure 9). Between 2005 and 2015, over 80 percent of the waste rock was removed for disposal in the underground mine. The catchment area contributing runoff to the outfall is approximately 3.3 acres in size. Receiving water monitoring is performed in Greens Creek at Site 48 (upstream) and Site 1 (downstream). Site 48, also sampled monthly as part of the FWMP, is located upstream of all mining activity and represents natural background quality for Greens Creek.

Zinc concentrations in the outfall samples collected during the reporting period exceeded AWQS (Table 7). Concentrations in the receiving water, however, were well below standards indicating no substantial impact from the outfall.

**APDES Outfall 009 Monitoring Locations  
1350 Site**
