2008 Annual Report

Hecla
MINING COMPANY

Site 23/D

June 2, 2009

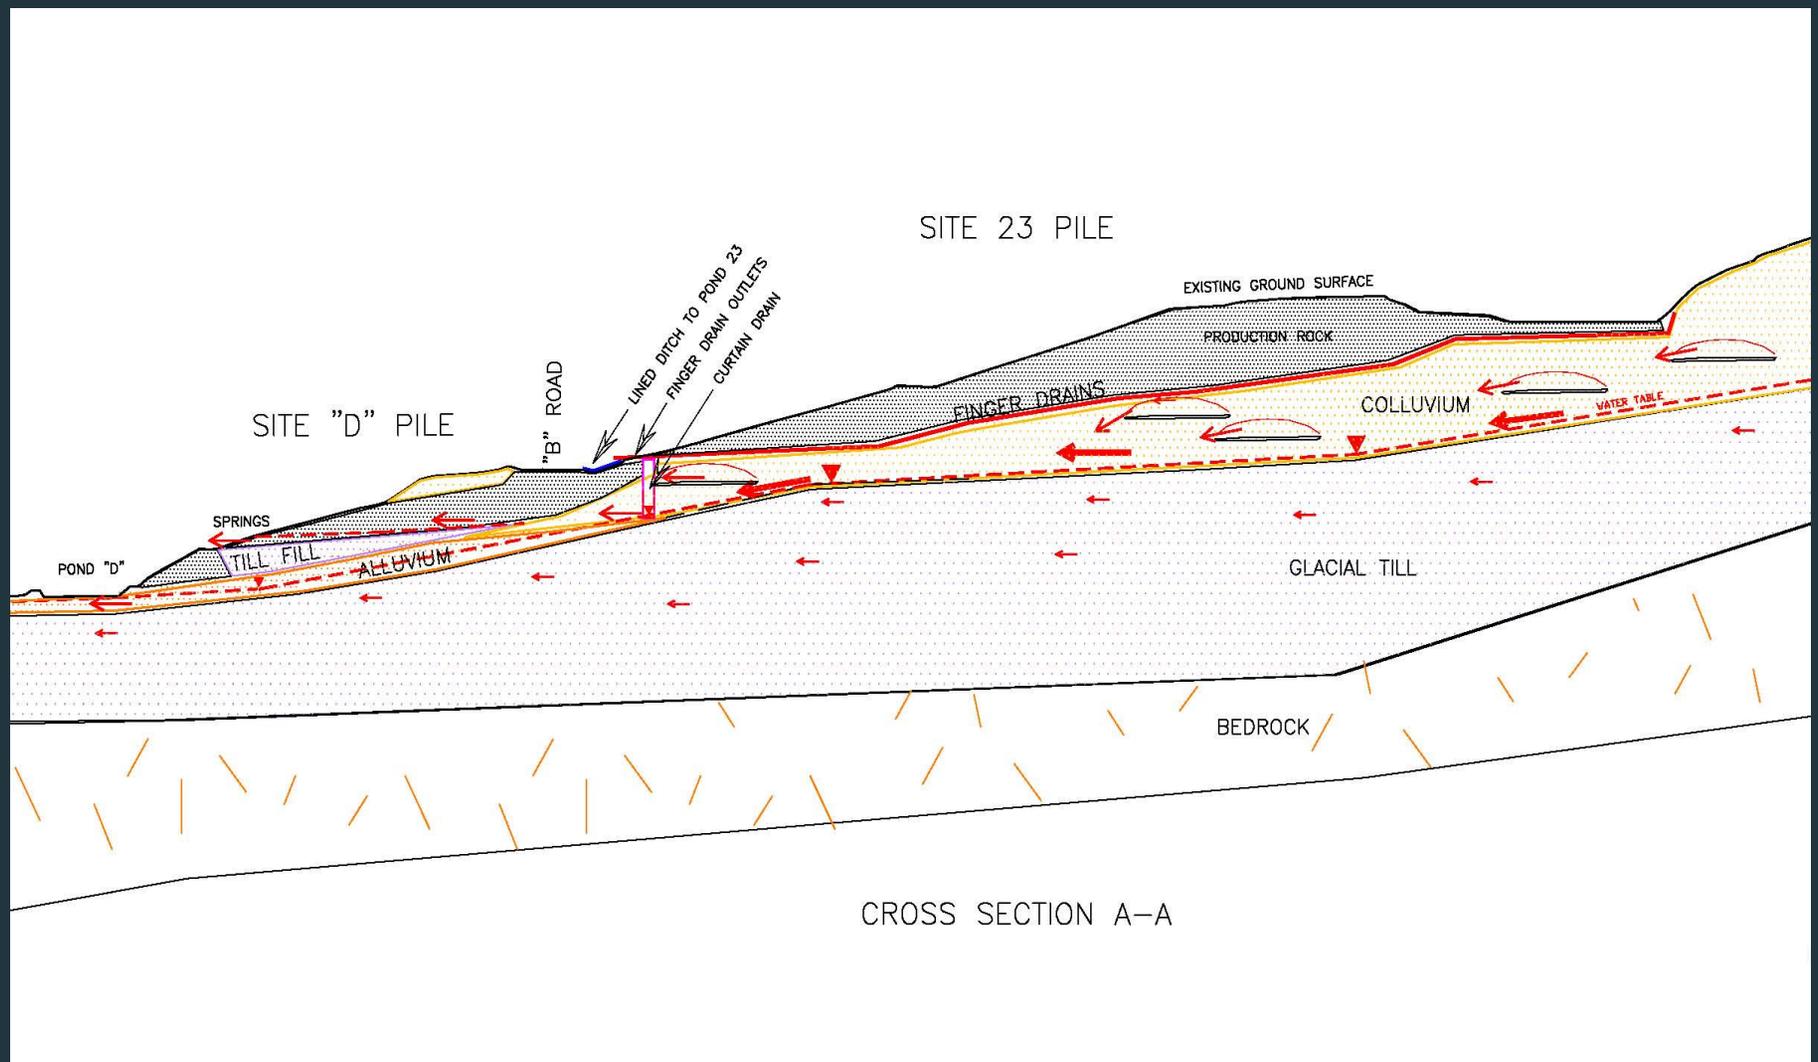
Appendix 2 Site 23/D Conceptual Cross Section

CROSS SECTION A-A

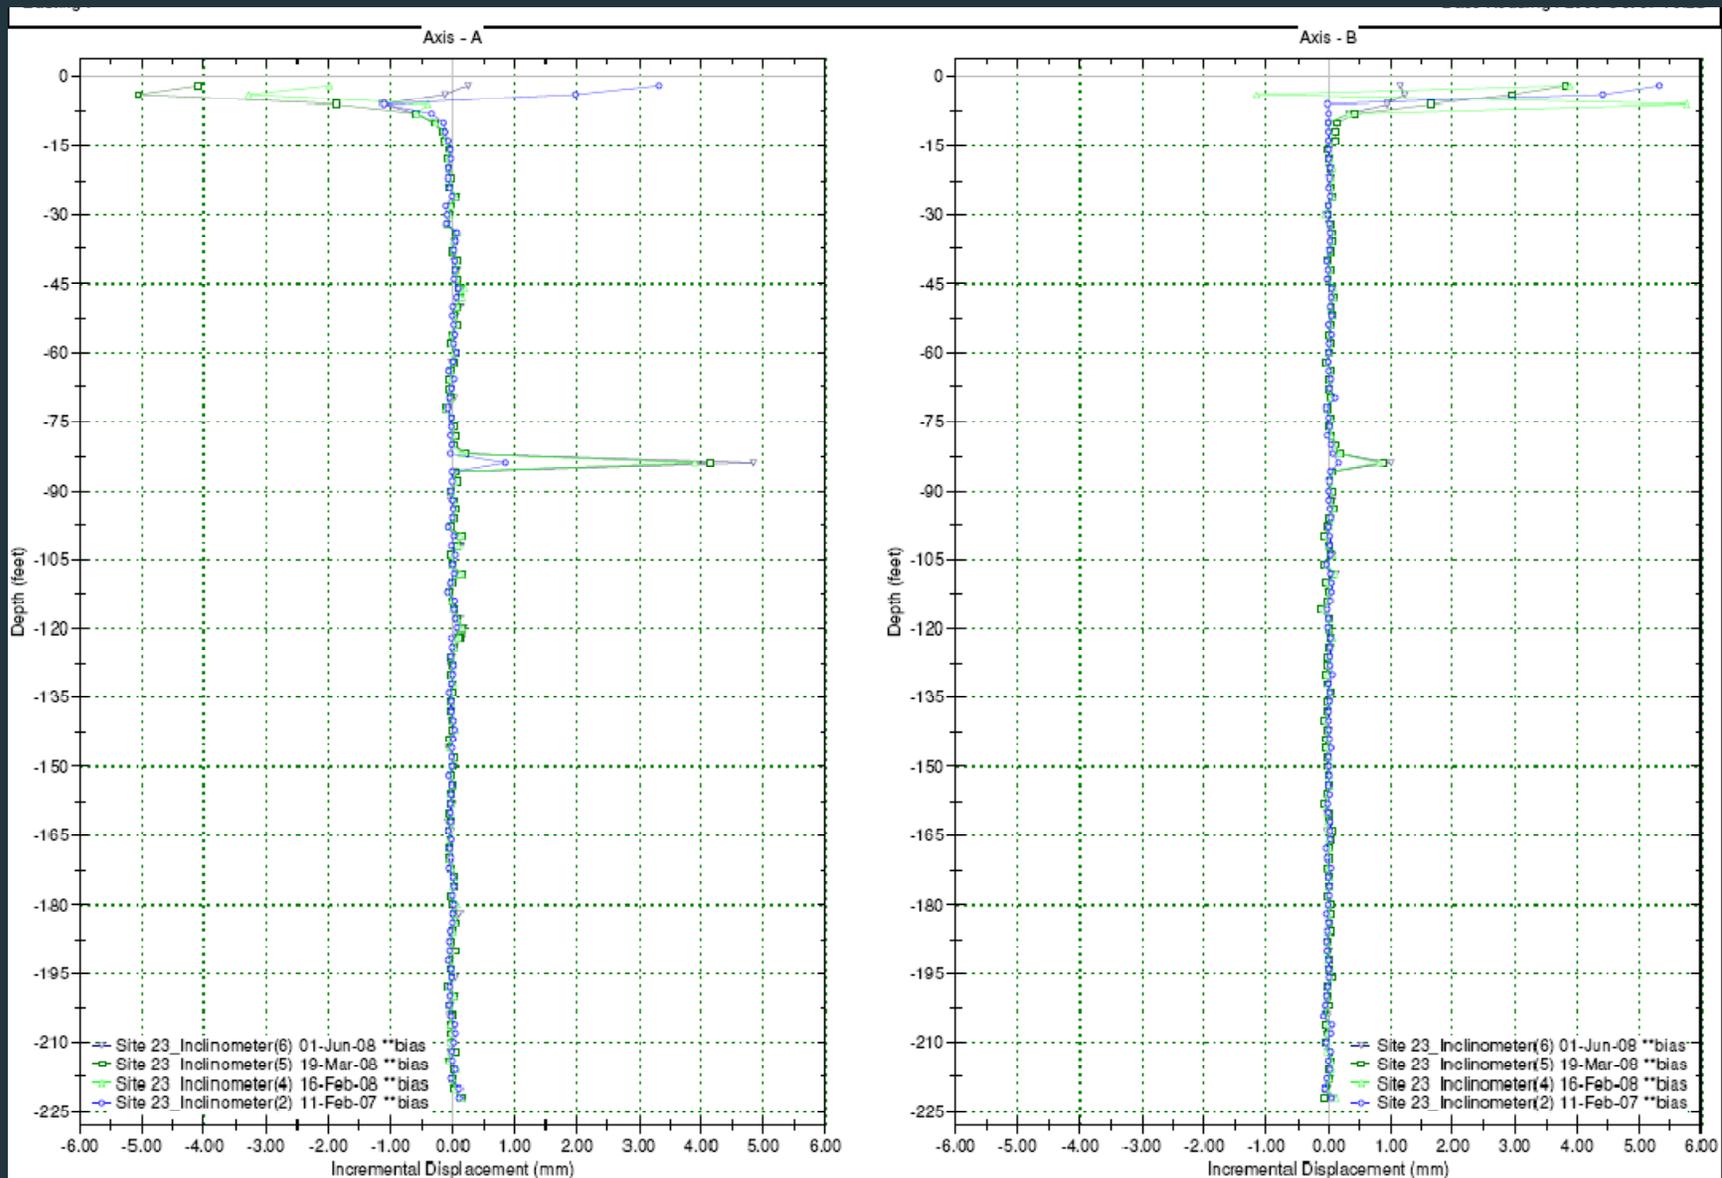
Figure 3.30 Inclinometer Incremental Displacement

- Compaction
 - Method specification includes spreading in less than 24" lifts with at least one pass with bulldozer and four passes with vibratory compactor
- Inspections
 - Results of operator, engineering, environmental and regulatory inspections revealed no visible signs of instability
 - No issues of non-compliance were noted in 32 USFS and 1 ADEC/ADNR inspections
- Slope monitoring
 - 12 survey hubs monitored with GPS
 - No large movements were identified
 - Inclinator readings
 - Minor creep at 85' (~3mm/yr)

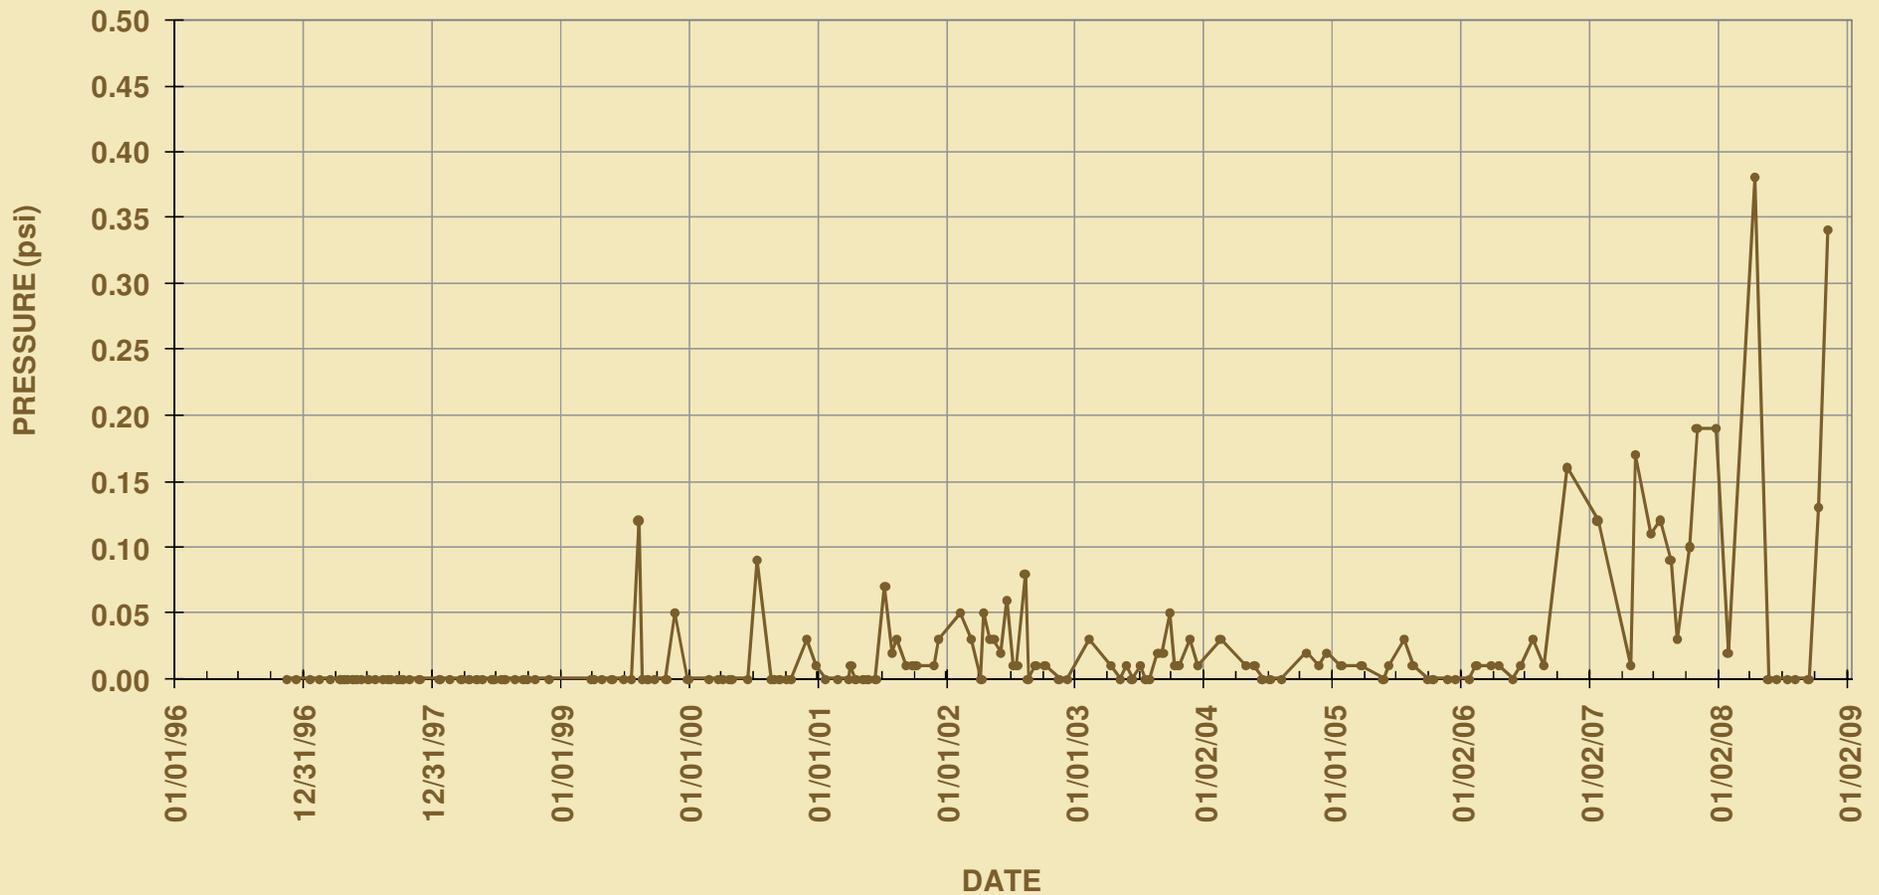
Figure 3.1 Pressure Data for Piezometer 52

- Water table is below base of pile
- Well-drained pile and foundation indicate pile stability is maximized
- Perched water tables in colluvial wedge and alluvial sands
- Braided flow paths
- Distinct seasonal pattern, especially in alluvial sands
- Silt/clay till below colluvial wedge inhibits downward water movement

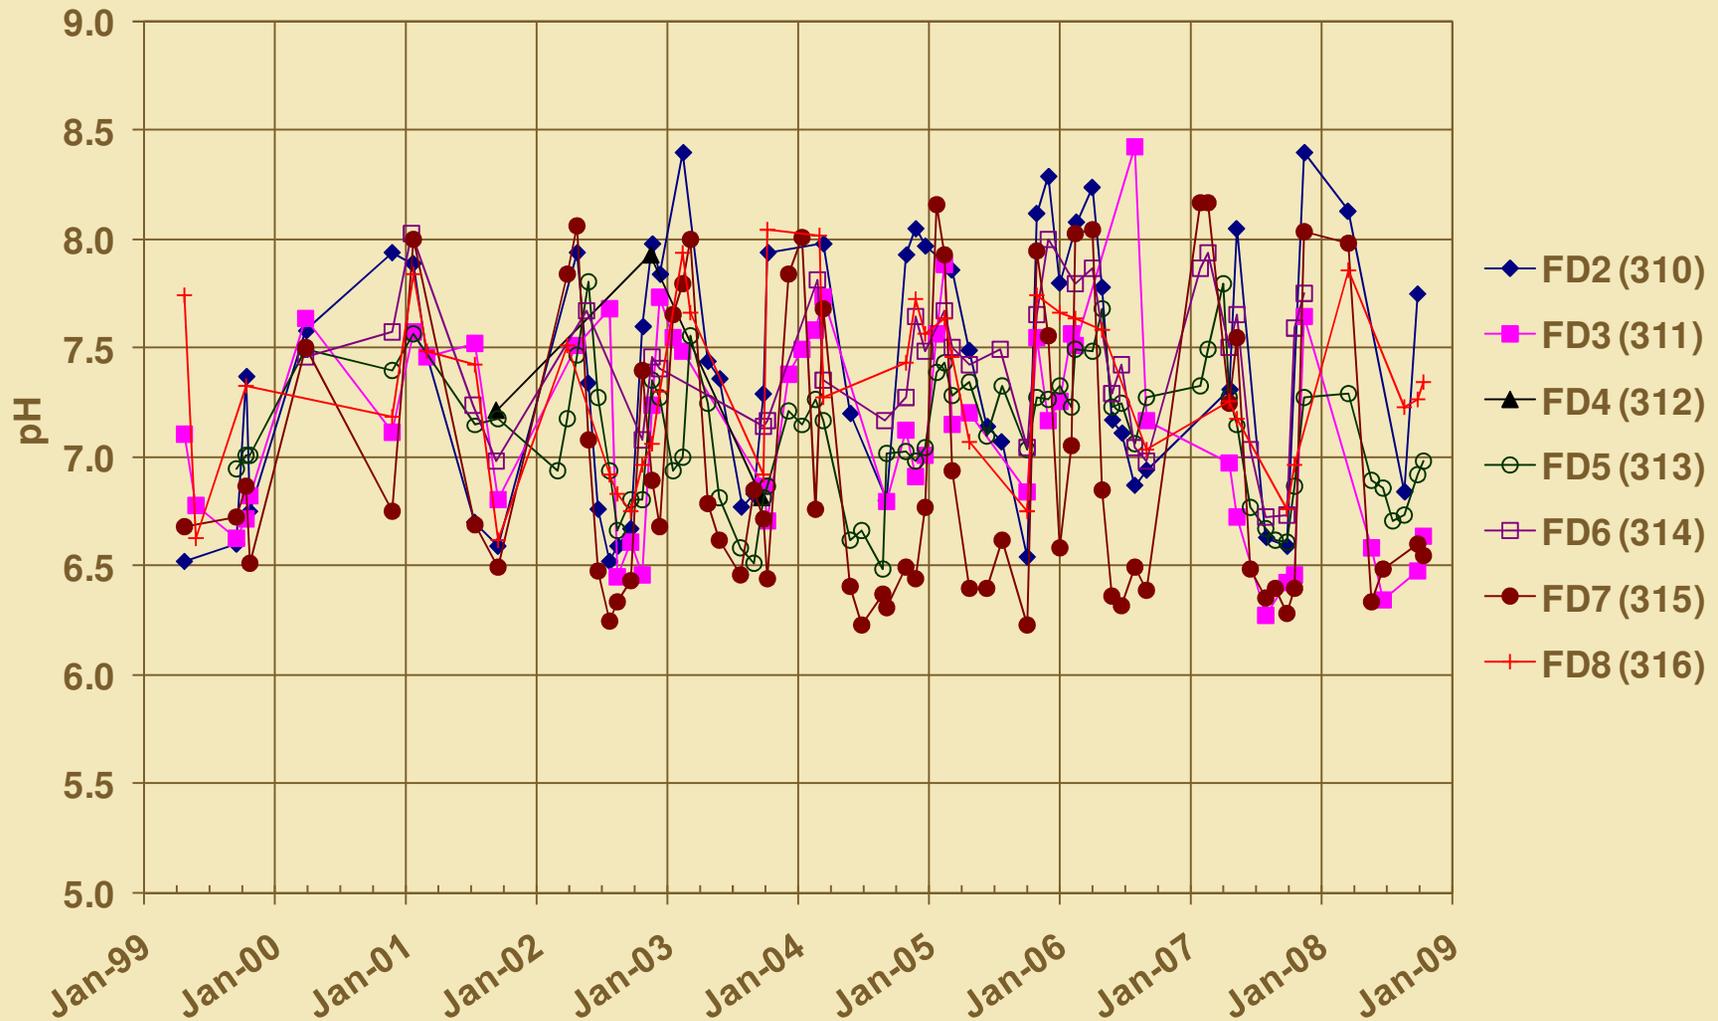
Figure 3.14a Site 23 Finger Drains pH

- Internal site waters are captured, treated and discharged per HGCMC's NPDES permit
- pH values are between 6.0 and 8.5 (high buffering capacity)
- Conductivities are between 200 and 5000 umho/cm
- Variations in conductivity reflect differences in contributions of groundwater and infiltration, seasonal fluctuations
- Zinc concentrations are variable (typically less than 5 mg/l)
- Precipitation, mixing and sorption mechanisms determine metals concentrations

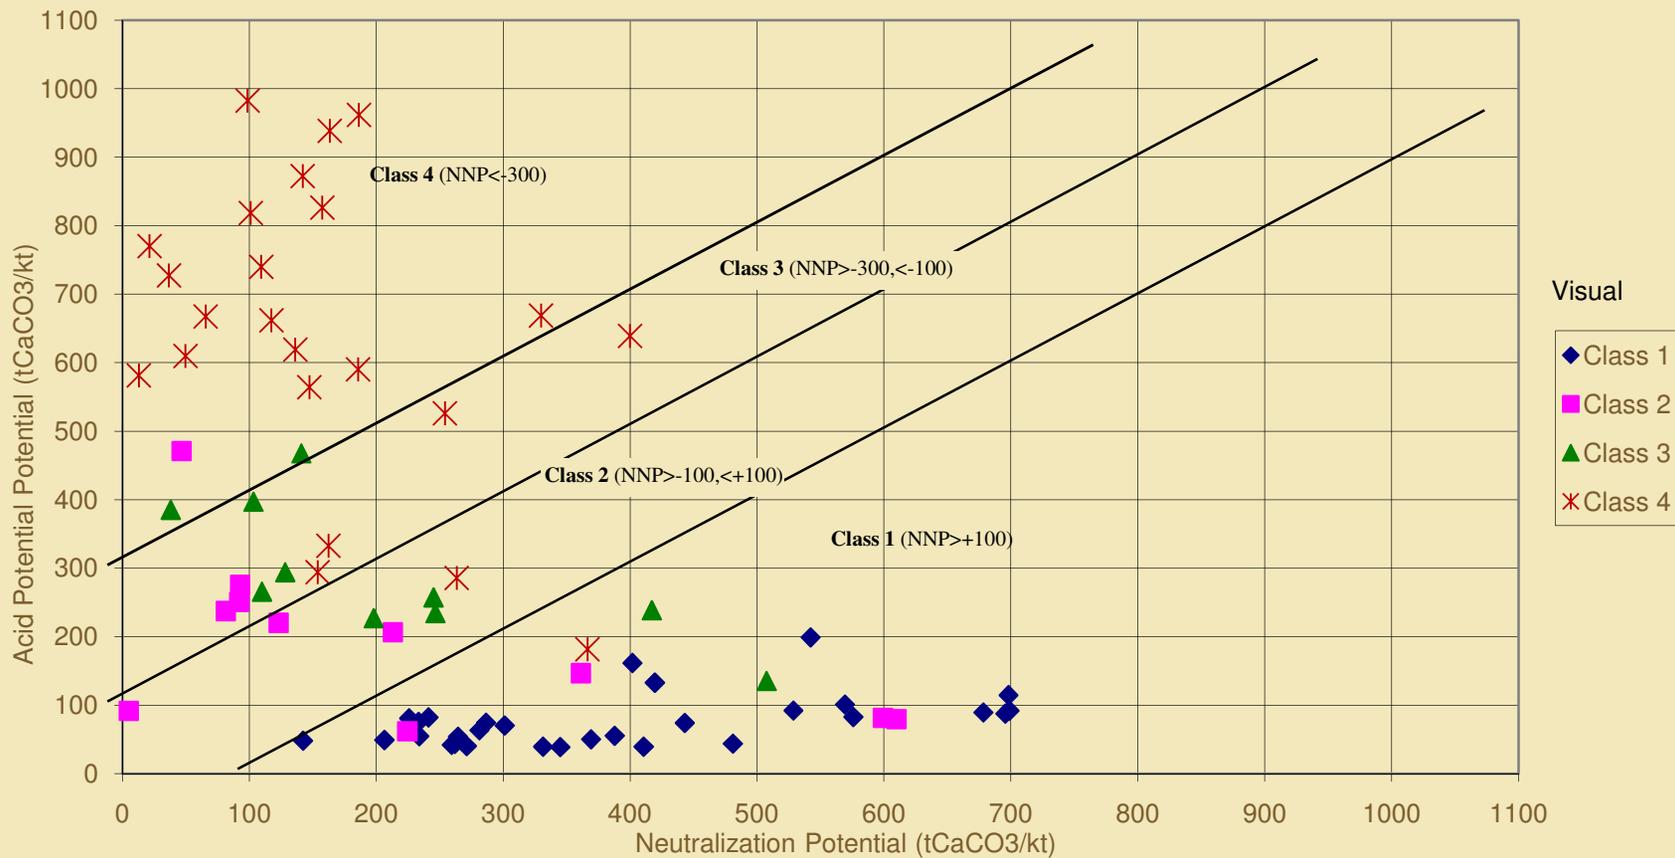
Figure 3.28 ABA Data Underground Rib Sampling

FIGURE 3.28 2008 ABA DATA FROM UNDERGROUND RIB SAMPLES

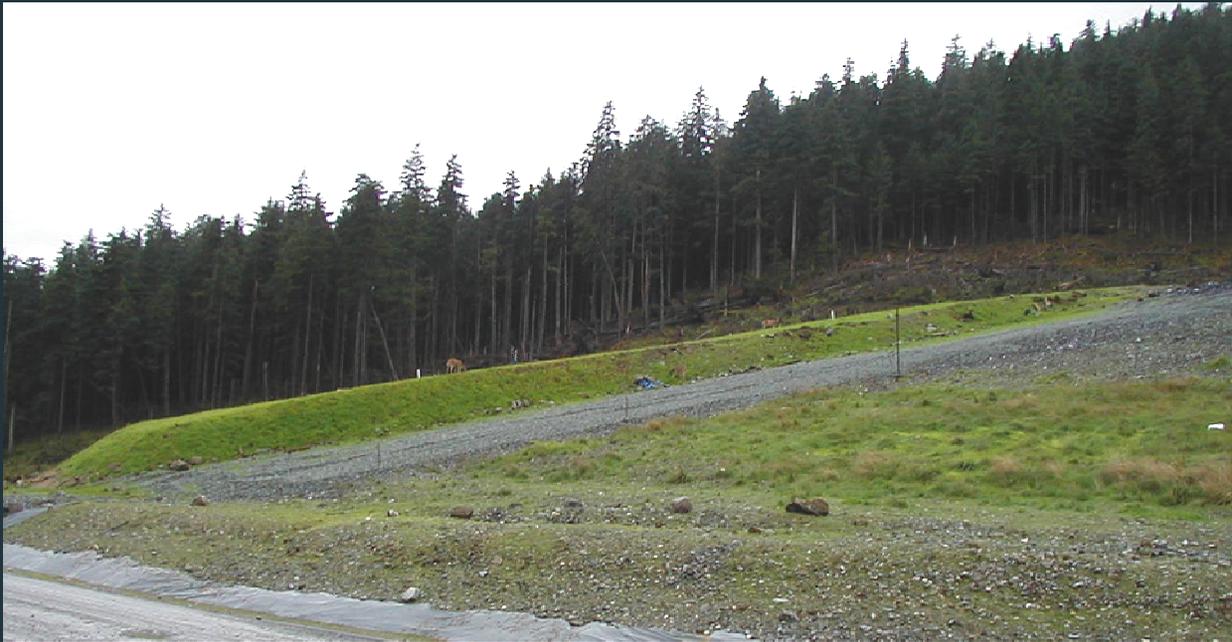
Cover Design

Growth Medium

Capillary Break

Barrier Layer

2 meters

- About 85% of the water collected in the chalet trench system reported via the upper capillary break
- The growth medium contributed 15% of trench flow and the barrier layer flow was 0.2%
- The lag time between peak precipitation and peak trench flow is about 6 hours for dry conditions and 2 hours for wet conditions
- Modeling with Hydrus-2D/3D software compares favorably with field results
- Greater than 85% water saturation in barrier layer minimizes oxygen ingress
- Water percolation through barrier layer 15-20% of annual precipitation
- Barrier layer does not freeze during the winter
- Numerical modeling of alternative cover designs indicates that the upper capillary break is necessary to maximize lateral flow and prevent buildup of head pressures in the growth medium and barrier layer
